OB 13/3/8

Cow Tag 595	Function Code S4-7

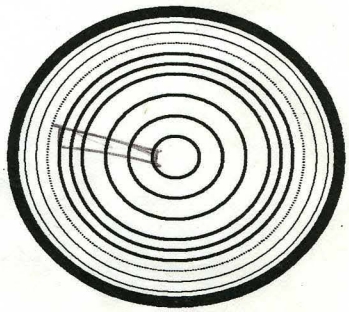
Brief Description: [timber element, p/s, condition, fragments]
GOOD ~~CONDITION~~ CONDITION

2 PLUGGED HOLES AFT OF FORW. END, LOWER + UPPER EDGE

1 — ¼" — HOLE AFT OF OUTBD. SCARF, UPPER EDGE

4 PLUGGED HOLES CA. MIDDLE OF PLANK, 2 AT LOWER, 2 AT UPPER EDGE

1 PLUGGED HOLE ~~A~~ FORW. OF AFT END, LOWER EDGE

———— " ————, MIDDLE OF PLANK

2 ADD. NAILS FORW. OF AFT END, RIGHT BY THE EDGE

SOME DIMPELS ON TREENAILS Type 3 scribed < inboard forward edge.

Wood Science: [rings, ARW, knots, sapwood, conversion]
Offradial 85 H. + SS. Pith beyond lower edge ARW: 200/90.

Recommended action: [samples, additional photos, moulding, queries and problems]
DEVIATION: x-axis: 0.176 mm
y-axis: 0.691 mm
} LAST 50 cm OF AFT END OF OUTBD. FACE

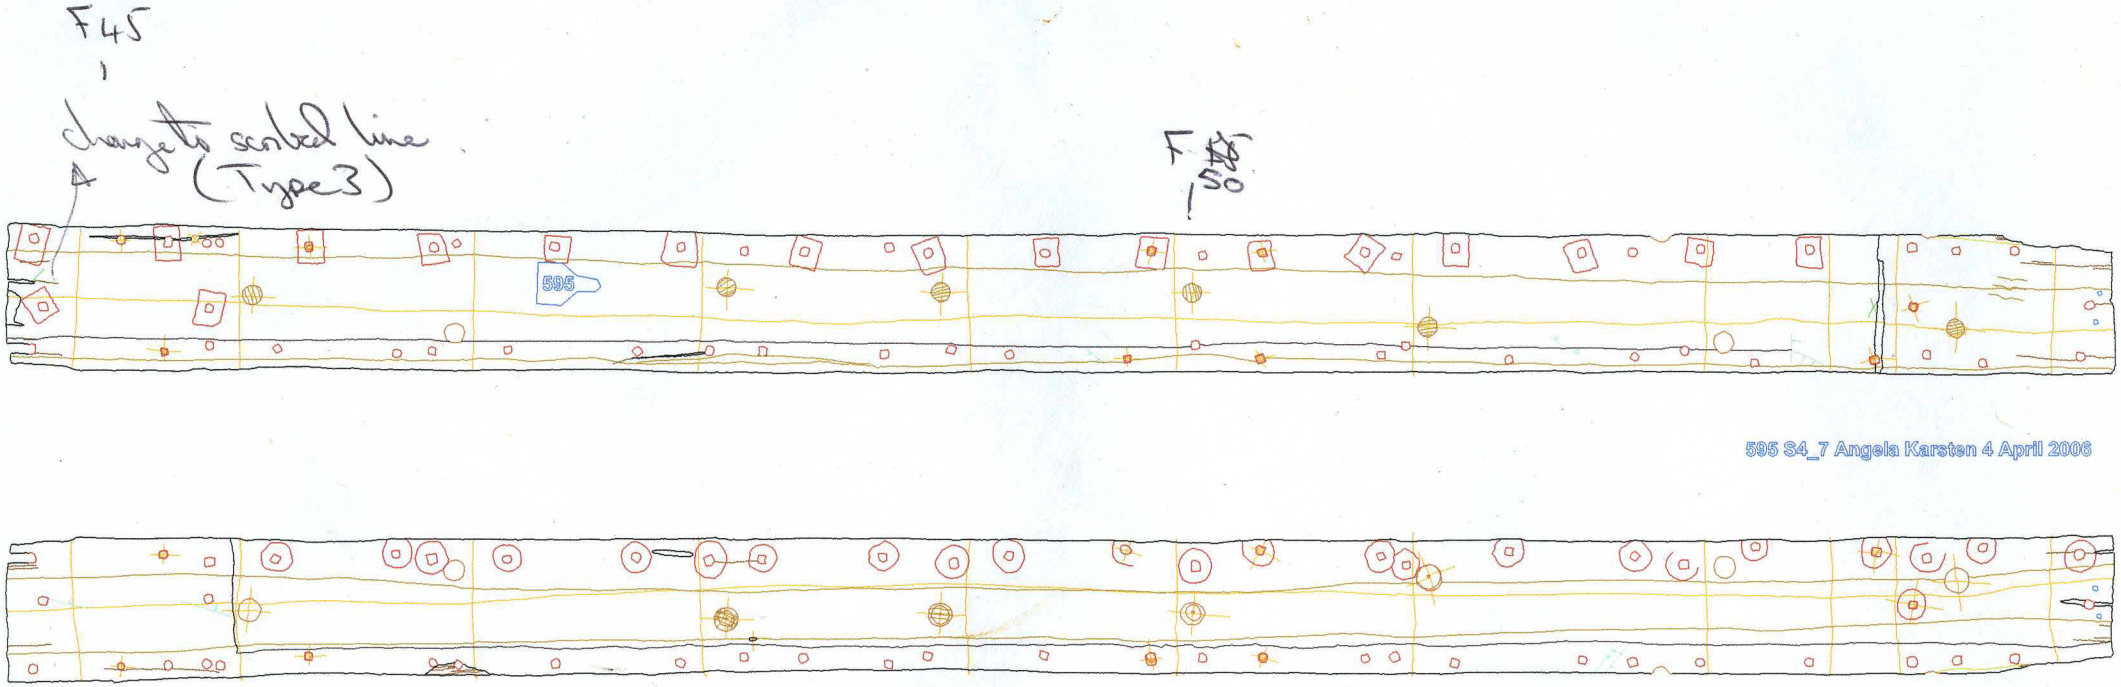
F45
change to scribed line
(Type 3)
F 50
595
595 S4_7 Angela Karsten 4 April 2006
