| Cow Tag 095. | Function Code S9.1 |

Brief Description: [timber element, p/s, condition, fragments]

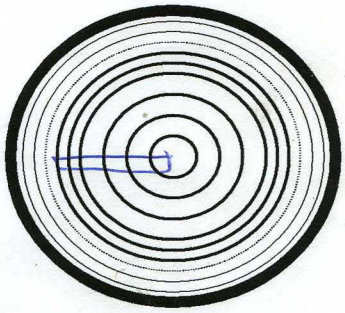
Damaged at forward end — poss match with piece from bow excavation?

Wooden Spikes
Add nails
Good Axe marks.

Hard to see but near radial path at upper edge
105 H ARW = 196/105

Sapwood.

Photo on head forward nail/head + wooden nail relationship? ~~on upper edge~~
