An Historic Building Recording at Hampton Farm, Hampton Lovett, Worcestershire

A report for Simcra Construction Ltd.

May 2003

Project: PJ 103

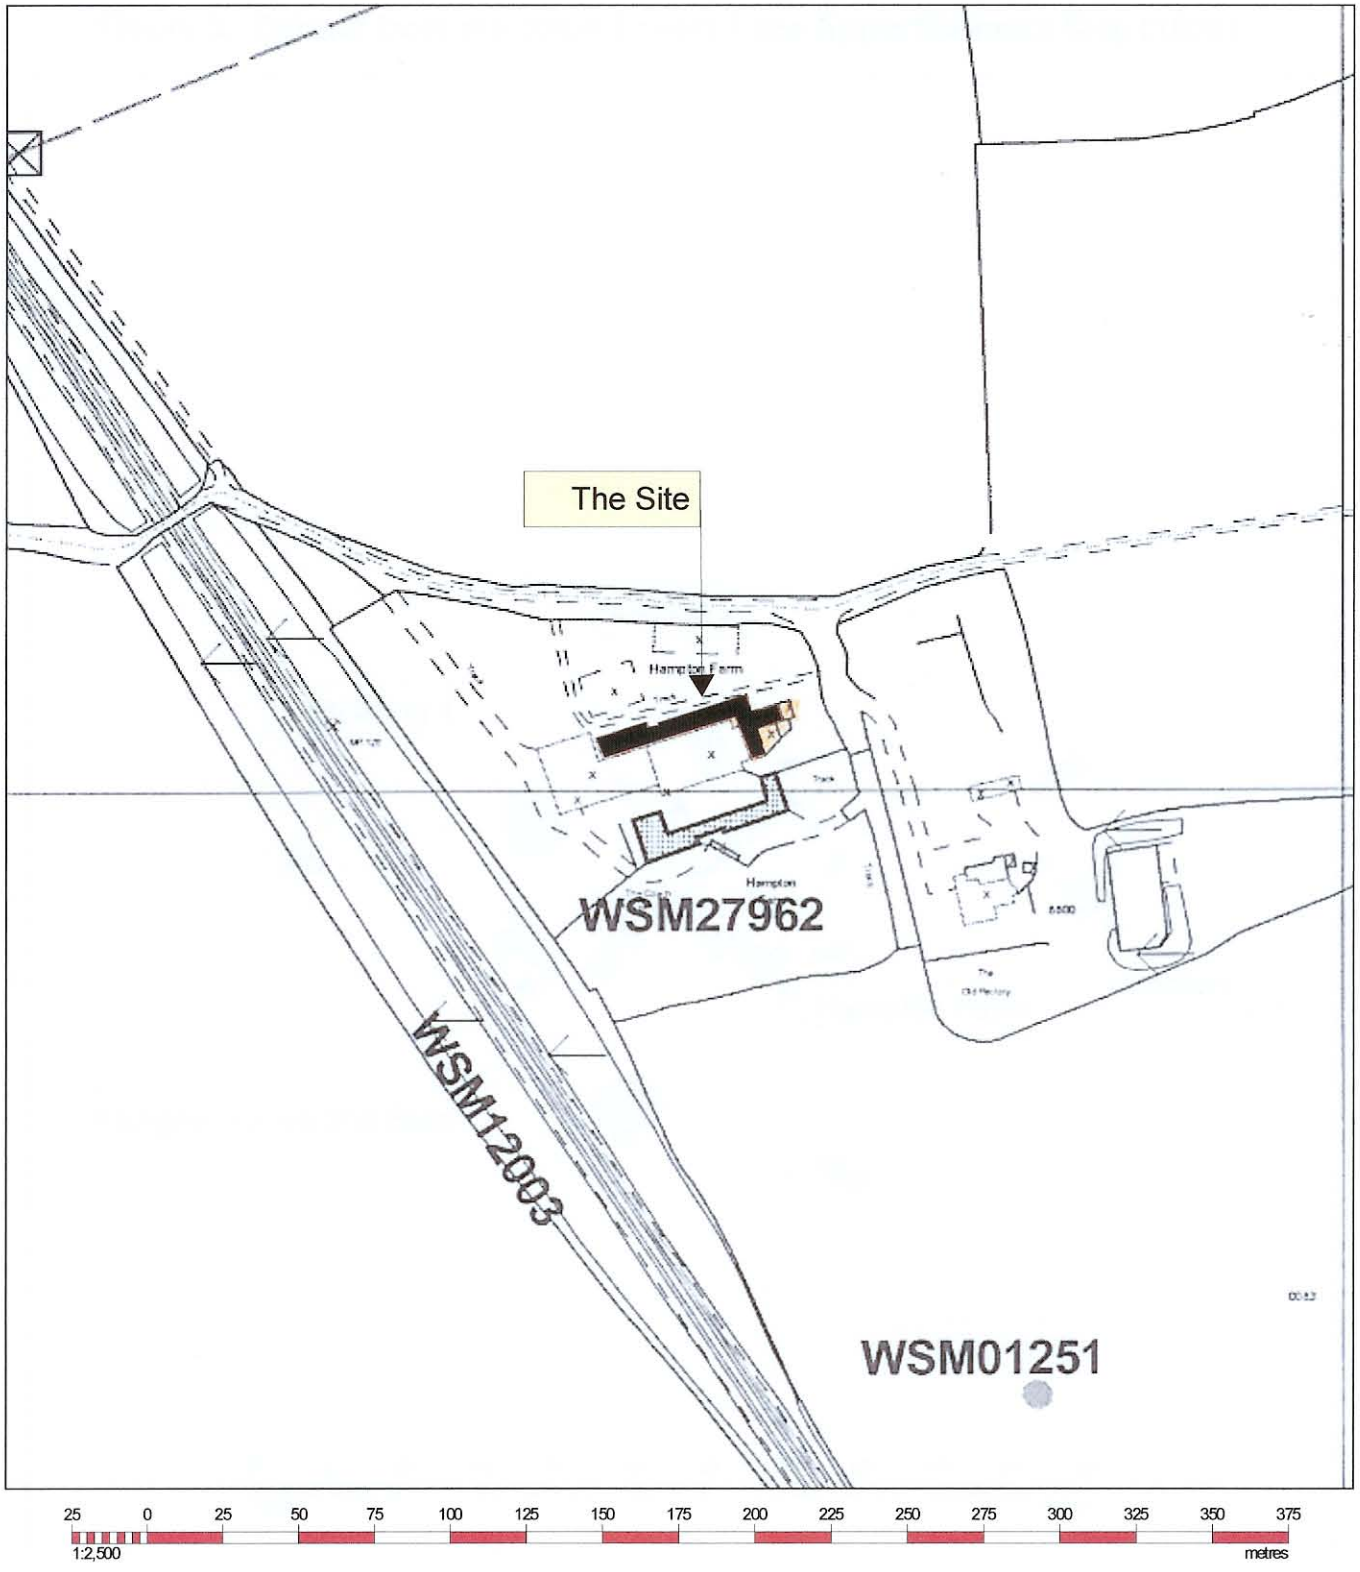
Figure 2. SMR Data Plan of the Area

The Worcestershire County Sites and Monuments Record indicates that the fields directly adjacent to the south of Hampton Farm are designated as the site of a shrunken village (Figure 2), probably abandoned during the medieval period (WSM 01251). The observation is based on various similar earthworks in other locations, some of which have been excavated or proven to be medieval through documentary research. There are further indicators to the medieval past of Hampton Lovett in the immediate vicinity. Fabric survives in the parish church from the 12th century (WSM 02400); an earthwork south of the farm and close to the railway may also be from the medieval period (WSM 08065). It has been suggested as the site of a castle motte. The village is located within an area of remnant ridge and furrow (WSM11929; WSM 23110), serving testimony to the village's agrarian past (Figure 2).

The Sites and Monuments Record data plan showing the sites of archaeological interest in the area.

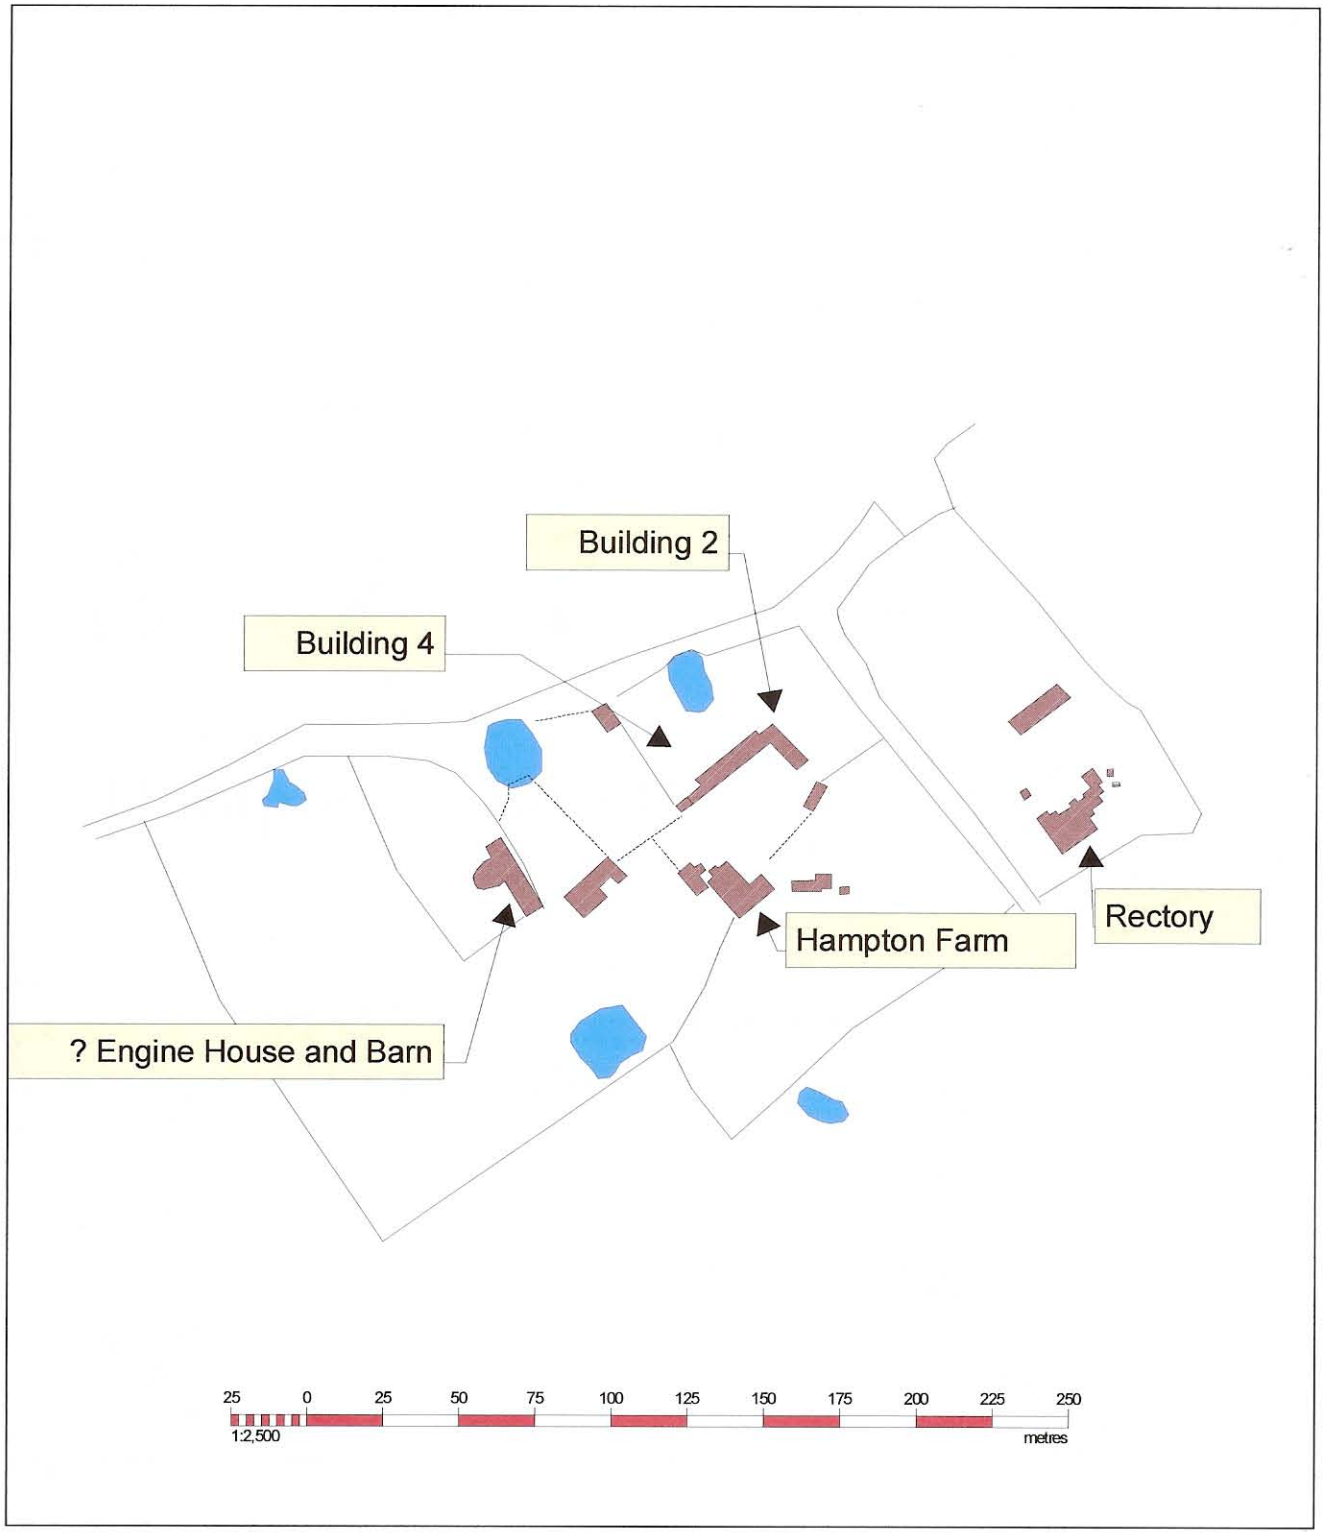
Figure 3. Extract from Hampton Lovett Tithe Apportionment Map (1838)

Extractffrom Tithe Apportionment Map of Hampton Lovett (1838). Scale approx 1:2500.

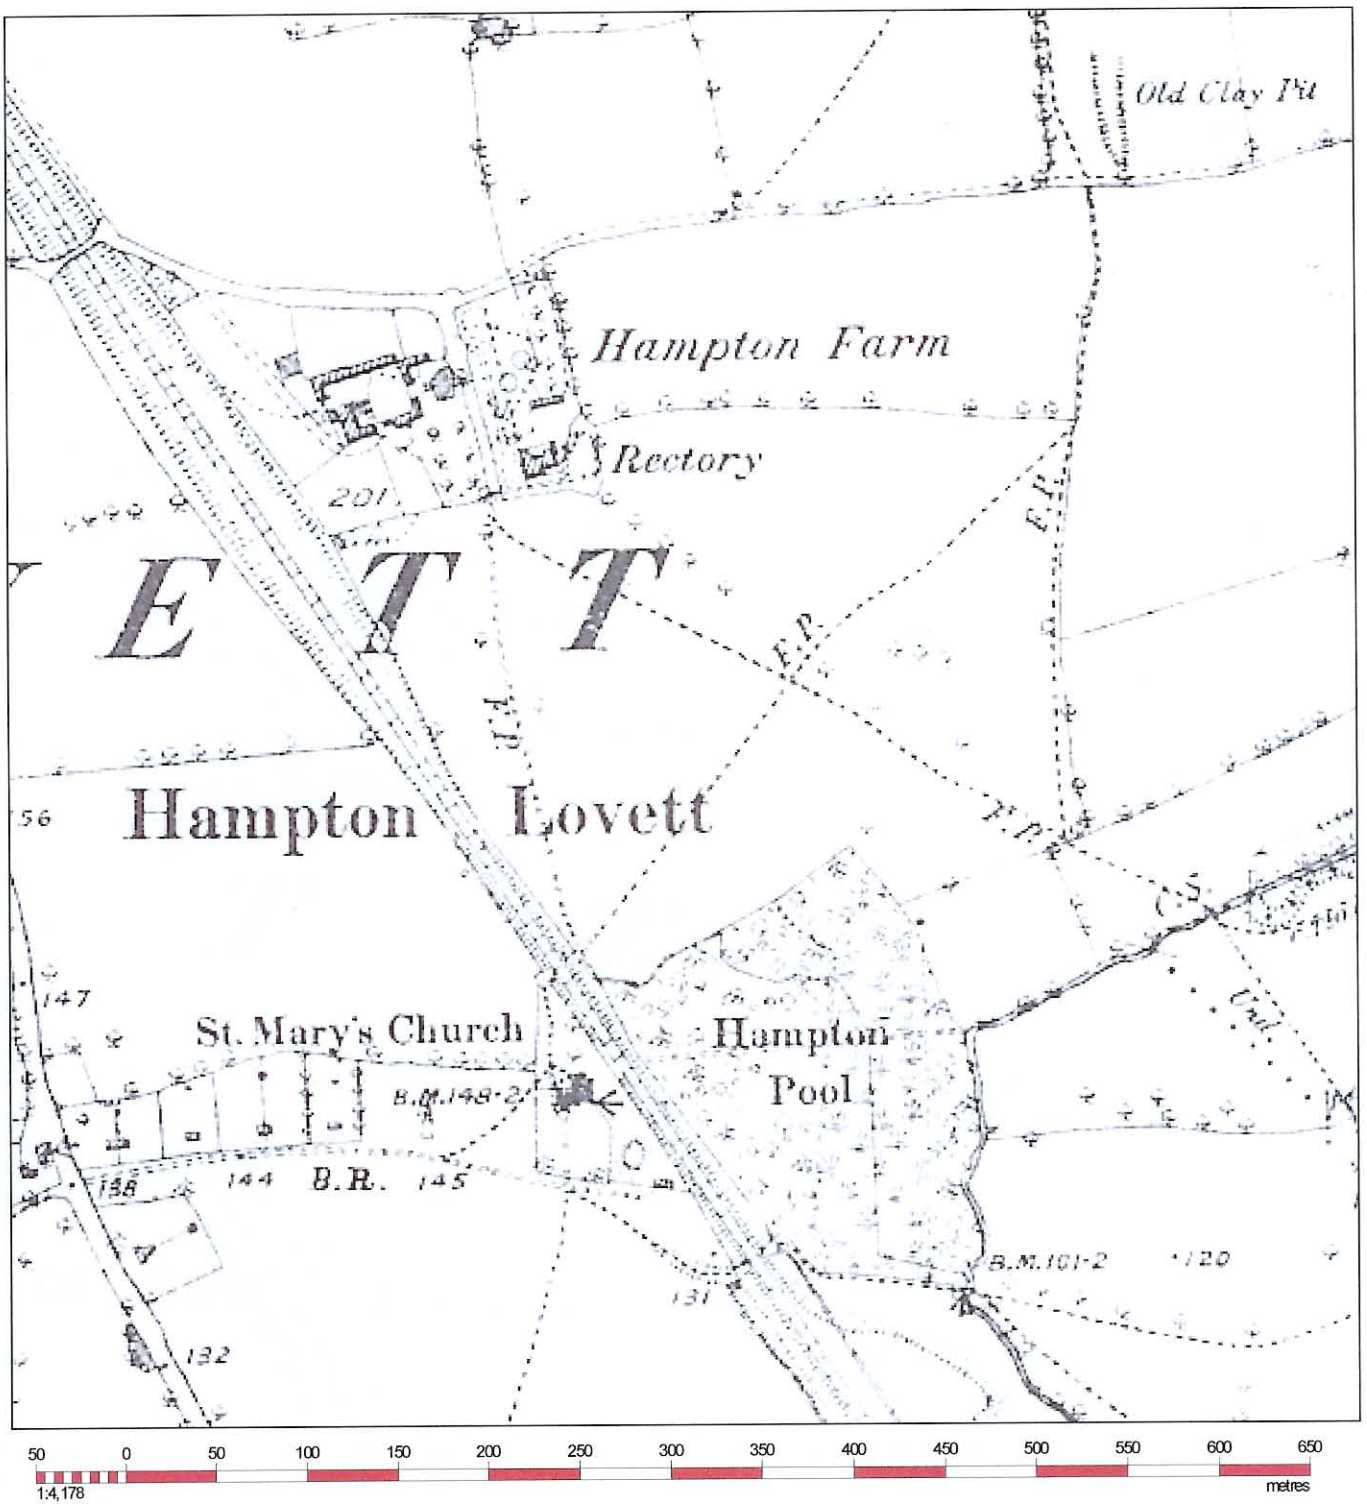
Figure 4. Hampton Farm, Hampton Lovett; 1st Edition Ordnance Survey (1888)

The first edition Ordnance Survey map shows that by 1888 the barn had been added and there were further attached builings at the west.

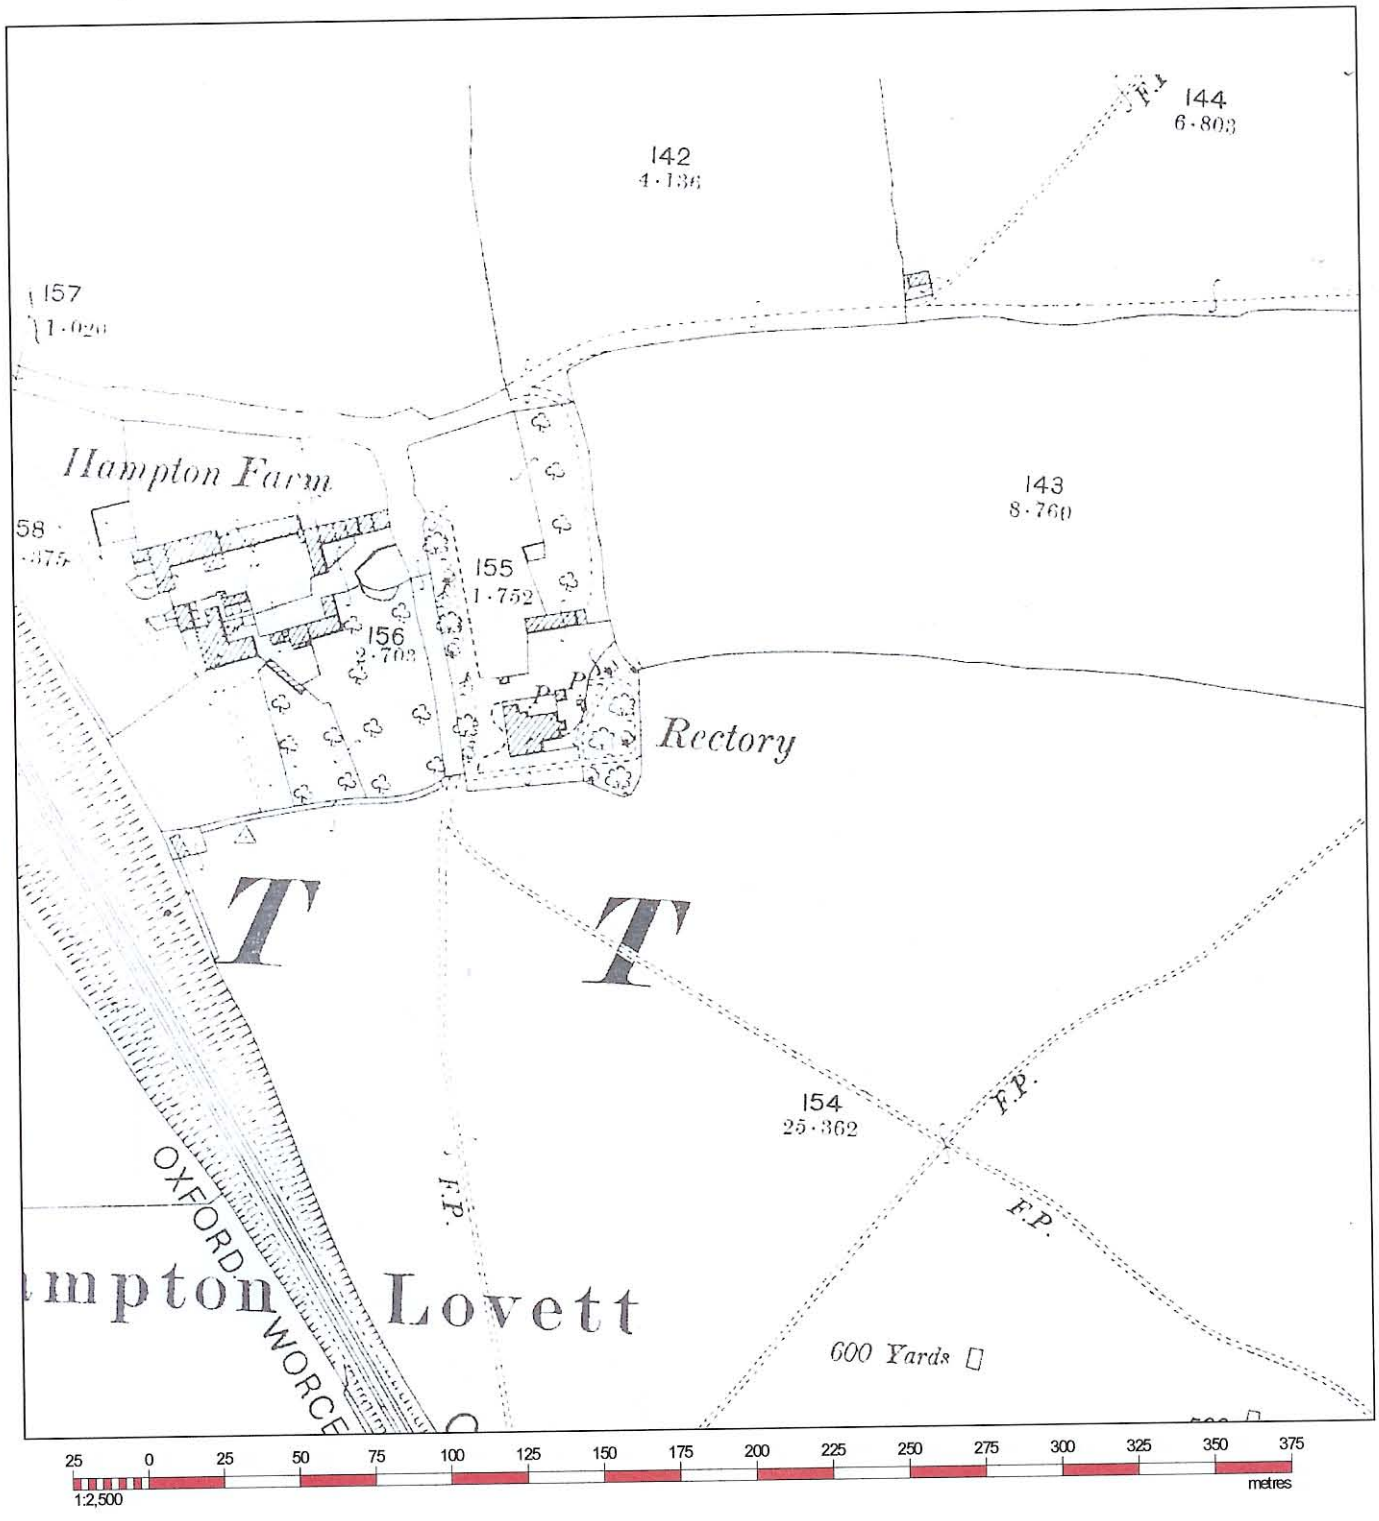
Figure 5. Hampton Farm, Hampton Lovett; 2nd Edition Ordnance Survey (1903)

The 2nd edition Ordnance Survey map shows development since 1888 when the 1st edition map was published.

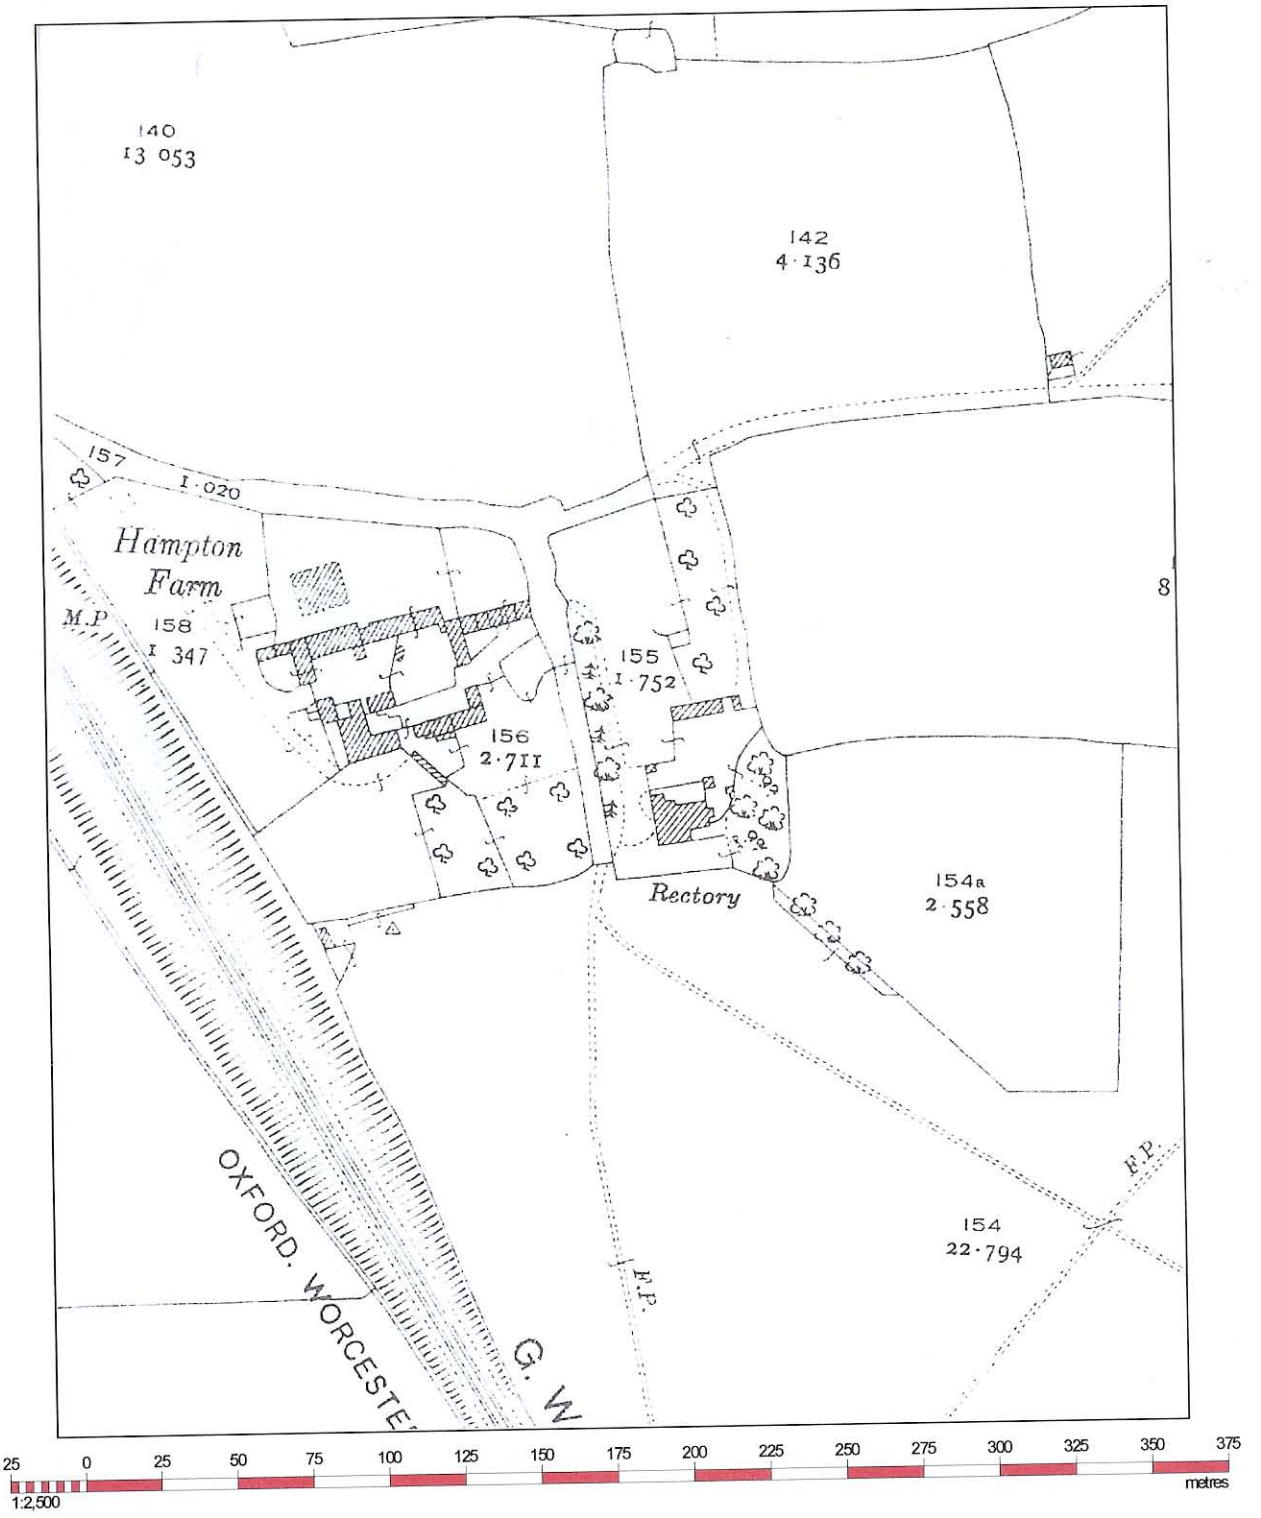
Figure 6. Hampton Farm, Hampton Lovett; 3rd Edition Ordnance Survey (1927)

The third edition Ordnance Survey map shows that by 1927, further buildings had been added at both west and east ends.

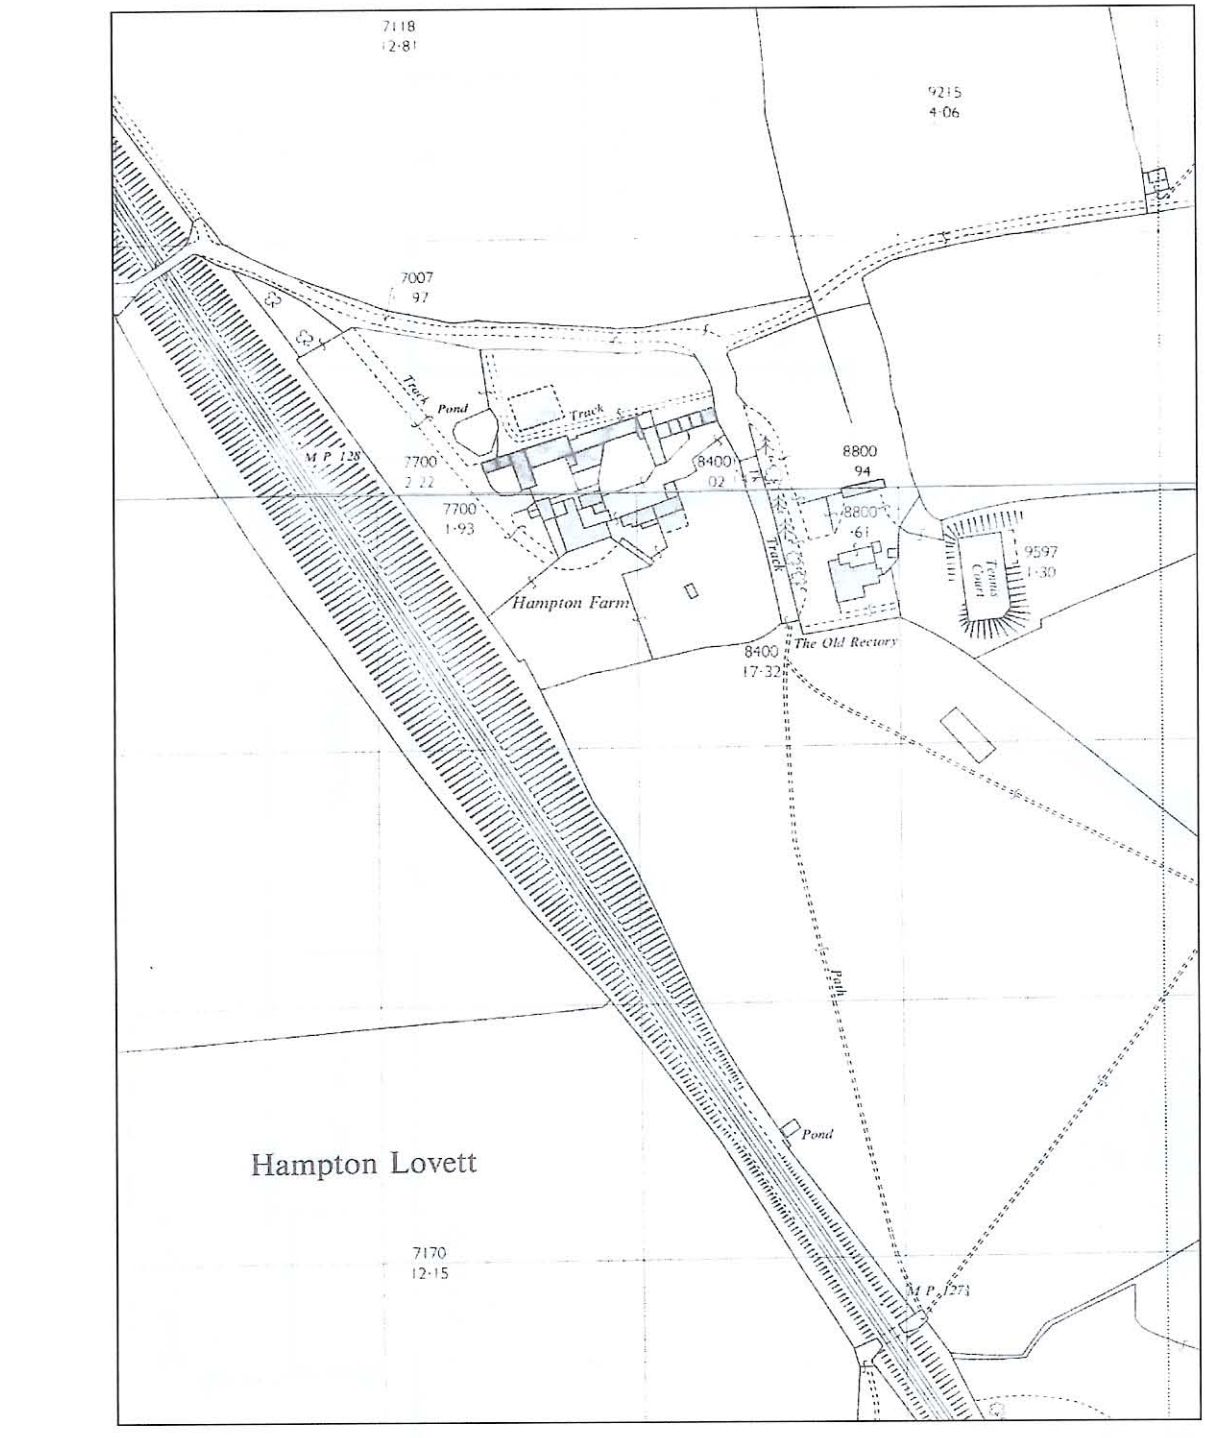
Figure 7. Hampton Farm, Hampton Lovett; 4th Edition Ordnance Survey (1965)

The 4th edition Ordnance Survey map shows that by 1965 the farm complex had changed little since 1927.

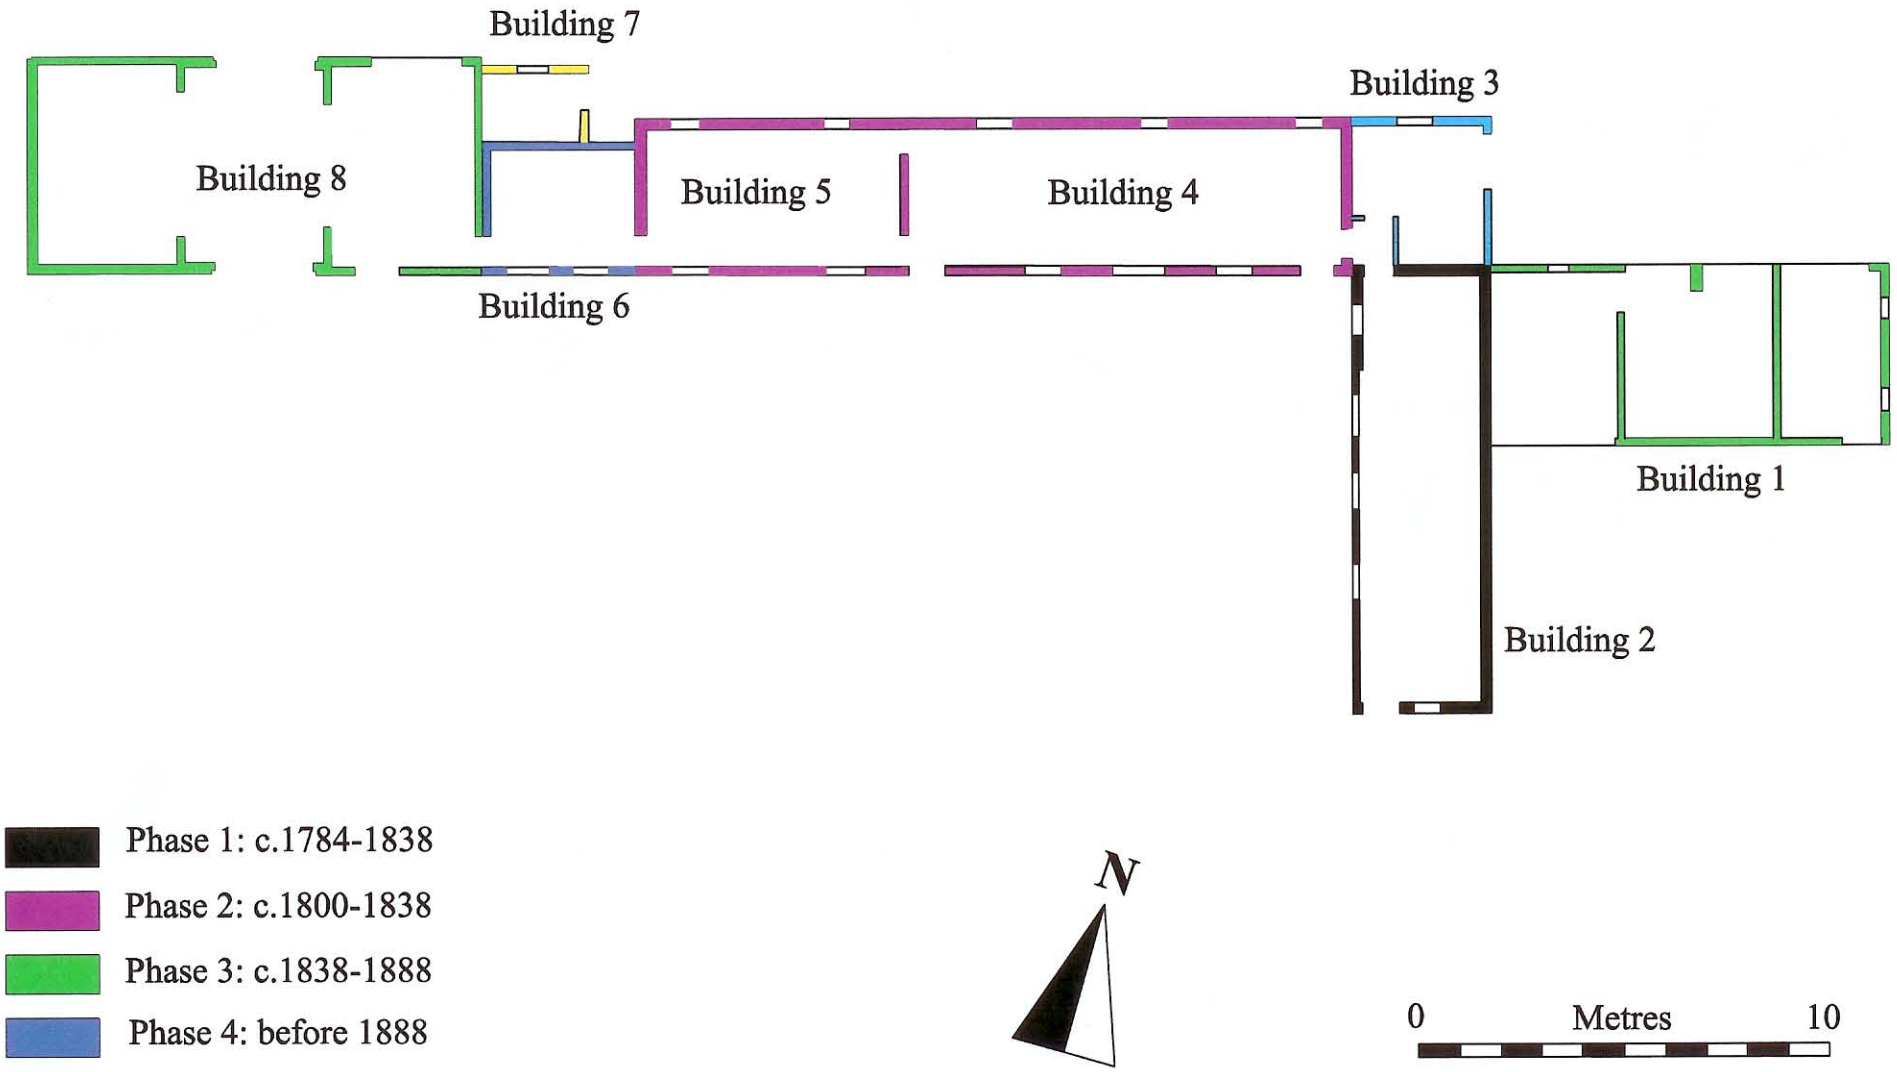
Figure 8: Building Reference and Phase Plan

Using the evidence available and the results of the survey, the following phase analysis has been produced (see also Site Drawing 2):

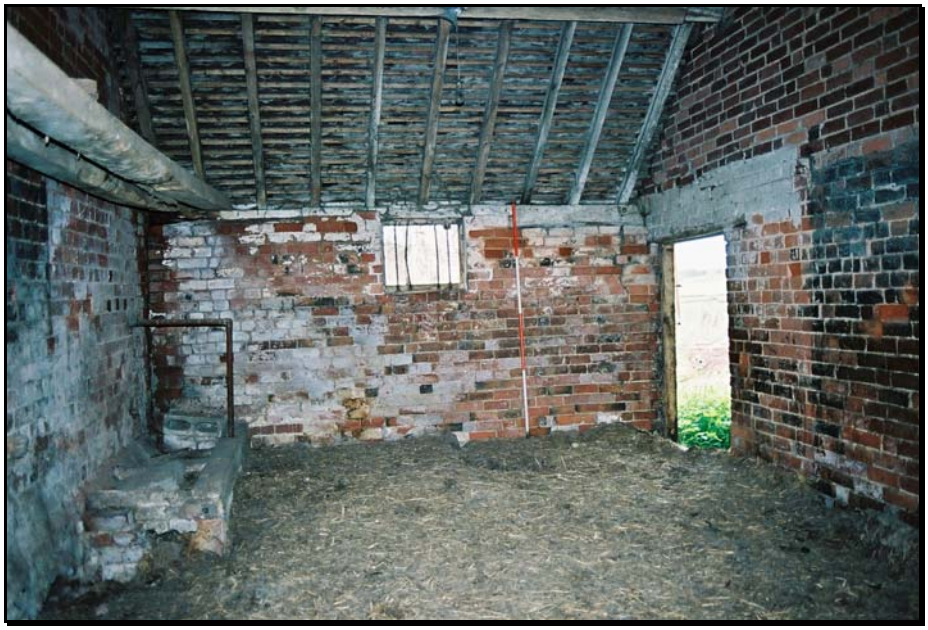
Plate 4

In the wall of building 2, onto which building 1 butts, the arched drain exit can be seen, demonstrating that this was once the east elevation external wall of Building 2 (Plate 4). The drain has now been diverted to exude into a sump alongside the external northern wall of building 1.

Building 1 showing arched drain in bottom left corner (scale 2 metres)

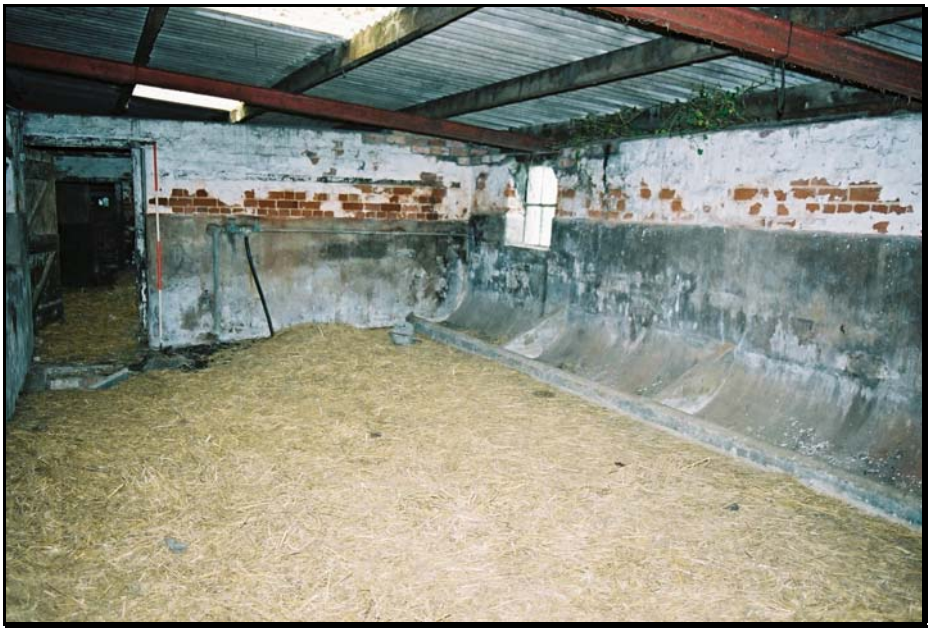
Plate 8

Building 5
Building number extends from Building 4 and is essentially part of it. This suggests that the partition wall between 4 and 5 is a later addition, probably from the same date as the insertion of the milking infrastructure. The building has lately been used as an animal house, probably for calves, but it seems likely that originally buildings 4 and 5 formed one long cow house (Plate 8).

View from building 4, through Building's 5 and 6 towards the barn (scale 2 metres)

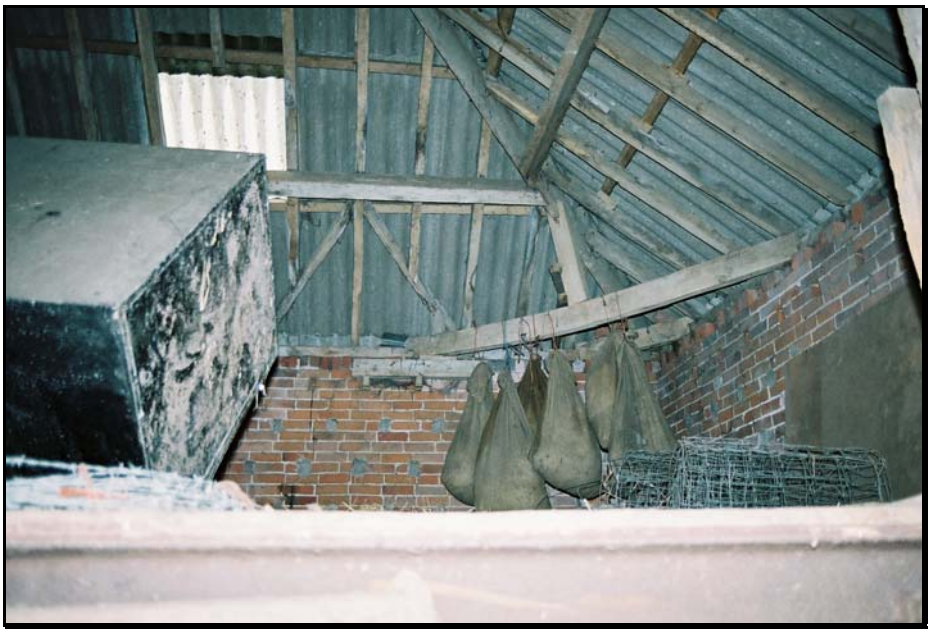
Plate 13

a series of sacks hanging on hooks on the upper level (Plate 13). In the rafters at the edge of the loft there is an in-situ wooden sack hoist (Plate 14).

Sacks hanging in the hayloft above the eastern bay of the barn, Building 8
