Manor Farm
Kingston Deverill
Wiltshire.

A Programme of archaeological recording and erosion repair on three Scheduled Bronze Age Barrows.

March 2017

COAS project code: C1/SUR/14/MKW **R. F. Stratton & Company**

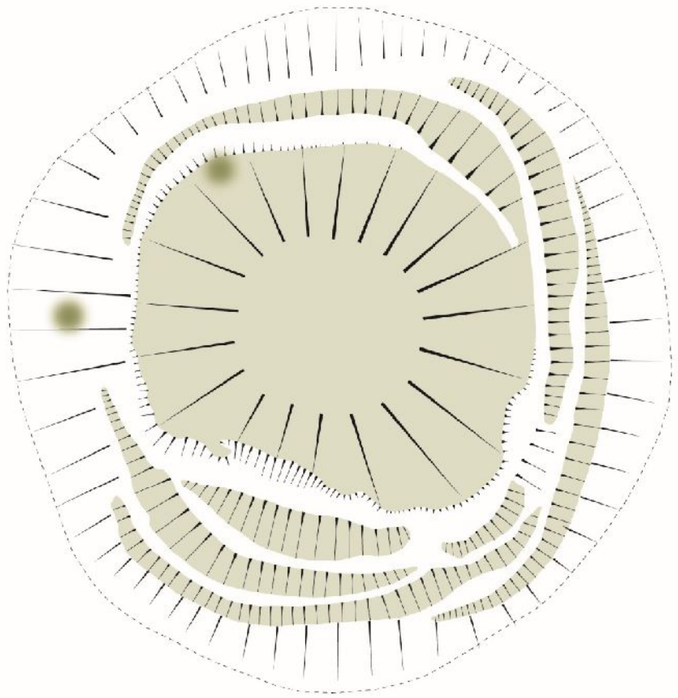
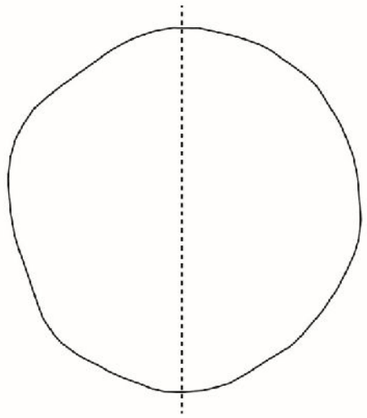
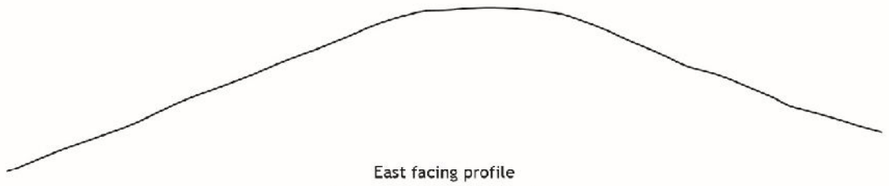
Figure 2. Profile and plan of Dairy Farm barrow

4.2 Two hawthorn trees growing on the western side of the Dairy Farm barrow (**Figure 2; Plate 12**), and one young hawthorn on Truncombe Wood (**Figure 3; Plate 13**) were cut down and the stumps treated to accelerate rotting. An old animal burrow on the south-eastern side of the Truncombe Wood barrow was lined with permeable membrane before being filled with chalk.
