JOHN MOORE HERITAGE SERVICES

AN ARCHAEOLOGICAL EVALUATION

GLENDA SPOONER FARM, BRINCIL HILL LANE, KINGSDON, SOMERSET

AUGUST 2008

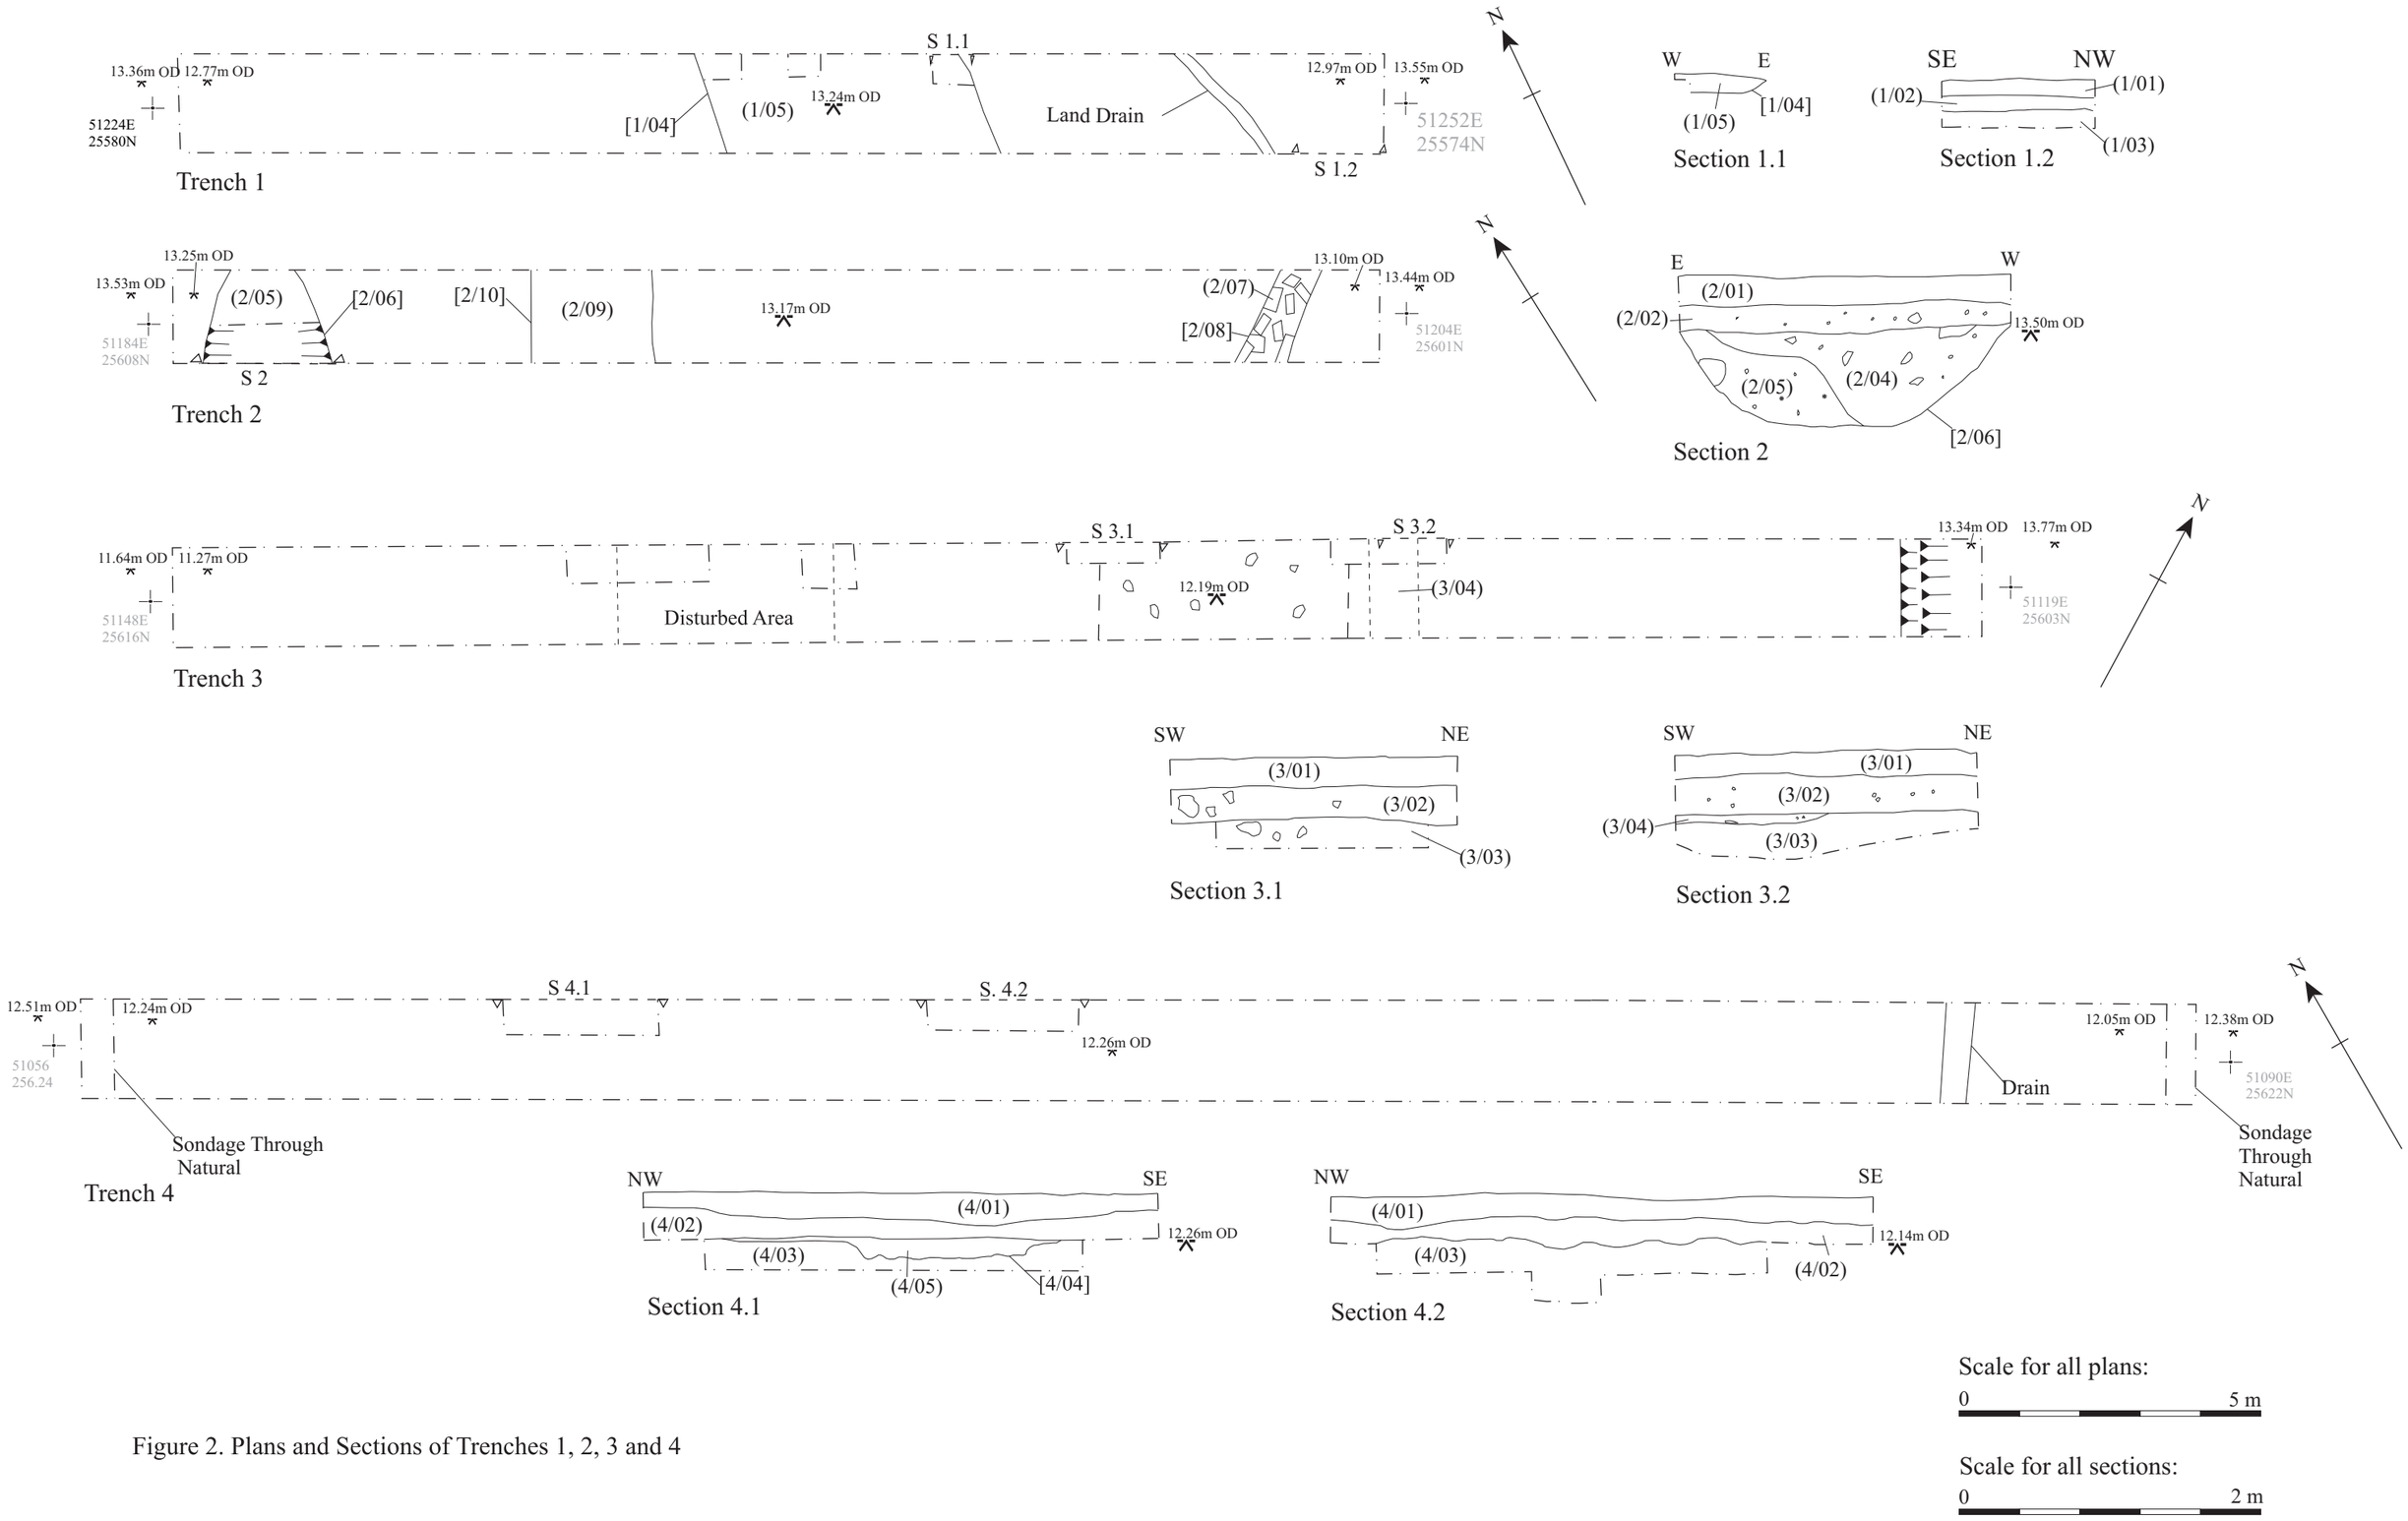
Figure 2. Plans and Sections of Trenches 1, 2, 3 and 4

Aligned roughly north to south was the remains of a modern track-way. It was cut [1/04] into the natural (1/03) and was 4.2m wide and 0.15m deep. This was filled with a mix of gravel, stone and grey clay (1/05) that made up the track surface. A slight camber of this track could be seen in section.

At the eastern end of the trench was a field drain constructed of flat stones angled at 45° in a linear cut. It was aligned roughly northwest to southeast.

The geophysical survey predicted two large oval pits and an area of disturbed ground where this trench was placed. The western most of the predicted pits was cut [2/06] into the natural (2/03), 2.2m wide and 0.6m deep with rounded sides and a flat base. It was filled with a mid orange-brown clay (2/05) with some stone and brick fragments up to 0.6m thick. An upper fill, of greenish-brown clay (2/04) with stone and brick fragments, is indicative of either dumping layers or a re-cut of the original pit.

There was no sign of the seconded predicted pit; however there was a concentration of ash, stone and brick (2/09) within the subsoil roughly 2m wide in approximately the same area.

At the eastern end of the trench in the area of disturbed ground was a large modern french drain [2/08] filled with breeze-blocks and concrete in a dark brown clay matrix (2/07).

The ground sloped sharply from the east to the west forming what was originally thought to be a remnant of a bank; this was also the prediction of the geophysics. Upon excavation this was seen to be a slope in the natural geology; although a natural feature it was probably enhanced by human activity.

Against the lower portion of the slope was a build up of light brown-grey silty-clay (3/04) approximately 1m wide and 0.06m thick. To the west of this were the remains of the Roman road that survived in very poor condition, as a deposit of mid brownish orange clay (3/05) with some stone approximately 4.1m wide. This was distinguishable from surrounding deposits due to the high concentration of stone.

The poor condition of the road and indistinct edges could be explained if it remained in use as a cattle or drovers track. Constant churning of the soil would remove any evidence for a construction cut disperse the stone and even erode the soil in the area enhancing the natural slope forming something like a hollow-way. The deposit against the slope (3/04) could be a build up of material from this process or the remains of a roadside ditch.

The trench was placed to cut across three linear features predicted by the geophysical survey. The easterly feature was a modern field drain with a ceramic pipe. There was no sign of the middle feature within the trench although a slight undulation of the surface was noted roughly in the predicted location (Fig. 2, section 4.2).

The western most feature was the remains of a very ephemeral ditch aligned NE - SW, again surface undulations were visible in the area. The cut [4/04] was very indistinct with the edges defuse due to root action. It was approximately 1.2m wide and 0.12m deep with an irregular flattish base (Fig. 2, section 4.1). The silty-clay fill was only barely distinguishable from the subsoil being a fraction darker and was not visible in plan.

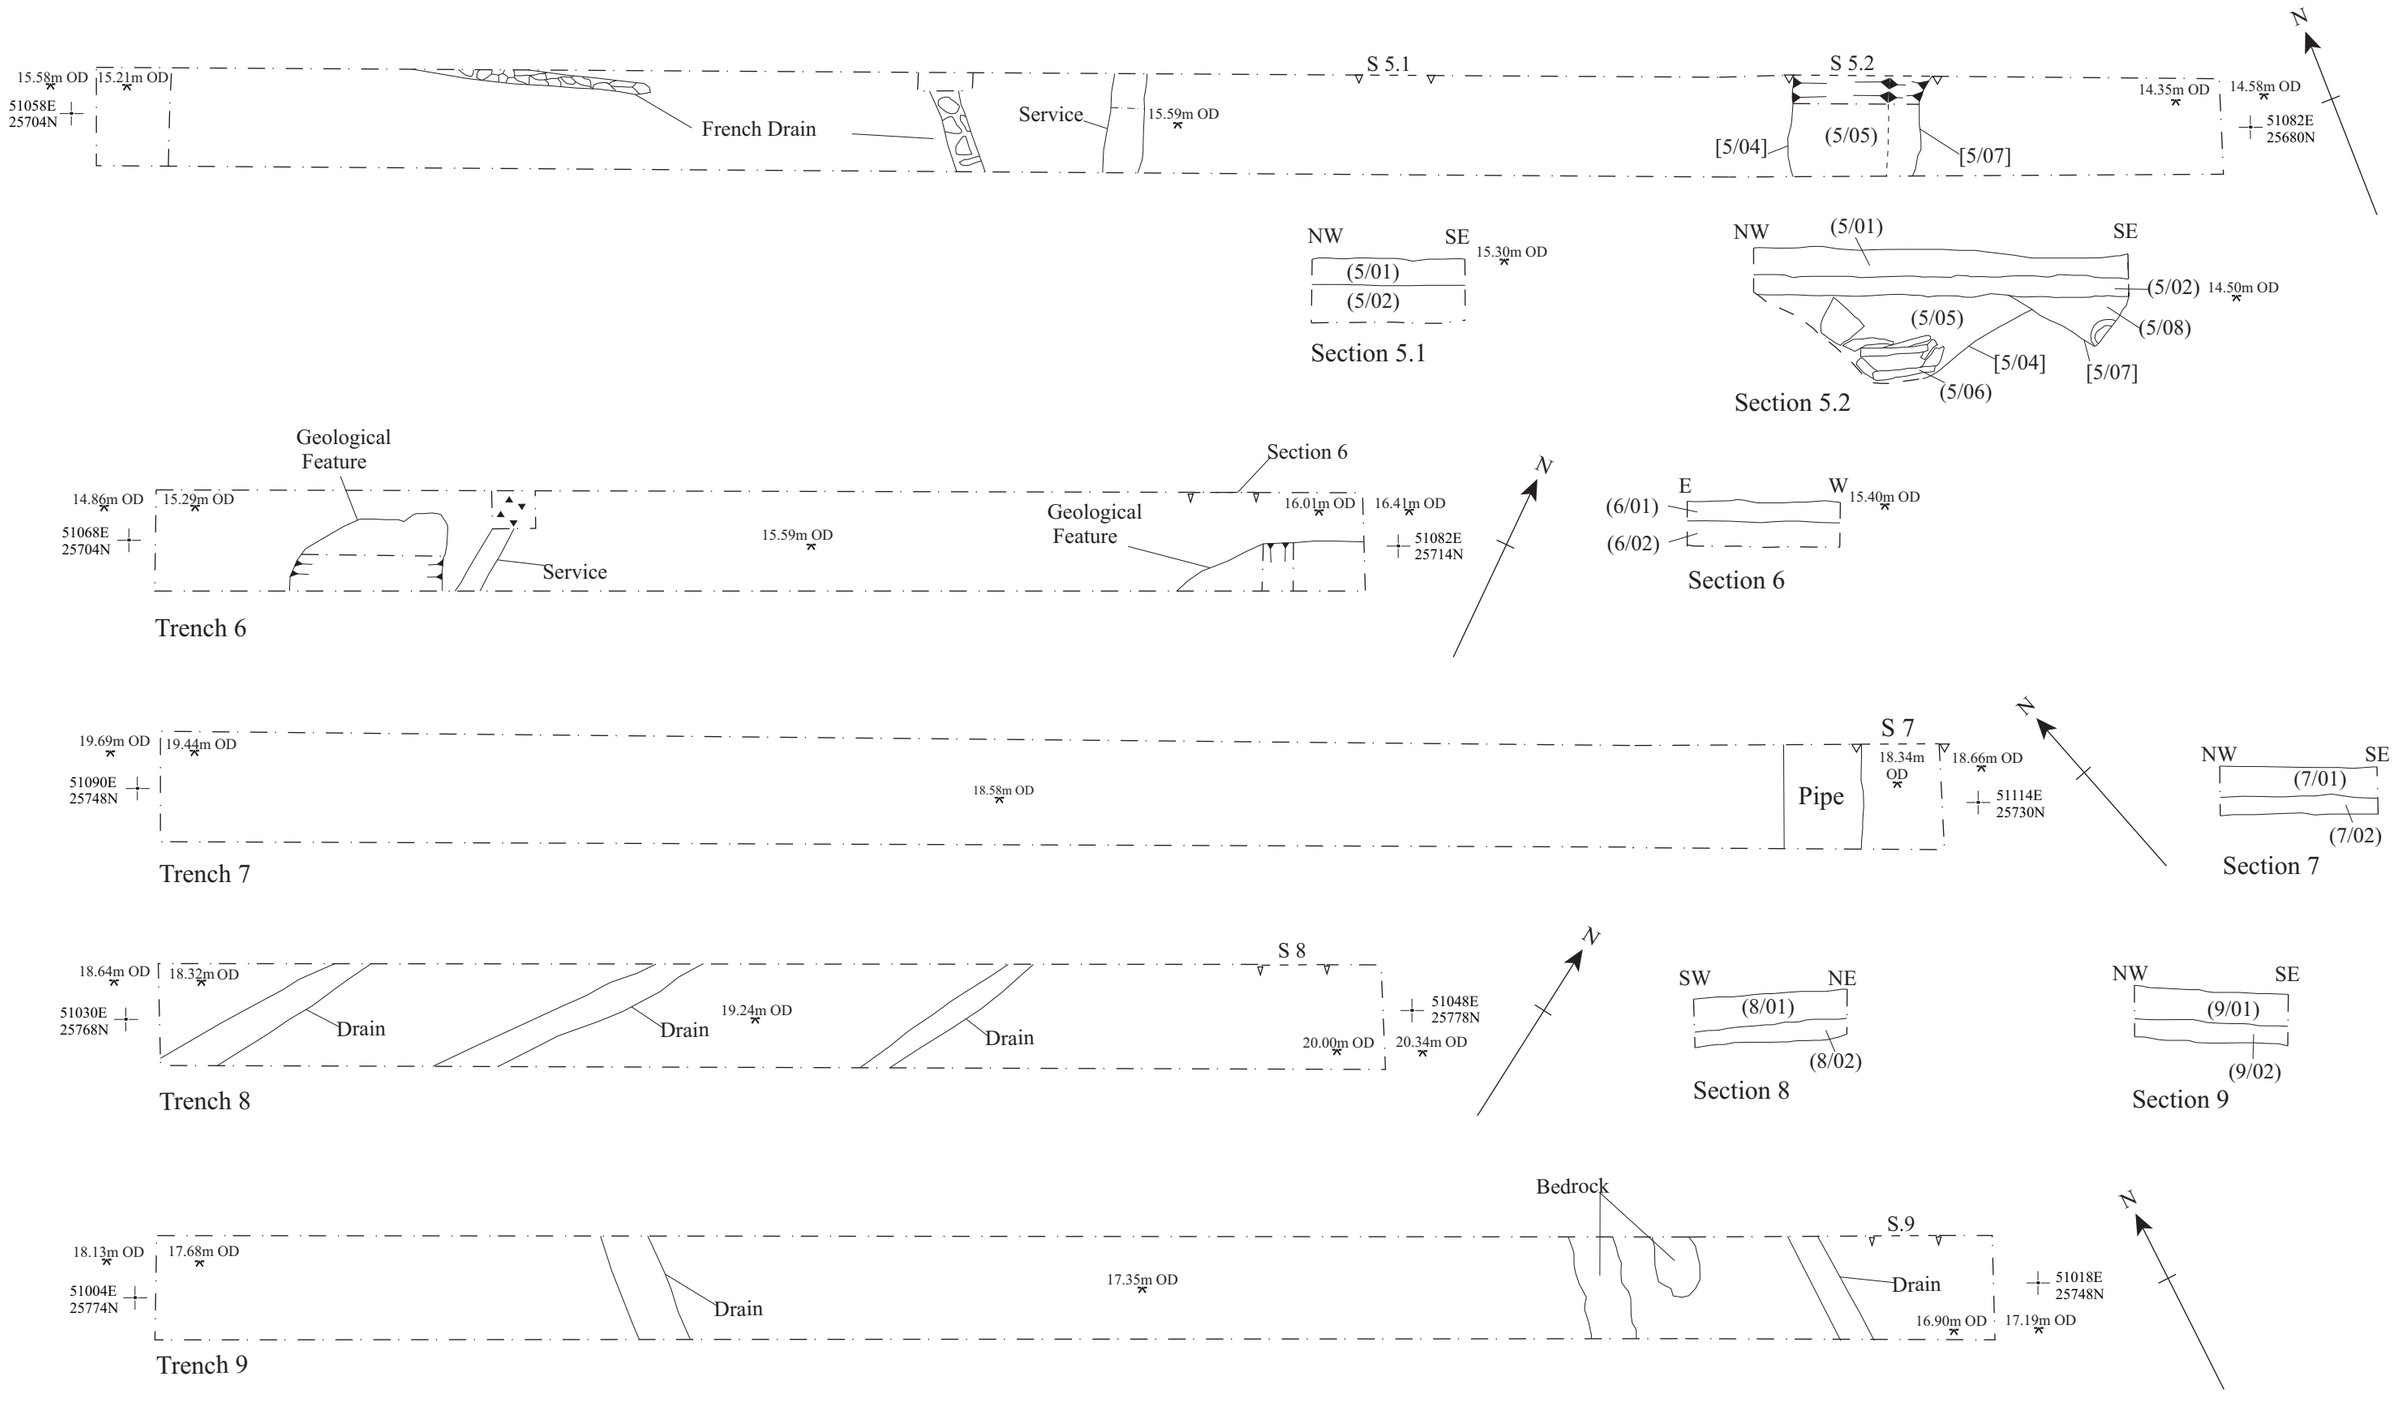
Figure 3. Plans and Sections of Trenches 5, 6, 7, 8 and 9

The trench was placed to intersect a linear feature and a line of large pits predicted by the geophysical survey. There was no sign of the linear feature within the trench and the line of pits was in fact two modern field drains. To the south-eastern end of the trench was a stone lined drain (5/06) cut by a later modern pipeline [5/07], neither of which was observed in the geophysical survey.

The cut [5/04] for the stone lined drain (5/06) was over 1.8m wide and 0.55m deep with a flattened U-shaped profile. The drain was constructed with flattish stone blocks with a base, sides and capping. It was rectangular in section and filled with a mid grey silt. The cut of the drain was filled with greenish-brown clay (5/05) that contained a single sherd of pottery.

The linear feature predicted by the geophysical survey was a modern service. Other anomalies within the trench were variations within the natural geology.

The bank predicted by the geophysical survey in fact turned out to be the backfill of a modern pipe trench. No other features were seen within this trench.

No archaeological features were recorded. Three field drains similar to the one recorded in Trench 1 ran roughly north south across the trench; these were not picked up by the geophysical survey.

A modern field drain filled with brick in the fill was seen at the northern end of the trench, this was not predicted by the geophysical survey. To the south the linear feature predicted appeared to coincide with shelving of the bedrock close to the surface. To the south of this was a second field drain.

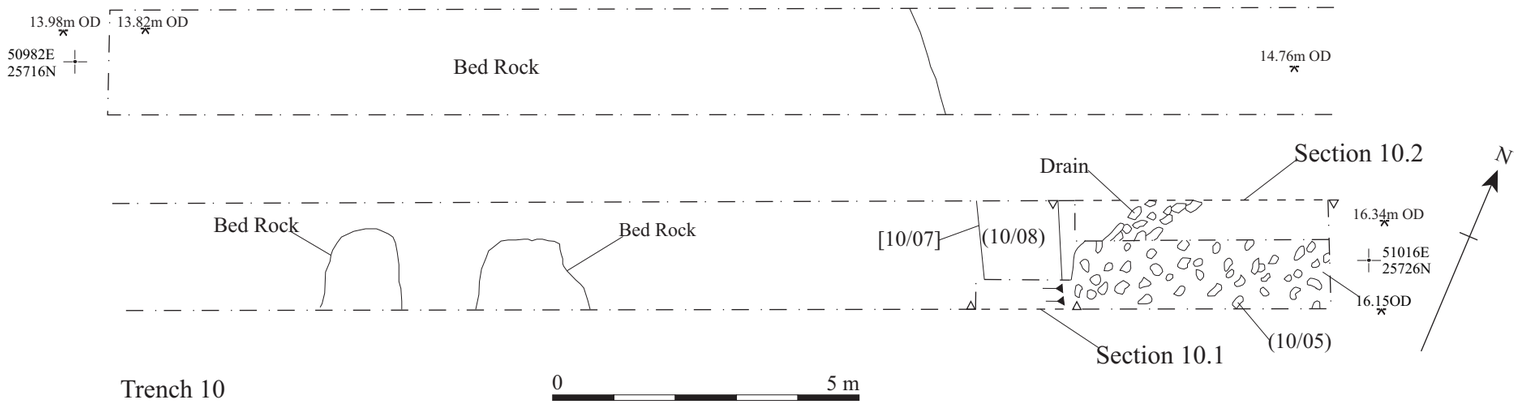
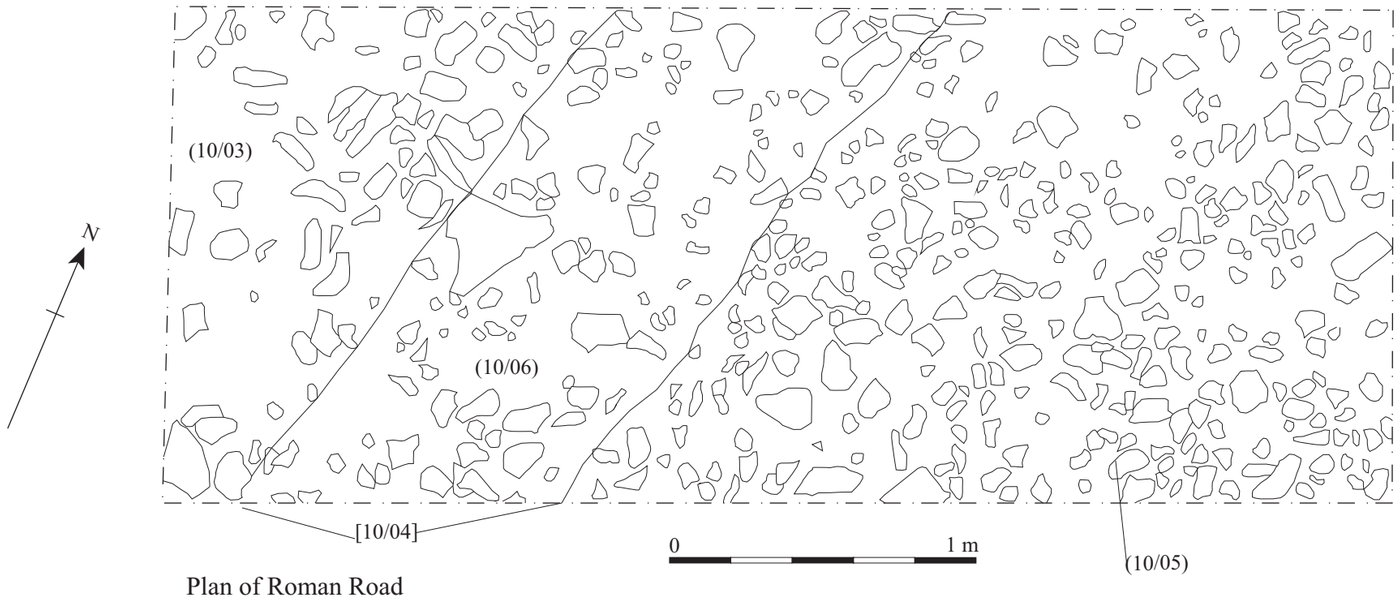
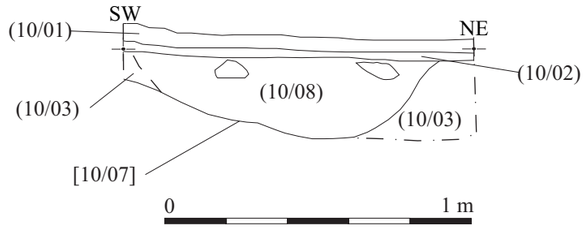
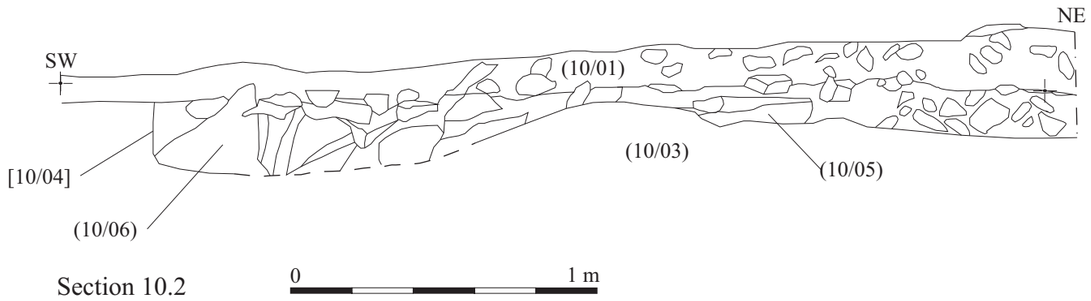
Figure 4. Plans and Sections of Trench 10

At the north-eastern end of the trench the remains of the Roman road (10/05) was present. It consisted of angular stones pressed into the upper surface of the natural (10/03). It had seen considerable disturbance. A single course of stone survived, these stones varied greatly in size from 0.3m to 0.05m.

To the south west of the road and parallel to it was a ditch [10/07] that was 1m wide and 0.26m deep with a very shallow U-shaped profile. It was filled with a mid orange-brown clay (10/08) with the odd small stone.

Aligned roughly N-S and cutting the road (10/05) was a drain [10/04]. This was 0.5m wide and 0.3m deep filled with large flat angular stones in an orange brown silty clay matrix (10/06).

This drain appeared to stop at the edge of the ditch [10/07]. Perhaps this ditch was still in use or at least visible at the time of construction.

There was no evidence for the predicted linear feature in the southeast of the trench. In this area the bedrock was only about 0.1 – 0.15m below ground surface.

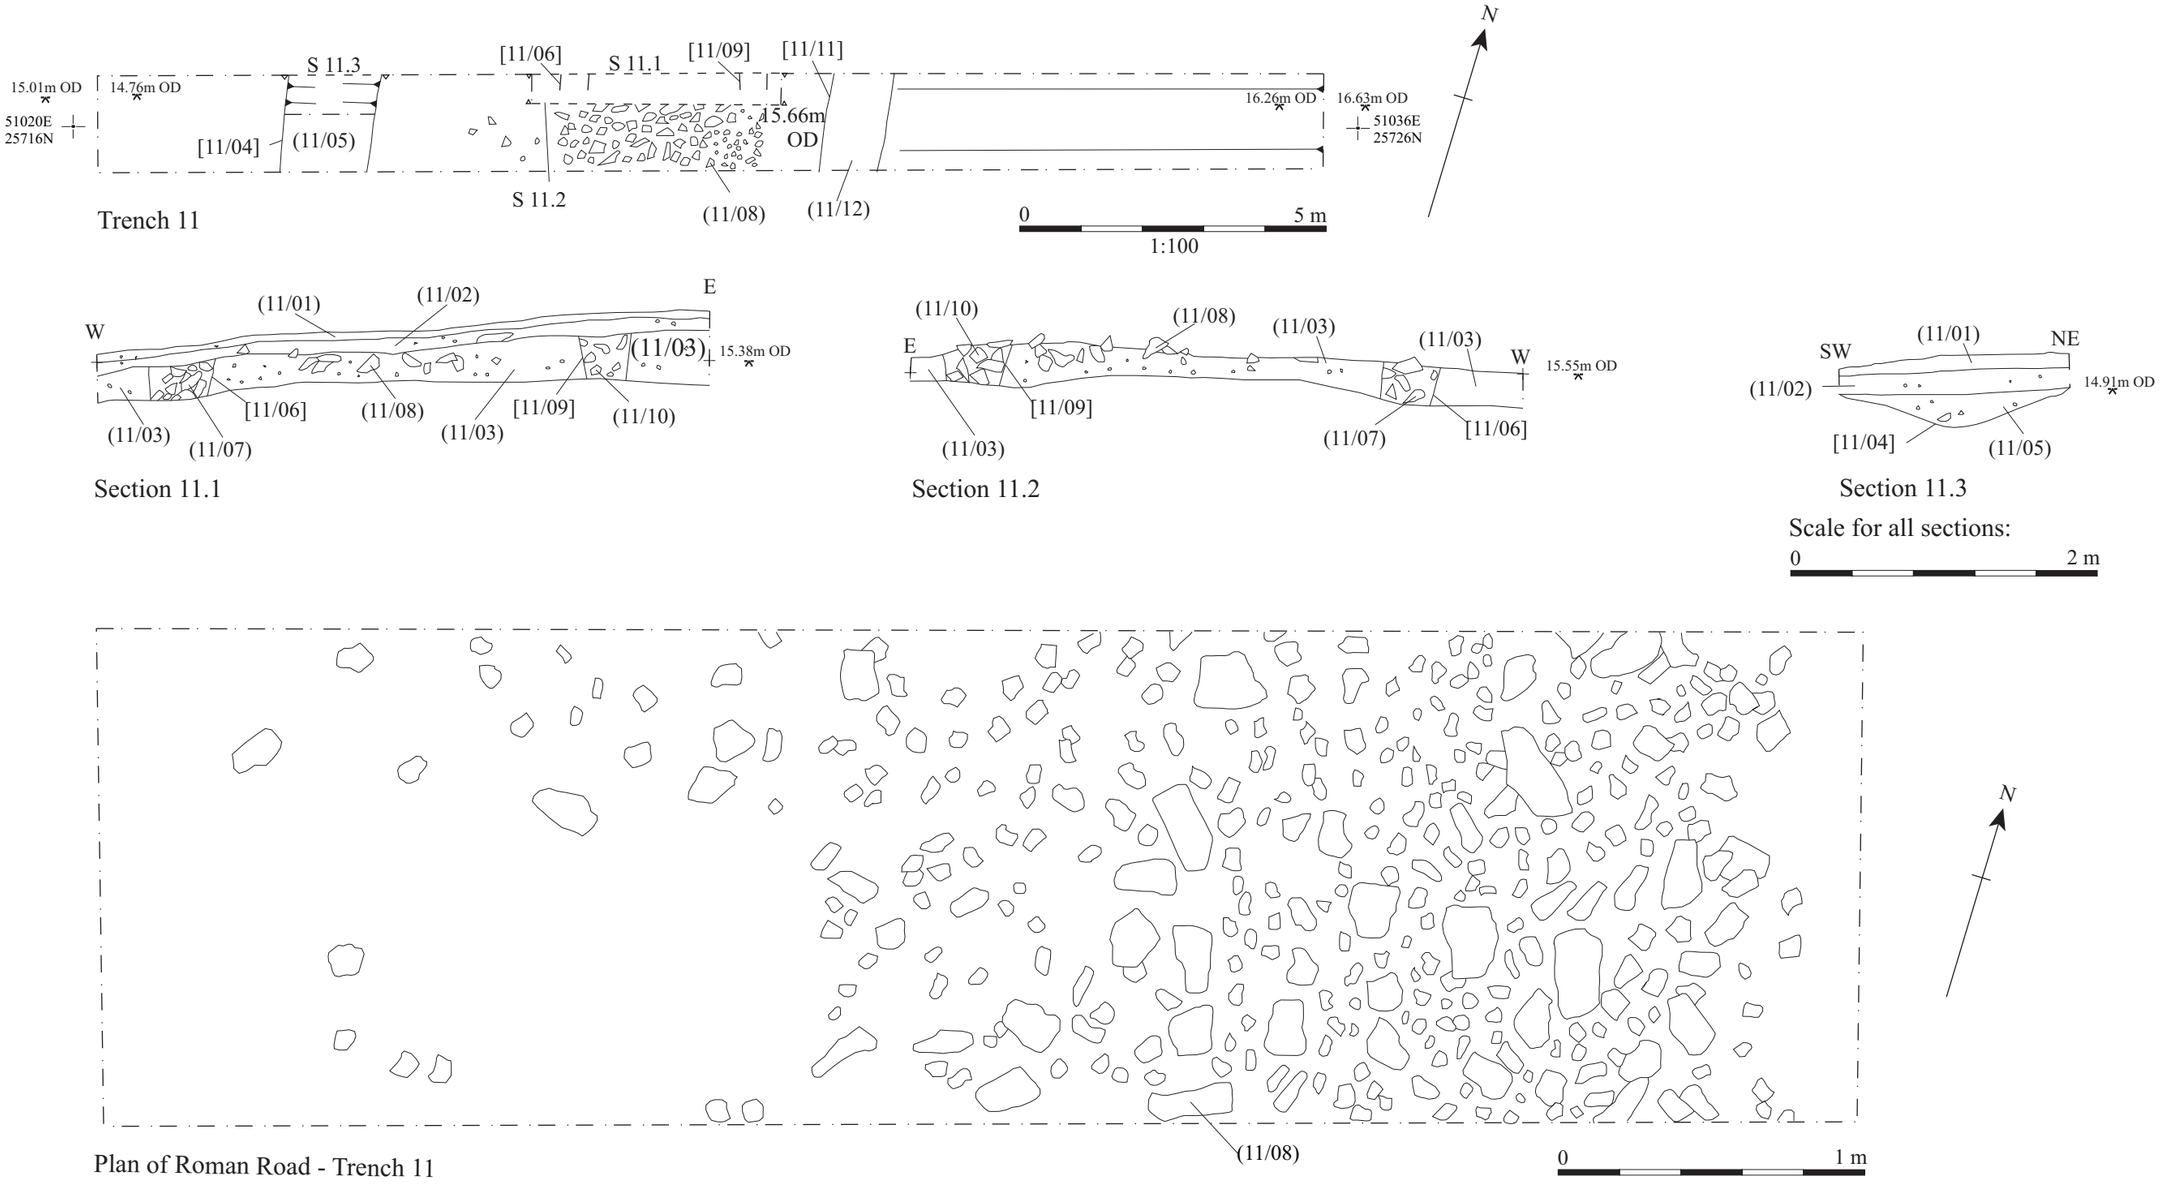
Figure 5. Plans and Sections of Trench 11

The remains of the Roman road (11/08) were present. It consisted of angular stones pressed into the upper surface of the natural (11/03), and had seen some disturbance. The edges of the road were defined by two gully-like cuts in the natural [11/06] and [11/09] these were 0.3m – 0.4m wide and 0.3m deep and filled with angular stones in a mid-orange brown clay matrix (11/07) and (11/10) respectively. The construction layer (11/08) of the road was laid over and in between these. There function would appear to be that of basic foundations keeping the road edges and the intervening construction deposit (11/08) in place. A slight camber could be seen in the surface of (11/08). The width of the road from the outer edge of the two gullies was 3.7m. As was seen in Trench 10 the size of the stones within the road varied in size although those within the gullies where generally smaller in size.

Along either flank of the road was a ditch. The northerly one [11/11] was heavily truncated, 0.9m wide and 0.04m deep with a slightly concave base. It was filled with a loose dark grey-brown silty clay (11/12). The southerly ditch [11/04] was less truncated being 1.5m wide, 0.2m deep with a shallow U-shaped profile. It was filled with a friable mid grey-brown silty clay (11/05). The southern ditch is further from road than north one.

The road as seen within Trench 11 is not equidistant from both roadside ditches. The reason for this remains uncertain, but may be due to drainage issues on the sloping ground as well as the apparent curve in direction of the road itself.

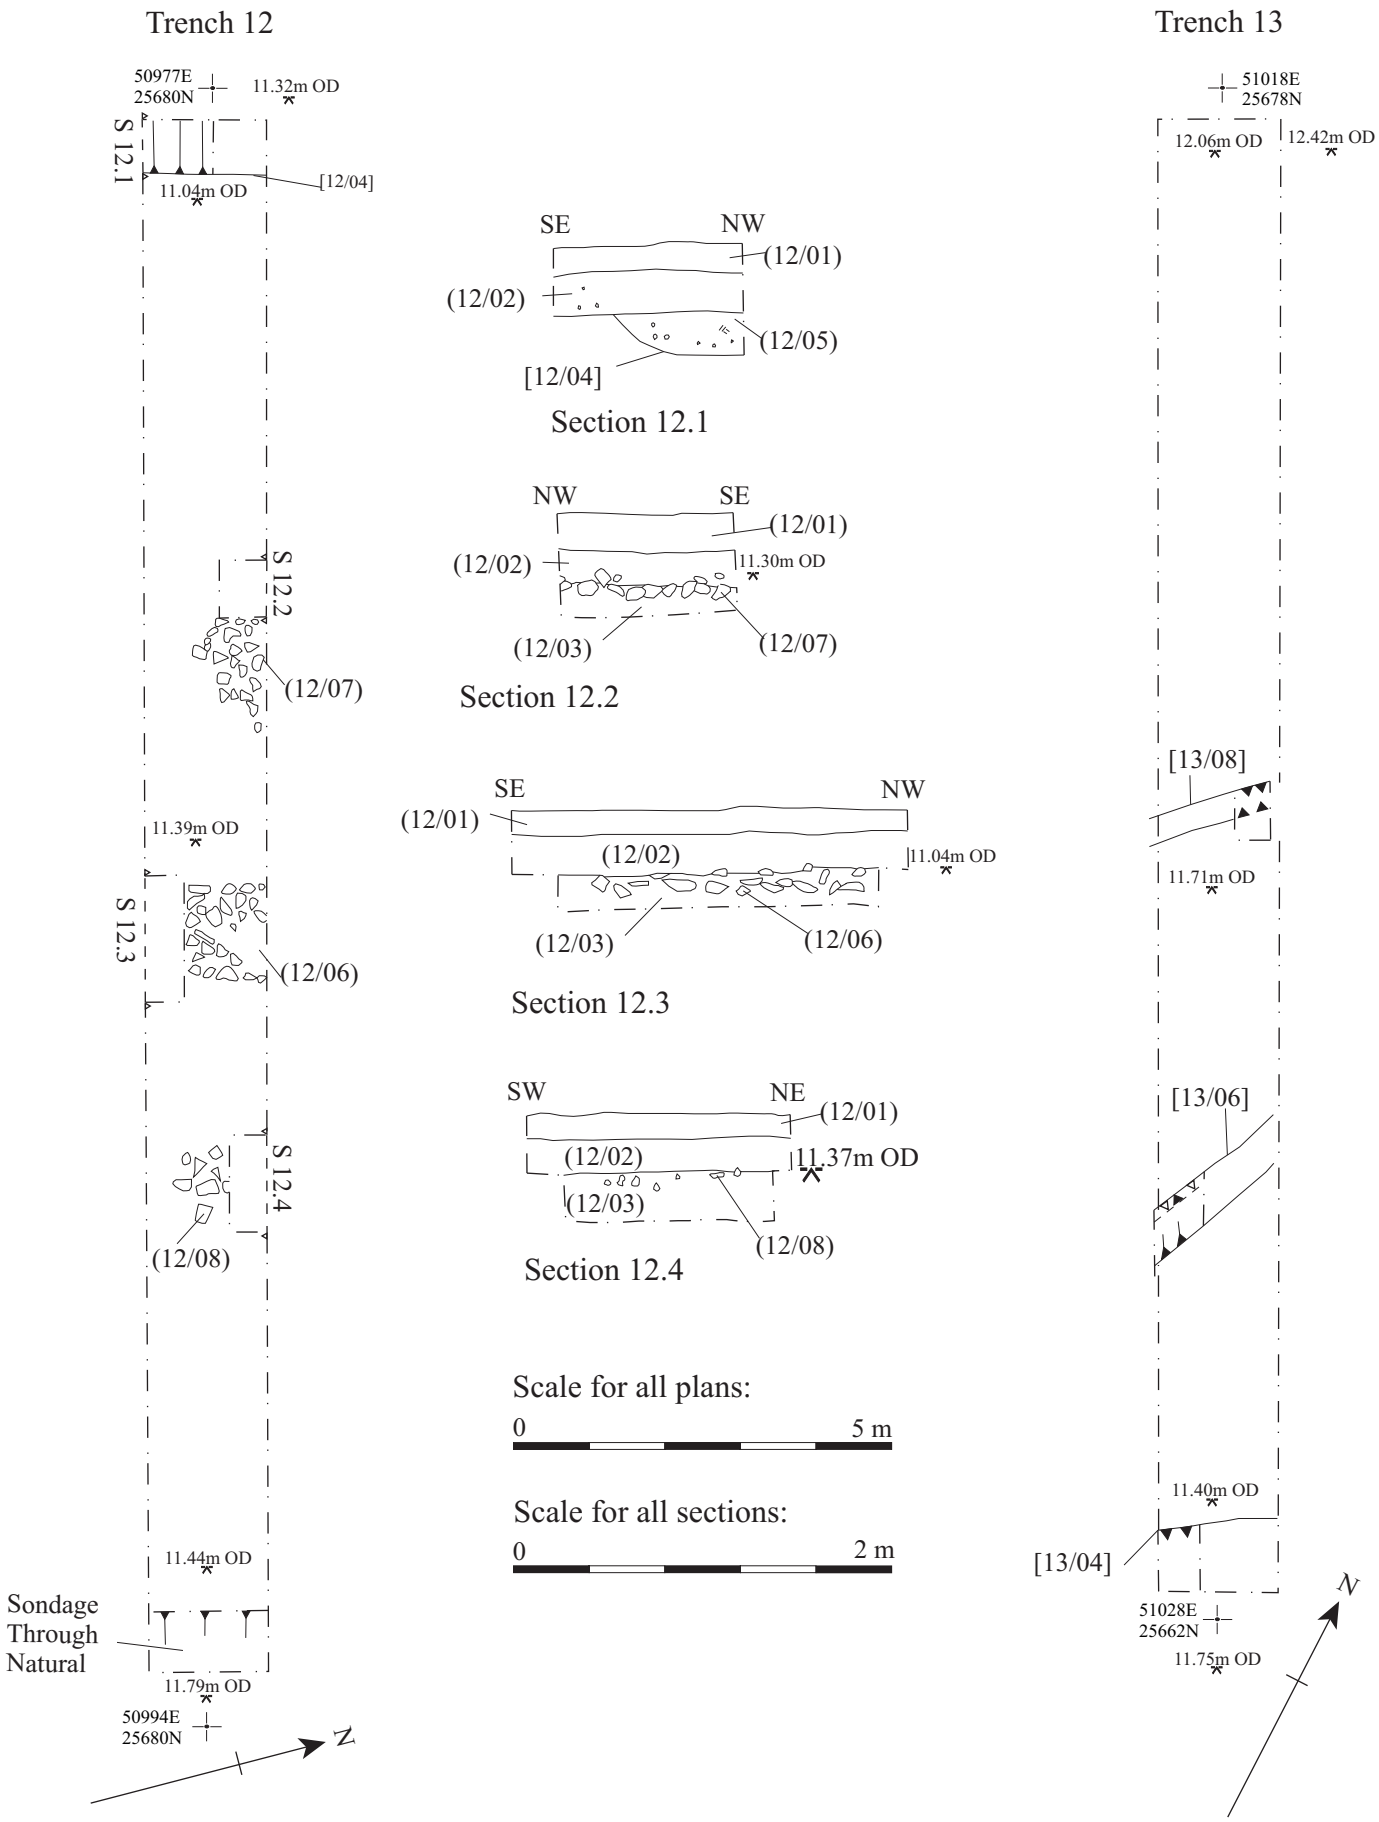
Figure 6. Plans and Sections of Trenches 12 and 13

The predicted pit and linear feature were not evident during excavation. The edge of a ditch or pit [12/04] was located at the western end of the trench. It was at least 0.7m wide, and 0.3m deep with shallow concave sides and a flattish base. It was filled with dark brown-grey clay (12/05) containing the occasional small stone and modern glass.

Within the trench were three distinct spreads of stone rubble (12/06), (12/07) and (12/08). All were only one stone thick, which was pressed into the upper surface of the natural. They measured 1.3m wide, 1.5m wide and 1m wide respectively.

It would seem likely that these represent the up-cast from the two pits predicted to the north and south of the trench on the geophysical survey. It is possible these represent heavily damaged remains of a floor or yard surface, with the geophysical results being erroneous as proved elsewhere.

The NW-SE linear feature predicted by the geophysical survey was a modern service [13/04]. A second modern service [13/08] was seen to the north of the trench. The other anomaly [13/06] within the trench was a variation within the natural geology.
