BOSTON GUILDHALL

ARCHAEOLOGICAL INVESTIGATION OF THE NORTH ELEVATION

Dr. KATE GILES
UNIVERSITY OF YORK

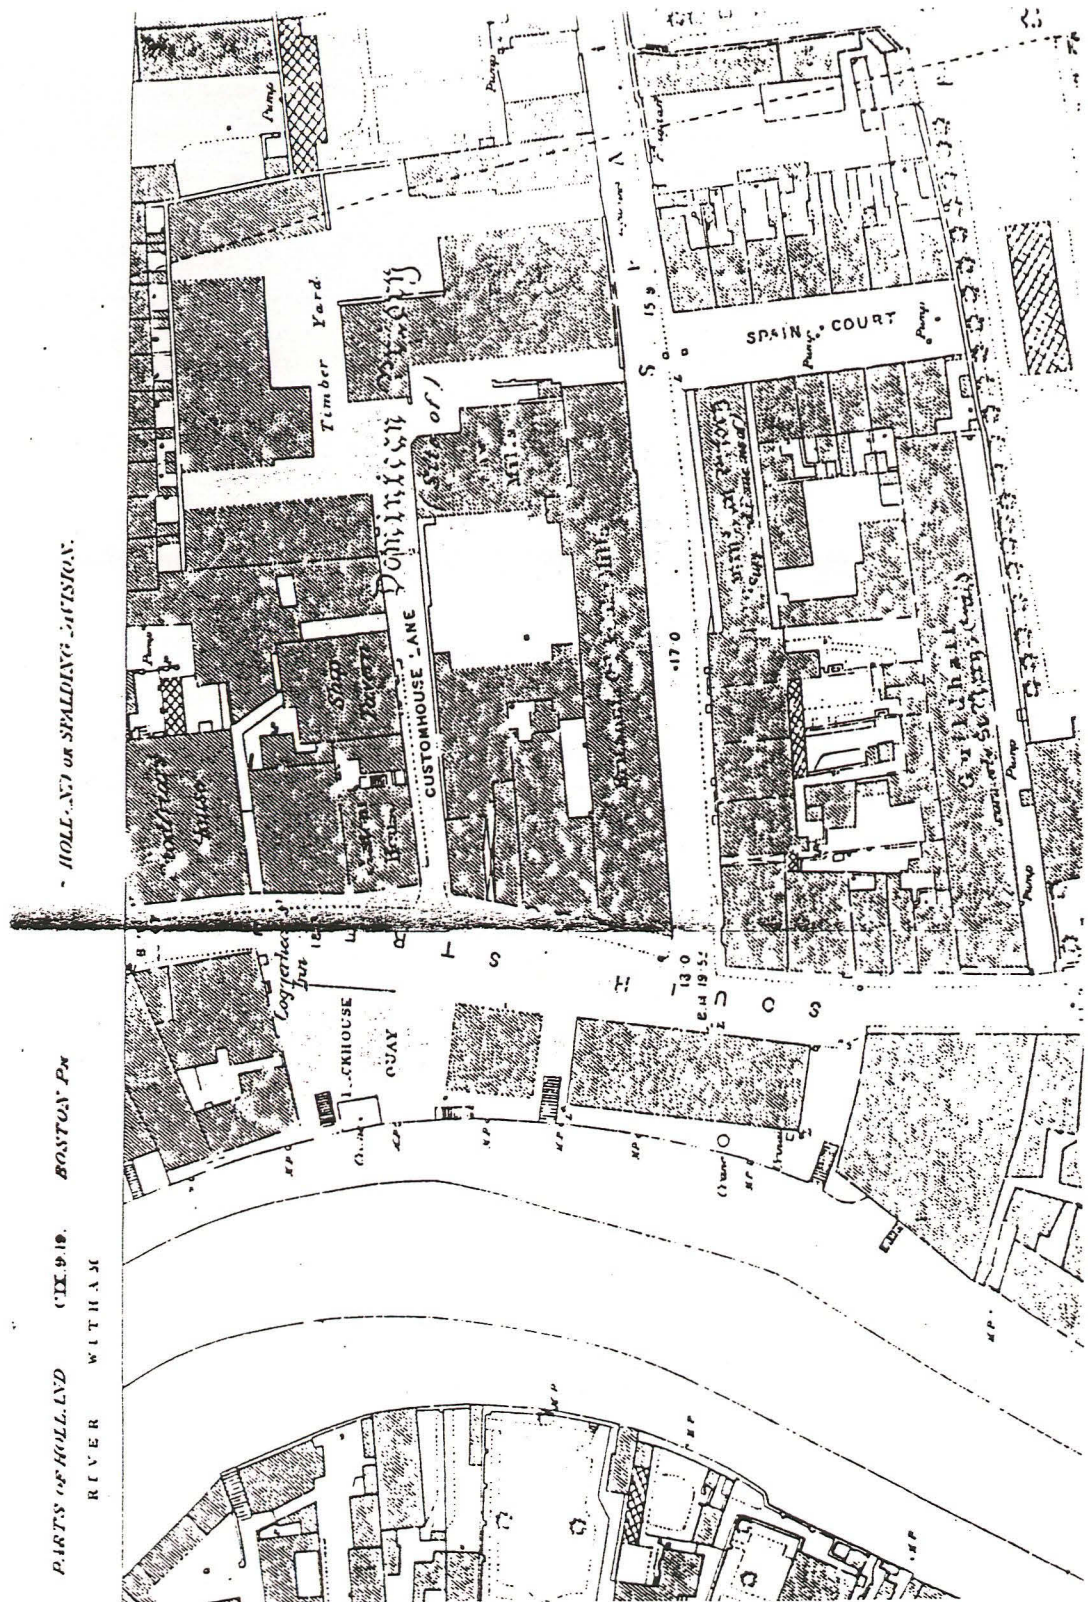
Fig. 2 O.S. Map of Boston, 1877.

2.2.2 The earliest map of Boston dates to 1741 (fig. 1) and shows the relationship between the Guildhall, Spain Lane and Beadsman's Lane. It is drawn schematically as a part of an undifferentiated block flanking a central open courtyard. More detail is provided by the early 1887 OS map (fig. 2), which contains important details about the tenements fronting Spain Lane and structures abutting the north wall of the Guildhall.

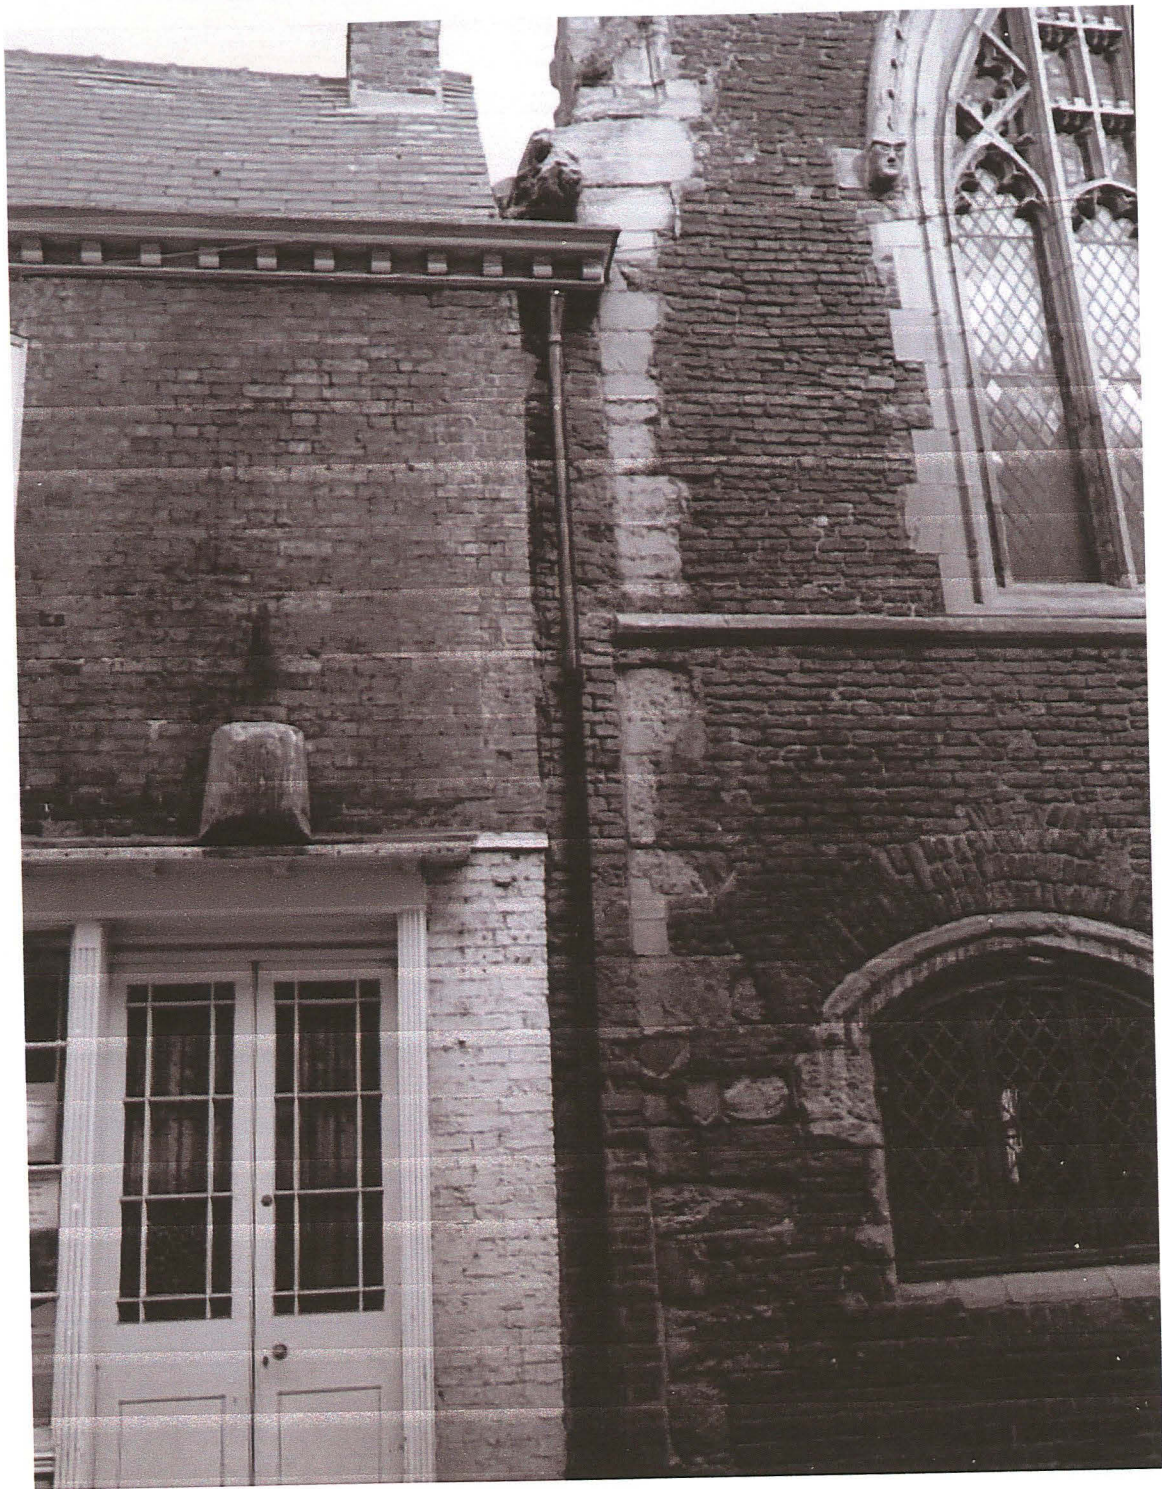
Fig. 3 The relationship between nos. 24-28 South Street and the Guildhall.

2.2.3 The site also comprises a range of three small shop units, nos. 24-28 South Street. These appear to abut the Guildhall but are actually separated from it by a gap of 0.30 m (fig.3). The present subdivision of the properties can be traced back to the early nineteenth century. It is shown on the OS plan of 1887. However, behind their eighteenth-century facade, the properties contain medieval fabric which is described and discussed in the Conservation Plan (3.5 Anderson and Glenn 2001, 29).

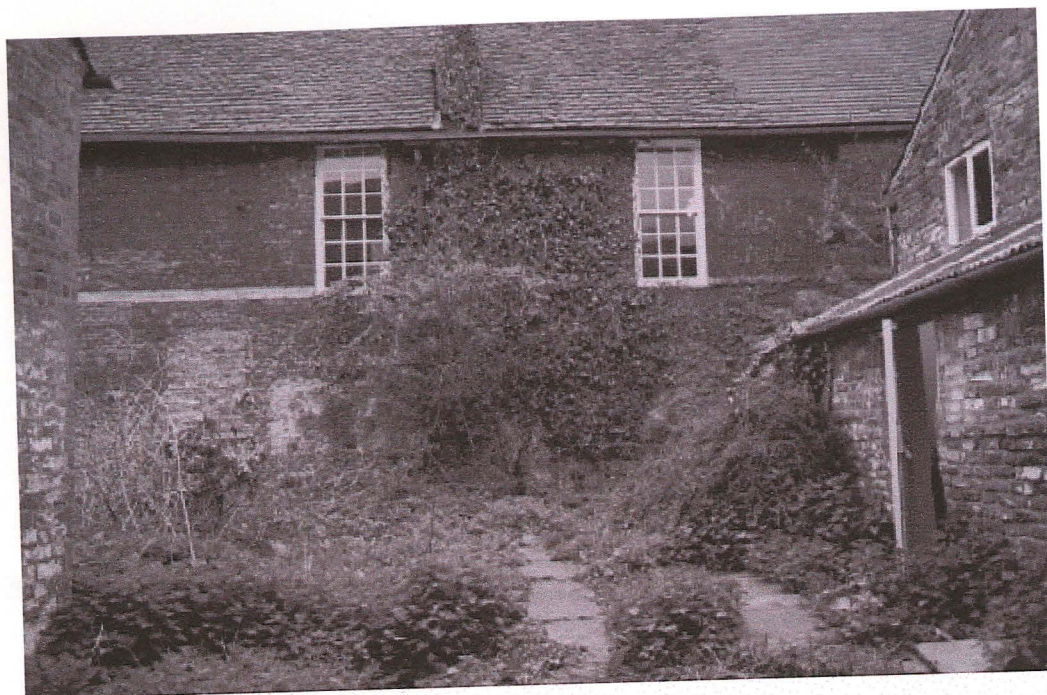
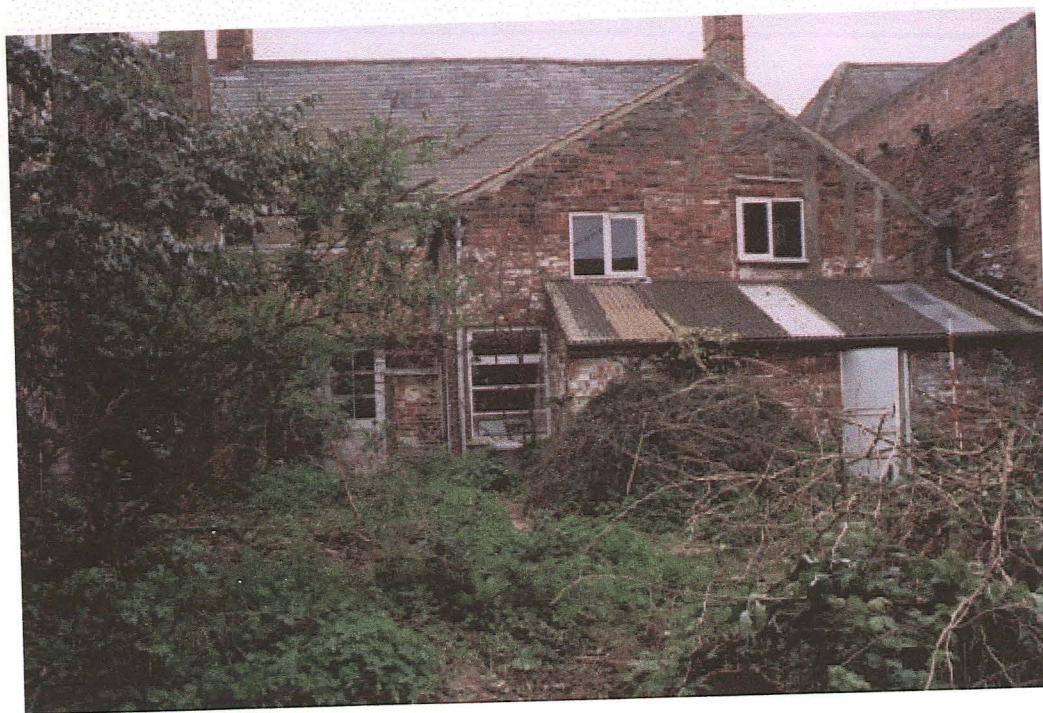
Fig. 4 The area north of the Guildhall, looking south (above) and looking north (below).

The area north of the elevation (fig. 4) is largely clear, except for extensive vegetation and the footings of former boundary walls and building structures. In the north-east corner of the plot is a brick shed with slate roof. This abuts a boundary wall which marks the limit of the survey.

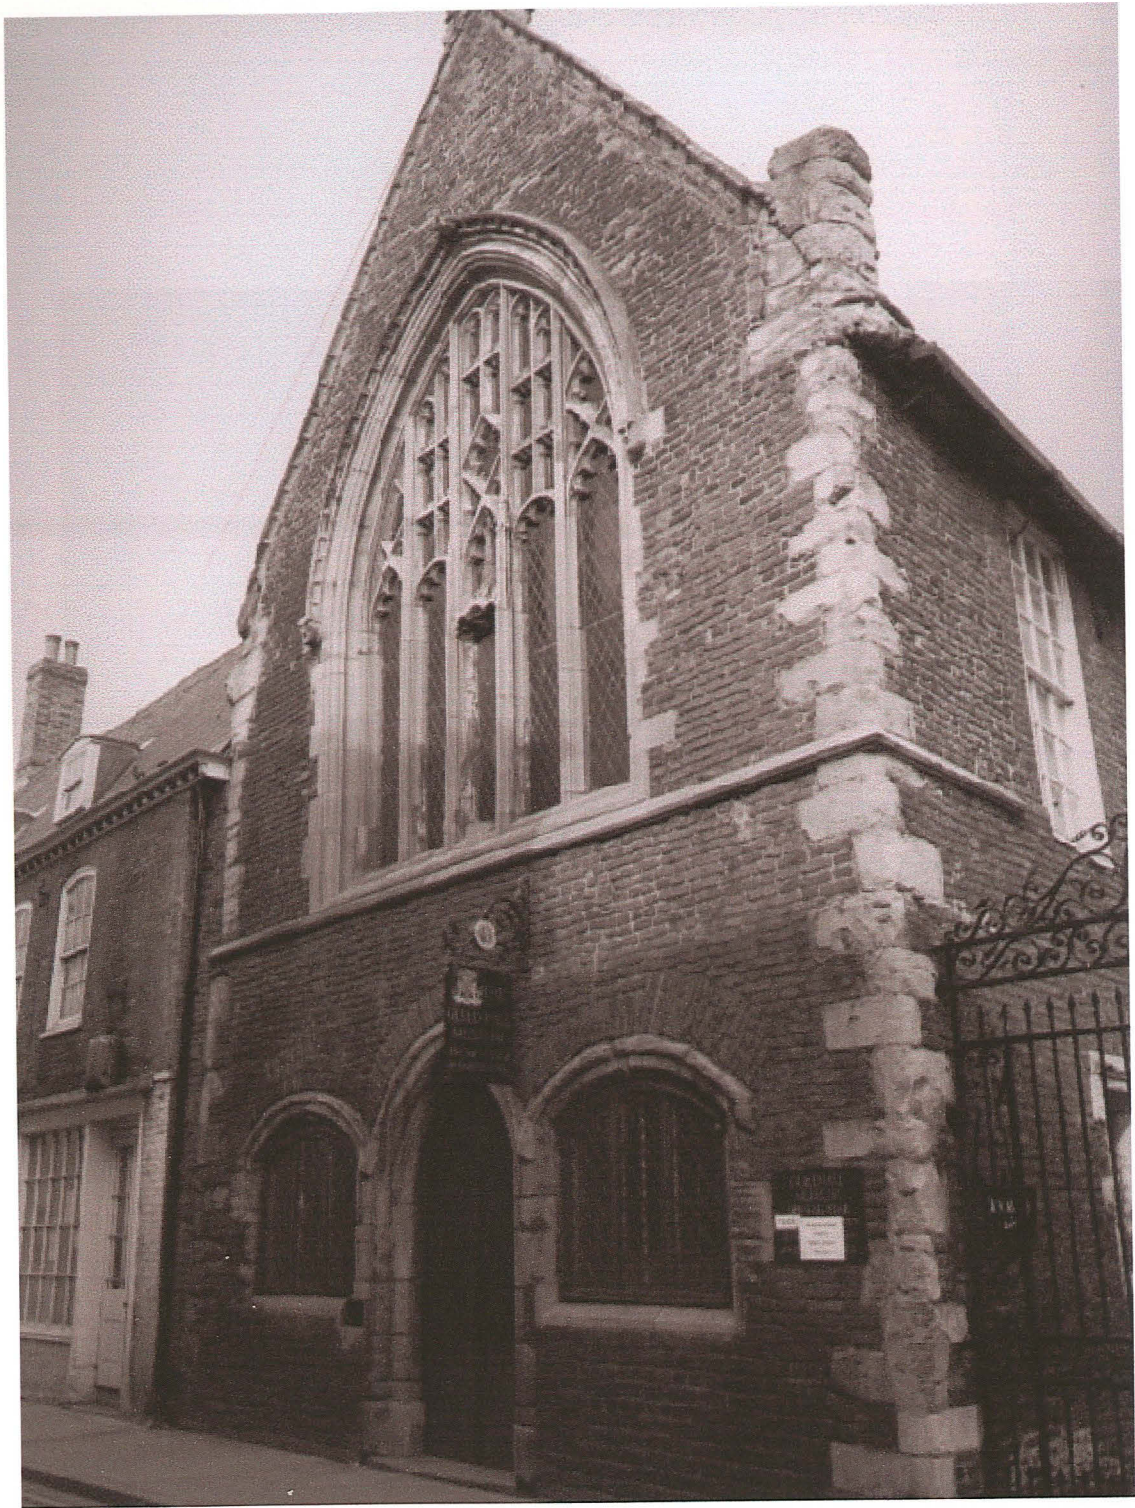
Fig. 5 The Boston Guildhall, West Elevation.

2.3.2 Construction date. The date of construction of the Guildhall has been given as c.1450 (figs. 5 and 6). This is based on stylistic and historical grounds rather than archaeological or documentary evidence. The brickwork appears to parallel that used in contemporary buildings such as Tattershall Castle.

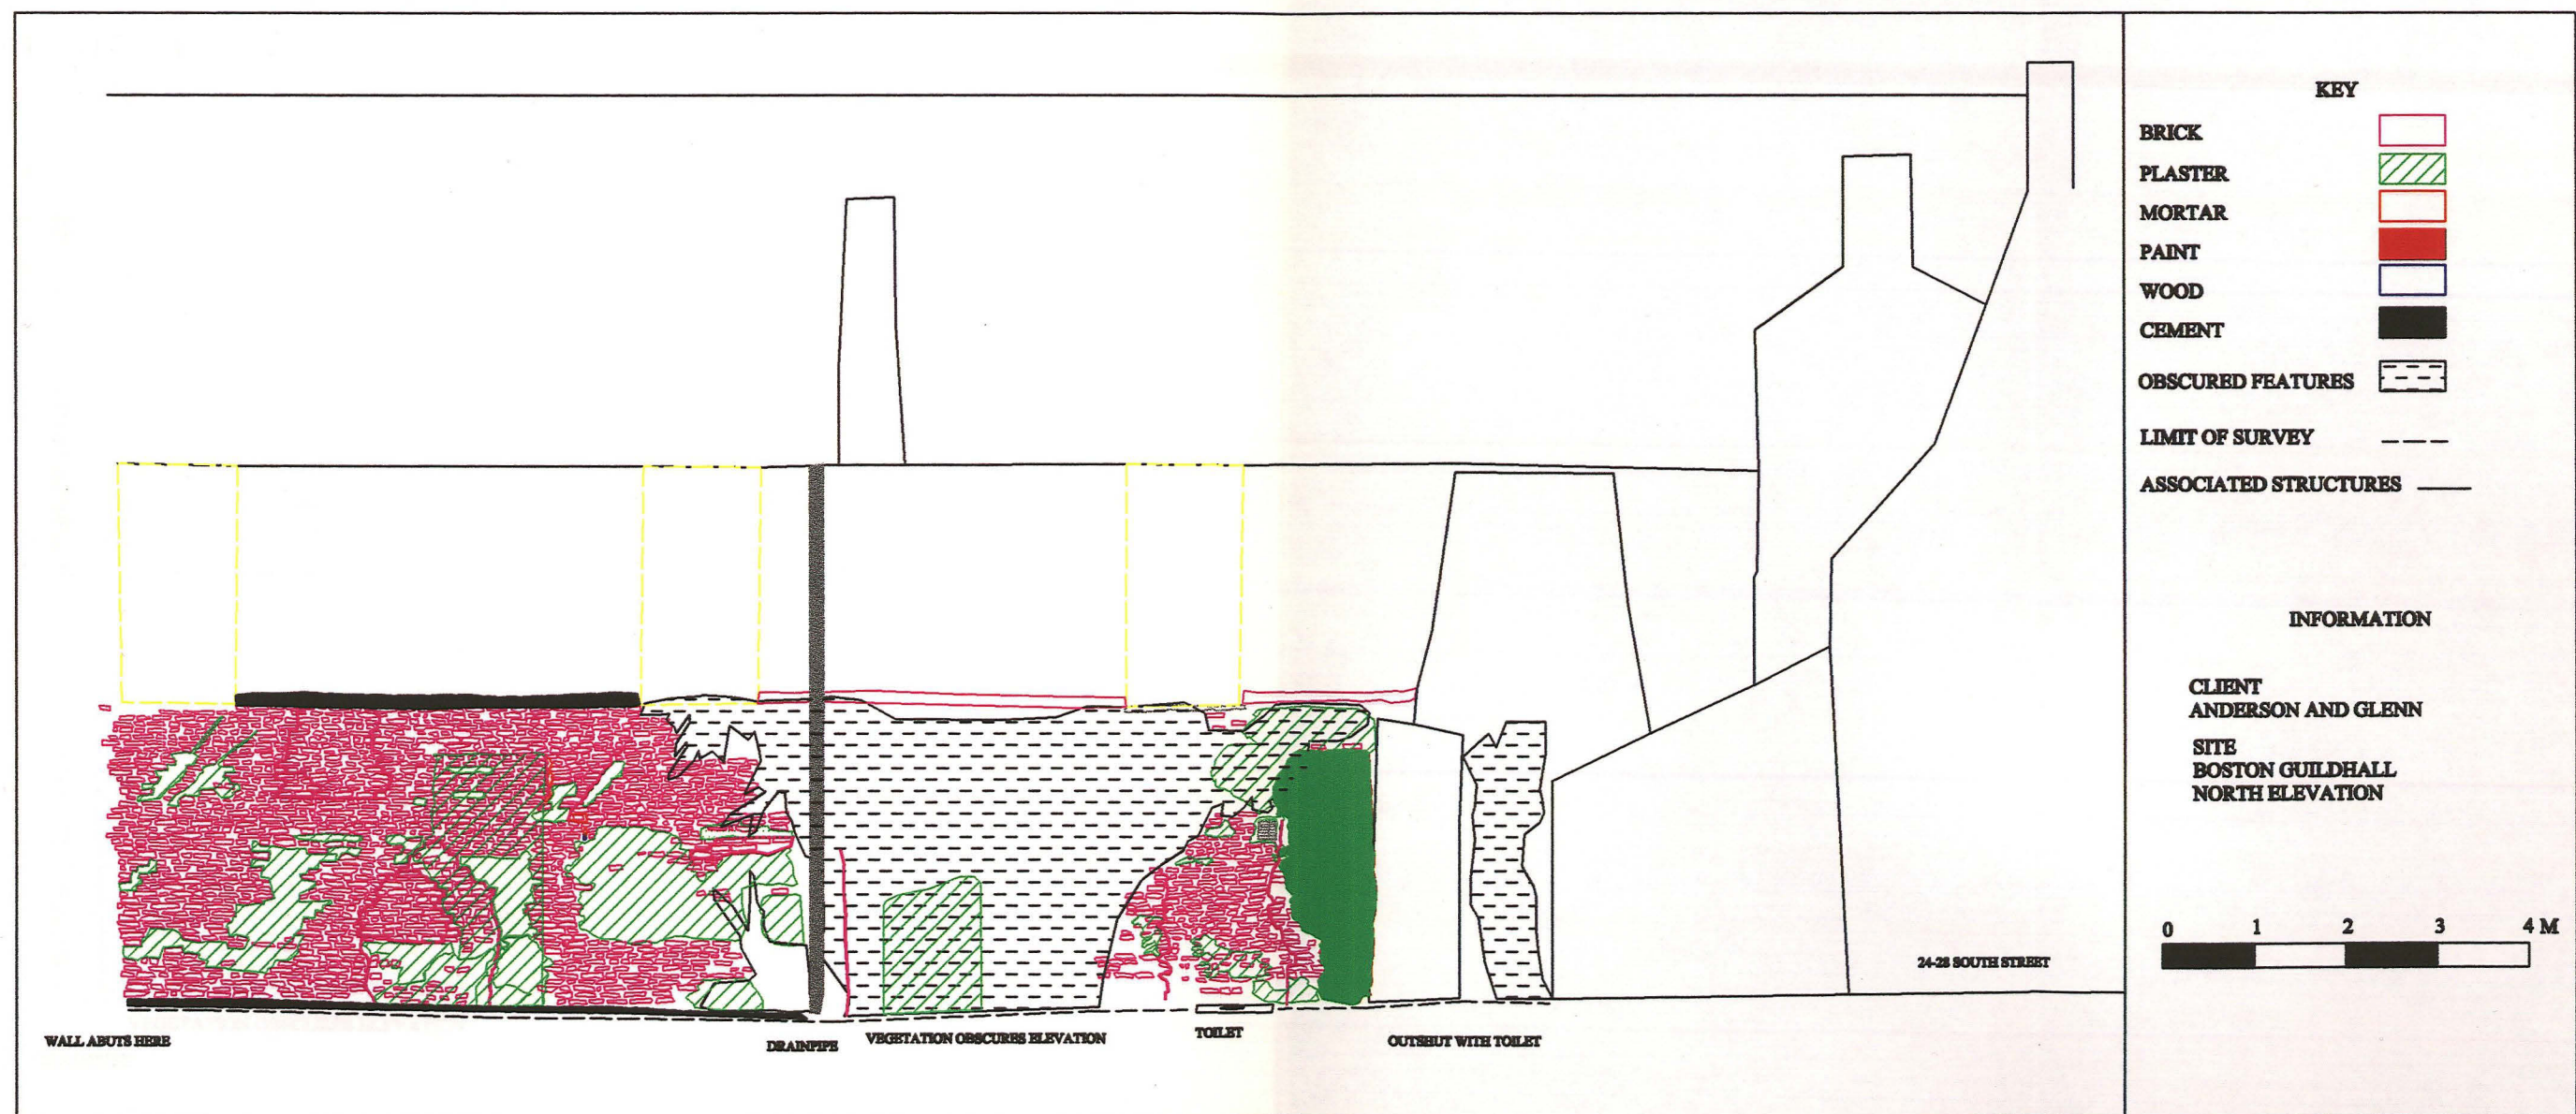
Fig. 13. CAD plot of north elevation of Boston Guildhall

The archaeological analysis which follows commences with a description of the architectural features and archaeological contexts at the west end of the building and moves eastwards. It relates to CAD drawings (figs 13, 14, 19) and photographs (figs. 15-18; 20-22).
