Bentfield Bury Farm, Stansted Mountfitchet, Essex.
Description and analysis of a timber-framed granary. Surveyed 19 03 2011.

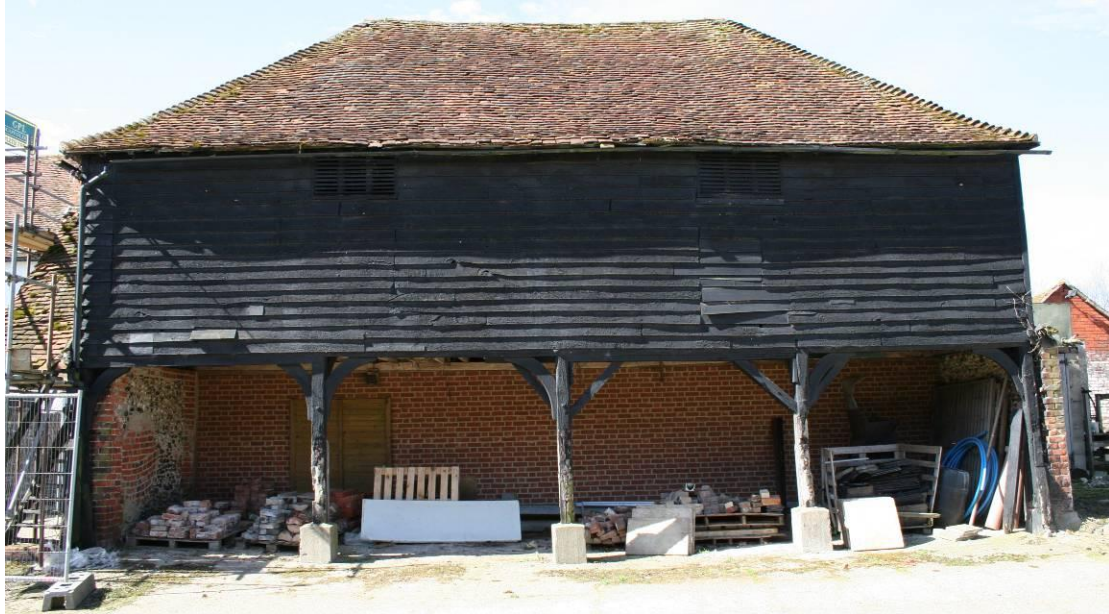
The eastern elevation.

The upper floor is a timber-frame clad with tarred 7in weather-boards fixed with wrought iron nails. There are a few inserted C20th replacement boards but most are original. There are two louvres positioned under the eaves to ventilate the granary floor.

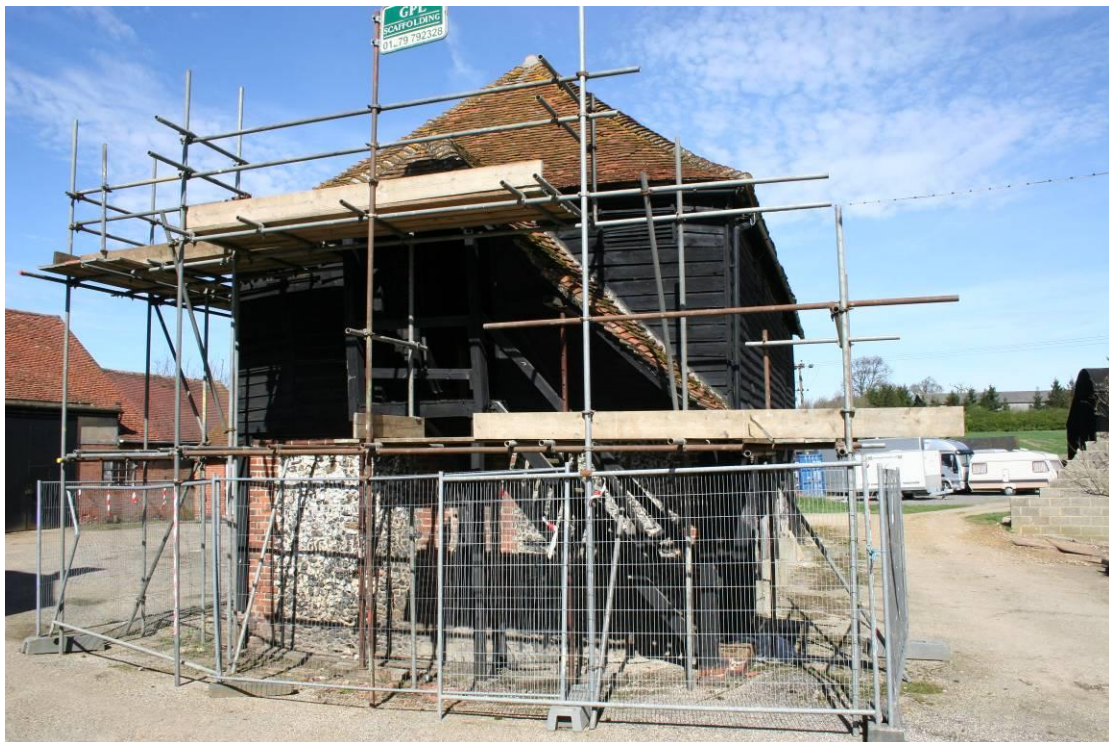
The south elevation shrouded in scaffolding.

At the time of the survey the south elevation was obscured by scaffolding. The elevation is dominated by the lucam, its ladder and a tiled roof which has been added later. The upper wall details are the same as for the eastern elevation with 7in tarred weather-boards and louvres beneath the eaves. There is a central timber door from the lucam.

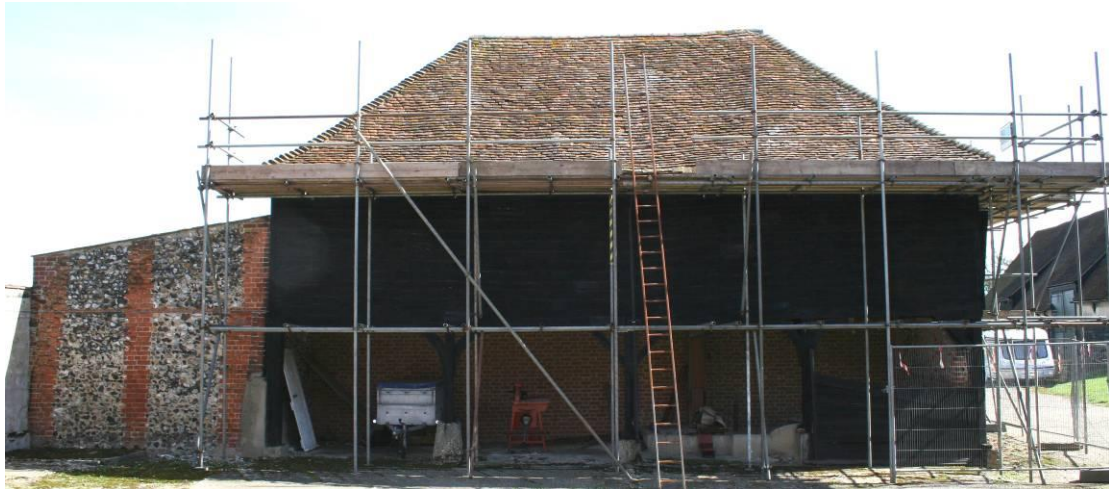
The western elevation.

The western elevation is a reflection of the eastern. Most of the original posts and braces are in-situ except for that at the NW corner which is a reused cill plate from a similar building.

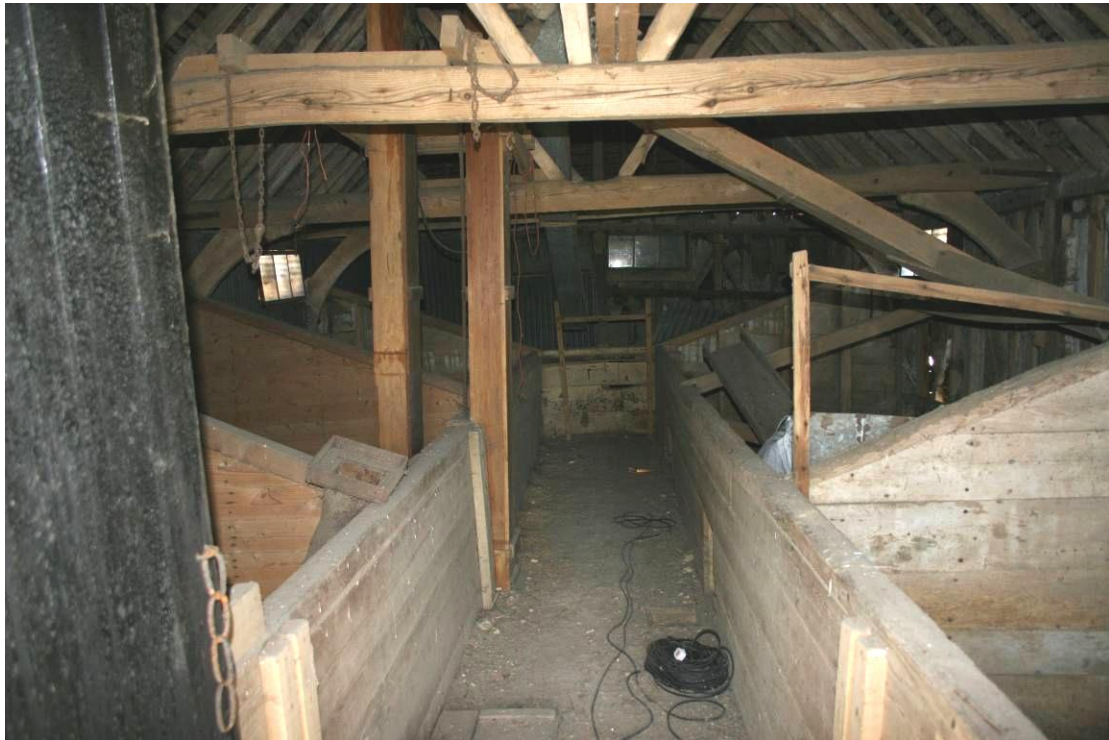
The granary looking north from the door.

The granary floor has been divided into 6 large grain bins each constructed of timber-frames clad with plain boards fastened with wrought iron rose headed nails. The grain bins to the west have been reclad with C20th tongue and grooved boards with galvanised French nails. There are also rails for drop boards so that the corridor can also be filled with grain. Each section has its own release chute cut into the floor which is made of 6.5in softwood tongue and grooved boards.

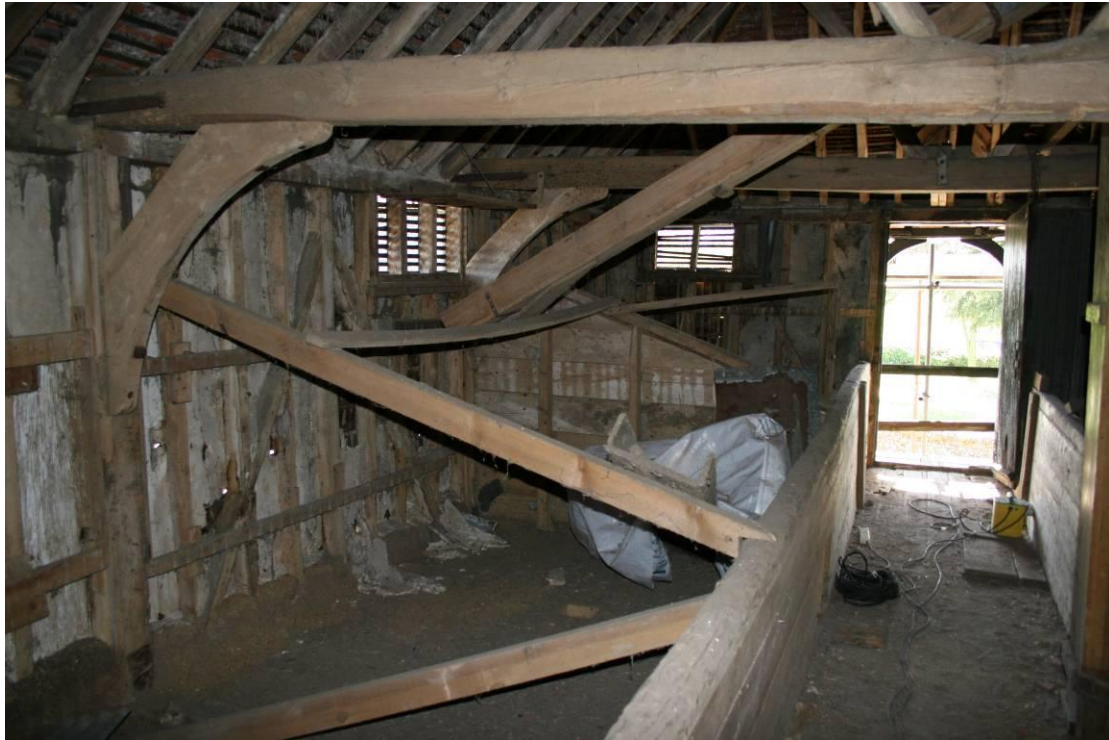
Tie-beams are supported on sculpted spandrels. Looking SE.

The walls are held in position by softwood tie-beams, sawn and adze finished to shape and supported on sculpted braces similar to those on the external posts and lucam. These are secured with large clout nails and slender wrought iron bolts with square heads. The tie-beams are held in place with wrought iron L-ties. There are a number of added C20th struts to prevent the frame from bulging under the weight of the grain.
