**ARCHAEOLOGICAL BUILDING SURVEY AND  
WATCHING BRIEF AT LOXBEARE BARTON,  
LOXBEARE, DEVON**

**Exeter Archaeology**

**Report No. 07.81**

**October 2007**

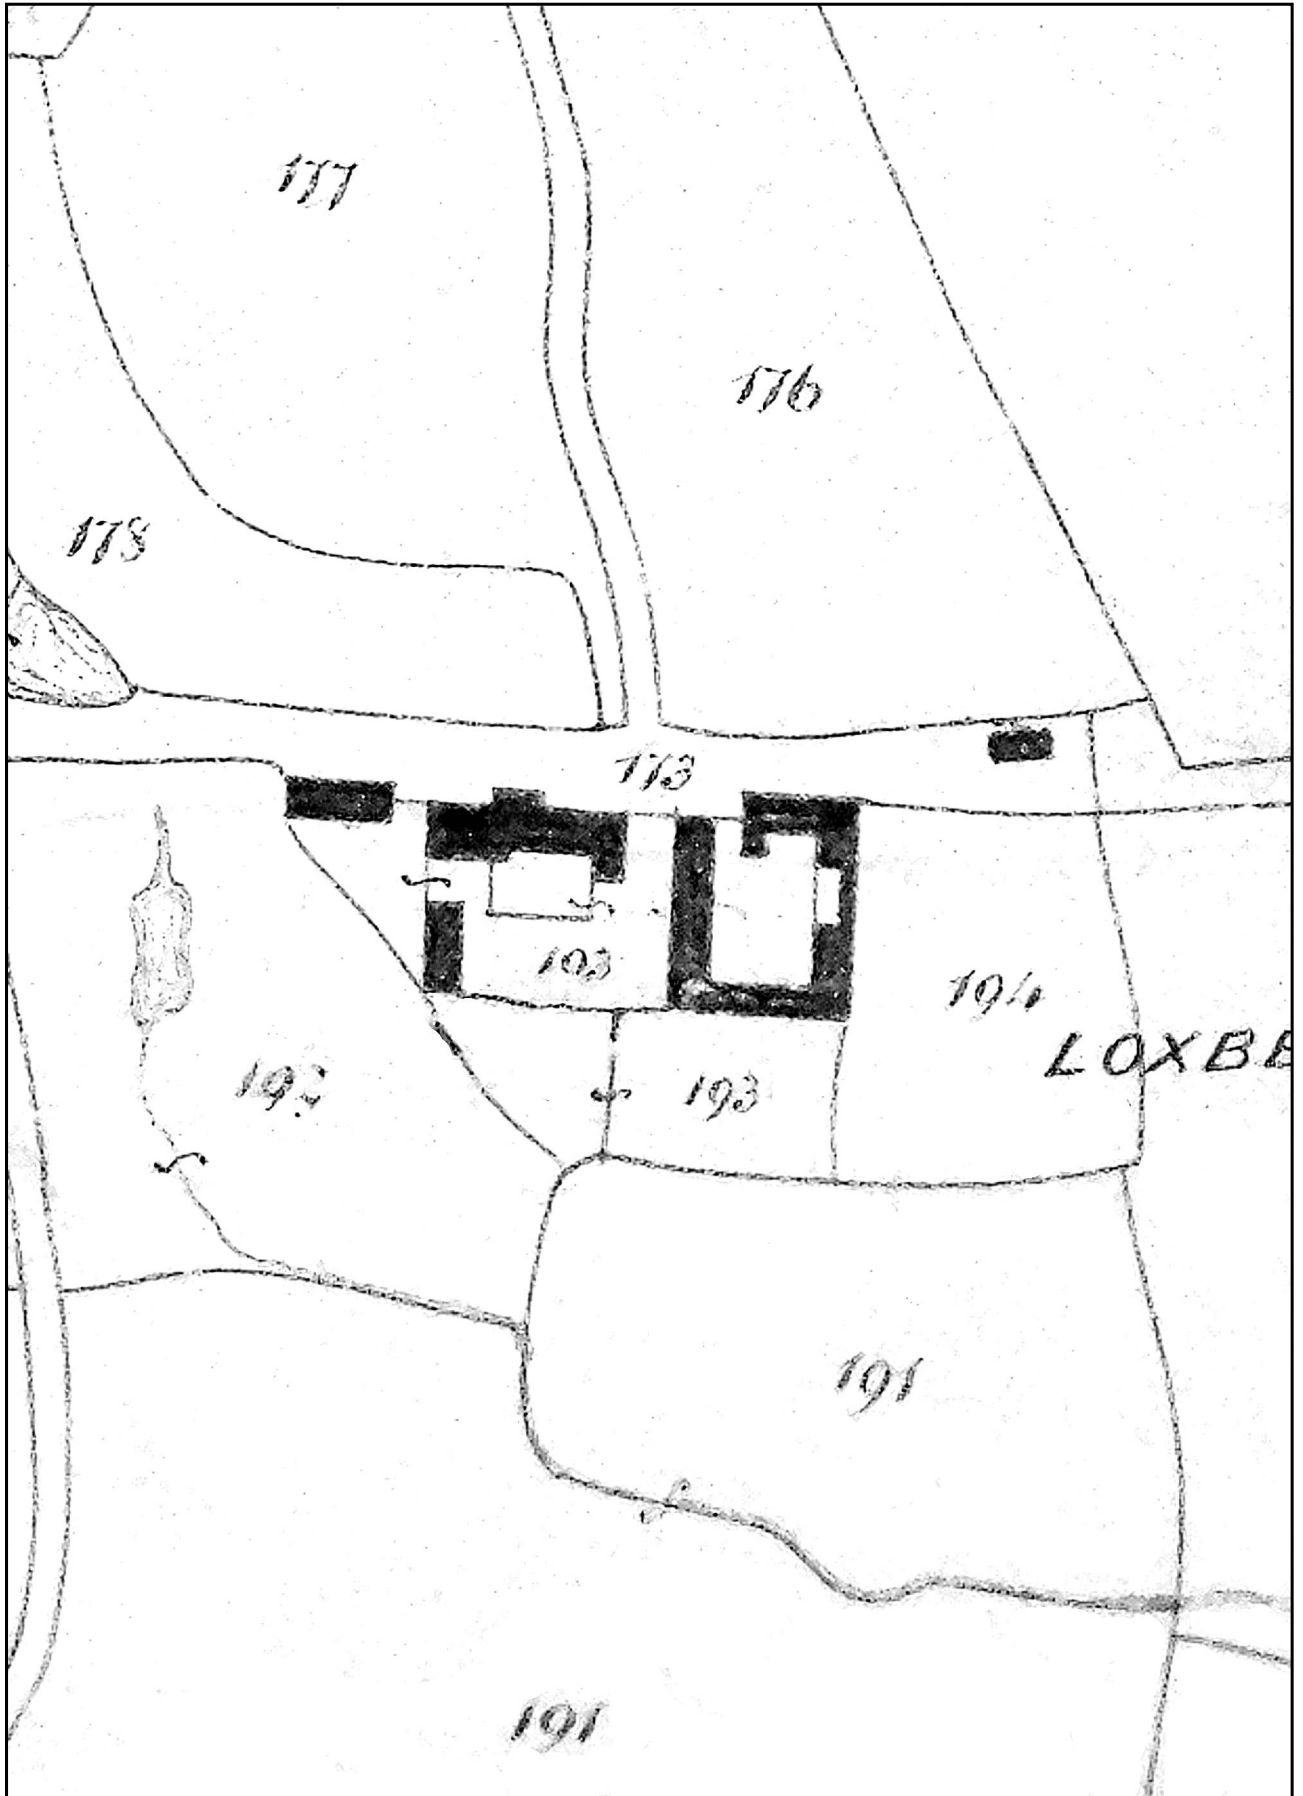
Fig. 3 Tithe Map of Loxbeare parish, Devon 1843.

Together with the threshing barn, the stable and the lincay, the root house, the lean-to against the south wall of the barn and cattle shed all seem to be represented on the 1843 parish tithe map (Fig. 3). The shed to the north-east of the threshing barn is not depicted however, and must date from between 1843 and 1888 when it is first shown on a map (Fig. 4). Its position against the barn suggests it housed some form of power source. Typically such a building might have housed a horse engine for a threshing machine, particularly as the northern elevation of the shed was originally open and would have provided significant ventilation. However, there is no sign of a beam for such an engine and the only opening into the barn is the single doorway, which would appear to be too low set. Based on information supplied by the builders, a waterwheel had been housed within the building, and Mr Heywood, the previous owner, had informed them that it ran a small mill. A working mill would benefit from the good ventilation of the building, and the door between the threshing barn and the shed allow for easy movement between the two.

It is notable that the tithe map of 1843 shows an unroofed area near the centre of the range on the eastern side. The area appears to match the location of the cob walling and altered doorway. The 19th-century trusses here would accord with the unroofed area being covered by 1888 (Fig. 4). This would also suggest that there was a return of the wall across the interior of the cattle shed from the northern jamb of the altered doorway.

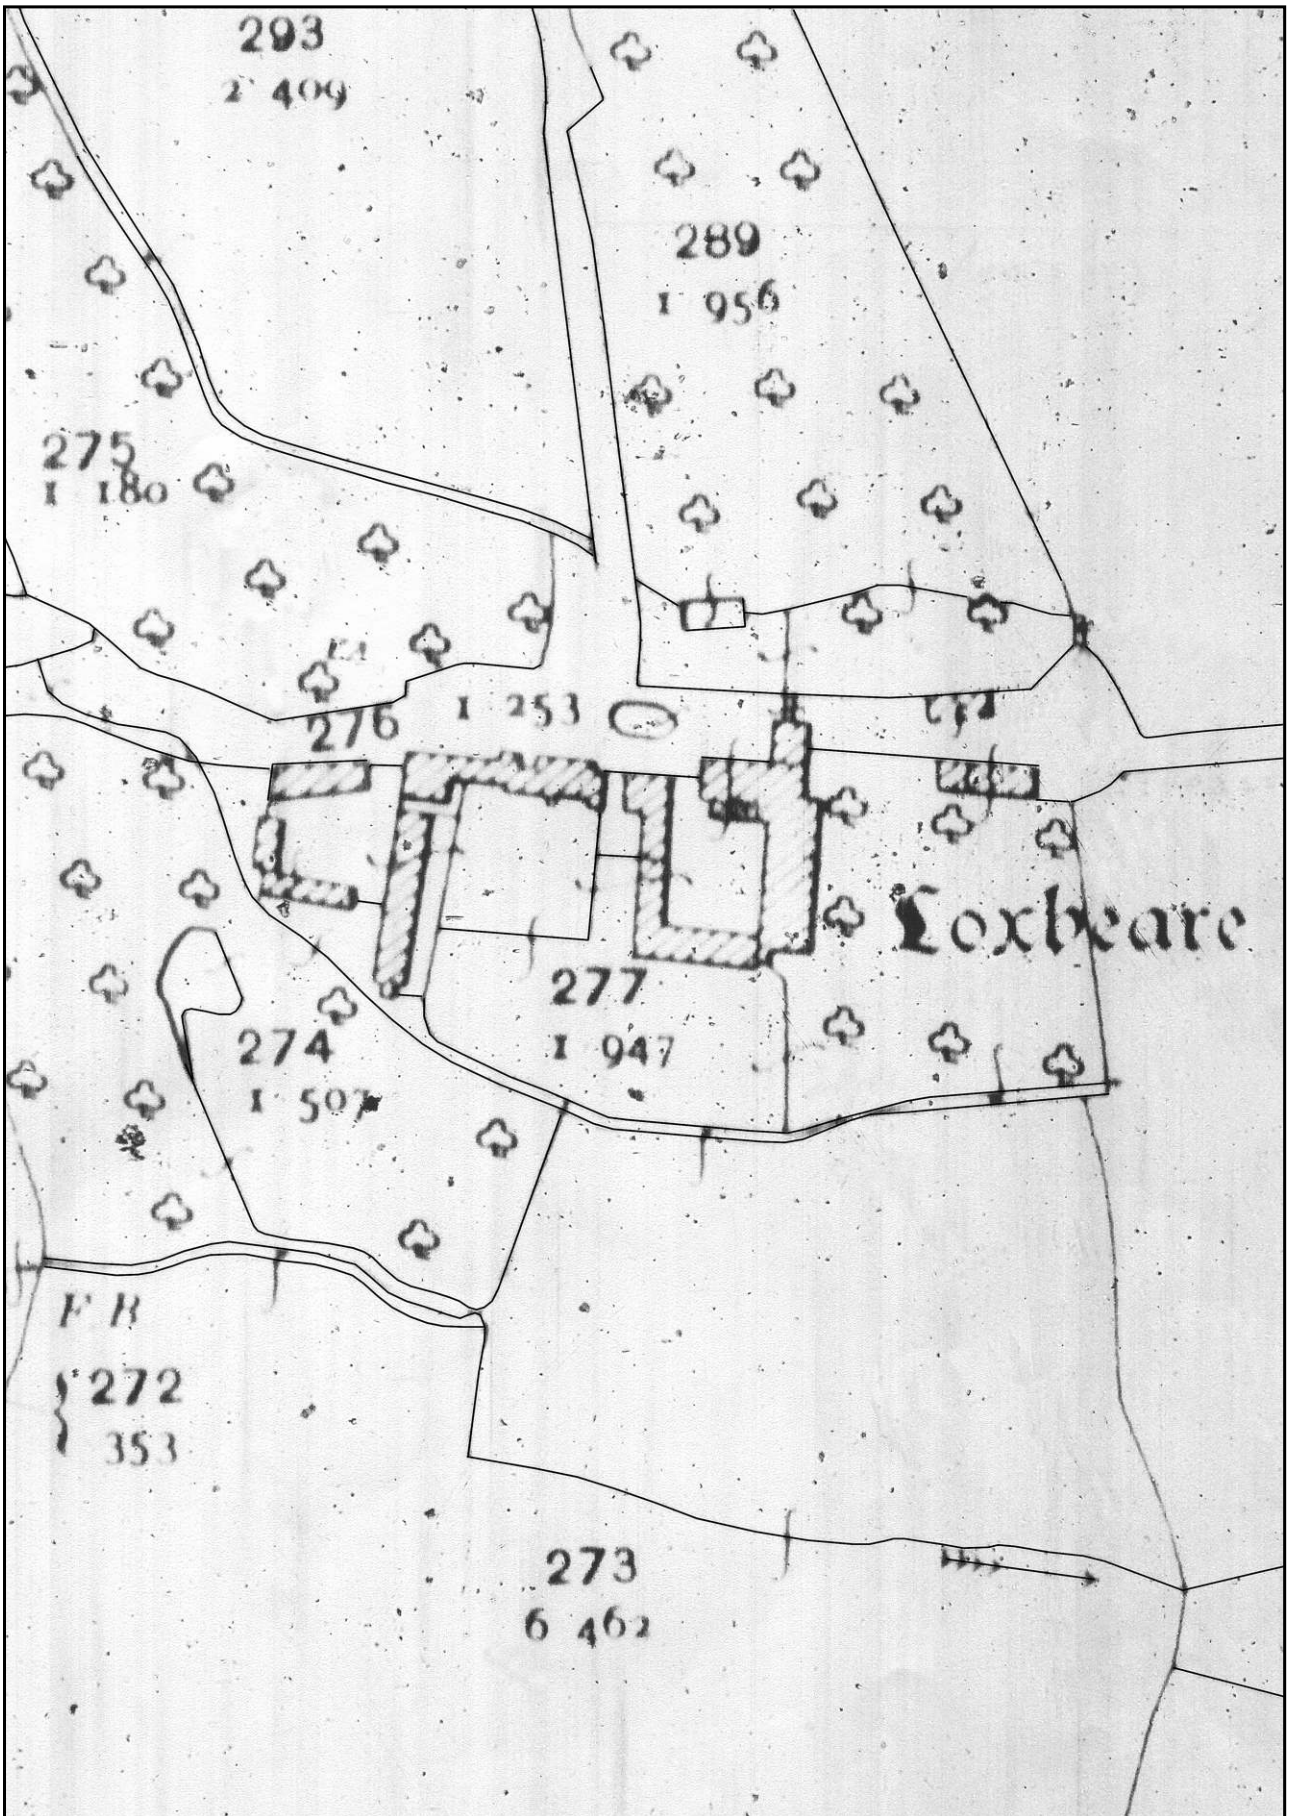
Fig. 6 2nd edition OS map 1:2500 Devon sheet XXXIV 13, 1904 (revision of 1903).

The lean-to looseboxes on the northern side of the threshing barn have brick built walls, and do not feature on the 1904 OS map (Fig. 6). As such, they may be identified as the latest construction on site, most likely dating to the early-mid 20th century.
