# **Jones' Farm, Dawson Lane, Chorley, Lancashire.**

## **An Archaeological Building Survey**

**October 2008**

Report ref. 0804

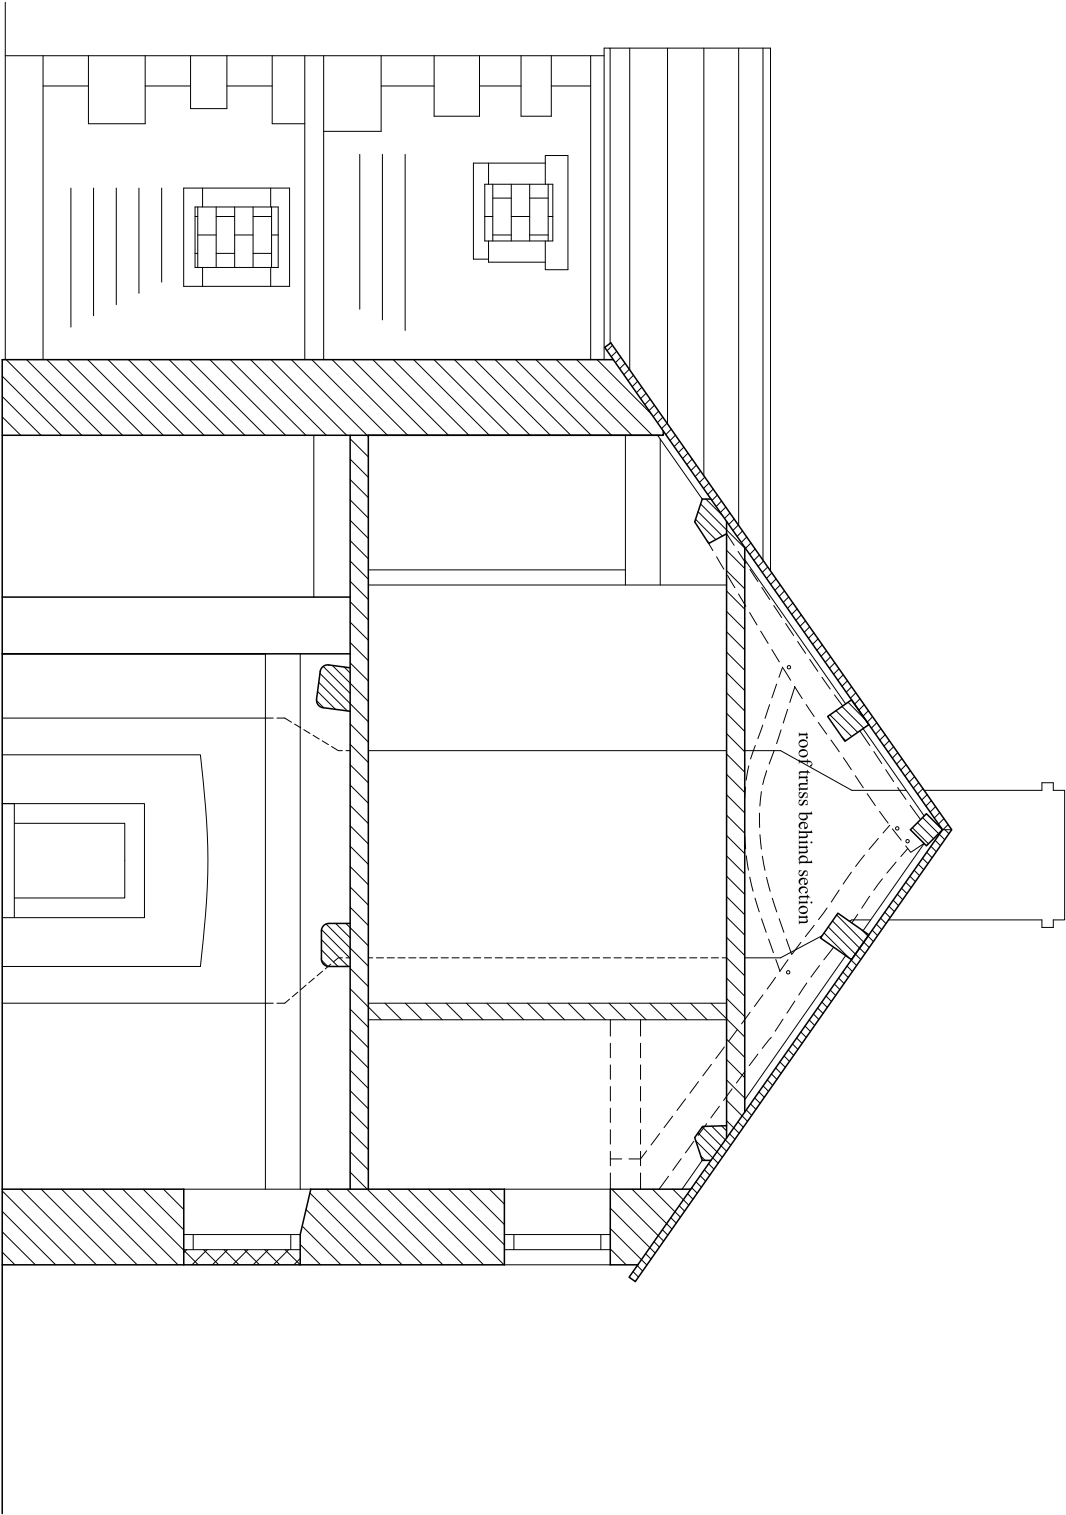
Figure No. 2  
Section A - A1

- Key for existing roof coverings:
- A = Slate roof coverings within indicated arrows
  - B = Large area of roof slate missing covered over with tarpaulin
  - C = Stone flag coverings within indicated area
  - D = Stone flag coverings within indicated area

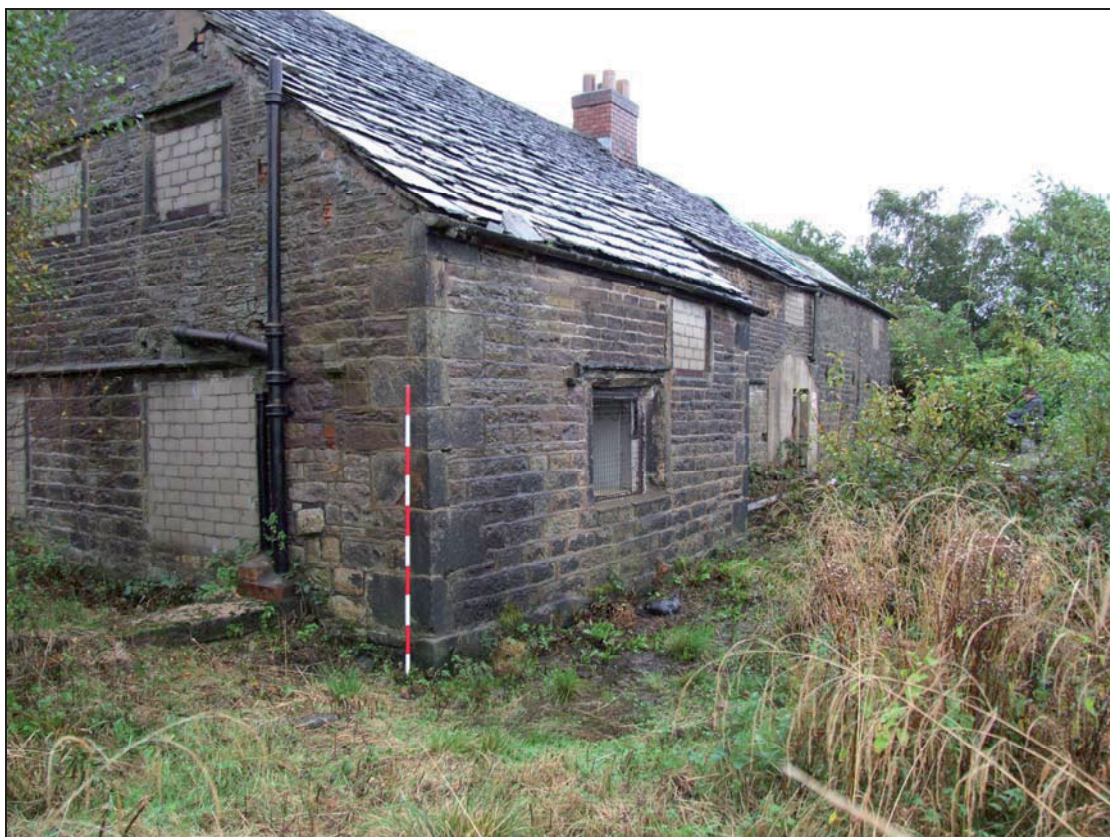
**Plate 8.** South and west elevation from the southwest

**6.5 Southern Elevation** (plates 7 & 8). This elevation forms the rear of the building and is characterised by several windows, most of which are sealed with modern concrete blocks. At the western end, the building protrudes, with the sandstone tile roof running down beyond the normal roof level. In this section are two square windows, both with chamfered sandstone jambs, one at ground floor level and the other on the below the eaves in the stairwell. The lower window is not blocked and has a timber frame with a cement rendered cill and a chamfered sandstone lintel. Above this is a hood mould with a dog-legged label stop at the west end, the right end butting the stairwell window. This latter window has a chamfered sandstone cill. The corners of this projection are constructed in staggered quoins. To the east of this the face of the main building continues. It has three windows, two of which at first floor level are situated below the eaves. The western most of these two is not blocked and contains a timber frame with three lights. Below this window is another, but with chamfered sandstone jambs, lintel and cill, and a hood mould above. To the west, this the hood mould joins the east face of the projection and to the west terminates by a patch of cement rendering around a personal doorway. This is timber framed and fitted with a batten & braced timber door. The lintel is chamfered sandstone and the top half of the eastern jamb is also chamfered. The area around the doorway retains evidence in the form of a roofline, of an attached single storey gabled porch. The eastern end of the main building is marked by a straight joint and quoins running down the wall. The first extension houses two windows at ground floor level, both blocked in the same style as the wall, making them difficult to recognise, except for the large sandstone lintels above. Quoins and a straight joint once again mark the end of this building and the construction of the second extension. This has a single square window at first floor level, with a heavy sandstone cill and lintel. The whole building is constructed in coursed, shaped sandstone rubble. However, the first floor level of the first extension is constructed in rough un-coursed sandstone, as is the second extension. Six diamond shaped iron-bracing plates are also located across the face of both extensions.

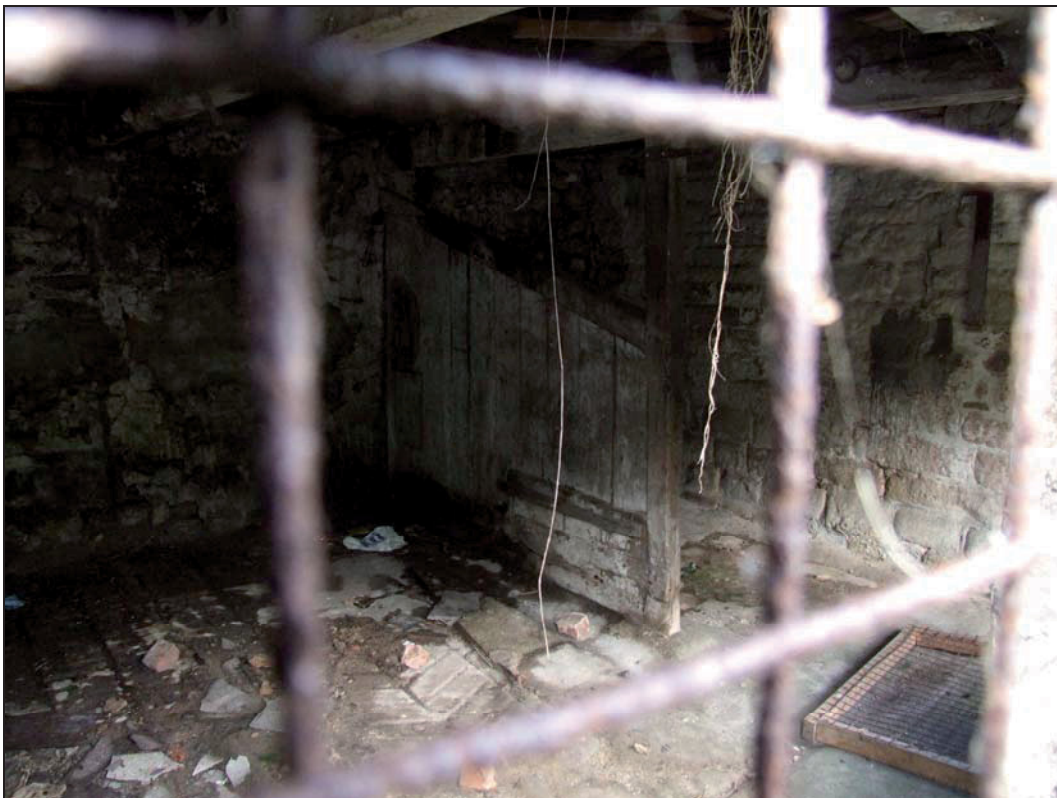
**Plate 10.** View of interior of the first extension from the north east

- 6.7 Extensions 1 and 2.** (4.48 x 4.92m & 4.48 x 3.60m) Full access to these rooms was not available and consequently only a limited survey could be undertaken. Access to the first extension is via a doorway in the northern wall. Although having no frame or door the doorway is fitted with an iron grate. The floor of the room is concrete and the walls whitewashed in lime. The walls appear to have been constructed with uncoursed rough rubble, with the exception of the west wall, which is coursed sandstone blocks, having once formed the original east elevation of the main building. A timber partition (stall) is located at the east end of the room, running from the south wall halfway into the room, suggesting use as a stable. The ceiling is timber with two timber beams running north – south across the room. A square window fitted with an iron grate is located in the north wall, west of the door (plate 10). The second extension was originally accessed via a door in the east elevation, although this has been recently blocked. The walls have again been whitewashed and are constructed of uncoursed rough rubble. Likewise, the western wall is once again constructed in coursed sandstone blocks, having once formed the east elevation of the first extension. The ceiling is timber and the floor concrete. A timber workbench is located on the east wall and a window fitted with an iron grate is located in the east of the north wall (plate 11).

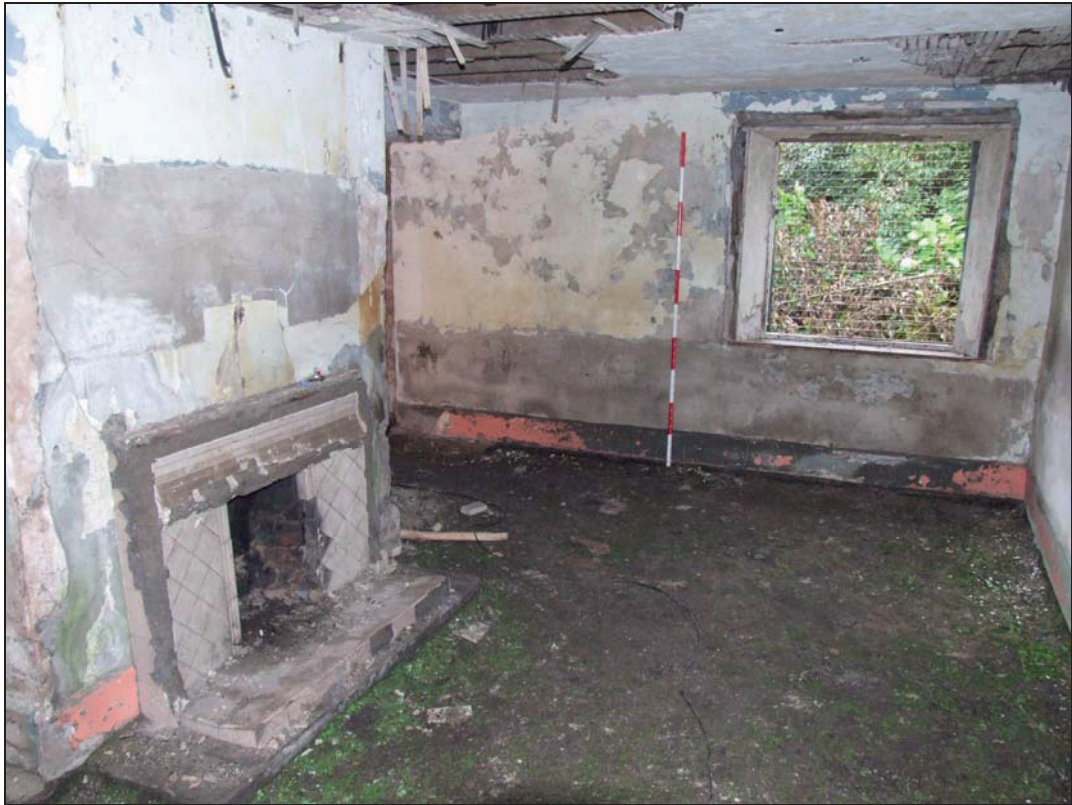
**Plate 13.** Room 1 from the south east

to a small corridor giving access to room 2 and the porch (plate 13). The ceiling, though dilapidated, still has patches of lath and plaster on the timber joists and a concrete skirting runs around the base of all the walls.

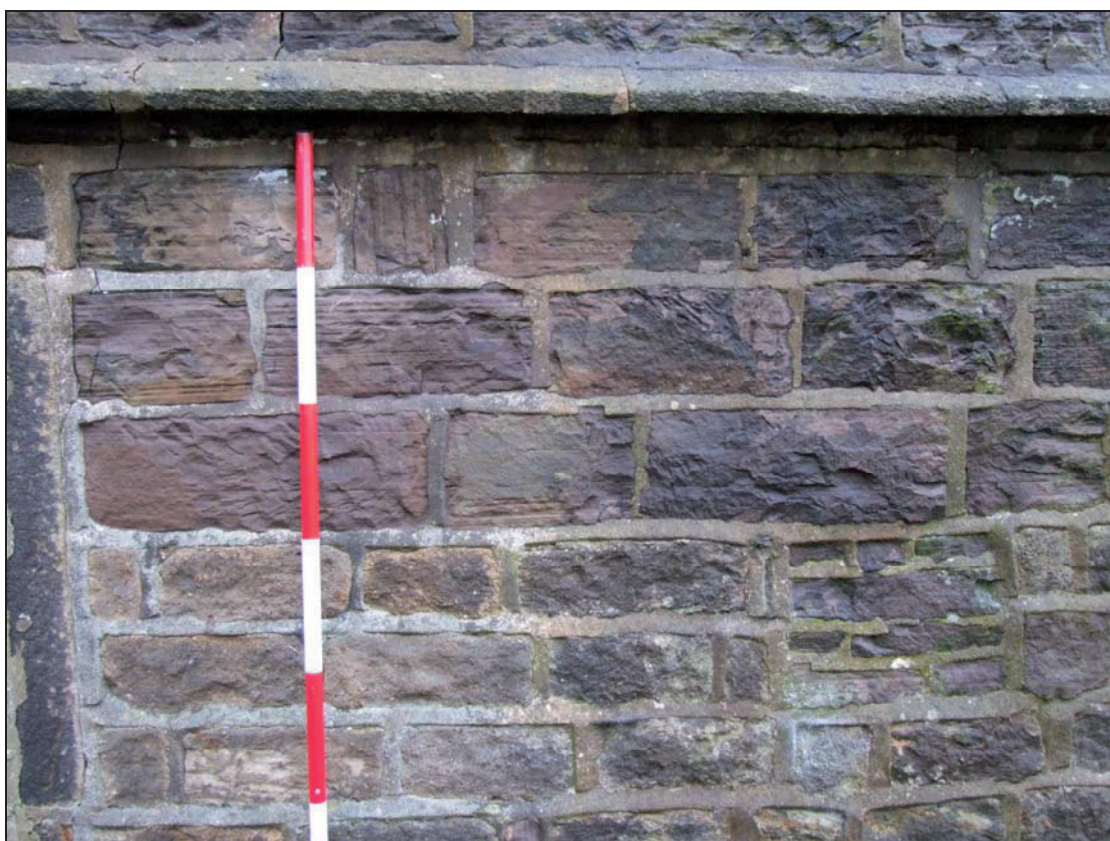
**Plate 34.** Detail of stonework of main building

- 6.3 Northern Elevation** (plates 1 & 3). This elevation comprises the front of the building and is constructed in coursed and shaped sandstone block, re-pointed with cement (plate 34). The second extension, furthest to the east, is constructed in uncoursed rough rubble (plate 35). The face is characterised by several windows and a protruding porch. The second extension has a single window at ground floor level, with a sandstone cill and dressed sandstone jambs and lintel. It has no frame remaining and was previously a doorway, blocked to form a window, as evidenced in the straight joints and sandstone jambs reaching ground level and the sandstone blocking beneath it; it has been fitted with a metal grate. A small wind eye is located centrally, close to the roofline. In the first extension, located between the second extension to the east and the main building to the west, two square windows, one at ground floor level, the other above it, are located in the western side. The ground floor window has a sandstone cill and lintel, but no frame and is fitted with a metal grate. The first floor window has no cill or jambs and is located below the roofline, the aperture is fitted with a timber frame. A large personal timber framed door with heavy sandstone lintel is located to the east, fitted with a metal grate. Six diamond shaped faceplates are located across the face of both extensions (plate 4). The main building has eight windows in total, four at each level, all of which are blocked, with the exception of the eastern ground floor window. This square timber framed window has a chamfered sandstone cill, jambs and lintel, although the cill has been cement rendered. A hood mould is located above this with a dog-legged label stop at its eastern end and runs west. Above this window is another square window, located below the eaves has a cement rendered cill. West of these is the projecting face of the porch, built in the same manner as the rest of the building, but with a gabled slate roof running south to meet the northern pitch of the main building. This contains two small, decorative arched windows. The ground floor window has a sandstone surround, the lintel shaped to form an arch. Located at first floor level, is a two light chamfered mullion window with a sandstone surround shaped similar to the window below, but having two round-headed lights. Between these is the extended hood (drip) mould, which continues to run along the elevation (plate 5). To the west, on the face of the main building once again, are four landscape windows. The two at ground floor level have chamfered sandstone cills and lintels, and sandstone half jambs, supporting the lintel. Above this, the prominent hood mould runs the length of the face. The two windows above have cement rendered cills and rise up to the roof level. The eastern most of these is not fully blocked, and three lights can be seen at the top. A low chamfered plinth runs around the face of the building.
