Reconstruction of Marton Bridge, Warwickshire:

Archaeological Recording - Stage 1 Preliminary

Surveys and Stage 2 Trial Trenching

Report 9921
April 1999

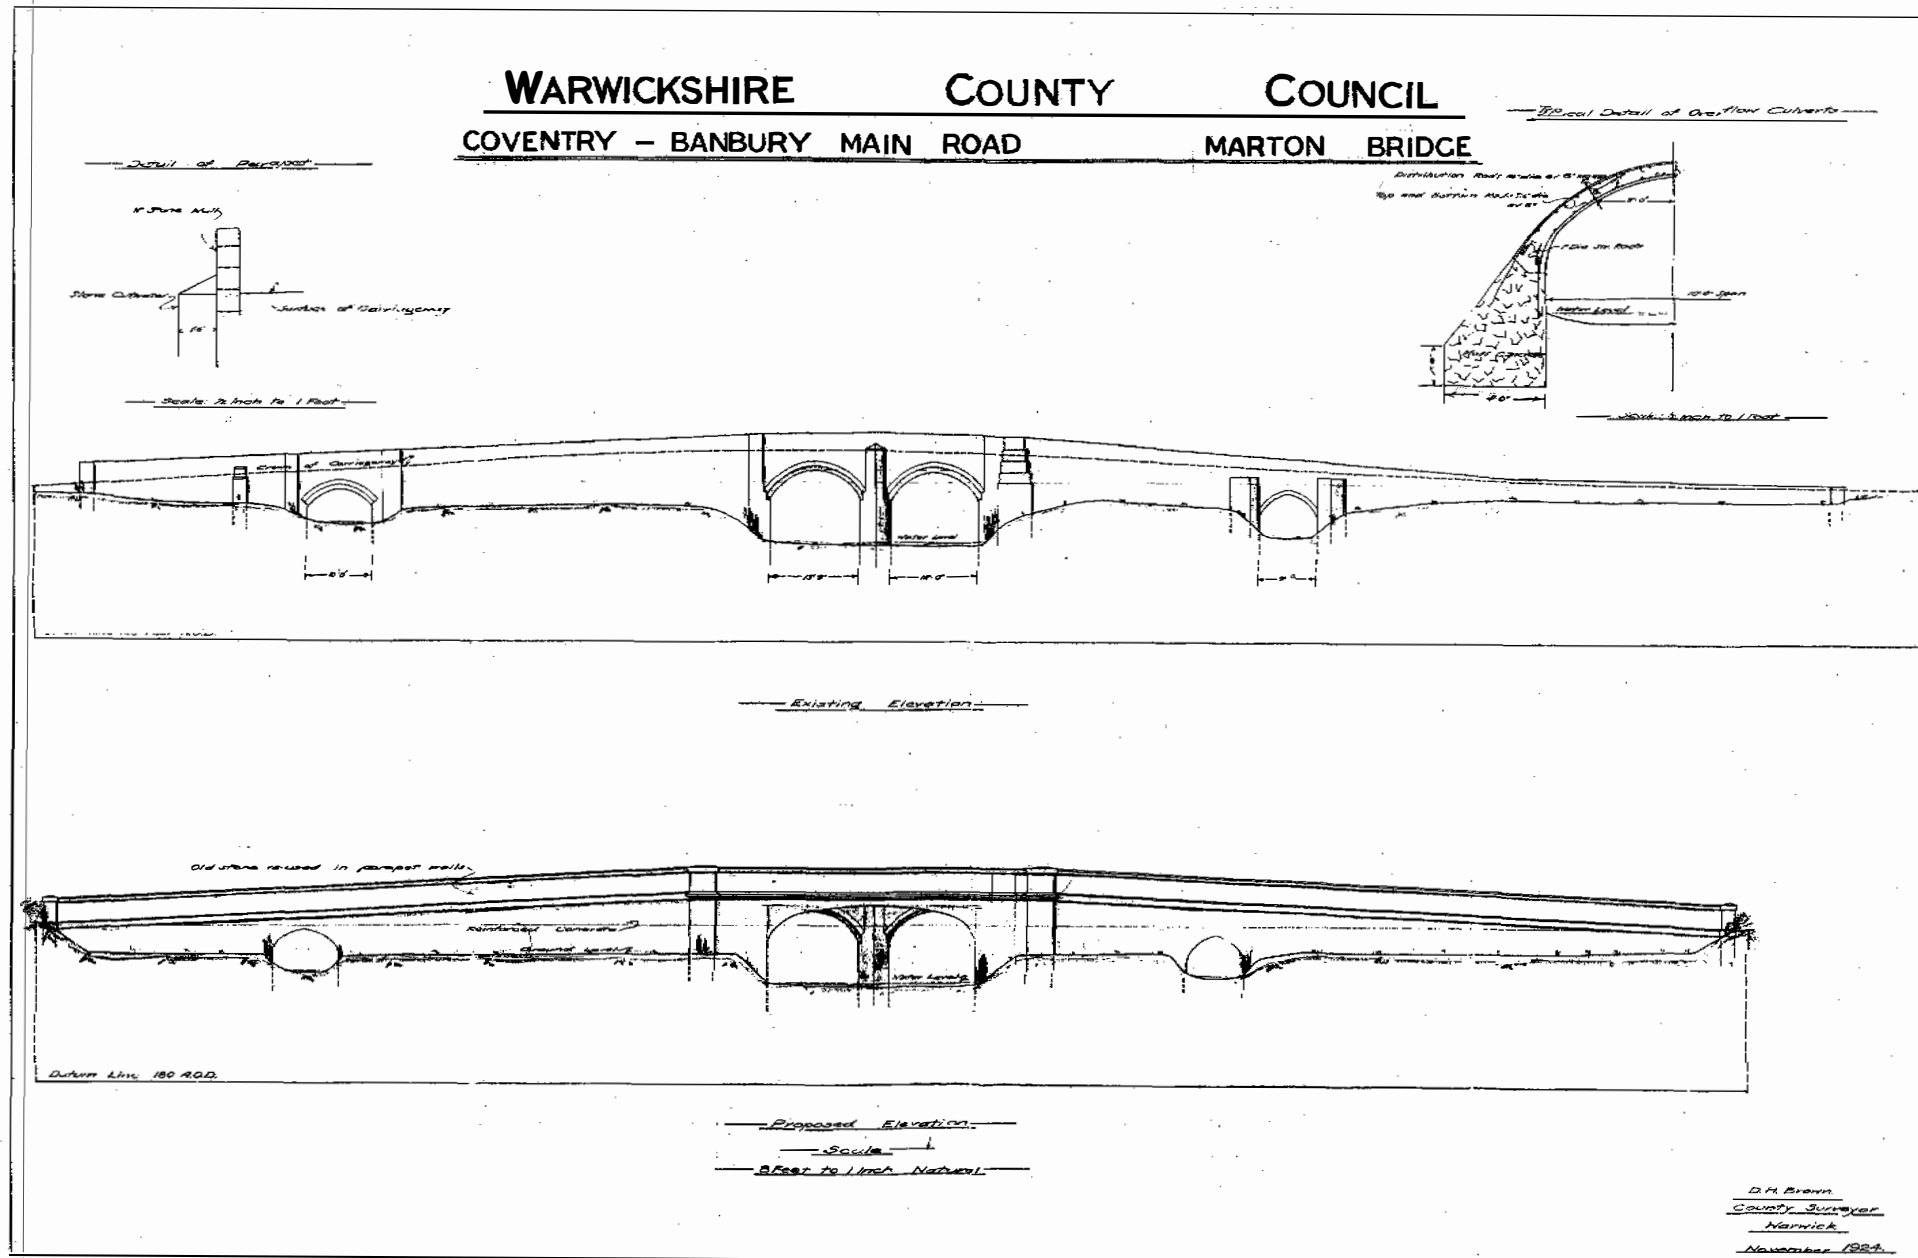
Fig 7: Marton Bridge, 1924, north elevation, existing and proposed (WCC Bridges Section 1924) [NB the proposed elevation differs from that actually built]

3.7 Historically the most significant of these drawings are the plan of the existing bridge in 1925 (WCC Bridges Section B16/01) and the elevation of the north side of the medieval bridge (Fig 7, WCC Bridges Section 1924, originally drawn at 1:96, here reproduced at 1:250). Although the latter is not sufficiently detailed to show differences in masonry it does show the main features of the bridge: the two main arches and central cutwater in their splayed recess, the eastern flood arch also in a splayed recess, the western flood arch flanked by triangular buttresses, a wide stepped buttress just west of the main arches and a smaller buttress to the east of the eastern flood arch. All these features were also there on the Aylesford Collection view of c.1790.

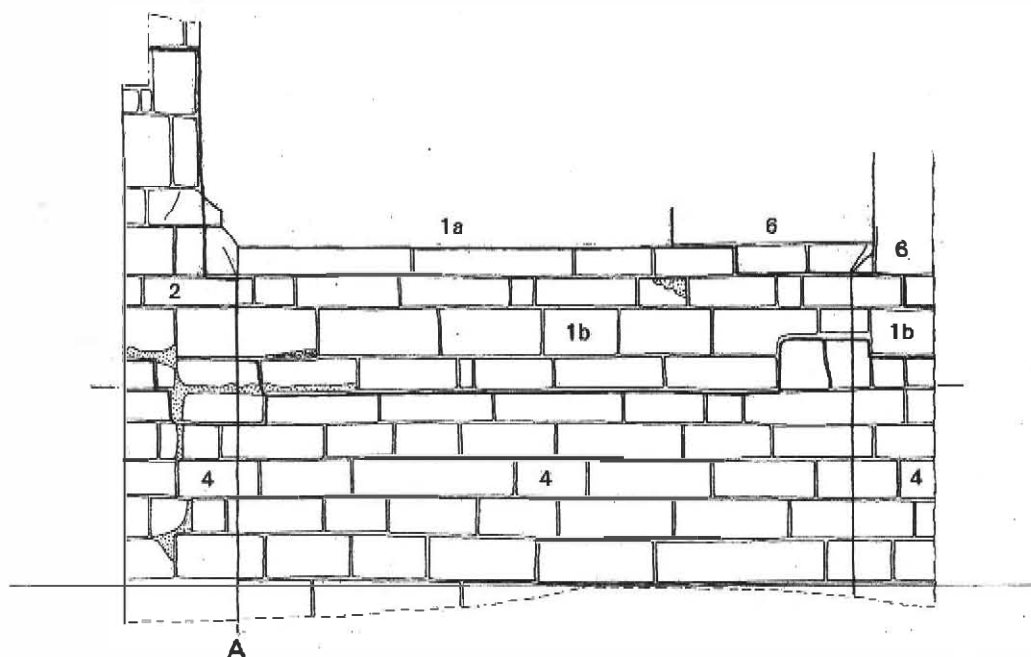
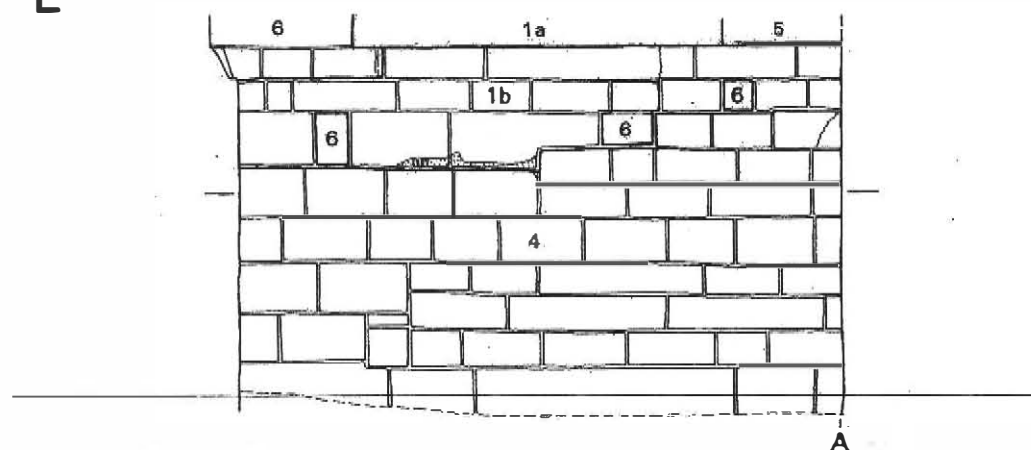
Fig 16: West main arch, D, east side and E, west side

4.3 The following phases of repair and rebuilding could be detected (Figs 12, 13, 16, 19):

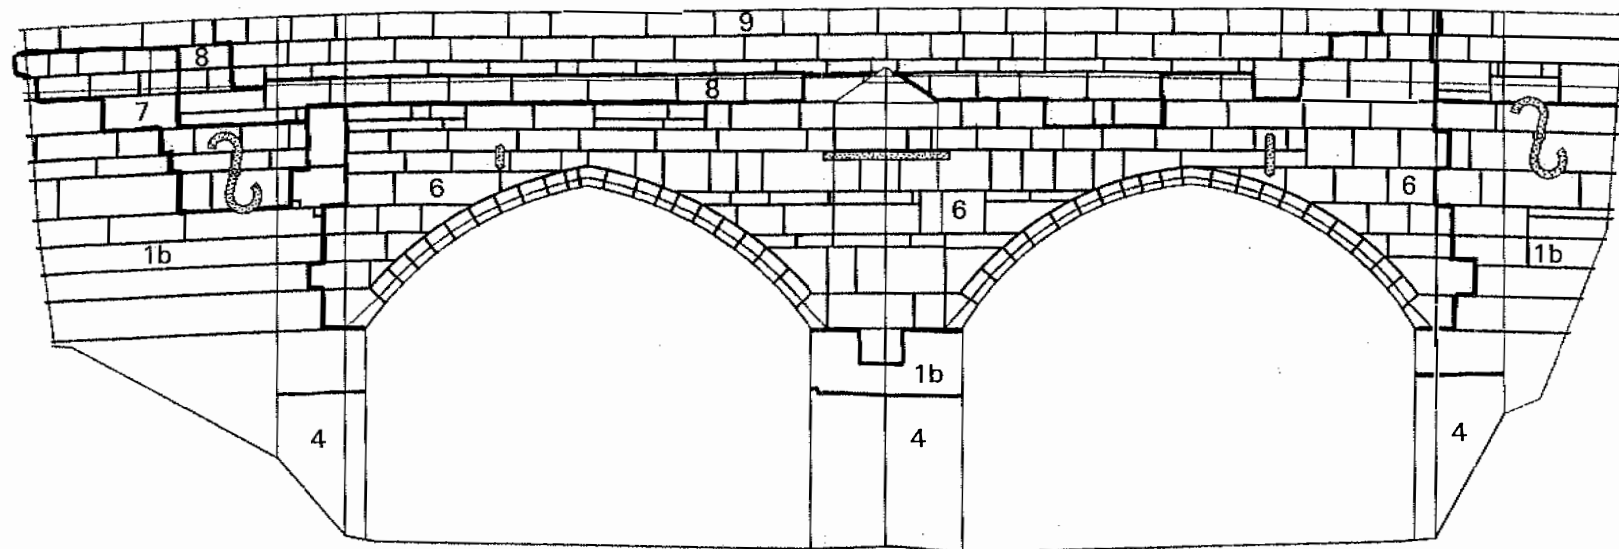
Fig 19: Main arches, south side
(WCC Bridges Section SW3 363/10a, manually amended 1999)

4.2 The masonry on each of the visible elevations was then examined for variations in coursing, stone type, weathering, tooling marks and lichen growth in order to identify different phases of rebuilding and repair. An elevation drawing of the south side of the main arches produced by the WCC Bridges Section (SWB 363/10A) in June 1995, and manually updated (in January 1999) to include a recent repair to the bridge parapet (Fig 19) enables the structural phasing to be carried round this side of the bridge as well.
