AYSCOUGHFEE HALL SPALDING, LINCOLNSHIRE

CONSERVATION PLAN SECOND DRAFT: JULY 2000

ANDERSON & GLENN, BOSTON (UK)

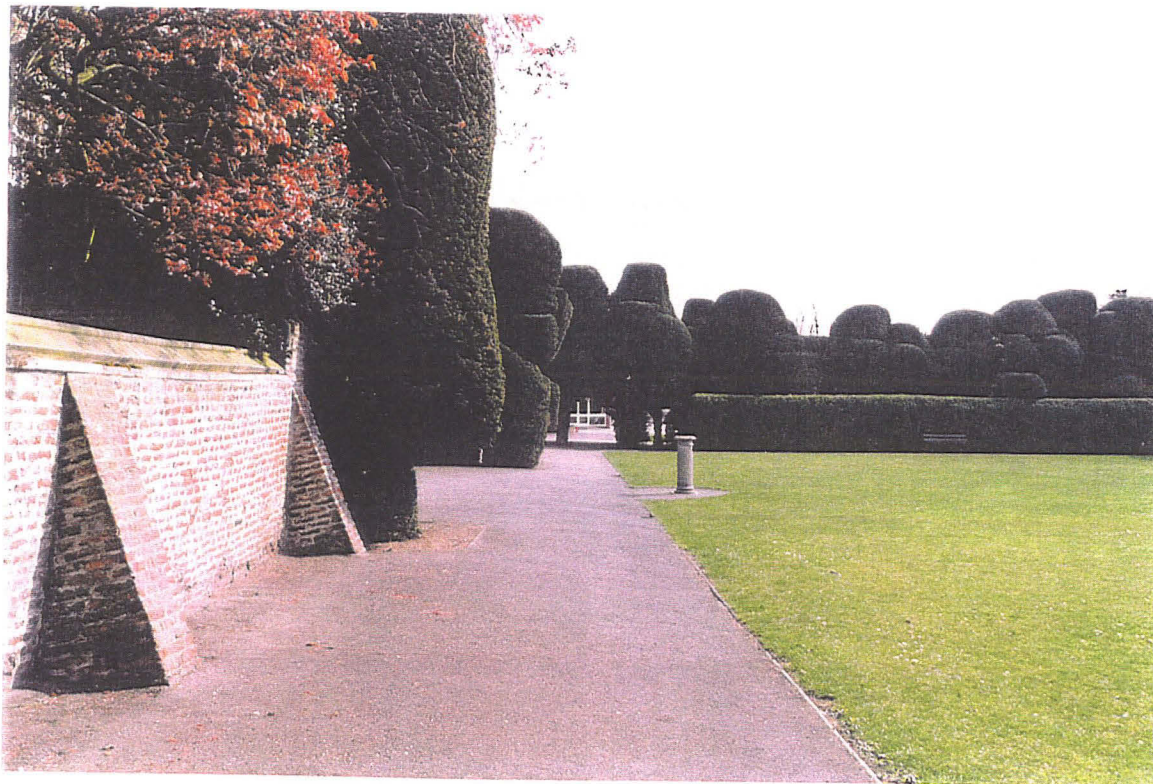
3.4.8 Adjacent to the Hall is a tarmac path. Inset into the lawn on a concrete brick pavior base is a modern fluted sundial in artificial stone; it has been set on the axis of the yew walk in Area C. *Plate 1.*

Plate 1 [area B]
The south lawns, modern sundial and yew arcade beyond.

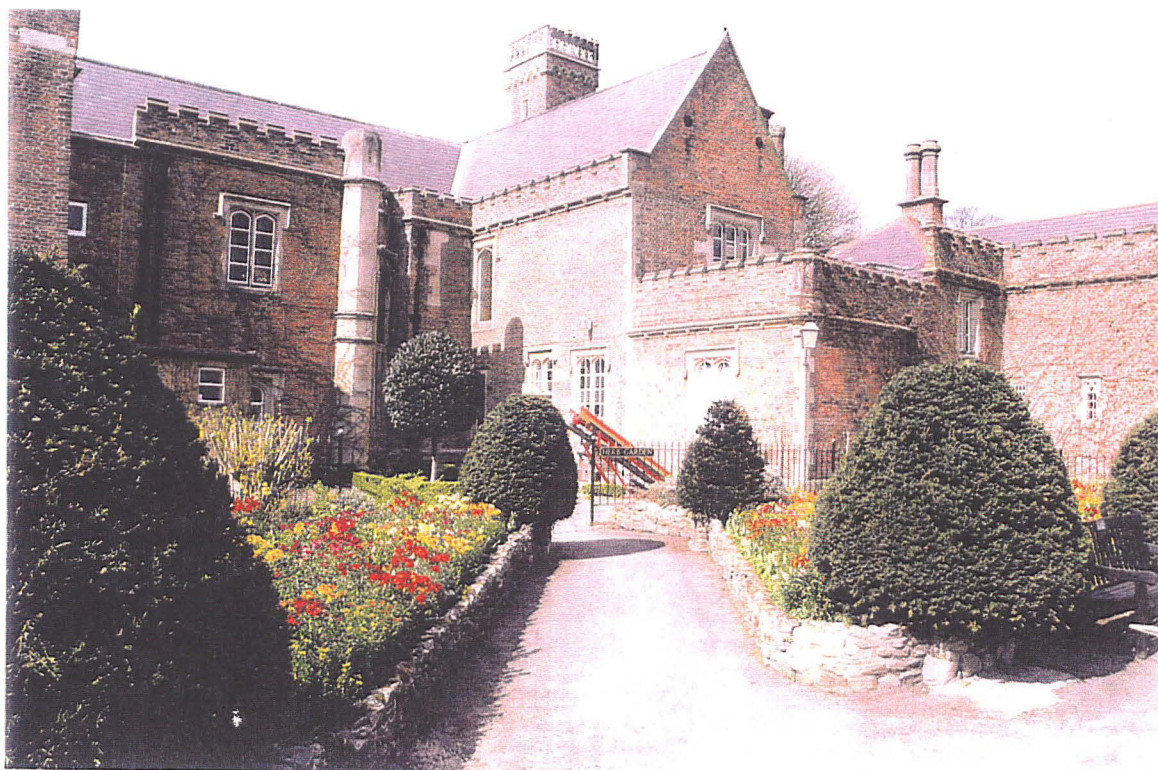
3.4.31 **Area G Gardens immediately to rear of hall.** Between the path alongside the bowling green and the rear of the hall are raised bedding borders in limestone edged walling with clipped yew cones. There is a diagonal path to the rear courtyard area of the Hall. This is defined by further modern insubstantial railings with golden spearheads. *Plate 4*

Plate 4 [area G]
Gardens to the rear of the Hall.

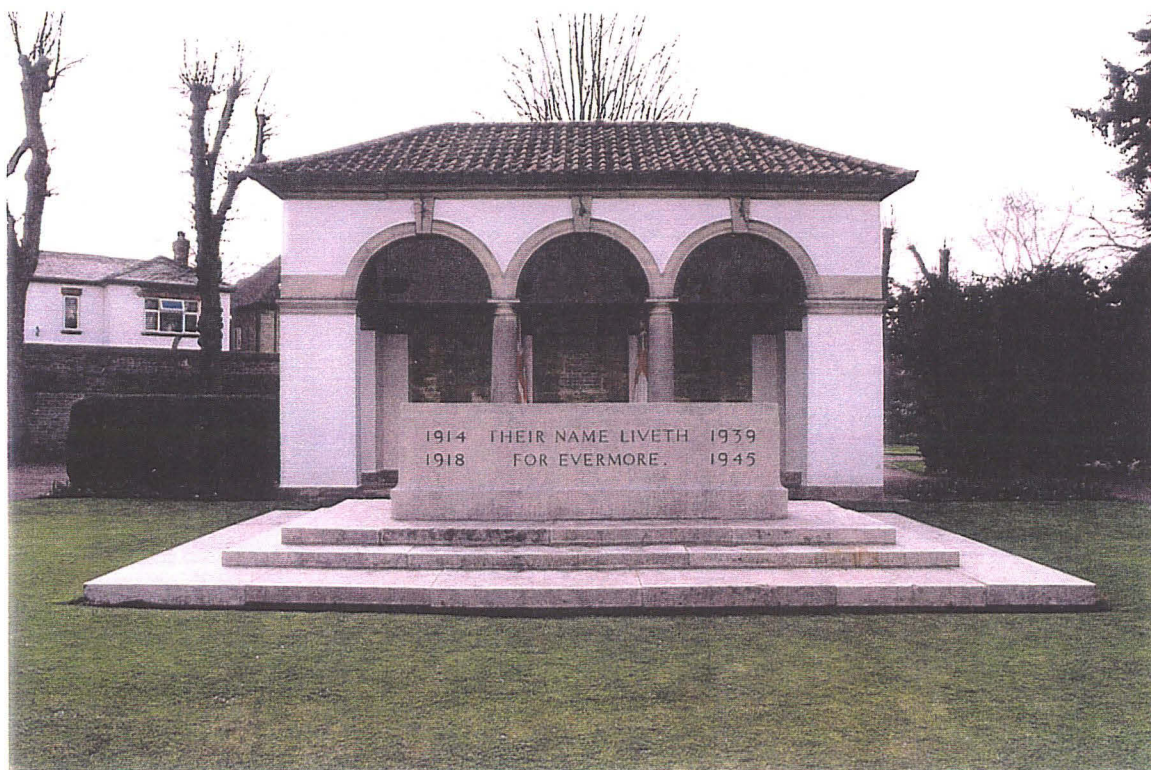
Plate 6

3.5.2 The War Memorial. Constructed in 1922 to the designs of Sir Edwin Lutyens in an Italianate Temple style. It is rendered with ashlar dressings and a shallow hipped pantile roof. The remembrance stone in front on its triple stepped plinth is part of the original design. Notice the beautiful draped flags in carved stone. It is one of about 20 war memorials designed by Lutyens, who also designed the Cenotaph in London. It is located at the end of the lake in Area D. The history of its design and the support for its erection is fully covered in the Anderson and Glenn Historical Appraisal of the Gardens. *Plate 6*

The War Memorial and remembrance stone by Sir Edwin Lutyens.

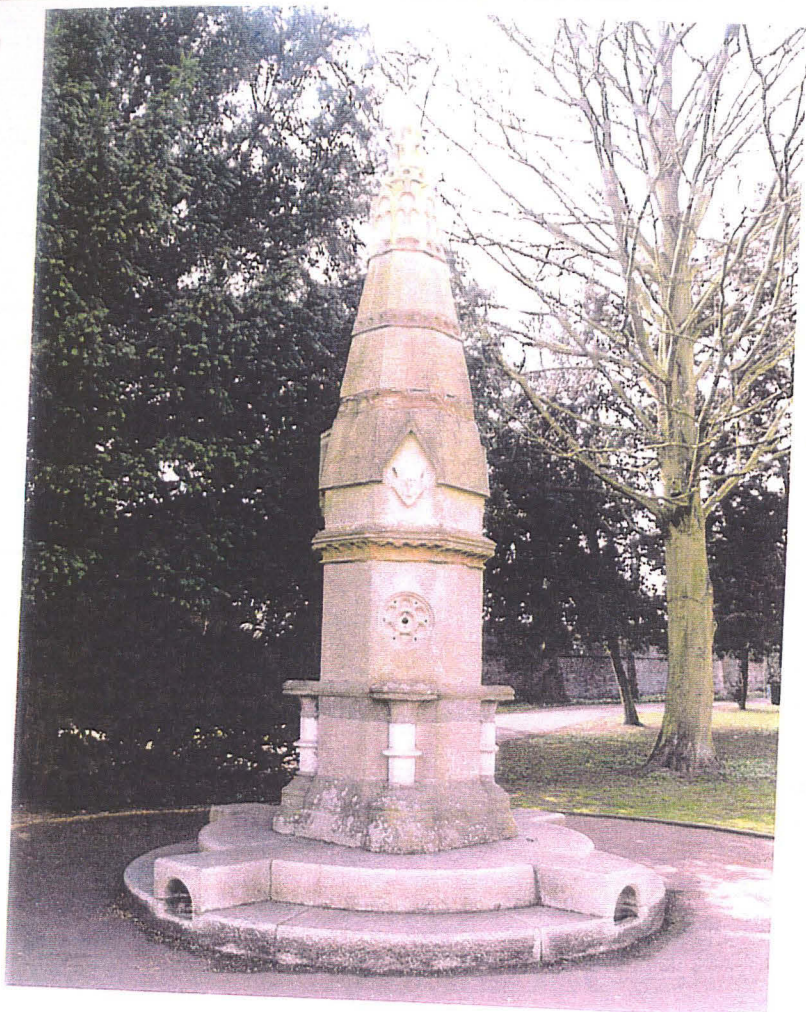
3.5.3 The Drinking Fountain. This stone structure dates from 1847 and was moved here from a site in the centre of town in 1954. Its connection to this site is that it was given to the town as a memorial to Mary Ann Johnson. It sits on a circular base, but the fountain itself is octagonal in the form of a banded pinnacle with traceried top surmounted by a cross fleury. Its siting relates to the peace garden in Area E. *Plate 7*

Plate 7
Drinking Fountain of 1847.

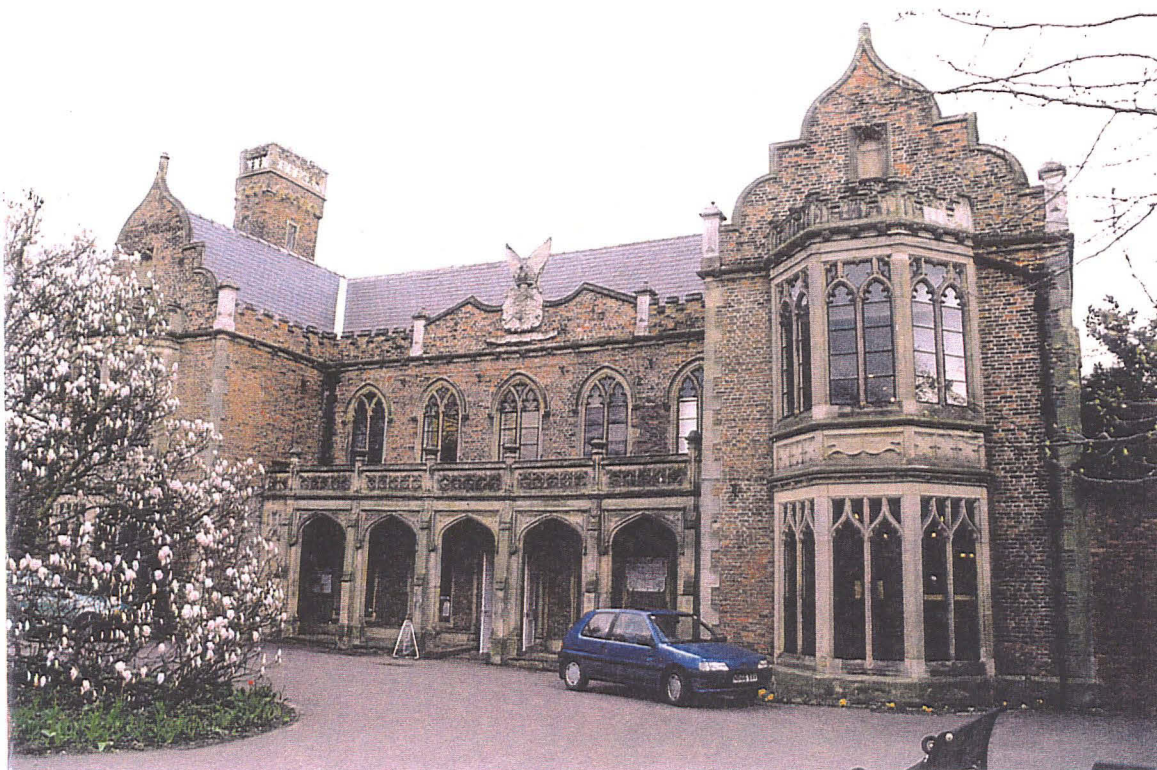
3.6.3 The western entrance elevation is of two storeys, in brick with gritstone dressings and Welsh slate roof. *Plate 9* Five bay recessed front with projecting end wings. Smooth slightly raised stone quoins, with chamfered ashlar plinth. At eaves level is a moulded fleuron frieze stone course with stone coped brick battlements above. Shaped Dutch gabled raised parapets, stone coped, with panelled pinnacles to each end. Each gable has a 2 storey canted bay window in gritstone, with paired Gothic lights to each face with ogee traceried heads to ground floor and cusped heads to first floor. Crenellated stone parapet to bays. In the gables a nodding ogee headed recess. To each end are lead hopper heads dated 1794. Central Tudor style arched entrance, with pair of 19th century panelled and traceried entrance doors, is set beneath five bayed open loggia with Tudor arches with hood moulds having shield stops, cusped panels. To each end an ogee niche with statute base. Pierced parapet conceals flat lead roof. In the frieze below, in raised stone lettering 'Ayscoughfee Hall'. To first floor 5 two light pointed windows in stone surrounds. Battlemented parapet raised at the centre with shield and motto. *This front was largely rebuilt in 1840s.*

Plate 9
West front elevation, remodelled in the mid 19th century.

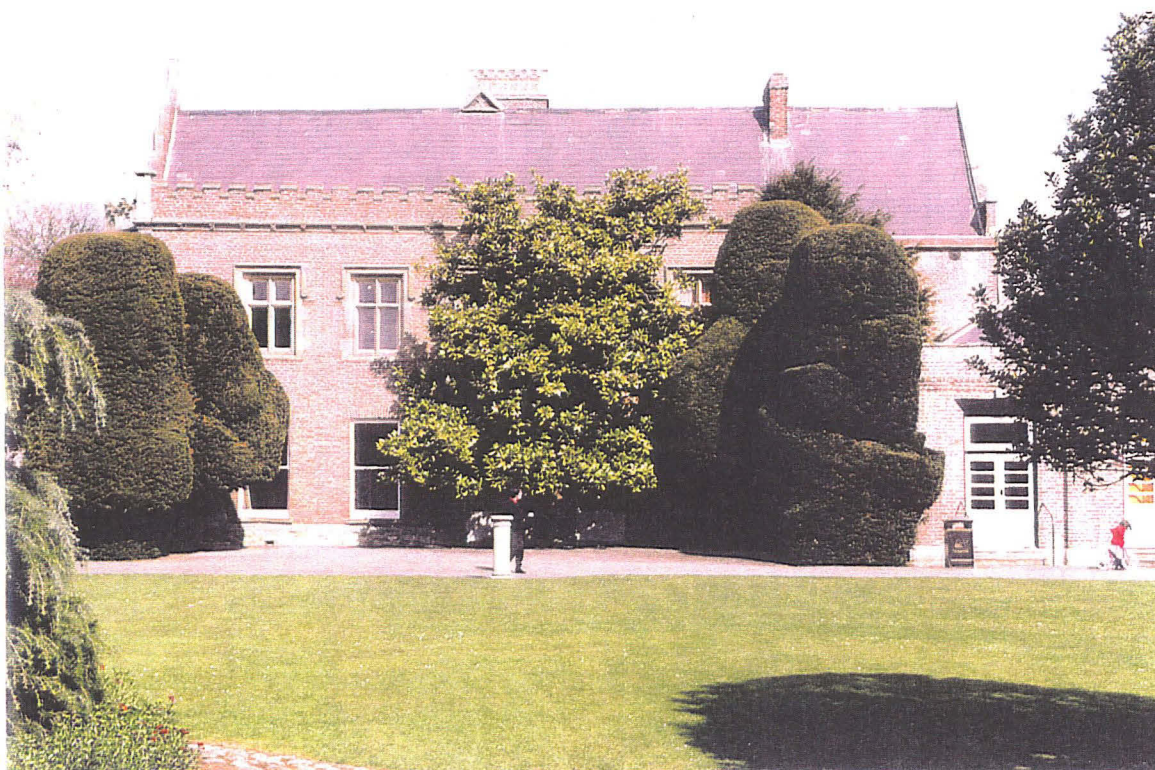
Plate 10
South front, refenestrated in the 18th century.

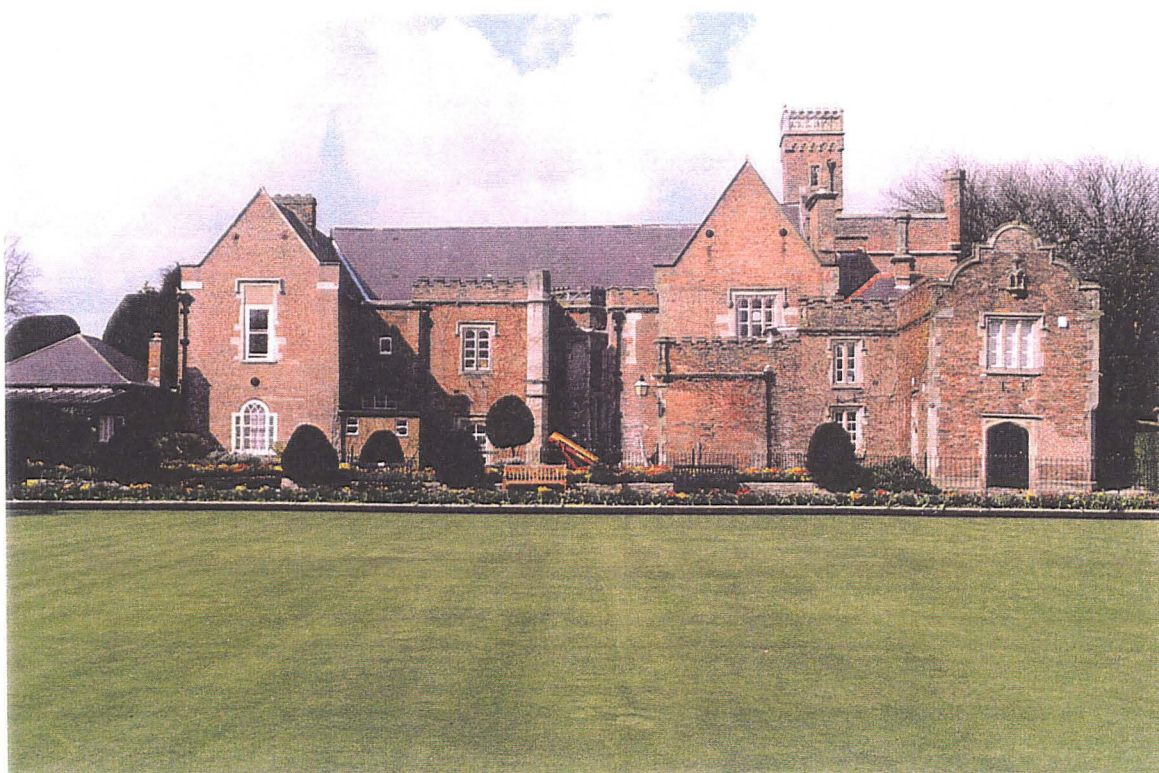
Plate 11
East elevation, showing H plan, with 19th century additions to rear & north wing.

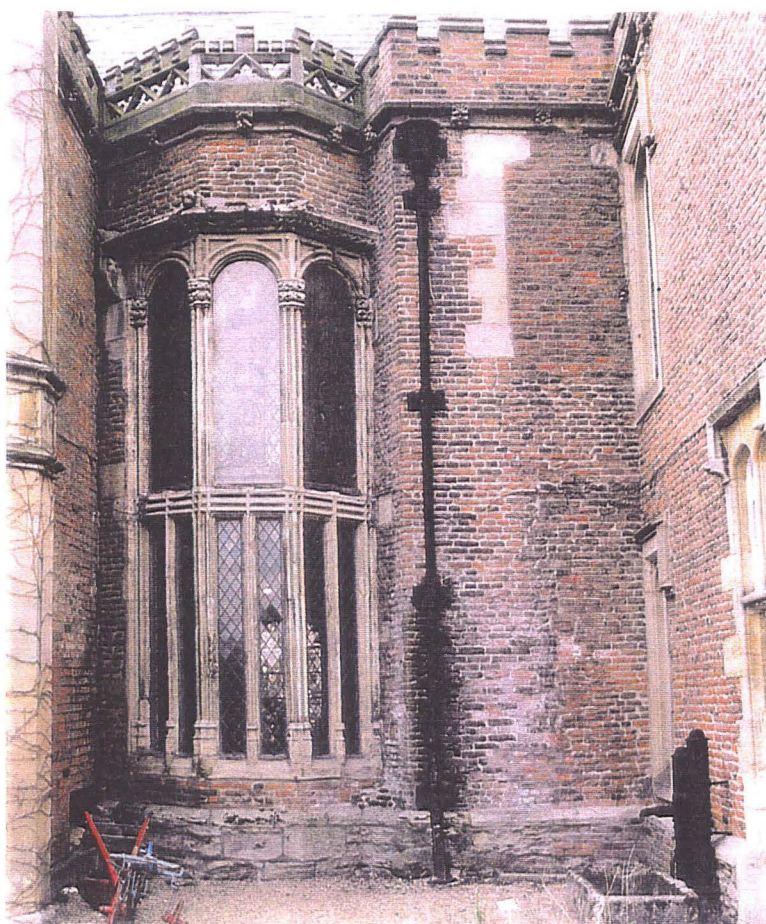
Plate 12
Early 16th century canted bay window on east wall.

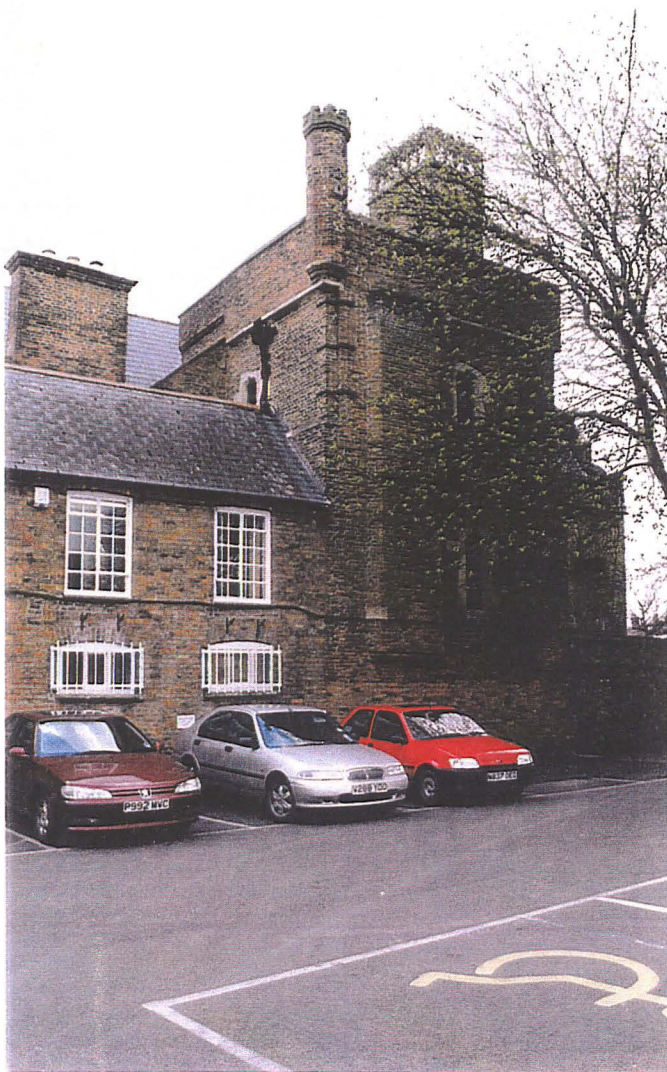
Plate 13
North elevation, 19th century
rear wing on 15th century tower.

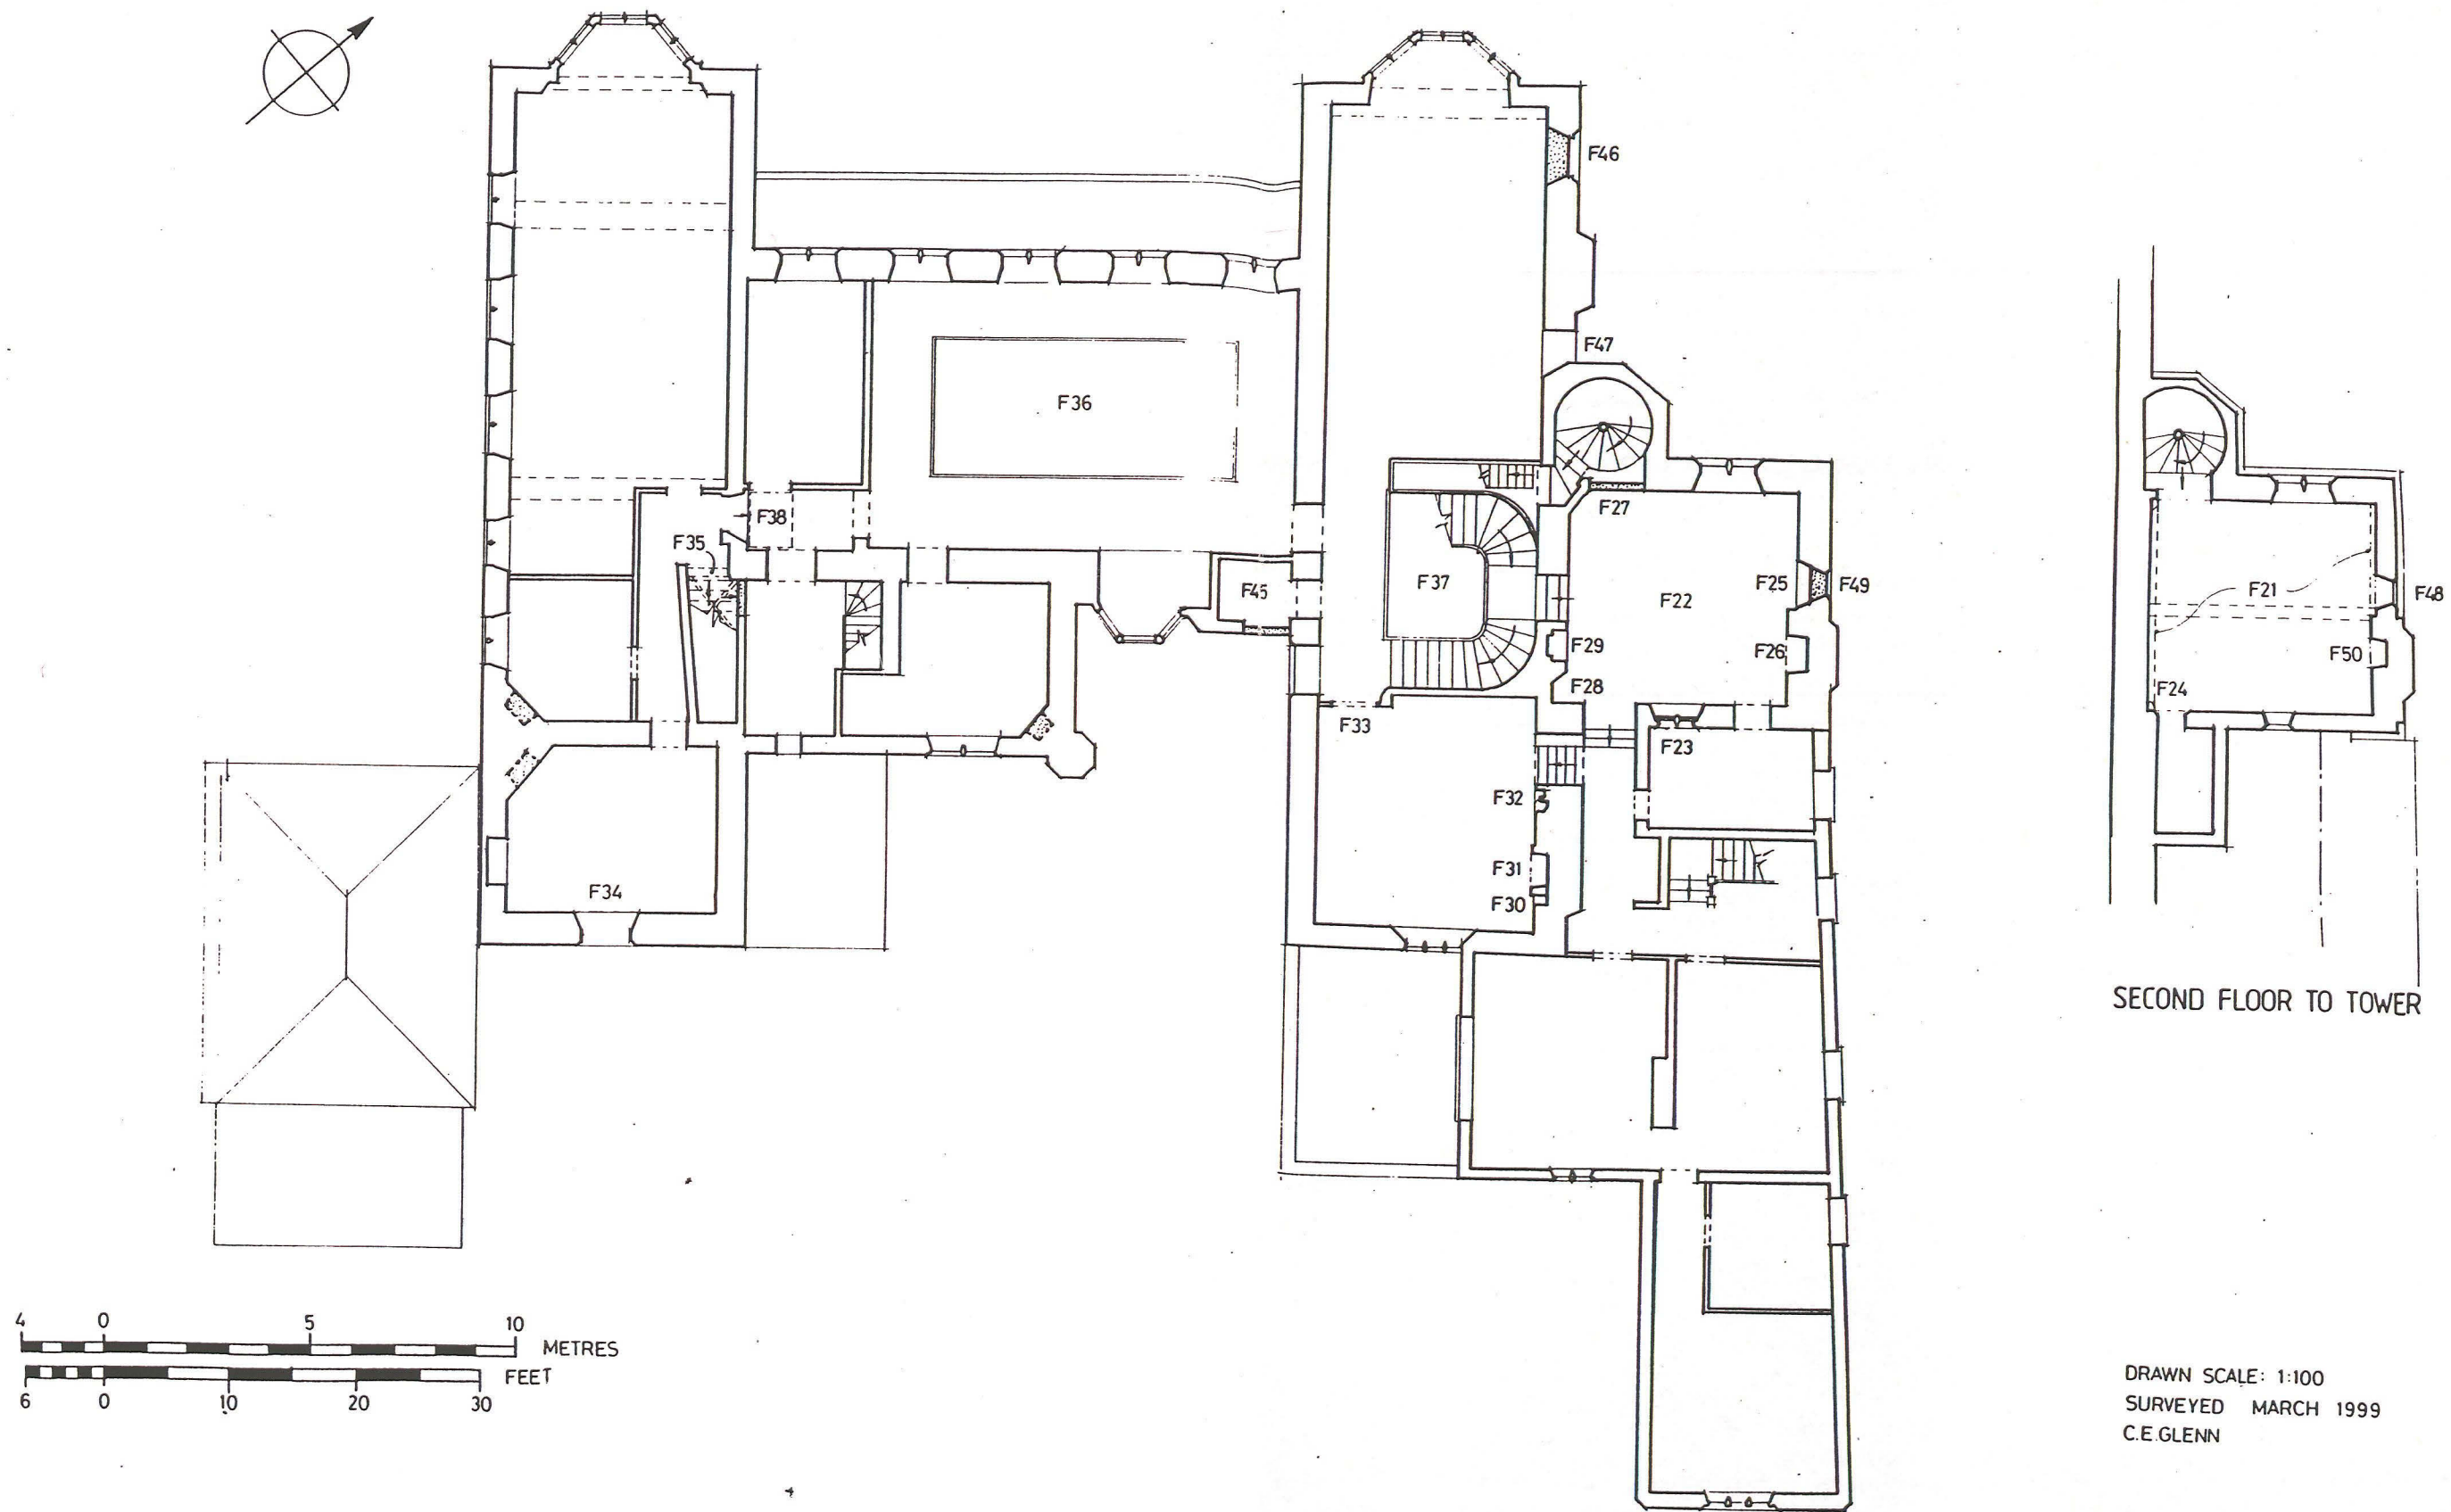
Figure 16 - Ayscoughfee Hall, upper floor plan with location of features

F48	North wall of the tower second floor level. A stone window opening with an ogee head, identical to another window opening at the same level on the east wall of the tower. The latter is shown in Nattes' 1791 view of the east front. It is probable that these are originals rather than part of the 18th or 19th century remodellings in a 'gothic' style. This window has the same plain chamfered jambs as the two light window to the east wall of the tower (F23) which appears to pre-date the pentice (F11 & F12).	No	Yes
F49	North wall of the tower. First floor level. A blocked stone window opening with a four-centred arched head. Very similar in its plain chamfered jambs to F48. It appears on the watercolour of Ayscoughfee Hall viewed from the northeast and dated to c1821.	No	Yes

F No	Description	Drawing	Photographed
F50	Fireplace. Second floor of the tower. Stone. Hob grate. Possibly early 18th century. Very similar to F26.	No	No
