LANGTOFT HALL FARM
ARCHAEOLOGICAL EVALUATION

June 1991

LINDSEY ARCHAEOLOGICAL SERVICES
FRANCIS HOUSE SILVER BIRCH PARK GREAT NORTHERN TERRACE LINCOLN LN5 8LG

LANGTOFT HALL, LANGTOFT **Archaeological Evaluation**

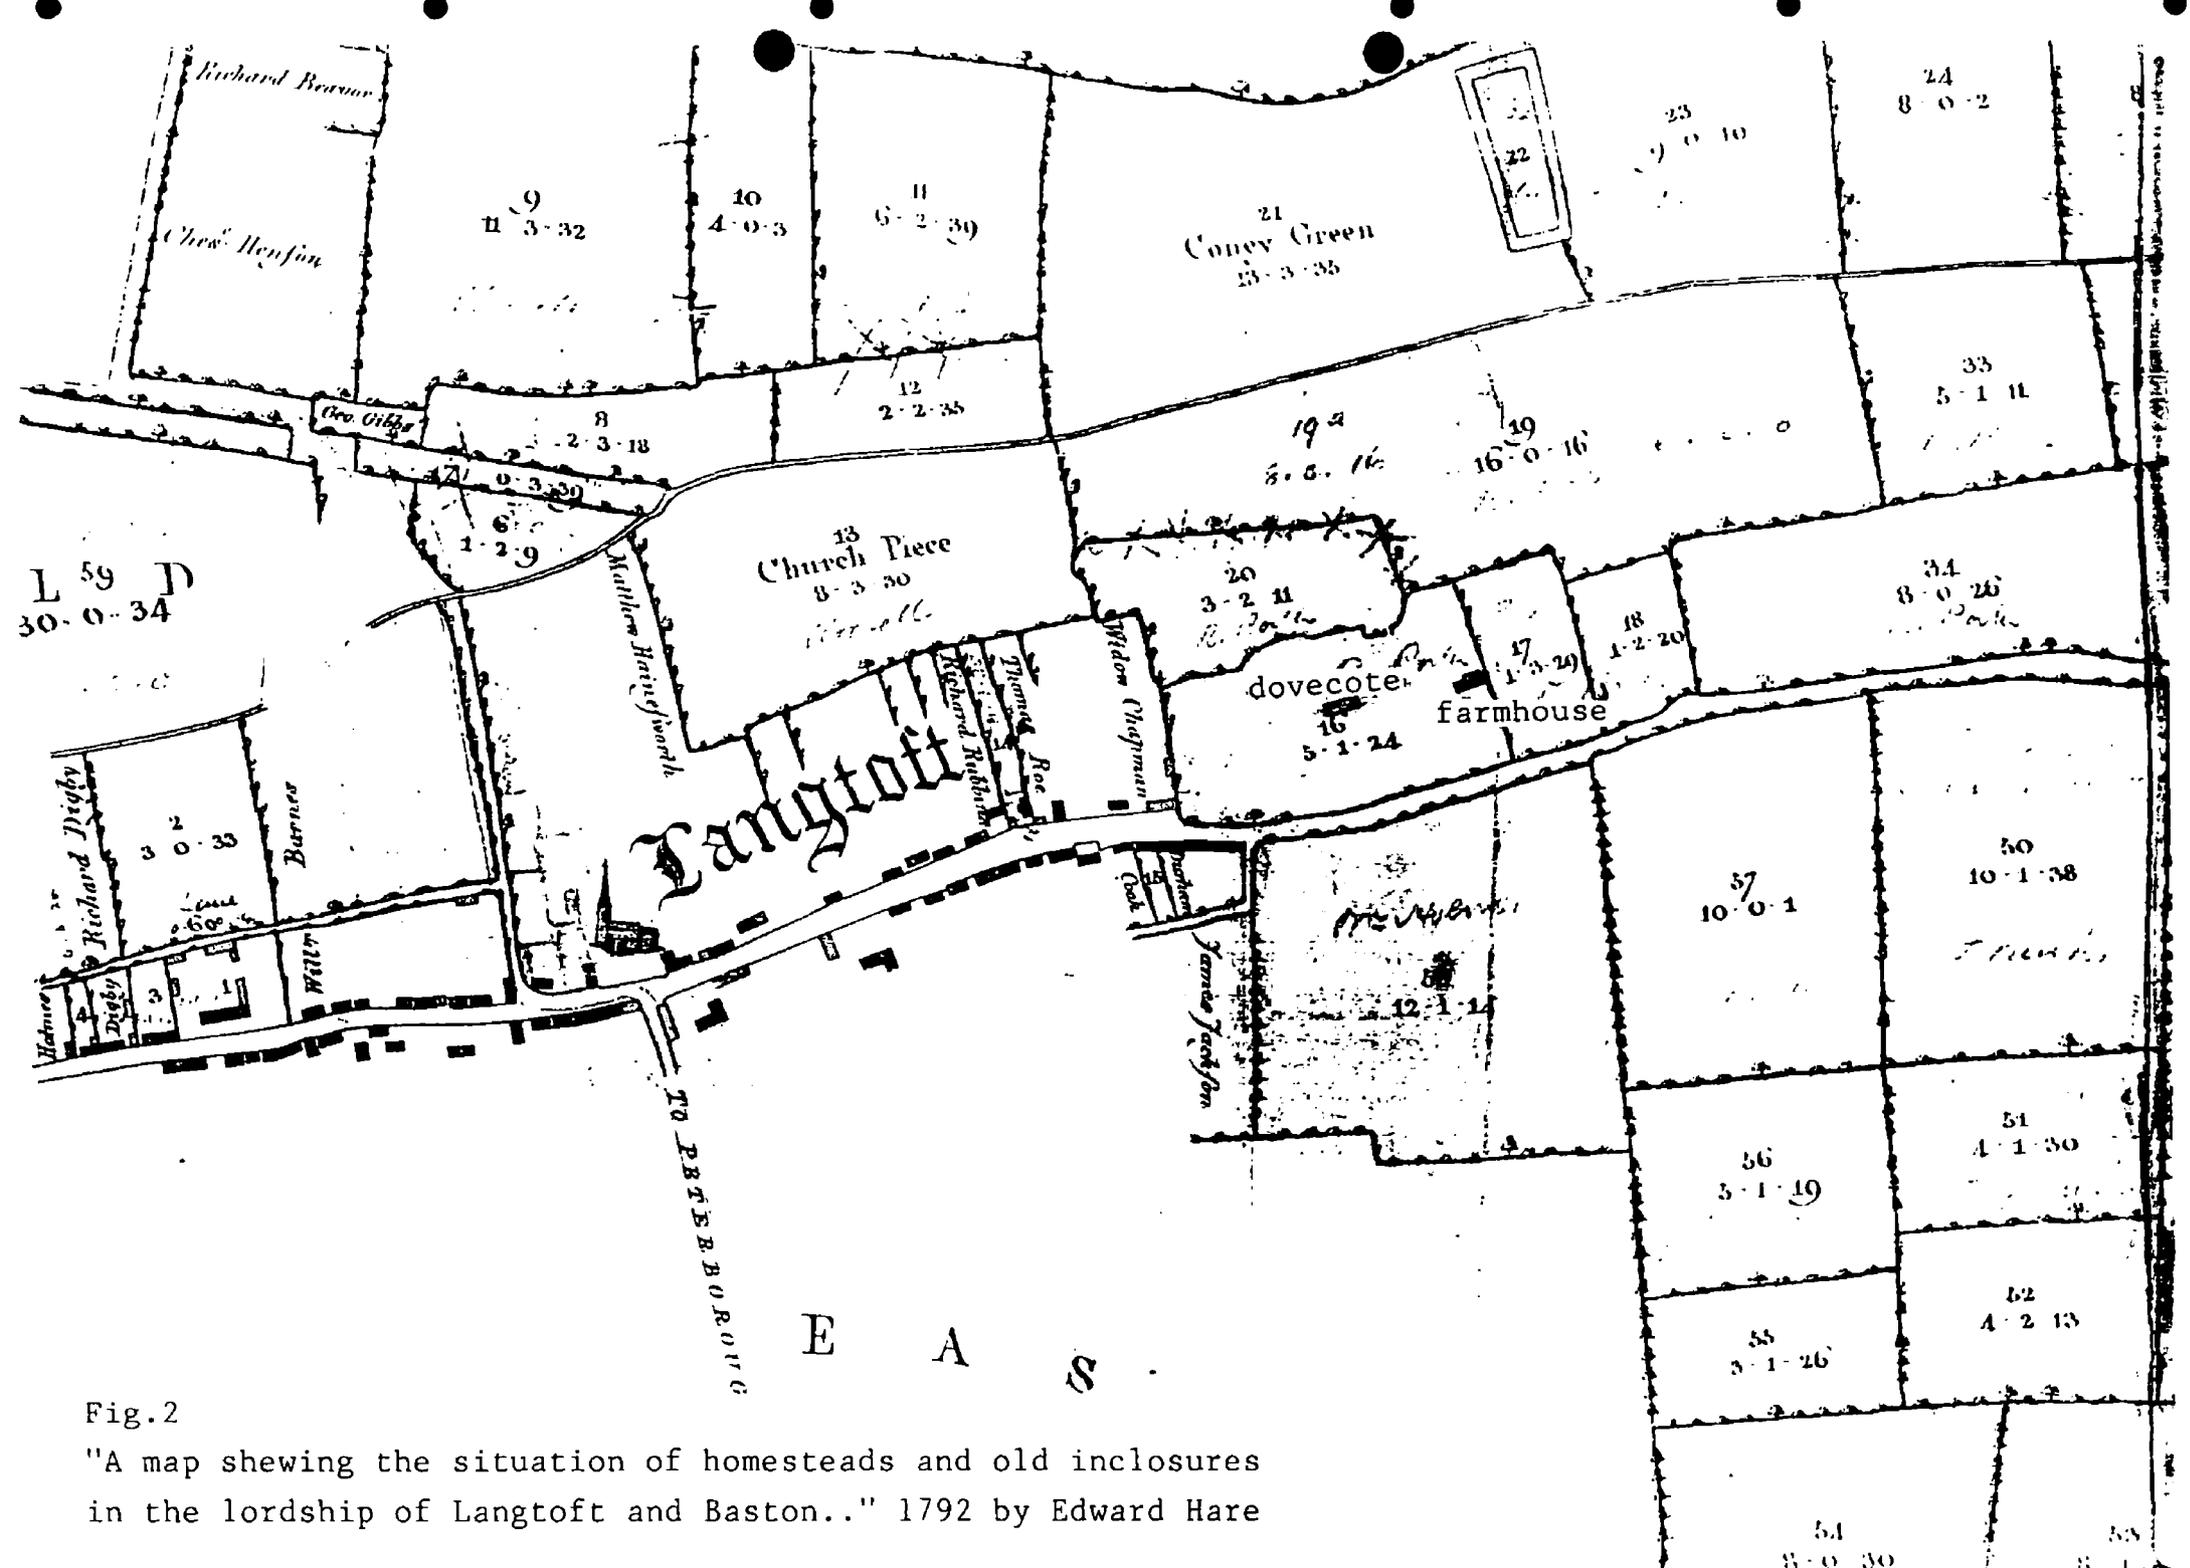
Fig.2
 "A map shewing the situation of homesteads and old inclosures
 in the lordship of Langtoft and Baston.." 1792 by Edward Hare

Maps at the Lincolnshire Archives Office were inspected. The earliest was an estate map dated 1792 (fig. 2) showing the present farmhouse and a building in the same position as the site of a dovecote marked on recent O.S. maps. In addition it showed the present boundaries. There was no fishpond on this map.

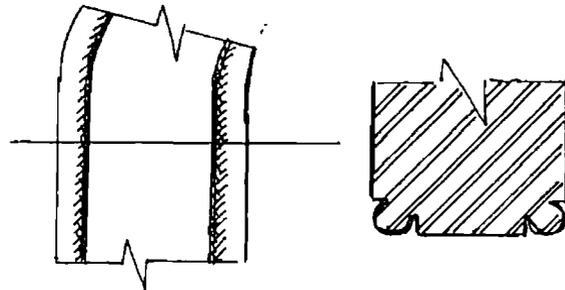
Fig.5

The decorative limestone coping has diagonally opposed sockets, 40mm², and c. 12 cm from centre to centre (P35), for iron railings, or possibly a balustrade on top (see reconstruction in fig.5a). Some of the projecting copes have a large centre recess as if for a main stanchion. The two measured examples were c.70mm² (not diagonally opposed) and 3.04m from centre to centre. One recess contains an iron stump c. 18mm² and set in lead.

a) Suggested reconstruction of wall W3

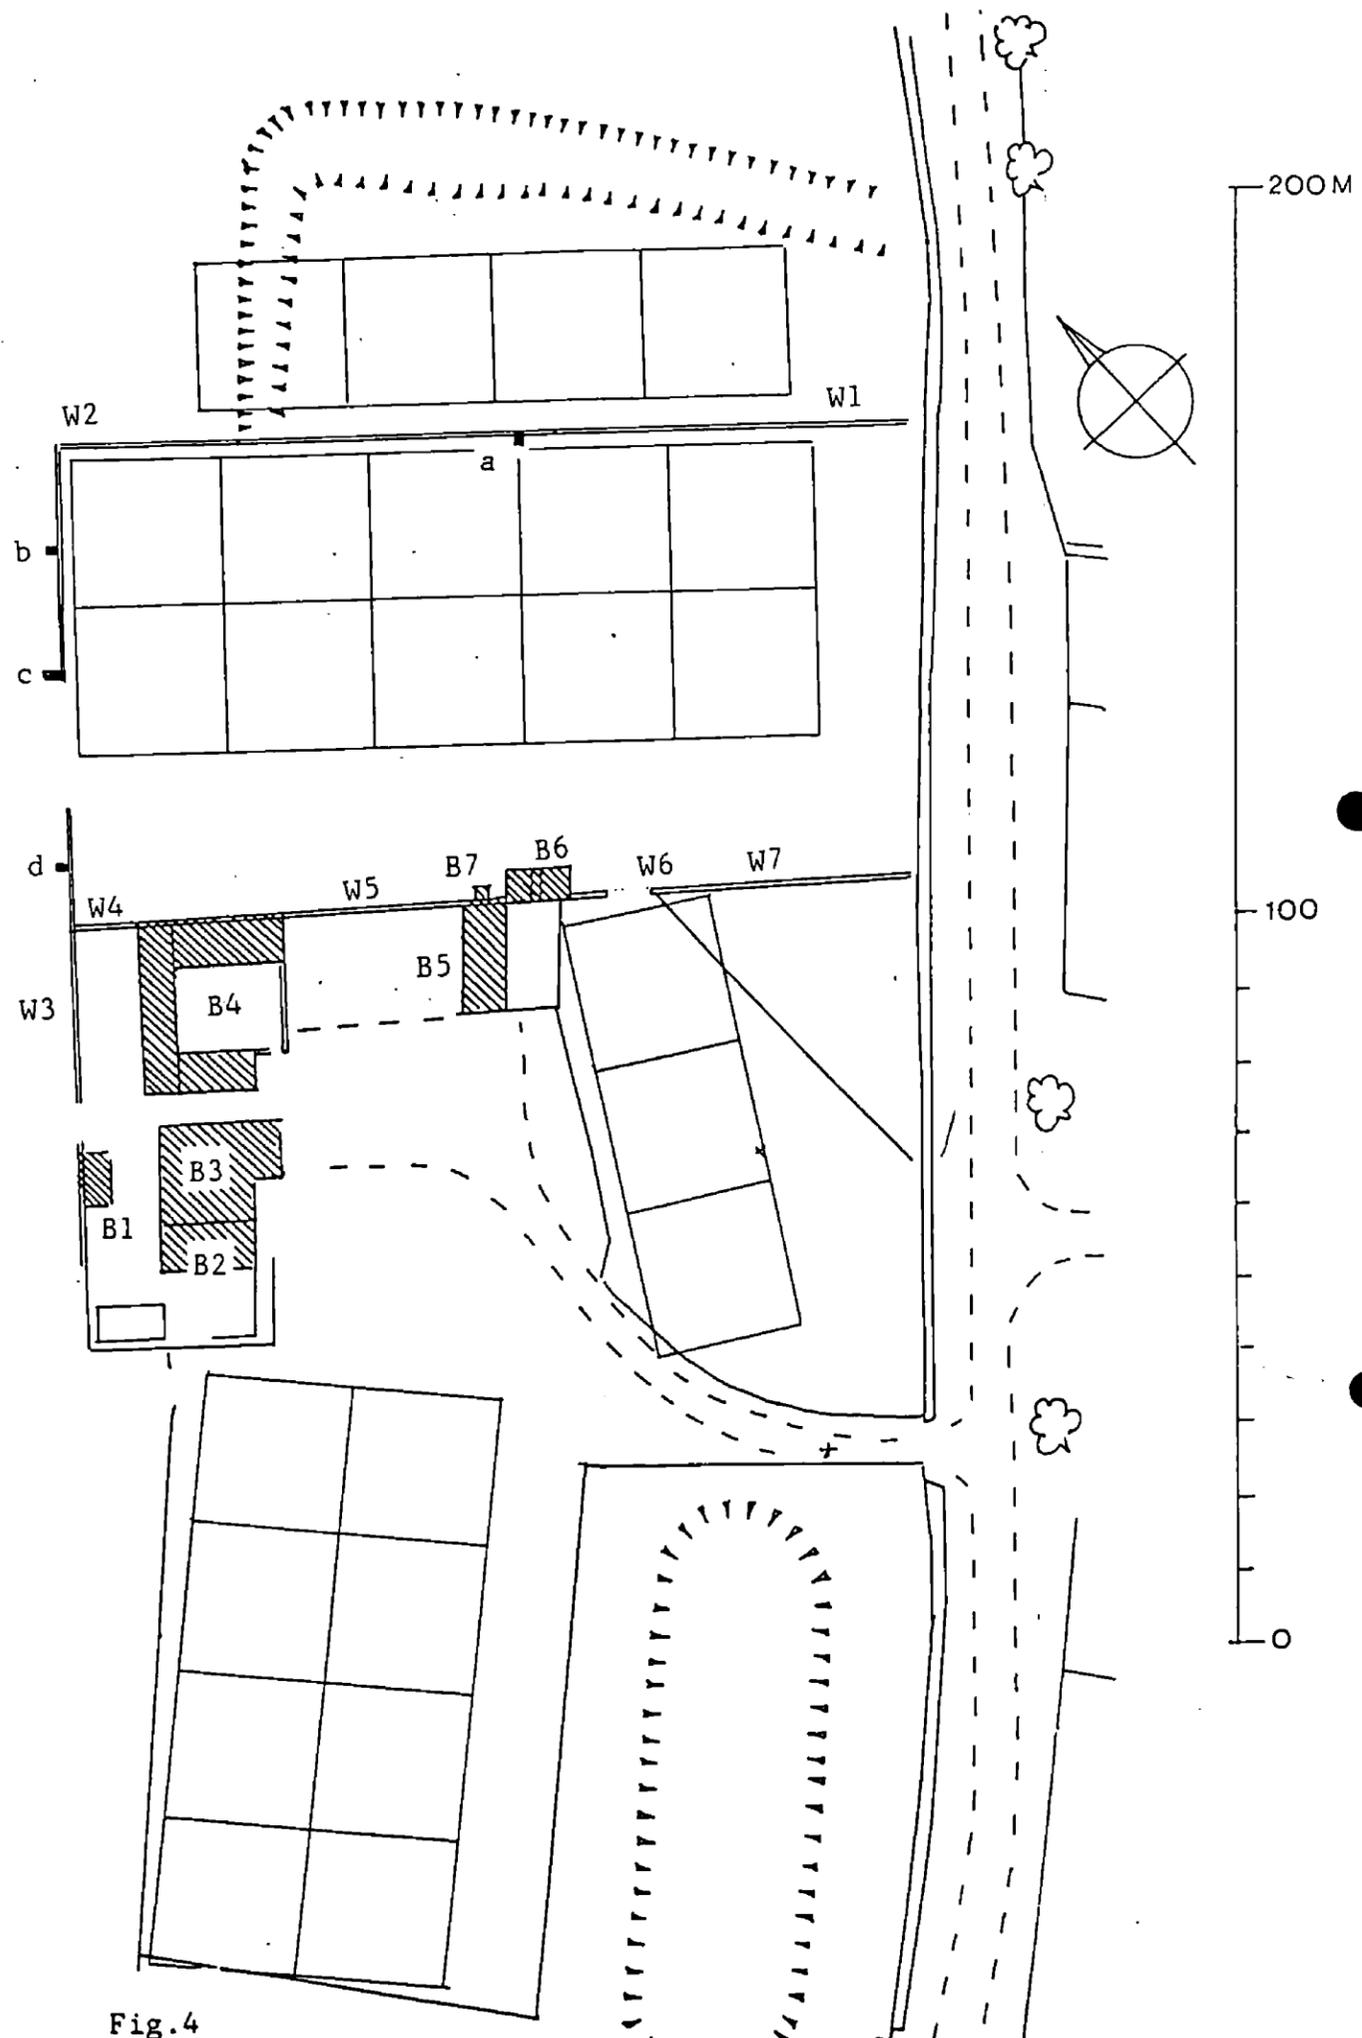
Seven building units (B1-7) were identified on the site the earliest of which is the 18th-century farmhouse, B5 (see fig.4 on the gold fold-out).

The earliest surviving features were not the buildings but the garden walls which belonged to a grand Hall in the 16th-18th centuries which has now gone. Of the walls which enclosed the orchard/kitchen garden the south-east boundary is missing, presumably removed by the drain which runs parallel to the modern road. Surviving portions are in poor condition but are nevertheless of great interest. These are described in seven sections (W1-7 on fig.4, gold fold-out).

Fig.4
 Location map of site showing buildings (B1-7) and walls (W1-7)
 Butt sses marked a-d.

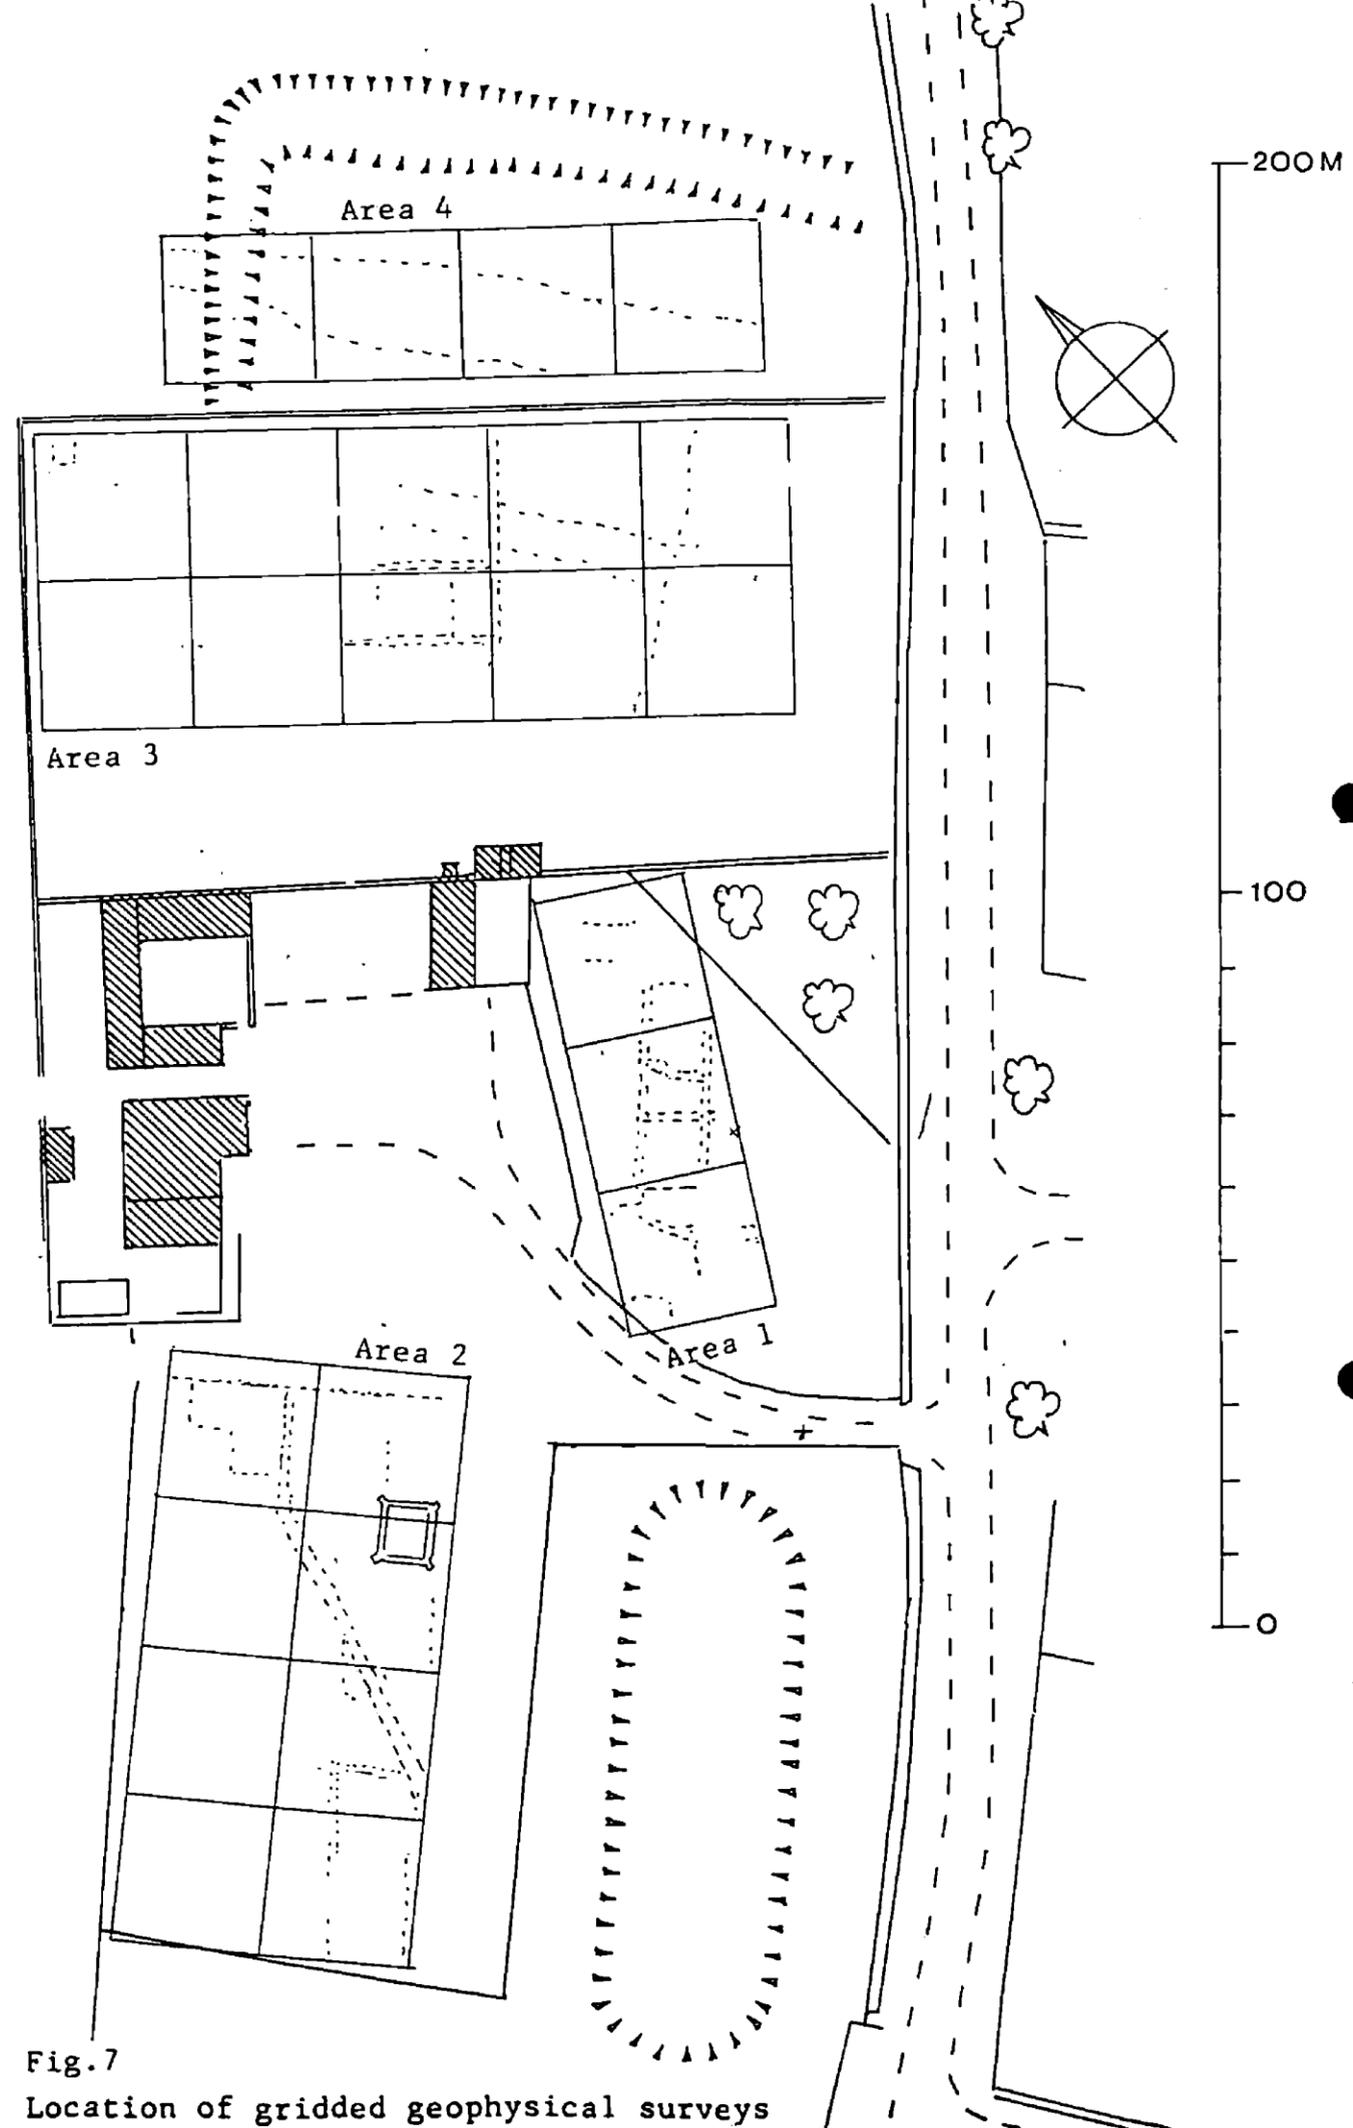
In order to identify remains below the ground which did not survive as earthworks four gridded surveys were carried out, three within the proposed development area and one to the east but within the moated site (fig. 7, see blue fold-out). A resistivity meter was used in all areas and in Area 3 a magnetometer was also used (P52). The moat was located, cutting

Area 3 shows remains of rectangular wall foundations near centre.

Area 4 shows dark band which is the bank of the Car Dyke. The break on the left hand side shows the moat cutting through the bank.

Fig. 7
Location of gridded geophysical surveys
