**64/65 HIGH STREET, ST.MARTIN'S,
STAMFORD, LINCOLNSHIRE**

An Archaeological Building Appraisal

NETWORK ARCHAEOLOGY LTD

Report No.160

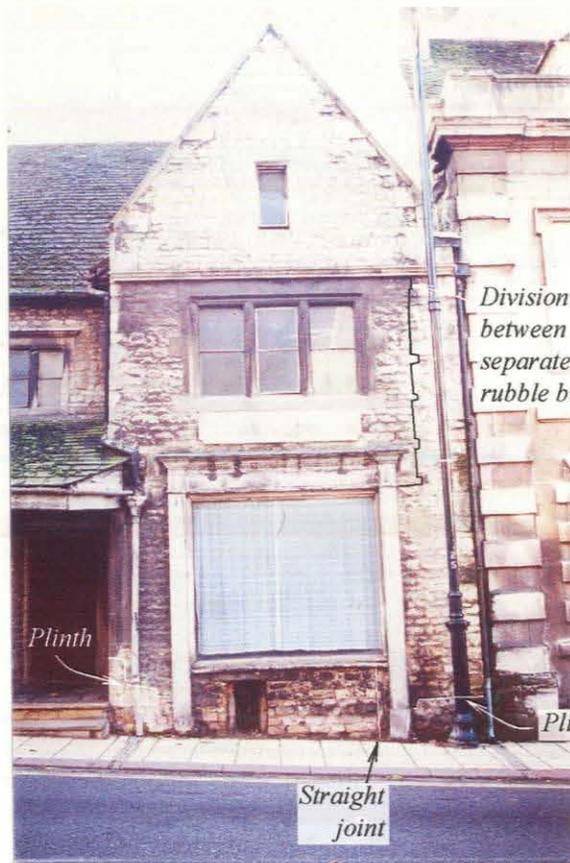
*Division
between two
separate
rubble builds*

*Straight
joint*

Plate 4: East elevation, no.65; showing street frontage fenestration detail set within a full-height rectangular gabled window bay.

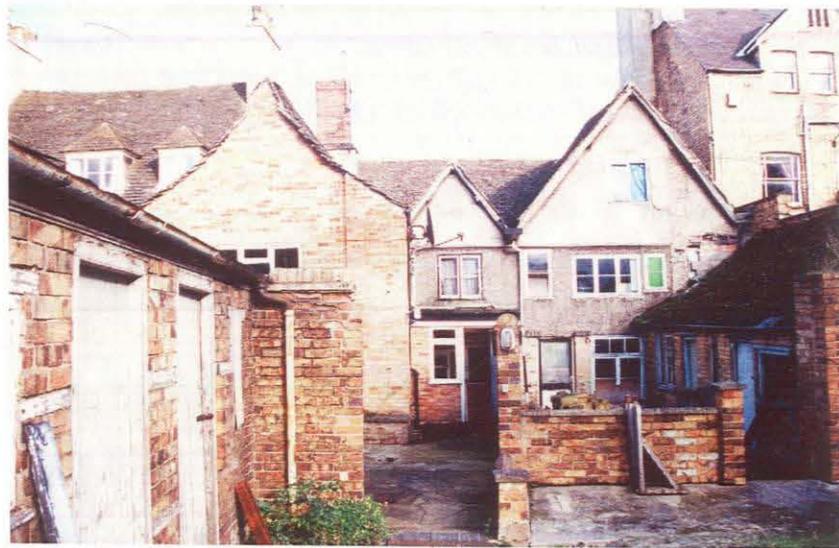
Plate 9: West elevation: view of the three gable ends of the rear ranges (no.64 to the right), which overlook several brick outbuildings and the two concrete yards.

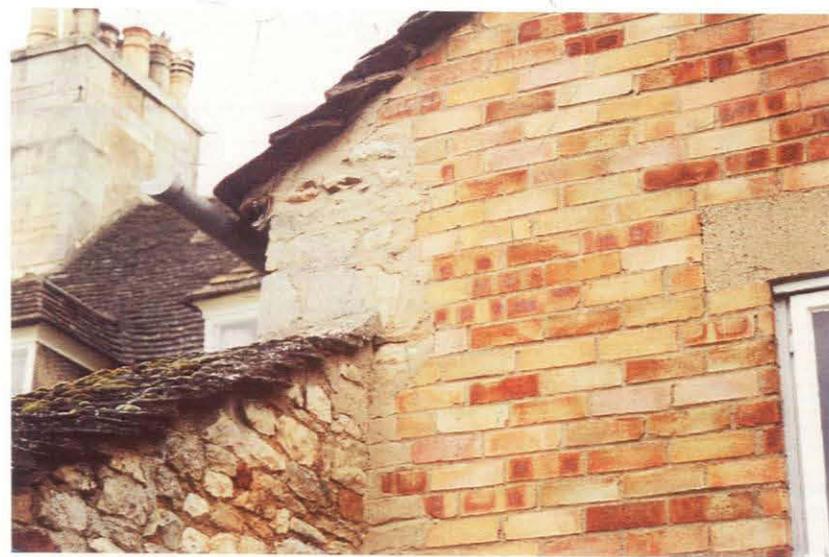
Plate 10: West elevation, northernmost gable end; showing area of stonework in the top corner of the gable just below the eaves. The abutting stone wall below is the northern property boundary wall which runs westwards.

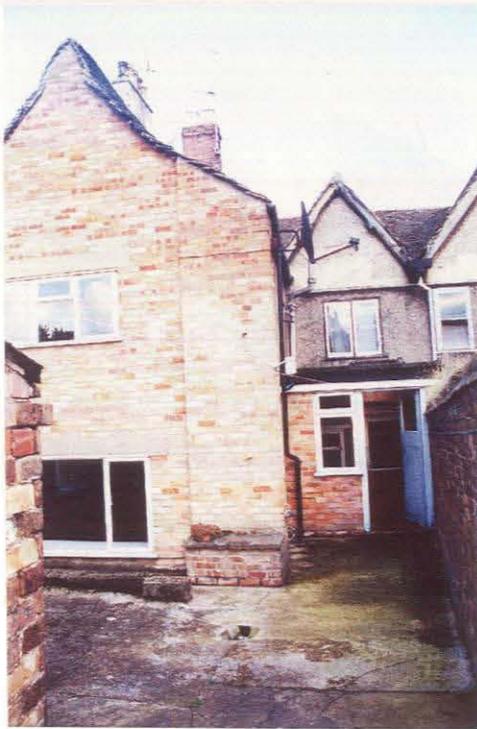
Plate 11: West elevation, northernmost gable end (no.65) is featured on the left-hand side of the shot. Note the 1.2 metre wide brick "buttress" feature built down the southern side of the gable wall

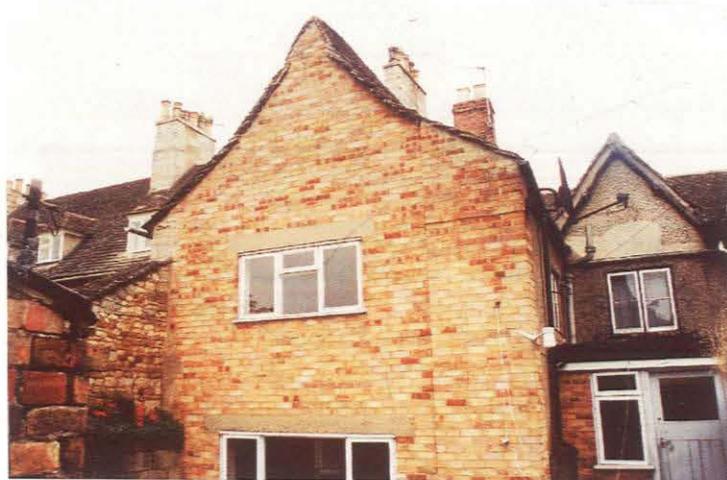
Plate 12: West elevation, northernmost gable end (no.65) - in the foreground; showing two large casement windows with concrete lintels.

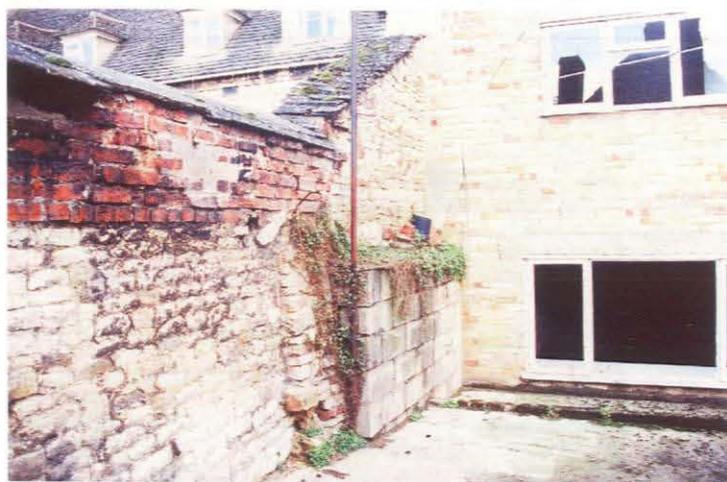
Plate 13: West elevation, northernmost gable end (no.65); note the raised ground level of Yard 65/6 which lies only just below the bottom of the window sill.

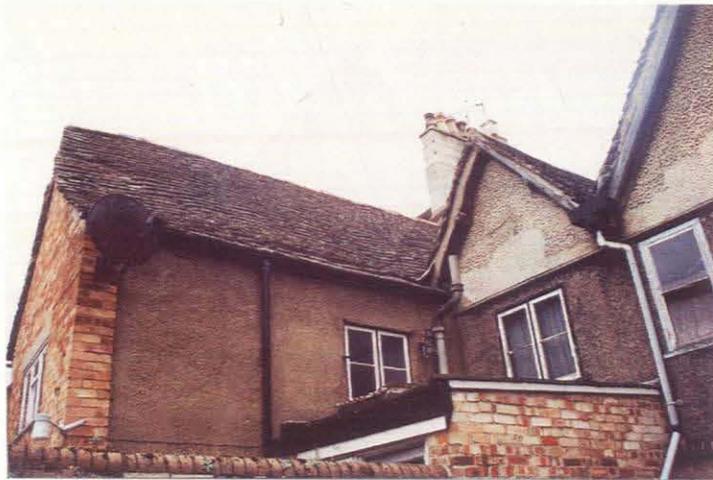
Plate 14: Rear ranges of nos. 64/65 showing the southern side wall of the northernmost range (no. 65), the (western) central gable end of no. 65 and part of the southernmost gable end of no. 64.

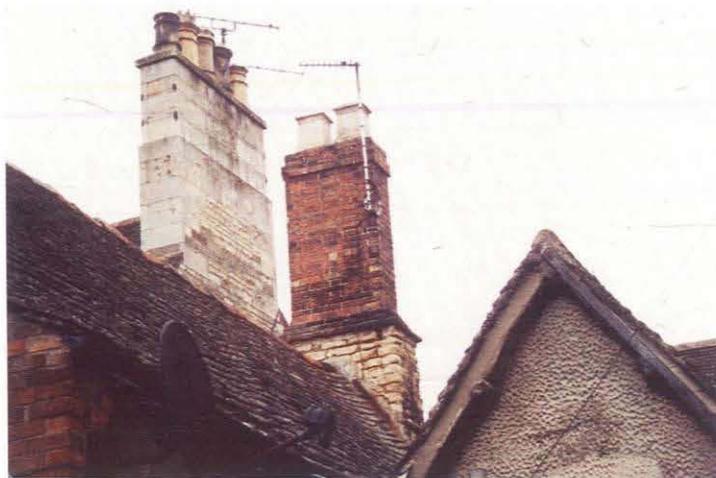
Plate 15: Looking northeast from the back of the property. The apex of the gable end featured on the right belongs to the central gabled range (no. 65). The brick and stone stack serves the fireplace located within the west wall of Room 65/1 and Room 65/4. (The tall ashlar and rubble stack behind belongs to house no. 66).

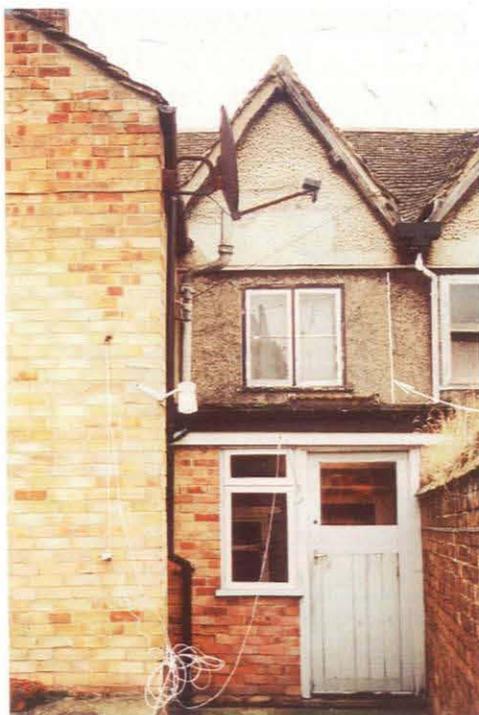
*Straight joint
beneath render*

Plate 16: West (rear) elevation, central end gable (no. 65)

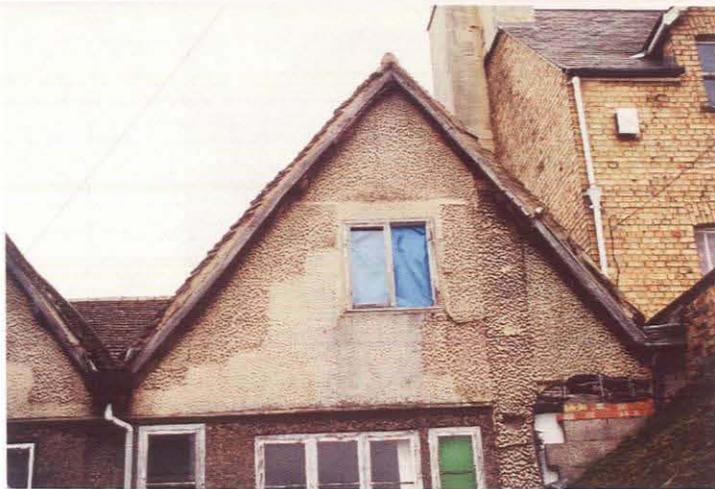
Plate 17: Upper reaches of the western (rear) elevation, southernmost gable end (no.64).

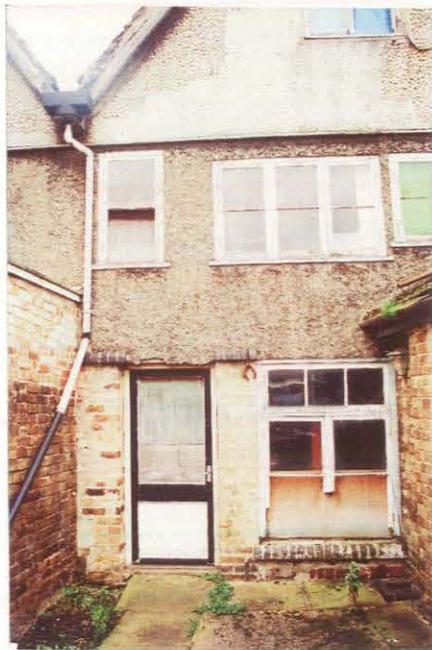
Plate 20: West (rear) gable end, north side of southernmost range (no.64).

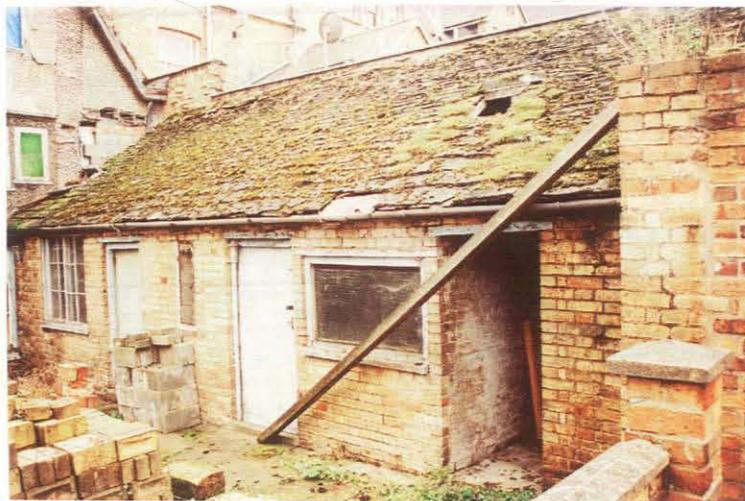
Plate 21: Outbuilding (Rooms 64/3 - 64/6) situated in Yard 64/7 at the rear of the property, looking southeast

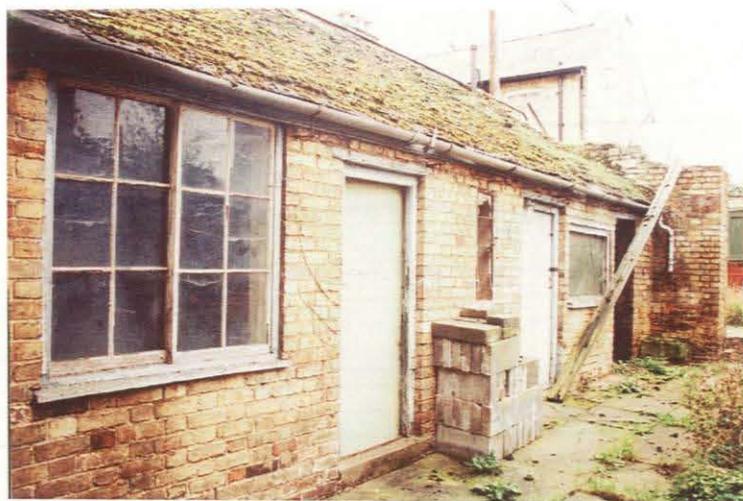
Plate 22: Outbuilding (Rooms 64/3 - 64/6) situated in Yard 64/7 at the rear of the property, looking southwest.

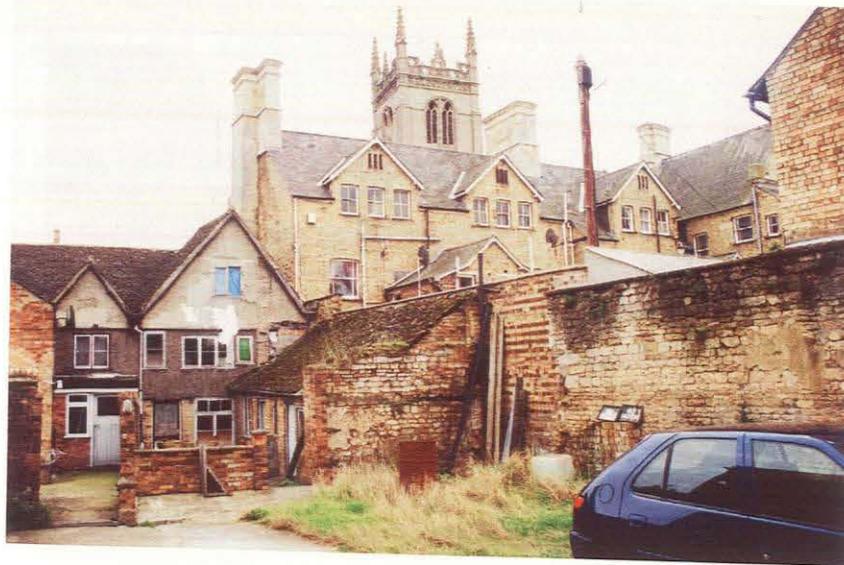
Plate 23: View of rear of property looking southeast from concreted area in front of no.19, Church Court.

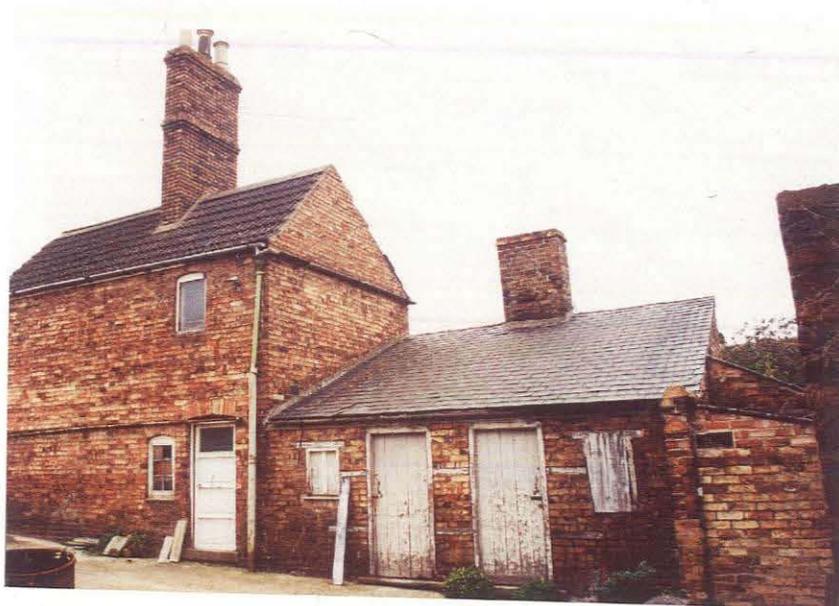
Plate 24: View of no.19, Church Court and adjacent lean-to Outhouse 65/9, looking north.

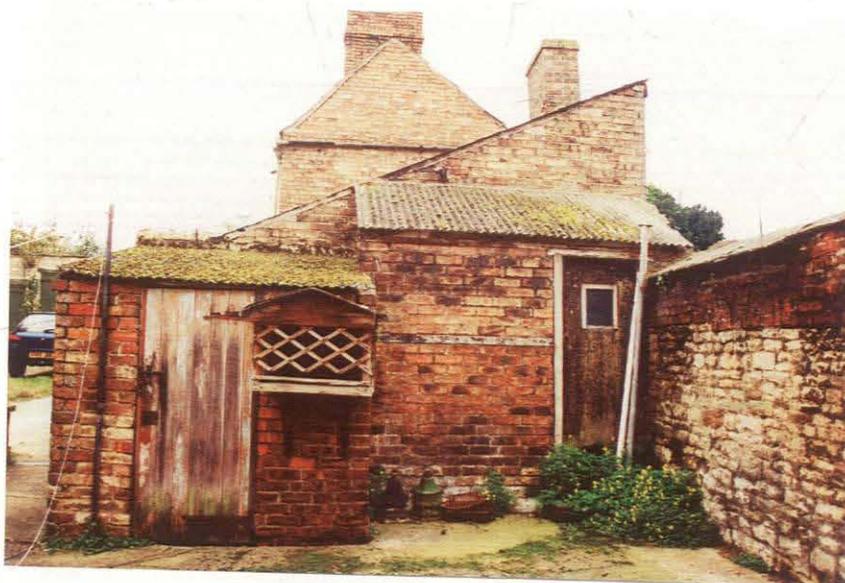
Plate 25: Sheds 65/7 and 65/8 in Yard 65/6 at the rear of the property, looking west.

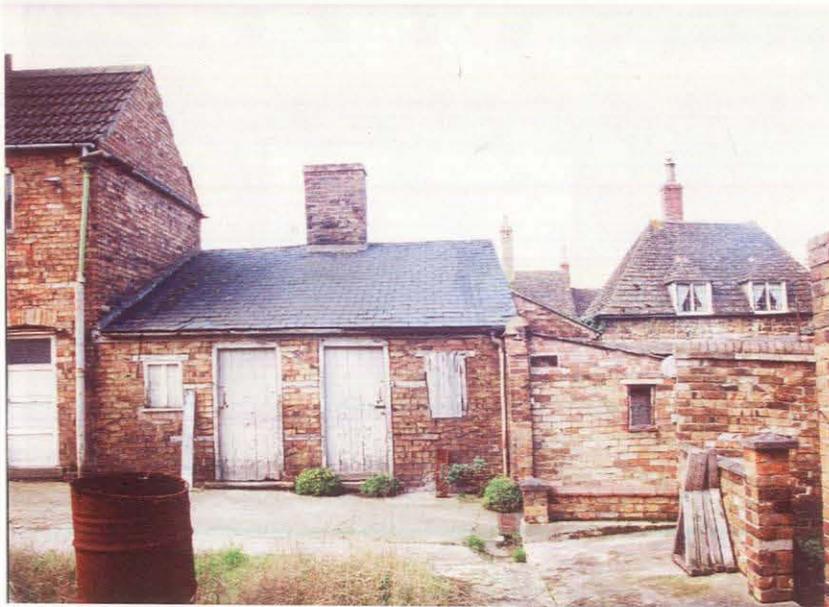
Plate 26: Outhouse 65/9 and the south side of shed 65/8 at the rear of the property, looking north.

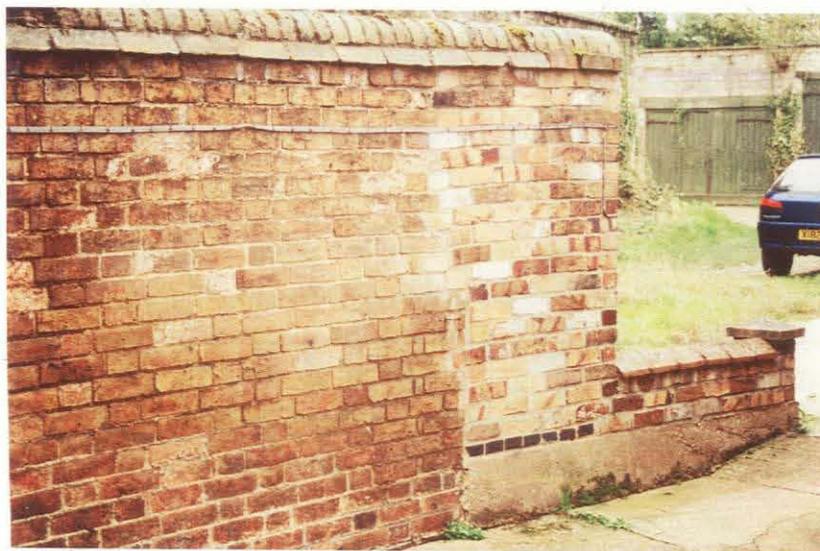
Plate 27: View of tall, brick wall which divides Yard 64/7 (of no. 64) from Yard 65/6 (belonging to no. 65), at the rear of the property. Shot is taken from Yard 65/6, looking southwest.

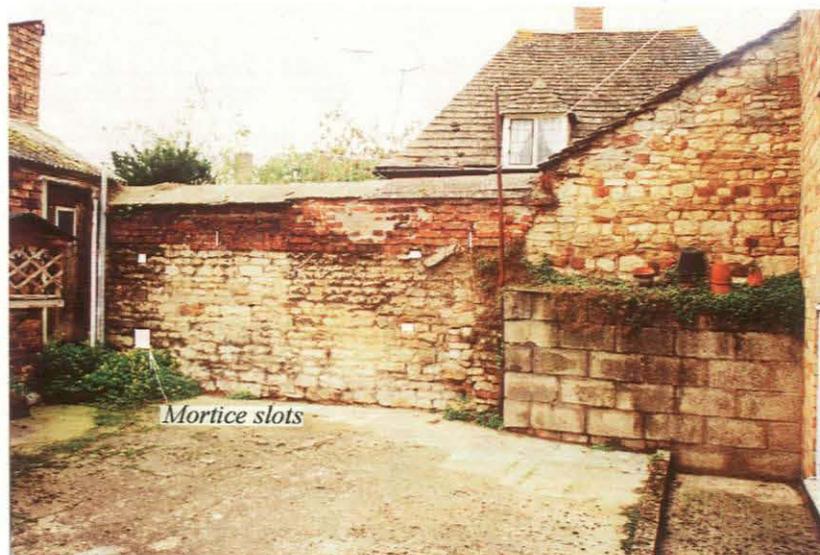
Plate 28: View of the northern property boundary wall taken from Yard 65/6, looking north. Note the variety of building fabrics, different periods of build, mortice slots and areas of blackening upon the wall.

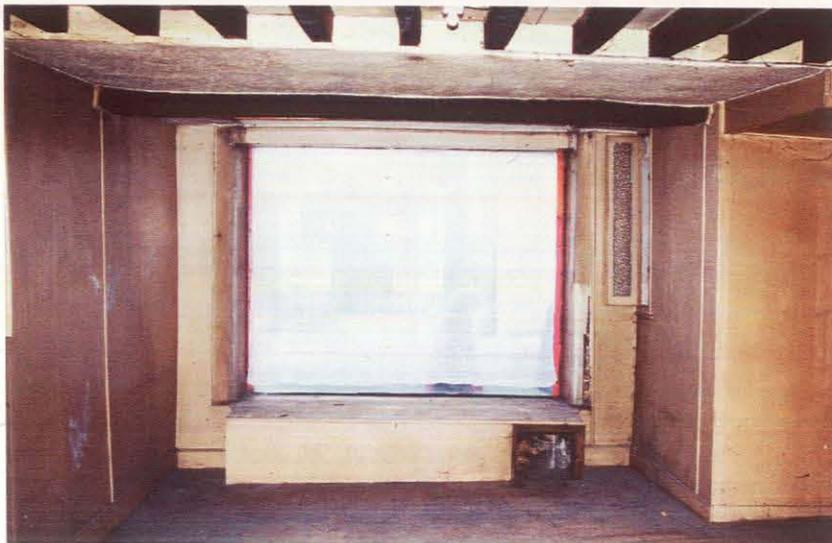
Plate 29: Front room 65/1, no.65; "shop" window featured within the east wall.

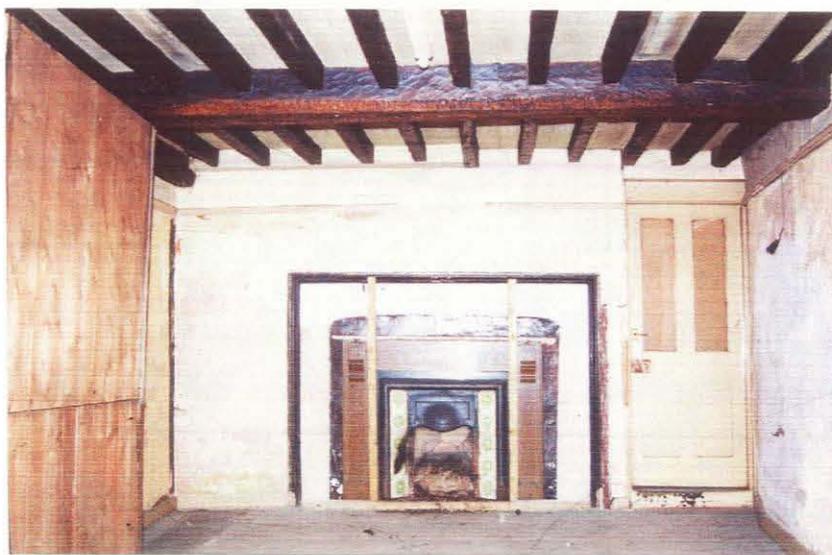
Plate 30: Front room 65/1, no.65; west wall features a dressed stone, moulded fireplace and a second, inserted fireplace set within it. The doorway to the north (right) of the flue leads into Room 65/4.

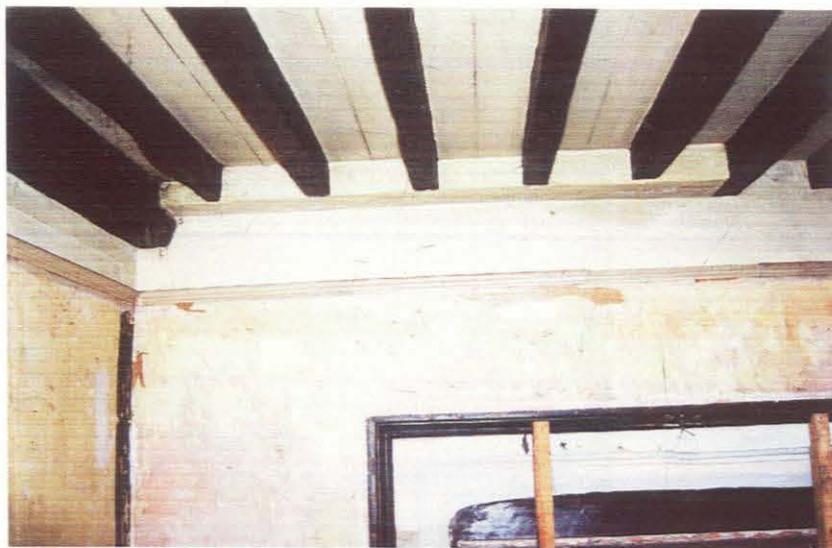
Plate 31: Front room 65/1, no.65; the west wall features a north-south beam set within the flue wall, and slightly protruding from it. The north end of this timber terminates about 1.80 metres from the north wall; the south end is supported by an east-west beam which lies somewhat obliquely along the top of the south wall.

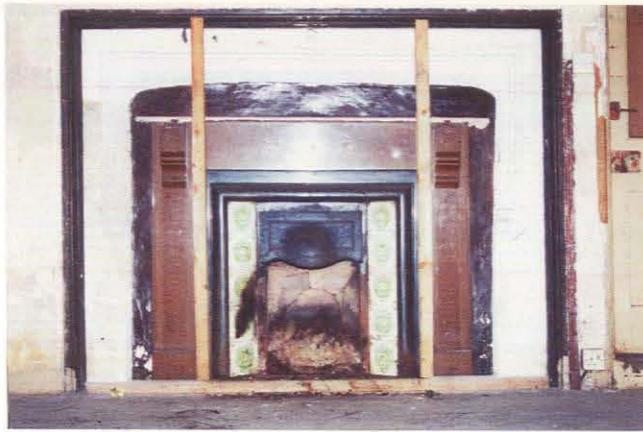
Plate 32: Front room 65/1, no.65; dressed stone, moulded fireplace set within the west wall. Set within the stone fireplace opening is a second (later) fireplace with a cast iron grate, tiles and wooden surround.

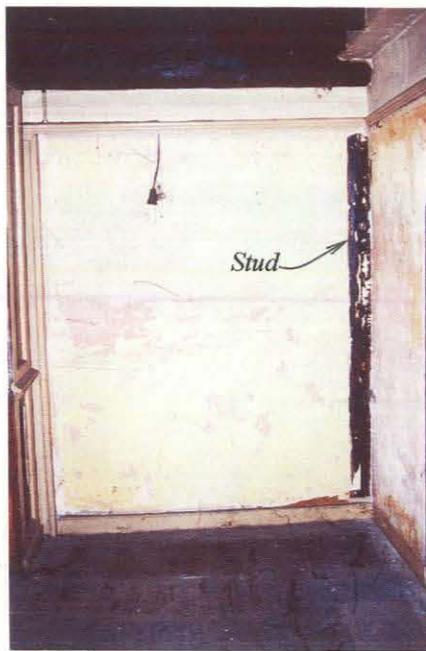
Plate 33: Front room 65/1, no.65; west end of the south wall featuring a single, upright timber in the western corner of the room.

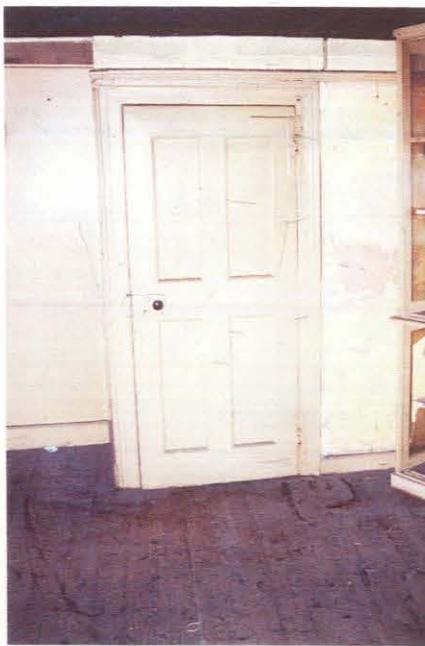
Plate 34: Front room 65/1, no.65; panellled door of walk-in cupboard featured midway along the south wall. Note the L-Hinges (CBA,1994,25) and moulded frame.

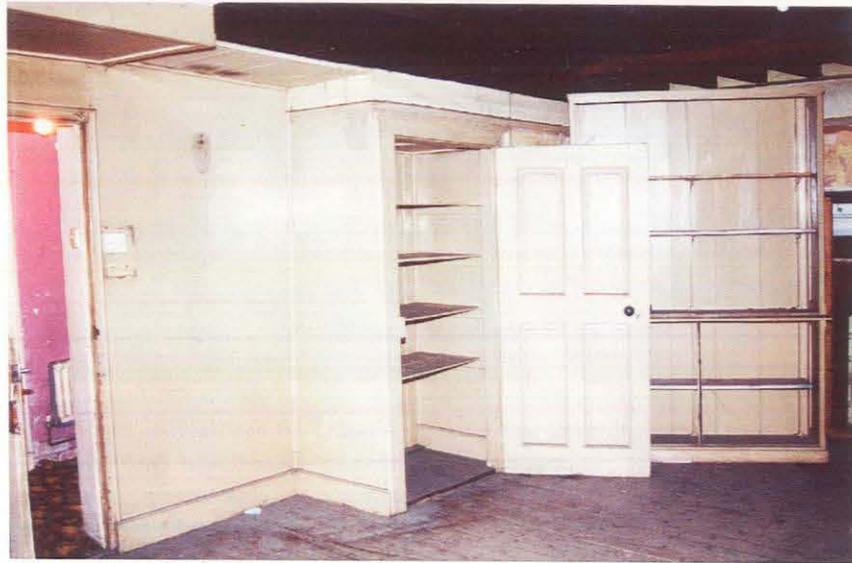
Plate 35: Front room 65/1, no.65; looking southwest, featuring the walk-in cupboard (and free-standing shelving unit behind!)

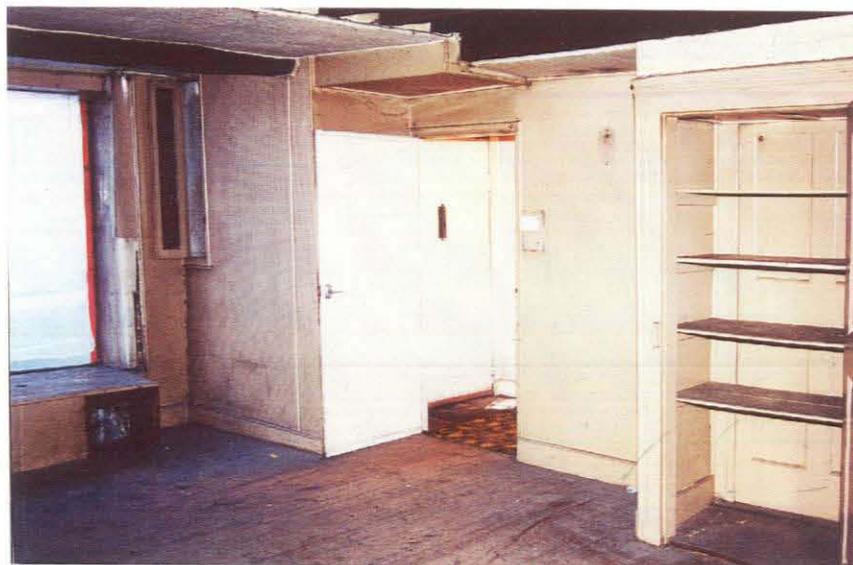
Plate 36: Front room 65/1, no.65; looking southeast, featuring doorway within the south wall, walk-in cupboard and the southern end of the "shop" window.

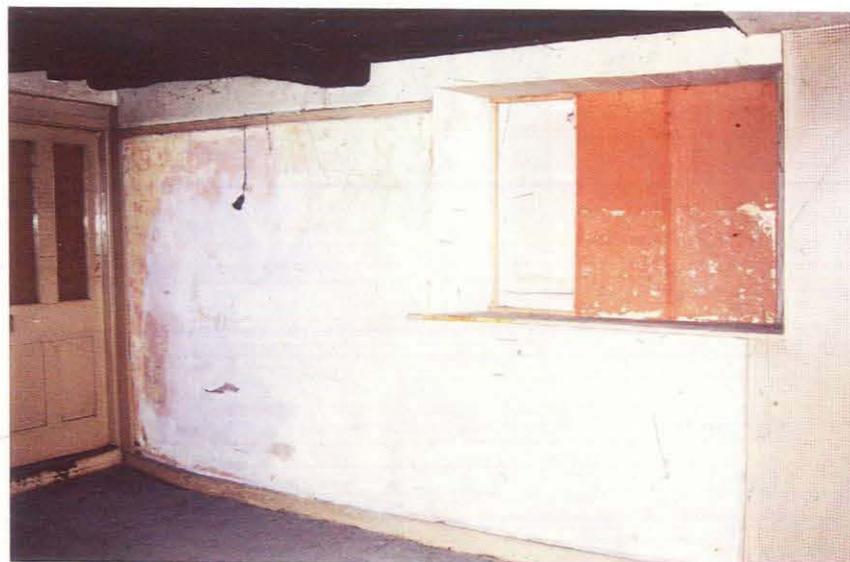
Plate 37: Front room 65/1, no.65; looking northwest, view of the blocked window with ovolo-moulded jambs and mullions set within the north wall.

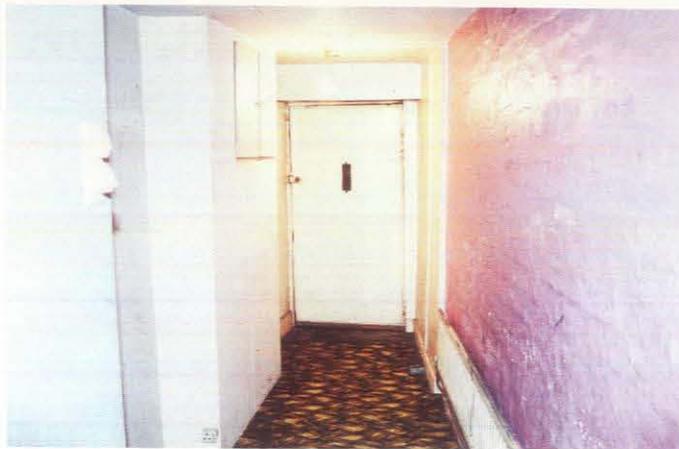
Plate 38: Hallway 65/2, no.65; looking east towards the doorway which leads out onto the High Street.

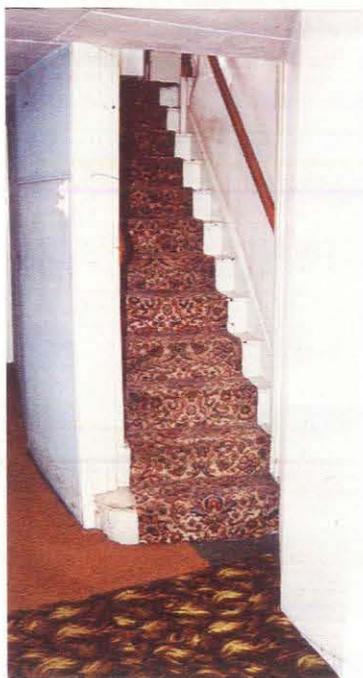
Plate 39: Hallway 65/2, no.65; looking west up the straight flight stairway which leads up to Landing 65/10.

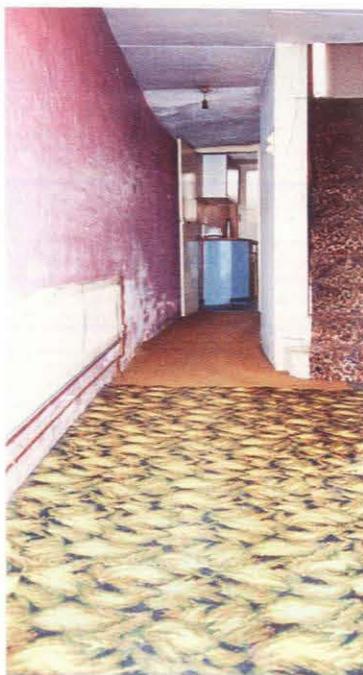
Plate 40: Hallway 65/2, no.65; looking west towards the doorway which leads into Kitchen 65/3.

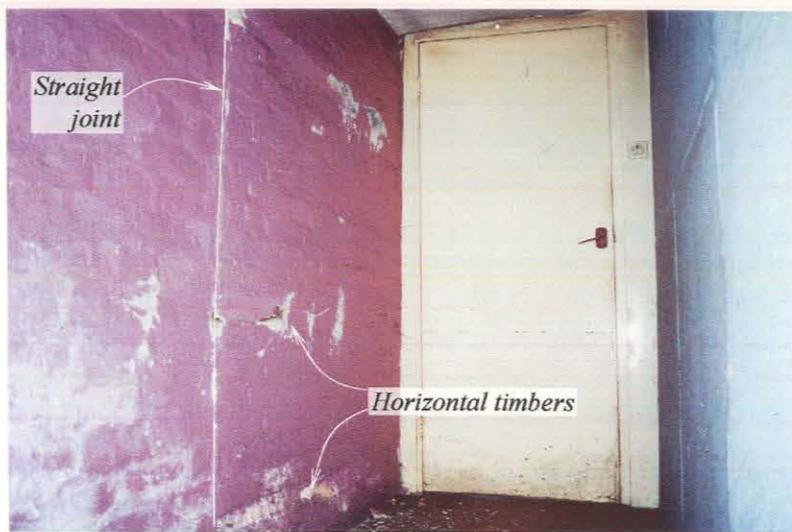
Plate 41: Hallway 65/2, no.65; looking west towards the doorway which leads into Kitchen 65/3. Note the straight joint in the brick wall on the left; this wall forms a division between no.64 and no.65.

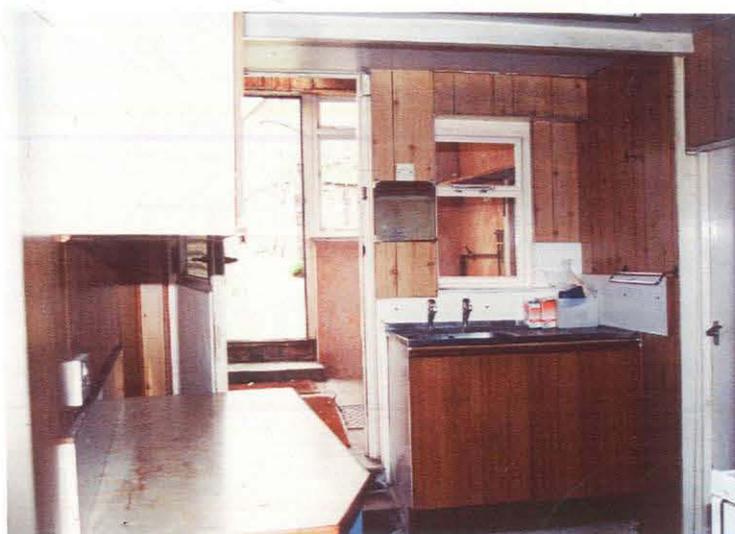
Plate 42: Kitchen 65/3, no.65, looking west; the walls of the kitchen area are completely obscured by plywood, fitted units and modern fixtures/fitings.

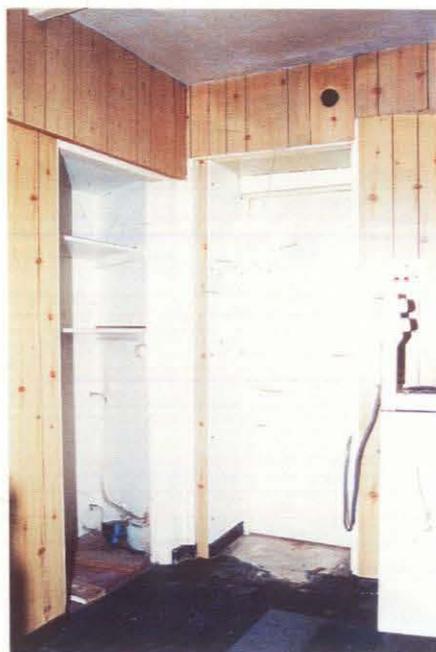
Plate 43: Kitchen 65/3, no.65; northeast corner of kitchen area featuring the door which leads down to Cellar basement 65/20 (right), and a walk-in cupboard to the left.

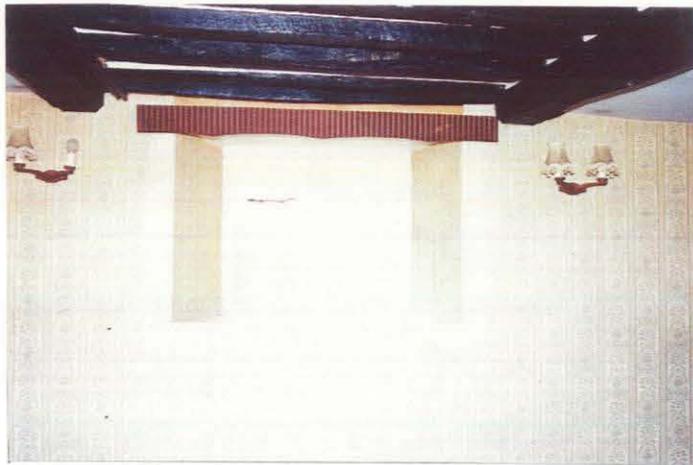
Plate 44: Lounge 65/4, no.65; north wall featuring splayed window opening at the its western end.

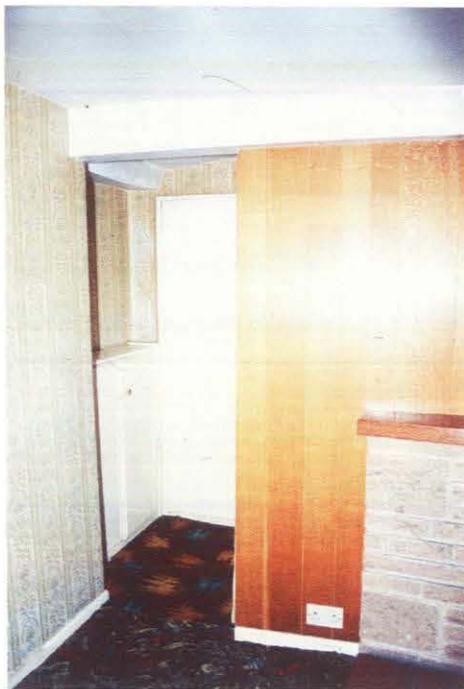
Plate 45: Lounge 65/4, no.65; northeast corner of the room featuring door leading down into Front room 65/1, and a cupboard built into the lower half of a recess within the north wall.

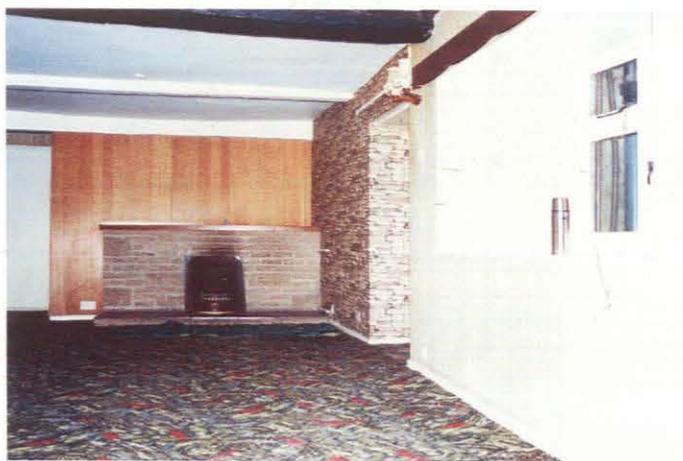
Plate 46: Lounge 65/4, no.65: looking east towards the fireplace. Note the papered walls, and modern cladding material attached to the flue wall. The splayed window opening in the south wall (right) today looks through into Back Kitchen 65/5.

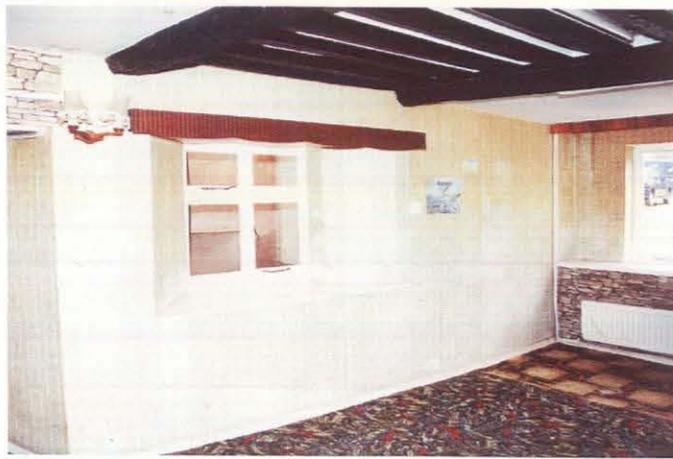
Plate 47: Lounge 65/4, no.65; looking over towards the southwest corner of the room and featuring a splayed window opening in the south wall (left), which today looks through into Back Kitchen 65/5.

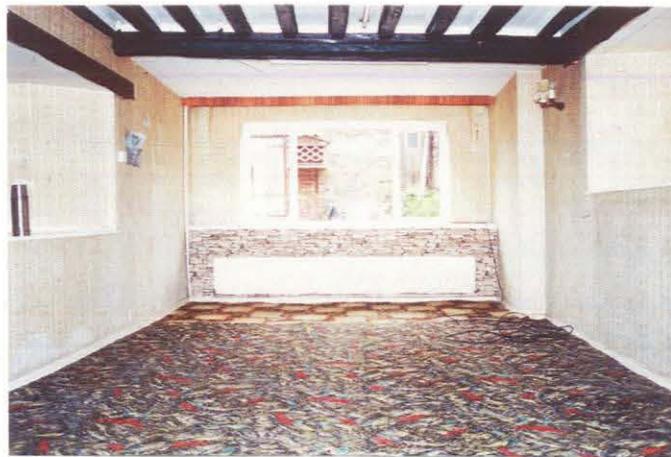
Plate 48: Lounge 65/4, no.65; looking west towards the large, modern casement set within the end gable wall.

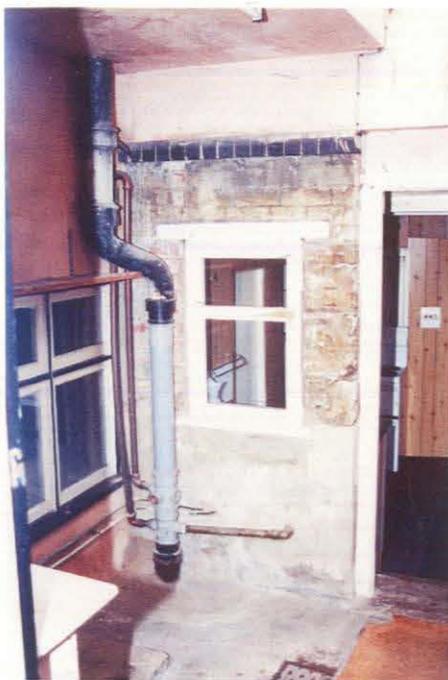
Plate 49: Back Kitchen 65/5, no.65; northeast corner of room.

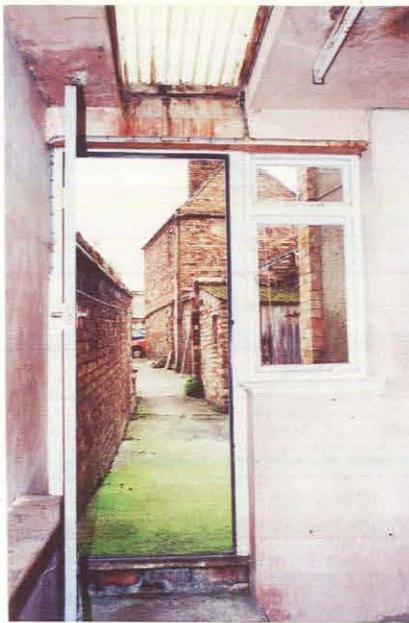
Plate 50: Back Kitchen 65/5, no.65;
looking west and out into Yard area 65/6.

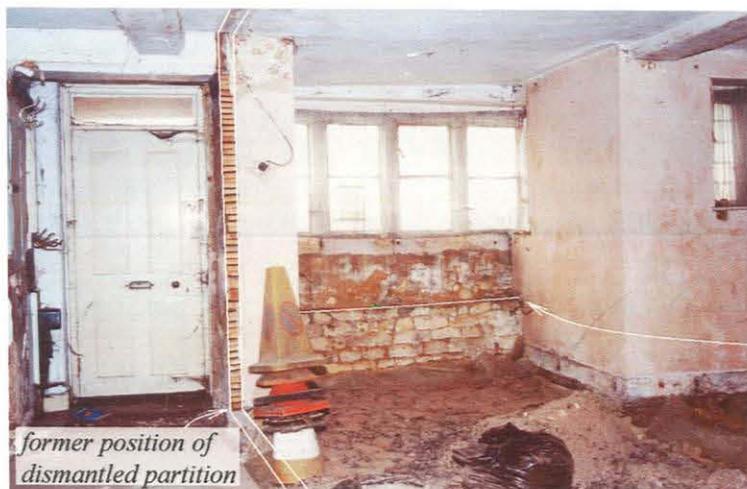
Thickness of wall much greater below this line. (Remains of plinth; see section 7.21).

Plate 51: Front room 64/1, no.64, looking east; the doorway (left) leads out onto the High Street. Note the ovolo-moulded mullion window within the window bay, with its four east-facing lights, the thicker section of walling below, and the excavated floor surface.

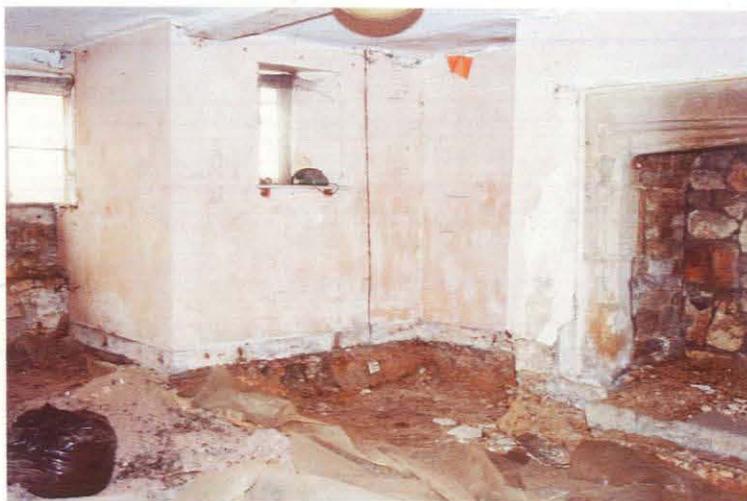
Plate 52: Front room 64/1, no.64; southeast corner of room. Note the small, splayed window opening in the east wall. The eastern corner of the moulded, dressed stone fireplace is just visible to the right of the picture.

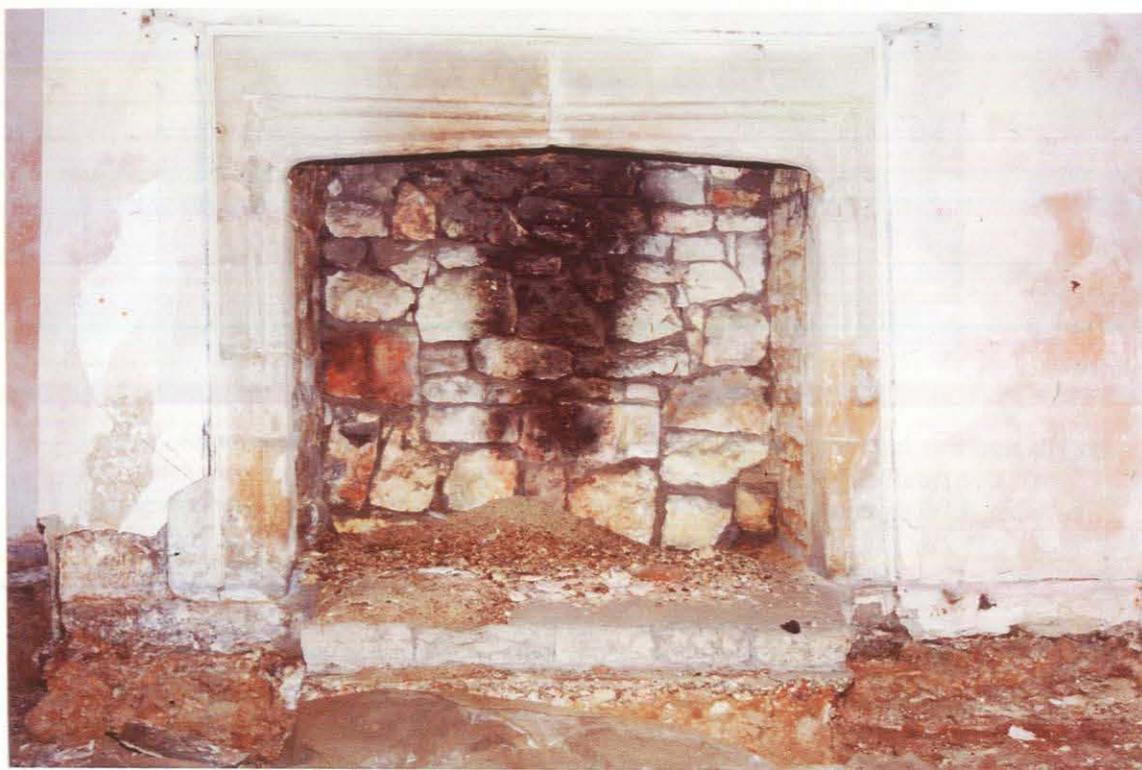
Plate 53: Front room 64/1, no.64; featuring the dressed stone fireplace set within the southern wall.

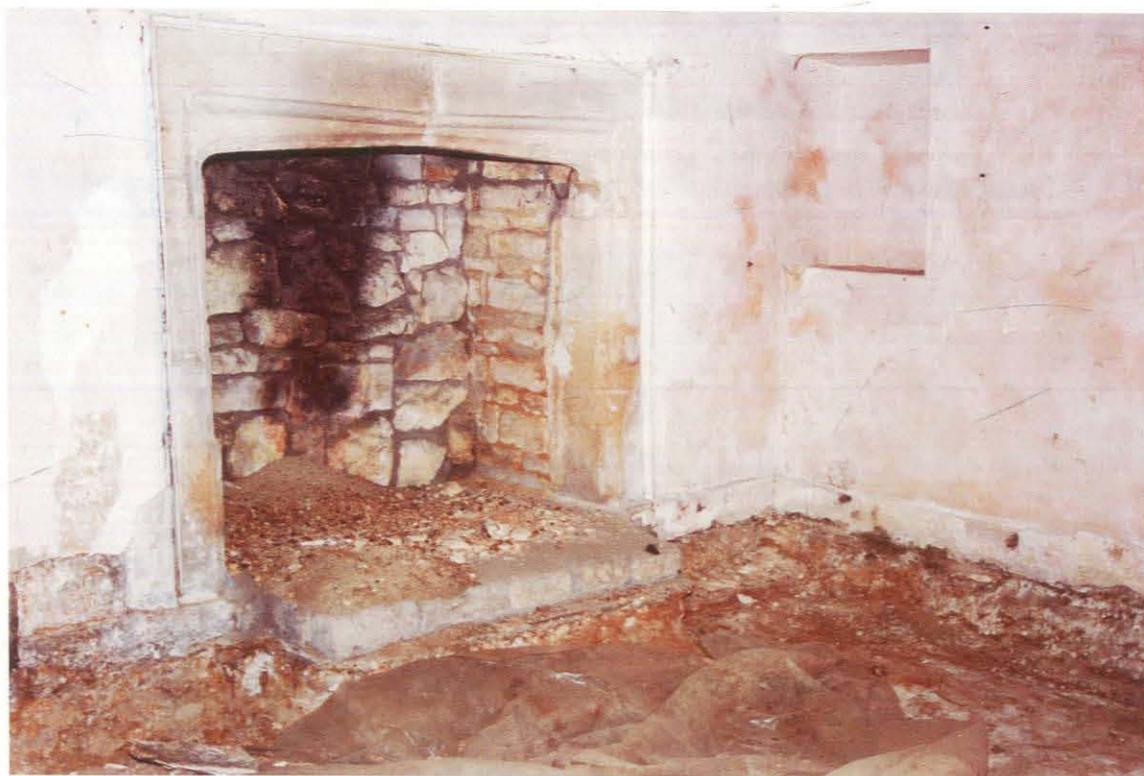
Plate 54: Front room 64/1, no.64; southwest corner of the room featuring the dressed stone fireplace and a square-shaped recess built into the corner of the western wall.

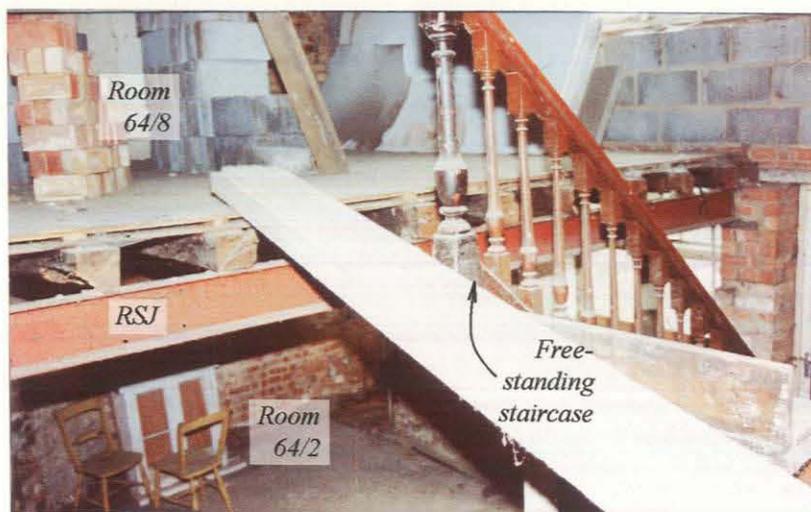
Plate 55: Rooms 64/2 & 64/8, no.64; looking southwest and featuring the steel, east-west aligned RSJ which supports the joists and remaining floorboarding which belong to Room 64/8. The ceiling area between the RSJ and the north wall of 64/2 & 64/8, has been completely removed.

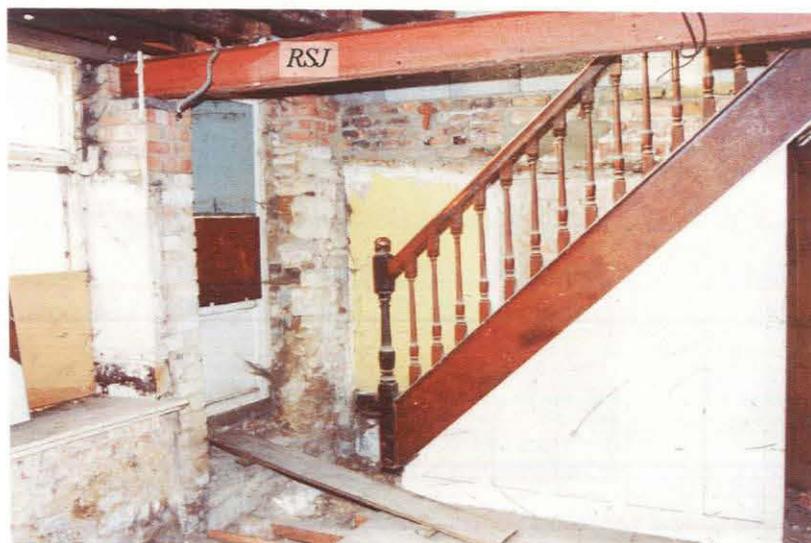
Plate 56: Room 64/2, no.64, looking into the northwest corner of the room. Note the free-standing staircase and steel RSJ which is supported at its western end by a brick pillar.

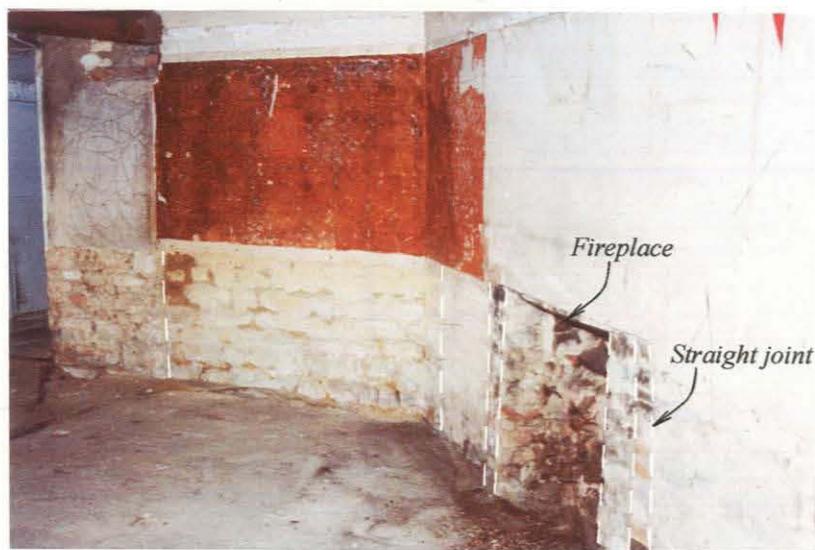
Plate 57: Room 64/2, no.64, looking east-southeast; the walls display a complicated sequence of building and re-building and comprise discrete areas of brick and roughly coursed limestone rubble. The southeast wall (right of picture) features a stone-built fireplace with iron lintel, now partly blocked with bricks.

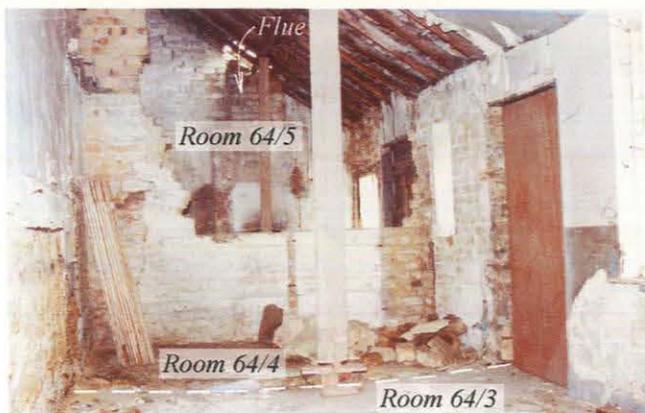
Plate 58: Outbuilding rooms 64/3 & 64/4, looking west; view through the two rooms and featuring the partly demolished partition wall which divides Room 64/4 from 64/5.

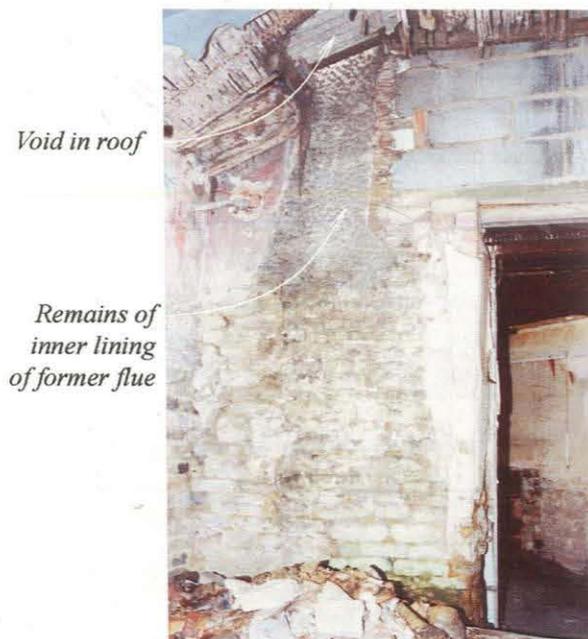
Plate 59: Outbuilding room 64/3, looking east; featuring a doorway leading down into Room 64/2 and, to the left, a wall scar and the remains of the inner lining of a flue which was once positioned here. Note the void in the roof above through which the flue would have risen.

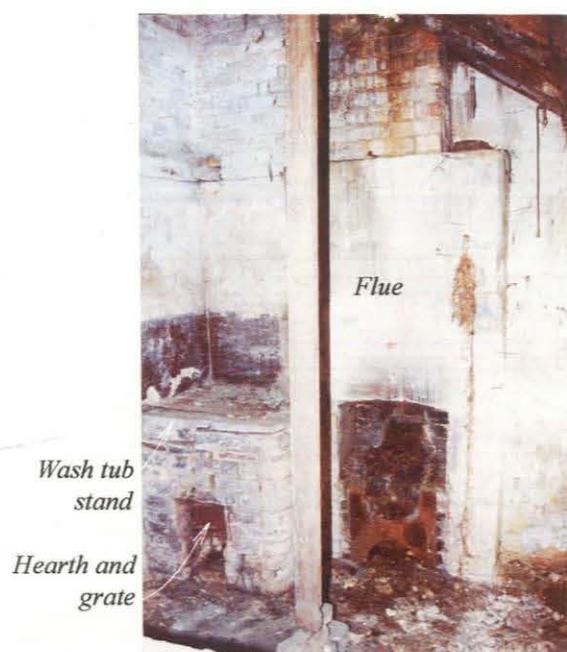
Plate 60: Outbuilding room 64/5, looking southwest; featuring a fireplace and flue built into the west wall, together with a brick-built, iron wash tub stand with a hearth and grate.

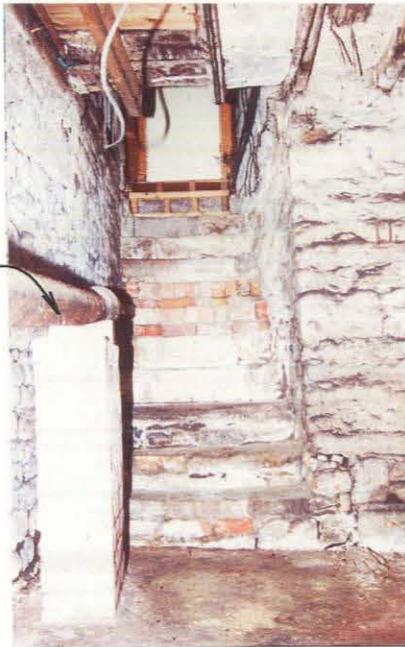
Plate 61: Cellar stairway 65/19, no.65; looking west and up the steps towards the doorway which leads through into Kitchen 65/3.
