**64/65 HIGH STREET, ST.MARTIN'S,
STAMFORD, LINCOLNSHIRE**

An Archaeological Building Appraisal

NETWORK ARCHAEOLOGY LTD

Report No.160

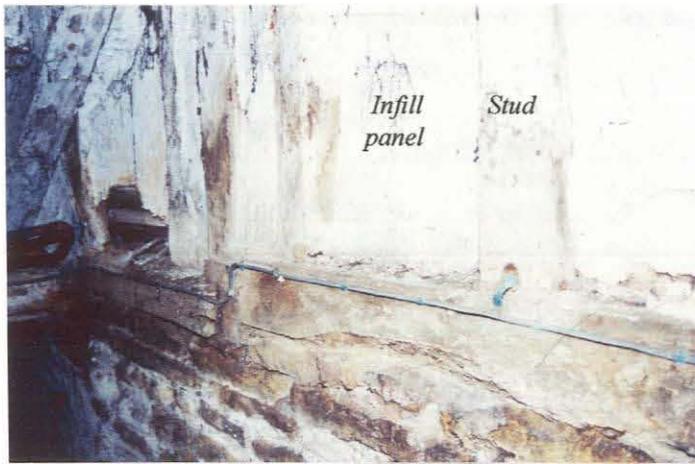
Plate 62: Cellar stairway 65/19, no.65; south side of stairway wall. The lower reaches comprise rubble, but the upper reaches of the wall display vertical posts (studs) set upon a wooden sill beam, with lath and plaster and reed infill panels between.

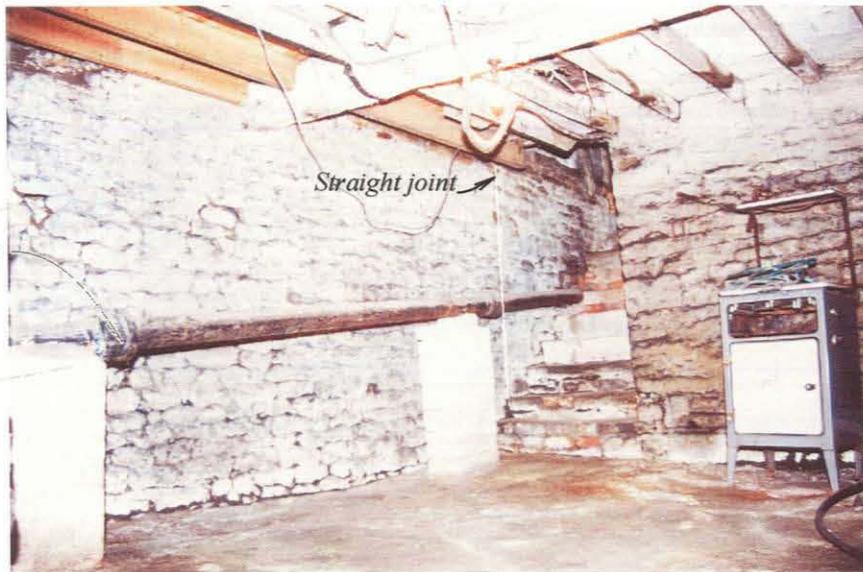
Plate 63: Cellar basement 65/20, no.65; looking southwest towards the steps (65/19) which lead up to Kitchen 65/3. Note the straight joint within the south stairway wall.

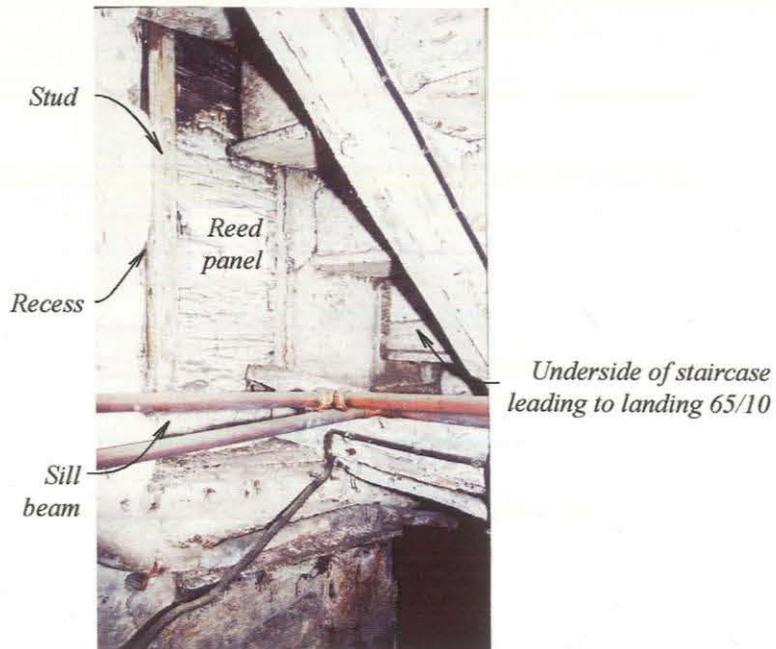
Plate 64: Cellar stairway 65/19, no.65; north side of stairway wall featuring a shallow recess set within the upper part of the wall at the eastern end. Note the sill beam beneath the recess and the reed infill panel at the back

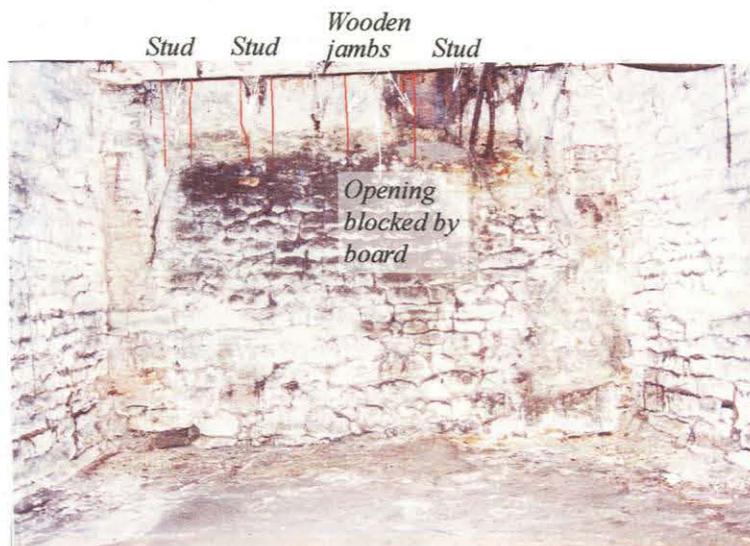
Plate 65: Cellar basement 65/20, no.65, looking eastwards; this wall lies directly below the "shop" window set within the east wall of Room 65/1 on the ground floor above. Note the wooden sill beam which supports a series of wooden studs and plastered over reed infill panels, and also the blocked opening.

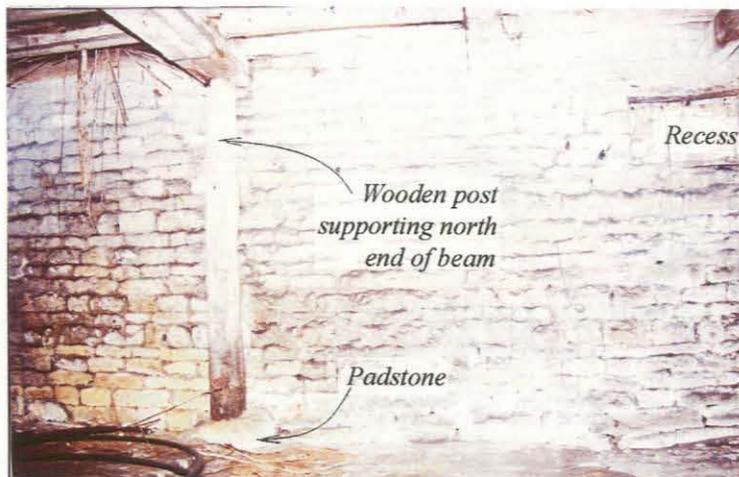
Plate 66: Cellar basement 65/20, no.65, looking north; featuring a small, rectangular splayed recess (far right of picture) set about two-thirds of the way up the wall, and also the northern end of the westernmost beam which is supported by a wooden post, itself positioned upon a padstone.

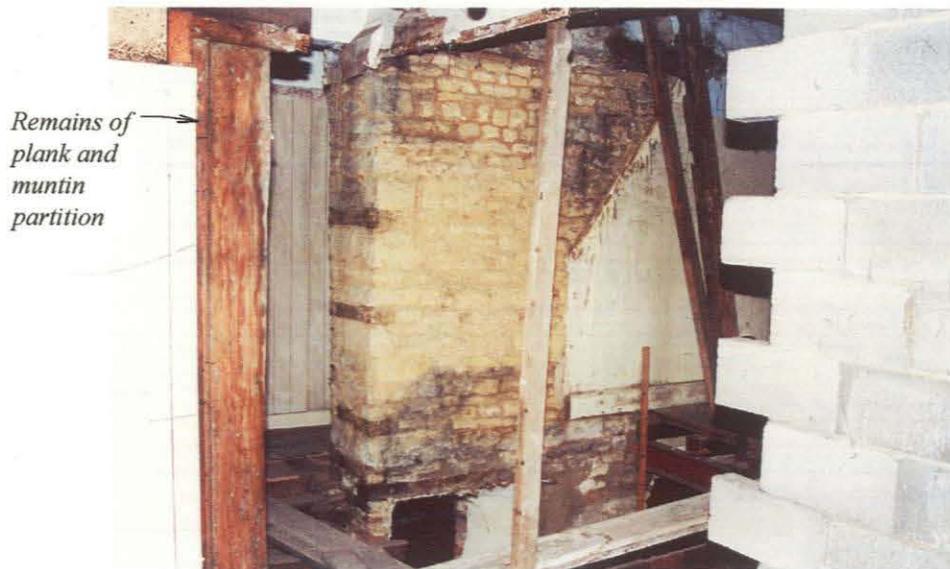
Plate 69: Room 65/11, no.65, first floor; view looking south east through the void in the east wall, and into Corridor 65/12 and Room 64/8. Note the single vertical partition board, lying adjacent to the doorway leading onto Landing 65/10, which represents the remains of the former plank and muntin partition wall.

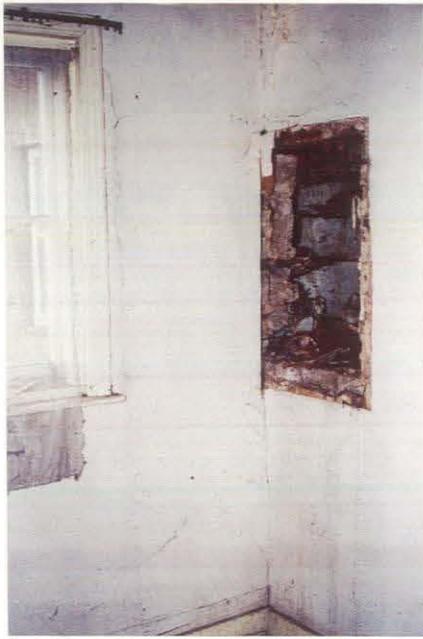
Plate 70: Room 65/11, no.65, first floor; northwest corner of room featuring a partly-blocked cupboard/former window opening, which is dissected by the west (external) wall of Room 65/11.

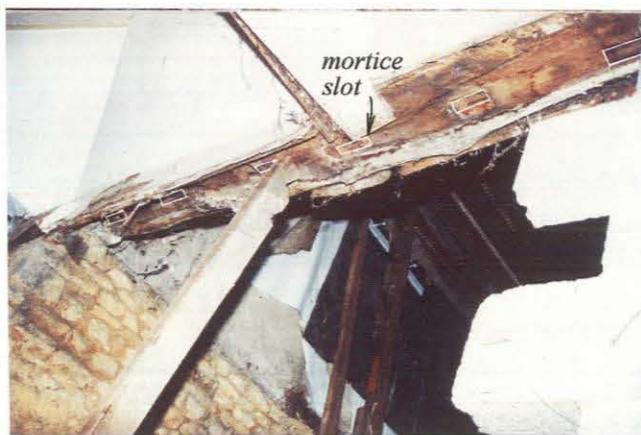
Plate 74: Corridor 65/12, no.65, first floor, featuring the underside of the east-west aligned beam which runs along the top of the south wall. Note the mortice slots.

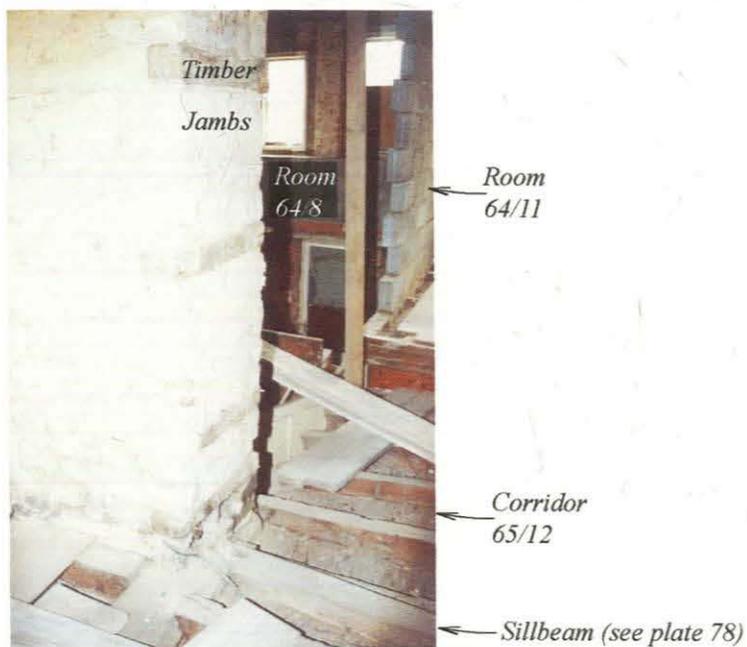
Plate 75: Corridor 65/12, no.65, first floor, looking southwest from the corridor, view of the northern end of the rubble wall which forms the division between Rooms 64/8 & 64/9. Note the ashlar jambs and horizontally-laid sections of timber built into the wall end.

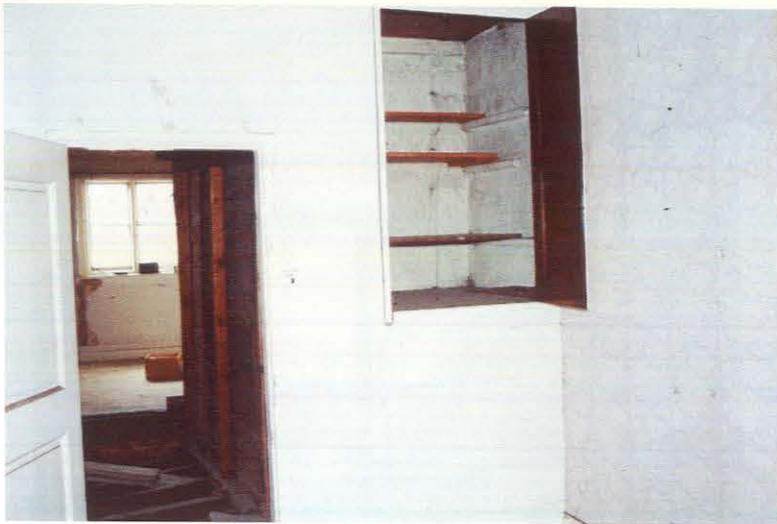
Plate 79: Room 65/13, no.65, first floor; northwest corner of the room featuring a built-in cupboard and the doorway leading out into Corridor 65/12.

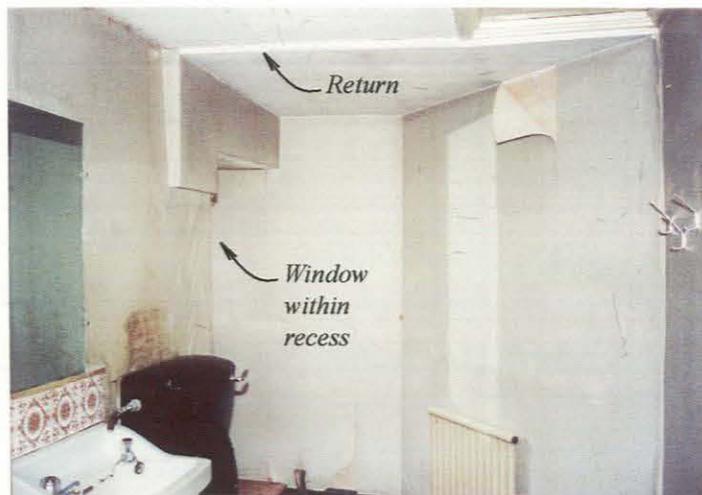
The ceiling is plastered and painted. Towards the western side there is a noticeable return in the ceiling plane which comprises approximately 6 centimetres; the ceiling height to the east of the return sits approximately 6 centimetres higher than that to the west (plate 84).

Plate 84: Bathroom 65/15, no.65, first floor, looking west; note the return in the ceiling - the ceiling height to the west of the return sits a few centimetres lower than that to the east.

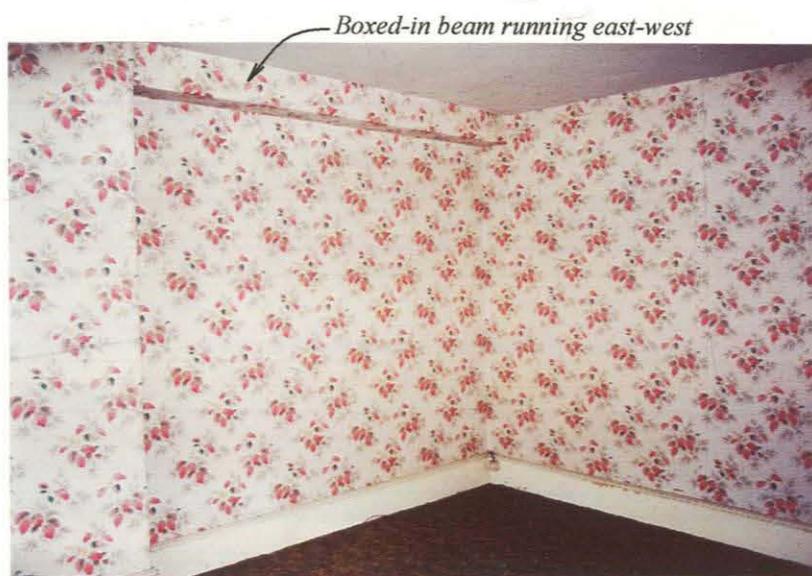
The southern wall is completely papered over. The western two-thirds of wall is set back slightly from the eastern end. A boxed-in beam runs along the top of the western end of the southern wall elevation (continuing along from room **65/17**); the eastern end of the beam disappears into the return of the projecting part of the south wall (plate 90).

Plate 90: Room 65/18, no.65, first floor; southwest corner of room featuring a boxed-in beam aligned east-west, and the south wall return.

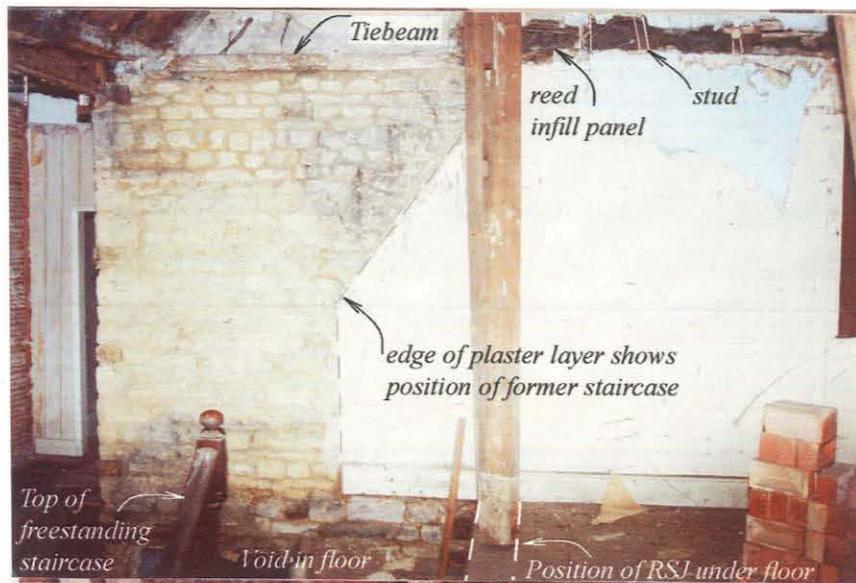
The eastern wall comprises roughly coursed limestone rubble up to the level of an exposed tiebeam. The wall's rubble make-up is visible at the northern end, but the southern end is covered with painted plaster and wallpaper; the vertical and diagonal straight edges of the plaster layer indicate the position of a former staircase (plate 92).

Plate 92: Room 64/8, no.64, first floor, looking east.

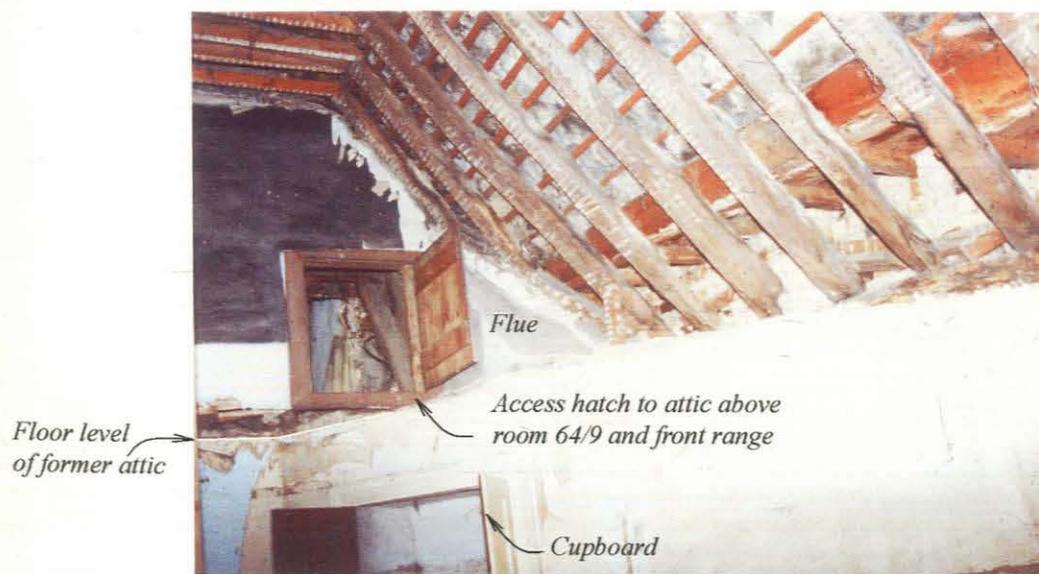
Room 64/8 has no ceiling and the common rafter roof timbers are all exposed. The east wall is entirely visible above tiebeam level and although most of the truss itself is obscured by plasterwork, an area of fallen plaster just above the tiebeam reveals the make-up of the wall beneath. Here, the base of several studs can be seen and also part of the remains of five separate infill panels, one comprising lath and plaster and the other four of daub and horizontally laid reeds (plates 92 & 93). The wall also features a square hatch which provides access into the attic space above room 64/9 and also to the attic area above the entire front range. The hatch has a wooden frame and a side-hung battened door. It is located immediately above the tiebeam at the southernmost end of the elevation (plate 93).

The south-eastern wall is angled diagonally across room 64/8 and stands only as high as the tiebeam within the eastern wall elevation, and up to the level of the wallplate in the southern elevation. The top of the wall has a flat ceiling and provides a platform immediately in front of the attic access hatch which is contained at the southernmost end of the eastern wall. Lying adjacent to the south side of the hatch, and angling up from the ceiling and disappearing into the corner of the east wall, is part of a flue (plate 93).

Plate 93: Room 64/8, no.64, first floor, southeast corner of room, featuring a square hatch set within the southern end of the east wall. The hatch provides access to the attic space above the first floor of the front range. The first floor ceiling/attic floor belonging to room 64/8 has been removed.

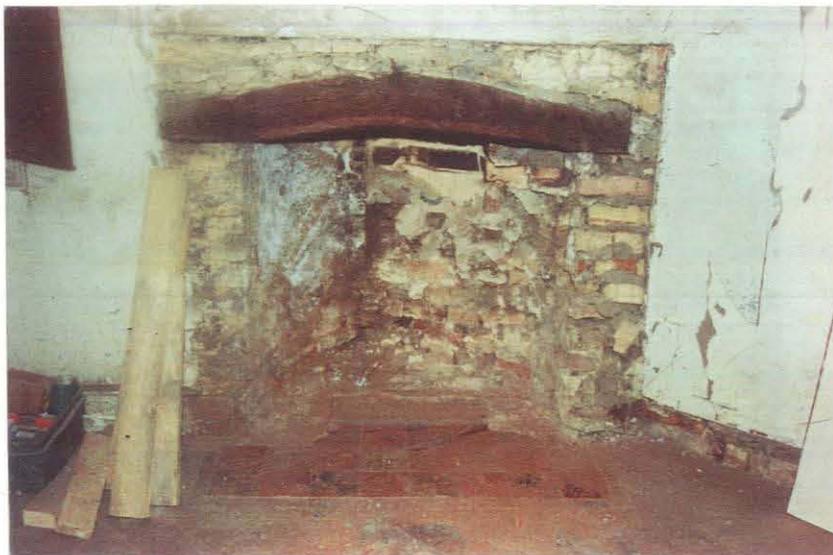
Plate 95: Room 64/8, no.64, first floor; fireplace set within the southeast wall

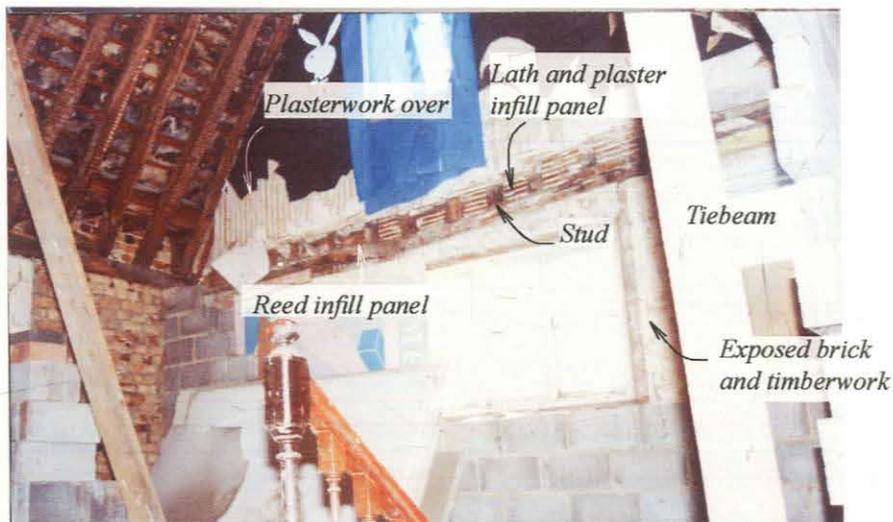
the central window above the level of the window sills, exposed brick and timberwork are visible (plates 96 & 97).

Plate 96: Room 64/8, no.64, first floor; southwest corner of the room, and featuring a breeze block area of rebuild within the west end gable. Note the brick and timberwork above and to the north (right) of the three-light window, and the studs with reed/lath and plaster infill panels between them, just above the tiebeam

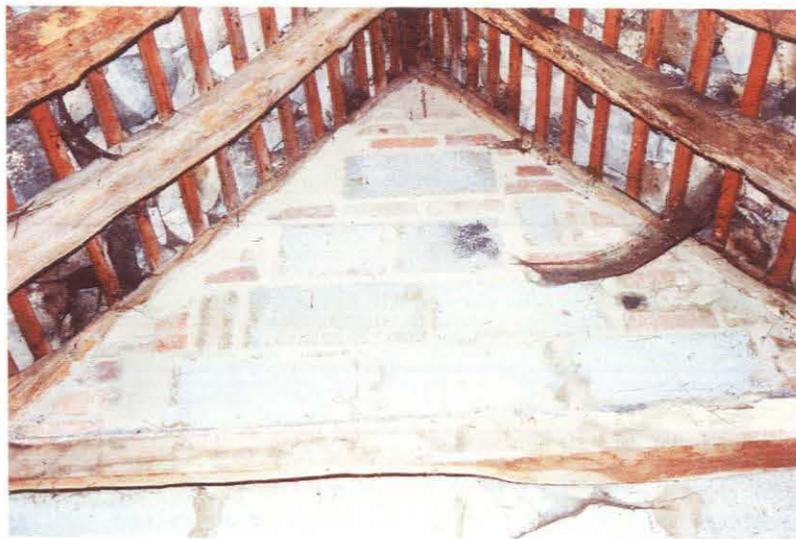
Plate 101: Room 64/9, no.64, first floor, view of the fabric comprising the apex of the window bay gable wall.

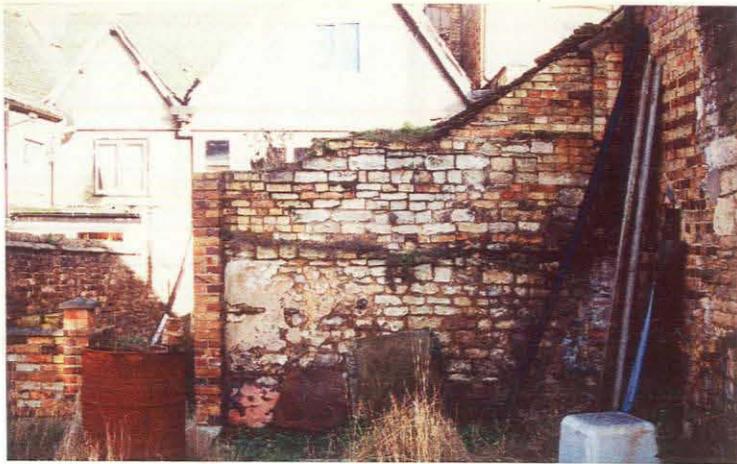
Plate 106: External west wall of the brick-built outbuilding located within Yard 64/7, (Rooms 64/3 - 64/6), featuring a variety of different fabrics and building phases.

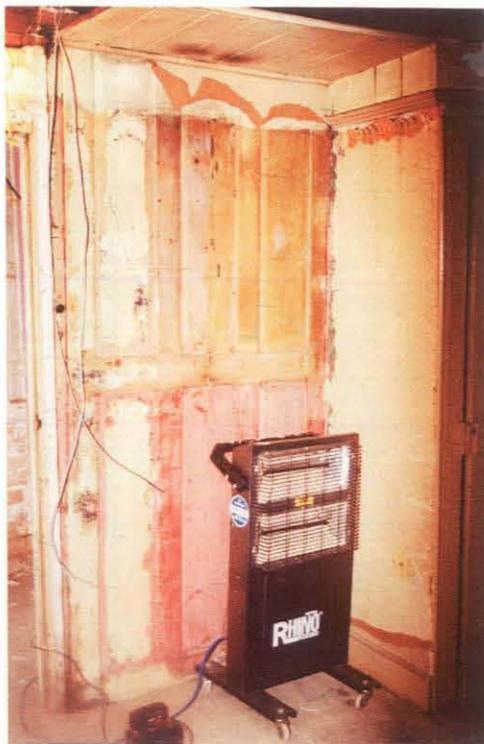
Plate 108: Room 65/1, no.65; view of the partition wall located between the present door within the south wall and the walk-in cupboard, after the plasterwork had been removed during the "opening-up" programme.

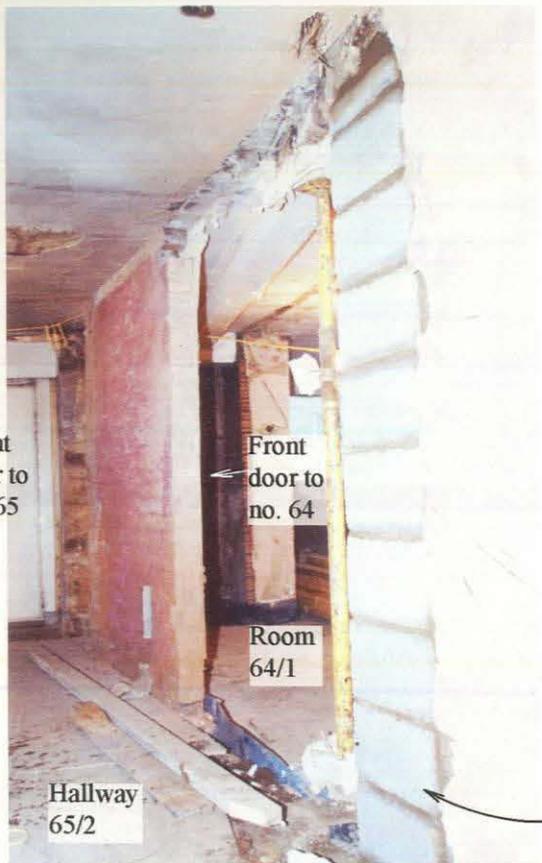
Breeze blocks inserted during building work.

Plate 109: Hallway 65/2, no.65, looking east; view of the partially demolished south brick wall which separated no.65 from no.64 at the time of initial survey.

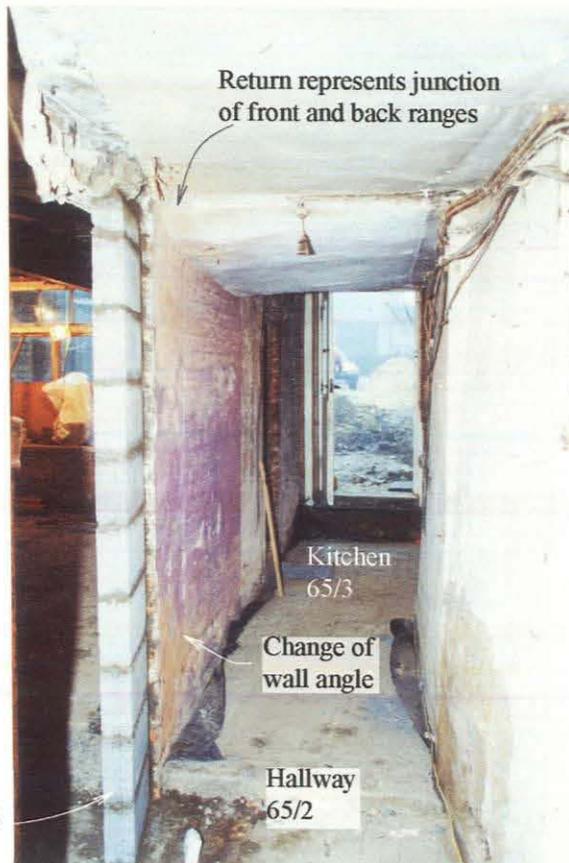
Plate 110: Hallway 65/2, no.65, looking west; view of the partially demolished south brick wall which separated no.65 from no.64, and featuring the shallow return in the ceiling which represents the junction between the front and back ranges.

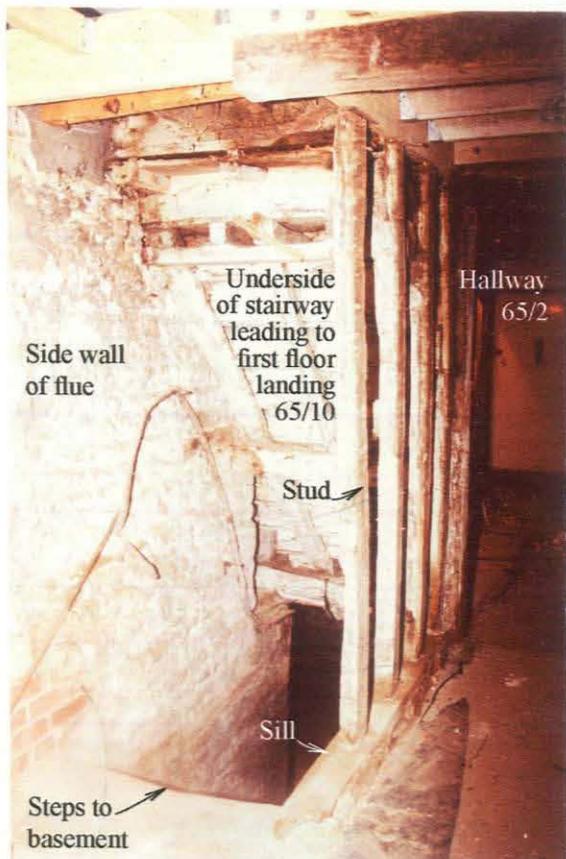
Plate 111: Hallway 65/2, no.65, looking east; view of revealed timberwork belonging to the south side wall of the stairway leading up to Landing 65/10. (The wall and doorway formerly separating Hallway 65/2 and Kitchen 65/3 has been removed).

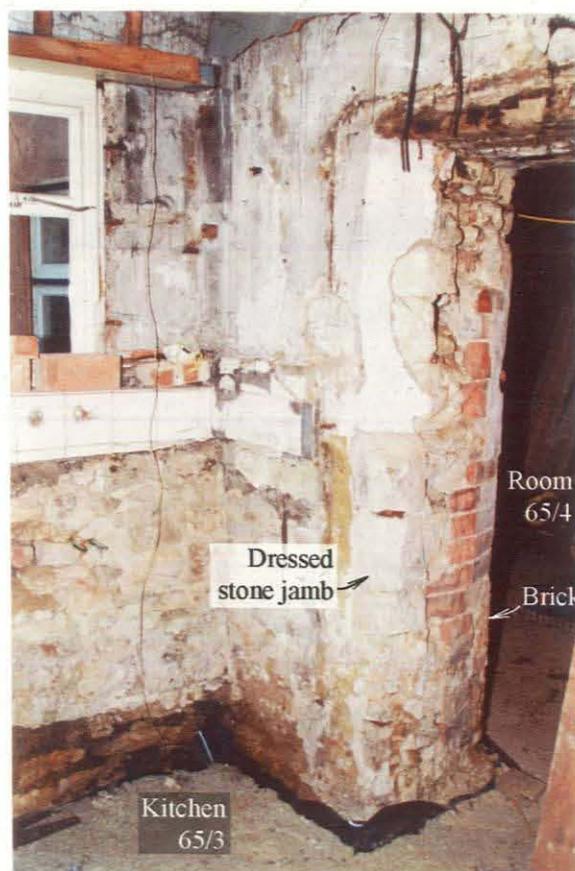
Plate 112: Kitchen 65/3, no.65, looking northwest; featuring the exposed wall fabric of the northwest corner of the room. Note the brickwork contained within the western door return and also the dressed stone door jamb.

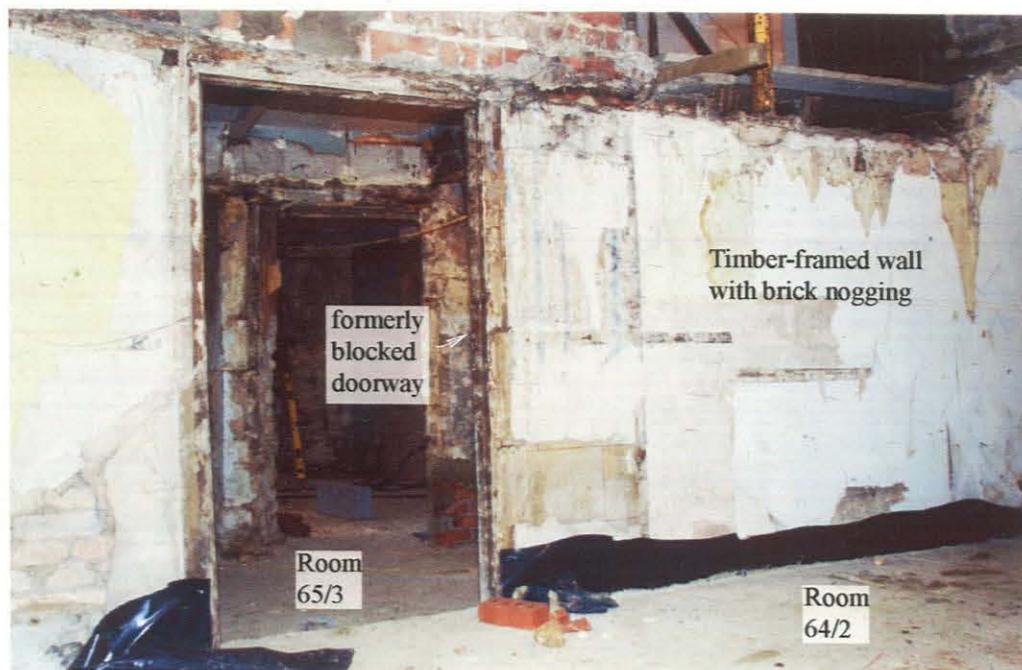
Plate 115: Kitchen 65/3 and Room 64/2, nos.65 and 64 respectively; view of the formerly blocked doorway revealed within the south wall of the kitchen/north wall of Room 64/2 during "opening-up" work. (Shot taken from Room 64/2).

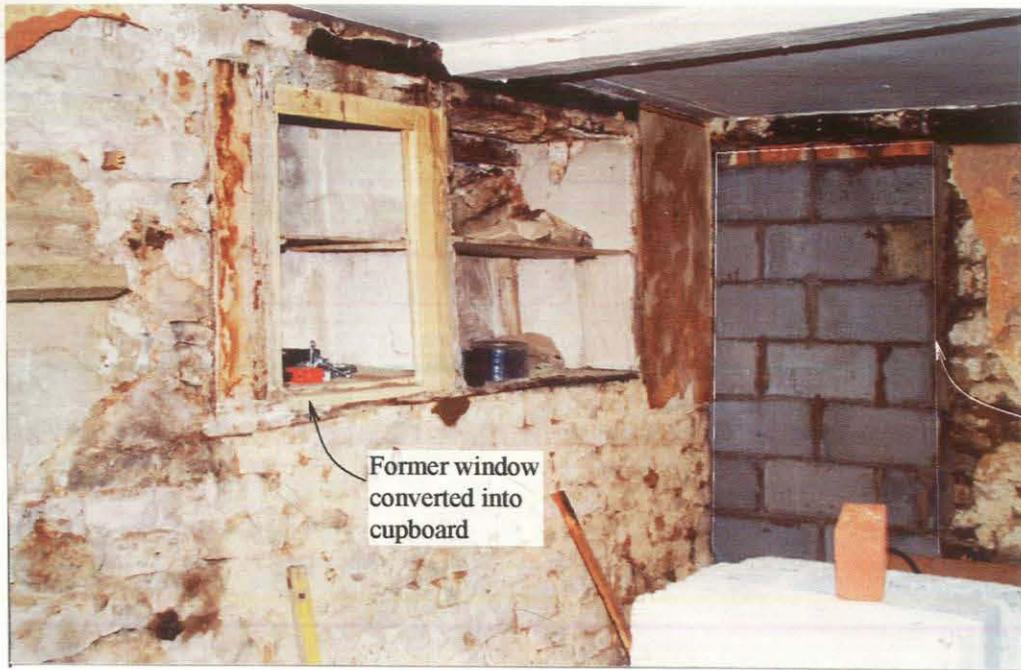
Former window converted into cupboard

Plate 116: Room 65/4, no.65, north wall; showing former window opening which has been converted into shelving. The feature was uncovered during building work.

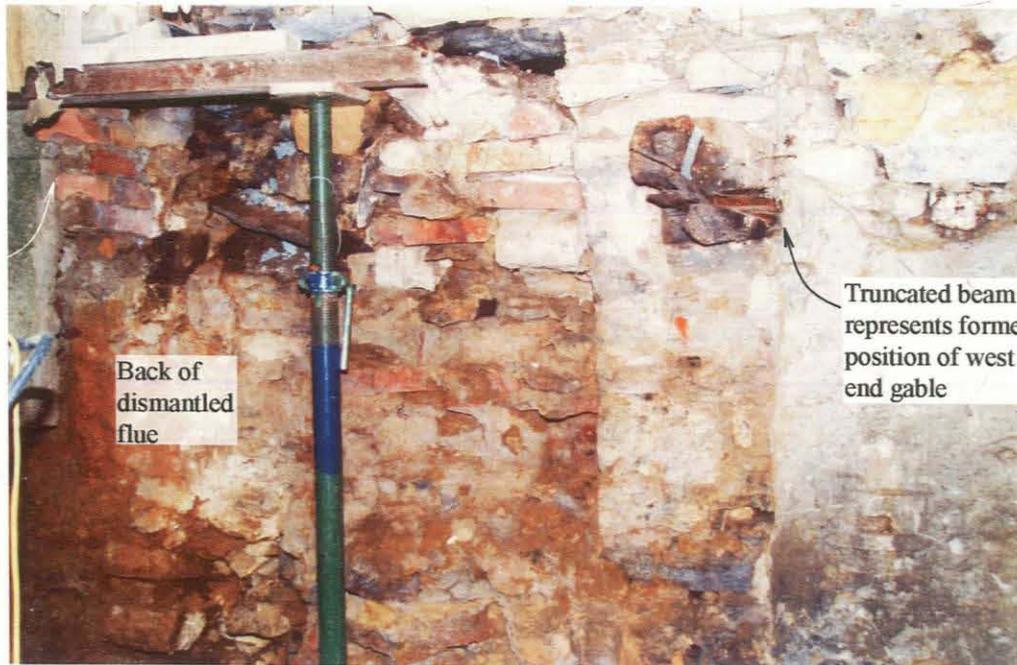
Truncated beam represents former position of west end gable

Plate 117: Room 65/4, no.65; exposed west end of north wall featuring the protruding (cut) end of a beam, a probable hearth and a complicated series of features, varied wall fabric and periods of build.

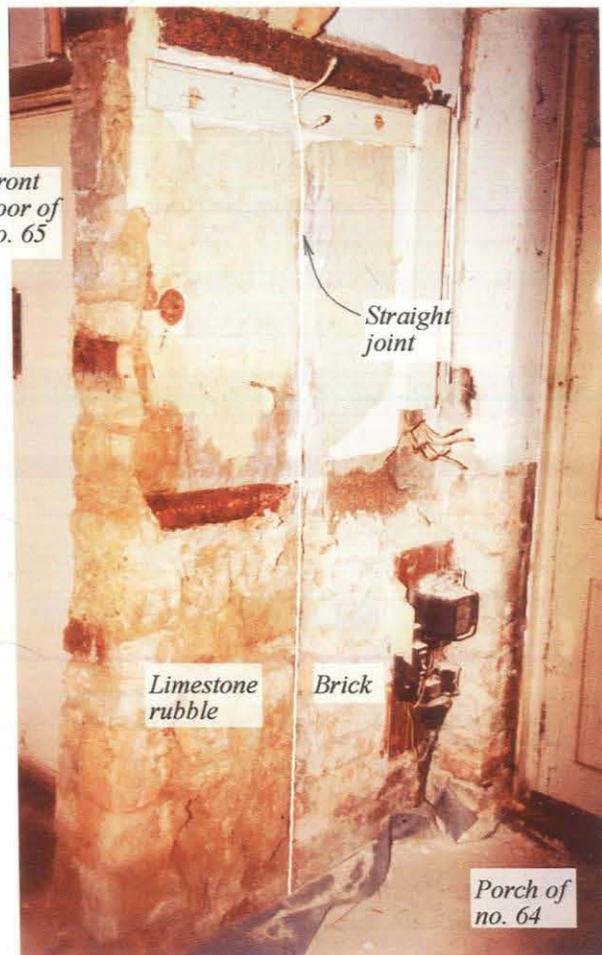
Plate 119: Front room 64/1, no.64; view of northeast corner of porch after "opening-up". Note the clear straight joint between the inserted brickwork to the east and the earlier limestone walling to the west.

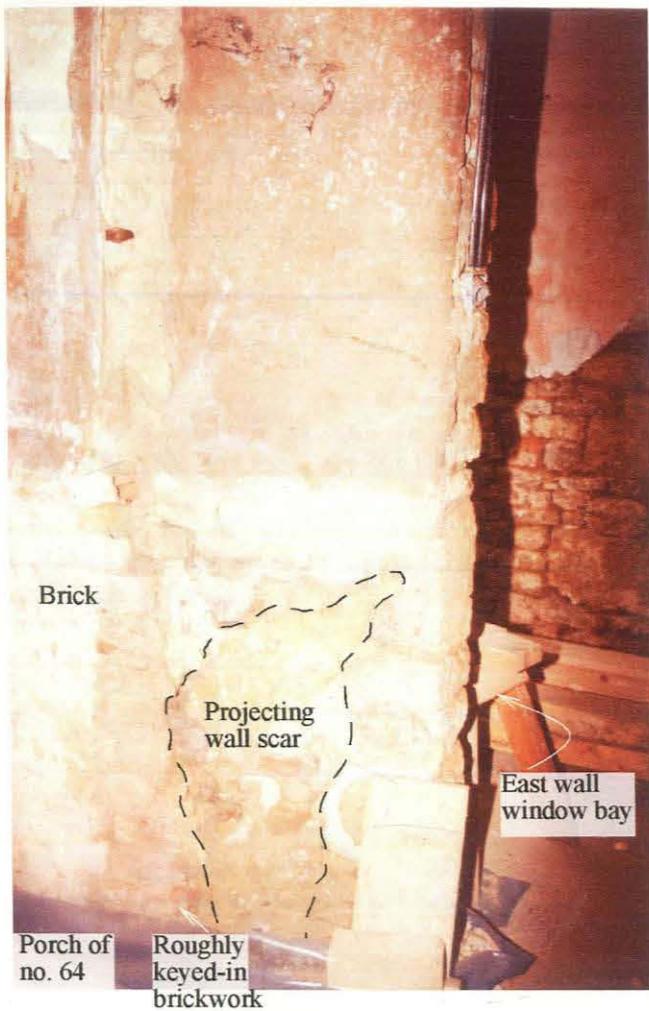
Plate 120: Front room 64/1, no.64, looking southeast; view of the western end of the southern section of porch wall. Note the roughly keyed-in brickwork built into the east side of the existing rubble wall, and the wall scar on the north face of the rubble wall.

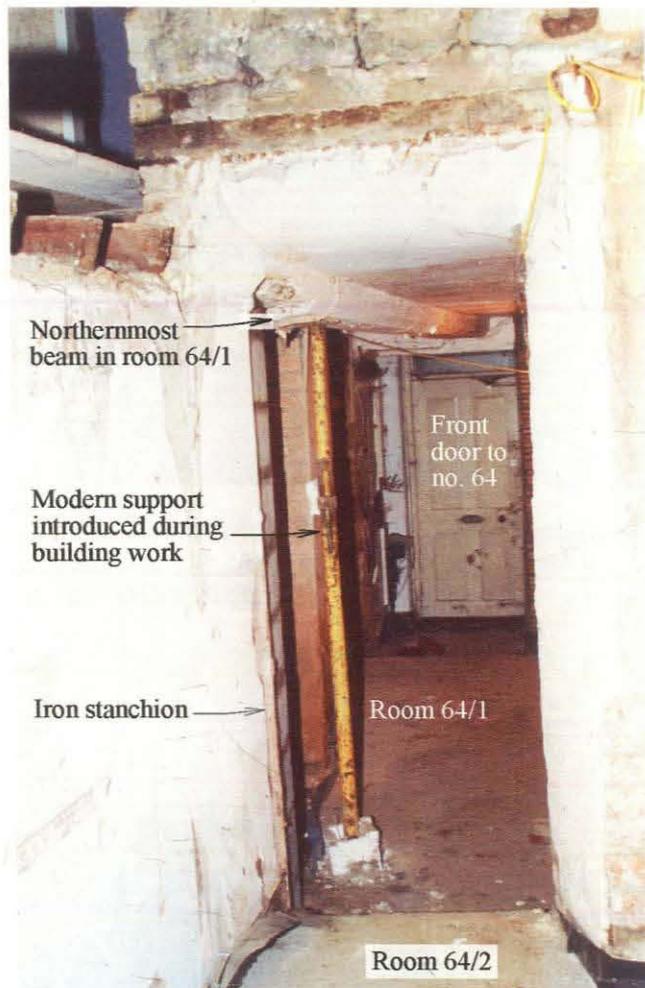
Plate 121: Front room 64/1, no.64, looking east; featuring the re-alignment of the northernmost beam which is supported at its western end by an iron stanchion.

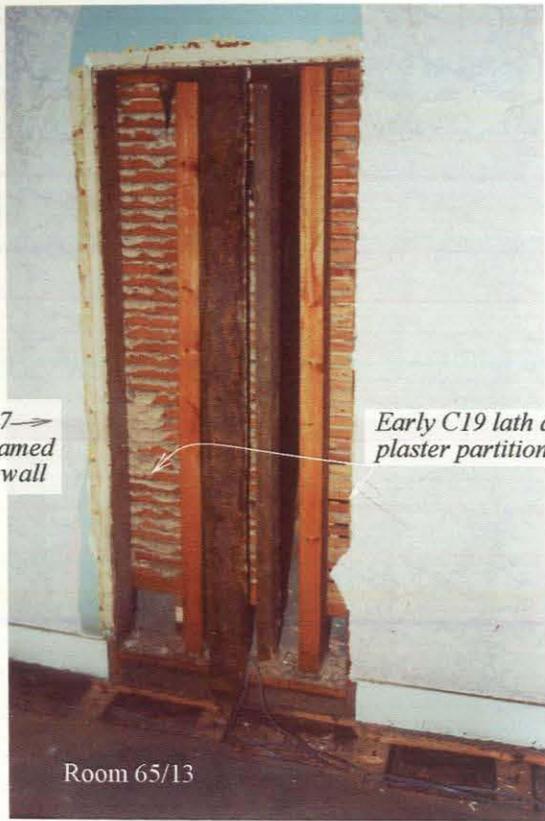
During "opening-up" work within rooms **65/13** and **65/17** it was discovered that the early 17th century partition wall between the two rooms (which is timber-framed with reed and plaster infill panels), had a later, additional lath and plaster partition "skin" built immediately adjacent to its north side, within room **65/17** (plate 122). This lath and plaster partition is almost certainly contemporary with the blocking of the early 17th century doorway and the subsequent insertion of the abutting, east partition wall within room **65/17** during the early 19th century.

The original, early 17th century timber-framed south partition wall possesses an early 19th century lath and plaster "skin" which has been built against its northern side, within room 65/18 (plate 122; see 7.21, room 65/17 text above). The west partition wall and doorway at its northern end date to the early 19th century (see 7.21, room 65/17 text above). Formerly, rooms 65/17 and 65/18 would almost certainly have comprised one, single room.

Plate 122: Room 65/13, looking north; early 17th century doorway revealed within north partition wall during "opening-up" work.

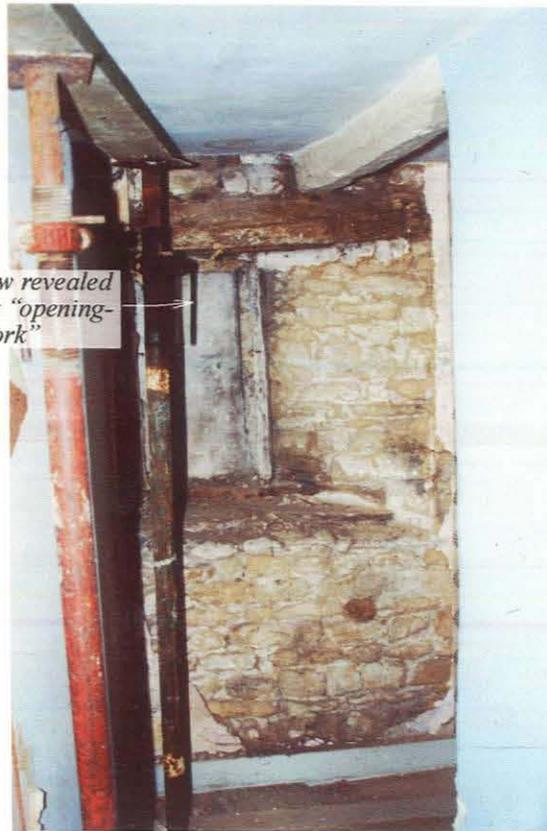
Plate 123: Corridor 65/14, no.65, looking north; mid-/late 17th century window revealed within the north wall during "opening-up" work.

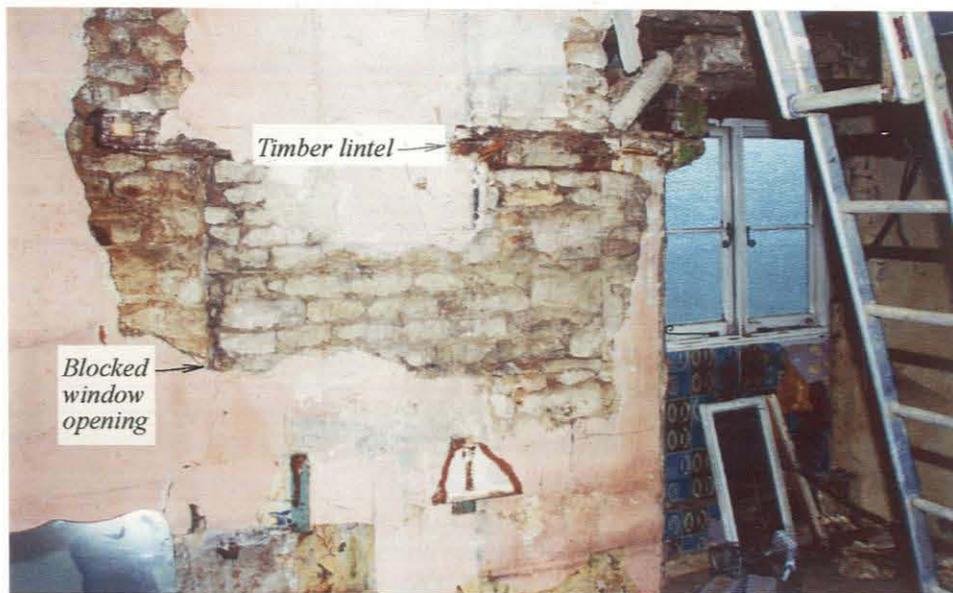
During "opening-up" work a rubble-blocked, splayed window opening with a timber lintel was revealed within the south wall beneath the plasterwork, immediately to the east of the present window (plates 124 & 125). The splayed window opening is an original feature and dates to the construction of the northern rear range in the mid-/late 17th century. The opening was almost certainly blocked during the early 19th century when the central rear range, adjacent to the south, was built. (The southern, formerly external face of this blocked window is visible from within room **65/11**).

Plate 124: Bathroom 65/15, no.65, looking south; mid-/late 17th century blocked window revealed within the south wall during "opening-up" work.

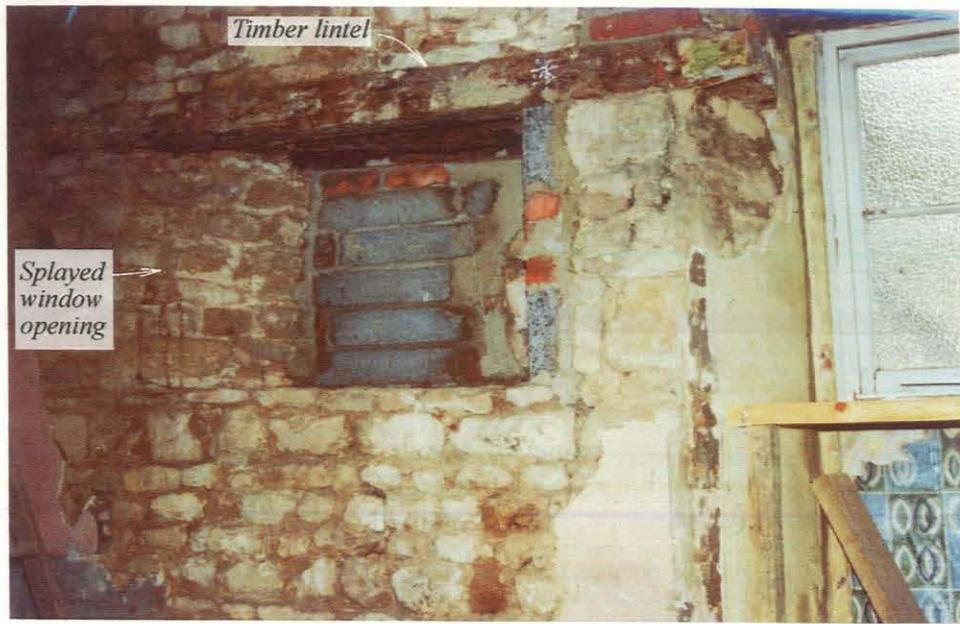
Plate 125: Bathroom 65/15, no.65, looking south; formerly blocked, mid-/late 17th century splayed window opening revealed within the south wall during "opening-up" work.

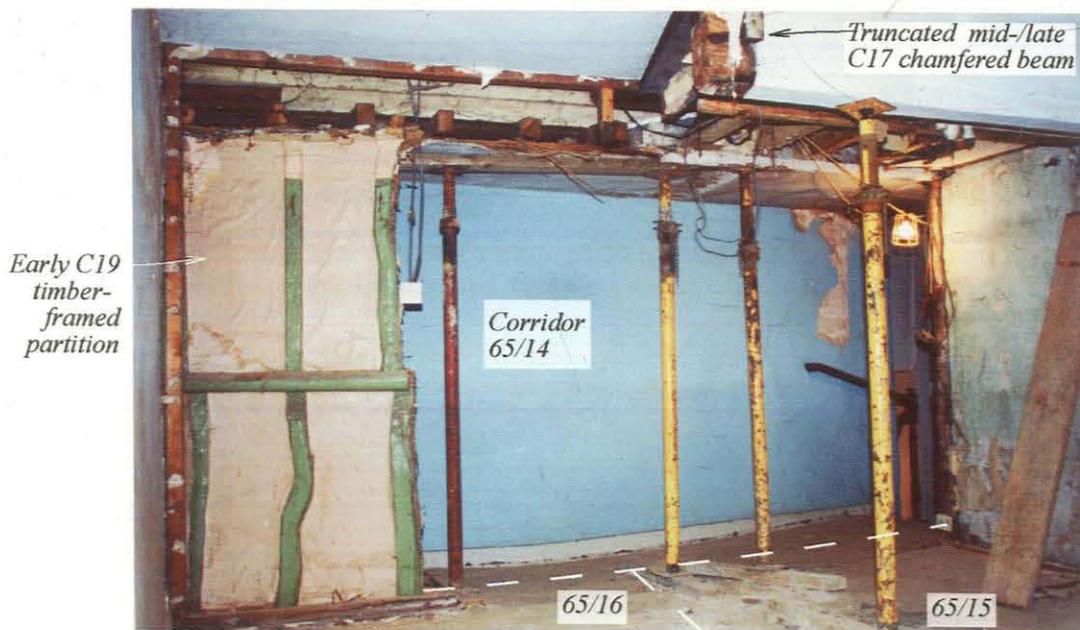
The eastern partition wall was exposed during "opening-up" work and found to be timber-framed, with lath and plaster infill panels (plate 126). The partition dates to the early 19th century (see room 65/14 text above). The splayed window opening within the north wall is an original feature and dates to the construction of the northern rear range in the mid-/late 17th century.

During "opening-up" work, the easternmost, chamfered beam visible within room 65/15 (which originally would have extended across room 65/16 from room 65/15), was seen to have been truncated at the point where the bathroom partition wall had been inserted (plate 126). This was most probably undertaken in relatively recent times in order to improve the headroom space within room 65/16, and simultaneously with the erection of the plasterboard partitions which were inserted into the first floor space to create bathroom 65/15. Also during "opening-up" work, two previously obscured beams were revealed lying just above present ceiling level, to the west of the truncated, easternmost beam. Each of these beams are modern insertions. The beam which extends across the centre of room 65/16 is a continuation of the westernmost beam recorded in bathroom 65/15.

Plate 126: Rooms 65/14-16, no.65, looking east; view of first floor space after the removal of bathroom 65/15 partition panels. Note the truncated mid-/late 17th century chamfered beam and exposed timber-framed, east partition wall.

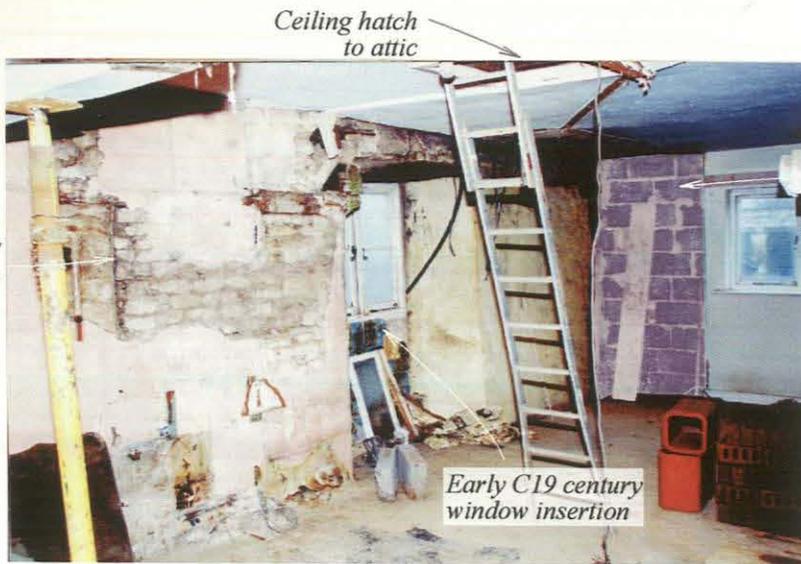
The completely re-built west end gable wall was exposed during "opening-up" work and seen to comprise modern breeze blocks (plate 127). The modern casement window set within the re-built wall is integral. During the re-building of the wall, the position of the gable end is known to have been altered; it now lies approximately 2.0 metres further to the west than it did originally (see 7.21, room 65/4 text). It seems more than likely that the extended western ends of both the north and south walls also incorporate the remains of the former bakehouse (see 7.21, room 65/4 text). Regrettably, any evidence of a return in the north and south walls towards their western ends at first floor level, which might represent the position of the original west end gable, remained obscured beneath a thick layer of plaster during each site visit made during "opening-up" work.

Plate 127: Rooms 65/15-16, no.65, looking southwest; view of the first floor space after the removal of bathroom 65/15 partition panels during "opening-up" work. Note the exposed breeze blocks within the rebuilt, west gable end wall.

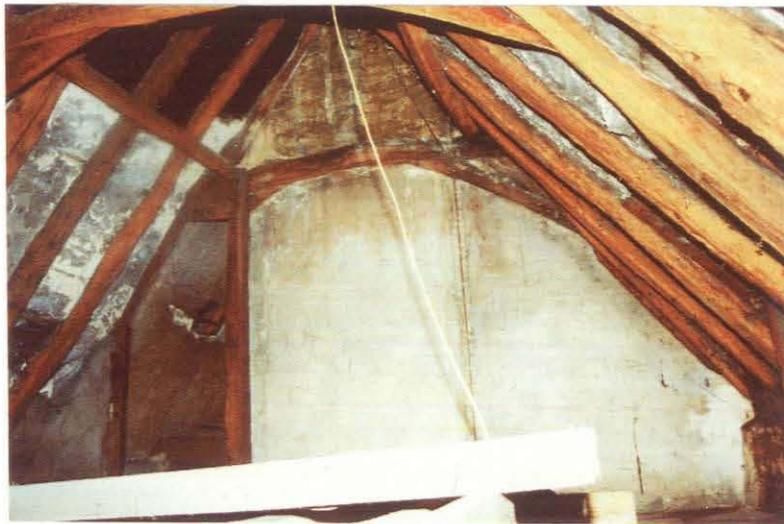
During "opening-up" work the attic floor joists were exposed and the attic space, including the roof timbers, were made visible from first floor level. The attic floor joists are modern and the insertion of the present attic floor is contemporary with the relatively recent re-building of the rear west gable end. At this time the floor appears to have been raised, probably in order to provide greater headroom space to the first floor rooms. The east (flue) wall was seen in its primary state; timberwork built into the early 17th century front range flue wall belongs to the mid-/late 17th century, when the northern rear range was built. Most of the flue wall is plastered, only at the very top is the coursed rubble limestone exposed (plate 128). The re-built west gable was seen to comprise both modern breeze blocks and bricks (plate 129).

Plate 128: Attic space above Corridor 65/14, looking east; view of timberwork and upper reaches of the flue wall exposed after the removal of the ceiling during "opening-up" work.

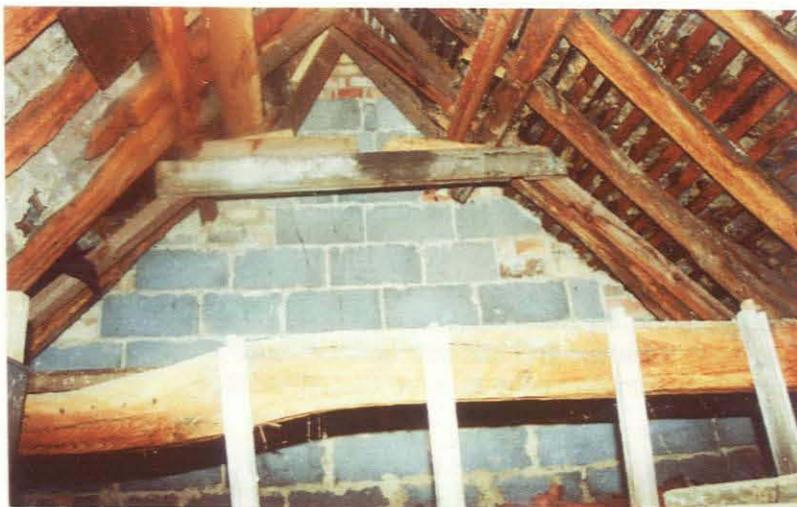
Plate 129: Attic space above Room 65/16, looking west; view of timberwork and rebuilt, west gable wall exposed after the removal of the ceiling during "opening-up" work.

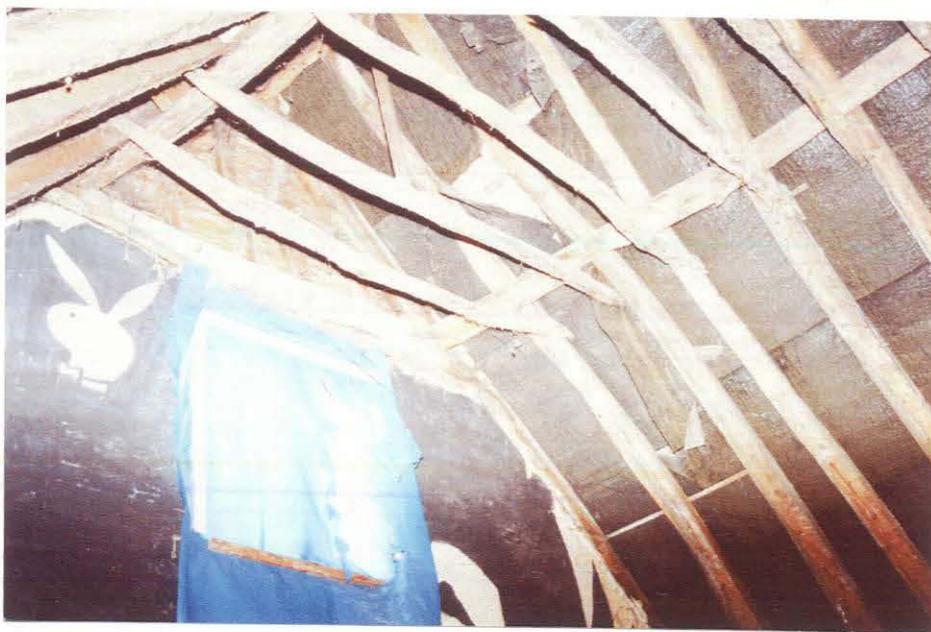
The clasped-purlin roof structure is an original feature and dates to the late 17th/early 18th century when the southern rear range was built. There are numerous timber repair insertions and modern, supplementary support members incorporated within the existing roof structure; several of the collars are modern, and many of the original collars have been re-attached to the rafters using nails. Only a few appear to remain *in situ*, and are still pegged to the rafters (plate 130).

Plate 130: Roof timbers and attic space above Room 64/8, looking west; view of the roof timbers and attic window within the west gable.
