# **Alford Manor House Alford, Lincolnshire.**

**Conservation Plan: Understanding the Place  
Volume Two: October 2006**

**Alford Manor House Conservation Plan: Volume Two**

**ARCHAEOLOGICAL WATCHING BRIEF**  
ALFORD MANOR HOUSE  
LINCOLNSHIRE

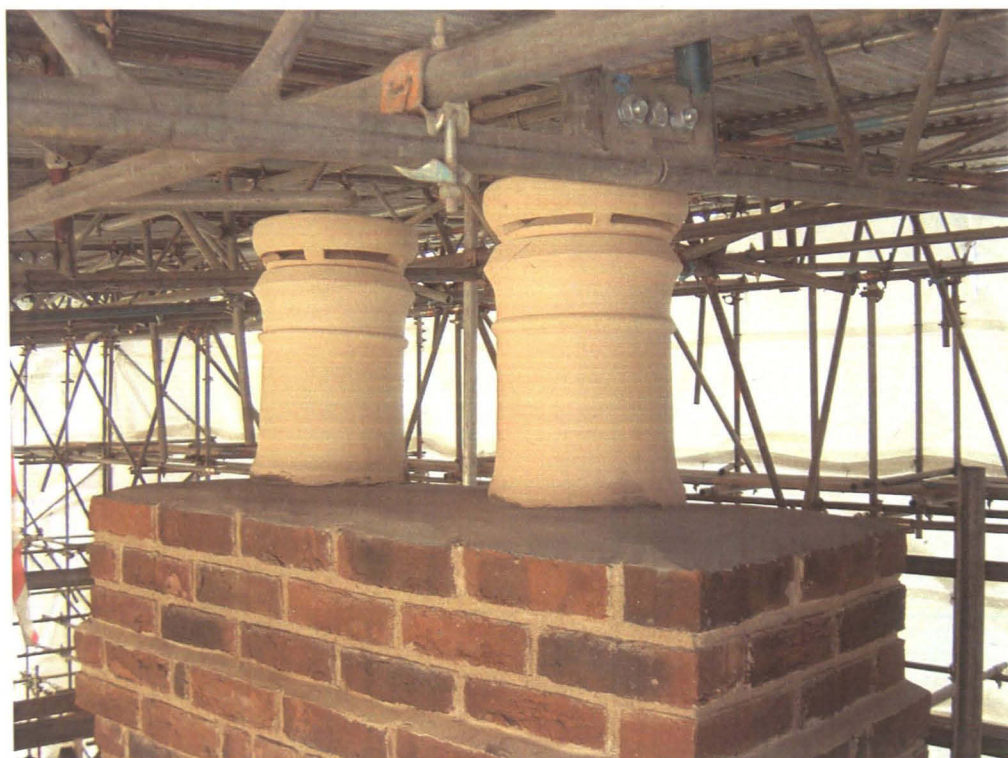
Plate 13: New hand-made bricks.

- Repointing of external brickwork using a pre mixed lime putty/coarse sand mortar from Skillington Workshop.
- Rebuilding of gable apexes and chimney stack tops using handmade bricks by York Handmade Brick Company.
- Rethatching of H plan roof using new long straw thatch by thatching specialist Roger Evans overseen by thatching adviser Keith Quantrill. The east slope of the eastern wing retained the reed thatch of 1969 as a base coat.
- Repairs to wall plates in new oak. New over roofing members to centre and west wing in treated softwood.
- Repairs to attic and first floor structures overseen by structural engineer Ed Morton of the Morton Partnership Ltd.
- Demolition of late nineteenth century lean to and porch at rear.

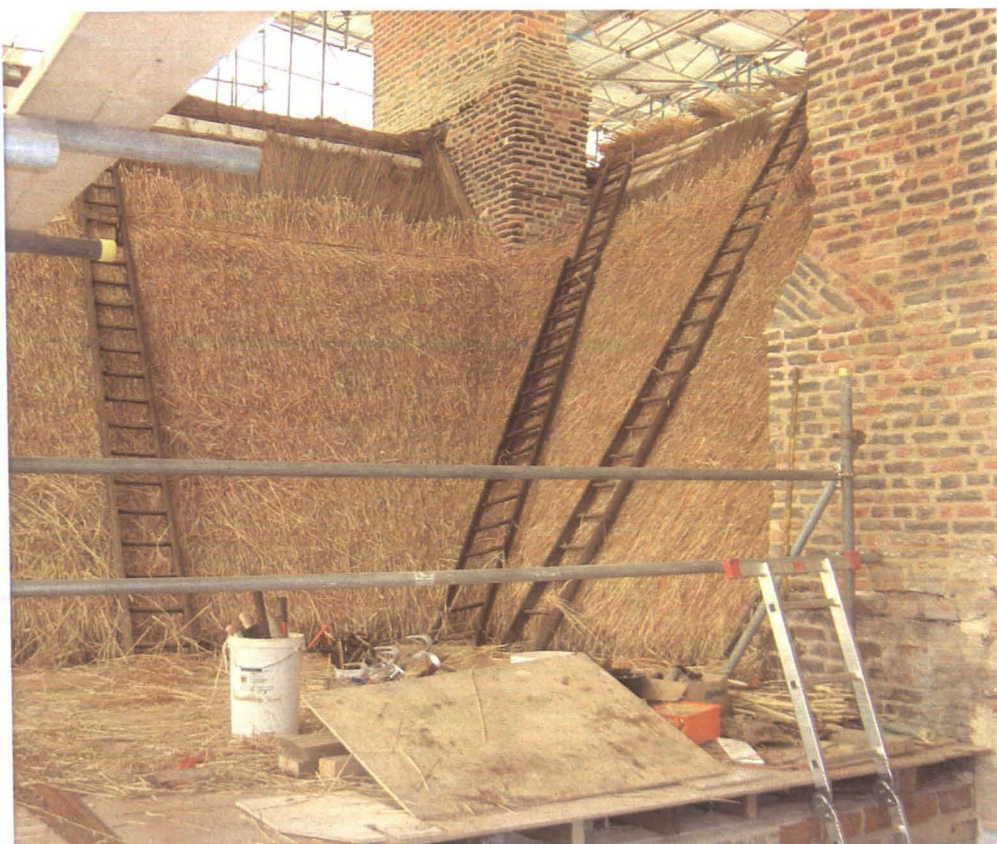
Plate 14: Re-thatching using new long straw.

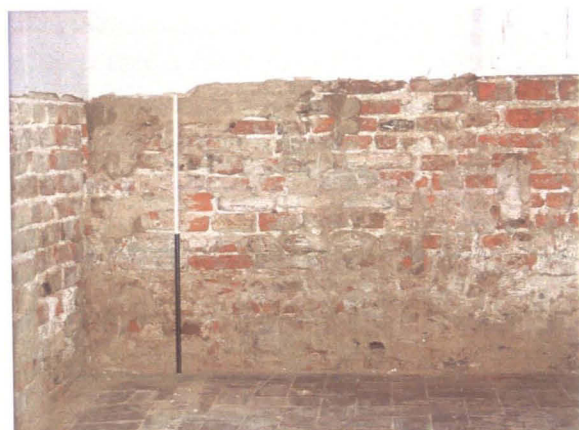
**Plate 4** Room G11, later brickwork of passageway wall

The evidence from the passage wall of room G11 suggests that the wall was an inserted feature. Once plaster had been removed it could be seen that the passage walling abutted the north wall of G11. The brickwork used in the passage walling appeared to be of late 18th or early 19th century date (Plate 4). It had been suggested that this wall and passage were an original feature, part of the early 17th century arrangement, typical of houses of this period, and it is possible that the brickwall replaced an earlier wall of timber framing. However, no certain evidence was found to indicate this.

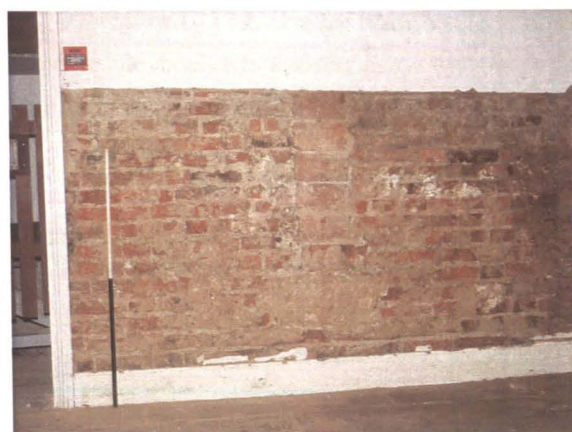
**Plate 5** Room G11, alterations to the walling

The west wall of the passage, also serving as the west wall of G11 (the kitchen) retained evidence for being a primary feature of the house. On removal of the plaster from the lower part of the wall it could be seen that there had originally been a timber post incorporated into the fabric (Plate 5). The post had been removed and replacement brickwork inserted. However, the pad stone, intended to support the post remained *in situ*. Within the same wall, to the south of the removed post and door opening to the buttery and pantry (rooms G13-14), a further post remained *in situ* along with its pad stone (Plate 6). The pad stone appeared to have been raised on several courses of brick, perhaps as a result of the bottom of the post decaying. This wall also provided evidence that the current access between the entrance hall (G3) and kitchen (G11) had been inserted. The brickwork forming the north jamb of the door could be seen to have been inserted crudely against a cut made into the primary brickwork. Access to the kitchen appears to have been either from the cellar door or *via* the common parlour (room G4).

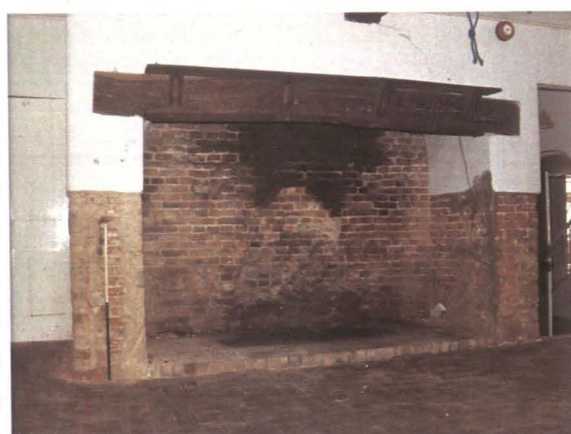
**Plate 7** Room G11, fireplace with east side reconstructed

The south wall of the kitchen (room G11) retains a large and original early 17th century fireplace. Stripping of the plaster in this area indicated that the east side of the fireplace had received some reconstruction (Plate 7). This was perhaps as a result of the removal of an oven from the fireplace and the creation of the door opening through into the common parlour (room G4).

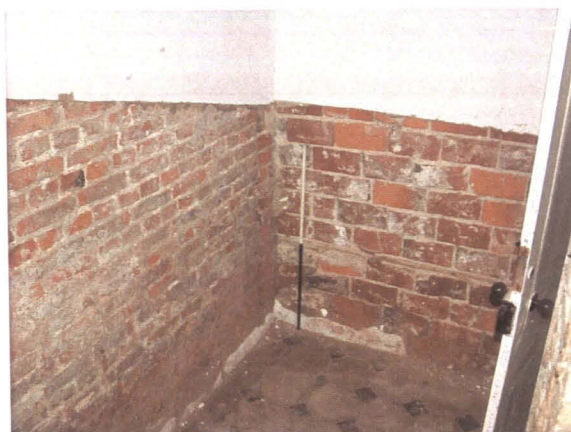
To the west of the fireplace is a short passage which provides the current access to the entrance hall (room G3). Originally, this passage only gave access to the common parlour to the south, the blocking of the passage being clearly visible on removal of some of the plaster (Plate 8).

**Plate 8** Room G11, blocked passageway to room G3

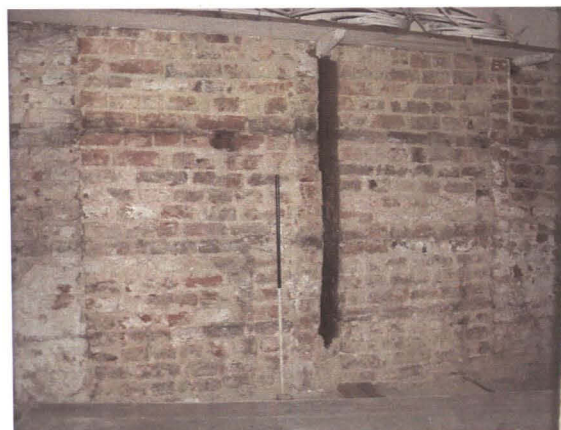
In the pantry or buttery (G14) a further door opening was identified after the stripping of plaster to reveal the original brickwork underneath. Although adhesions of limewash to both the original and the fill brickwork made the form difficult to discern, the straight joints identified indicate the presence of a doorway (Plate 9). Its presence was confirmed by excavation carried out on the exterior of this wall.

**Plate 9** Room G14, blocked external doorway

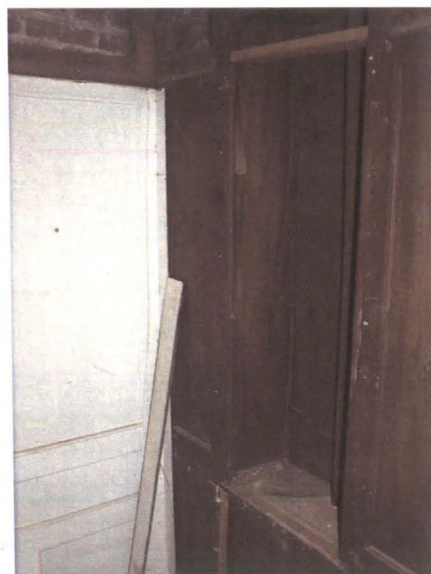
In the closet to the south of room F17, hardboard was removed from the external wall to reveal the interior of the blocked up window which originally lit the closet (Plate 10). The external blocking of the window was noted in the earlier phase of work (FAS 2003, 12). Internally, the opening for the window survives with its associated panelling *in situ*. Panelling has also survived on the other walls on the closet, providing a complete encasing. The form of the moulding and size of the panels suggests possibly a late 17th, but probably an early 18th century date. In places the interior of the panels is missing, but enough survives to ascertain the form of the panelling. The panelling is largely plain open panels with a simple moulding profile at the edge of the panels. Smaller panels at the top of the wall had a more decorative moulding which projected out from the face of the panel, providing a decorative feature in the room. Particularly notable is the survival of the shutters associated with the window. These were folding shutters, with plain strap hinges on the left hand side and at the centre, allowing the shutter to be folded up against the left hand side of the window. When closed, the shutters were secured by two metal latches secured by hinges to the left hand side of the window, and hooking into window stays on the right hand side. Visible approximately a third of the way up the shutter are two black marks. These appear to be singe marks and may be the result of candles being placed on the window sill.

**Plate 10** Closet in room F17, uncovered panelling and window shutters

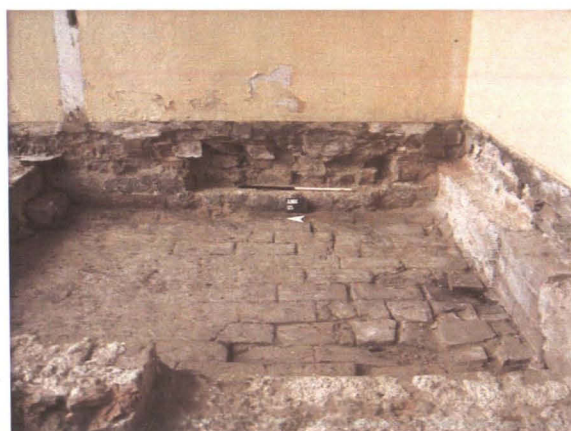
**Plate 12** Brick floor and associated doorway

The removal of the flooring to the area previously room G15 revealed an earlier brick floor surface under the brick footings for the floor to the room (Plate 12). This floor was composed of bricks approximately 0.11m x 0.22m x 0.06m deep, which appeared to be machine-made, but of relatively poor quality. The floor was clearly associated with a structure, the outer wall of which survived as the western wall of room G15, as this wall marked the extent of the surface. The surviving base of this wall comprised machine-made bricks of a better quality than those used in the floor surface.

The removal of the wooden flooring also revealed further sections of the wall to the west of room G14, which is obscured by plaster above floor level. On this wall, 0.30m from the returning wall to the south of the room, a disruption in the brick indicated the presence of a doorway, now blocked (see Plate 12). This feature was also observed internally as straight joints visible in the fabric of the wall to the west of the pantry (see Plate 9). Given the small amount revealed, it was not possible to ascertain whether this door was original or had been forced through the earlier wall. However, the presence of the room identified by the brick wall and associated flooring, makes it likely that this doorway provided access to that room, prior to the construction of the rest of the extension which then allowed entry from the west. This suggests that all three features are of the same date, and the machine-made nature of the bricks used, suggests a mid-19th century date at the earliest.

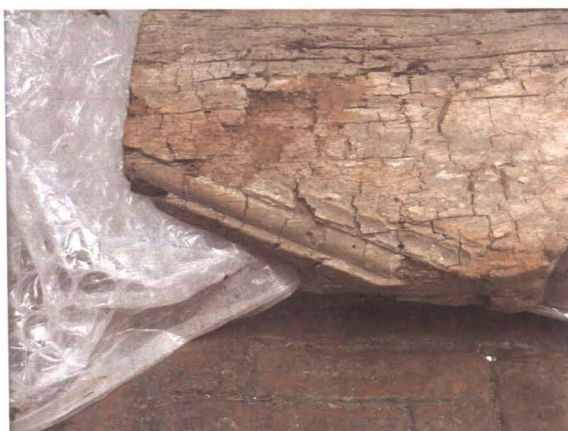
**Plate 14** Recovered window sill with moulding

The sill of the window had suffered more severely from cutting back when it was adapted for use as the lintel of the later window. The moulding of the outer edge survives in only one area with the rest of the front of the sill cut back. Only part of the moulding can now be distinguished and consists of an ovolo or quarter roll with further decayed sections above (Plate 14). It is possible that the original moulding matched or at least complemented the moulding taken of the lintel (see Figure 6). The two ends have also been truncated severely, although the surviving section of the angled outer edge indicated the sill had the same proportions originally as the lintel. Any features associated with the upright mullions and glazing of the window, located against the outer edge of the timber as with the lintel above, have also therefore been truncated, although the internal cuts of the two corner mortices survive, and half of a round chase along the front of the piece, indicate a pattern of glazing of the same proportions as the lintel. The underside of the sill had better surviving features with four mortices apparent towards the inner side. These are approximately 0.15m in length and spaced approximately 0.35m apart. From the spacing it seems likely that there would have been a further mortice in both of the truncated ends, with six in total to secure the sill. The interior of the mortices was well-preserved, with the scar of the core drill used to create the cuts visible on the right of all four of the surviving mortices.

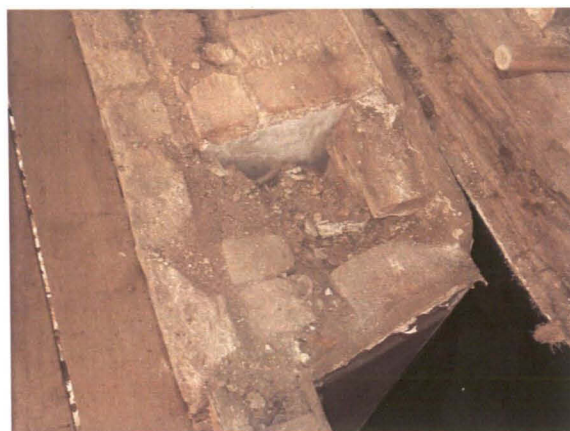
**Plate 15** South gable, surviving earlier window embrasure

The removal of the timber lintels revealed further evidence of the earlier window schemes in the brickwork at first-floor level. This phase was identified during the earlier phase of recording from straight joints in the brick elevation (FAS 2003)(see Figure 5). The section through the wall provided by the removal of the lintels revealed the embrasures of the earlier windows had survived intact, with plaster and limewash adhering to the line of the opening (Plate 15). The window to the west retained evidence for earlier embrasures to both sides of the current opening, with the original opening measuring approximately 1.60m across, with a 0.30m brick fill to the left of the window and 0.20m of fill to

the right. The window to the east had only one earlier embrasure remaining, but with almost 0.50m of brick fill. This window apparently followed the line of the earlier embrasure on the right hand side, with all the narrowing required to create the current opening inserted on the left. This presumably placed the window in line with that at ground-floor level, creating a more symmetrical appearance. The earlier embrasures were more square than the current window openings.

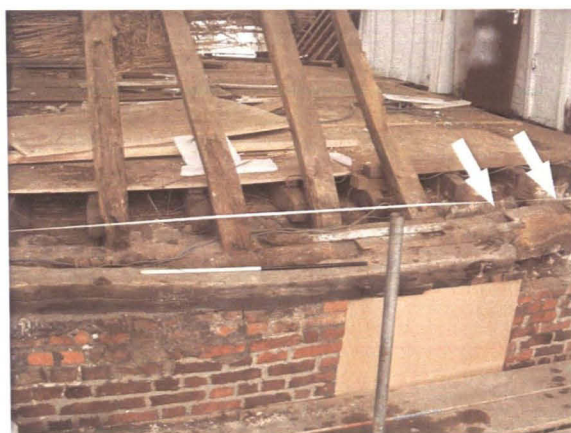
**Plate 16** Wall plate in central section with the trenching of original rafters

Repair was also evident to the southern wall plate in the central range, necessitated by the spreading of the wall at the western end of this range. The movement in the wall appeared to have been so severe that the rafters became detached from the original wall plate, which survived bonded into the wall, with clear indications of the trenching where the timbers used to rest (see Figure 8 to 10). As a remedy an additional wall plate has been inserted inside the original, and fixed to the earlier wall plate with metal ties (see Plate 16). The original rafters had then been fixed in the same manner as they were to the original, although with square-headed iron nails rather than timber pegs.

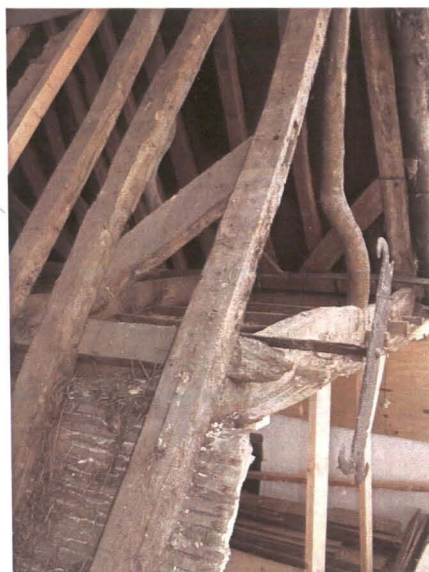
**Plate 17** East wing, empty mortice indicating the continuation of the wind brace to the south

clear whether this feature originally appeared elsewhere in the building, or was included in this area for a specific structural reason. Both the cross wings have curved wind braces included at the extreme south end of the range. These run from the clasped purlin and terminate against the final principal rafter, mid-way between the purlin and the ridge piece. The removal of the gable wall at the southern end of the east wing, revealed mortices on the south side of the final principal rafter (Plate 17). This suggests that originally the roof continued to the south of the present gable end, and that the wind brace, the northern section of which survives, originally continued into the rafters to the south terminating at the ridge piece.

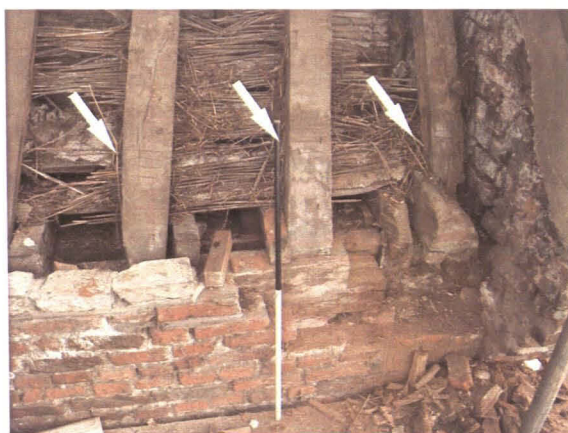
**Plate 21** Common rafters labelled (from right) with a sequence of carpenters' marks

The recording of the roof structure uncovered relatively full sequences of carpenters' marks on the upper surfaces of the roof timbers in the east and west cross wings, as well as some evidence of the sequence in the less intact central range (Figure 9 and 10). It is not unusual to see common rafters marked on the top of the timber, with principal rafters normally labelled to the side. This helped in the forming of the truss, with the construction of the joint between the principal rafters, collar and purlins. At Alford, however, the trusses were also marked at the top, reflecting the form of the roof, with no distinction in size and proportion between timbers of the common rafters and those acting as trusses (Plate 21). It is notable that both sides of each range had a different numbering system from that corresponding, suggesting a construction technique whereby the rafters on one side were installed independently from those opposite, rather than with the corresponding timber on the other side, and the roof was erected accordingly.

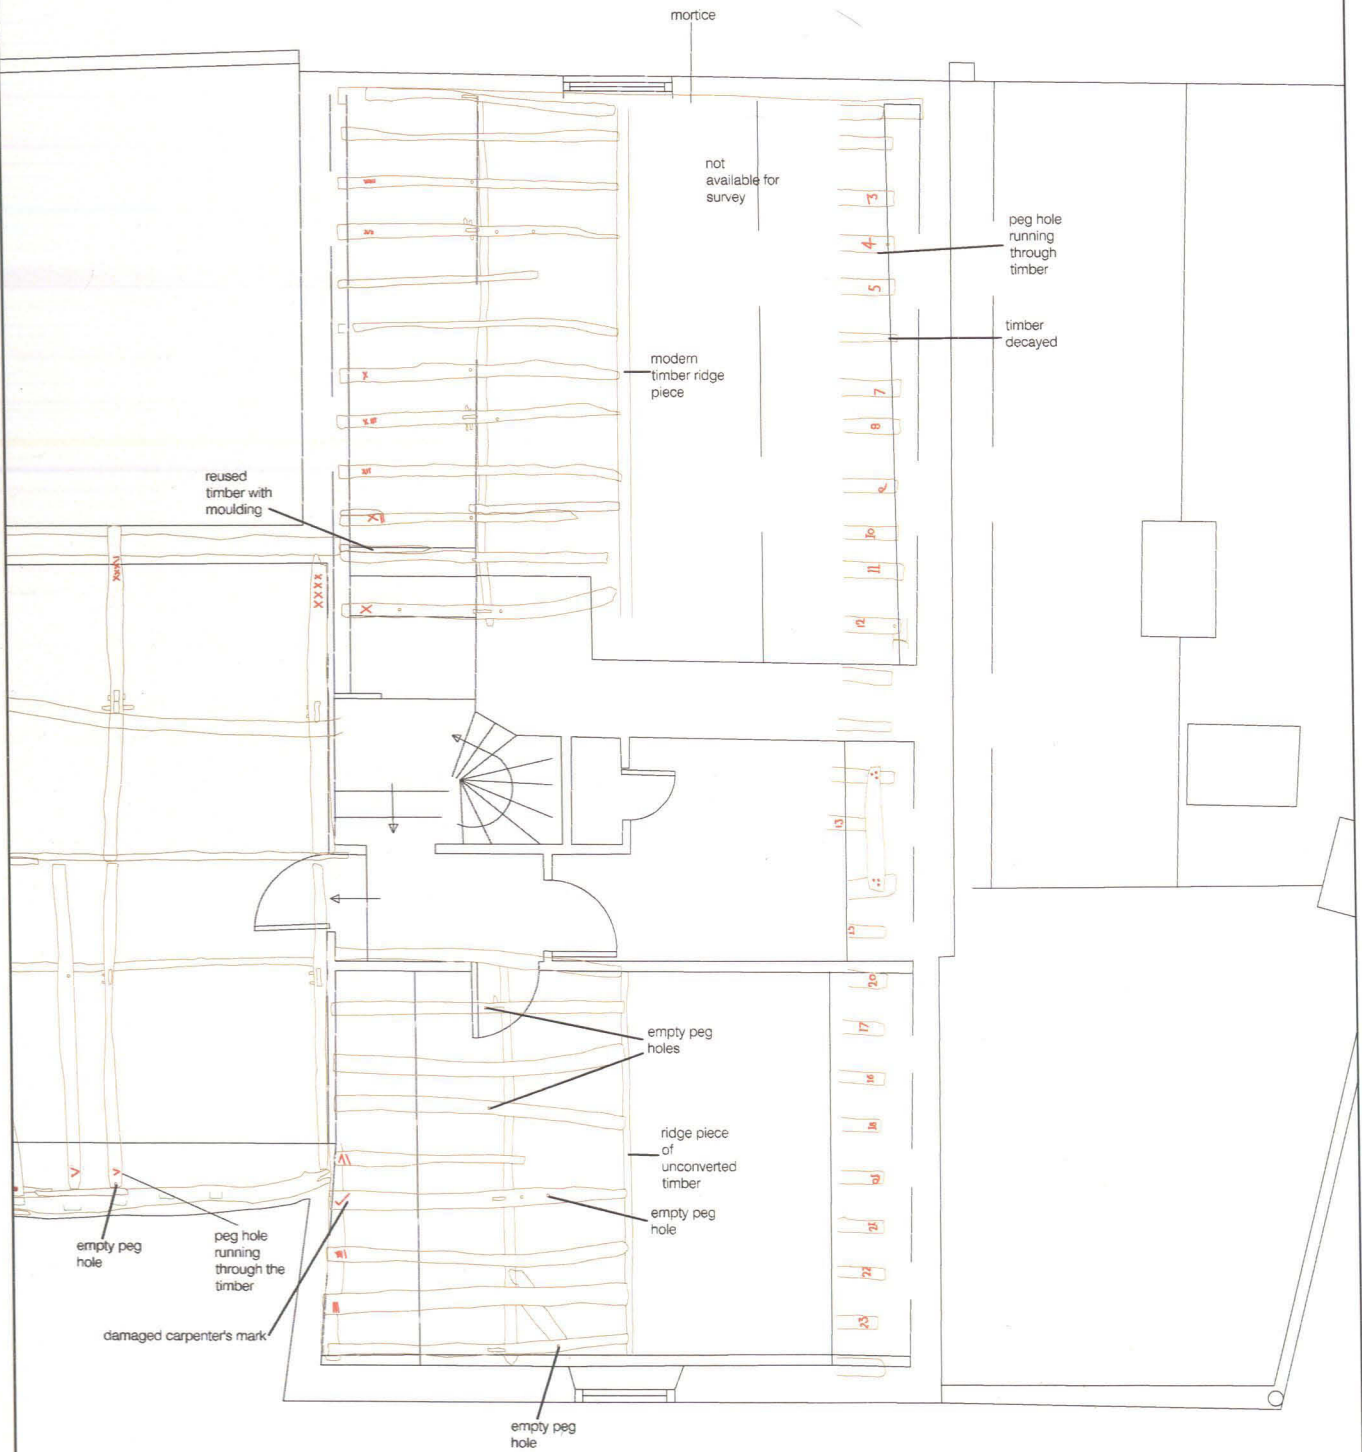
Figure 9

Roof structure over the east wing

As with the central range, both cross wings appear to have one sequence of carpenters' marks running from south to north and the other from north to south. Interestingly, in both wings all sequences appear to start with the second timber, implying an alteration to the roof structure at both the north and south gable ends (see Plate 21). As in all cases this second timber sits over the wall plate at the gable end, the original first timbers must have projected forward from both the north and south elevations.

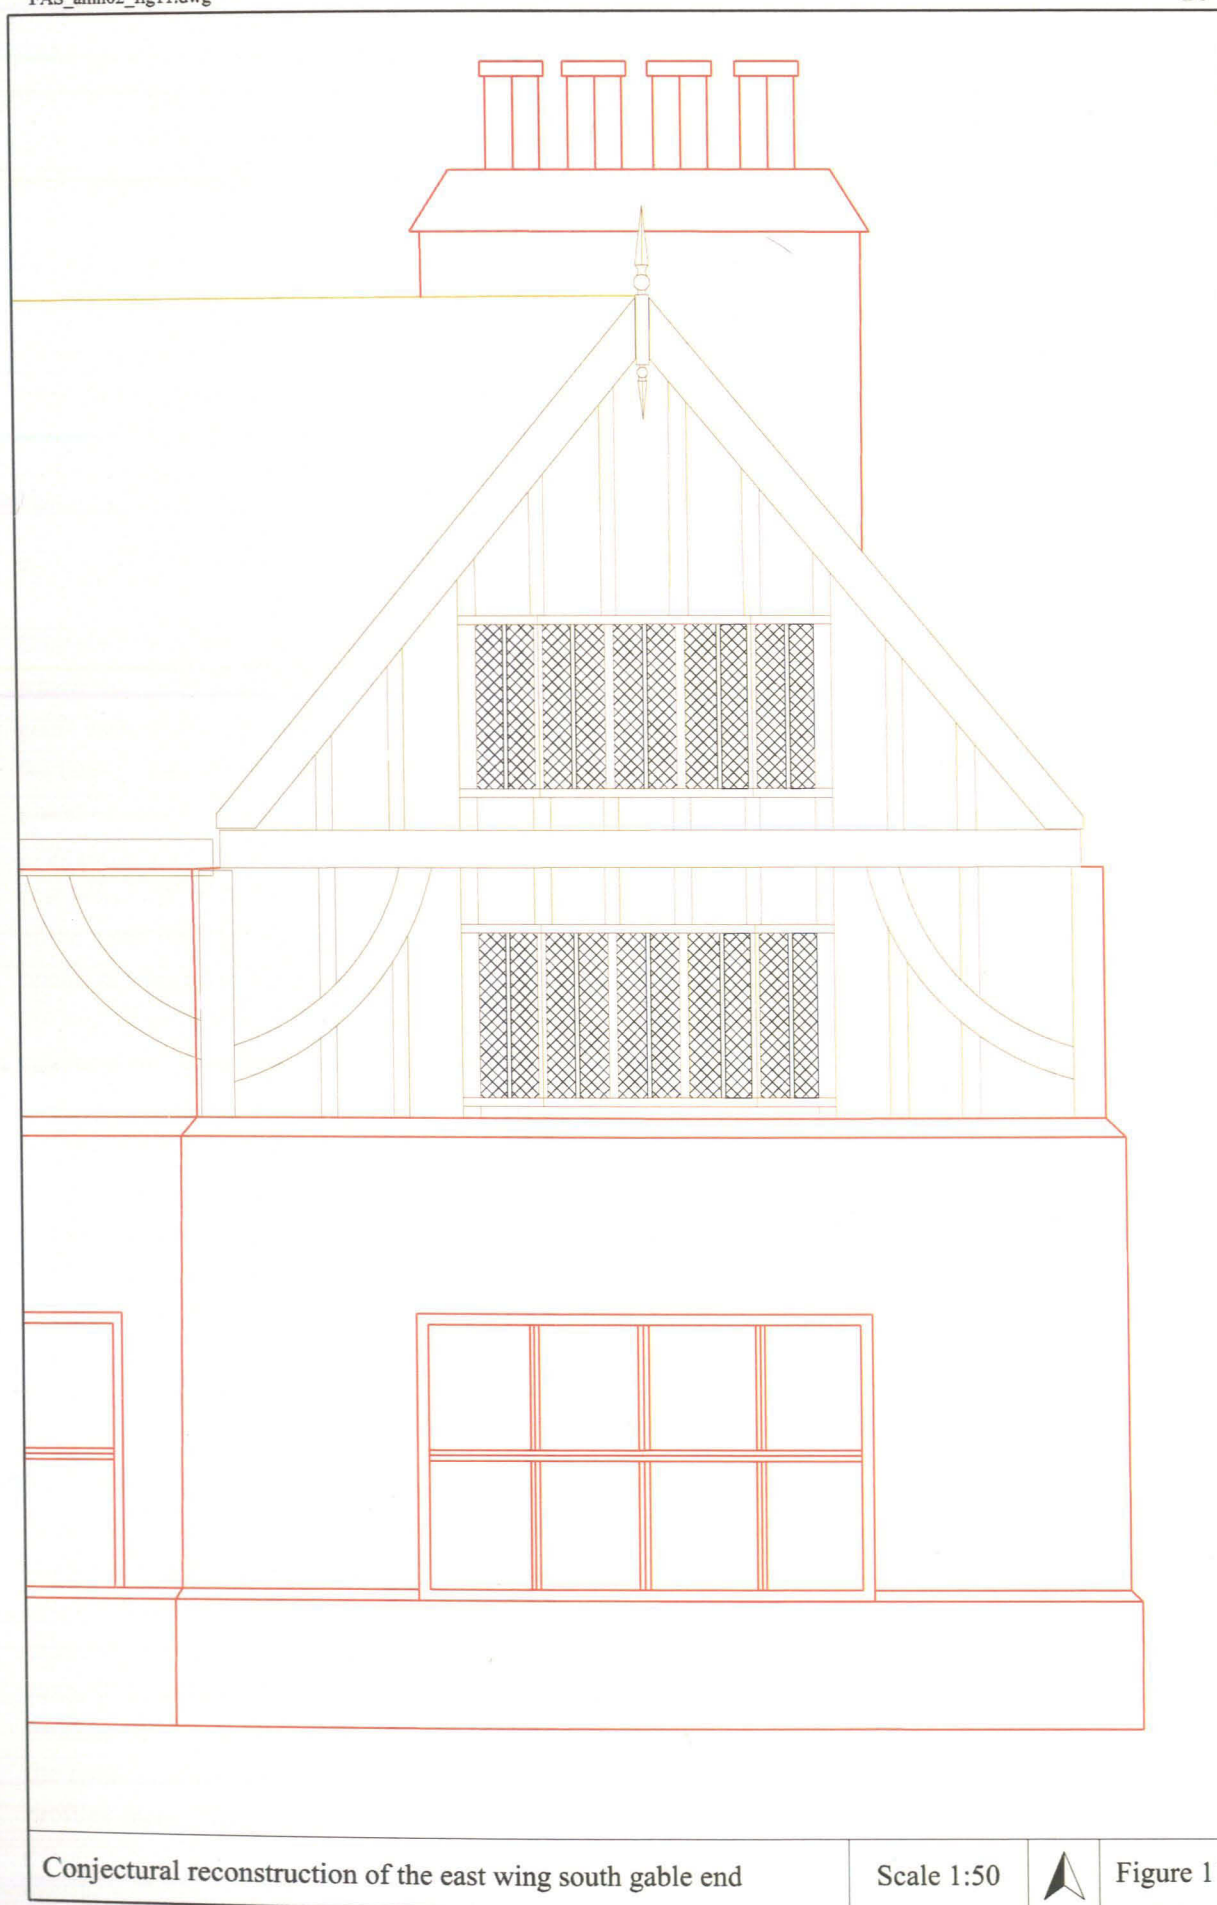
The recent work uncovered considerable evidence of the original form of the gable ends of the two cross wings, particularly the discovery of the sill and lintel, which showed the form of a window, probably that of the attic storey, as well as the nature of the timber-framing in the area around it (Figure 11). The evidence for the projecting form of the window, with the timber-framing above and below it apparently flush with the main wall elevation, further informed the reconstruction of the gable end. A reconstruction of a similar window form is provided in Plate 22 (Harris 1993, 24). The window is the same shape and follows a similar projecting form, although from the surviving evidence at Alford it is impossible for us to ascertain the glazing form or whether the windows had transoms running horizontally. The mortices surviving in the base of the sill, and the corresponding mortices noted on the upper face of the window plate surviving *in situ* also suggested that close studding was used, at least on the south elevation, which served a decorative, as well as structural, purpose.

Conjectural reconstruction of the east wing south gable end

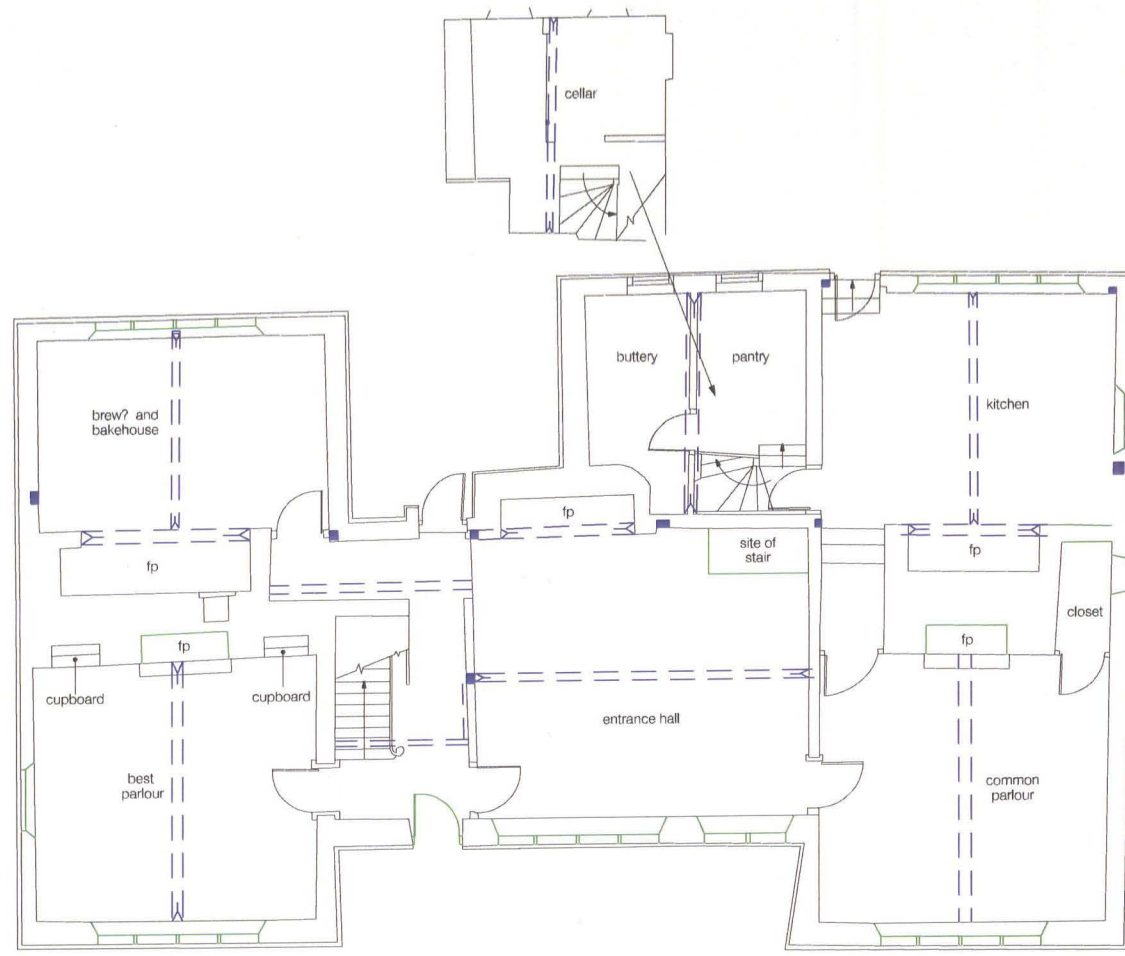
Figure 12

Some further evidence for the original planned form of the ground floor has also emerged from the watching brief work, particularly in the area of the of the kitchen and its access arrangements (Figure 12). However, the arrangement of the back or east stair still remains problematic. It is possible that the lower part of the stair was actually contained within the outshot rather than within the main body of the house, although without further evidence this remains a tentative suggestion.

Conjectural reconstruction of the original ground floor plan
