ARCHAEOLOGICAL BUILDING
INVESTIGATION
ALFORD MANOR HOUSE
ALFORD

SITE CODE: AMH02

REPORT

FIELD ARCHAEOLOGY SPECIALISTS LTD

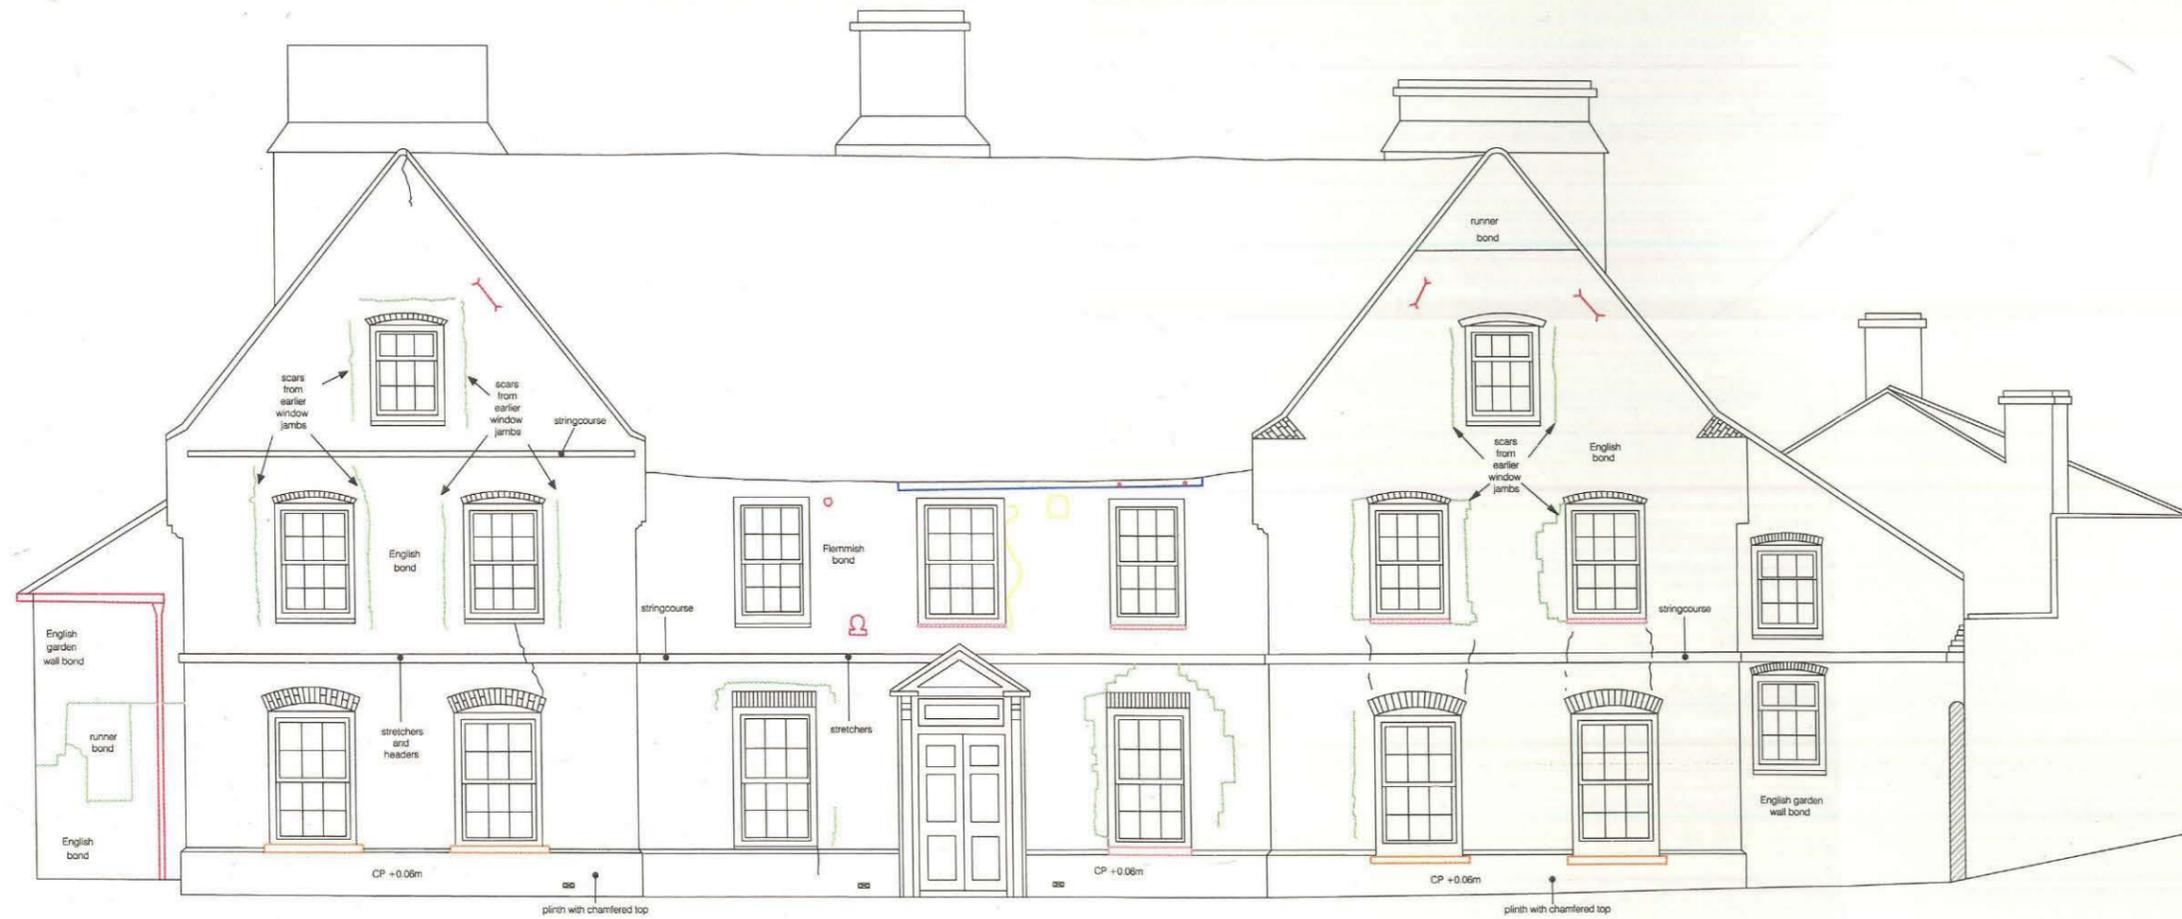
South elevation

The south elevation (Figure 2, Plate 1) represents the front facade of the building and is constructed mainly from brick. It consists of two projecting gabled wings to either side of a central range. The components of the elevation have been broken down and discussed separately below.

The brick plinth with the chamfered top also runs across the central range of Alford Manor House. The majority of the brickwork of this section of the south elevation is of Flemish bond. The central entrance to the house consists of a six-panelled timber door below a timber broken-bed pediment, all of which is modern. Flanking the door are two twelve-pane hung-sash windows with soldier arches above. The east window has tiles forming a sill. Straight joints around both of the windows denote the position of earlier doorways.

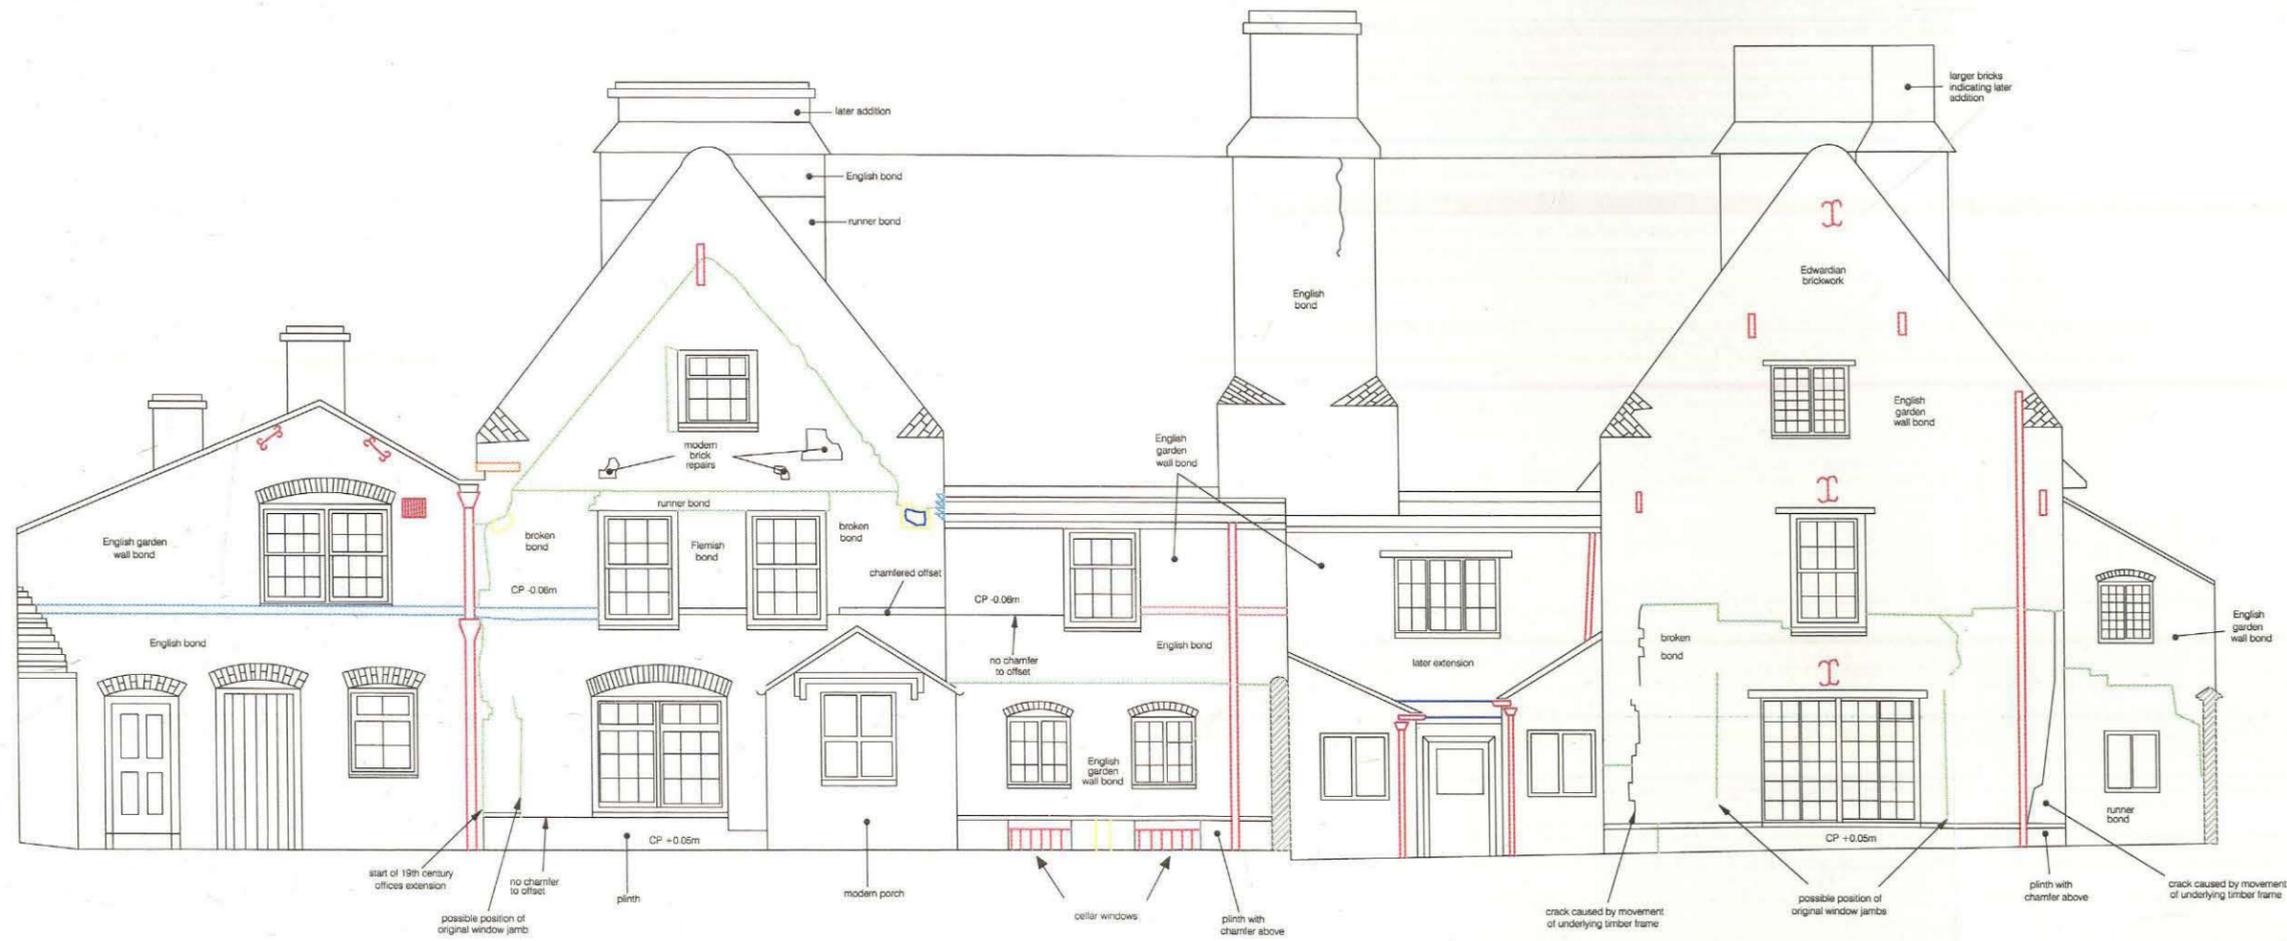
North elevation

A change in brick type reveals that the first floor is a later addition to this part of the building. The first floor has a brick offset just above sill level, but unlike the offset at ground-floor level, this offset displays no chamfer. However, to the west of the first-floor window, the offset is capped by sloping tiles. The first-floor is lit by a nine-pane casement window. This extension also has a flat roof, though it stands further forward than that to the west.

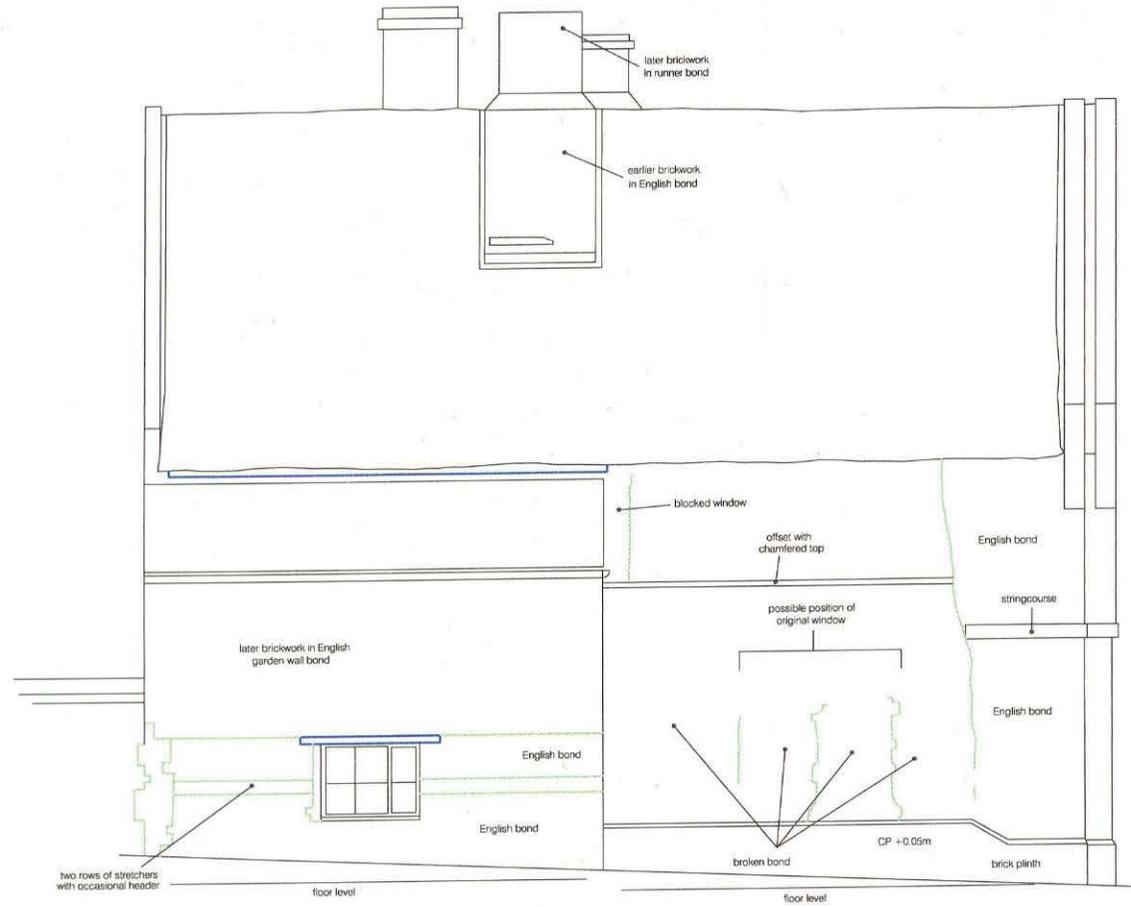
Figure 4

The west elevation of Alford Manor House (Figure 4) can be divided into two parts. The northern half of the elevation is taken up with the outshut. This includes one six-paned window at ground-floor level which may be an insertion, as a straight joint runs down its north side. Directly above the window the coursing changes from English bond to English garden wall bond, illustrating the addition of an extra storey in the 19th century. There are no windows at first-floor level.

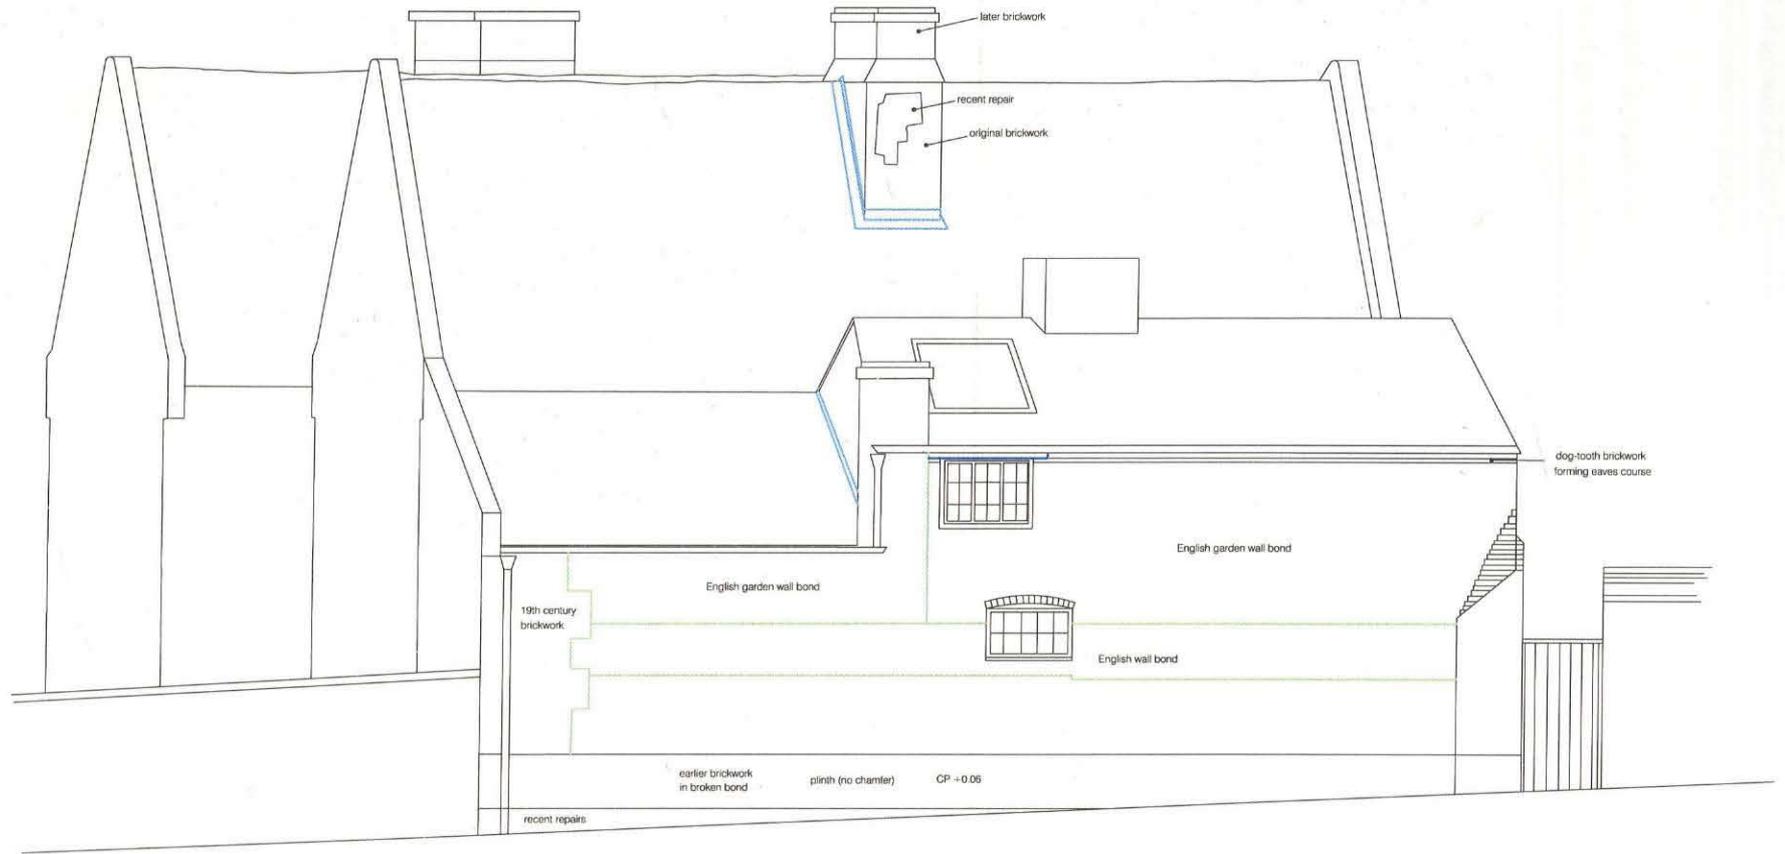
East elevation

The east elevation (Figure 5, Plate 4) is represented by the land estate offices. The south half of this elevation has no openings, and is of one and a half stories with a slate lean-to roof. The northern half of the elevation has a single ten-pane window under a segmental brick arch at ground-floor level, and a Yorkshire

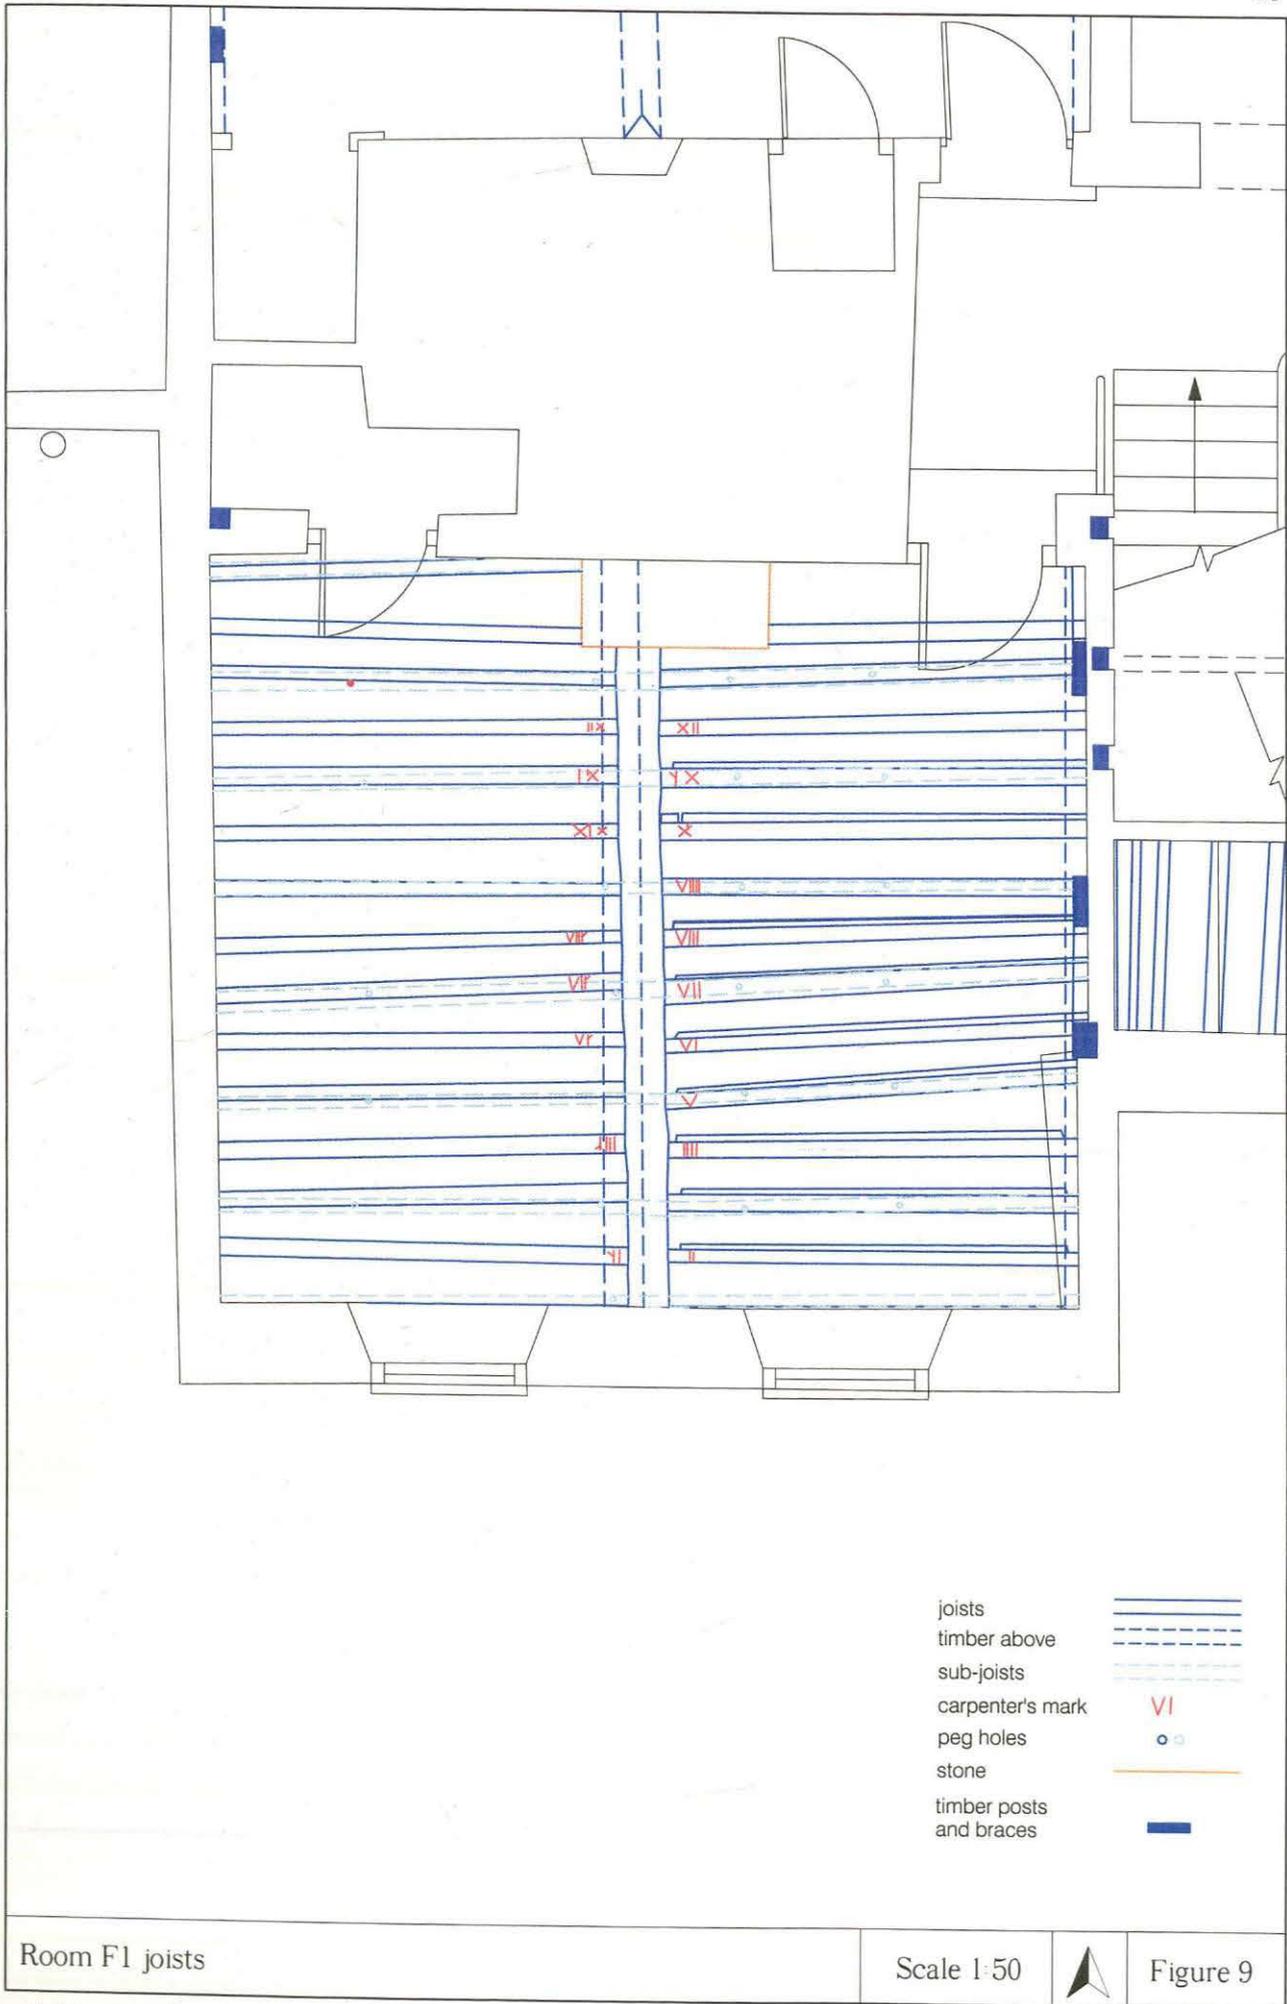
Room F1 joists

The floorboards were removed to permit an examination of the floor structure. This consists of a bridging beam running north to south with joists tenoned into it (Figure 9). The other ends of the joists are housed directly in the brickwork forming the east and west walls. As observed elsewhere in the house, the floor is provided with springing by means of sub-joists, set on packing pieces on top of the main joists. However, in contrast to the technique deployed elsewhere, the sub-joists are mounted on alternate joists only. Peg holes in the sub-joists indicate the fixing points for the original floor covering. The upper surfaces of the joists retain carpenters' marks, in the form of Roman numerals. Where visible, these appear to follow a coherent sequence from the south, the western side being indicated by a *versus* mark, although there appears to have been some redistribution of joists around those numbered X and XI. The rear surface of the ceiling over the ground-floor room (G1) was

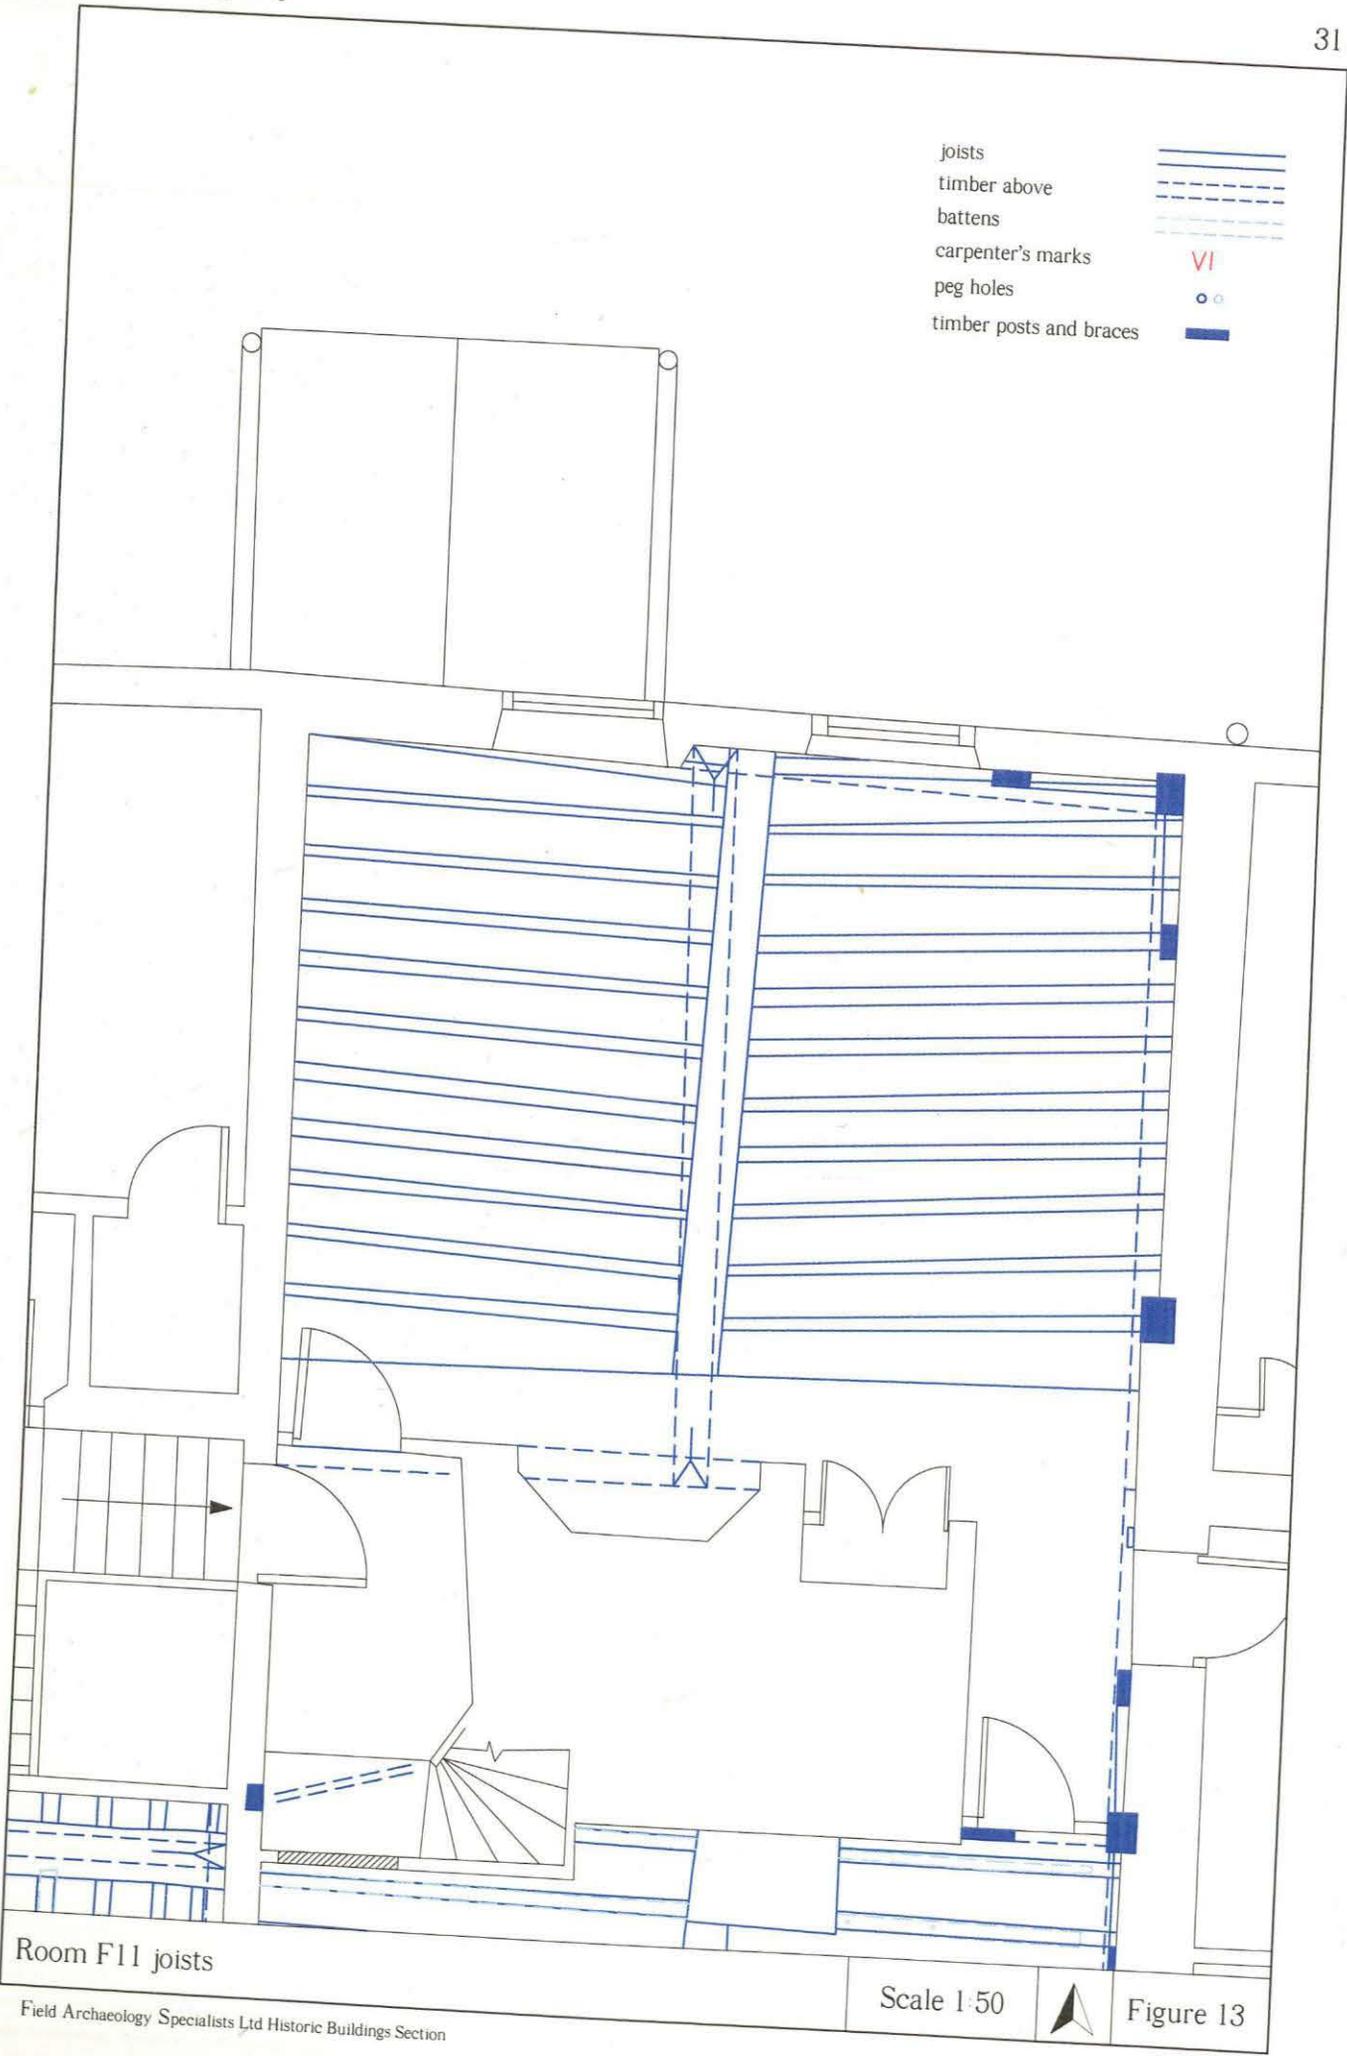
Room F11 joists

The floorboards in this room were lifted to allow an inspection of the floor structure (Figure 13). A bridging beam spans the room north to south, having a chamfer and stops at either end. The floor structure follows the pattern observed in other rooms, with joists jointed into the central beam and set within the brickwork of the east and west walls. This floor was subjected to modification in the 19th century, and includes a sand fill, presumably to provide sound- and fire-proofing.

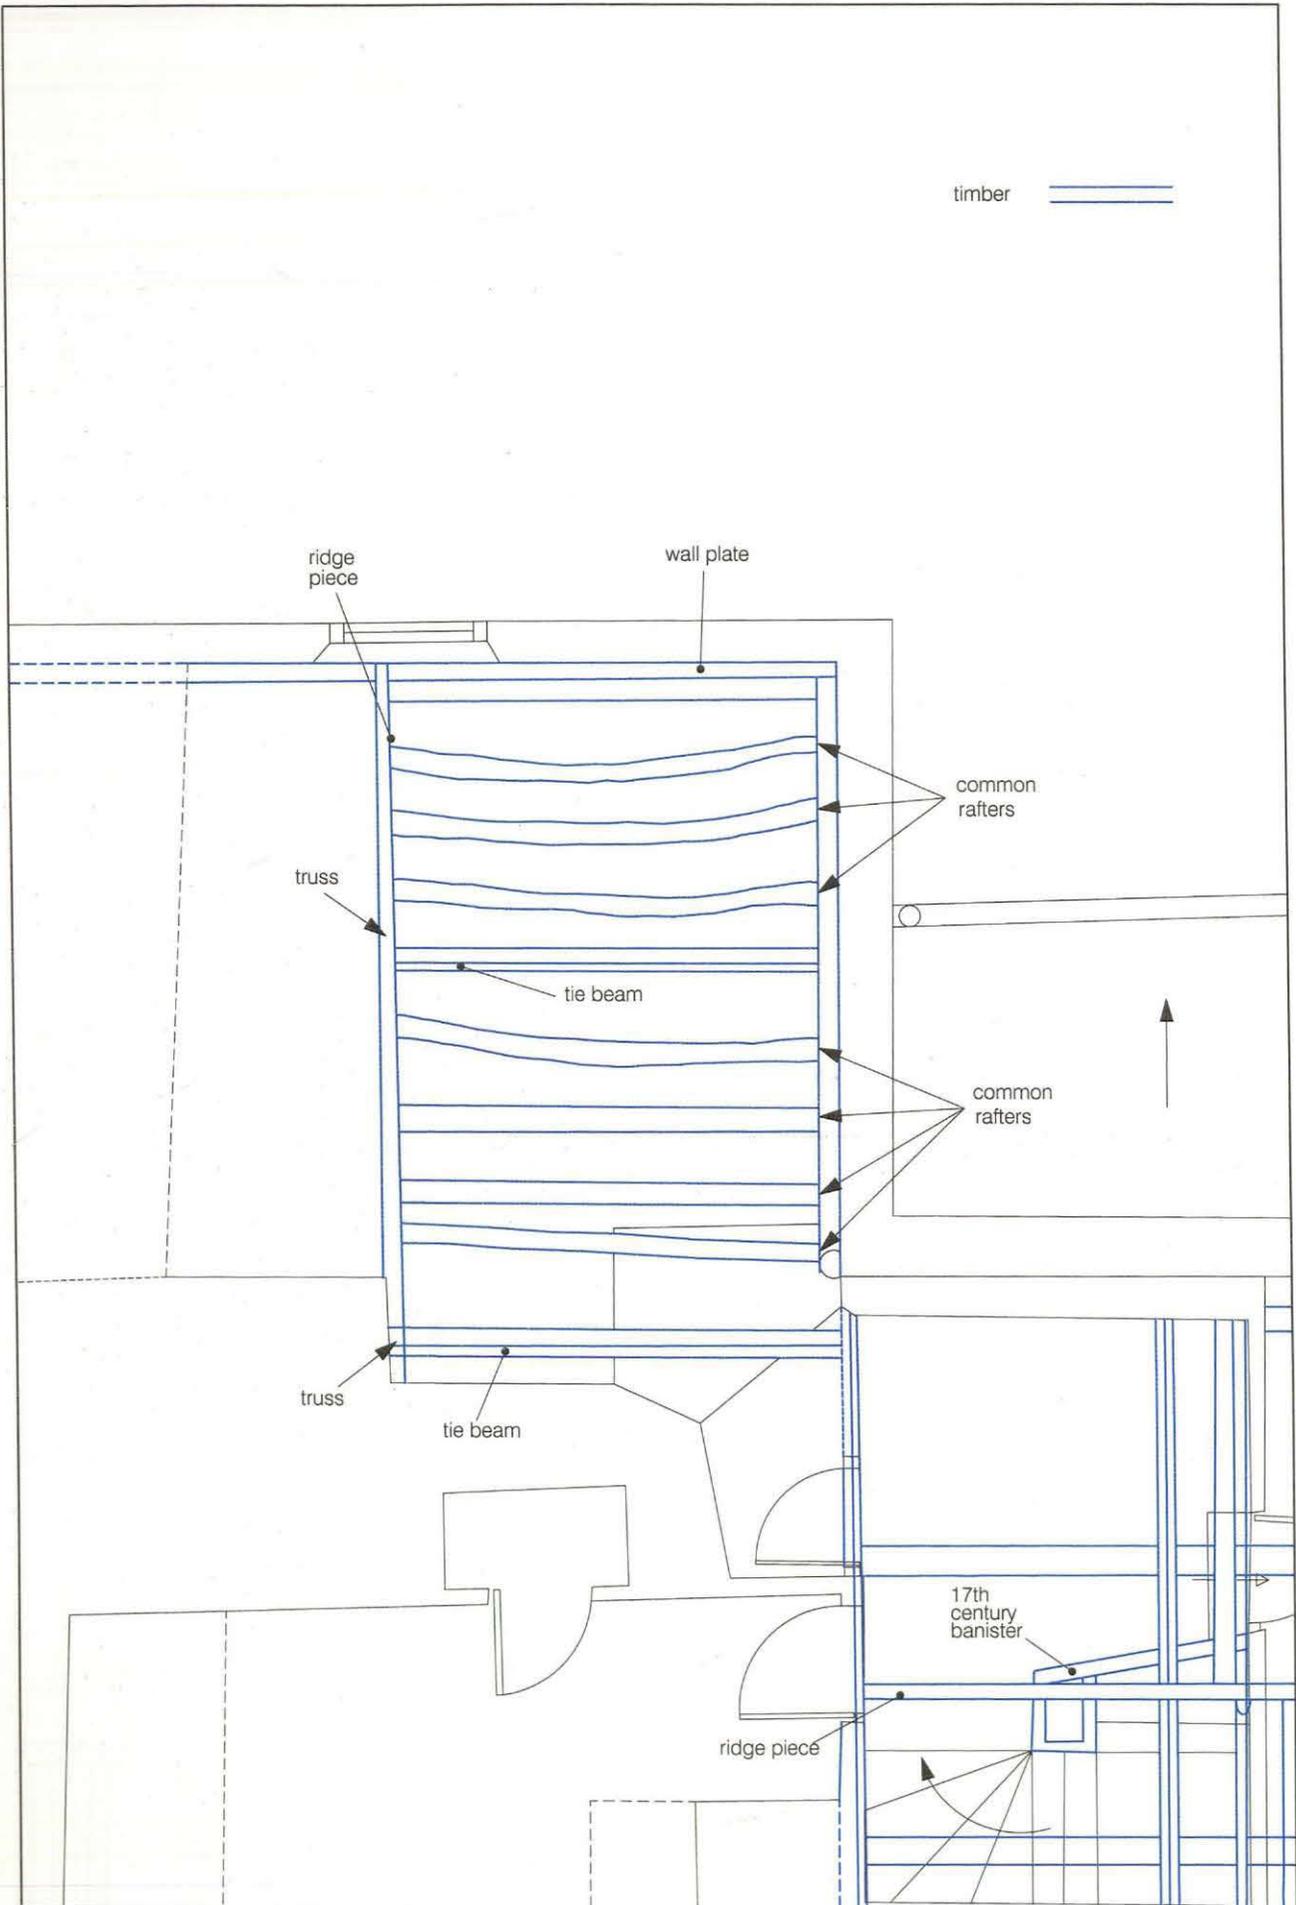
Figure 20

It was not possible to inspect the southern end of the roof structure as it was fully undersealed. However, inspection hatches were available to examine the northern portion of the roof (Figure 20), and much of the side lathe and plaster panelling had been removed historically.

The roof form is of simple and light construction (Plates 14 and 15). A basic A-frame is formed by common rafters, set directly onto the wall plates. A wall plate acts as a tie beam at the north end of the roof. The frame is further tied by collars, with clasped purlins. An additional collar would have been located in the gable wall, but this has since been removed - presumably when the upper part of the gable wall was rebuilt in brick. The rafters clasping the purlins with the collars would normally be of greater size (a principal rafter) than those adjacent, but this is not the case at Alford. Little additional tying is provided.

If the joists of the attic floor had been better secured into the bridging beam, further resistance to the spreading effect of the roof would have been provided. The ceiling joists of the attic are secured by hangers from the collars (see Plate 14) - these are of very modest dimensions.

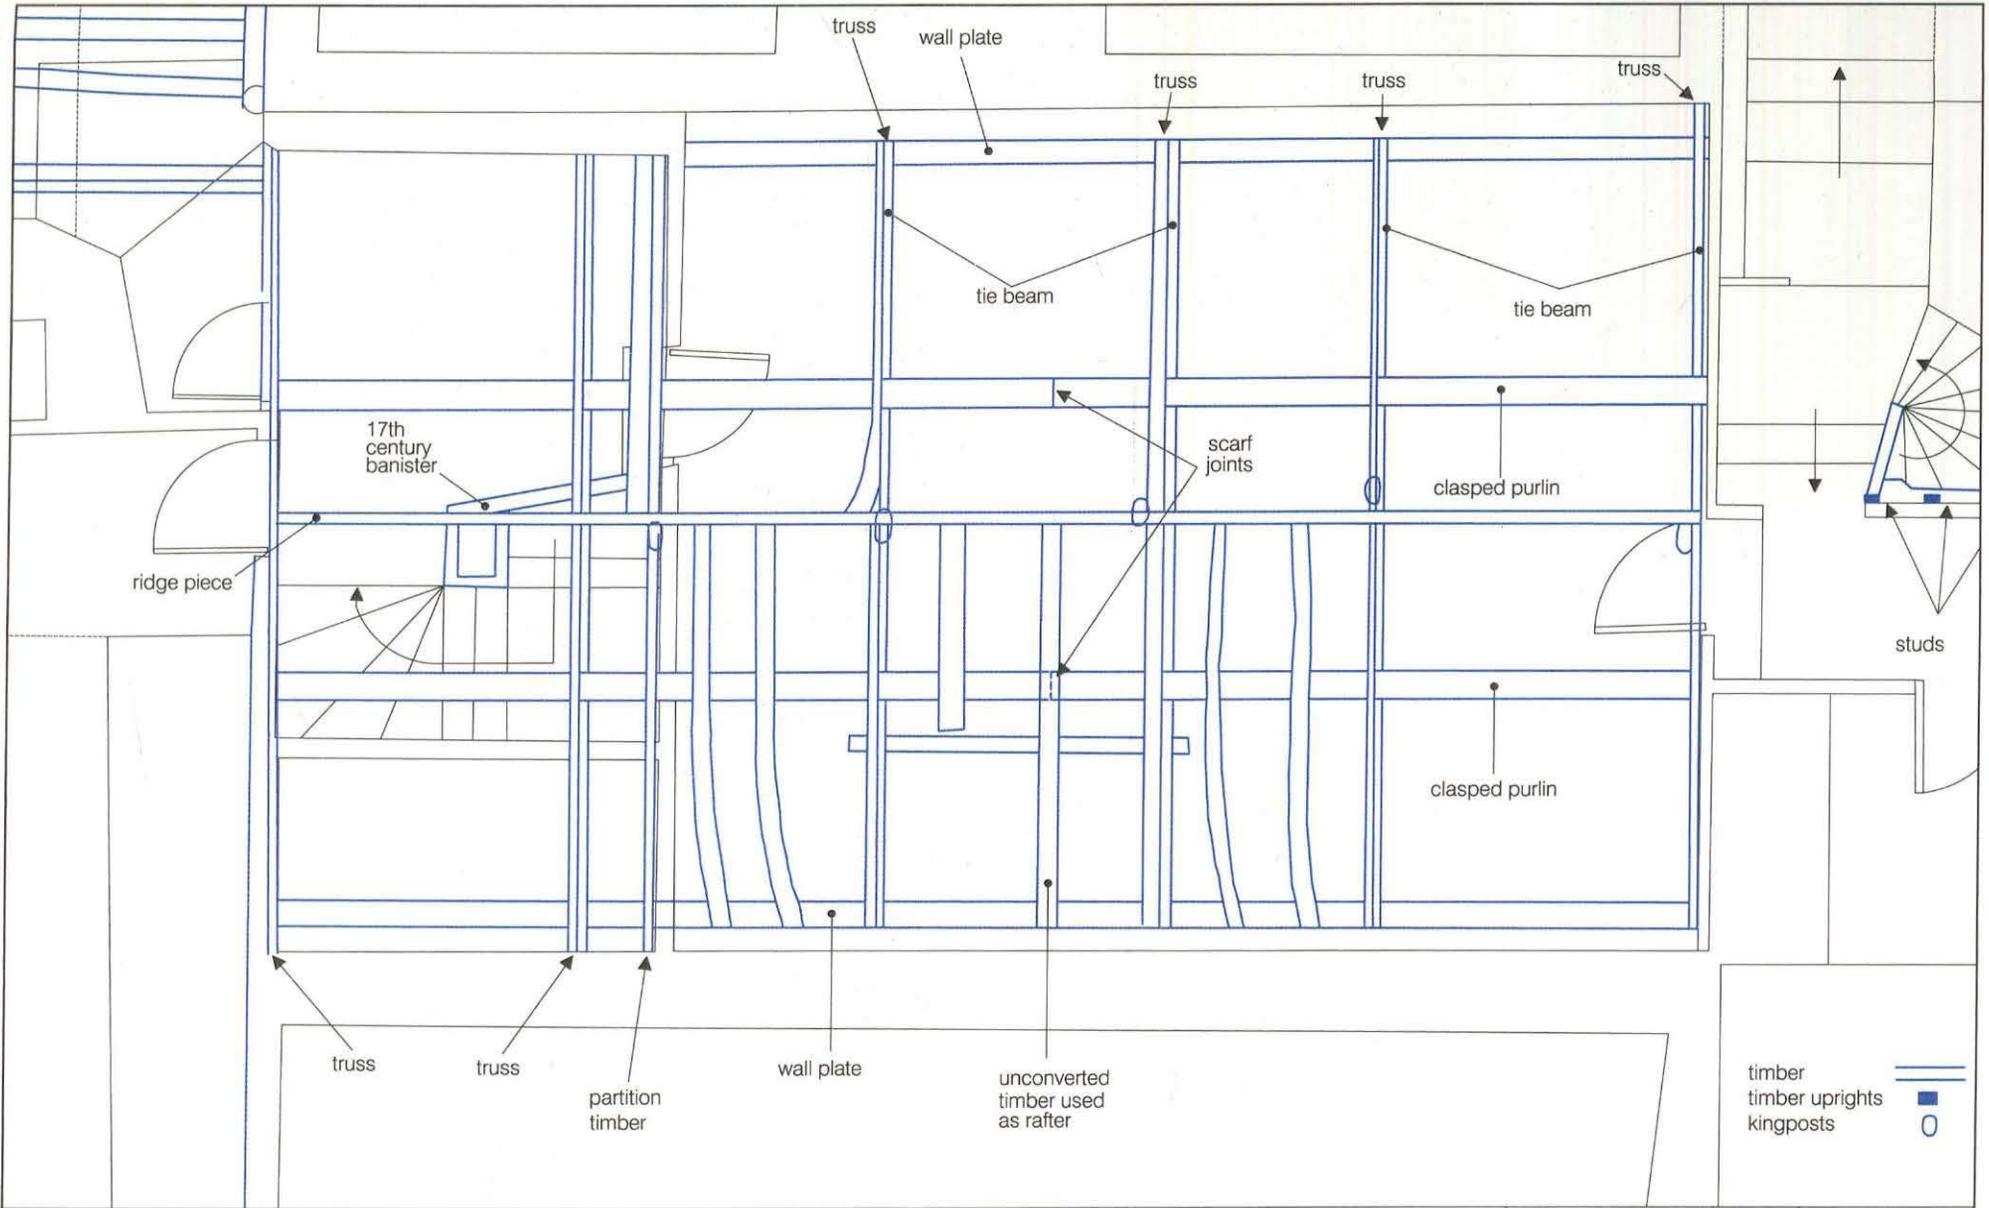
Figure 21

It was possible to examine the roof structure over this portion of the house in some detail (Figure 21). Essentially, the roof takes the same form as that above the west wing, consisting of collars, common rafters and clasped purlins supported on wall plates to the north and south. The wall plates, in turn, transfer their loads directly onto a series of posts at first-floor level. The positions of four posts are
