GNR FOOTBRIDGES

LINCOLN TO GRANTHAM LINE

**SOUTH COMMON CUTTING
LINCOLN**

**Industrial Archaeology Section
University of the Third Age (Sleaford Branch)
July 2002**

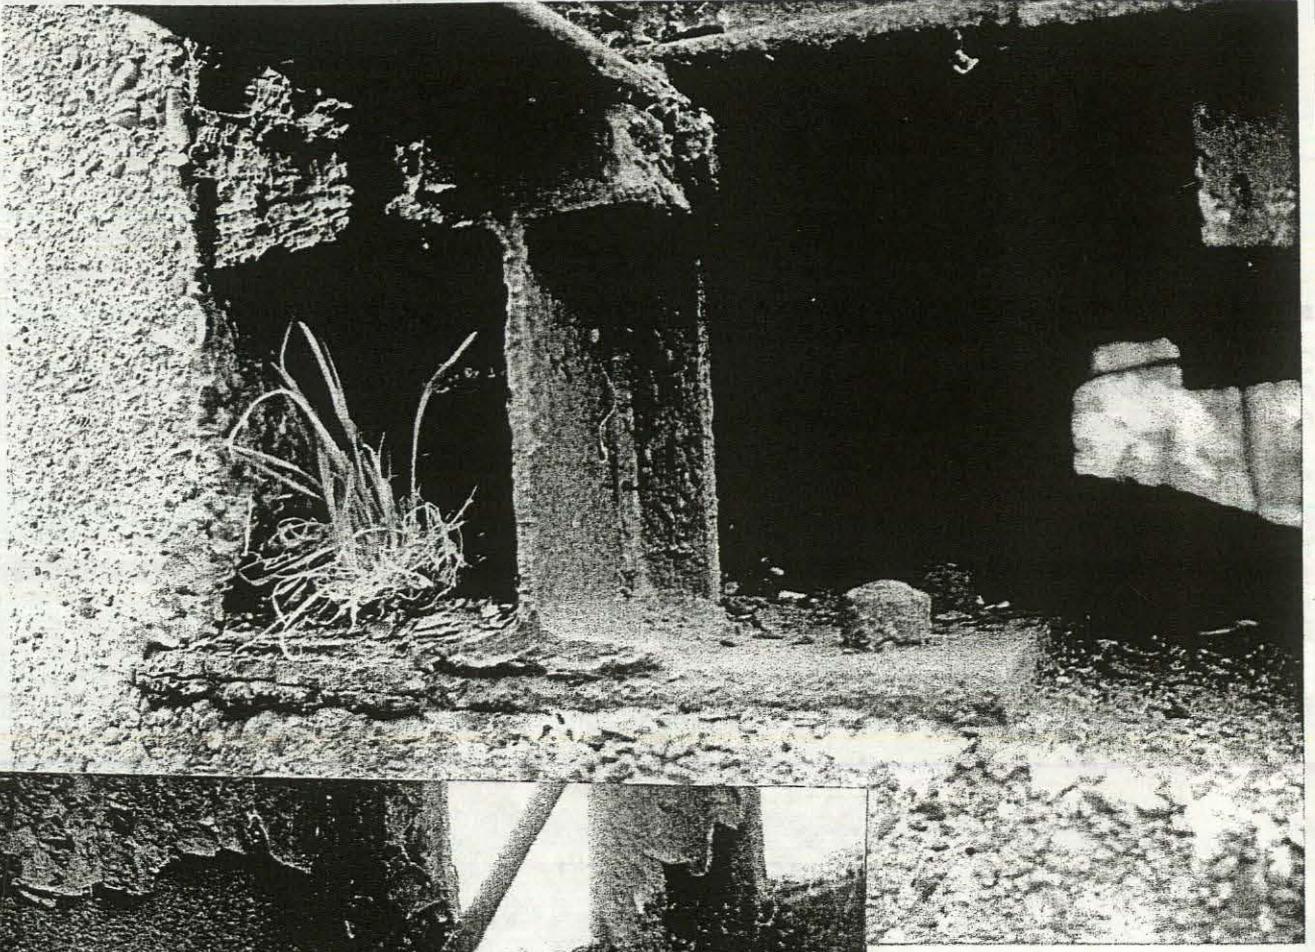
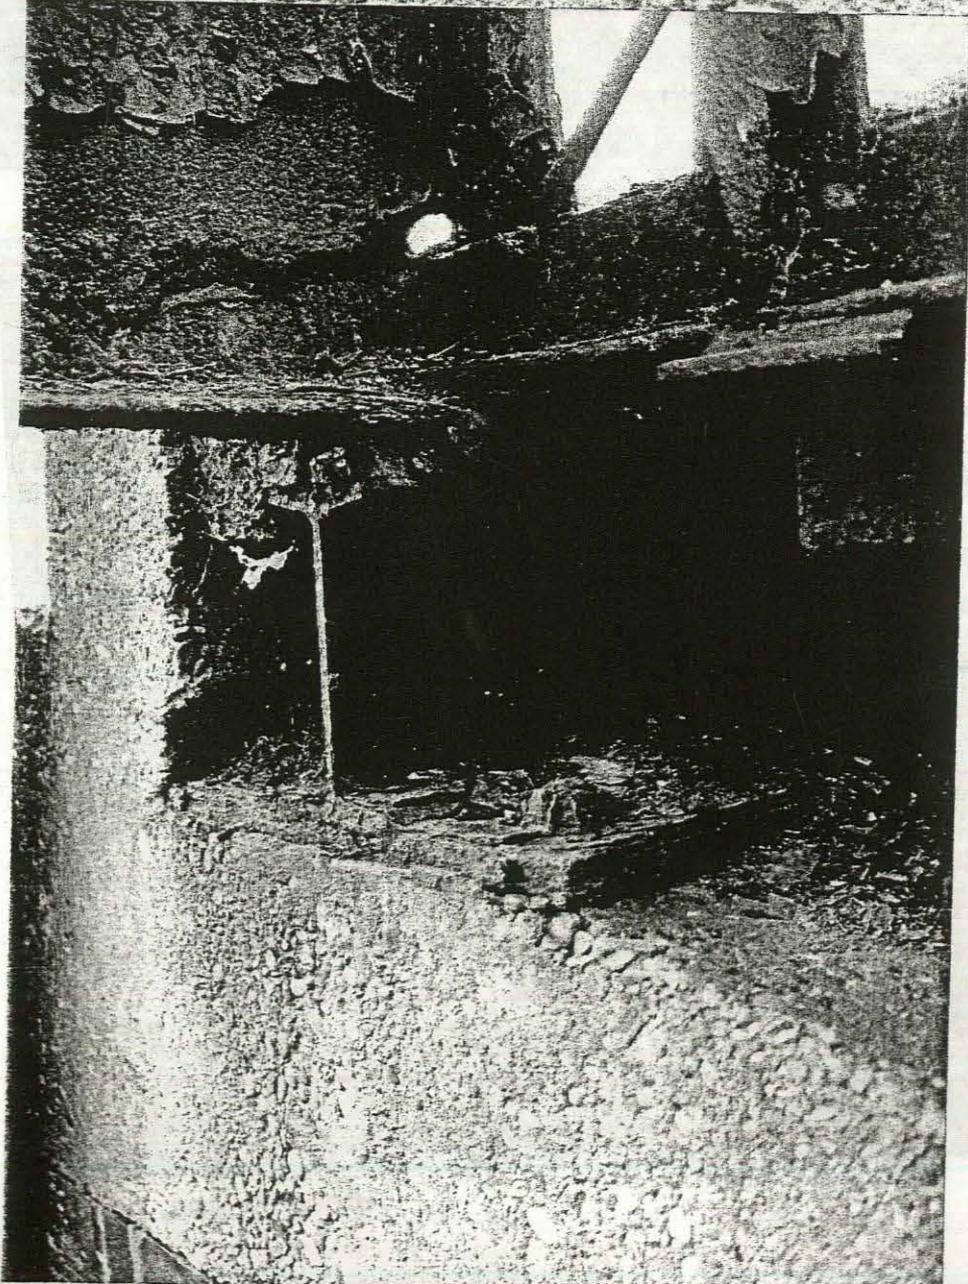
Appendix One

Item two - Two photographs taken June 2002 of Bridge Number 31. These show the cast concrete block on top of the central piers. In the first shows clearly the RSJ support (note the strengthening fillet) and the fixing foot welded to it. The base of the outrigger strut can also be seen and it should be noted that this is welded to the RSJ. This was part of the 1960 modification as initially the strut was riveted to the RSJ. The second shows the same feature but in this case the joint plate connecting the top and bottom and the inner and outer 'T' section rails.

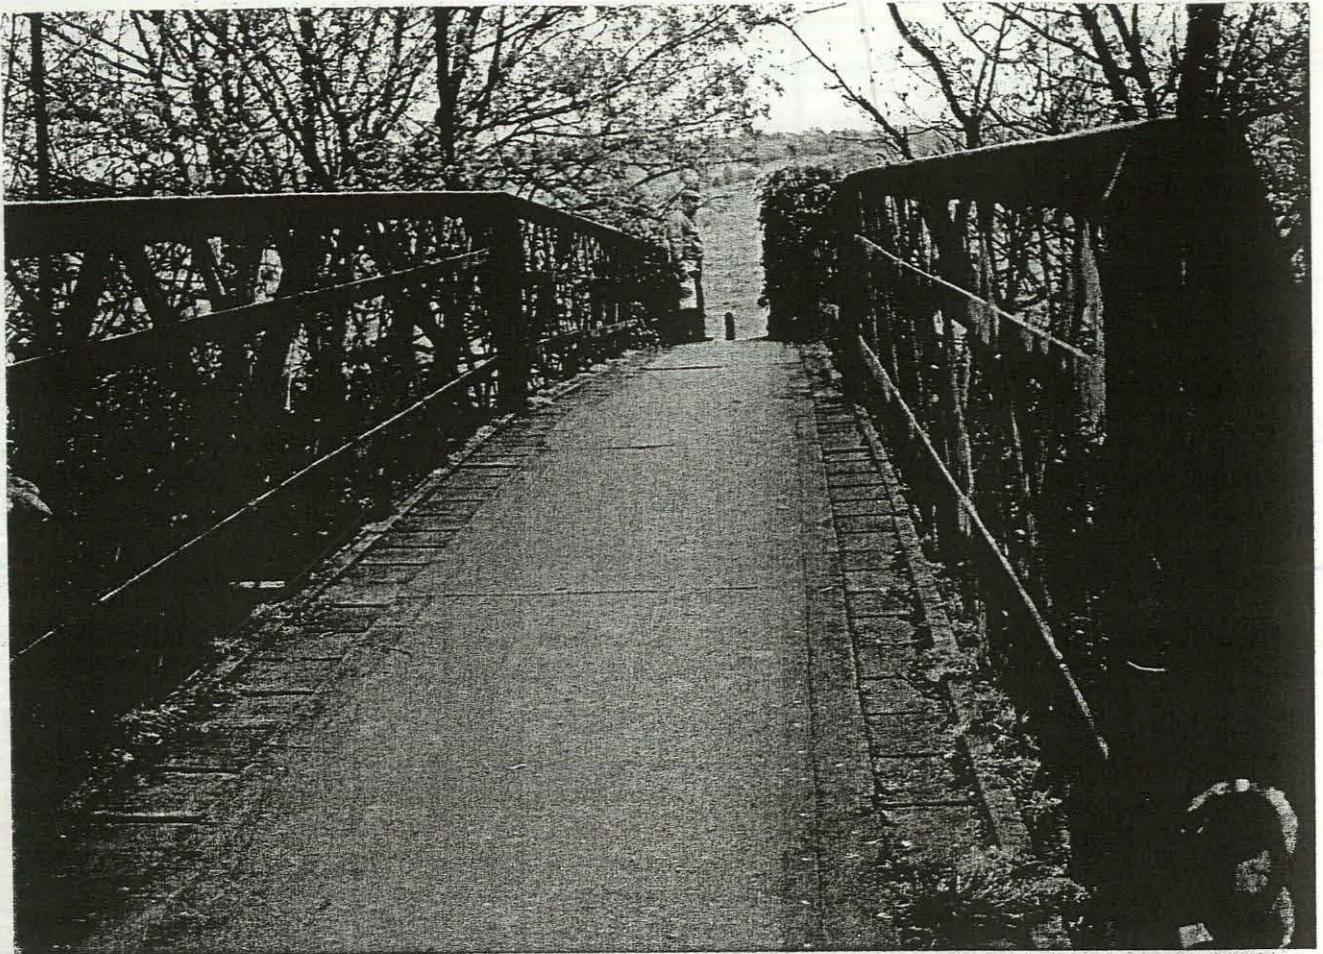
Item three - Two photographs taken June 2002 of Bridge Number 31 showing details of the end supports of the bridge. The first is of the support at the south end and the second of the opposite support at the north end of the bridge. On both photographs it can be seen that the bracket has been cut down from the original RSJ's, and the bottom edge of the 4" angle iron rail that replaced it.
