STRUCTURAL SURVEY  
OF  
CATHEDRAL CLOSE WALL  
POTTERGATE  
LINCOLN  
LCW98

Undertaken for  
the Dean and Chapter  
Cathedral Works Department  
Lincoln

June 1998

A.P.S. Report No. 44.98

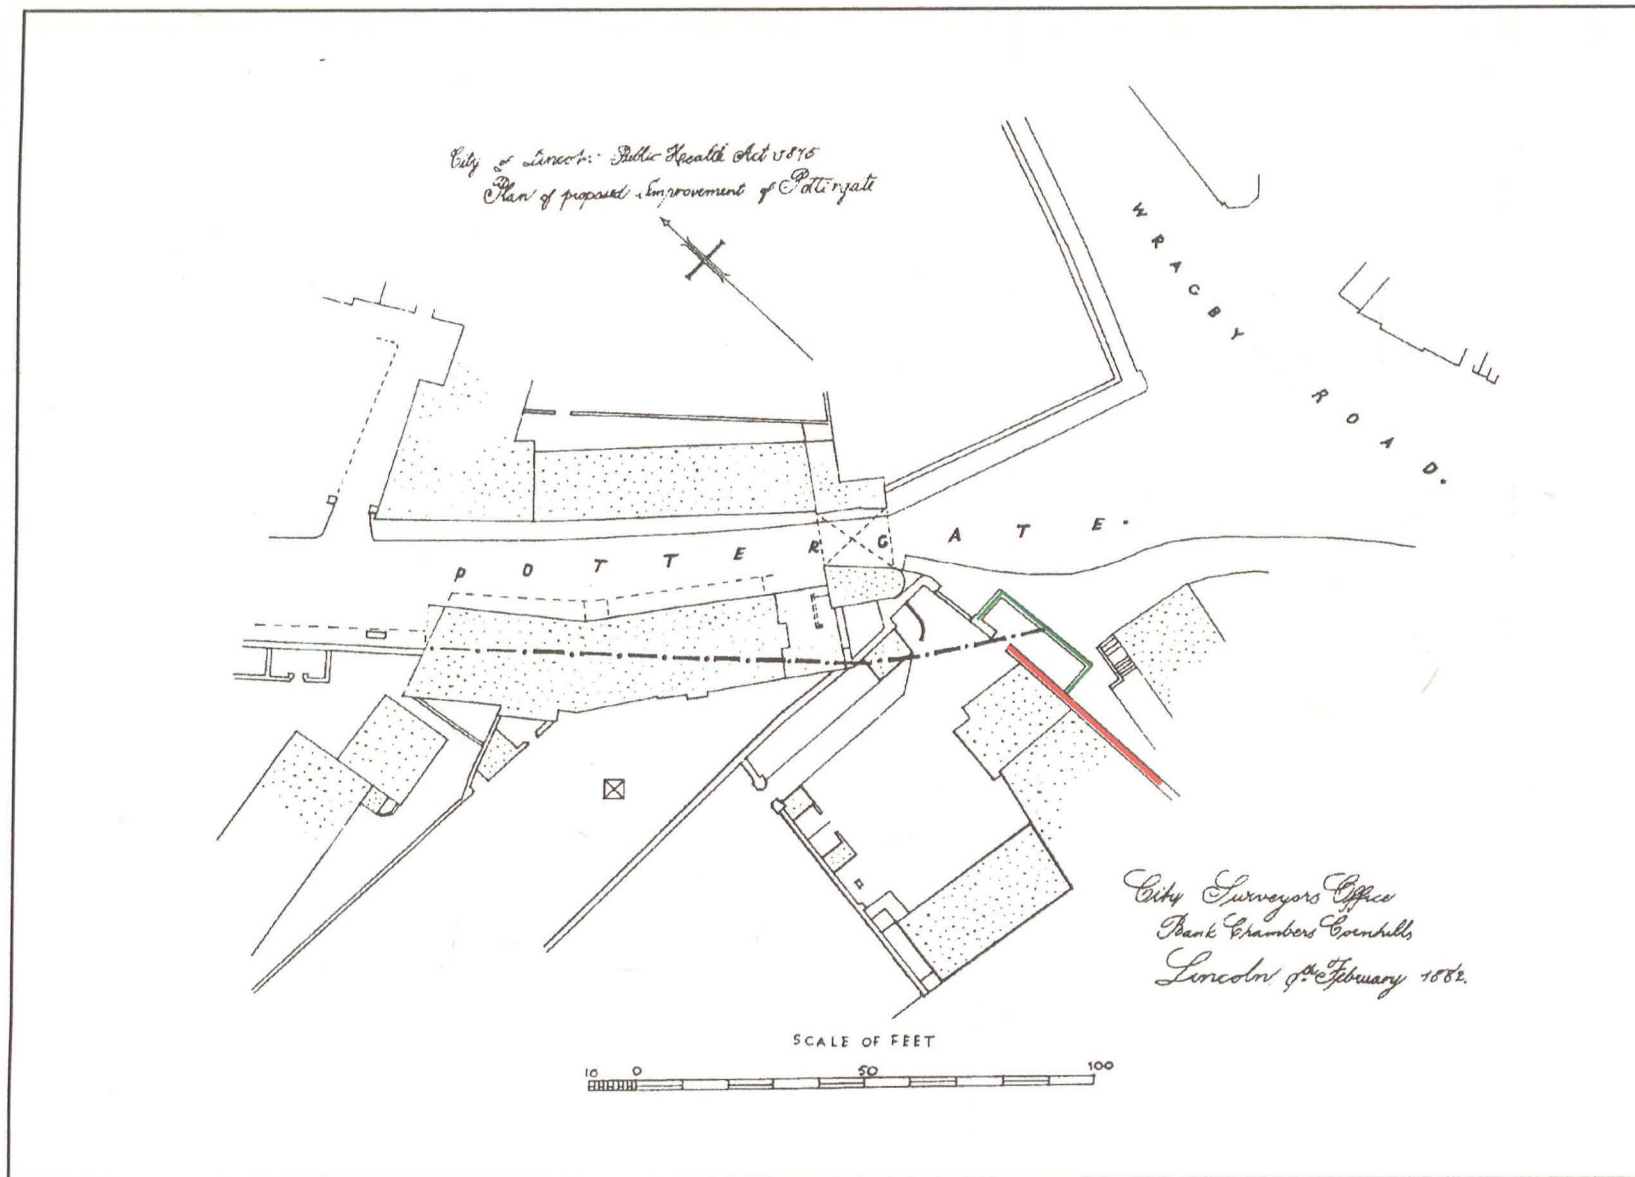
A survey of this area of the wall conducted in 1875 by the City Surveyors Office (Fig. 6) shows a rectangular walled area attached to the east face of this section of the Close Wall. The map also shows a gap between the southeast corner of this structure and the properties to the east (Jones 1987). It is thought that the garden wall shown on the elevation (Fig. 5) is the surviving southern wall of this structure. This walled area is likely to represent a yard or garden area linked to the properties on the west side of the Close Wall. The bricks are of the same type and bond as those of Phase 3 and it is likely that the two are of a similar date. Therefore, the section of the Close Wall located north of the current garden wall once formed the west side of the enclosed area shown on the 1875 map.

Figure 6 1875 plan showing Pottergate before road widening.  
Note walled yard/garden (marked in green) attached to east side of Close Wall (drawn section marked in red).

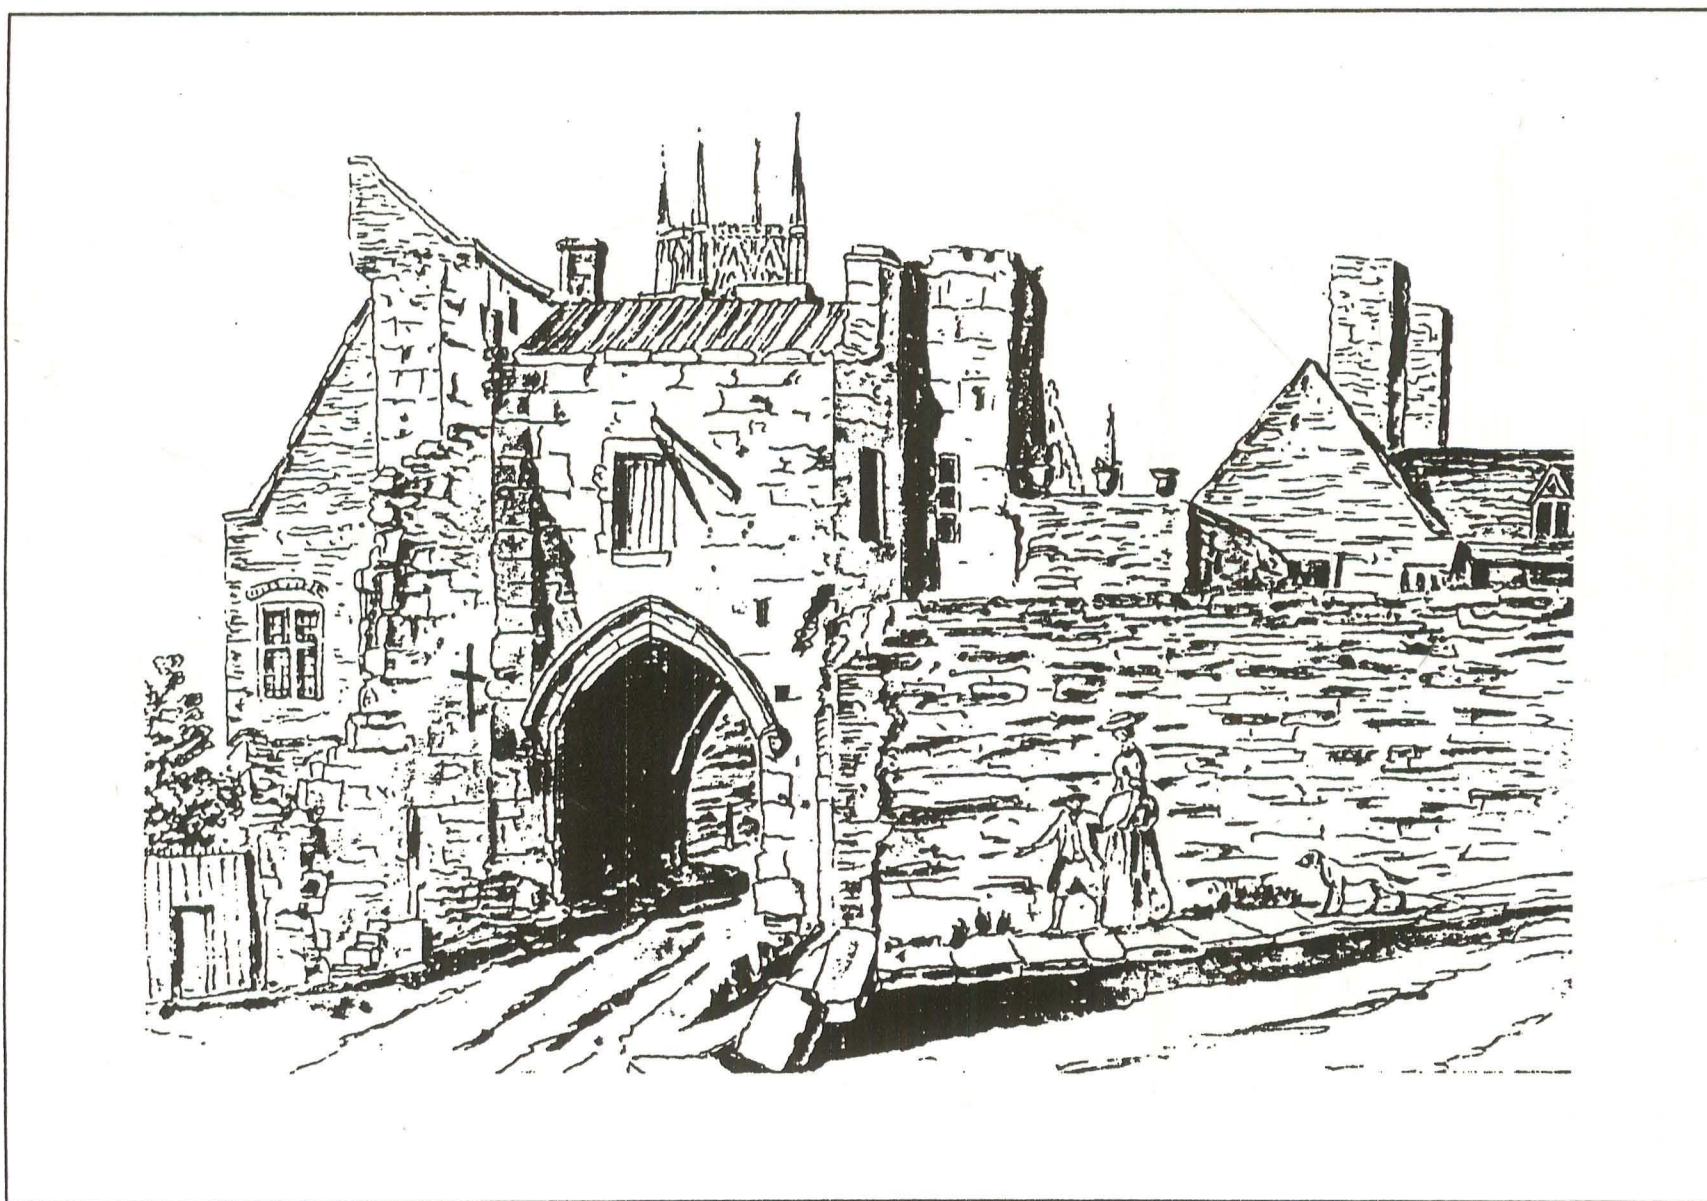
Figure 7 Drawing of Pottergate Arch by S.H.Grim c.1784

A sketch of the Pottergate Arch by S. H. Grimm c 1784 (Fig. 7) shows the altered Close Wall. The stonework shown on the south side of the arch in this drawing is very similar to that of Phase 2.
