Ironbridge Archaeological Series No. 342

Archaeological Watching Brief during Investigative Works at the Iron Bridge

July 2016

Ramboll on behalf of English Heritage

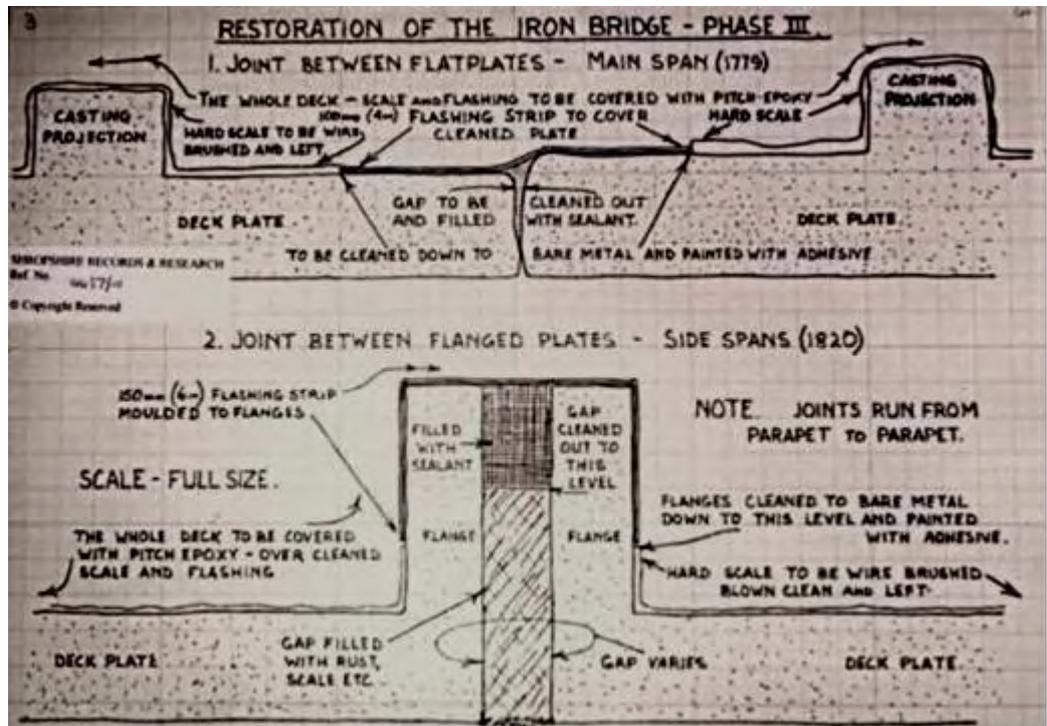
Figure 4: Undated sketch (presumed 1970s) by Sam Blackwell showing the proposed specifications for caulking and sealing the gaps between the deck plates and between the upstands (Courtesy IGMT 2011)

The investigative works have gone a long way to show that the specifications for waterproofing the joints between the deck plates and upstands produced in the 1970s (IGMT 2011, 180, Figure 4 this report) were carried out. These show that on the side arches, the upstands were to be cleaned back to bare metal, with the lower section of the gap to be filled with rust and scale, and the upper section of the gap to be filled with sealant. The upstands were then to be painted with adhesive, and covered with 150mm wide flashing strip. The whole deck plate, including the flashing and upstands was to be covered with pitch epoxy. On the main arch the deck plates were to be cleaned down to bare metal and the gap between the deck plates was to be cleaned out and filled with sealant. The joint was then to be covered with 100mm wide flashing strip and then the whole deck plate, including the flashing was to be covered with pitch epoxy. This also

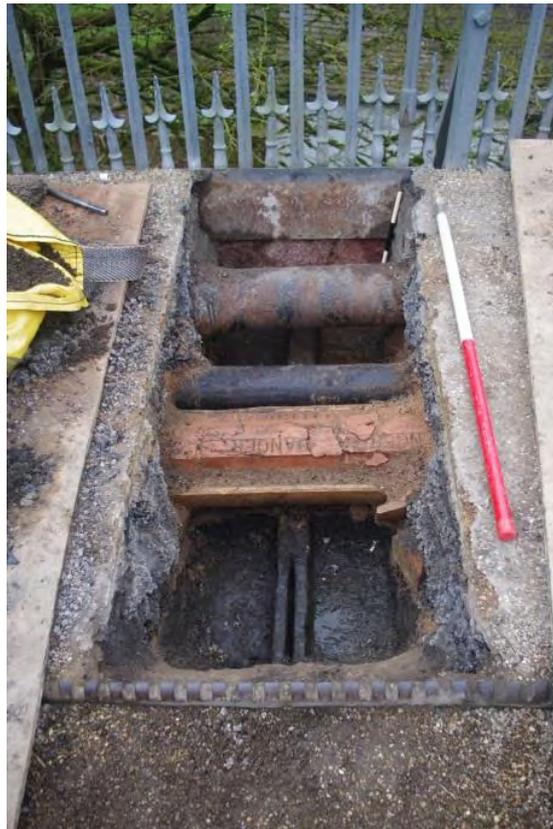
Plate 16: TH01 from the east

A 600mm x 1540mm trench was excavated at this location. This was excavated to deck plate level, which was located at a depth of approximately 465mm below surface level. The trench revealed two metal service pipes (gas and water) and a ceramic electric cable conduit. The westernmost pipe (water) pipe, which was 170mm in diameter and flanged at the joints, was located approximately 110mm below surface level, approximately 80mm above deck plate level, and c.220mm from the western edge of the trial hole. Located 110mm to the east of this was the gas pipe, which was 130mm in diameter, and 185mm from surface level and 60mm from deck plate level. The ceramic electric cable conduit was uncovered almost immediately adjacent to this (c.35mm) to the east. This was approximately 165 mm below surface level and 265mm wide at its widest point. This conduit was surrounded by sand and was stamped with the words 'DANGER ELECTRICITY'.

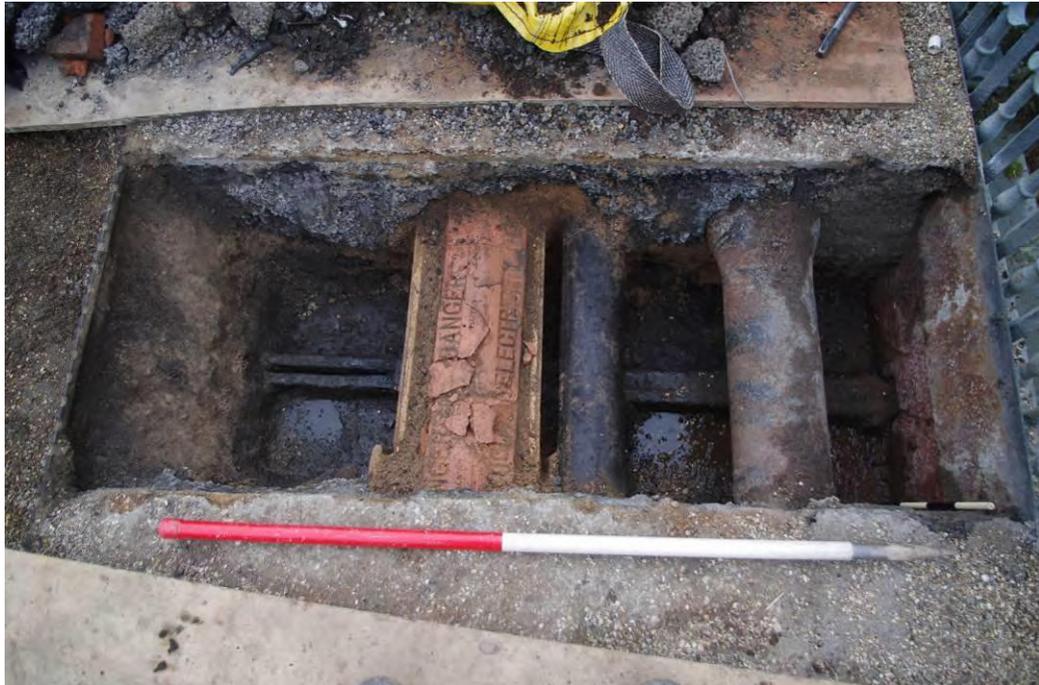
Plate 17: TH01 from the north.

The deck plate upstands, which ran east-west through the midpoint of the trench, were 70mm high and 22mm wide. The gap between the deck plate upstands was found to be approximately 18mm wide and filled with caulking. Similar to TH02, the excavation revealed some pooling of water on the north side of the upstands on the western side of the trench. The caulking between the upstands and the sealant material, were similar in nature to that outlined in TH02 above.

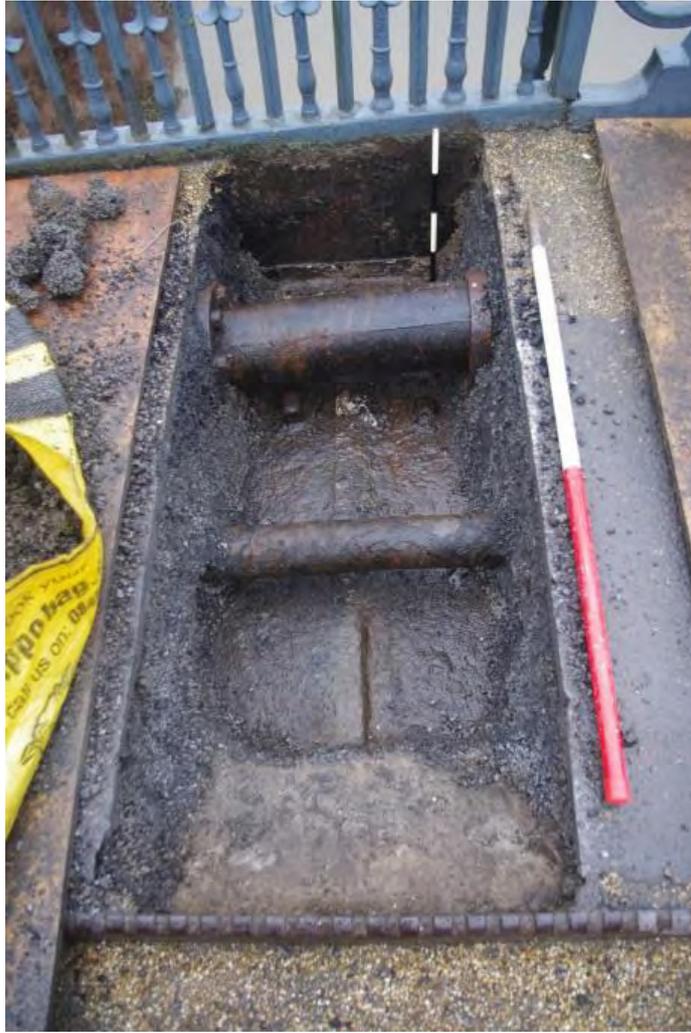
Plate 19: TH08 from west

As this trial hole was located on the main arch of the bridge no deck plate upstands were found to be present. The gap between the deck plates was filled with a hard bituminous-type material similar to that recorded in TH02 and TH01 above, and covered over with flashband tape (110mm wide). Samples of this were removed by the contractors who noted that it was only possible to expose c.15mm of the material as the join between deck plates grew tighter at depth. This was possibly due to the fact it was observed that the north plate was 6 to 8mm higher than the south plate at the join.

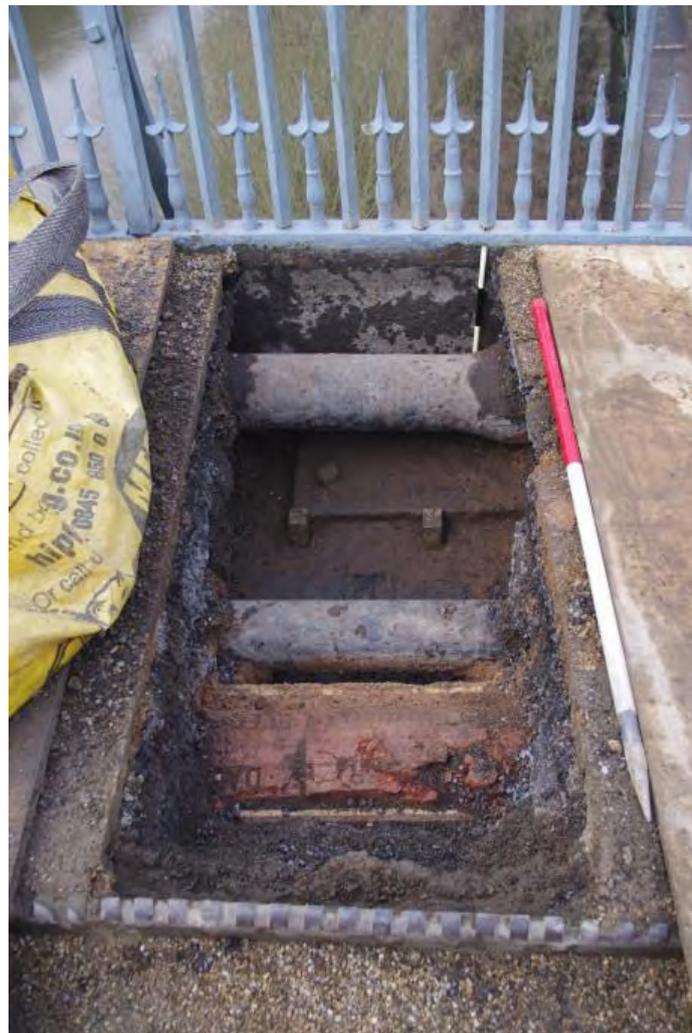
Plate 22: TH09 from the east

Two MIO coated pure iron wedges, which were installed in 2011 (see Ironbridge Archaeology 2011), were uncovered towards the western side of the trench. These were located approximately 440mm to the east of the bridge edge plate. Some corrosion was observed on the deck plates in the around the wedges, presumably where waterproofing had been removed.

Immediately to the west of these wedges was a repair plate which was secured to the deck plates with square headed bolts. This was located approximately 70mm from the bridge edge plate and was 370mm wide (east to west) and c.500mm long (north to south). The plate was found to be 38mm thick (see Plates 22, 23 and 24).

The only other features of particular note were the repair plate found in TH09 (Plates 22, 23, and 24) and the repair plate found in TH05 (Plates 28 and 29). David de Haan, the author of the Iron Bridge Conservation Plan, has highlighted a photograph of the underside of TH09 which shows a crack across the corner of the deck plate. This is what he believes the repair plate was aimed at reinforcing. He also noted that the bolt on the plate is directly over the deck bearer and therefore will not be visible from below. He suggests that it is a coach bolt screwed into a tapped hole, and it could have been installed in 1902-3 or 1926. With regards to the repair plate encountered in TH05, he believes that the repairs were undertaken when the road material was last removed in 1975.

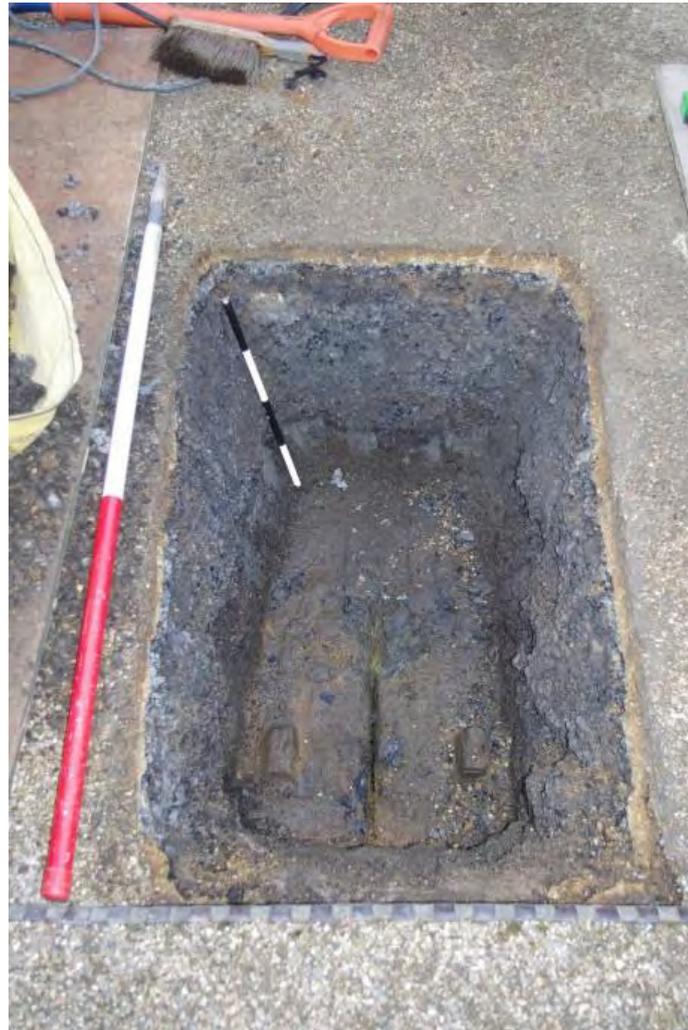
Plate 25: TH06 from the west (NB black and white scale is 40cm long, red and white scale is 50cm long)

This excavation revealed two wedges on the western side of the trench. These were located 285mm from the kerbing and were c. 85mm long and 45mm wide.

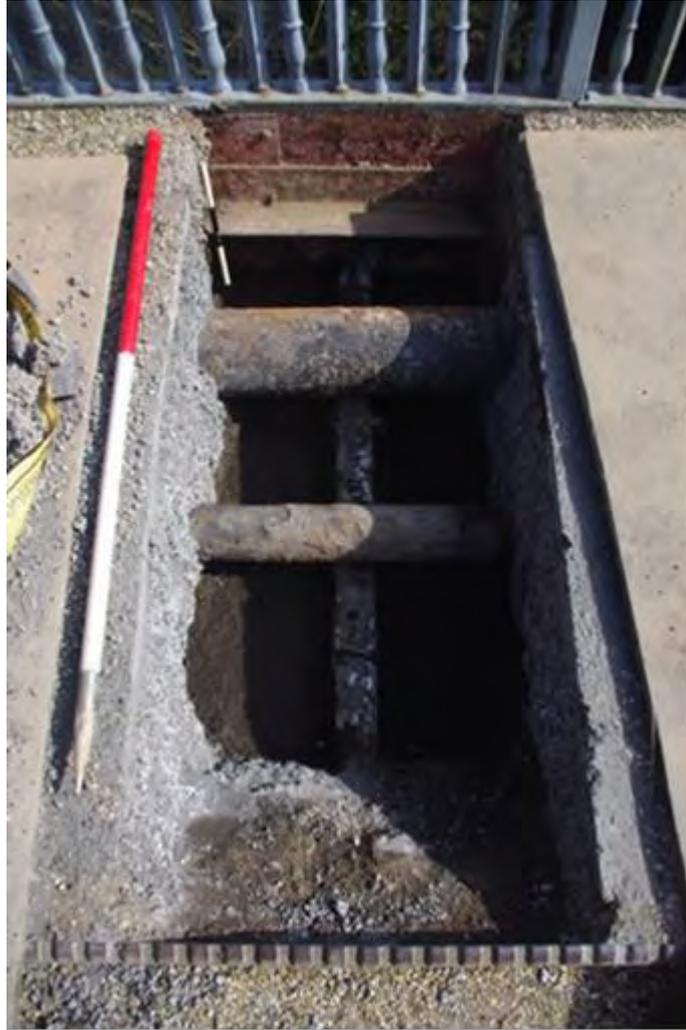
Plate 27: TH05 from the west

As this trial hole was located on a side arch deck plate upstands were found to be present. These were c.70mm high and were found to be bolted together approximately 470mm to the west of the bridge edge plate.

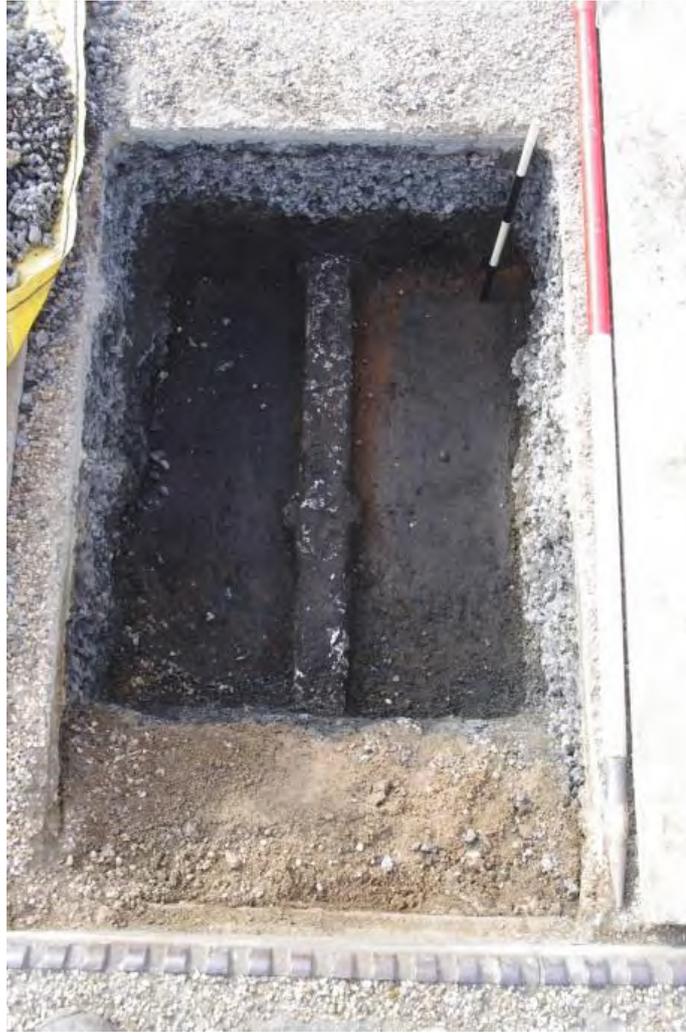
Plate 31:TF04 from the east

The trench revealed the deck plate upstands which were found to be c.70mm high and 22mm wide with a 20mm gap in between, which had been filled with a caulking as detailed above. The upstands were bolted together (approx. 500m from both ends of the trial hole) and sealed with flashband tape with a thin brittle coating as in the other trial holes described above.

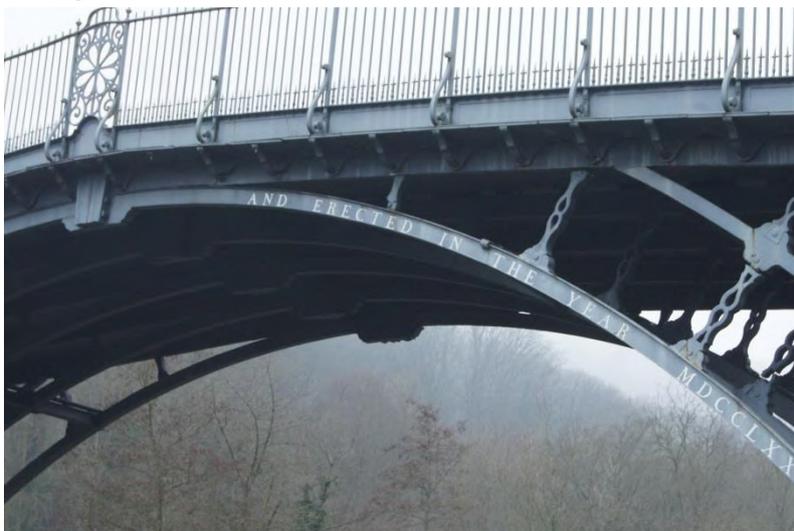
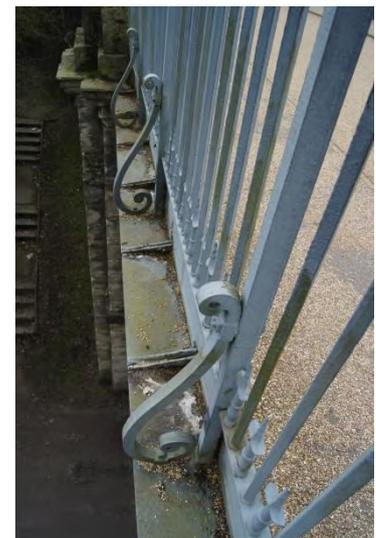
Edge of Deck Plates to be inspected at height, over water
