Archaeological Survey of Westcliffe Hospital Turnhurst Road, Stoke-on-Trent

June 2008

<p>Ironbridge Archaeology</p> <p>Historic Building Recording at Westcliffe Hospital, Stoke-on-Trent</p> <p>Ironbridge Archaeological Series No.220</p>	
Checked by Author	
<p>Anna Wallis</p> <p><i>Archaeology Supervisor</i></p>	<p>Date</p>
Passed for Submission to Client	
<p>Paul Belford</p> <p><i>Head of Archaeology</i></p>	<p>Date</p>

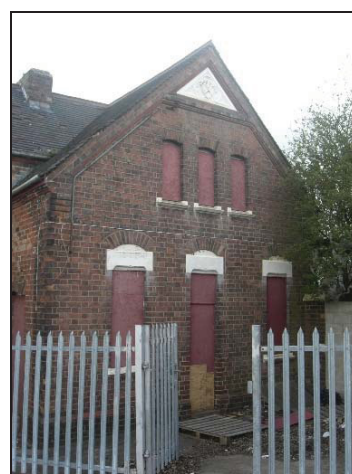
Figure 10: Detail from a different angle showing former window later altered to a doorway.

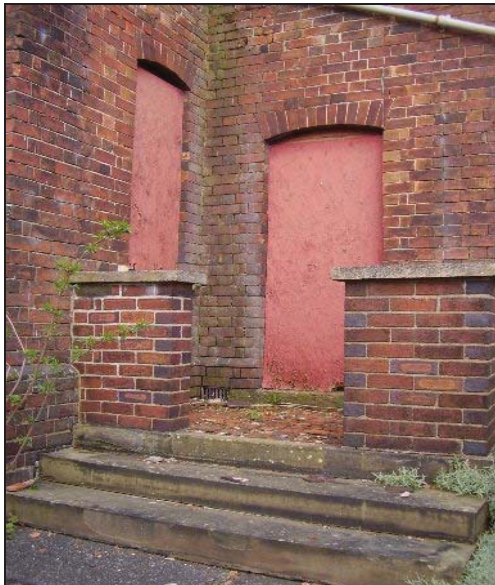
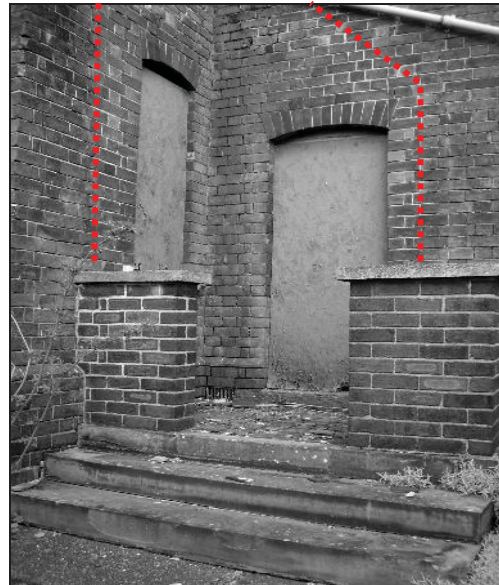
Clear scarring was evident on the south and east facing elevations whilst further possible scarring was visible on the west facing elevation. This scarring suggested a porch or canopy originally protruded from the east and possibly the west sides of the The Lodge and covered the entrances to the building (see Figs. 17 & 18).

Figure 18: Possible scarring around west entrance, as shown by lighter brickwork suggesting outline of former lean-to porch (photo on right is key to photo on left).

The low walls at either side of the west entrance to The Lodge (as evident on Fig. 18) were a later addition to the building. However they appear to broadly follow part of the outline of the former lean-to porch.

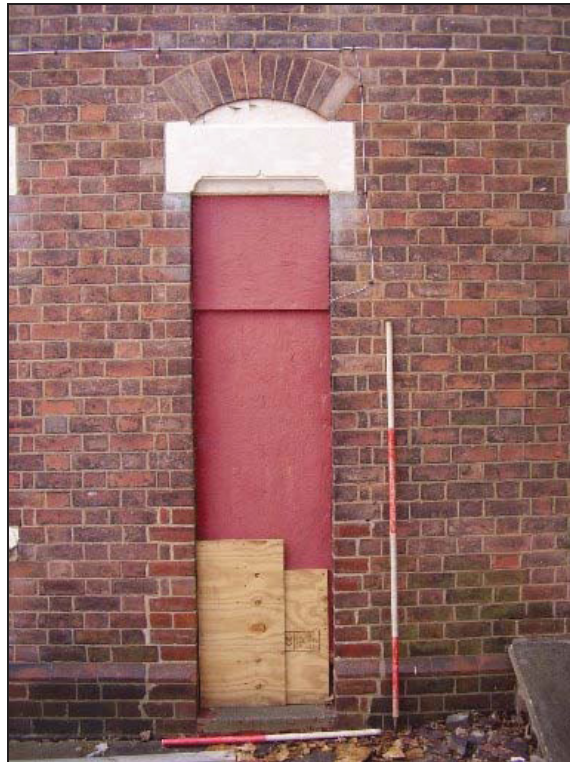
Figure 19: Doorway, east facing elevation

The door between the two windows on the east facing elevation was likely to have been a window originally, as was suggested by the white lintel and segmental relieving arch above the doorway, along with the brickwork around the lower portion of the door (see Fig. 19).

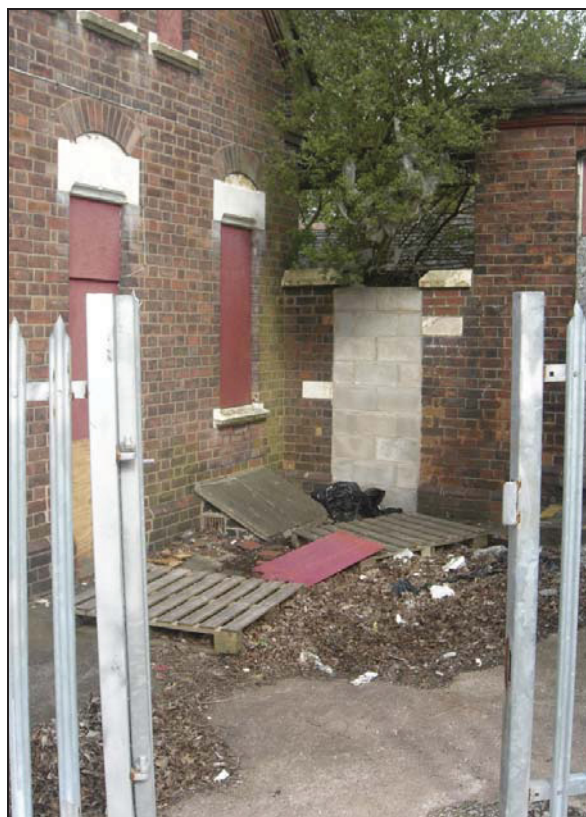
Figure 20: Opening in connecting wall, blocked in

The opening in the wall which joined The Lodge and the Vagrants' Ward was sealed off with breeze blocks (see Fig. 20).

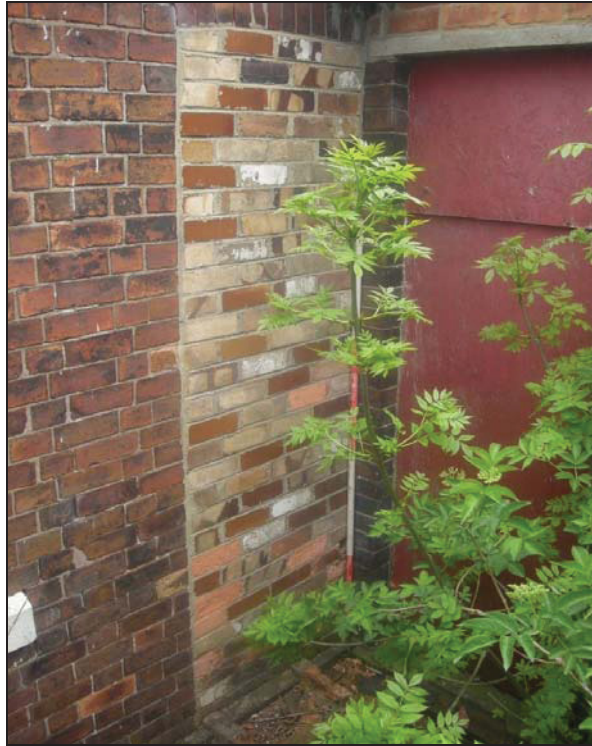
Figure 23: Blocked in doorway

There was brickwork to the left side of the single doorway and to the left of the doorstep which suggested there may once have been a wall or partition here (see Fig. 22). Next to the window in the wing was brickwork which suggested there was once a doorway here (see Fig. 23). The step to this door remained and a drain was later built over it (see Fig. 24).

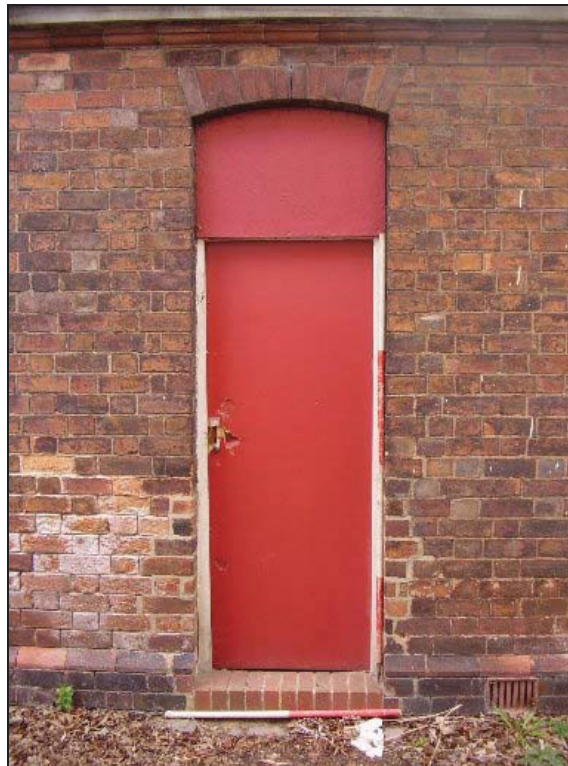
Figure 26: South door

The south door in the east facing elevation was likely to have been a large window originally. The brickwork around the bottom portion of the door as well as the 'square' brick arch above the door and the later doorstep all suggested this was the case (see Fig. 26). The north door was wider and the brickwork around it was probably the result of widening the opening. As a result it was unclear whether this was originally a narrower door or a window, but for reasons of symmetry it is likely that this too was originally a large window (see Fig. 27).

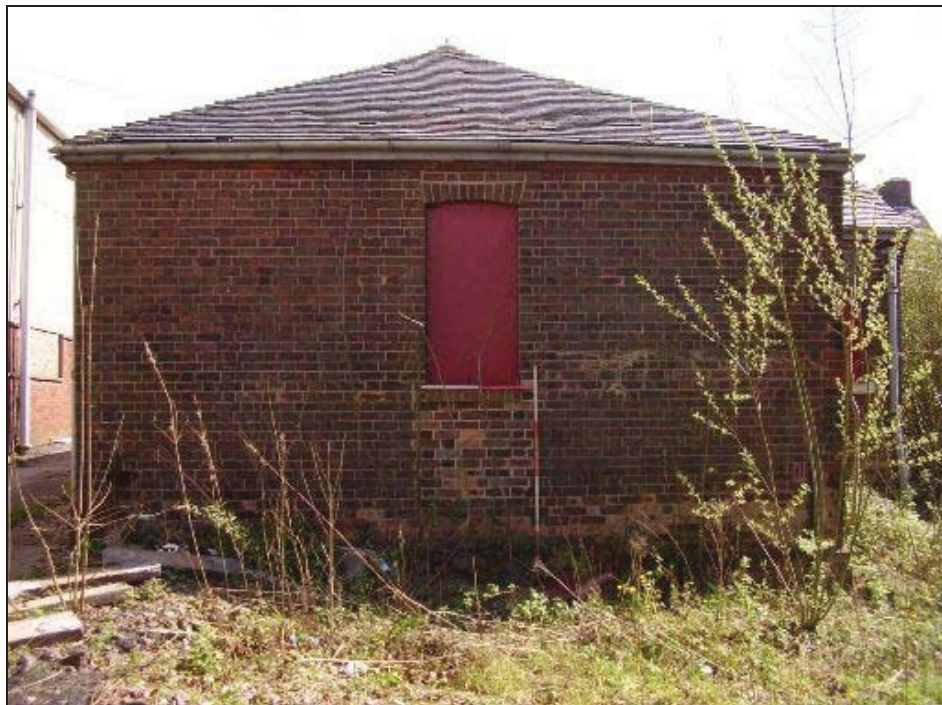
Figure 28: North facing elevation

The single window in the north facing elevation is likely to have been a door, as was suggested by the brickwork beneath the window and the later brick sill (see Fig. 28).

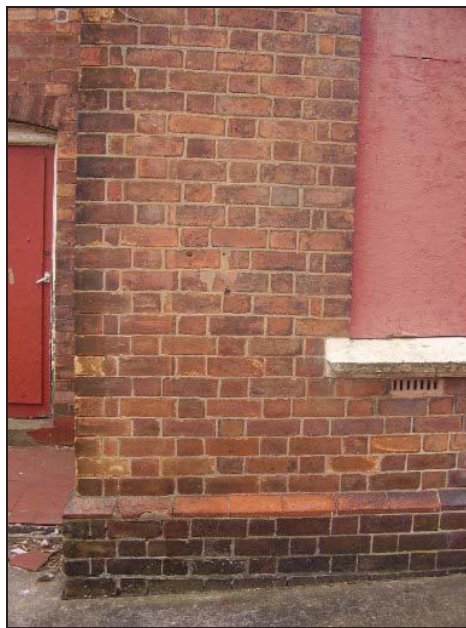
Figure 32: Scarring on wall

The Lodge and the Vagrants' Ward were connected by a wall which joined their east and west facing elevations respectively (see Fig. 11). The connection of the two buildings had the effect of creating a courtyard area to the front of them. The connecting wall had an opening which gave access to another courtyard area to the rear of The Lodge (see below) but this was now blocked in. The front courtyard area was open at the south side but brickwork on the east facing wall of The Lodge suggested the south side may originally have been enclosed (see Figs. 32 & 33).

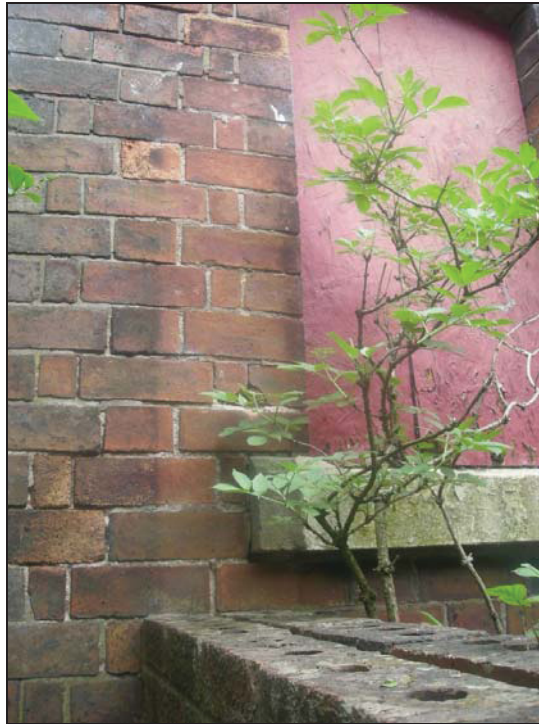
Figure 35: Scarring on south facing wall of wing

In addition to the wall which connected the east and west facing walls of The Lodge and the Vagrants' Ward, there was a second wall which joined the north facing elevation of the Lodge with the south facing elevation of the wing of the Vagrants' Ward (see Fig. 34). This wall was divided by a toilet block which also ran east-west across the courtyard and effectively divided it into two parts (see Fig. 36). The section of north-south running wall located south of the toilet block was a later construction but scarring on the south facing elevation of the Vagrants' ward suggested there was an earlier wall here (see Fig. 35).

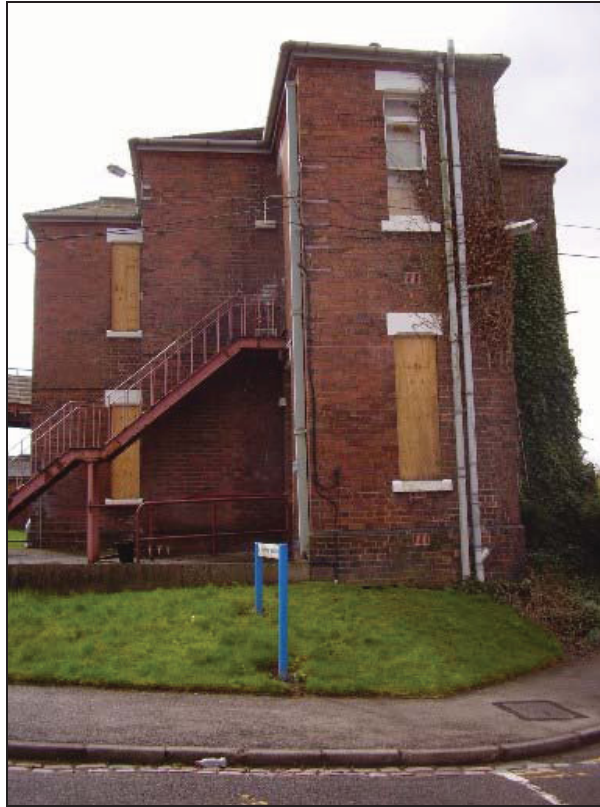
Figure 44: North facing elevation

The north facing elevation (see Fig. 44) included the north facing elevation of tower A. There was a window on the ground floor and a window on the first floor of tower A, as was the case for the main north facing section. All windows were narrower than those on the front of the building. The windows on the ground floor had white stone sills and lintels and a segmental relieving arch above them. The brick arches were undecorated (see Fig. 45). The windows on the first floor also had white stone sills and lintels but no brick arch above them. The first floor window in the main front section was the only un-boarded window in the building (see Fig. 46). It was a sliding sash window with a fixed light above. The windows each had a type 1 grill beneath them and type 2 grills were located between the windows at ground level. Two type 1 drainpipes ran down the main front section.

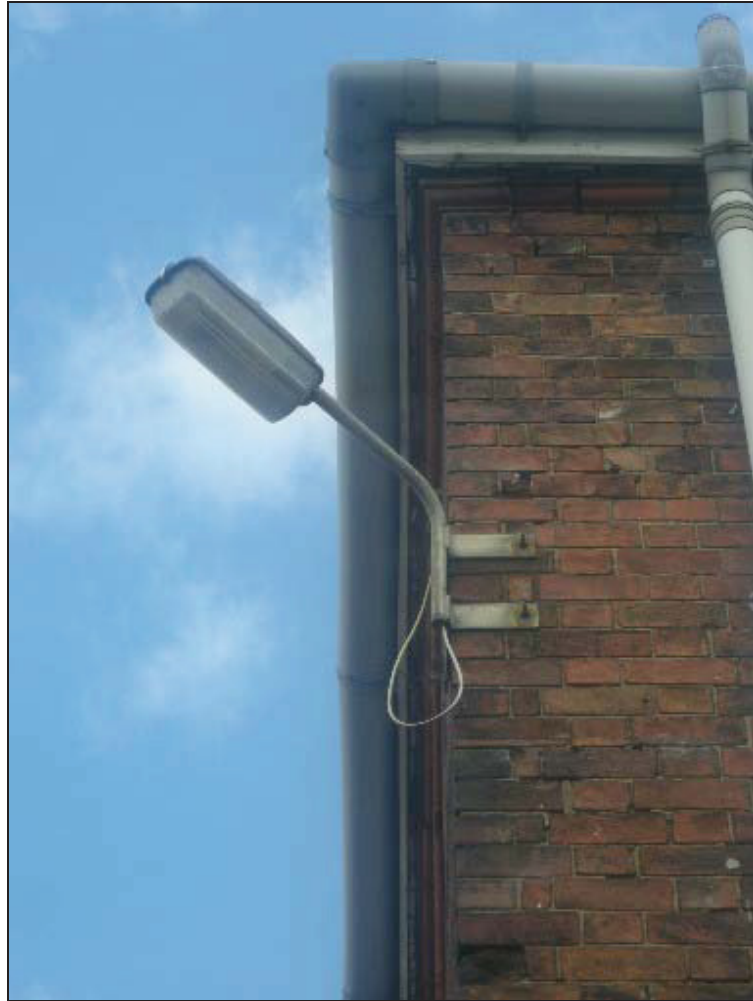
Figure 47: Street lamp

A street light (see Fig. 47) was attached to the wall on the east and west sides and a modern lamp was attached to the wall to the east. Black telephone cable ran down the length of the main front section and ran through the brackets on the north-east corner at first floor level.

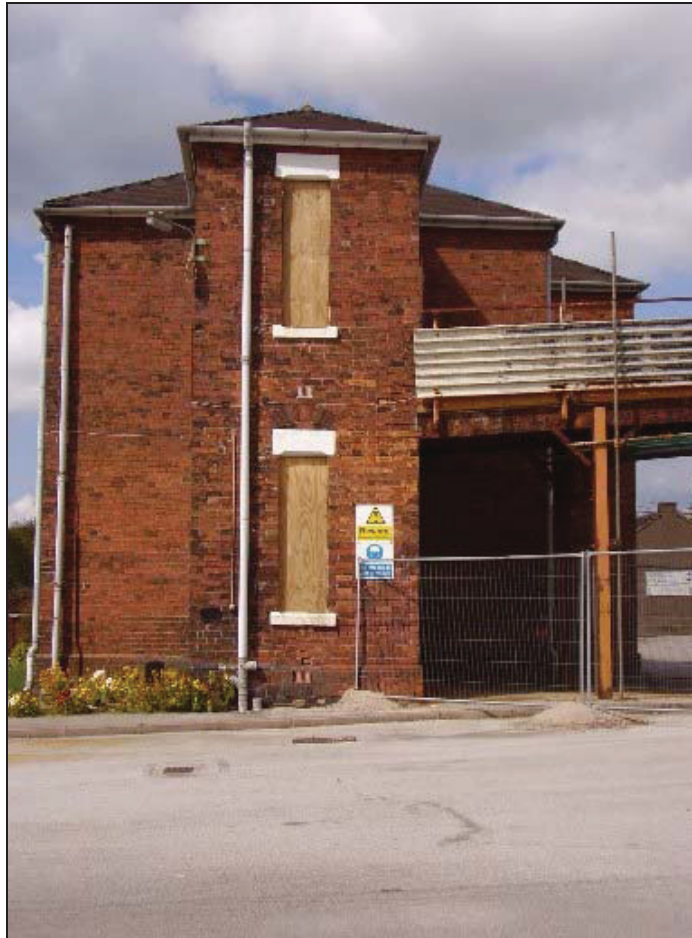
Figure 48: South facing elevation

The south elevation (see Fig. 48) was a repetition of the north facing elevation and included the south facing elevation of tower D. The only differences were the Fire Hydrant sign located at this end (see Fig. 49), the lack of a modern lamp on the east side, a recent 'warning' sign and, most significantly, the bridge which joined the east facing elevation at this end and at first floor level.

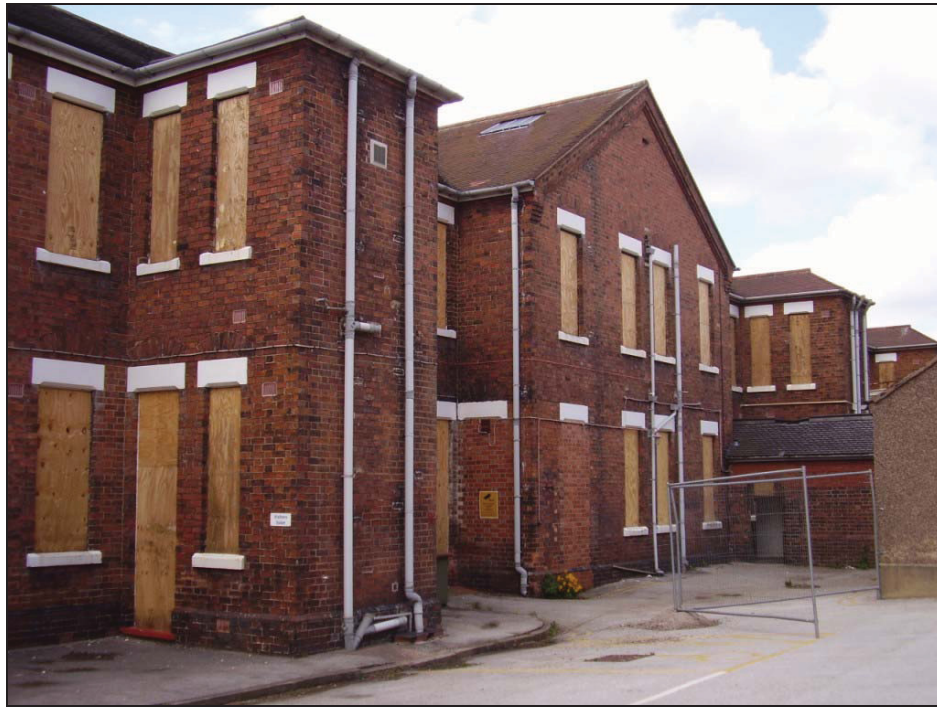
Figure 50: Rear elevation, central section

The east facing (rear elevation) had a central section (see Fig. 50), as at the front of the building. This central section had four windows at first floor level and three at ground floor level. At the south end, a lintel still remained with brickwork beneath it to suggest this was once a doorway.

Two drainpipes (types 1 and 2) ran down the centre of the section. A length of red metal electrical casing ran horizontally across. A second length began with a switch (see Fig. 51) and ran vertically up the building before turning at 90 degrees and running horizontally. It finished with an early lamp (see Fig. 52).

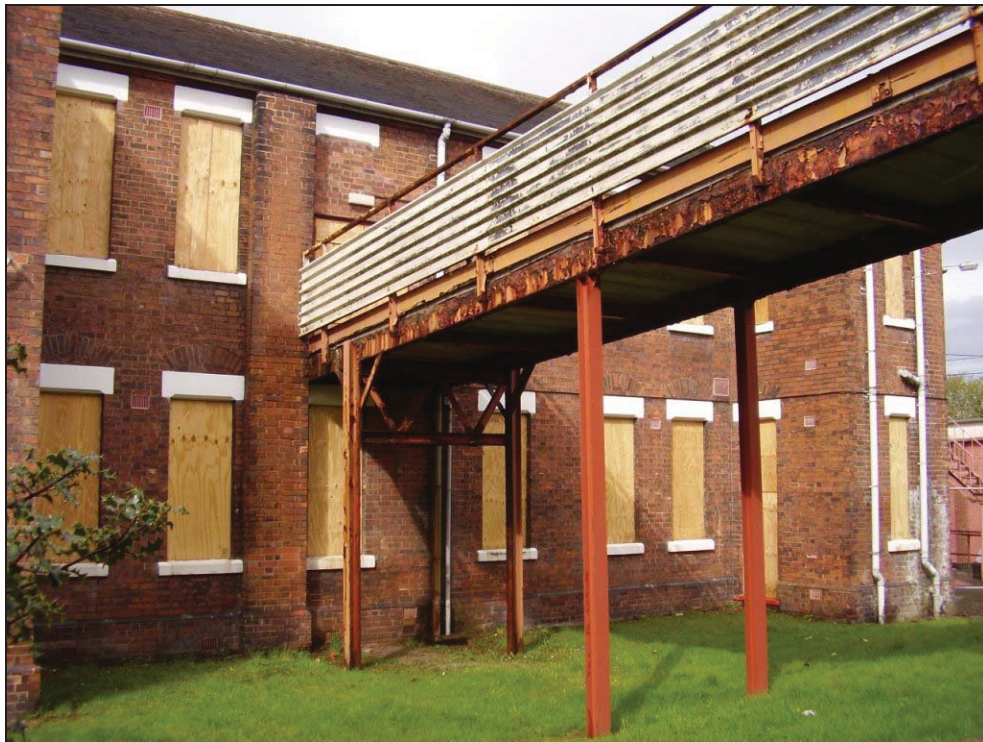
Figure 53: 1st floor doorway giving access to bridge, north end

There were three doorways on the first floor, two of which give access to a bridge (See Figs. 53 & 54) and one of which was reached by a set of iron stairs (see Fig. 55). There were six doorways on the ground floor: two at the north end, two at the south and two either side of the central section. Unlike the doorways on the front elevation, the two entrances flanking the central section of the back elevation were single doorways. However, they had wide brick arches above them which also incorporated a window immediately to their side (see Fig. 56). The door to the north of the central section gave access to a covered walkway (see Fig. 57). The doorways to the far north and south were single doorways whilst the second doorways at either end were lower and wider and had ramps up to them (see Fig. 58).

To the south of tower A, a later door had been created which gave access to a bridge (see Fig. 53). This was a double doorway and was relatively low. This was likely to have been a window originally and the lintel remained.

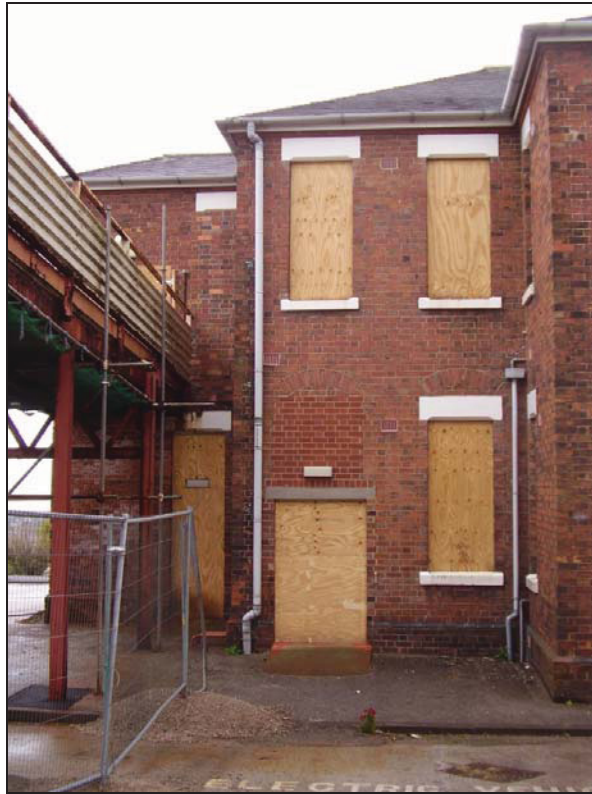
Figure 54: 1st floor doorway giving access to bridge, south end

At the far south end the doorway had been blocked in on the first floor (see Fig. 54) and a new door created to the left of it. This was a double doorway and gave access to a bridge. Immediately north of the blocked in door but on the ground floor, a new door had been created identical to that at the north end of the building (see Fig. 58). This door was quite low and relatively wide. It was unclear whether this was originally a door or window.

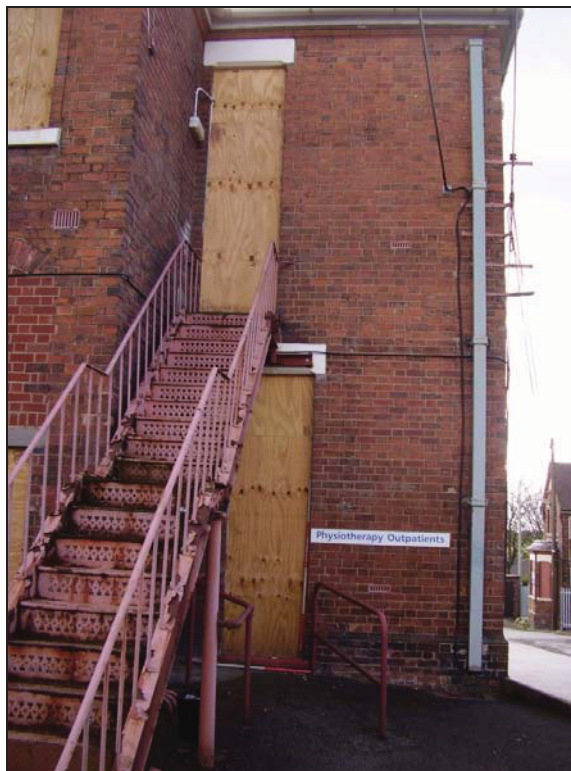
Figure 55: 1st floor doorway accessed by iron staircase, north end

A sign at the north end stated 'Physiotherapy Outpatients' and a set of metal rails led up to the door to which the sign refers (see Fig. 55).

An iron staircase was installed at some point to give access to the far north door on the first floor and a set of railings were also introduced to aid access to the northernmost door on the ground floor (see Fig. 55).

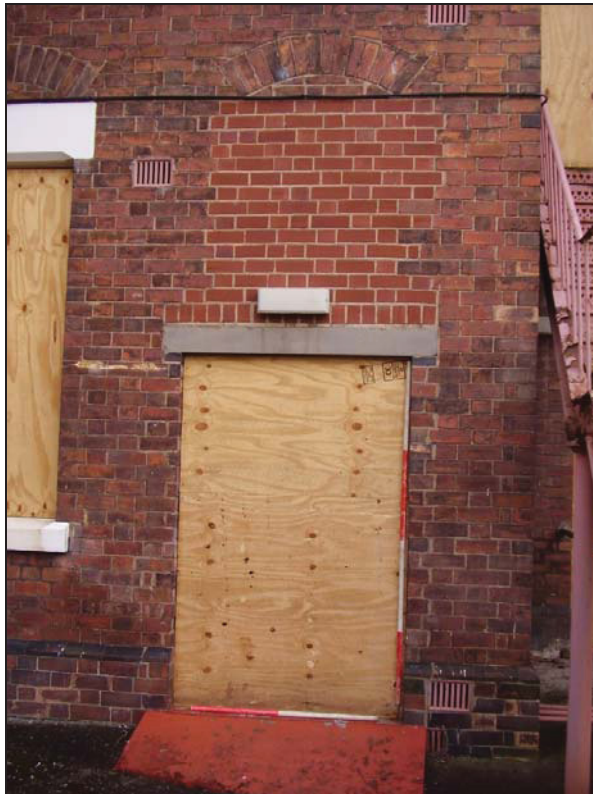
Figure 58: Lower doorway with ramp, north end

Towards the far north end of the elevation, a wider and lower door had been created. This door mirrored that at the south end and, in the same way, it was unclear whether this was originally a window or a door. A ramp led up to this later doorway (see Fig. 58).

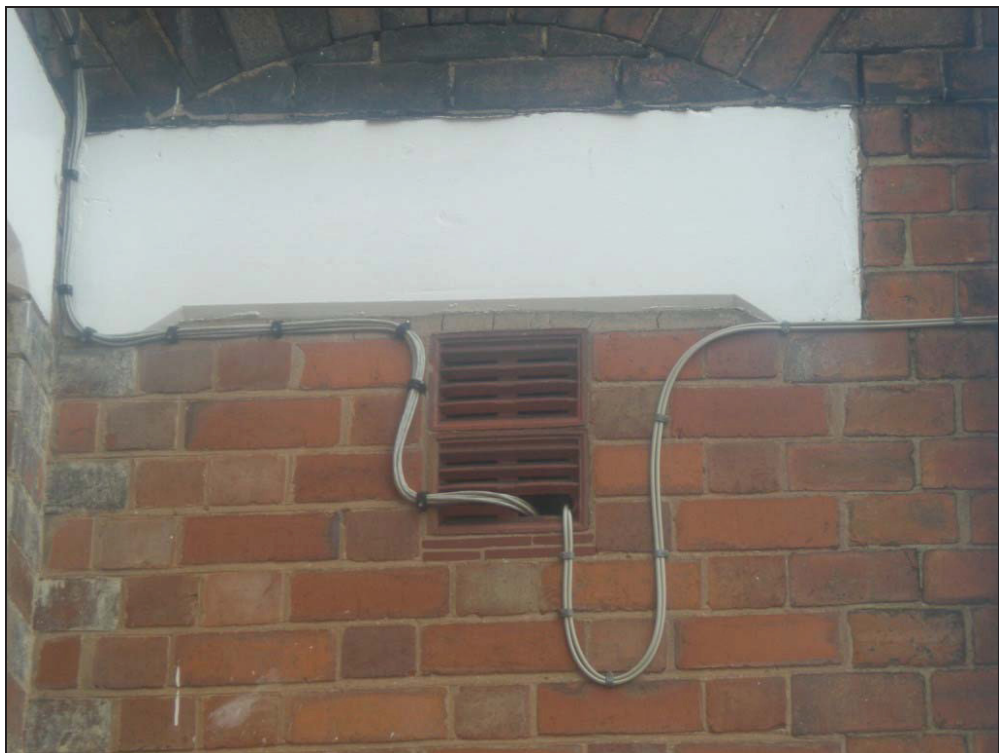
Figure 59: Computer cables entering the building, south facing elevation of central section

A series of computer cables ran around part of the outside of the building and entered through a type 5 grill on the south facing elevation of the central section (see Fig. 59). The cables also entered the building through a type 2 grill to the north of tower D.

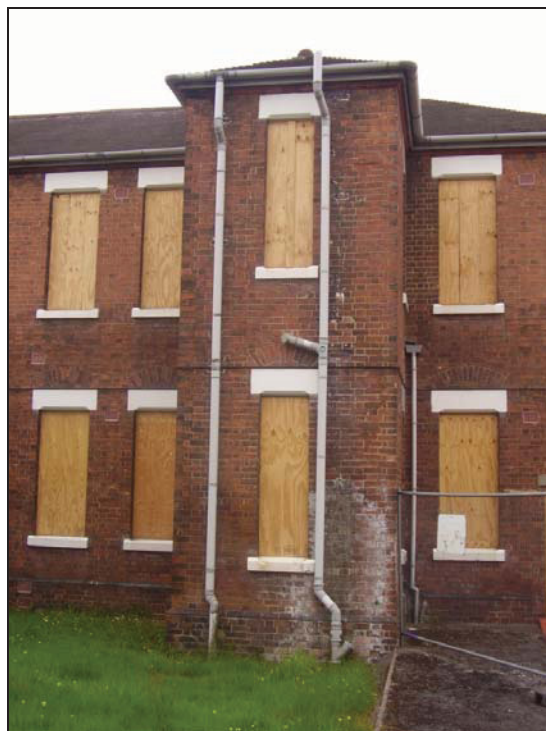
Figure 64: Tower A, east facing elevation

The east elevation (See Fig. 64) had a window at ground floor level and a window at first floor level. There were type 1 grills beneath these windows. The elevation had two type 1 drainpipes running down the length of it. Marks which showed the location of earlier drainpipes were clearly visible on the wall. At some point a drainpipe possibly burst as there was a white stain on the wall at ground floor level.

The existing drainpipes replaced older ones, the marks for which can still be seen on the walls.

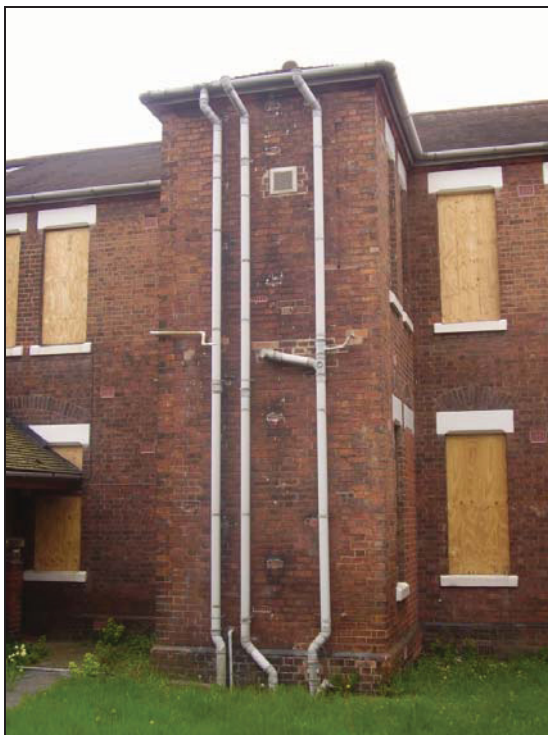
Figure 67: Tower B, east facing elevation

On the east facing elevation (See Fig. 67) there were three type 1 drainpipes, three type 1 grills, centrally located down the wall and a type 4 grill at the top. The pipe to the north of the elevation branched off on its south side and there was some patching up around this section of pipe. Marks showing the location of earlier drainpipes were clearly visible. A small pipe ran from the south side of the southern drainpipe and ran horizontally across the remainder of the east facing elevation and across the entirety of the south facing elevation.

The visible drainpipes were a later addition to the building and replaced earlier ones, the marks for which could still clearly be seen. The type 4 grill was a modern grill and was therefore a later amendment to the tower. The brickwork around part of the northern pipe served to emphasise these drainpipes as a later addition.

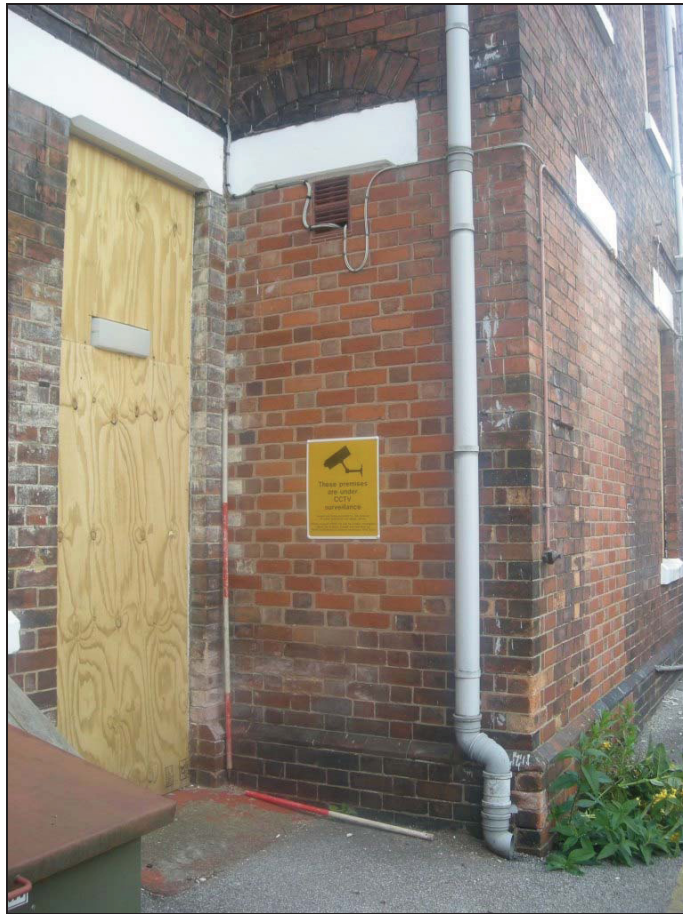
Figure 70: Central cross wing, south facing elevation

The central section of the rear elevation had no features at first floor level on its north and south elevations. At ground floor level, there was a window on the north facing elevation which looked into the walkway (See Fig. 69) and a bricked up window on the south facing elevation (See Fig. 70).

As stated above, a window had been bricked in on the south facing elevation.

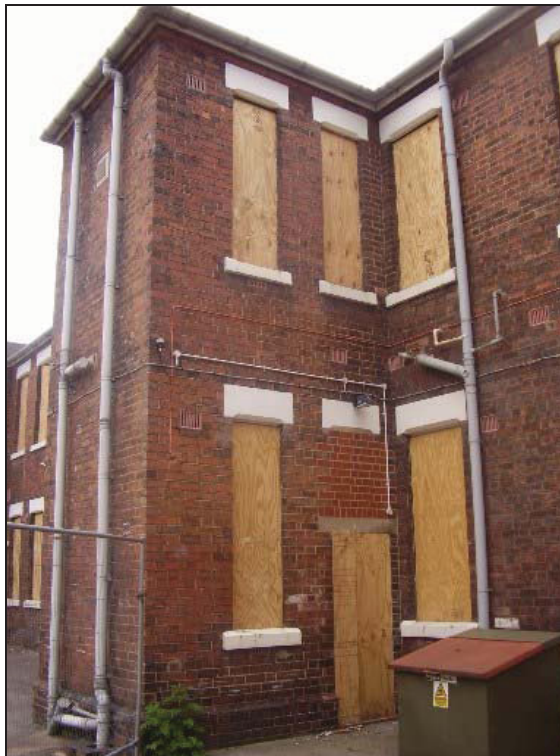
Figure 71: Tower C, north facing elevation

In its north facing elevation (See Fig. 71) Tower C had two windows at first floor level and a window and door at ground floor level. There was blocking in brickwork above the doorway. There was a type 1 grill beneath the eastern windows on ground floor and first floor level and there were a number of type 2 grills within the wall. Computer cables ran horizontally across the elevation, as did a strip of white electrical piping and a strip of red piping, probably electrical.

The doorway in the north facing elevation was originally a window. This had been altered to become a lower doorway. This ensured the tower could be accessed from the outside at both sides. The drainpipes replaced earlier drainpipes, of which the marks could be seen, and the type 4 grill, as a modern grill, was a later addition to the tower.

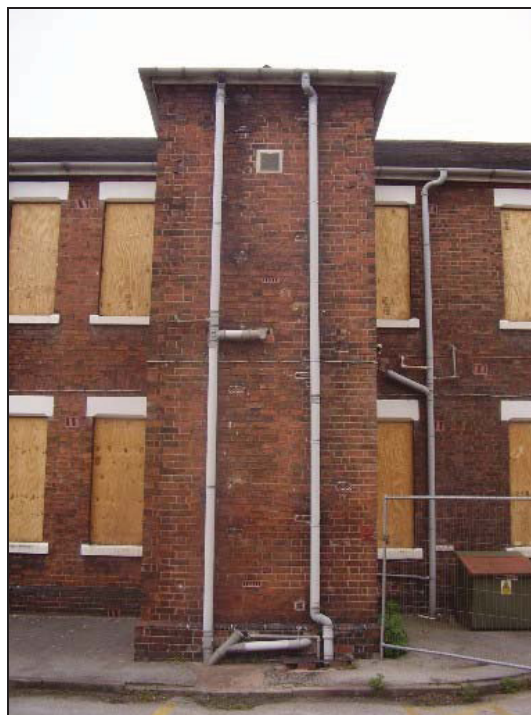
Figure 72: Tower C, east facing elevation

The east facing elevation (See Fig. 72) had two type 1 drainpipes, a type 1 grill at ground floor level and a type 4 grill at first floor level. The marks showing the location of earlier drainpipes could clearly be seen.

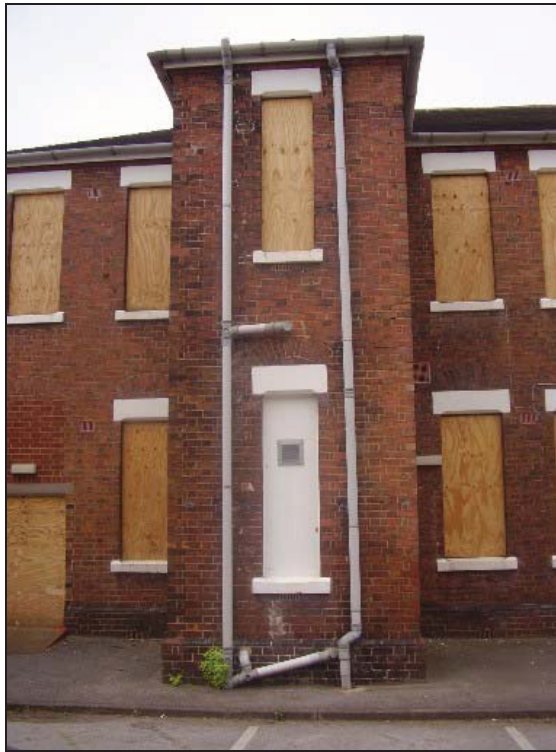
Figure 75: Tower D, east facing elevation

The east facing elevation (See Fig. 75) had a window on the first floor and another on the ground floor. The ground floor window had been blocked with white board and a type 4 grill had been set into it. Both windows had type 1 grills beneath them. This elevation also had two type 1 drainpipes running down the length of it.

The ground floor window of the east facing elevation had been sealed off and a grill placed into it. The drainpipes were a later addition to the tower and replaced earlier pipes, the location of which was still clear from the marks which remain on the walls.

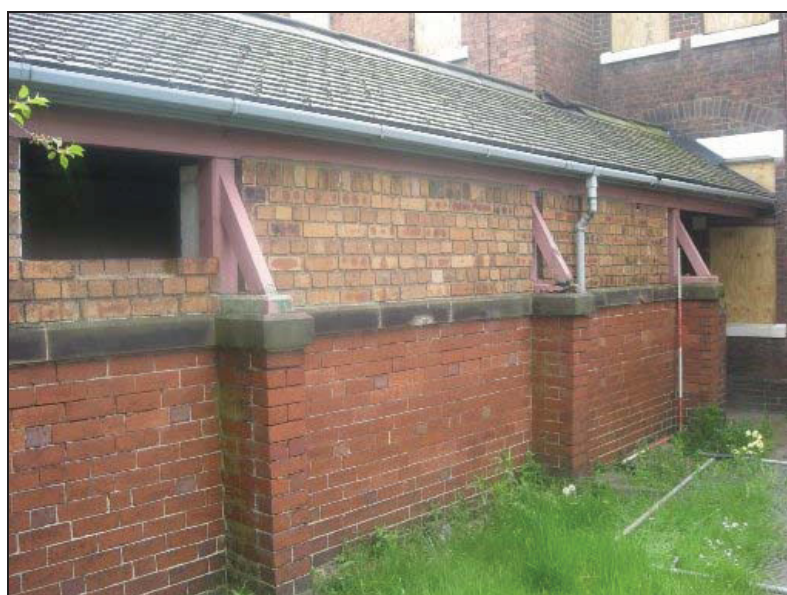
Figure 84: Walkway, phase 3

3. The gap between the walls and the roof was bricked up in the section of walkway which joins the two infirmaries (see Fig. 84). It is unclear when this occurred but it took place later than 1906.

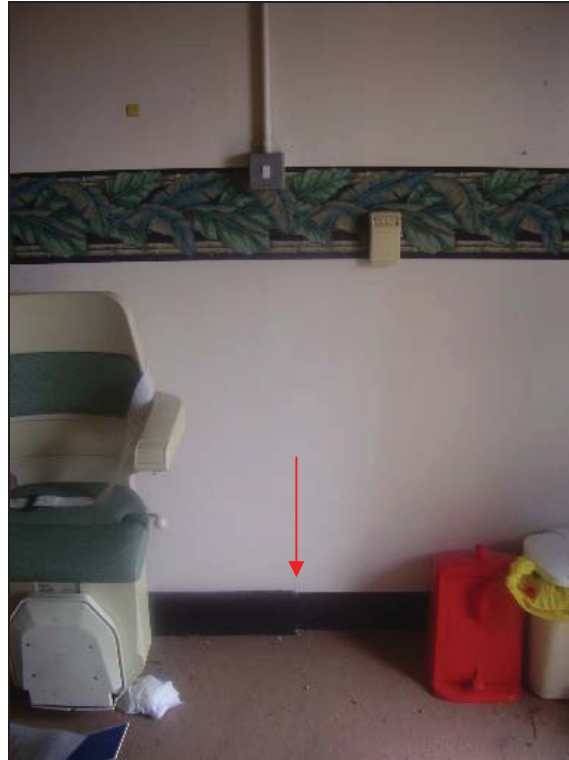
Figure 94: Chair lift and switch. Note the 'stepping in' of the skirting board just right of the chair.

There was evidence that the South Hallway originally had a partition between the north and south walls which divided a vestibule from the hallway (identical to that which is in place in the North Hallway). The skirting board on the south wall stepped in just west of the stairs (see Fig. 94) and on the north wall some plastering over was evident (see Fig. 98).

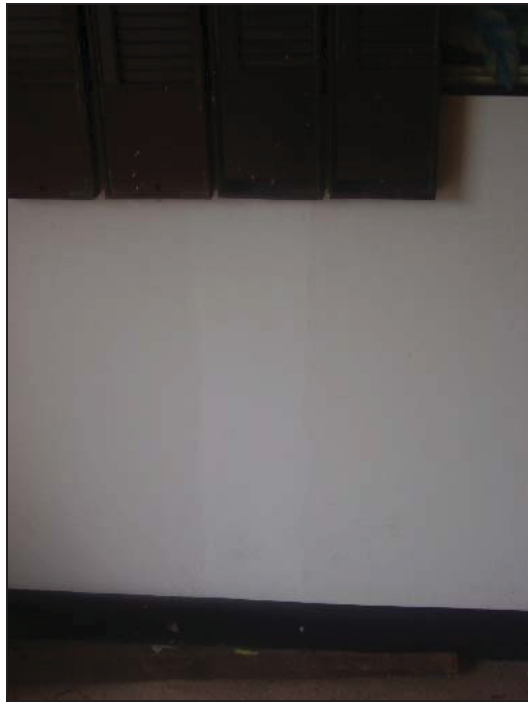
Figure 98: Strip of plaster beneath the paint, South Hallway

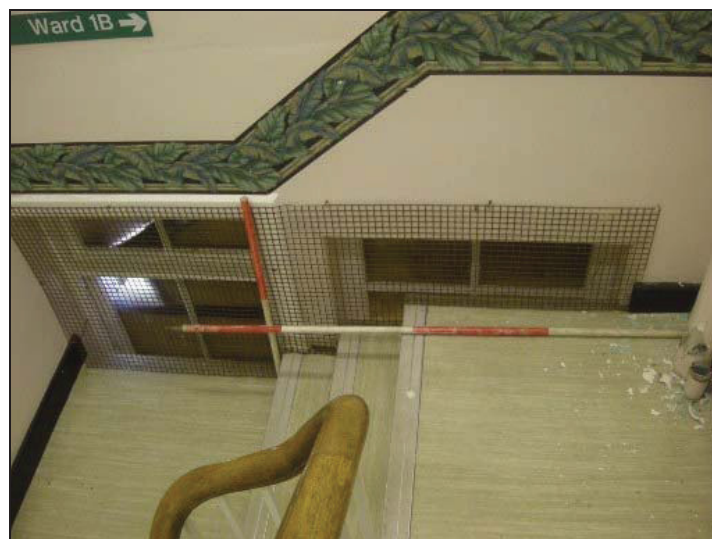
It is likely that the stairs in their final form were a later addition since they covered a large section of the window next to the back door and some of the top of the back door itself (see Fig. 99). There was a mark on the wall

Figure 99: Stairs built across door and window in the North Hall

As in the case of the South Hallway, the stairs covered a portion of the back door and the window immediately next to it so that the final stairway was probably a later addition (see Fig. 99). A line visible beneath the paint about half way up the stairs and up towards the main landing may have represented the line of the original stairs and landing.

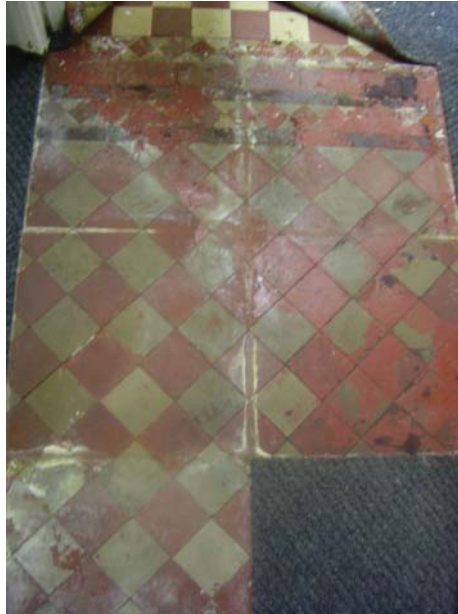
Figure 102: Tiled floor surface in vestibule, North Hall

The floor was originally tiled. It had since been laid with carpet tiles but the original flooring could still be seen beneath. There was a definite border within the tile decoration which clearly defined the threshold between the vestibule and hall (see Fig. 102).

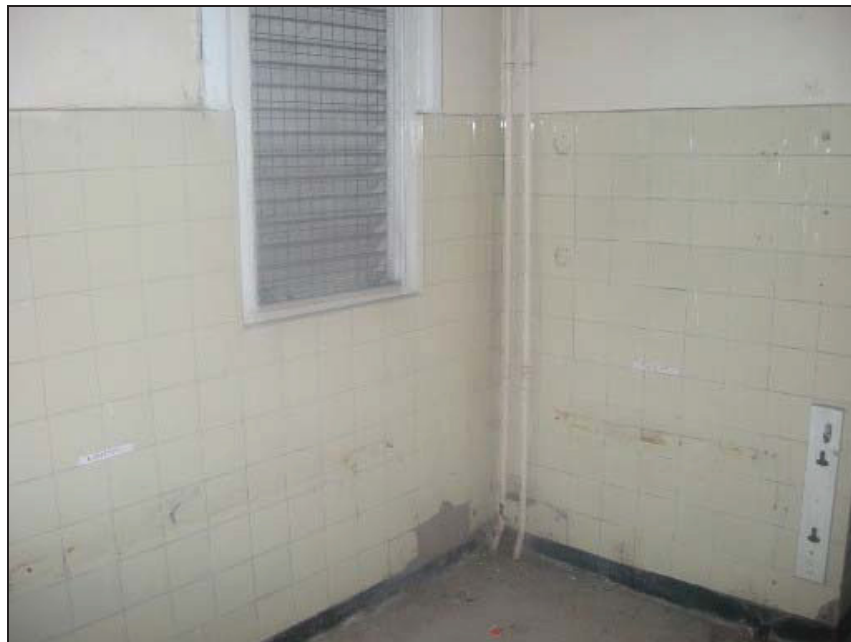
This room measured 3.31m x 2.44m and was accessed via a door in its north wall. It also had a door in its east wall which led outside. There was a window in the south wall and another in the west wall. The windows had metal grills which covered them completely (see Fig. 110). All of the walls were tiled half way up with light yellow tiles (see Fig. 111). Some of these

exhibited scarring in the form of horizontal ‘shadows’ where items may have been affixed to the walls. A rectangular patch of tiles was missing from the south wall beneath the window; this may have been the location of the sluice. The light switch was waterproof and was like those found in the toilets.

Figure 111: Tiled walls, Sluice Room 1

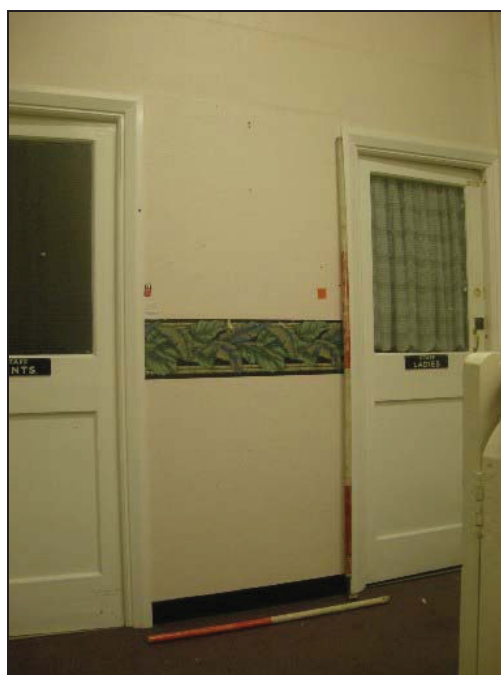
Figure 121: Male & Female staff toilets on North Landing with gap of original doorway between

The Staff Toilets were a later creation and their partitioning wall divided the window in the west wall in two. Furthermore, the wall which divided the toilets from the hallway was a false wall (see Fig. 121). The area which now contained these Staff Toilets may originally have formed part of a much larger hallway.

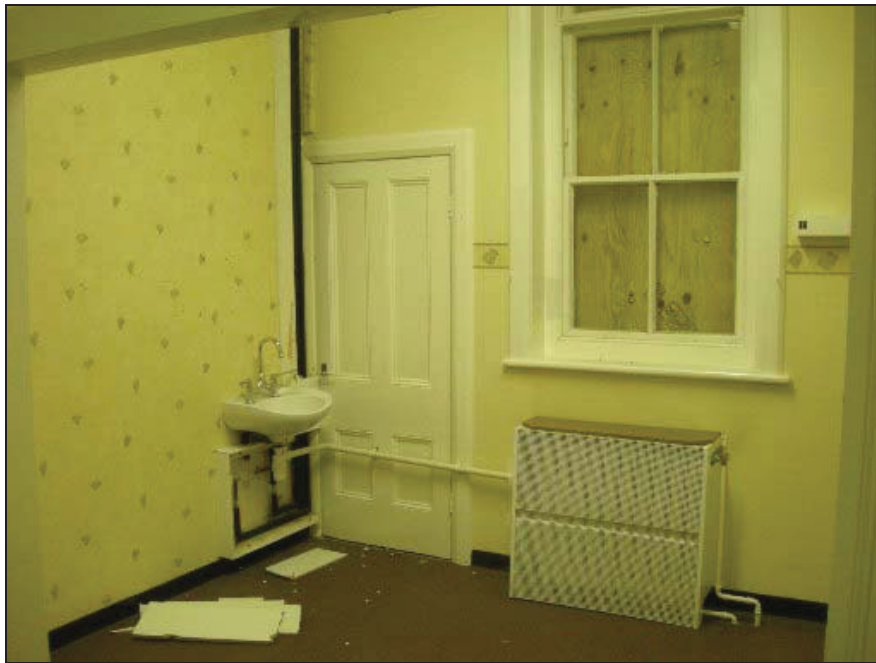
The partitions were a later addition and Examination Room 1 was probably originally part of one large room along with Examination Room 2 and Corridor 4. Access to Toilet 4 was originally possible from this large room. Having created a corridor and two smaller rooms from this space, a sink had been placed in Examination Room 1 which required the door to Toilet 4 to be blocked off. The door was still visible but a pipe now runs across the front of it (see Fig. 122).

Figure 122: Exam Room 1
