Warship *Hazardous*

Site Evaluation Report and Statement of Research Potential

Warship *Hazardous*: Site Evaluation Report and Statement of Research Potential

November 2014

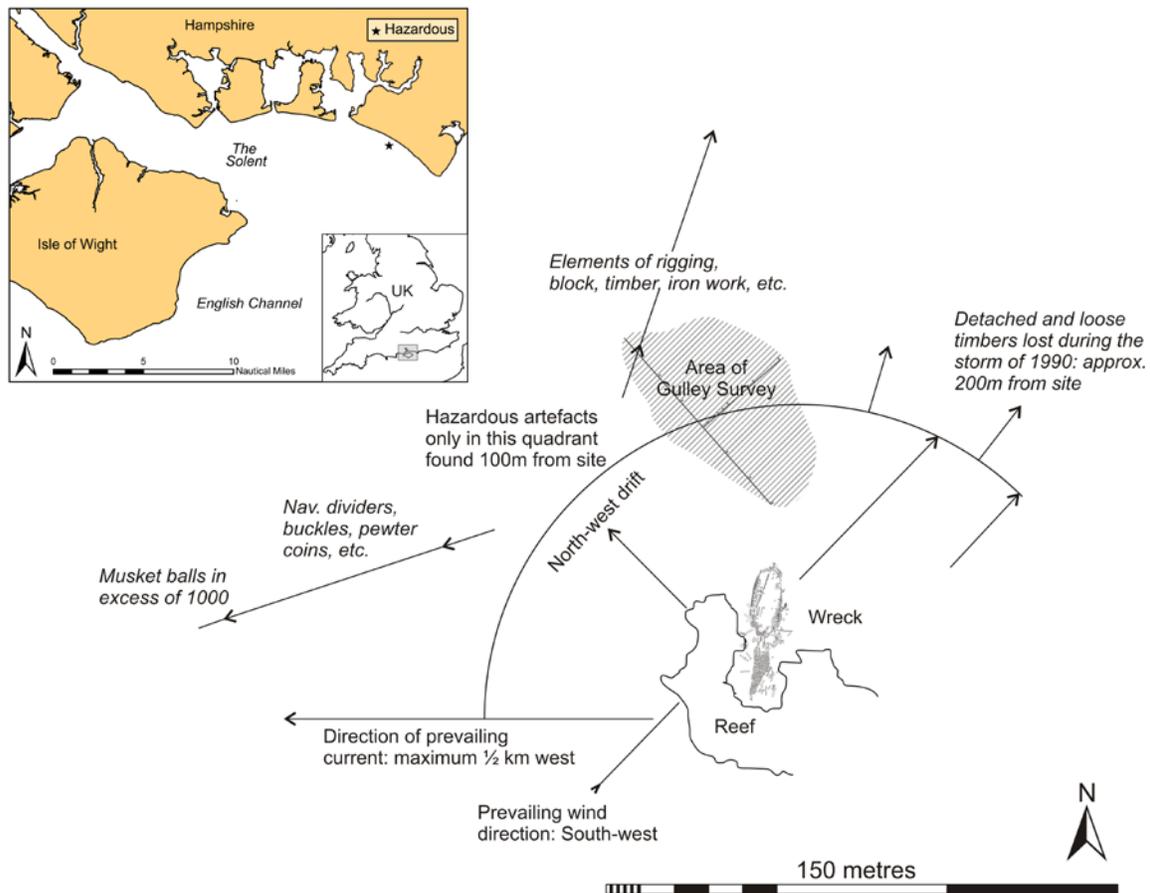
Conversely, there had been a movement of sand away from gullies in the underlying geology which had been uncovered some 20 years ago but since reburied and from which a significant number of artefacts had been recovered. Figure 1.1 shows the wreck site, the reef to the south and the area of gullies to the north west where material was recovered in the late 1980s. It is based on a figure by Norman Owen. The reduction in sand levels in this area was noted again in 2008. However, it had increased by 2010 with *in-situ* (since the wrecking process, rather than within their original vessel position) artefacts being located such as a wooden spar and stray finds including a copper alloy buckle, some lead tingles and glass shards from onion bottles. In response to these changes the work on site in 2010 was adapted (see Section 2 for further details).

Figure 1.1 Location of the Hazardous wreck in relation to the reef to the south and the area of gullies to the north west

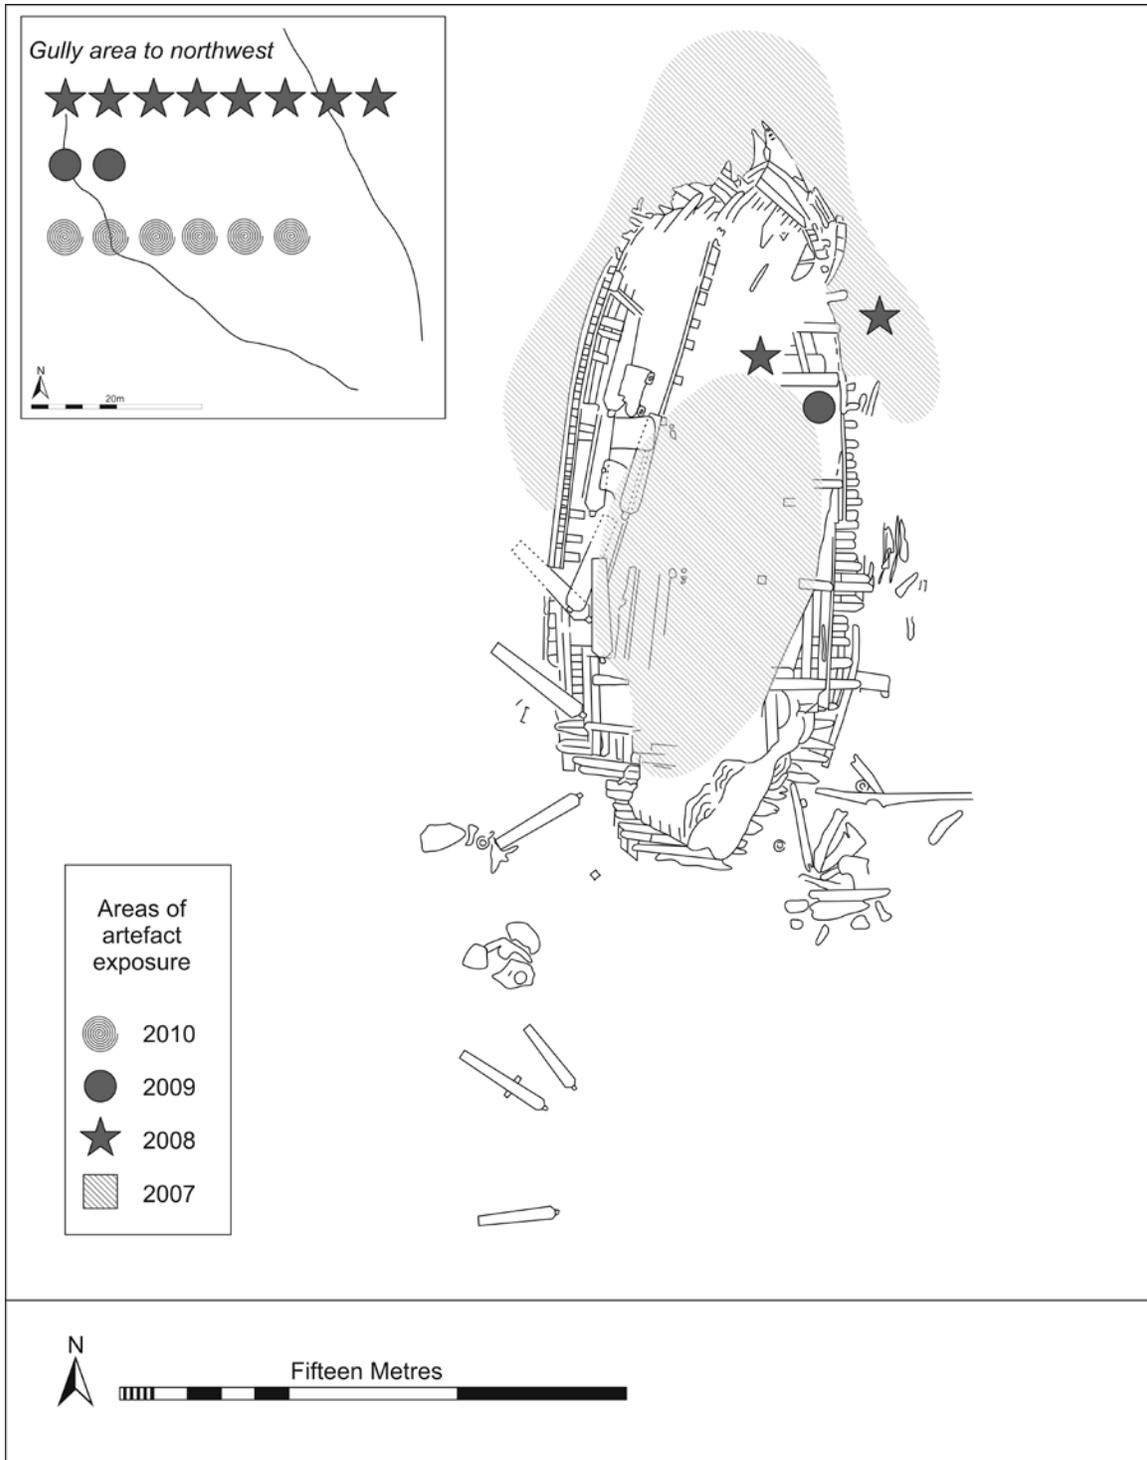
2009: Three artefacts were recovered. One brass pommel from the main site and two pulley sheaves from the rigging block in the area of gullies (Figure 3.7).

2010: Eleven artefacts were recovered from the area of gullies (Figure 3.7). These included more brass buckles and pieces of pewter plates.

As expected, the numbers and distribution of artefacts recovered are directly related to the seabed movement, and the effects of this on diving operations undertaken. The recovery of twenty four artefacts in 2007 is a relatively large number and reflects the extent of the loss of covering sediment which occurred over winter 2006/07. The recoveries in 2008 and 2009 are relatively small in number, but they also reflect the ongoing loss of sediment from both the main wreck site and areas of gullies. In 2010, no items were recovered from the main wreck site due to the large increase in sediment, while a larger number were collected from the gullies which is a product of both continued loss of sediment covering and the period of fieldwork in that area.

Figure 3.7 Distribution of artefact recoveries from the main site 2007 - 2010

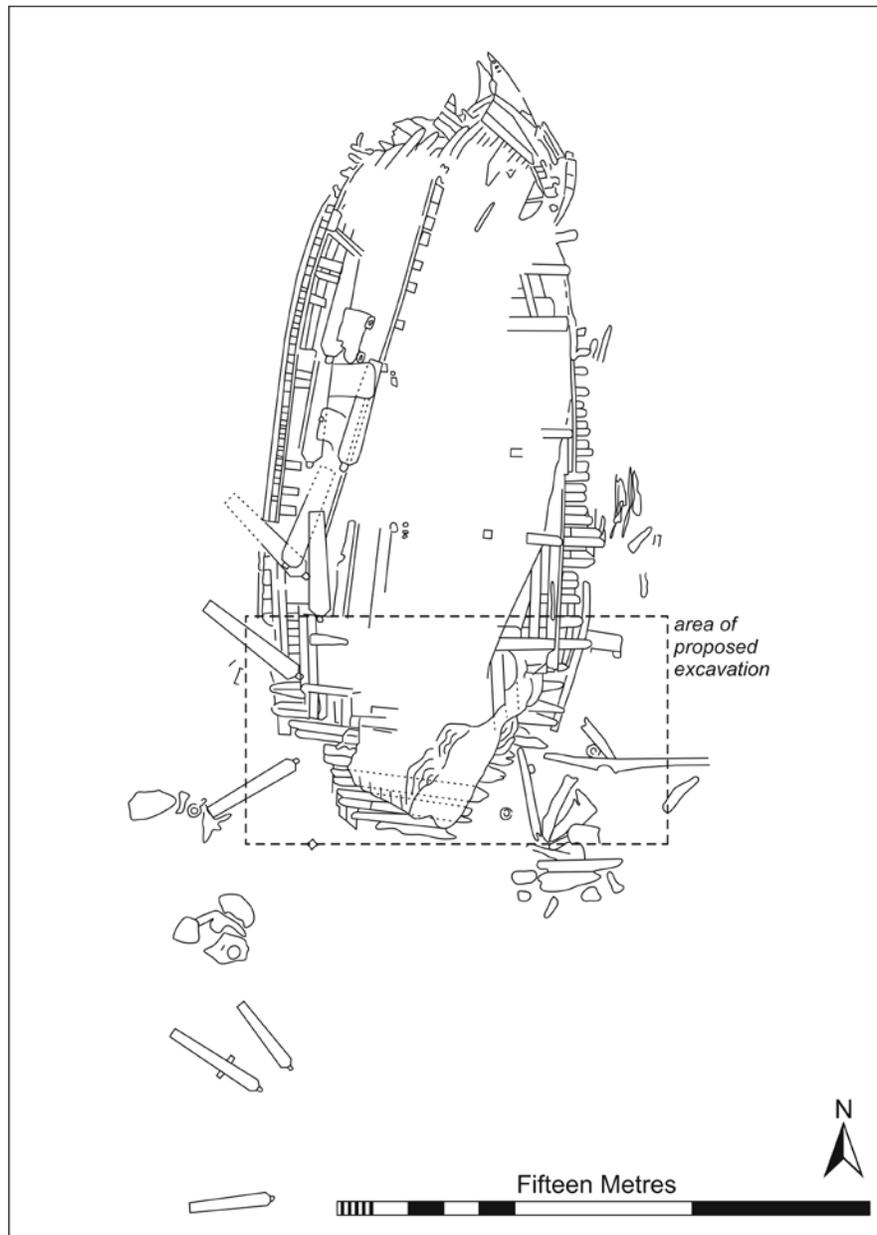
The area to be targeted by excavation had been selected due to being at severe risk due to erosion and as it held the highest potential for answering research aims and objectives.

Figure 3.8: Proposed trench location for the 2008 excavation

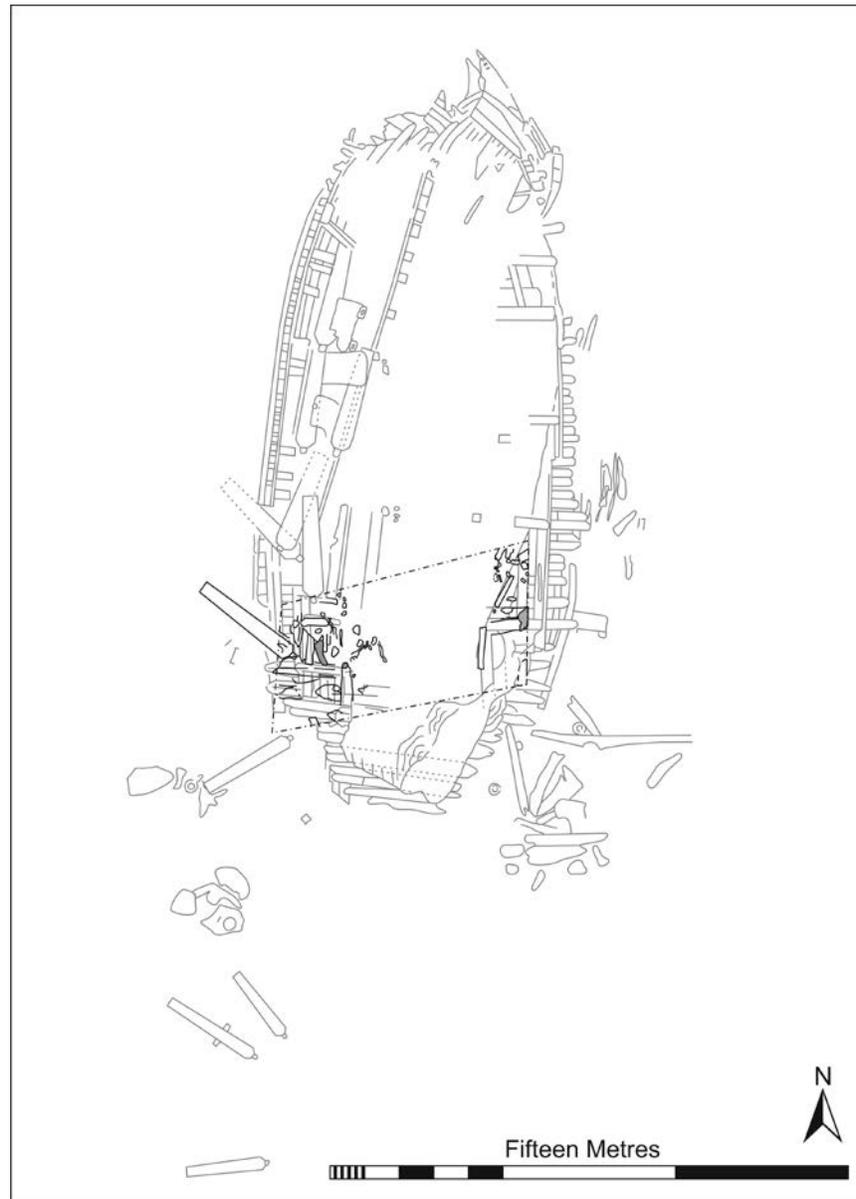
A pre-excitation plan of the area was then produced by establishing baselines between the datum points and using metre-square planning frames to produce a plan at 1:20 scale. A total of 14 square metres were surveyed in detail (see Figure 3.9).

Figure 3.9 Pre-excitation plan of trench area targeted in 2008 prior to having to postpone the excavation.

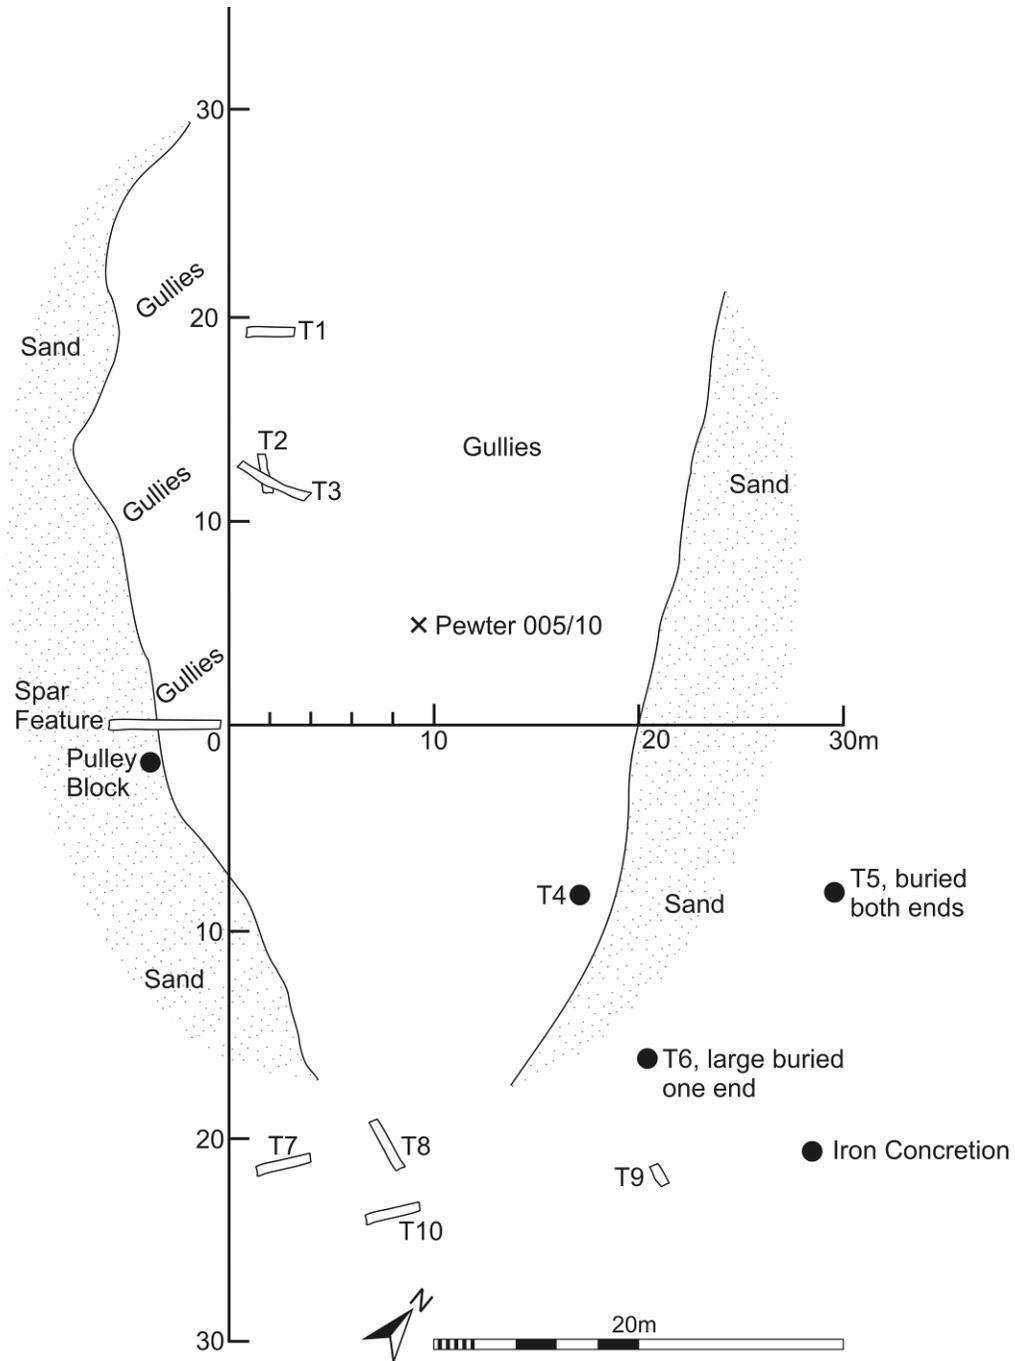
With the base lines established, pairs of divers were able to use these to undertake corridor searches. Due to the visibility, corridors of 4m width were usually established with a tape running down the centre of the corridor and a diver on each side of the tape, this meant each diver concentrated on a 2m wide strip of seabed. When artefacts or features were encountered the position was then recorded in relation to two of the four main baselines. During the diving an area of 1,820 square metres was searched. Divers also noted when they reached the edge of the exposed area of clay gullies and the covering sand started. This allowed a picture of the extent of the exposed area to be gained (Figure 3.16). The presence of sand did not mean the search stopped. In fact, a number of timber features were noted protruding from the sand, particularly in the western sector of the search grid.

Figure 3.16 Survey of area of gullies undertaken in 2010

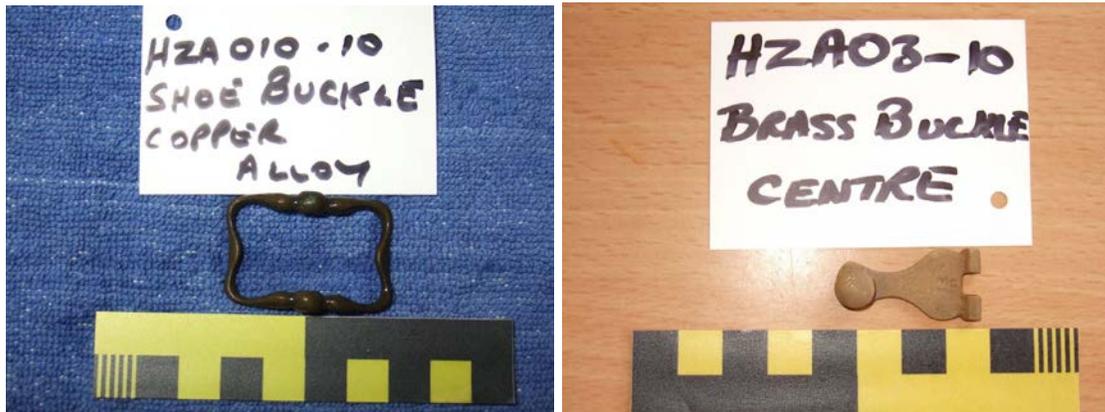
Figure 3.17 (left) Copper Alloy shoe buckle recovered from gully area.

Figure 3.18 (right) Brass buckle centre (Photos: Iain Grant)

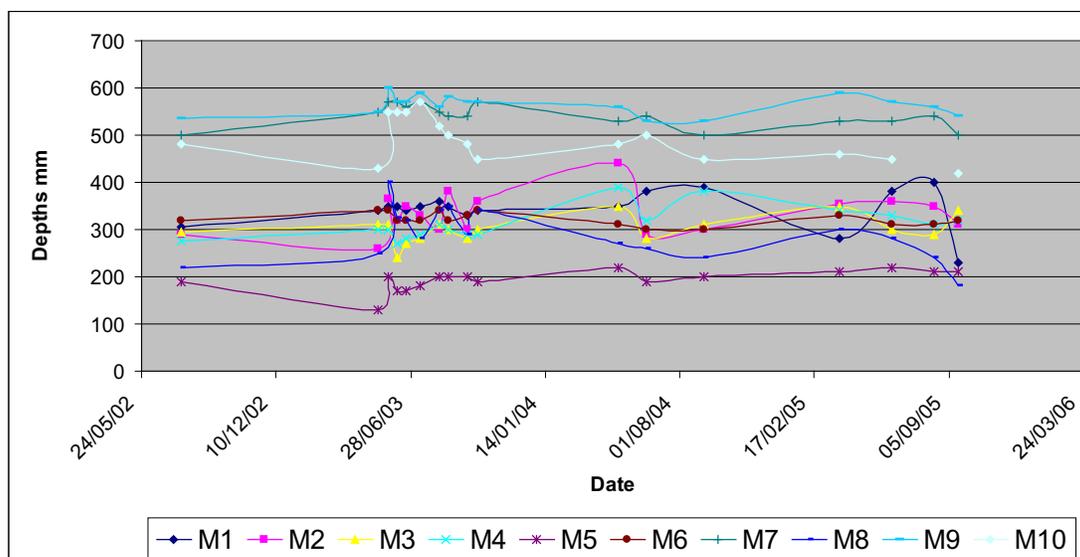
Following the installation of monitoring points around the wreck site in 2002, detailed measurements were taken that allowed changes in sediment levels to be tracked. Figure 4.1 shows the site, the monitoring points and the accumulated monitoring data from a period covering 2002 – 2005. Figure 4.2 shows the monitoring point data in more detail (it should be noted that the scale on the left indicates an increasing depth from the monitoring point to the seabed, so when the line rises this indicates a loss in seabed level).

Figure 4.2 – Detailed data from all sediment monitoring points

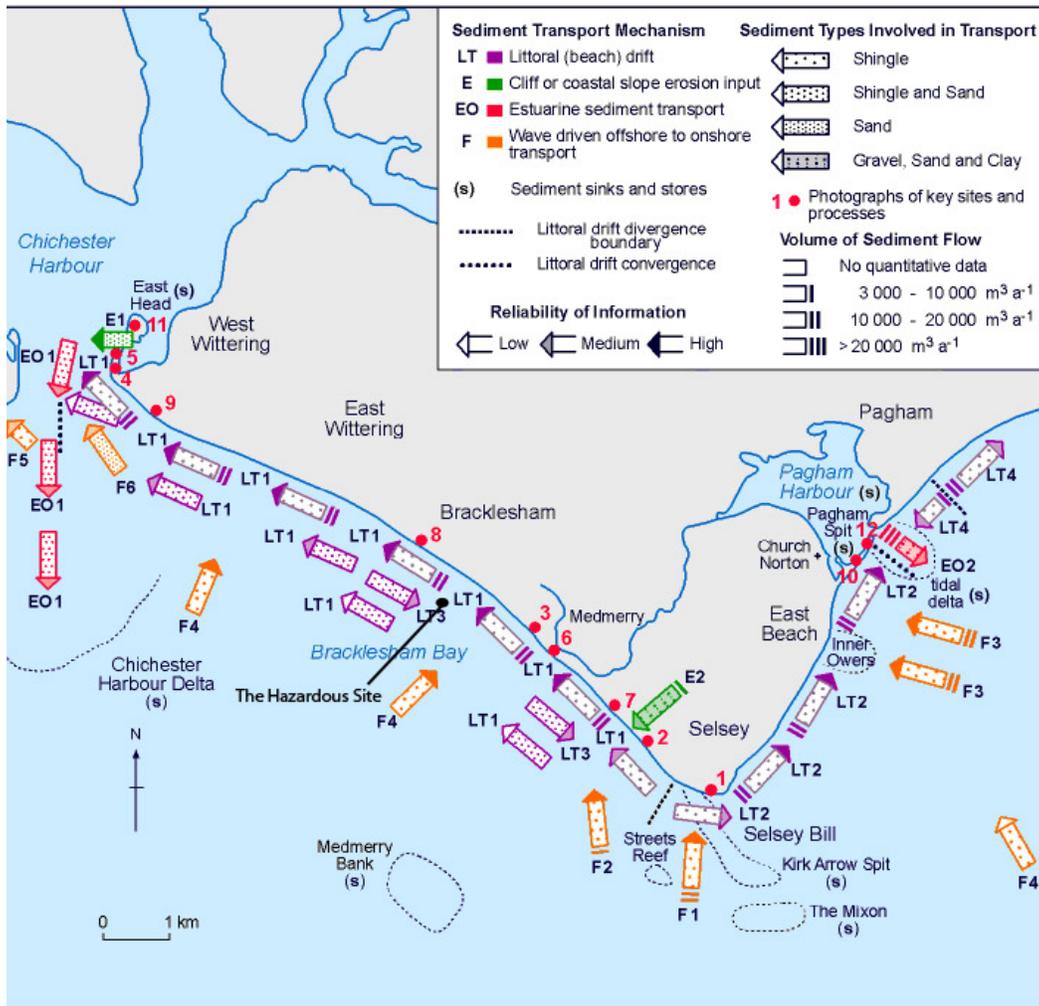
The environmental report noted that sediment processes in the Bracklesham Bay area are characterised by a net drift of shingle sediments in an east to west littoral drift pathway operating closest to the coast (Figure 4.4). Slightly further out there is then a compensatory west to east movement of shingle and sand, within this zone of movement there is a reversal in the area to the west of the wreck site, providing further complexity of sediment movement. Comparing the position of the *Hazardous* site with the coastal transport data it appears that the *Hazardous* lies in the area between the littoral drift processes. Further out to shore again there is another change to littoral drift of shingle and sand back from east to west. SCOPAC who are the authors of the sediment transport model recognise that the data on which this is based is most reliable close to the coast, becoming less well tested further out.

Figure 4.4 – SCOPAC map showing sediment transport patterns (SCOPAC ©)

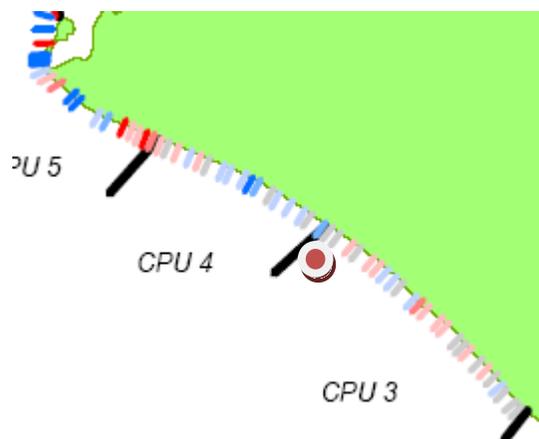
Figure 4.5 Extract from Channel Coastal Observatory coastal survey showing actual change to shoreline profiles in management units 3 and 4 between spring 2008 and spring 2009, red and pink indicates erosion, grey = no change, blue indicates accretion (Image Courtesy of Channel Coastal Observatory www.channelcoast.org). Red circle shows approximate position of the Hazardous site.

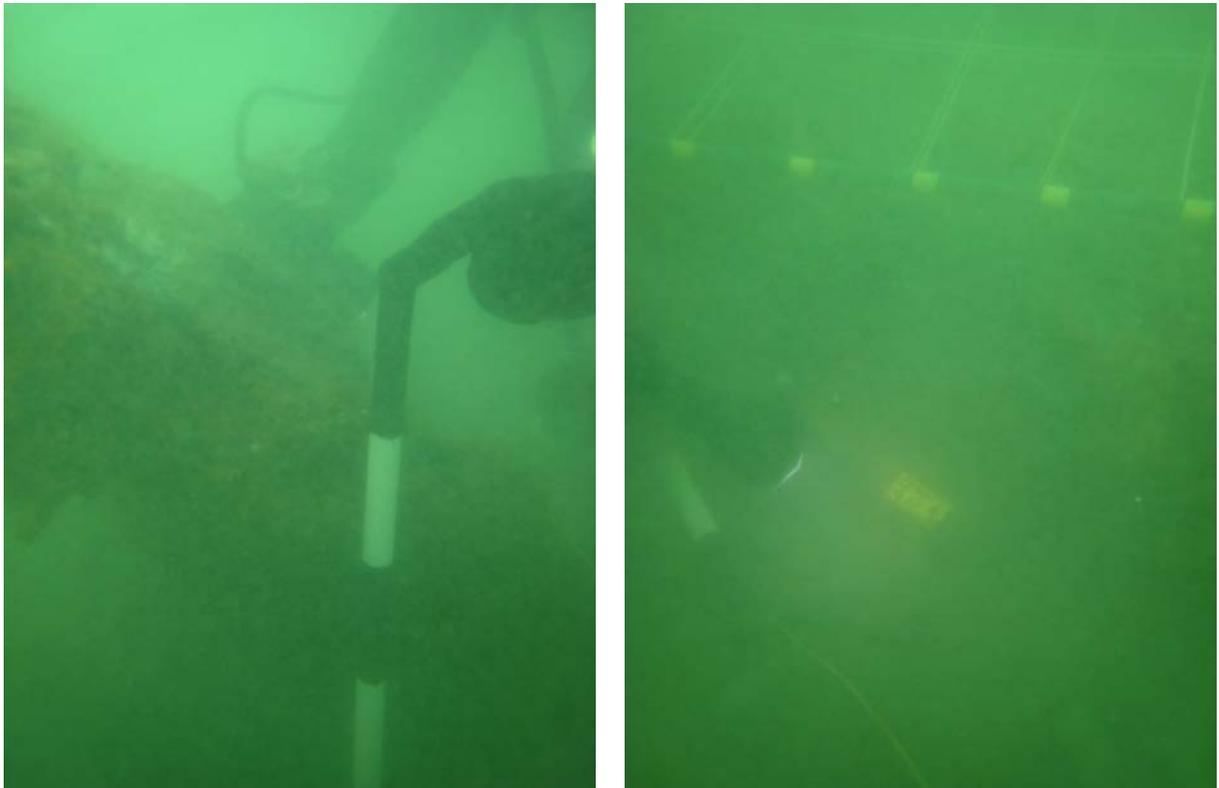
*Figure 8.1 (left) Structure at the bow of the main site
Figure 8.2 (right) Planning frame in position over area of newly exposed timber being surveyed, datum 2209 is just visible with the help of torch light*
