Historic Building Survey and Watching Brief

OLD MAIDS' COTTAGE, LEE, ILFRACOMBE, DEVON

By R.W. Parker

REPORT No. 2013.03

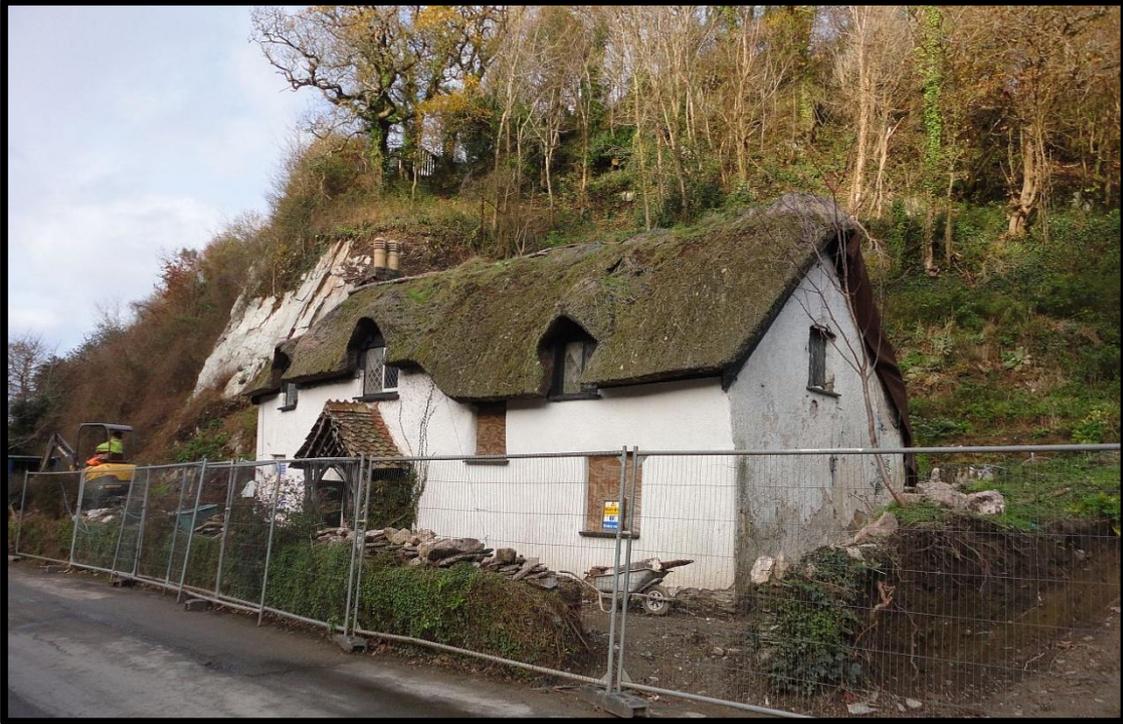
Fig. 2 View of the south front of Old Maids' Cottage from the south east, showing its location against the cliff face and woods behind.

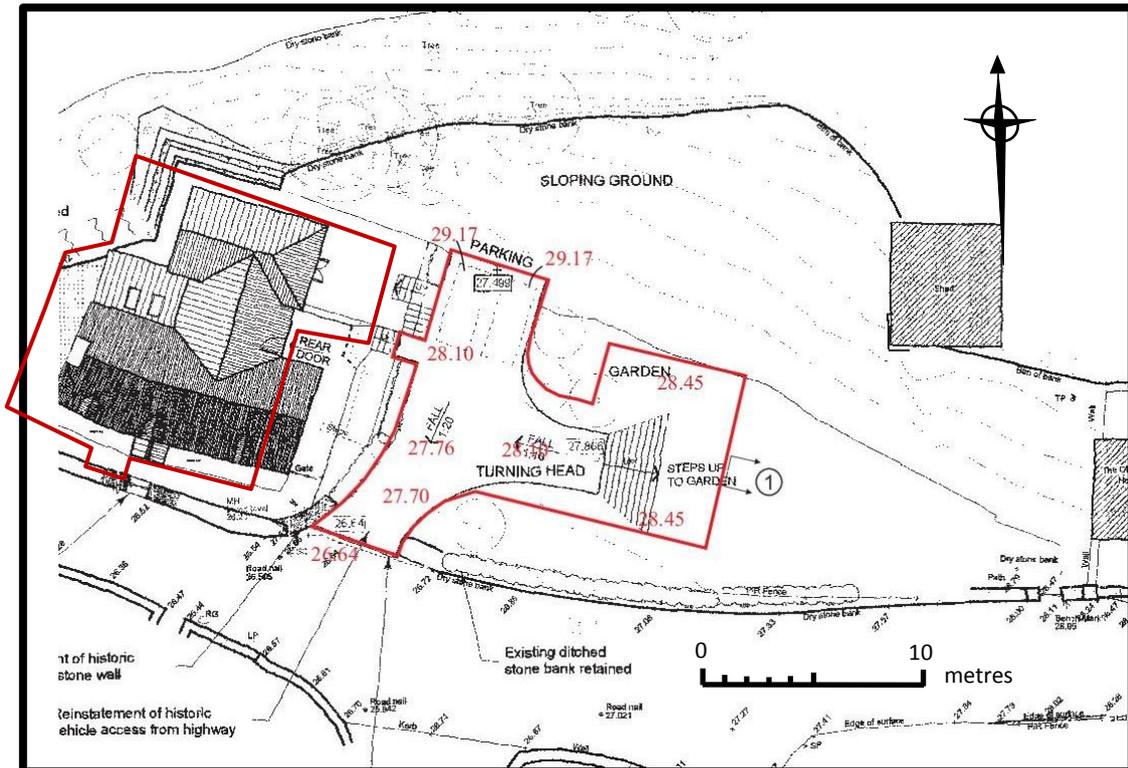
The areas affected by the development included the house and the land immediately north of it and also a second area within overgrown garden land to the east of the house, which was to be terraced and levelled to provide the driveway and hard standing. These areas are shown in Fig 4.

Fig. 4 Areas covered by the watching briefs on the historic buildings (left) and the groundworks for the driveway and parking areas (centre) outlined in red. The base map is taken from a drawing by Jonathan Rhind Architects.

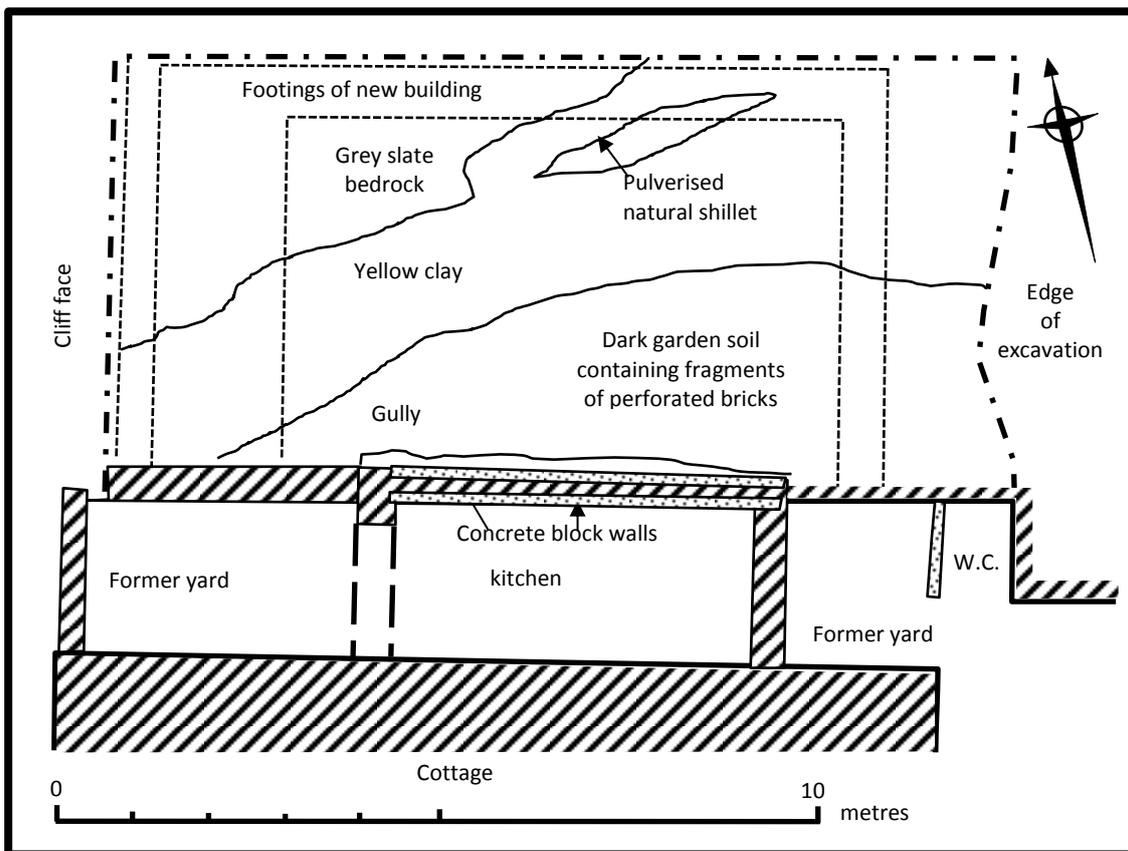
Fig. 7 Plan showing the features in the cleared ground north of the cottage.

The deposit is probably a modern dump or levelling layer, designed to create a level surface for the construction of the recently-demolished 20th-century extension at the rear of the house. Any earlier ground levels are assumed to lie at a much deeper level. The upper parts of the buildings at the rear of the house may originally have stood either wholly or partially above ground. They may have been buried to a degree by natural slumping and build-up of debris from the hillside above as well as by modern dumping to level the ground for the construction of the extension.

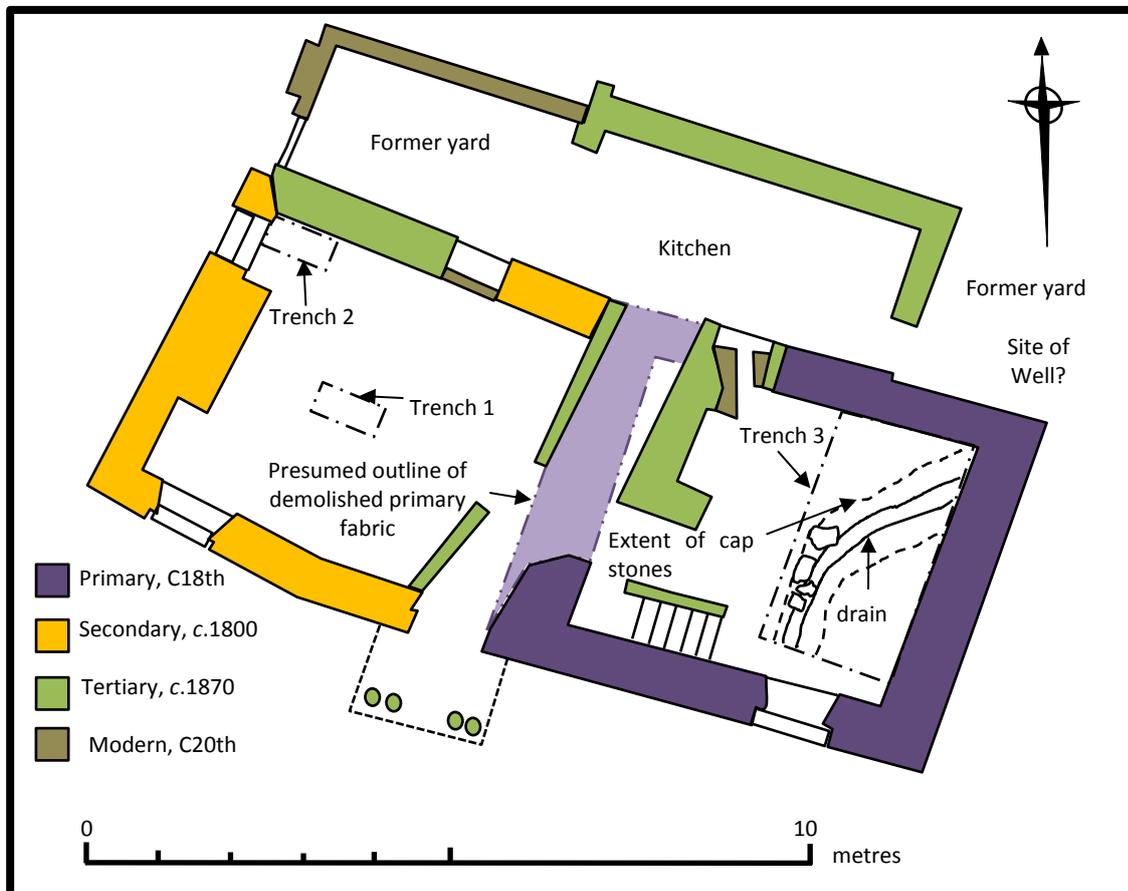
Fig. 9 Ground-floor plan showing revised suggested phasing and trench locations.

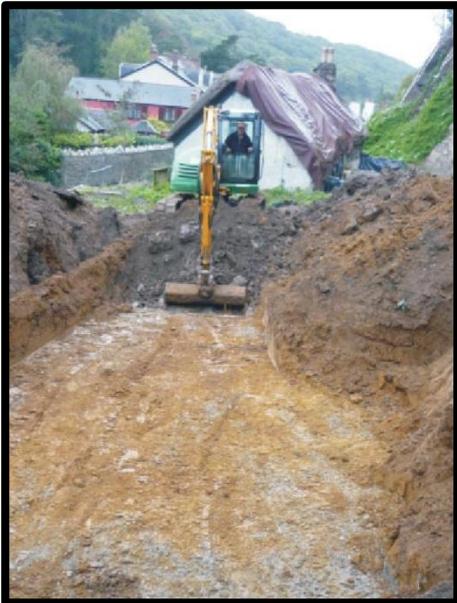
Fig. 16 View of the groundworks in October 2011, looking west (Photo by M. Steinmetzer).
