Archaeological Building Survey

No. 35, STRAND, TOPSHAM,

By R. W. Parker

REPORT No. 2012.01

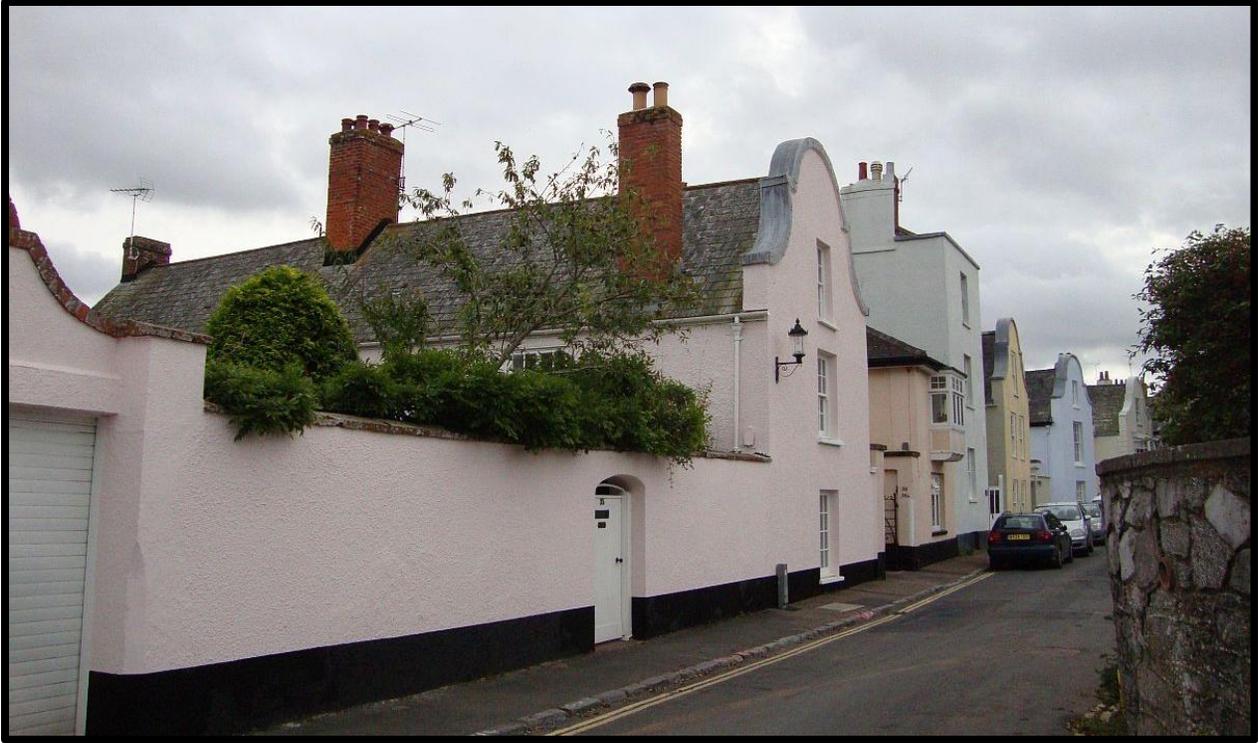
Fig. 1 No. 35, Strand, from the north, showing its position within the sequence of 'Dutch Houses' in the south part of the Strand

The eastern side of the street is bounded by a strip of residential development, which is also divided into narrow tenements aligned at right angles to the street and the shore. These plots extend eastward to a remarkably consistent eastern boundary, but the plot widths vary considerably, the plot occupied by No. 35 being one of the widest. Some of these variations might reflect the presence of earlier topographical features, or perhaps the subdivision or amalgamation of earlier properties, but the general impression is one of consistency, with the houses forming detached blocks on the street frontage alternating with yards and walled gardens (Fig. 1).

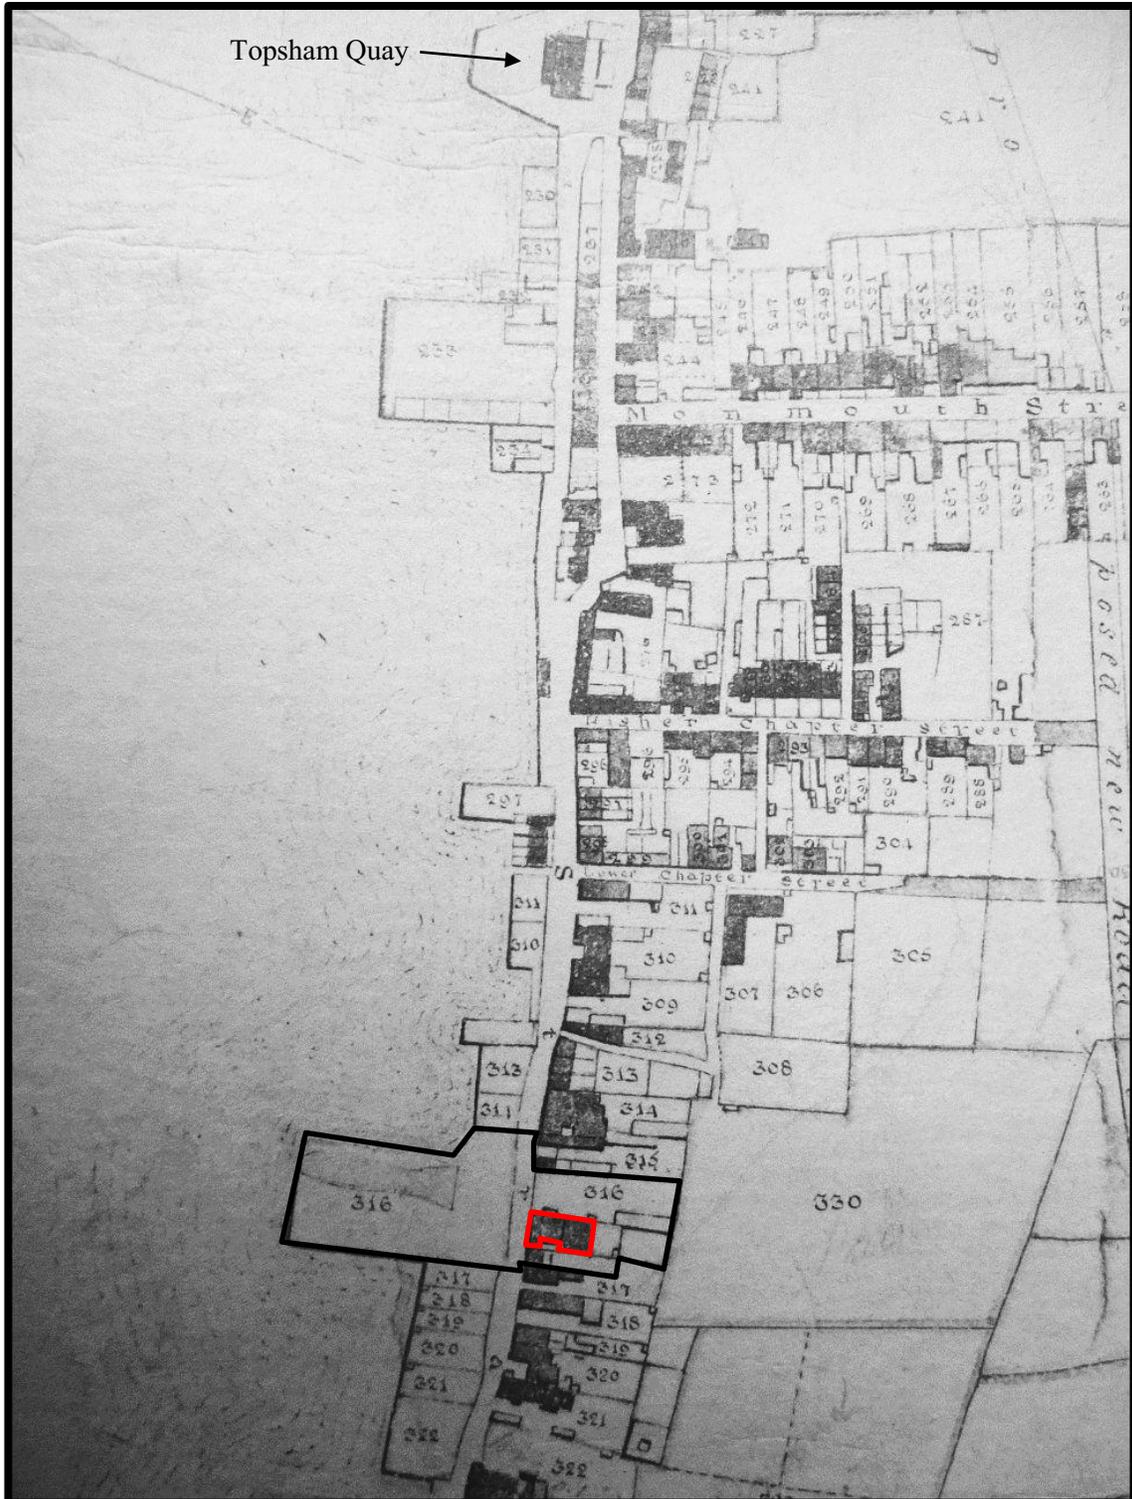
Fig. 2 Extract from Henry Troake's Map of Topsham, surveyed in 1836 and copied in 1842, showing Topsham Quay at the top and the probable extent of plot '316' (outlined in black), at the bottom, with the buildings on the site of No 35, Strand (outlined in red). (Westcountry Studies Library).

The earliest historic map of Topsham (known to the author) which shows the buildings of the town in any detail is Henry Troake's Map of Topsham, a copy of which is now held at the Westcountry Studies Library (Fig. 2). This map is annotated to show that it was surveyed in 1836 but was copied in 1842 in advance of the Topsham Improvement Act of July 1843. The map is accompanied by a Tithe Apportionment which records that plot now occupied by No. 35, then numbered '316' was an extensive one, described briefly as 'two houses, yard, garden and store', in the possession of the Earl of Egremont.

The presumed outline of the plot is given in Fig. 2, but the boundaries, particularly with Plot 317 are ambiguous and the ownership of the areas to the south of the present building remains uncertain. The plot certainly extended across the road and incorporated a large dry dock which is believed to have been used for docking and maintaining the Earl's private yacht (Mr Osborn, Pers Comm).

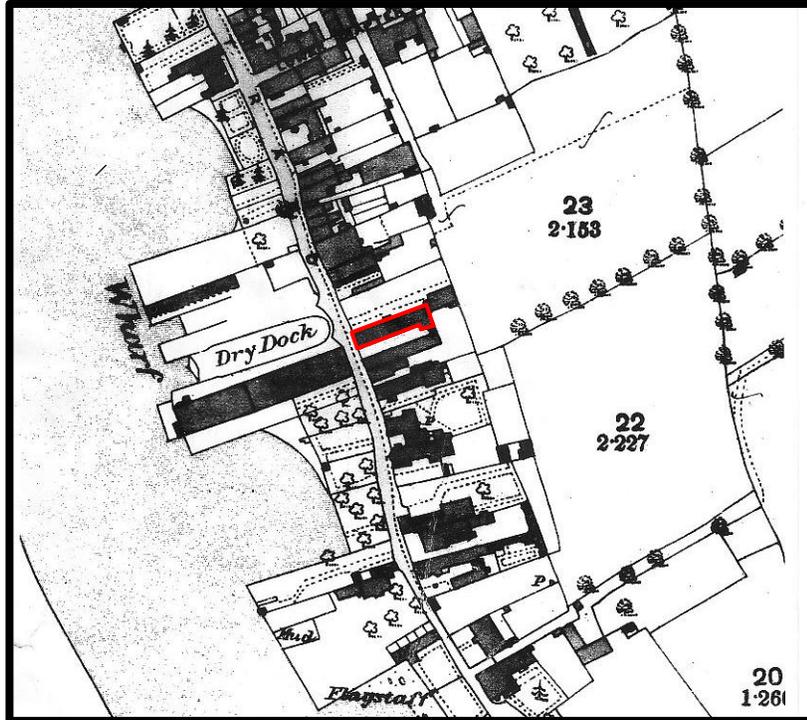
The next useful historic map known to the author is the 1st-edition Ordnance Survey map sheet 92.4, dating from 1890 (Fig. 3). This seems to show that substantial changes had taken place during the 19th century. By this period the property had been acquired by the Holman family, noted Topsham Ship builders (Obussier 2005, 30) and the docks and wharves on the western side of the road had been enlarged and redeveloped to include warehousing. The footprint of the house is now very different from that shown on Troake's map: the courtyard to the south is unencumbered by other buildings except at its extreme eastern end. The main range of the buildings appears to have been extended eastwards, occupying a small enclosure shown on the earlier map, and still further eastwards by an additional structure, offset to the north and springing from the north-eastern corner of the extended range. The buildings on the south side of the courtyard have also been extended eastward in the form of a similar long, narrow range matching the depth of the main house. One small projecting feature is visible on the north side of the house: this may represent a porch sheltering the eastern of the two entrances visible today.

Fig. 3 Extract from the 1890 1st-Edition OS map sheet 92.4, showing the footprint of the building after 19th-century alterations.
