Historic Building Survey
of
**FARM BUILDINGS AT EAST PEEKE,
WRANGATON, DEVON**

By R.W. Parker

REPORT No. 2010.02

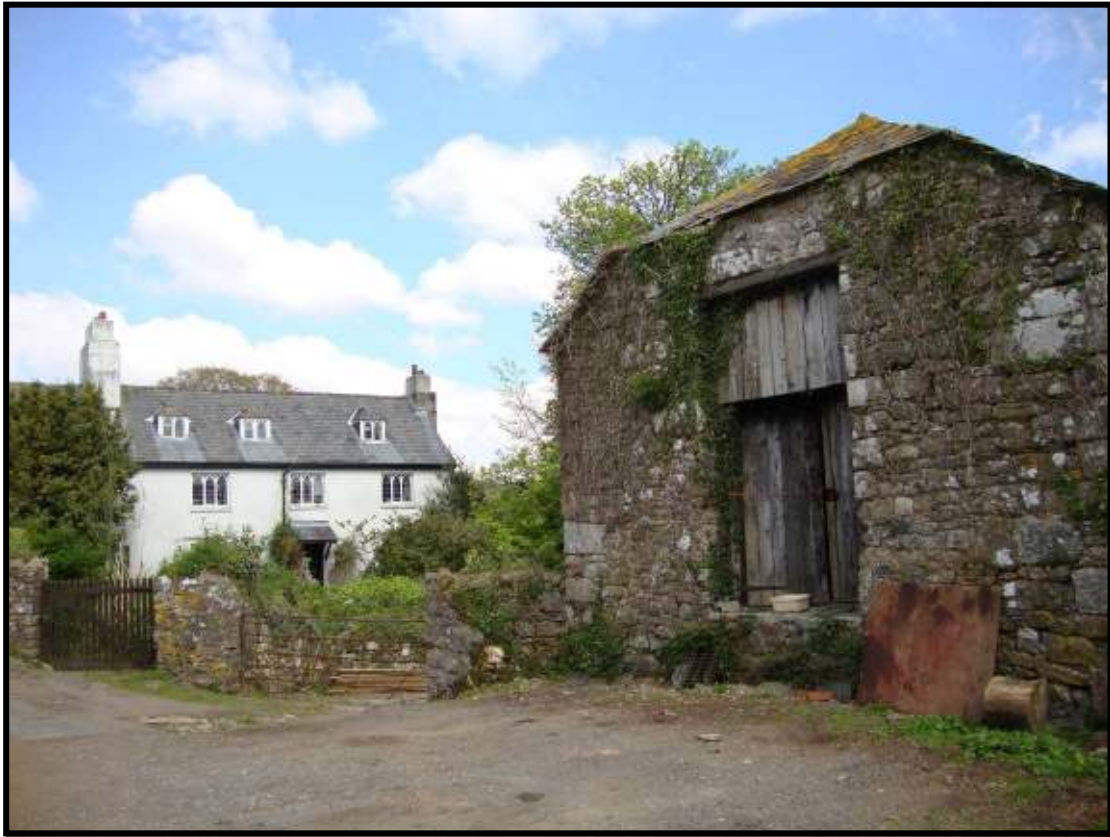
Fig. 2. View of the farmhouse and barn from the south.

Both farms retain historic farmhouses; that at ‘East Peak’ is identified by Cherry and Pevsner as of late 17th or early 18th-century date (Cherry & Pevsner 1989, 879), though the present rendered façade with ‘Gothick’ windows (Fig. 2) is likely to be the product of early 19th-century remodelling. The same source describes the barn thus: ‘a bank barn, built into the hillside, with a shippon below, dated 1755’ (*ibid.*). The date stone survives in the south-western gable, above the main doors, though much obscured by lichen. The only other visible inscription on the building was cut with a trowel in a patch of modern cement render above the doors in the north-east wall and, as far as it can be discerned, reads ‘TS VS AR..(illeg.)’.

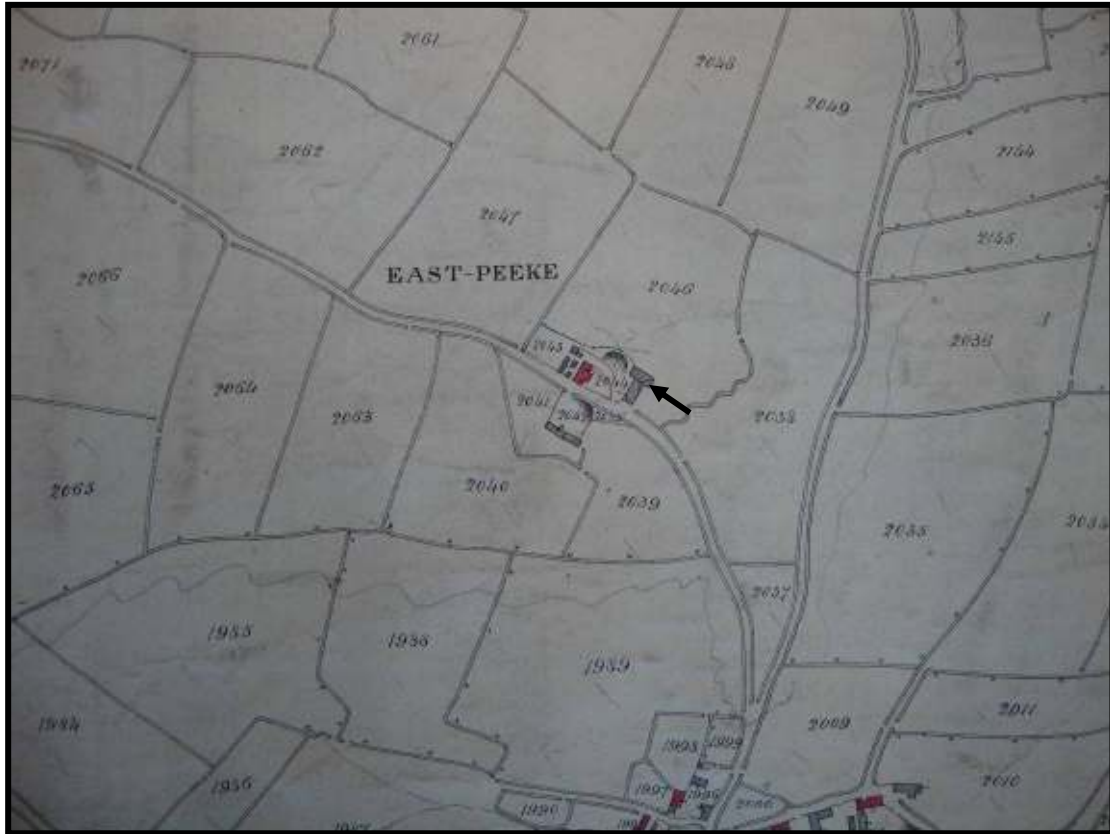
Historic maps held at local record libraries were examined for evidence of changes to the footprint of the barn. Comparison of the earliest map, the tithe map of 1843 (Fig. 3) with the OS 1st edition map of 1886 and the 2nd edition map of 1905 (Fig. 4) reveals little change to the footprint of the buildings during the 19th century; we may thus assume that the majority of the existing fabric must predate the 1840s.

Fig. 3. Extract from the 1834 Ugborough Tithe Map showing the footprint of the barn (arrowed).

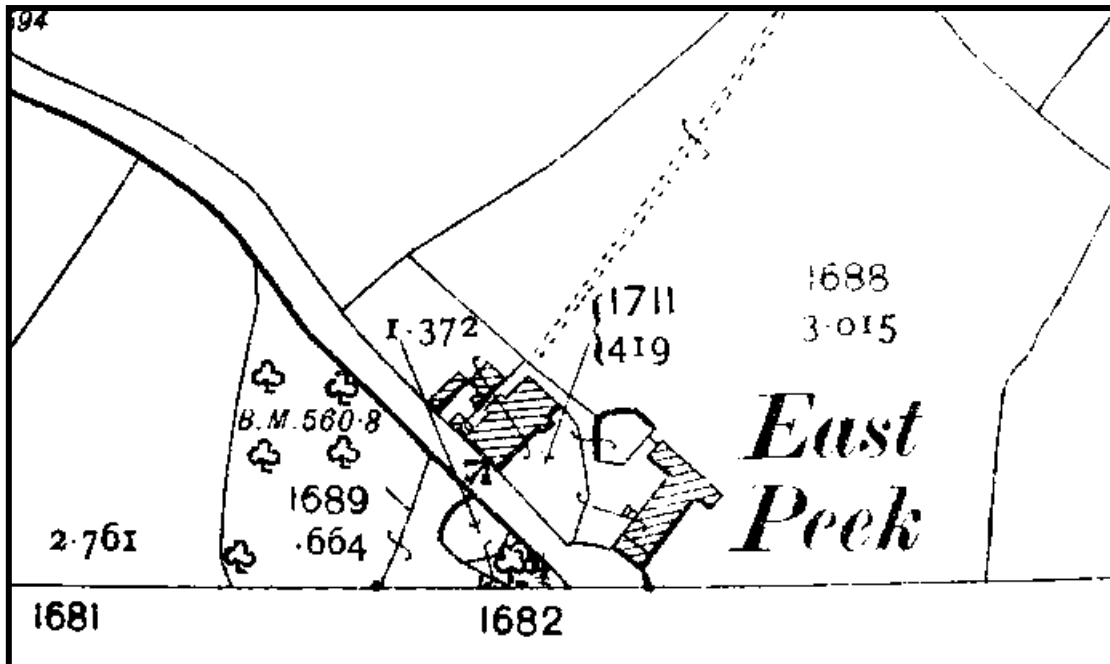
Fig. 4. Extract from the 1905 OS 2nd edition map sheet CXIX.12, showing no significant change in the footprint of the building.

The only apparent difference is a small circular feature with a dashed outline, barely discernible on the 1886 map. On the OS 25 inch map dating from 1887 (not suitable for reproduction) this feature shows more clearly; it is likely to represent a horse engine house with open sides supported by posts or columns in which a horse could work a capstan to provide power for mechanical threshing. The horse engine house was presumably added to the building in the mid 19th century and was demolished before 1905.

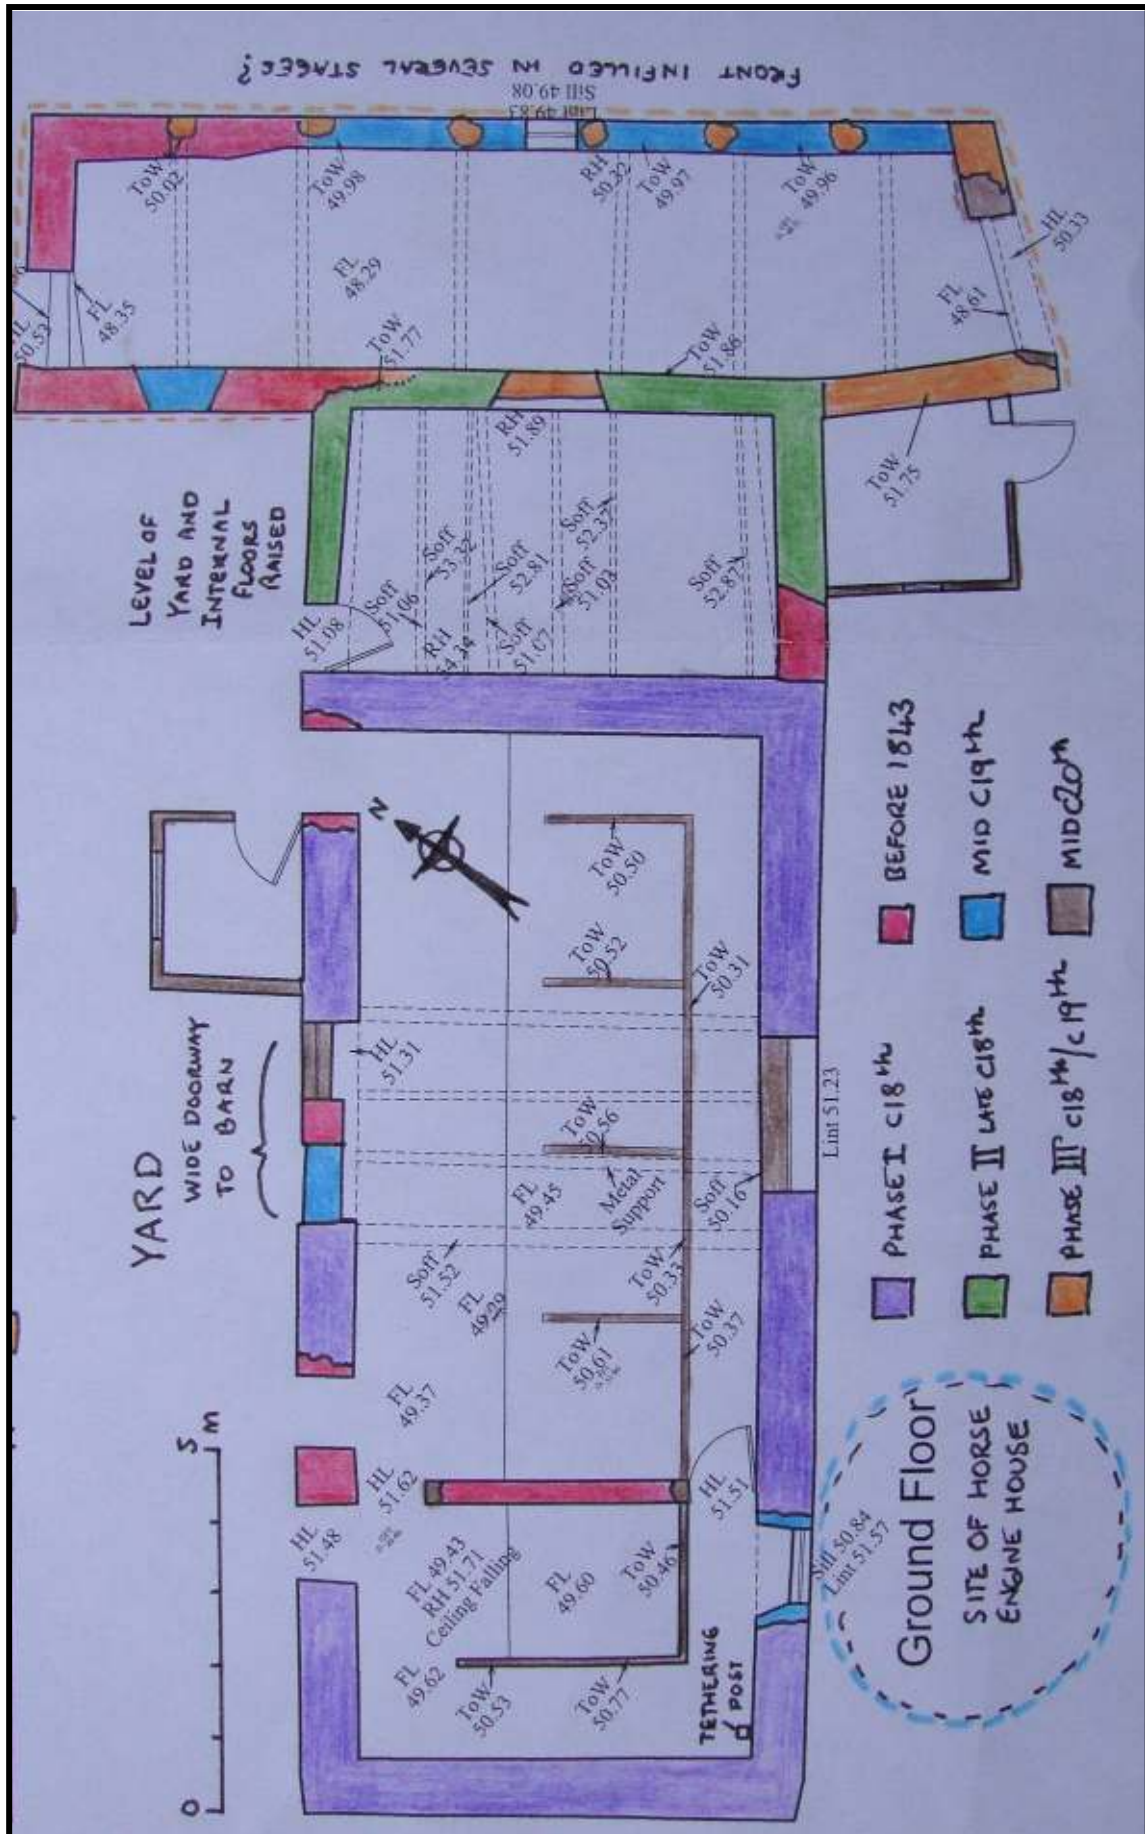
Fig. 18. Plan at ground-floor level showing suggested phasing. Based on drawings by DMR Design

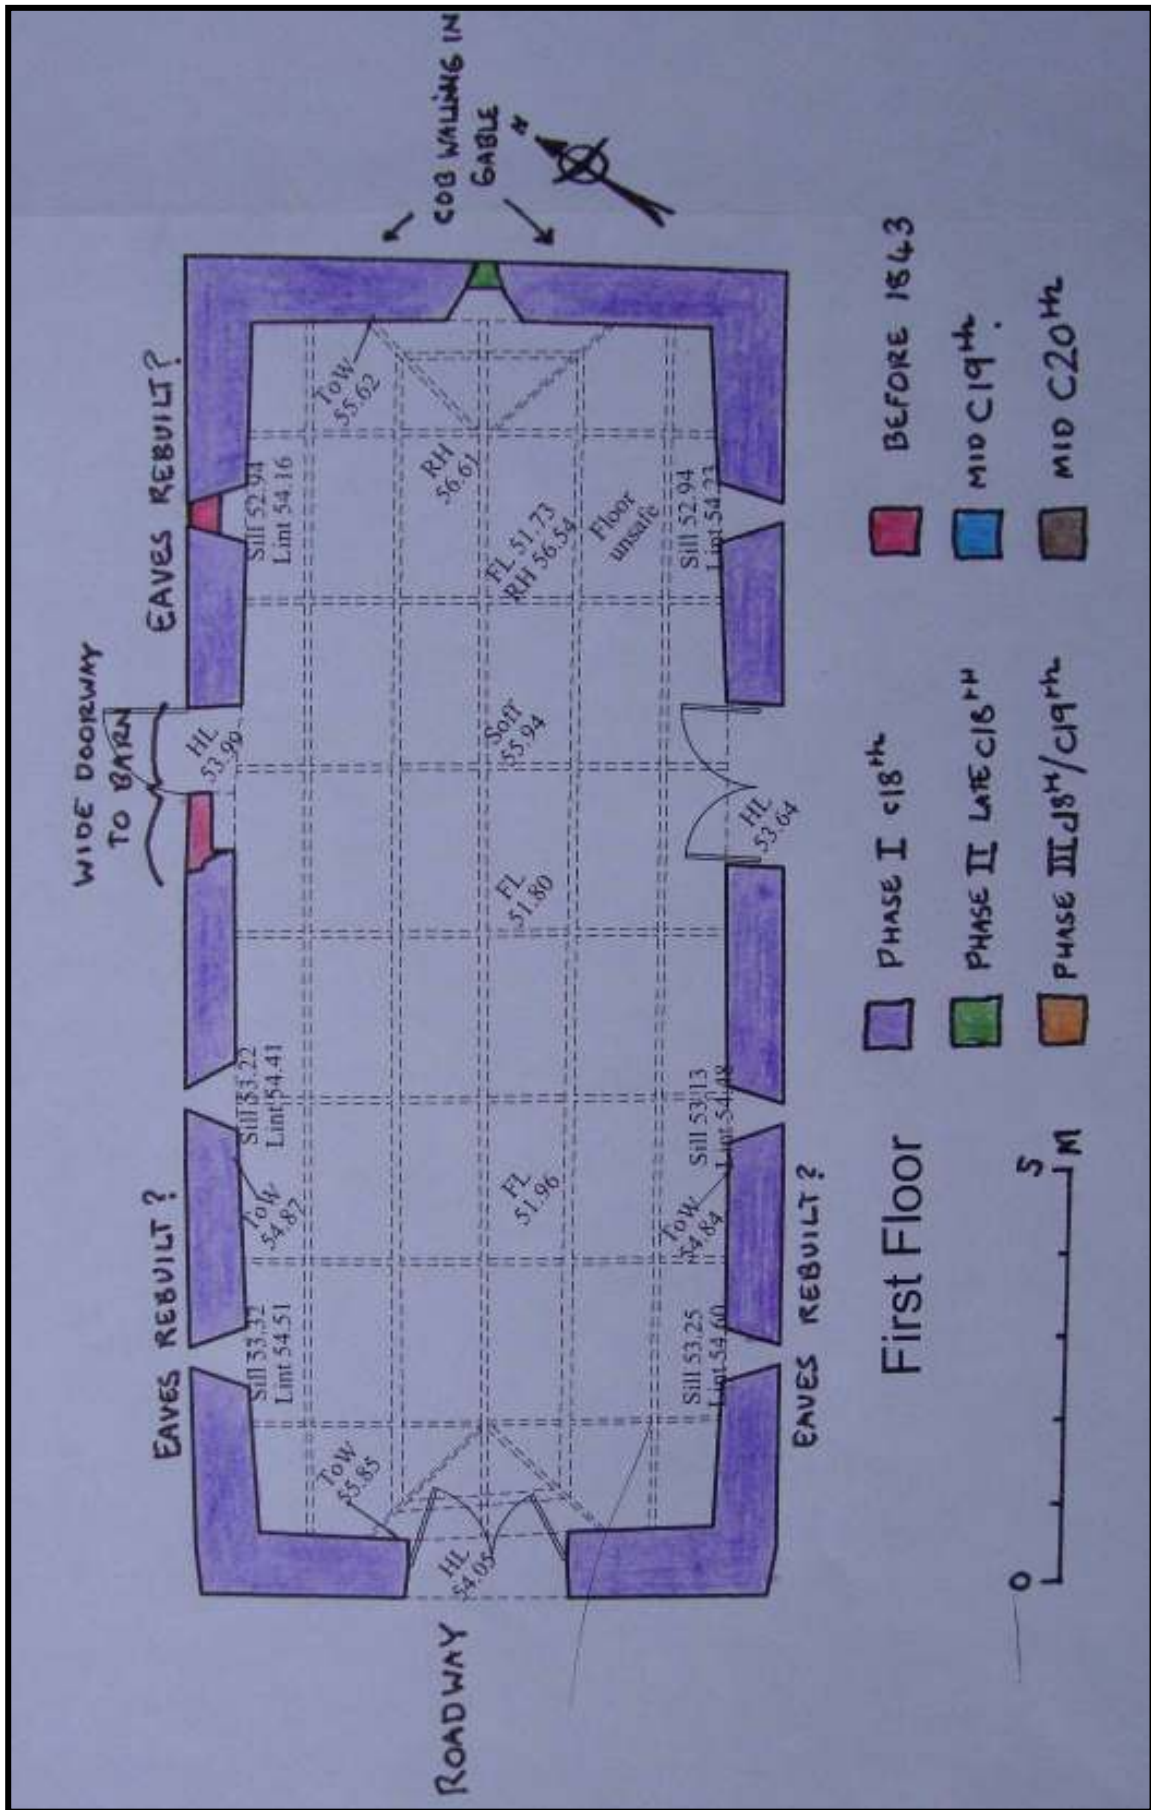
Fig. 19. Plan at first-floor level showing suggested phasing. Based on drawings by DMR Design
