# DONSIDE URBAN VILLAGE ABERDEEN

**- Archaeological Evaluation -  
&  
- Standing Structure Survey -  
Carried out 6<sup>th</sup> & 13<sup>th</sup> May 2010  
by  
Murray Archaeological Services Ltd**

**Report No: MAS 2010 - 10**  
by  
H K Murray and J C Murray

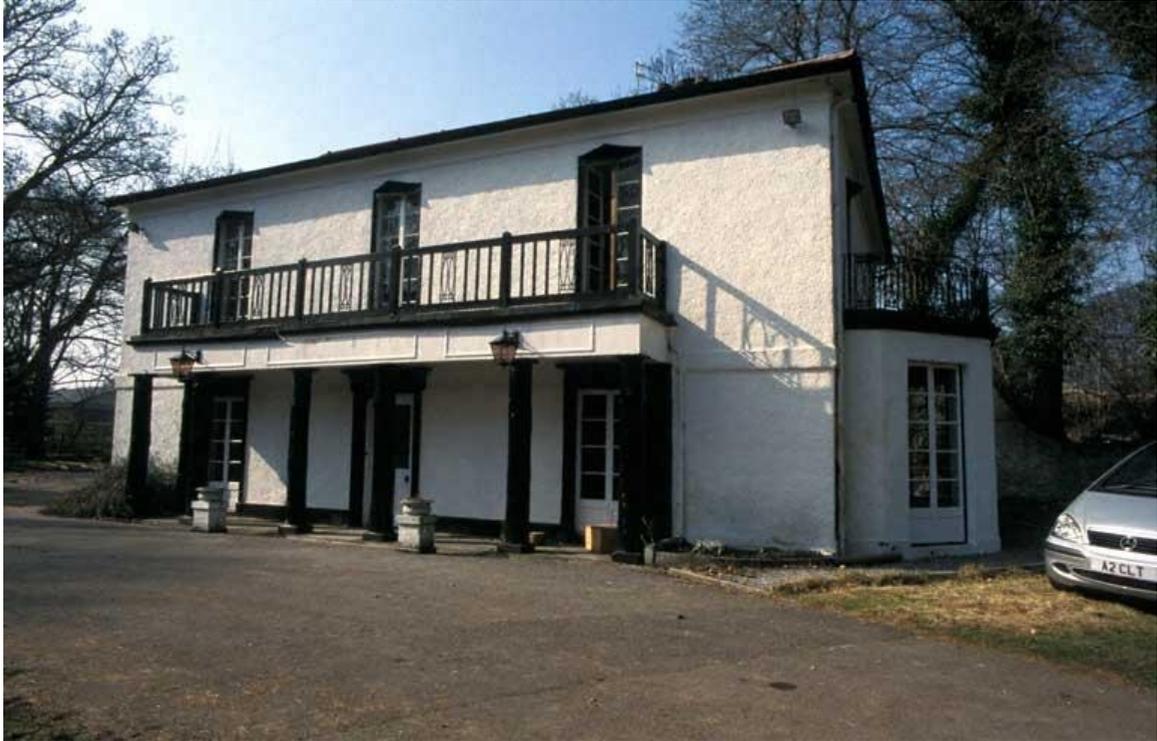
**Illus 9 Photograph SE Elevation (Aberdeen City Council 2002)**

The standing building survey was undertaken on 6<sup>th</sup> May 2010. At this time the building had been burnt out some months previously and partially demolished with only 2.5-3m of the wall height remaining. However it was possible to survey the ground plan and to note some details of construction and development that would not have been visible when the building was described in 2003 when it was awarded Listed Building status (Category B. HB number 49191. Item 185A).

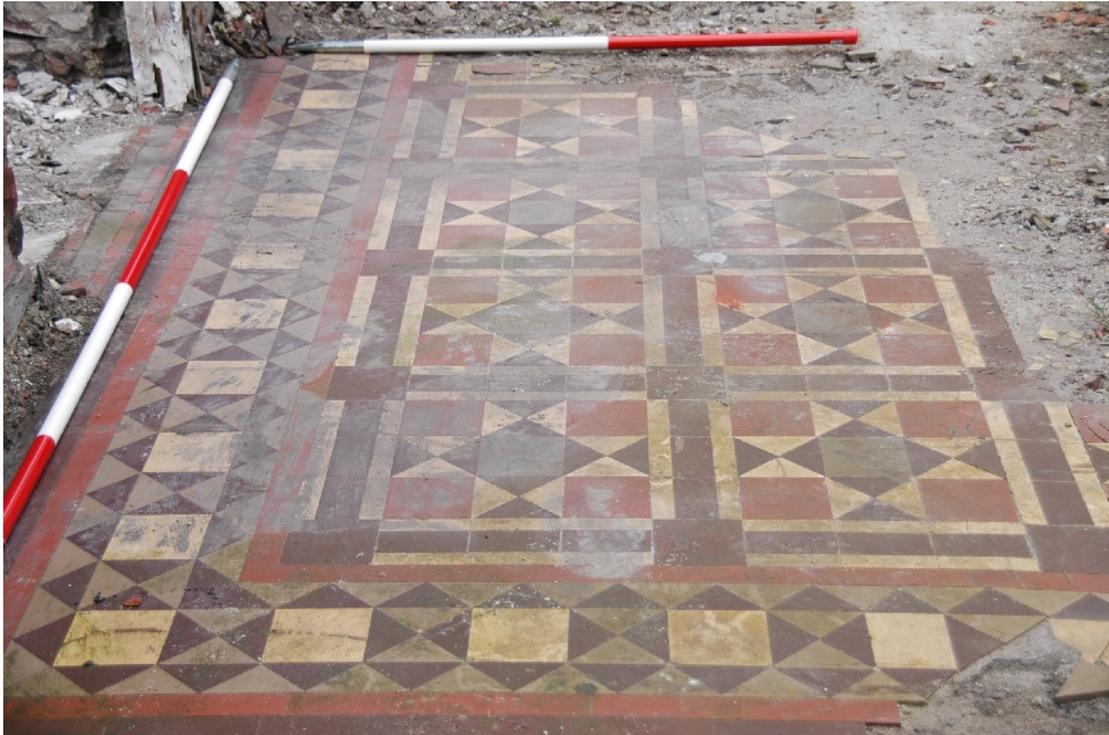
**Illus 15** Detail of tiling in passage

Internally little other detail survived although some of the tiling in the entrance area remained and was photographed.
