Hamsterley Hall
Hamsterley
County Durham
NZ 14257 55637

Archaeological Building Recording
for Mr. Steven Spry

*Report no. 069-13-HS
Final Version January 2014*

VINDOMORA SOLUTIONS
Heritage Support

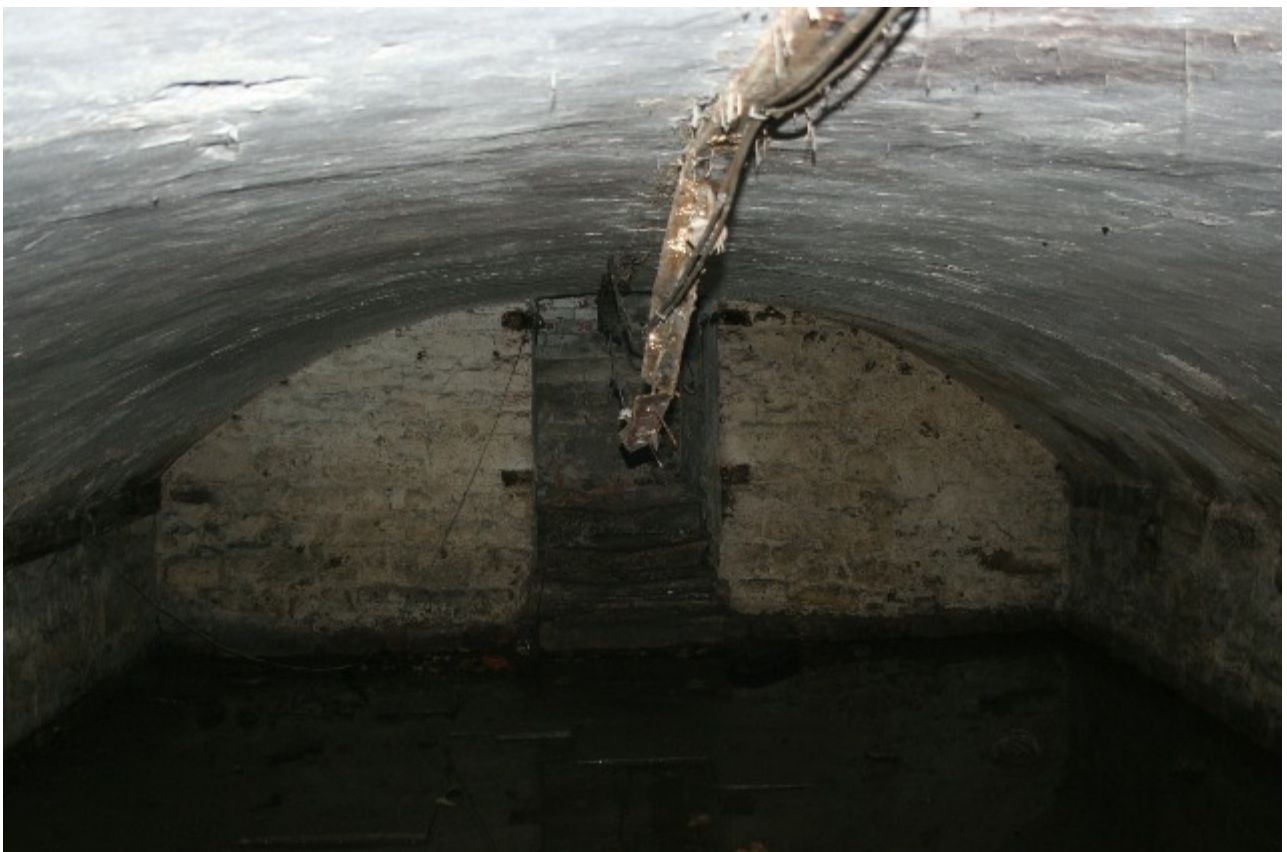
Plate 4. The cellar, looking west (frame HHR13001)

- 3.2.1 Cellar (Plate 4): 9.85m x 5.35m. The main cellar to the house is located in the north-east corner of the building, underneath the main ground floor lounge (Area 23, Section 3.3.25). The cellar is aligned east-west, with the entrance being a set of stone steps down from the ground floor accessed from the main through-corridor (Area 42, Section 3.3.45). The entrance is now sectioned off by a modern wall screen, but was likely originally part of a service room (Area 49, Section 3.3.76). The cellar is constructed of irregularly coursed stone with a rendered vaulted roof. There is evidence of the walls having been plastered, but the plaster has long since fallen off. In the eastern wall is the main external chute, providing evidence that goods such as coal were stored here. The chute is bricked up, with only a small area open for ventilation which can be seen externally beneath the bay window in the lounge above. The brickwork blocking the chute is of stone rubble and modern mortared brick, suggesting the chute was finally blocked up during the Gibsons' period of residence, when Area 25 (Section 3.3.38) was used as the fuel store. The floor

of the cellar is now flooded and heavily silted and will once have been flagged throughout, though now it can be noted that some of the flags are missing. An overhead wooden beam running centrally east-west across the cellar (and now in very poor condition) also acted as a conduit for electrical cabling running into the house (also utilising the chute).

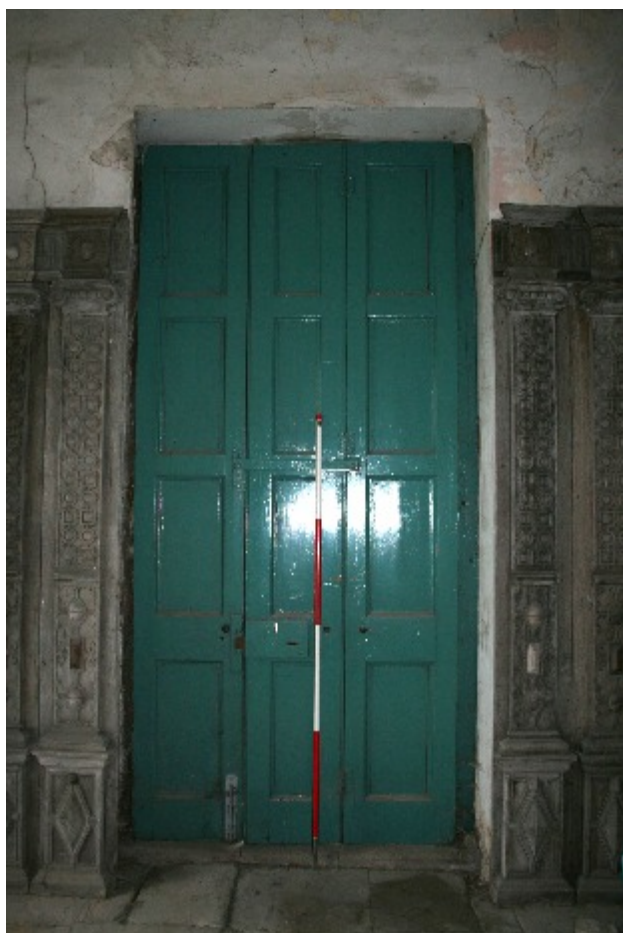
Plate 6. The main door, Area 16 (frame HHR13007)

- 3.3.1 *Area 16 and 17, Entrance Hall:* 9m x 3.4m. The main door is set in the south wall and was an addition in the 1930s by R.S. Vereker. It is a large wooden tri-fold door (Plate 6) containing 12 panels and replaced an earlier door set in the eastern elevation as the main entrance to the Hall when the east wing was extended eastwards with the addition of the imported bay window in the 1930s. The mullioned-and-transomed square bay window (Plate 7) itself is in poor condition, with the sandstone flaking and decaying, with the internal floorboards of the bay damaged by rot and uneven. The window is leaded, with a number of imported glass vignets which are discussed briefly

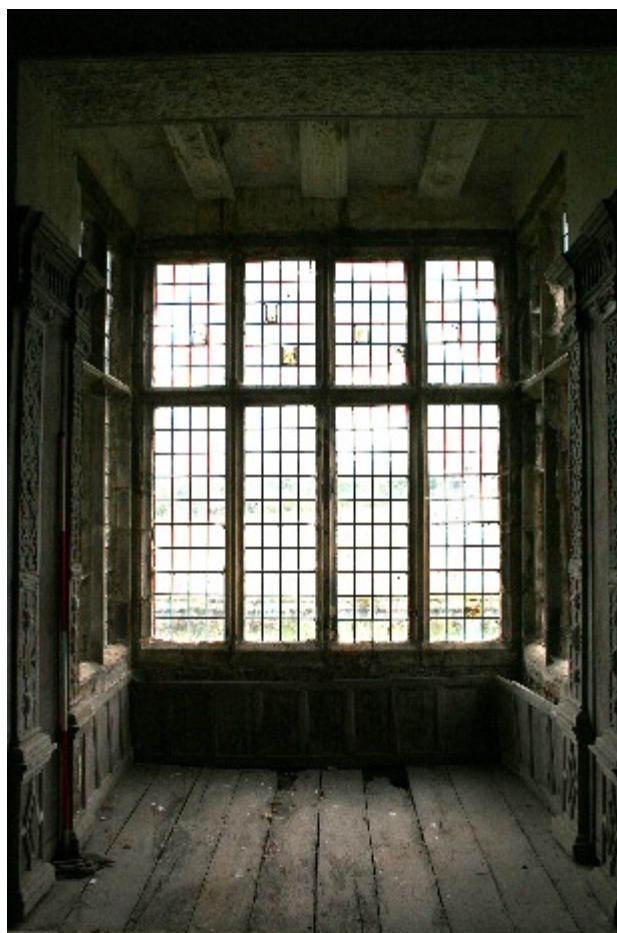
Plate 7. The bay window, Area 16 (frame HHR13020)

in Section 5.1.21. Structurally, it seems that the bay was inserted into the wall without being keyed in, evidenced externally as the visible straight joint (see Section 4.2.12). The north wall contains one doorway and two alcoves. The doorway (Plate 9) is located at the western extent of the wall and is constructed in the shape of an ogee arch. The doorway extends into a 2.6m long corridor (Area 17) which opens out into the ground floor stairwell hall, Area 18 (Section 3.3.6). Interestingly, upon studying the phasing of the Hall (Section 5), it appears that this northern wall was originally the southern external wall of the 1769 eastern wing, and that this doorway may indeed mark the location of the original southern door to the hall at the time. The apex of the arch is badly cracked, with loss of plaster work. Centrally in the north wall is an alcove, again set in an ogee arch (Plate 10). The alcove also contains a marble bench and shelf, with equilateral-arch decoration, styled to look like mullioned windows. To the east of this is a second ogee-arched alcove (Plate 11), set against the joining wall with the inset bay window structure.

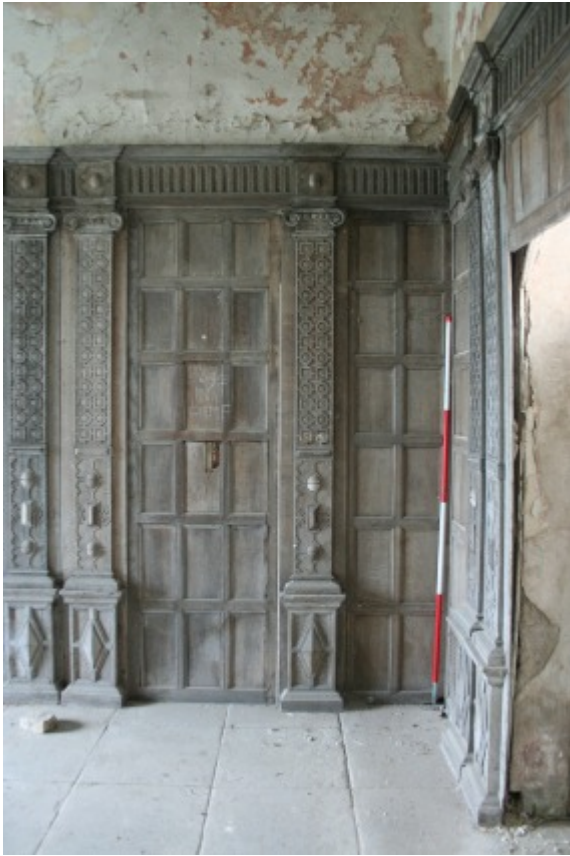
Plate 8. Panel detail, Room 16 (frame HHR13023)

- 3.3.2 The main ceiling to the room is vaulted and sports a ceiling rose, with the ceiling within the bay window (including the overhead beams) heavily decorated. The main room is lined with coving enhanced with an equilateral-arch design. The ceiling in the northeast corner of the main room is severely damaged, and further loss has occurred in the southwest corner where some of the frieze and cornice have been lost. In the area of damage, the embossed paper has peeled and degraded.
- 3.3.3 The room is heavily clad with imported oak Jacobean panelling (see Plates 8 and 12 for detailing), likely imported from Beaudesert, Staffordshire in the 1930s by S.R. Vereker. Whilst intricate in design and nature, the panelling is ill-fitting and requires restoration work. The northern wall of

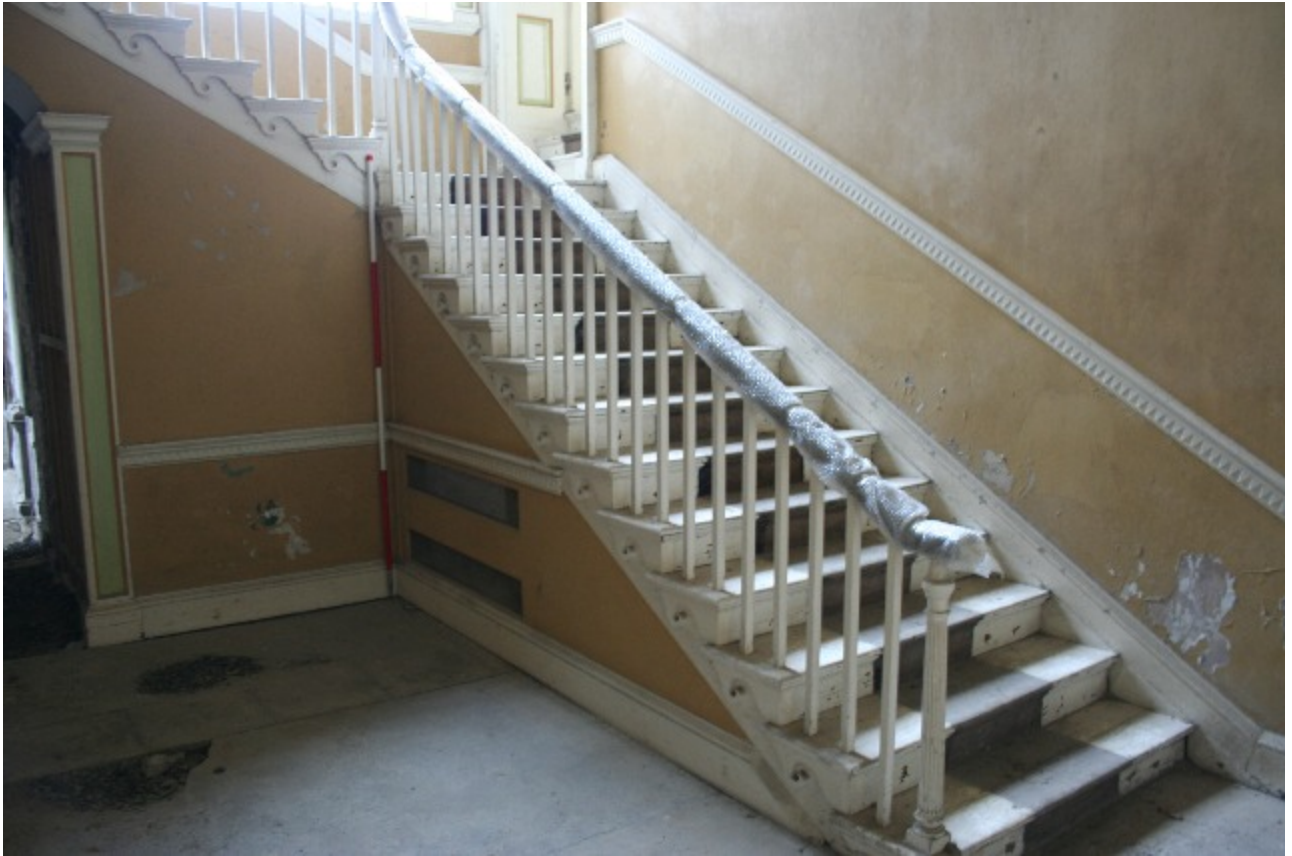
Plate 13. The stairwell, looking southwest (frame HHR13035)

- 3.3.7 The 18th century stairwell has a ramped handrail set on fat stick balusters and with fluted newels and is in relatively good condition (*Plate 13*): the current owners of the Hall have wrapped the handrails in plastic to prevent damage from the surrounding damp. The outer stringer of the staircase is in classical Vitruvian wave design.

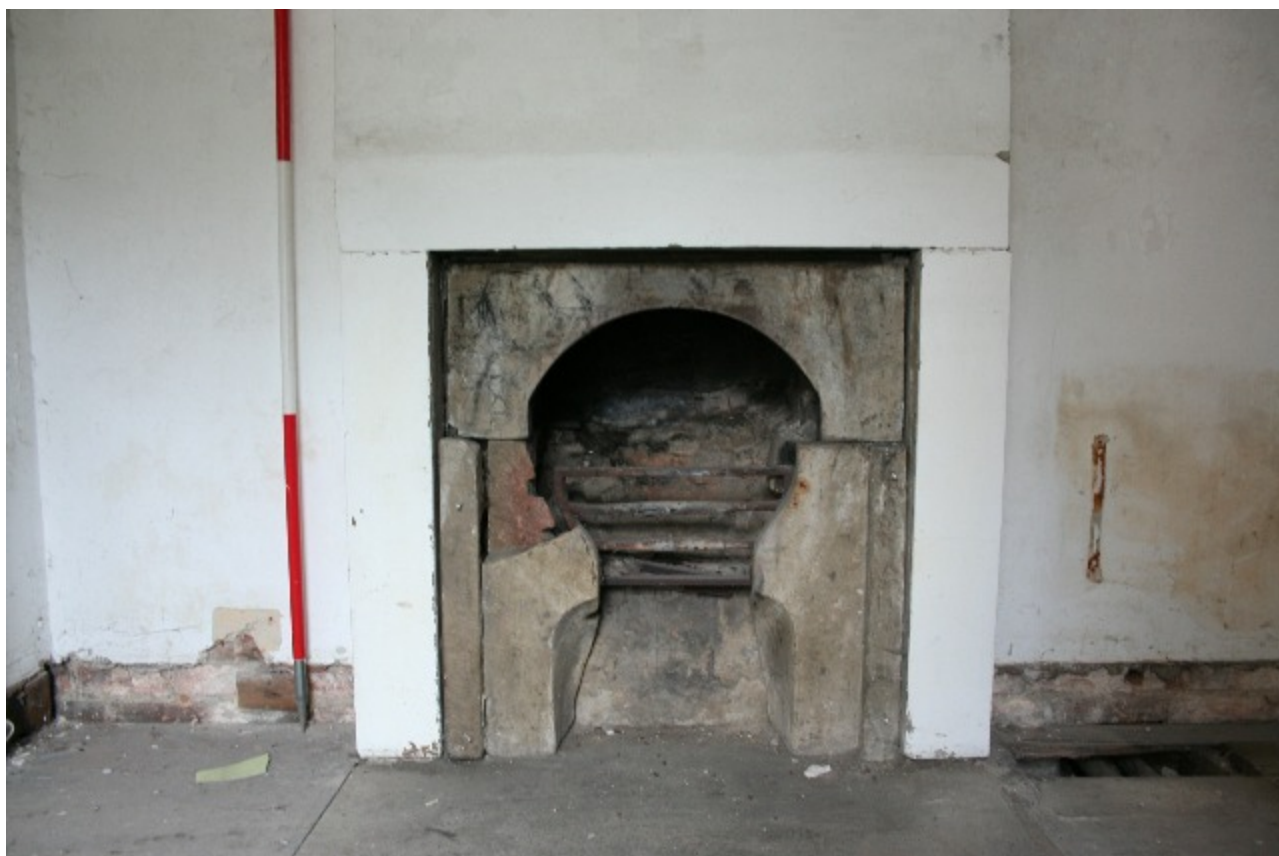
Plate 16. The fireplace in Area 20 (frame HHR13045)

conclusion is also supported by the photo not appearing on an early 20th century photograph, and is discussed more in Section 4.2.41. On the eastern wall is a small fireplace (Plate 16), now blocked with a simple grate. This form is a late 18th century hob-grate with the hob plates and many of the metal fittings removed. The positioning of the fireplace suggests that Areas 19-21 were originally one room, which would have meant that both the fireplace and the window were central on the east and west walls respectively. The door set in the north wall is six-panelled in a classical style architrave and matches the design of the door in the east wall leading to the stairwell down to the pantry, both late 18th century in design. Through this door lies a small (2.14m x 1.13m) landing area, with the underside of the main staircase visible up a step to the north, stone steps down to the pantry (Section 3.2.3) to the east and on the south there is an arched recess, likely the remains of a blocked up window. This is not visible externally, though the external brick wall does indicate rebuild.

- 3.3.14 The room has no coving, and the majority of the skirting has been removed as has the dado rail. There are traces of damp throughout and the floorboards have been lifted in places. The southwest corner of the room also contains modern electric equipment fittings such as a fuse box and associated wiring. The fittings are attached to the west wall on a metal bracket bolted into the wall.

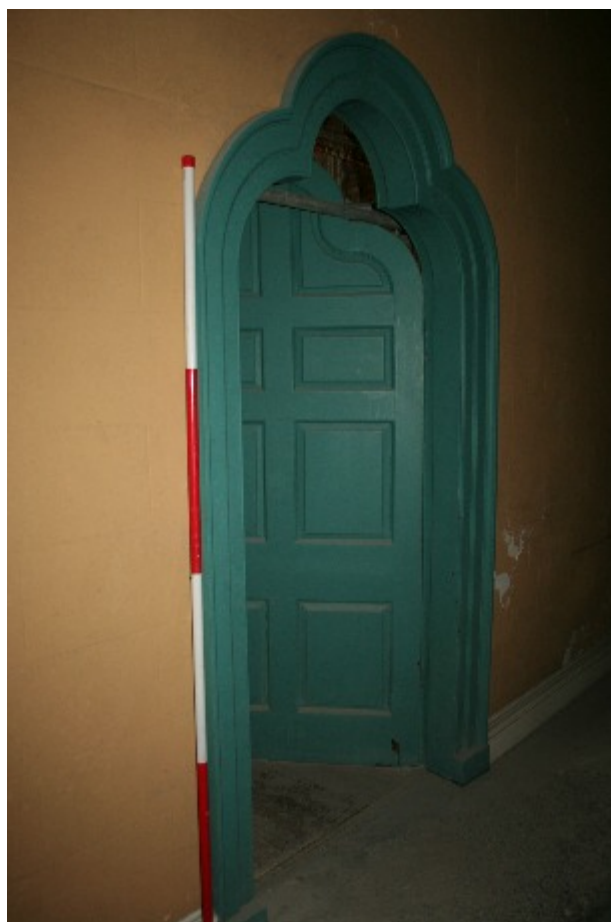
Plate 18. The trefoil door to the dining room (frame HHR13058)

- 3.3.21 In the east wall is a unique door in the building, leading into the dining room, Area 24 (Section 3.3.32). This door has a trefoil embossed architrave enclosing a trefoil shaped door (Plate 18), holding eight panels. The door is currently wedged open by scaffolding in the dining room.

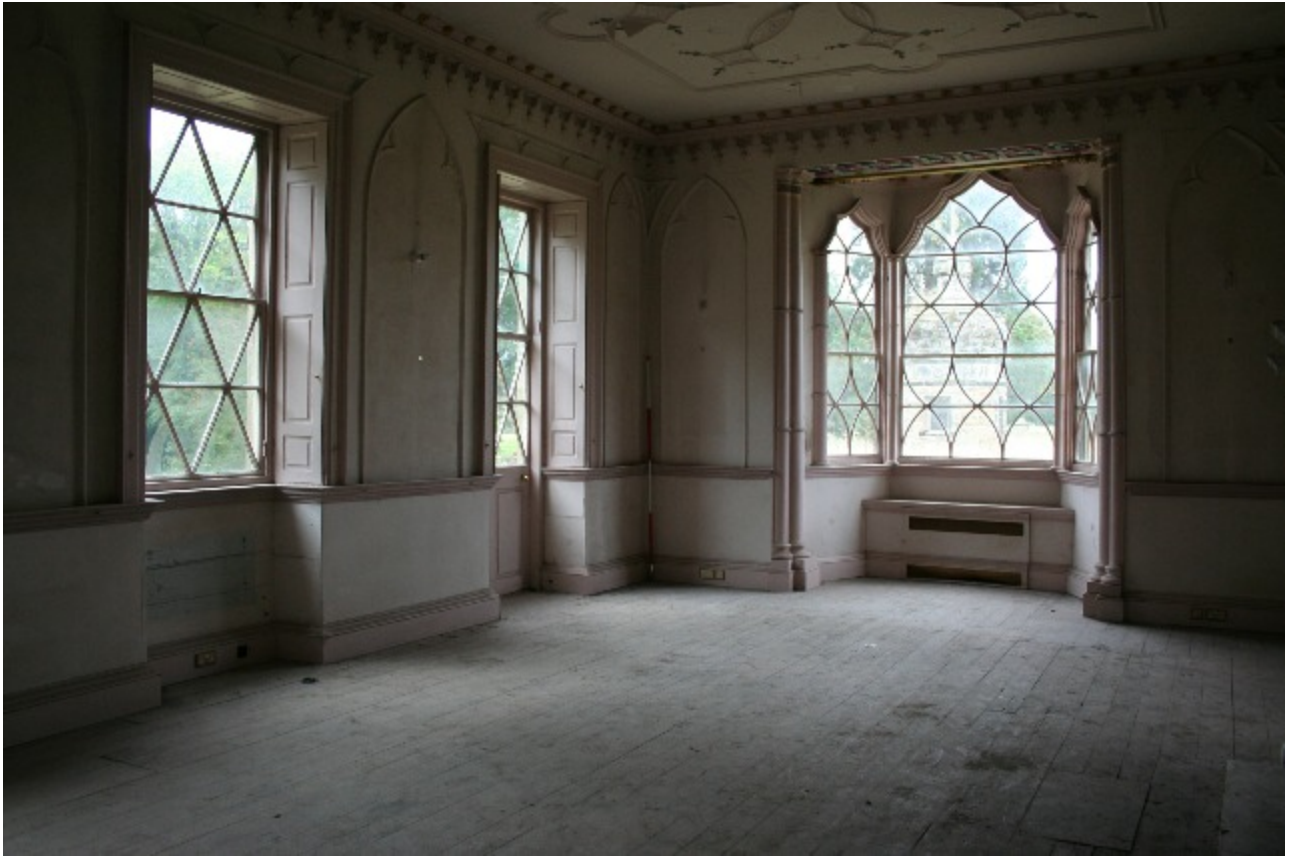
Plate 19. The Drawing Room looking northwest (frame HHR13068)

- 3.3.25 *Area 23:* 11.16m x 5.7m. The Drawing Room is the largest single room on the ground floor of the later house. The room houses a degrading Rococo-Gothic ceiling, severely damaged in the northwest corner due to water ingress and Rococco-Gothic trifoil arched wall panels forming an arcade with its base positioned on the room's dado rail. The room also sports skirting and an elaborate trifoil cornice with gold-embossed flowers (Plate 21) which matches the design above many of the doors on the ground floor.

- 3.3.28 The room has skirting throughout: however, modern electrical fittings have been inserted and it is unknown whether these are replacement or original boards. The floor is constructed of wooden floorboards, some of which are in need of repair.
- 3.3.29 *Country Life* magazine (Hussey 1939) shows us a photographic plate of the room with Gothic tapestries hanging on the west and south walls. It also shows a different fireplace to the one currently in-situ on the south wall: the current fireplace has an 18th century date, the surround

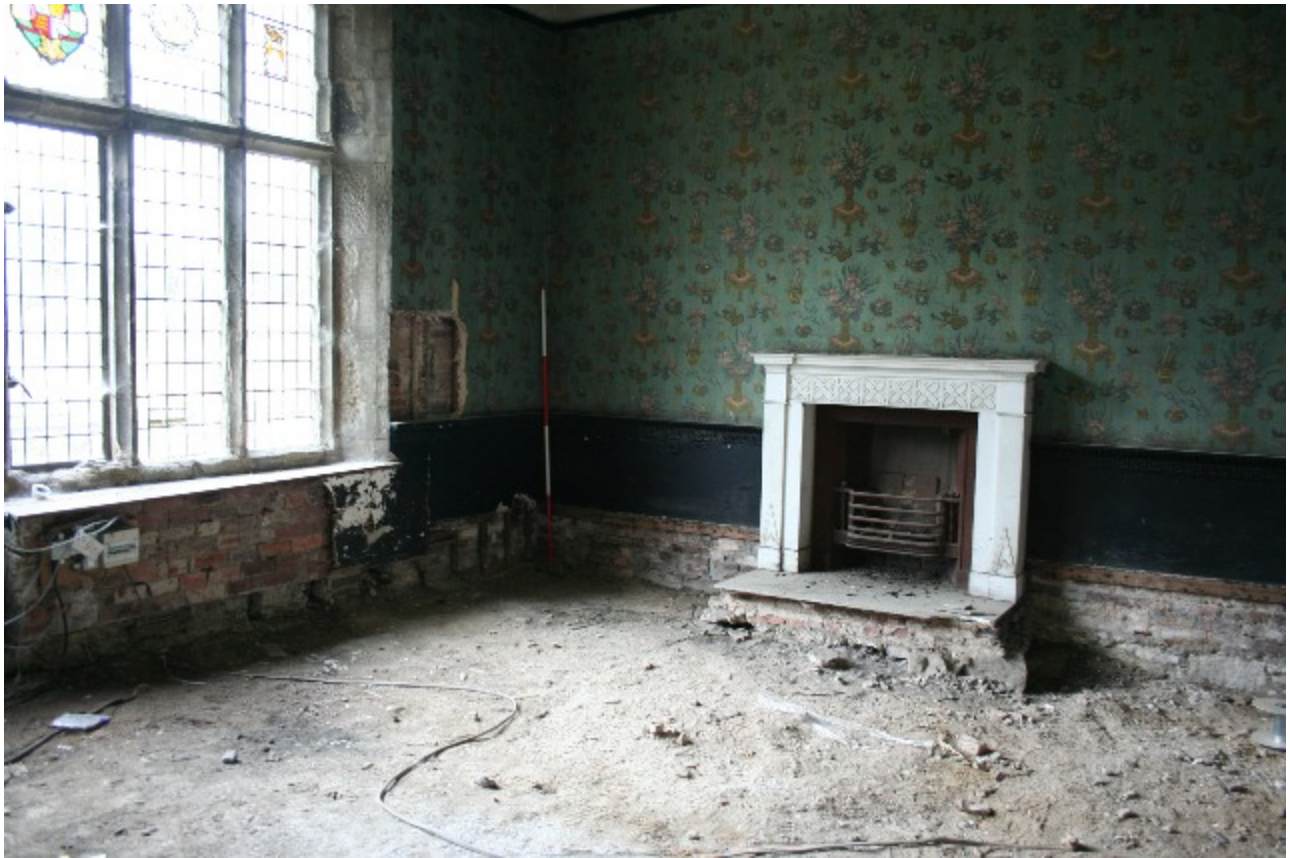
Plate 26. The Morning Room (frame HHR13112)

- 3.3.39 The room also contains a heavily enriched dado/picture rail, with plaster egg and dart over a key pattern.
- 3.3.40 The room is decorated with potentially antique oriental wallpaper, though the provenance of this is uncertain.
- 3.3.41 On the south wall is a marble Regency-style fireplace with a simple rusted iron grate. The fireplace surround is in classical Tuscan style, with dogtooth decoration.
- 3.3.42 The entire floor in this room is missing, and was this way when the current owners obtained the

property. It is thought that the Gibsons used the room as a timber store, with the timber being 'delivered' through the window in the east wall. The floor itself shows scree, but also a brick base at the fireplace, which may indicate an earlier fireplace in this area or may simply be the base of the current fitting. The skirting has been removed in this room, presumably when the floor was removed.

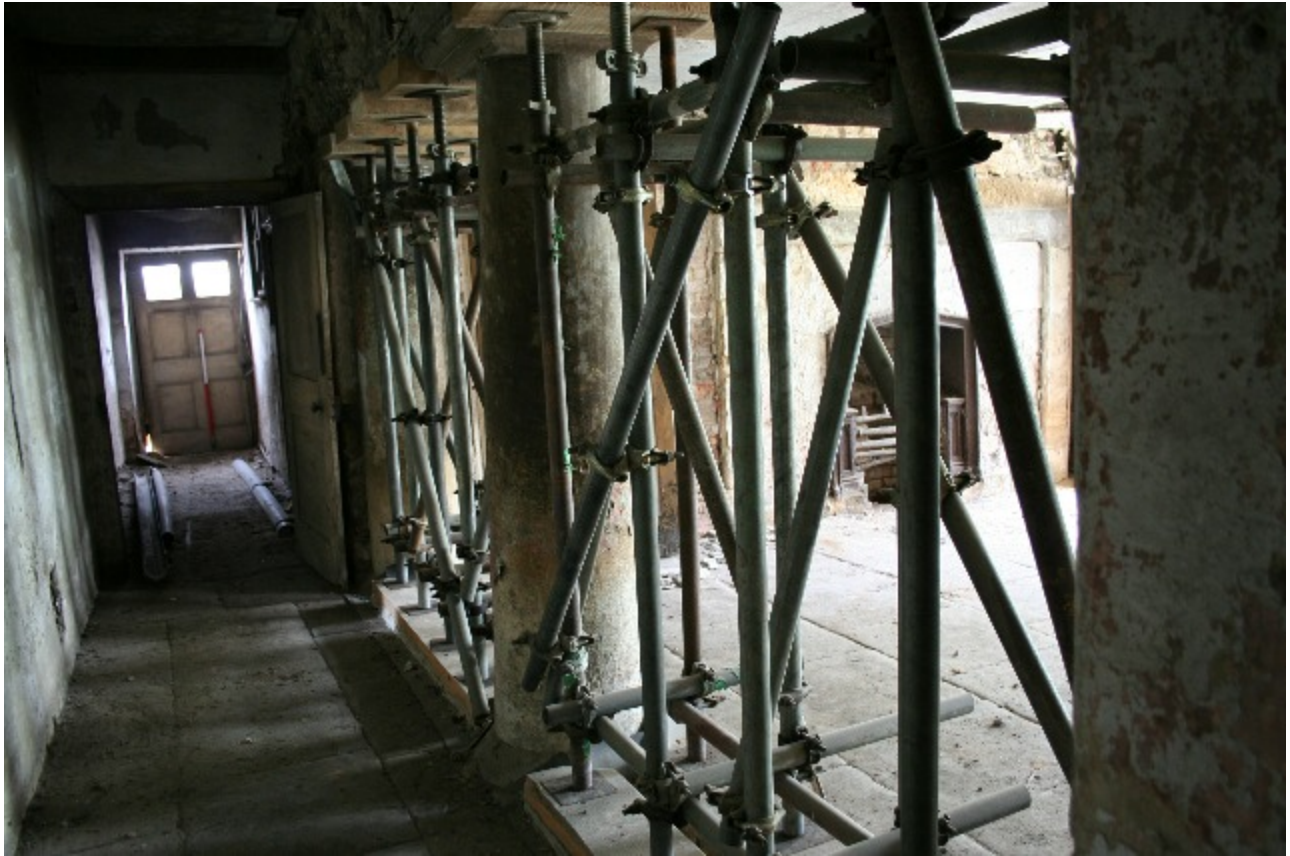
Plate 37. Corridor Area 46 (frame HHR13174)

- 3.3.65 The corridor is stone flagged, which continues into Area 48, suggesting the flagging was contemporary. The walls and ceiling are of plain plaster, in poor condition.

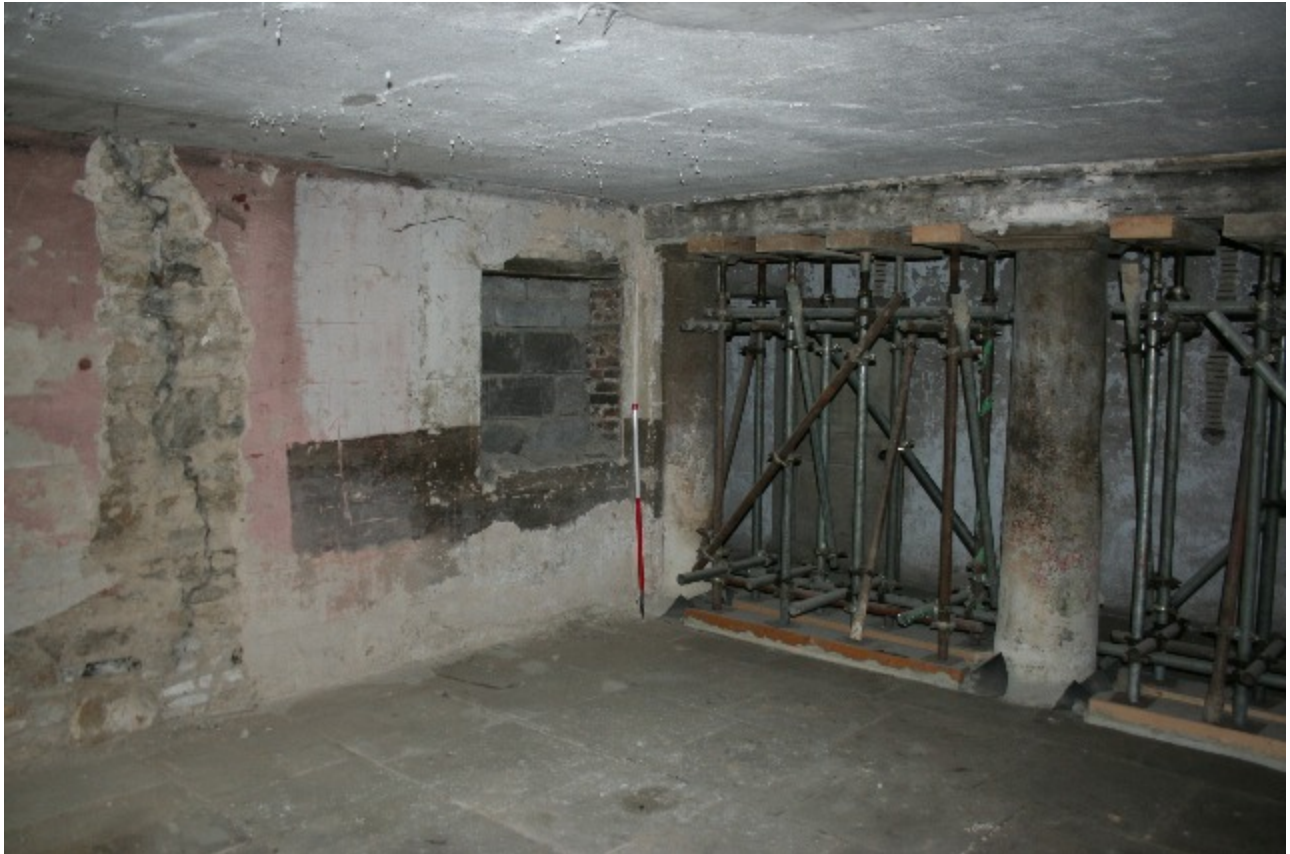
Plate 41. Area 48, looking toward the column and blocked window (frame HHR13191)

3.3.70 *Area 48:* 4.7m x 4.5m. This large room is accessed off corridor Area 46 through a wide opening with a central stone column, likely inserted during the Vereker period. The stone slabbed flooring is contiguous with that of the corridor, indicating that the flooring here was done at the same time as that of the corridor and forms a large open area or lobby rather than an enclosed room.

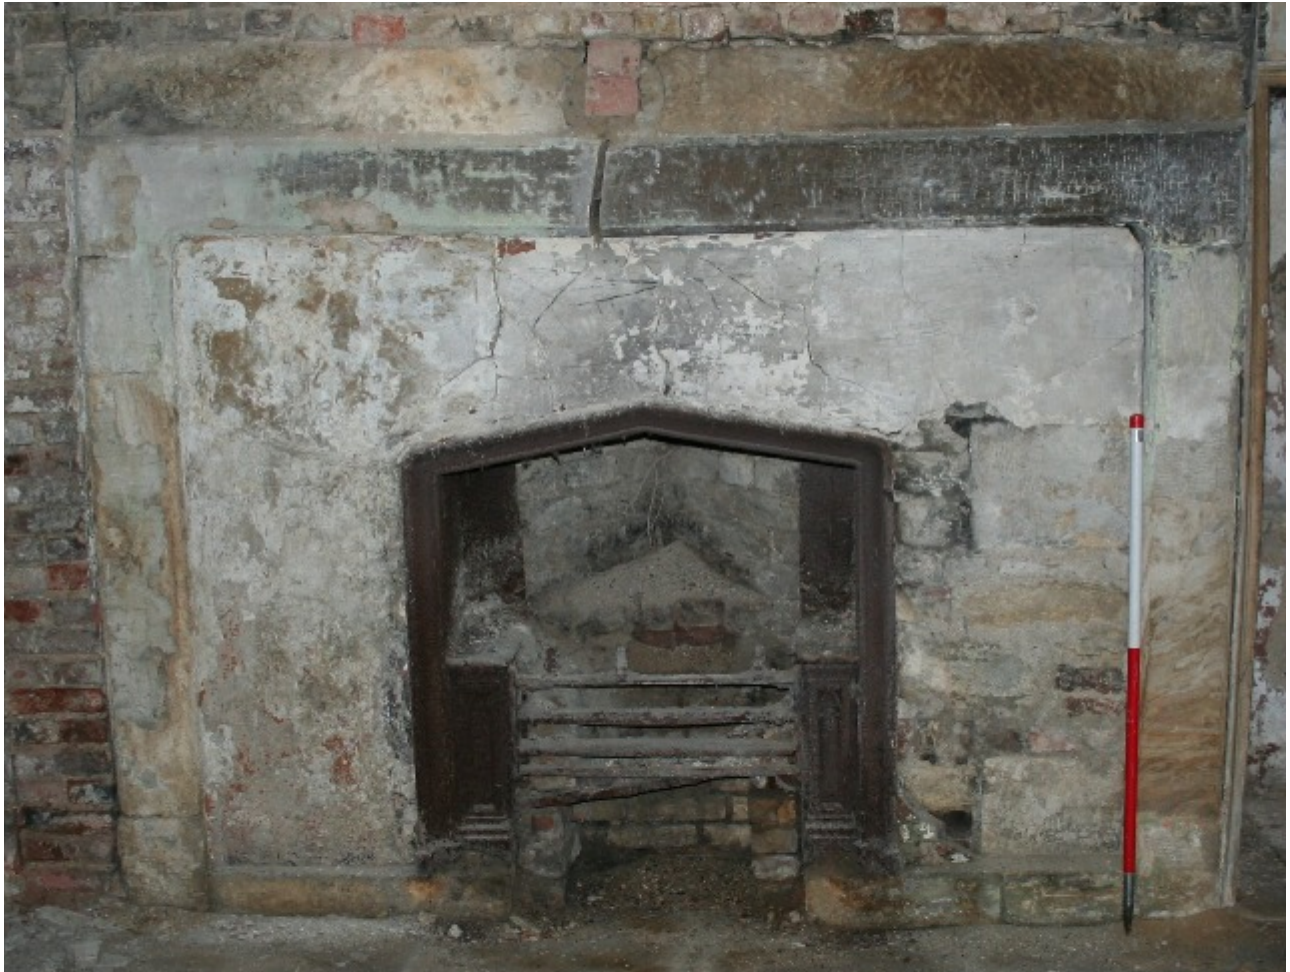
Plate 45. The fireplace, Area 48 (frame HHR13196)

room was stone flagged and the fireplace inserted into the earlier fireplace. In the 1930s, the ornate column was potentially inserted into the southern opening: the 1940s saw German POWs writing their signatures and messages in the plaster around the fireplace, which is now under threat of severe decay.

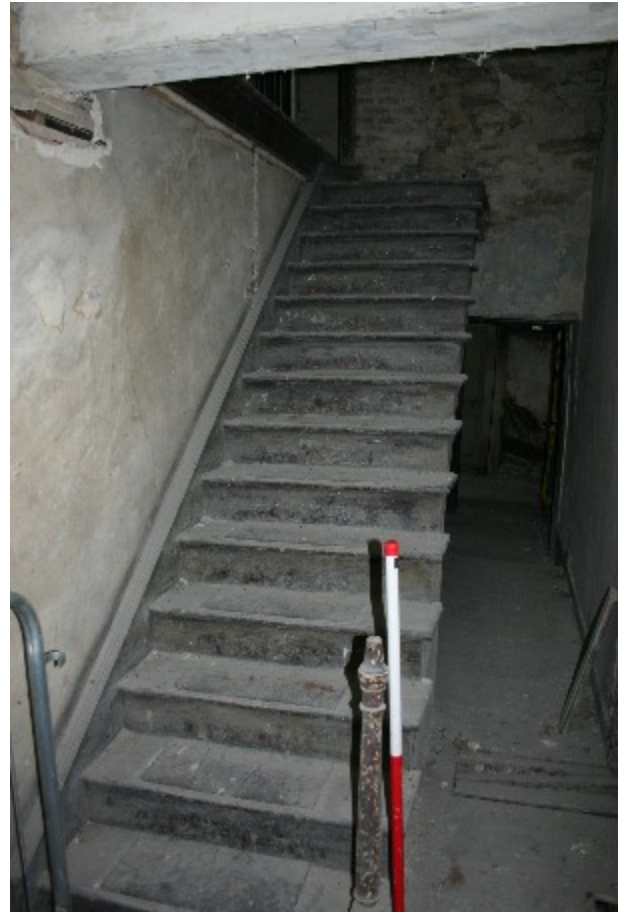
- 3.4.8 The ceiling is open to the first floor at the western and eastern extents of the corridor, with a staircase at the western extent leading up to the first floor. This staircase is in poor condition, with no rail remaining (*Plate 50*).

Plate 50. The stairs to the first floor (frame HHR13233)

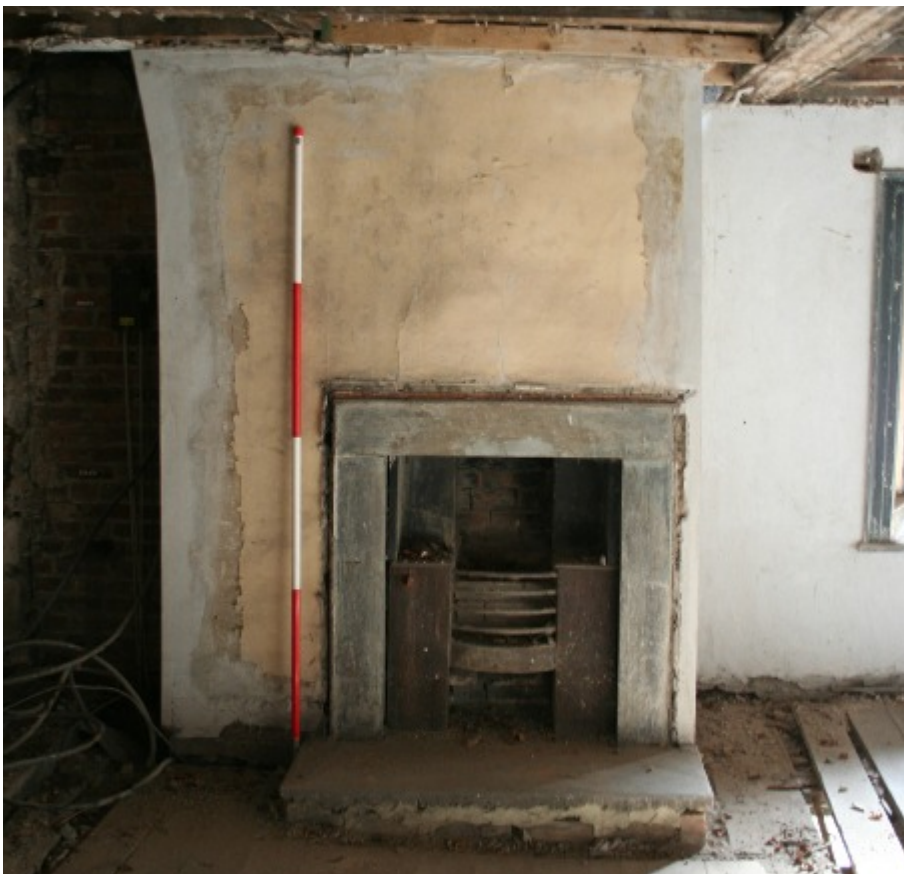
Plate 53. Fireplace in south wall and remains of arched alcove to the east (frame HHR13248)

- 3.4.14 In the south wall was a fireplace (*Plate 53*). The fireplace is similar to that in Area 15, a simple Regency style hob grate in a plain stone surround, only this time without any visible decoration. To the east of this was a slightly arched alcove.

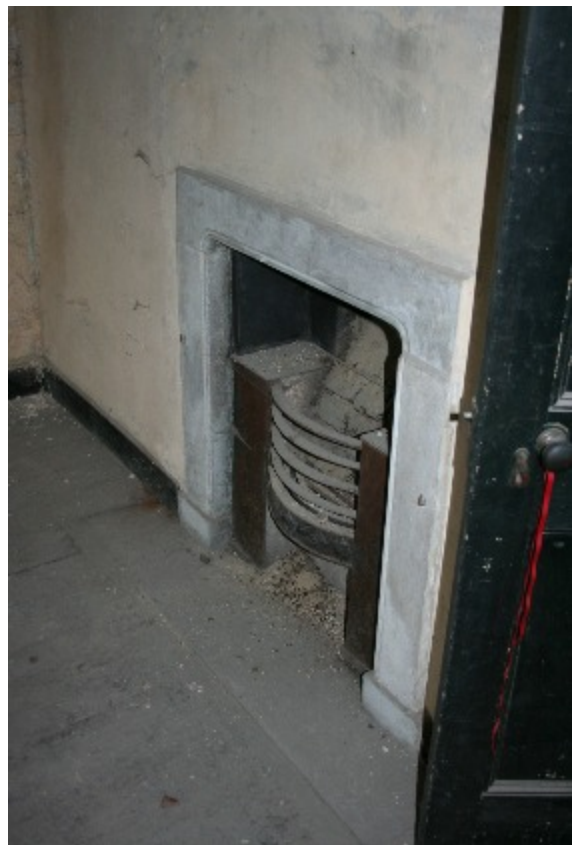
- 3.4.22 In the north wall was a small fireplace (*Plate 54*) with a basic mid-18th century hob grate identical to that in Area 36, with an identical chamfered stone surround to that in Area 37.

Plate 54. Hob-grate in north wall of Area 38 (frame HHR13255)

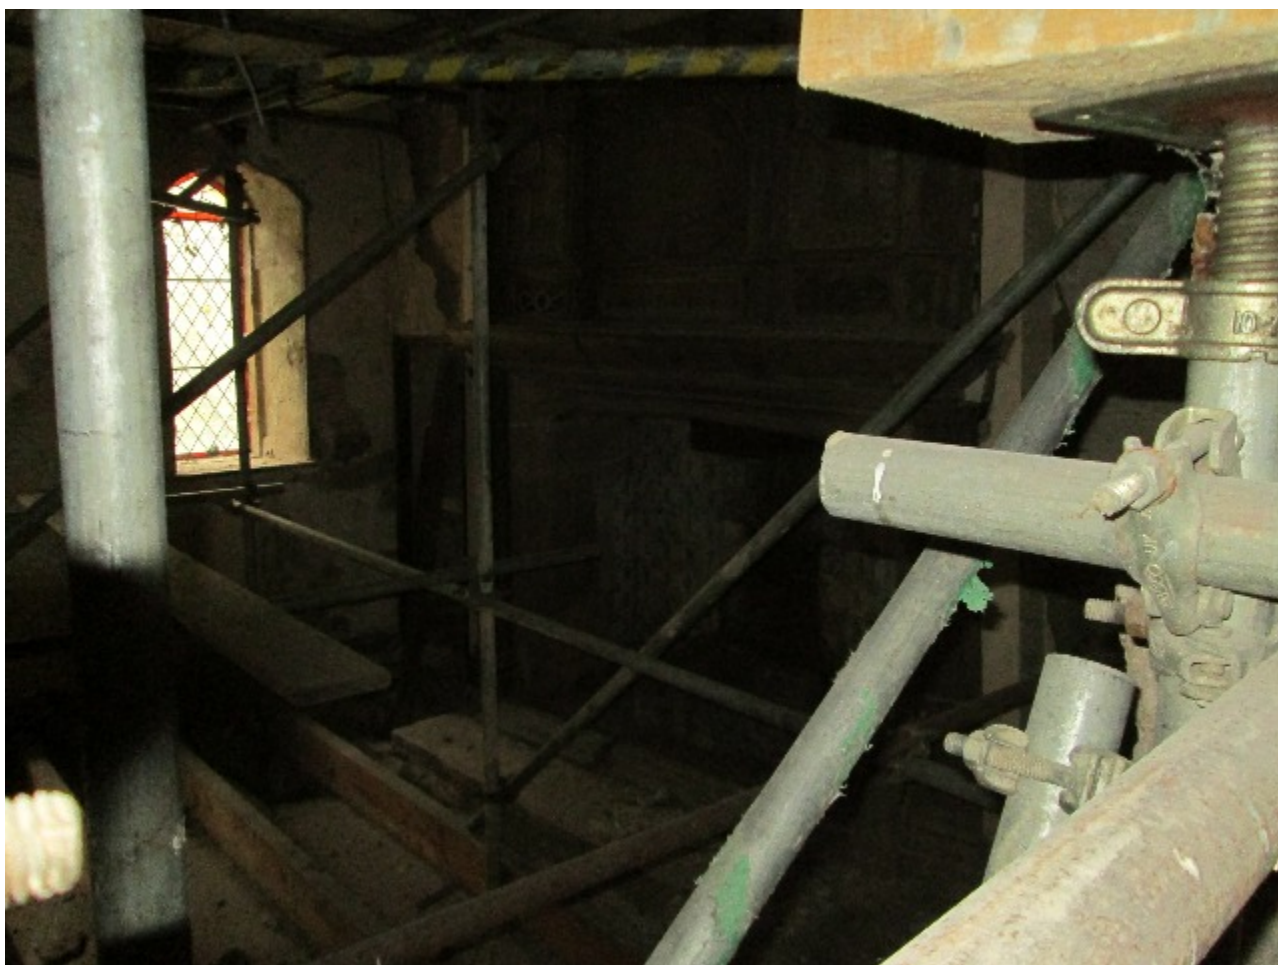
Plate 59. Area 41 (frame HHR13264)

- 3.4.x **Area 41:** 6m x 4.8m. This room was not accessible at the time of the survey due to scaffolding blocking the doorway. A very fine fireplace was visible on the eastern wall (Plate 59): the Dutch tiling work could possibly be 19th century, though the stone surround appeared to be potentially 17th century: closer inspection is required to adequately date the styling and craftsmanship: it is possible that this fireplace could have been brought in by Vereker from Beaudesert. The room also contained an early 19th century cornice, also in poor repair.

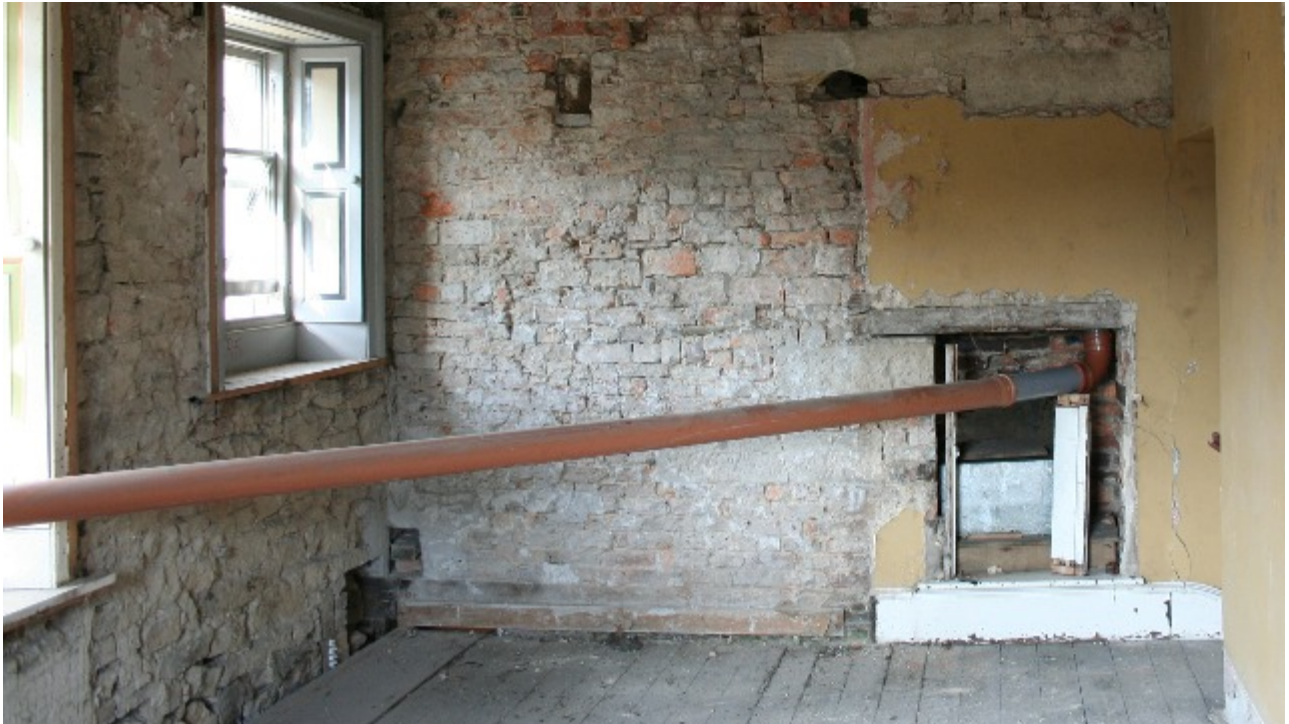
Plate 60. Area 2-5, north wall with mixed construction materials and duct (frame HHR13266)

3.5.2 The ceiling is completely missing in this area, revealing a modern roofing structure, and where the plasterwork has peeled off the walls, the construction can be noted as haphazard at best, with a mix of uncoursed stonework and brick forming the west and south walls, neatly coursed brick forming the east wall and a stone and brick patchwork forming the north wall, which also includes a number of stone lintels and blocks reused as building material (Plate 60). There is also a duct in the north wall revealing that the wall is double skinned (in brick) and containing heating apparatus.

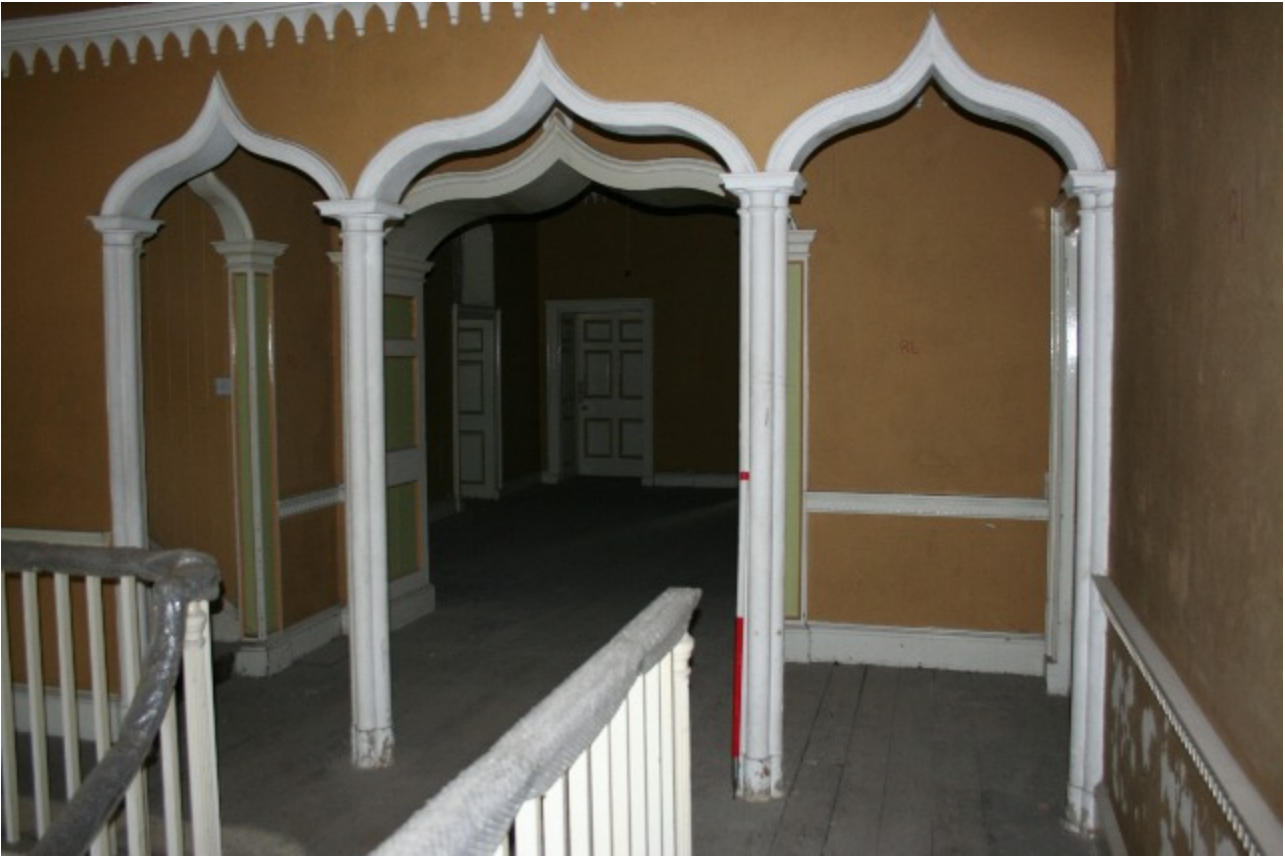
Plate 63. The ogee arcade (frame HHR13279)

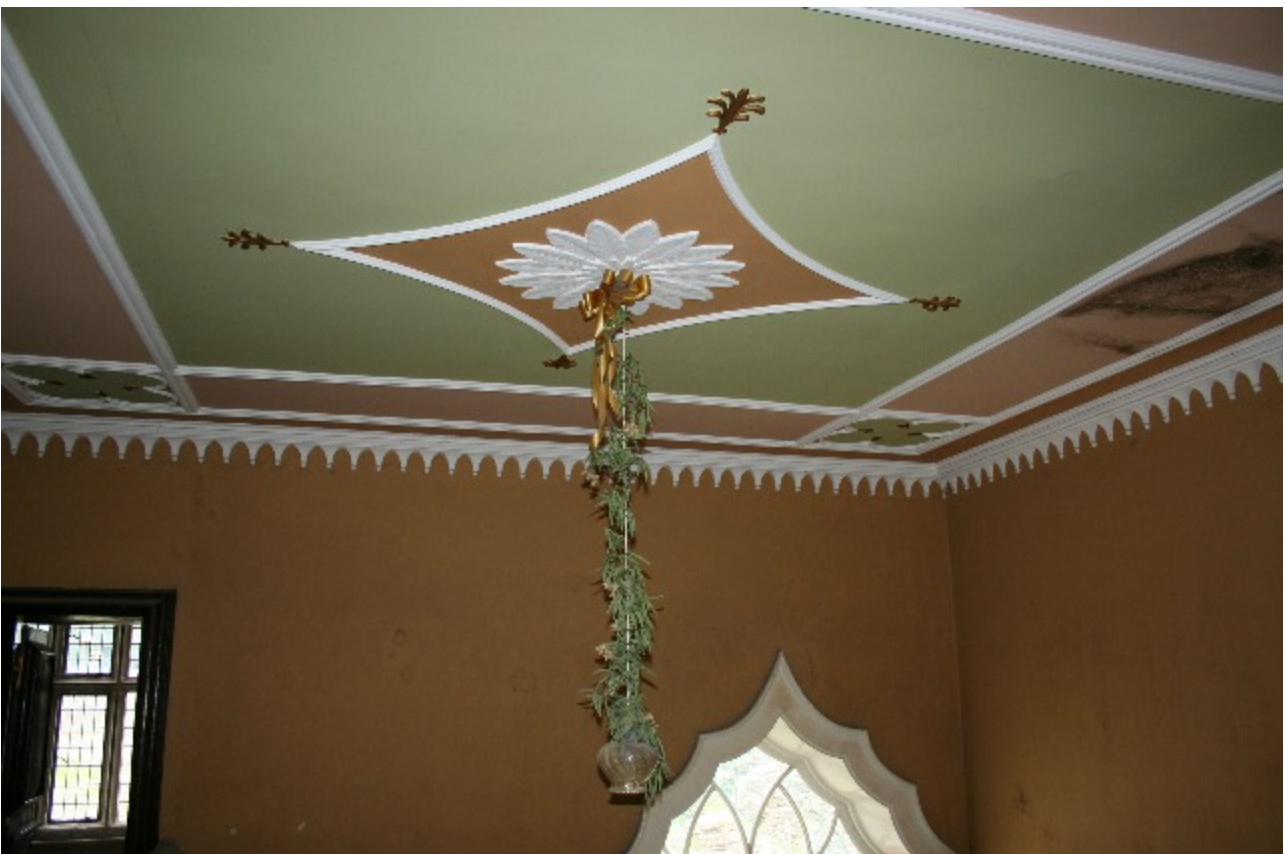
Plate 64. The Rococo Gothic ceiling and cornice (frame HHR13287)

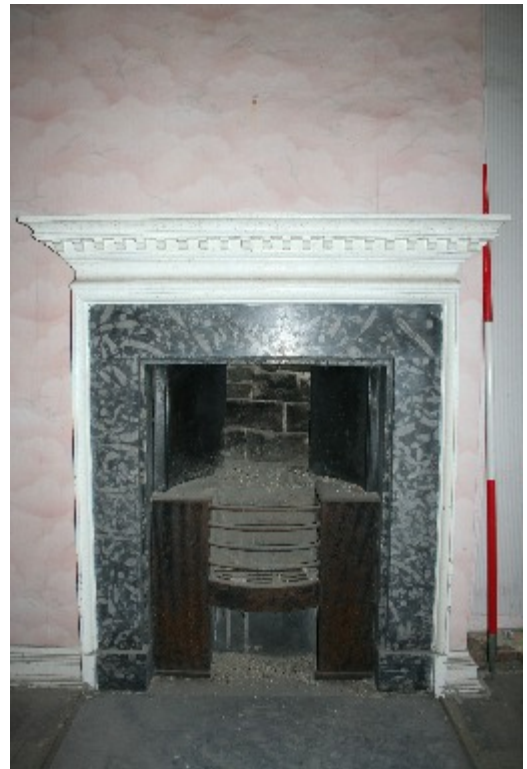
3.5.19 On the west wall is an ornate fireplace (Plate 65). Like many seen on this floor, the grate is a hob grate with etched fluting. However, the fireplace and hearth itself is constructed of Frosterley marble, and has an Edwardian surround.

Plate 65 (above). Frosterley marble fireplace in Area 8 (frame HHR13304)

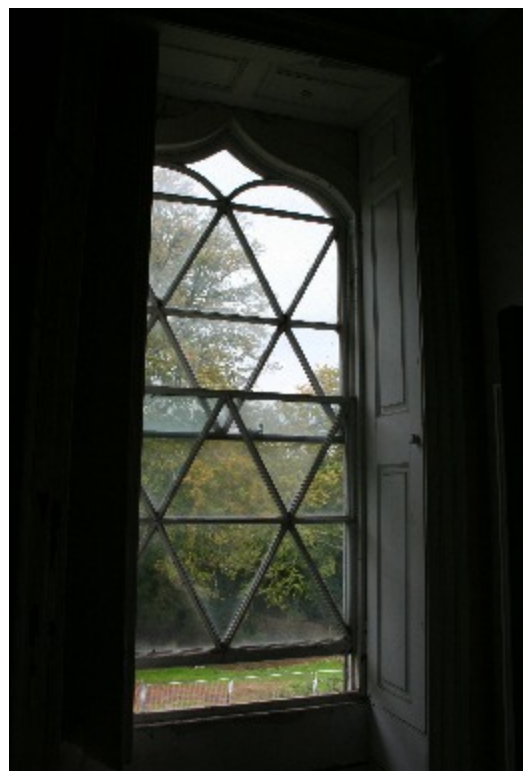
3.5.16 The room was used as a small bedroom, and may have originally been in use as a *boudoir*, and has a bracketed cornice with dentil moulding, as well as an ogee-arched sash window (Plate 66) in its northern wall with associated panelled folding shutters.

Plate 66 (below). Ogee arched window in Area 8 (frame HHR13305)

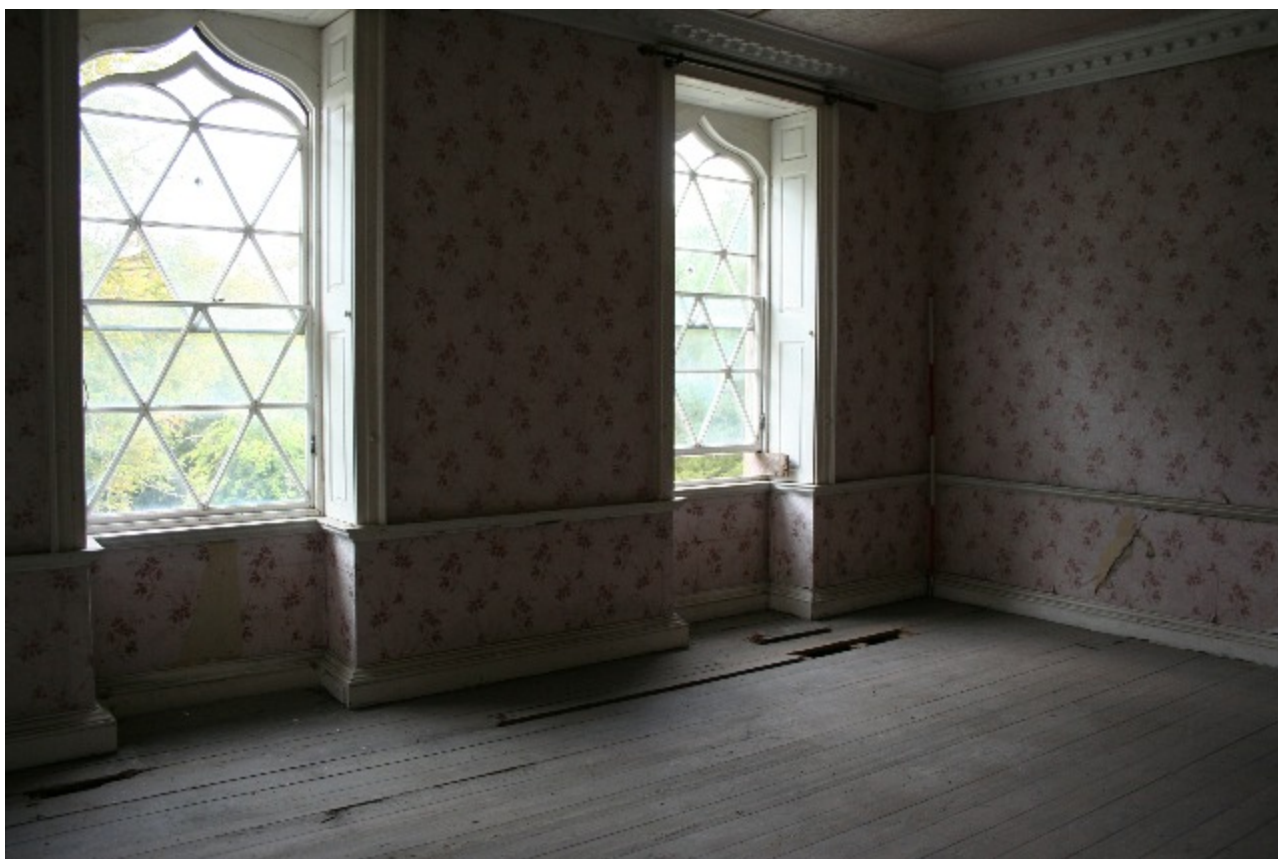
Plate 67. Bedroom Area 9 (frame HHR13310)
