Hamsterley Hall
Hamsterley
County Durham
NZ 14257 55637

Archaeological Building Recording
for Mr. Steven Spry

*Report no. 069-13-HS
Final Version January 2014*

VINDOMORA SOLUTIONS
Heritage Support

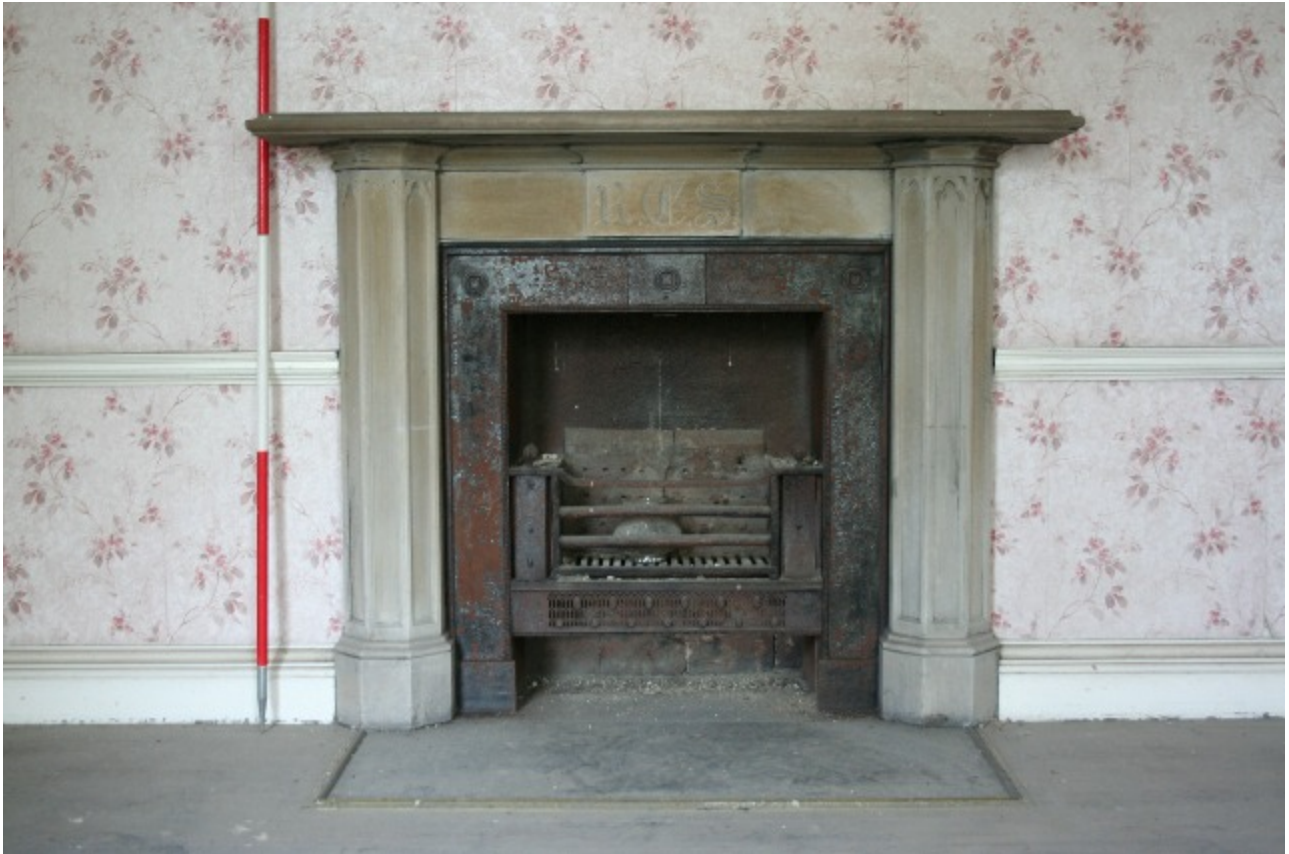
- 3.5.24 On the south wall is a large fireplace with a stone Gothic design surround (trefoil arches). The inset 'keystone' of the fireplace is inscribed with the initials 'RGS' in a bold Gothic script, which does not instantly tally with a known member of either the Swinburne or Surtees household linked to Hamsterley Hall. One tentative link lies in the churchyard at nearby Ebchester, where many of the Surtees family were buried. There is a Robert, son of George Surtees who died on the 18th December 1727, aged 59. Whilst this does not state that Robert did indeed have the middle name taken from his father, it was often a custom to do so, and this genealogical mystery requires more time to pursue: if the inscription is indeed Robert George Surtees, then the fireplace surround may well have been brought in from another family property during Robert Smith Surtees' residency in the 19th century. The firegrate is iron, decorated with quatrefoils and is a good example of a late 18th century register grate (Plate 68).

Plate 68. The Surtees fireplace, inscribed with 'RGS' (frame HHR13318)

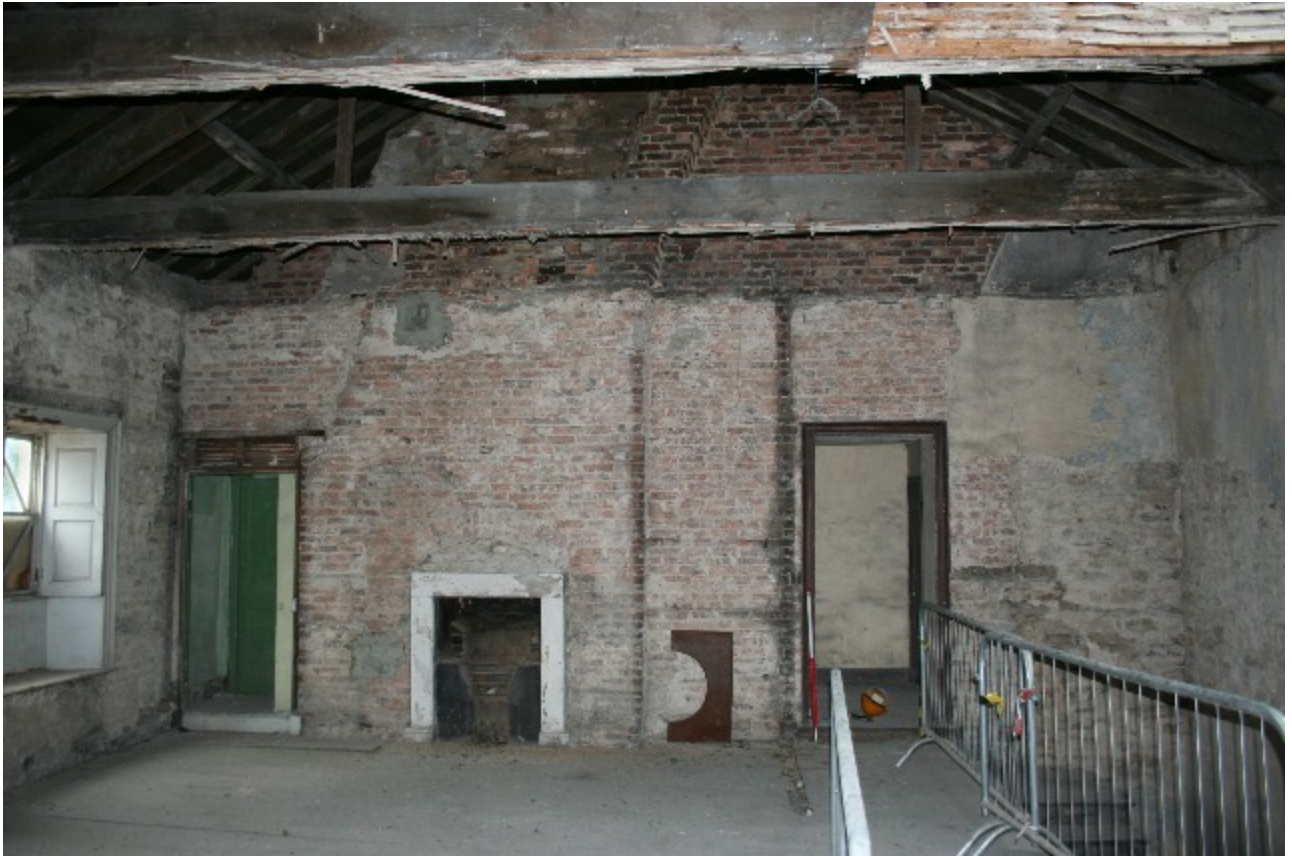
3.5.47 Area 27-30: 11.3m x 7.6m. This area is in a poor state of decay, and access to it and to the rooms lead off it was severely restricted on health and safety grounds. The floorboarding is broken and rotted

Plate 79. Area 27-30, looking toward Area 32. (frame HHR13355)

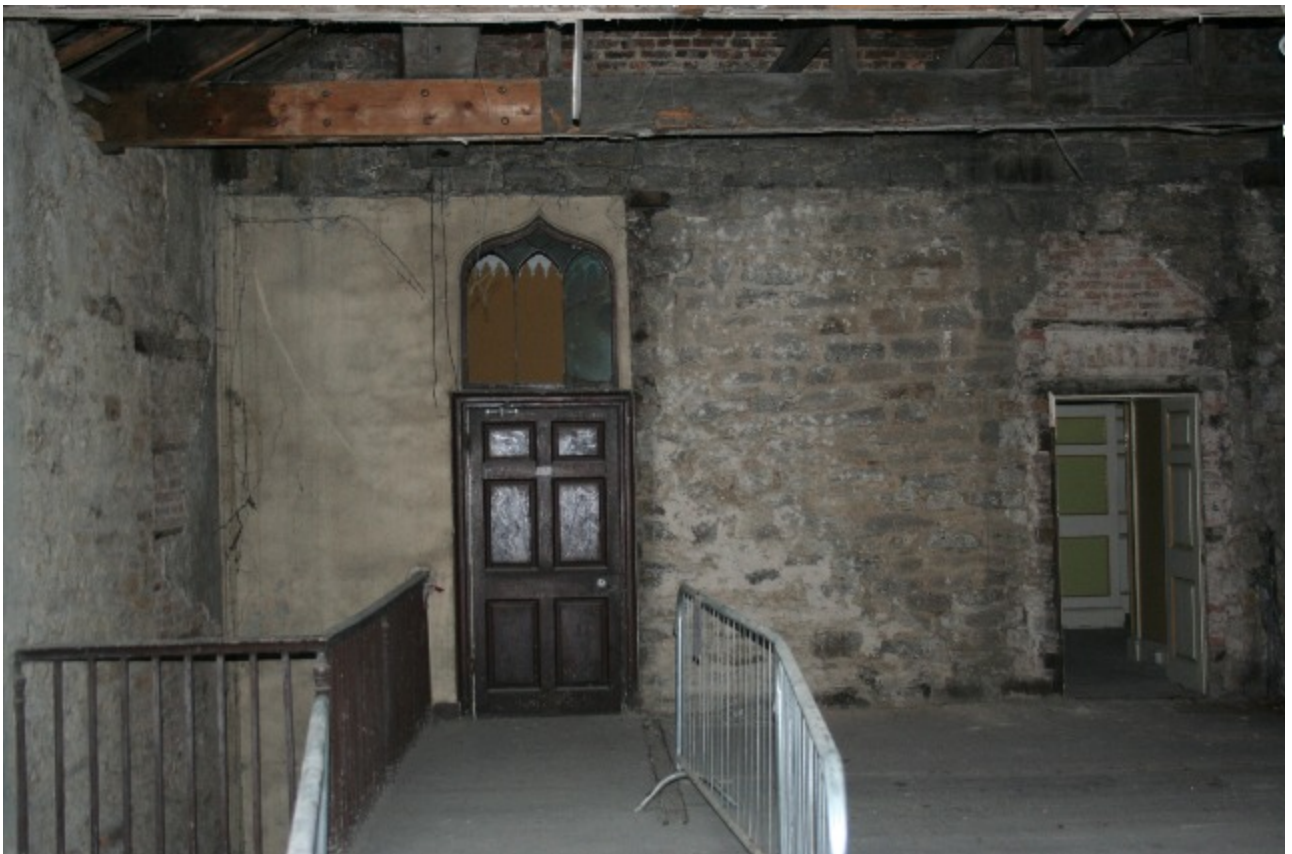
Plate 80. Area 27-30, looking toward the doors to Area 7. (frame HHR13355)

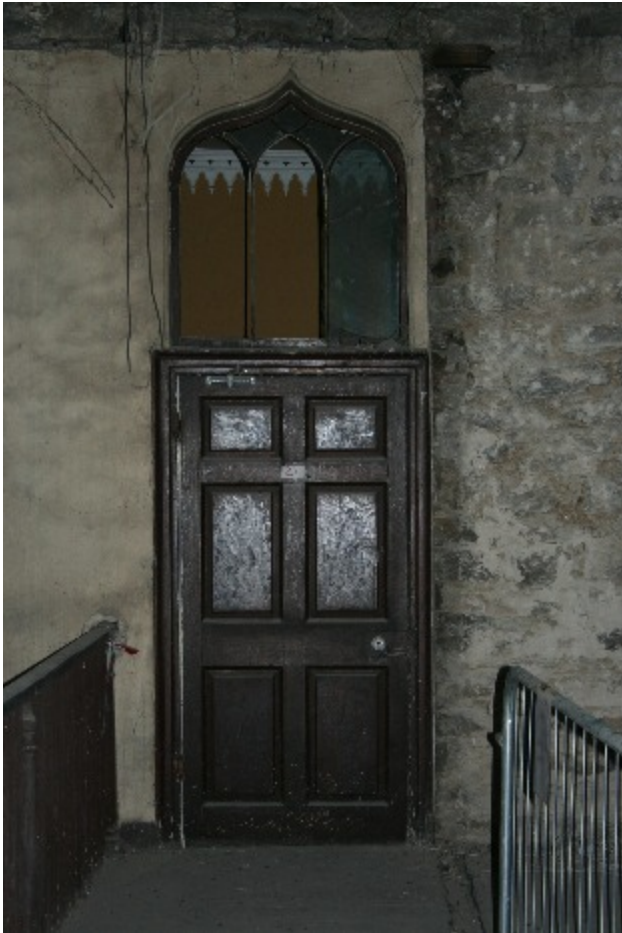
Plate 82. Doorway to Area 7, showing ogee-arched fanlight above door (frame HHR13368)

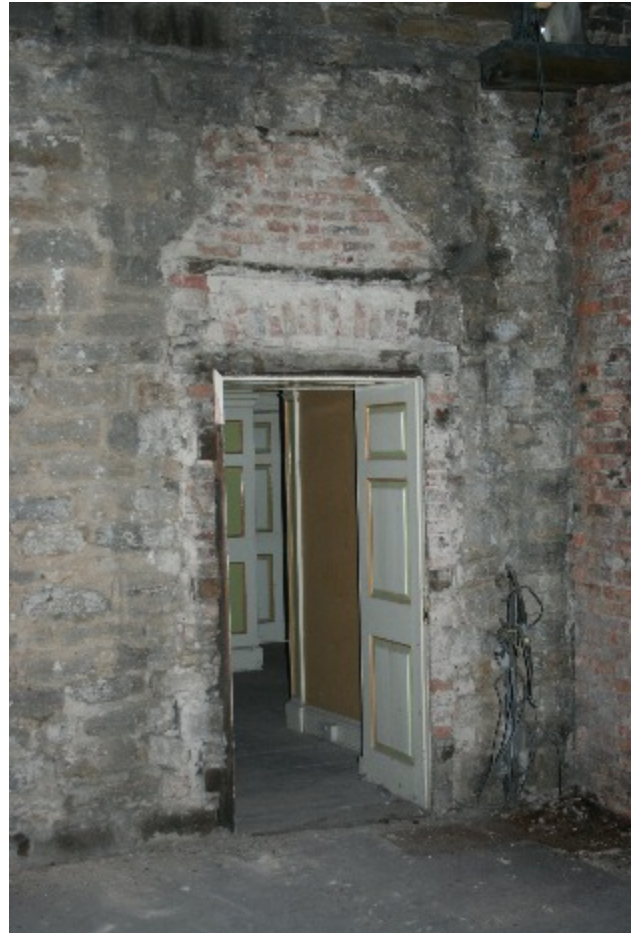
Plate 83. Doorway to Area 7, showing bricked up ogee-arched window (frame HHR13367)

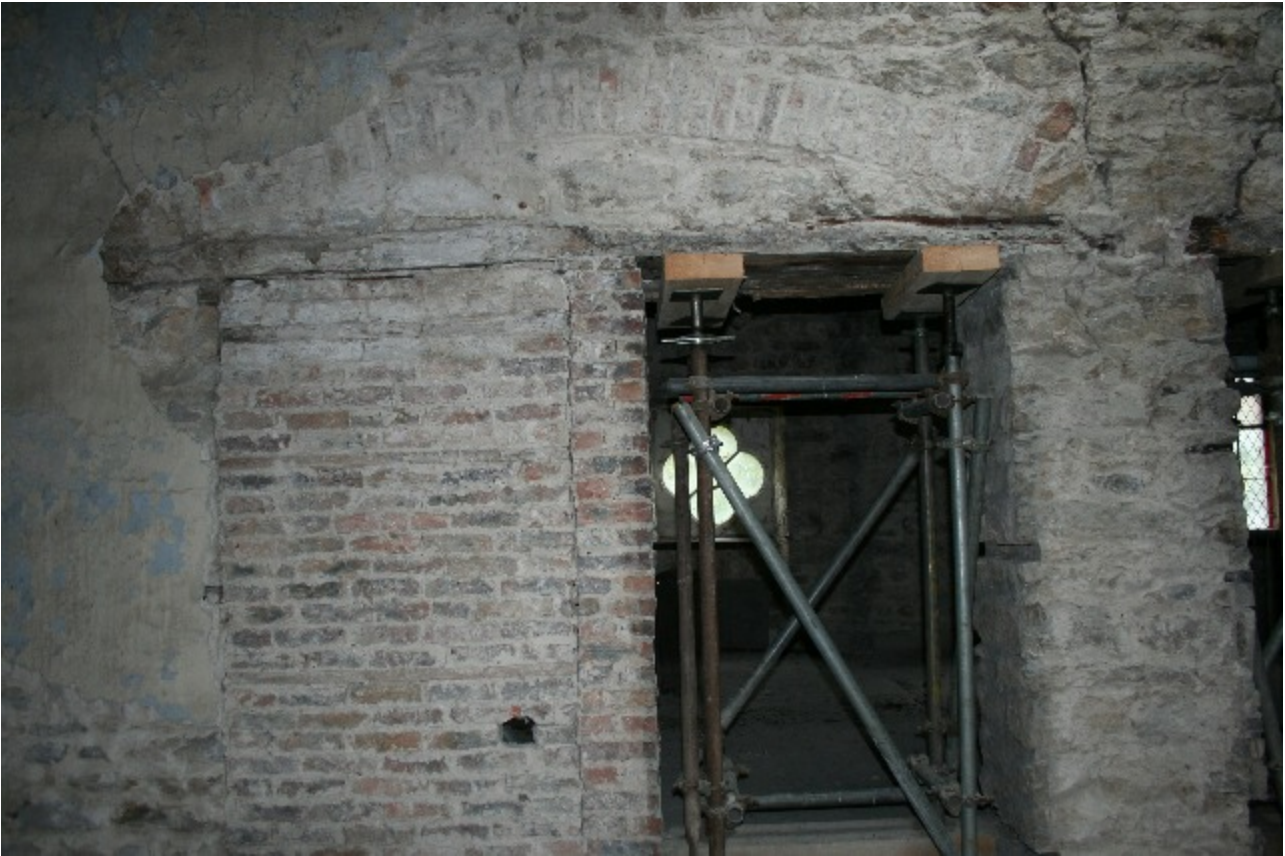
Plate 85. Blocked archway leading through to Area 33 (frame HHR13376)

- and 34 respectively. The western doorway (*Plate 85*), leading to Area 33, lies beneath a long timber lintel, over which is a brick-inset segmental arch similar to that seen over the fireplace in the western wall. Beneath the lintel is a central brick mullion, and to the west side of the mullion the recess has been bricked up with a straight-jointed block. The recess to the east of the mullion is open and provides access to the room beyond. This doorway is a much earlier feature than the surrounding layout, as the blocked recess lies over what is now the open stairwell.

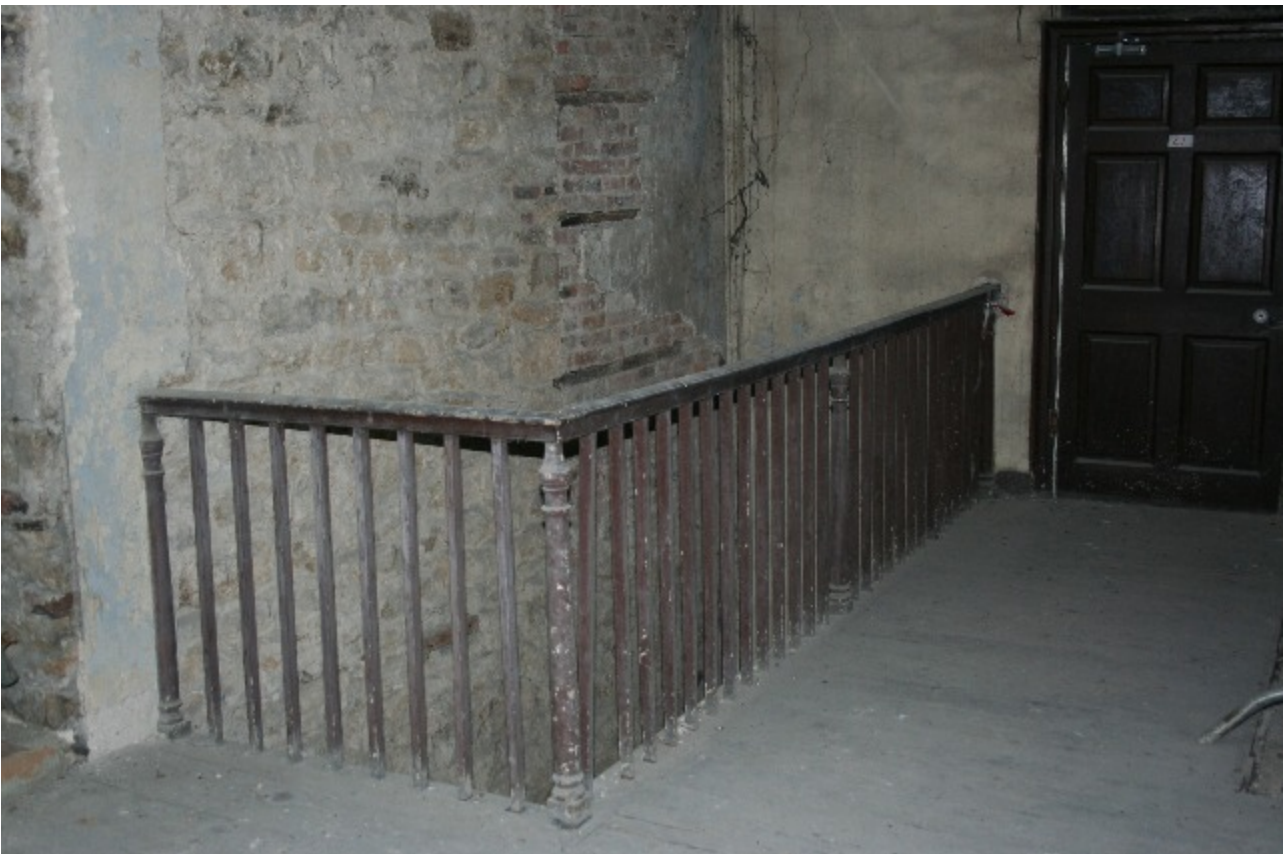
Plate 86. Blocked doorway above the stairlight, leading to Area 34 (frame HHR13382)

- 3.5.58 At the eastern extent of the wall is another blocked original doorway, this time lying directly above the rooflight balcony (*Plate 86*) and thus again belonging to an earlier phase of the building. This door would have once allowed access into Area 34, but has been blocked with coursed timbers and bricks.

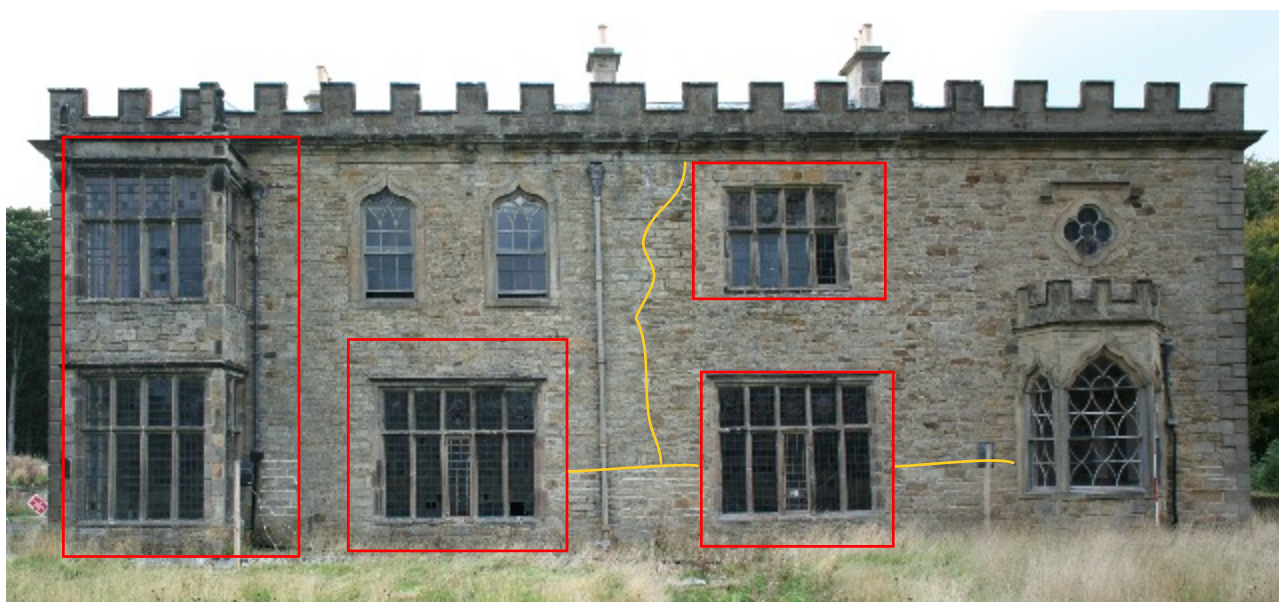
Plate 90. The eastern elevation with location of inserts from Beaudesert (red) and areas of different structural phasing (yellow) (frame HHR13405)

4.2.2 The actual main construction of this elevation can be split into two definite phases, with possible a third. Looking at this potential second phase in the wall's construction, the elevation can be roughly divided in two (as per *Plate 90*): the sandstone rubble on the northern half is finer, with the southern half rougher in nature and a slightly different colour. This may however be simply the product of repointing in the past, with only the southern half being done, giving the false impression of a separate phase of work. The definitive phase shift in this elevation however, is the whole southern extent, starting approximately 1m from the north of the southern bay, which appears to have a straight joint. This entire area (*Plate 91* shows the eastern elevation circa 1905 where the southern 'porch' can be seen to be wider) has been remodelled by Vereker in the 1930s. Evidence is also visible for repair and repointing to the 8-10 lower courses of the wall along much of the elevation's length.

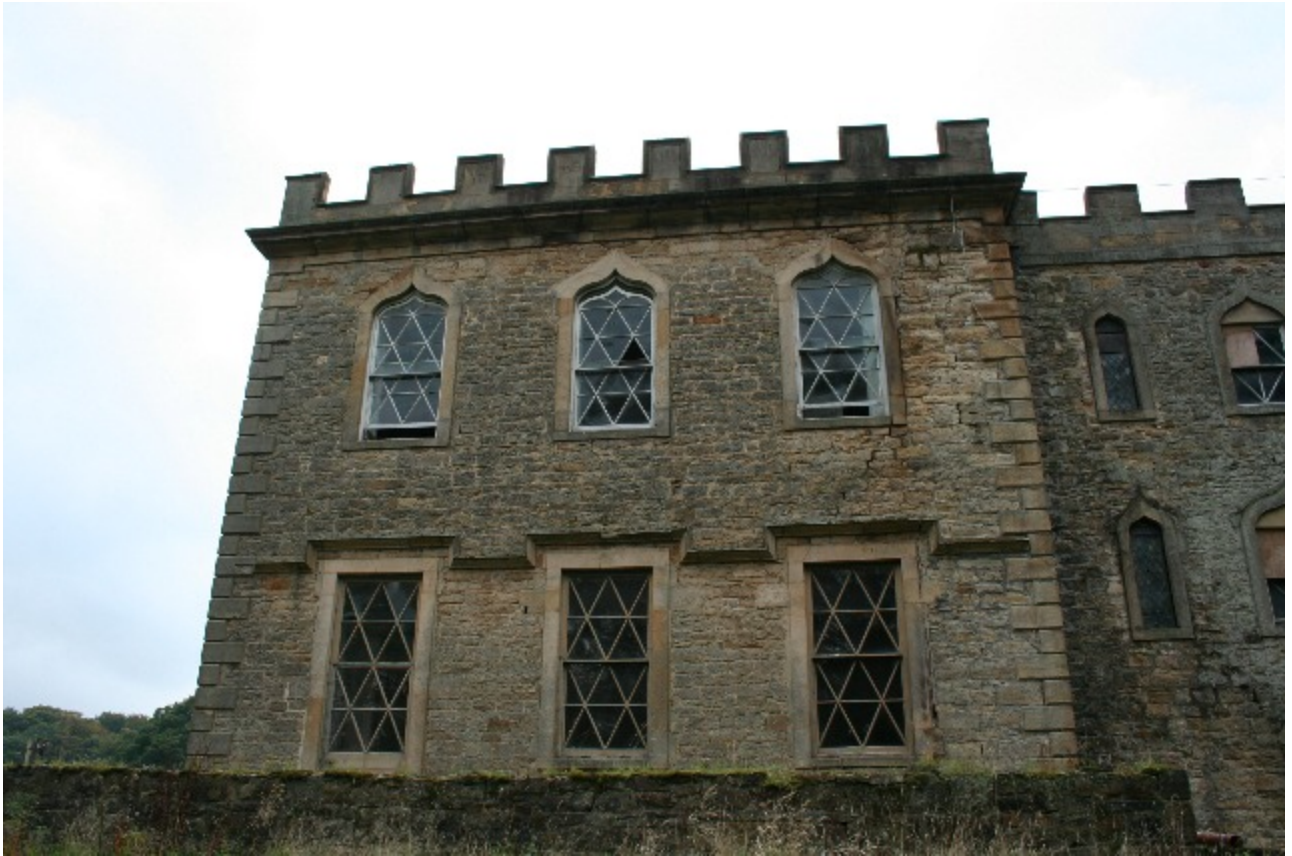
Plate 98 (above). The northern elevation, eastern wing (frame HHR13418)

- 4.2.13 Moving around to the north elevation (26.83m long), there are three phases of structural building work visible. To begin with, the eastern end of the elevation, ie. The northern gable of the eastern wing (*Plate 98*) is detailed below:

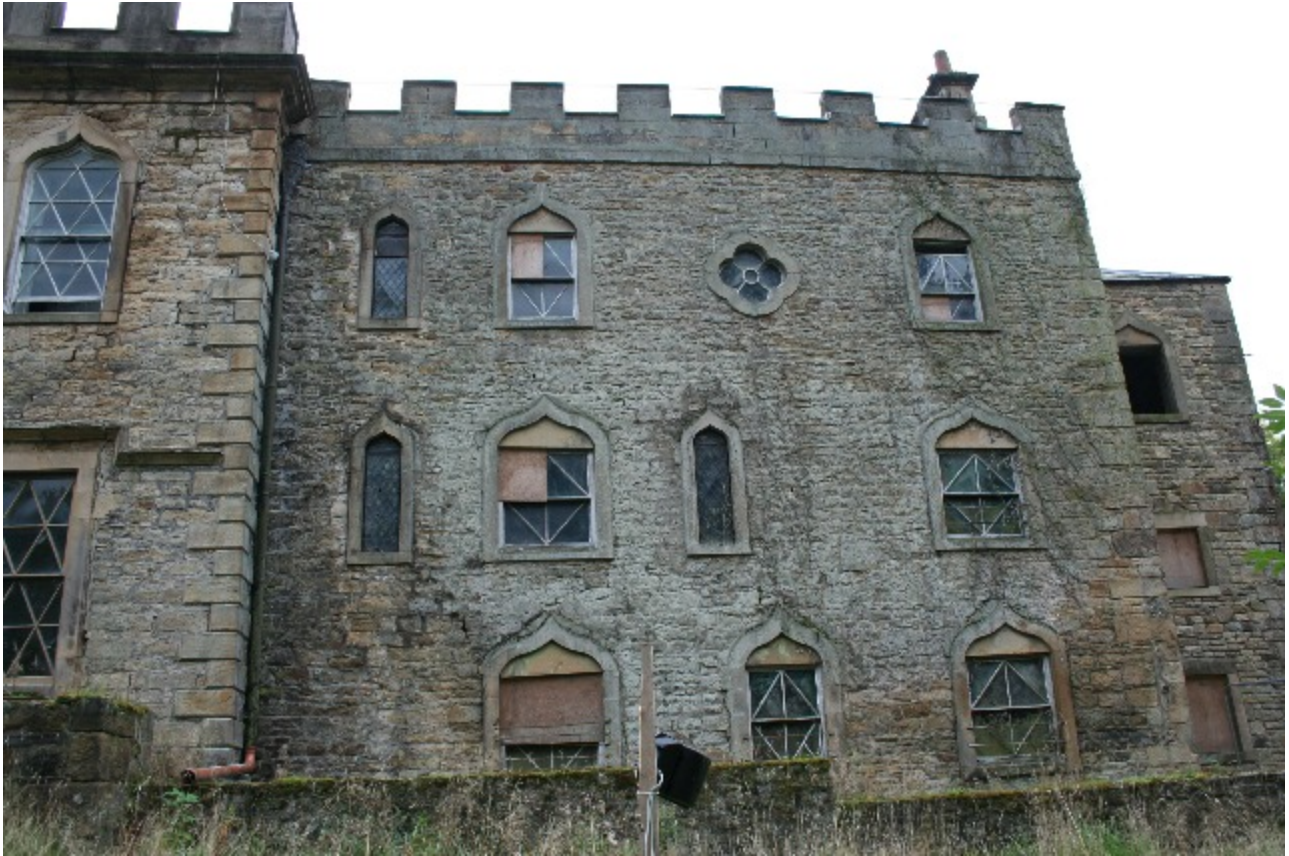
Plate 100. The northern elevation, central section (frame HHR13420)

(Plate 100). This section of the northern elevation measures 11.33m long and 8.9m high (to the base of the parapet). The wall is built of stone rubble, and had been covered by ivy for most of the building's later life. The roof has a Romanesque embattled parapet, but without the embellished coricing of the eastern wing. The elevation also shows signs of numerous repairs, especially its eastern extent with the original corner quoins having been repointed. The ground floor wall in this area also looks to be in poor condition, with evidence of a number of patches and repairs. The intersection between this block and the eastern wing also contains a lead rainwater head of the same design as seen on the eastern elevation, inscribed with 'HMS' for Henry [and] Martha Swinburne and '1769'.

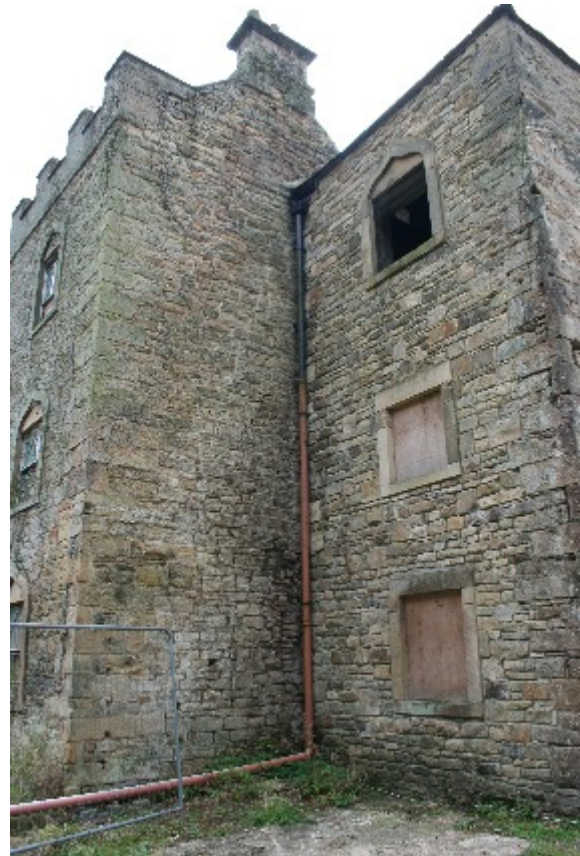
Plate 102. The rebuilt wall and western elevation of the original house (frame HHR13421)

- 4.2.25 Looking at Plate 102, it does become very apparent that looking at the western elevation of the original house, the embattled parapet was a later addition to the house and has been built into the roofline on the gable end.

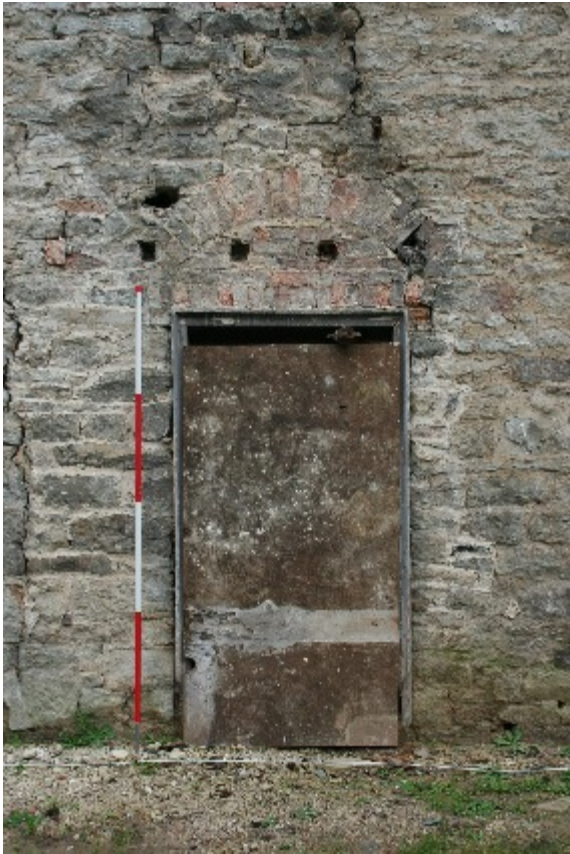
Plate 104. The northern door (frame HHR13426)

- 4.2.29 The northern door (*Plate 104*) can be seen to have replaced an earlier door, with remnants of the wooden lintel still in-situ. This door has a brick segmented arch above, and can also be seen to have once had a fairly large door hood, based on the holes where there joists would once have been. This suggests that at this was once an external door, which upon building the western wing became an internal door and the door hood was removed.

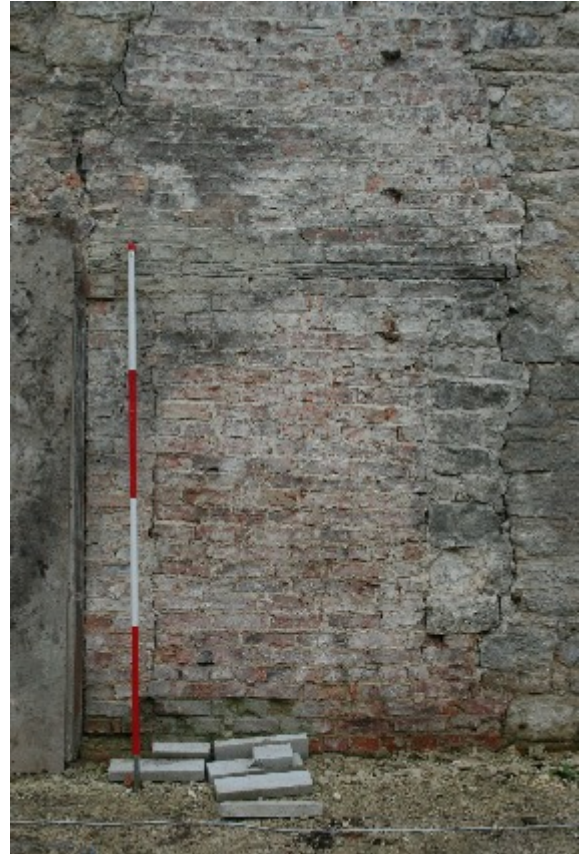
Plate 105. The blocked door (frame HHR13428)

- 4.2.30 The southern door also sports a brick segmented arch overhead, but this time without holes for a door hood, suggesting that this was set in place during the construction of the western wing. The blocked door (*Plate 105*) south of this has a plain timber lintel, but has been blocked by brick. South of this is another filled recess, this time of a small window. Access to the room inside was

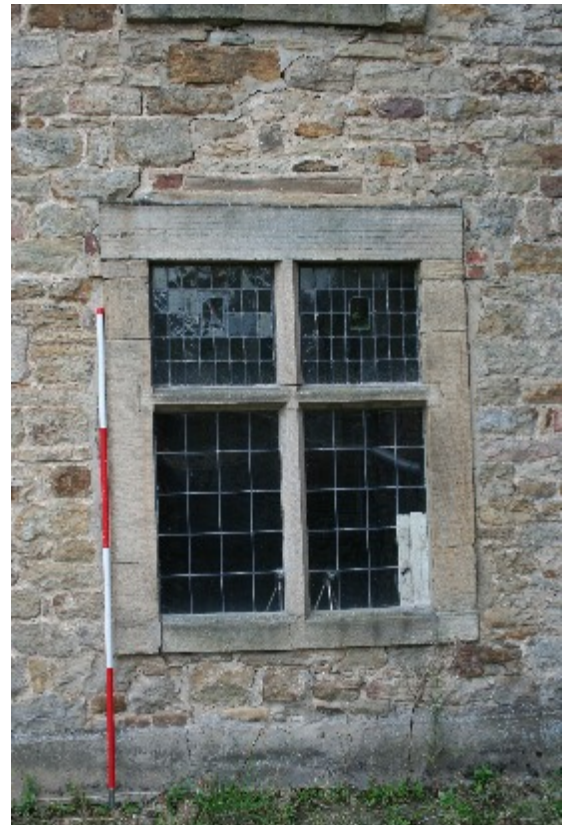
Plate 108. Detail of Window 39, showing blocked ogee-arch (frame HHR13433)

- 4.2.34 The ground floor holds two mullioned windows, likely imported from Beaudesert and placed by Vereker in the 1930s. The stonework around these windows can be seen to be repaired, the square windows obviously replacing ogee-arched windows (*Plate 108*).

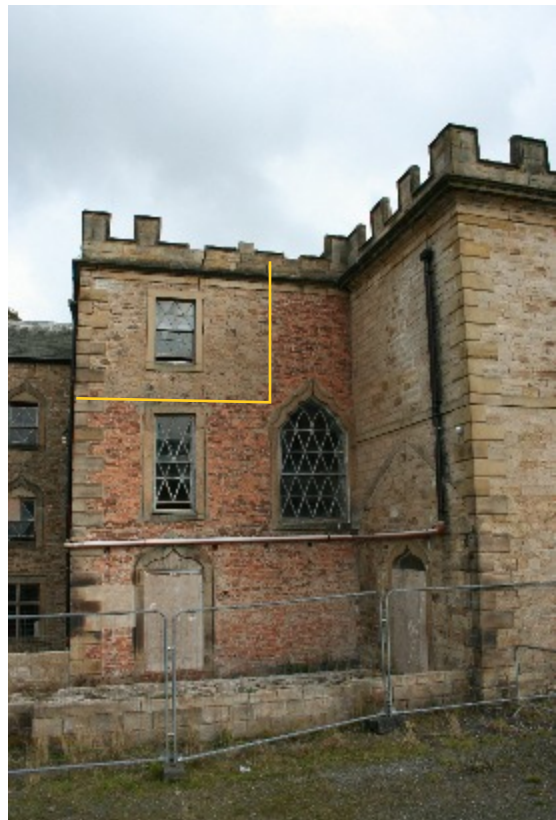
Plate 110. Later brick block, southern elevation, with phases in yellow (frame HHR13440)

4.2.43 Turning east, we see the southern elevation of the projection (Plate 110). The elevation holds three windows and one door, and the embattled parapet seems to be disintegrating over the join for the building of the upper floor of the projection, indicating some instability in the structure at this point.

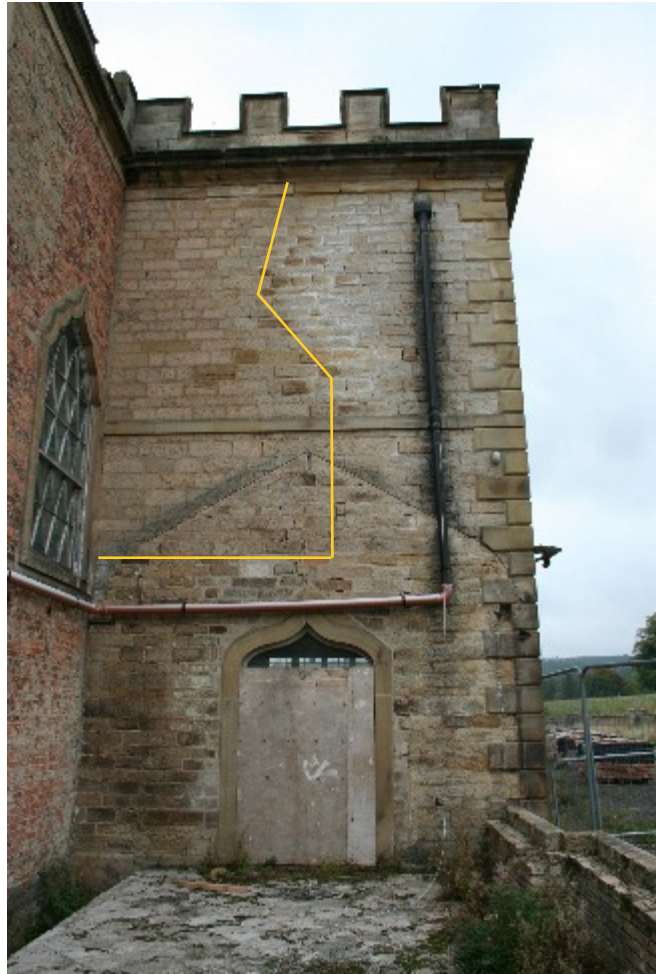
4.2.47 This elevation would have continued east, but has been blocked by the southeastern extension to the eastern wing (Plate 113). This extension has the continuation of the Romanesque corniced embattled parapet overhead, and is built of coursed sandstone rubble with ashlar quoins now the southwestern edge. The elevation still holds the scar from the dismantled early 20th century conservatory which used to reside in this area, and the stonework can be seen to be in two phases, suggesting heavy repair or replacement of stone at the inner extent.

Plate 113. The western elevation of the southeastern extension, with the stone phasing in yellow (frame HHR13441)

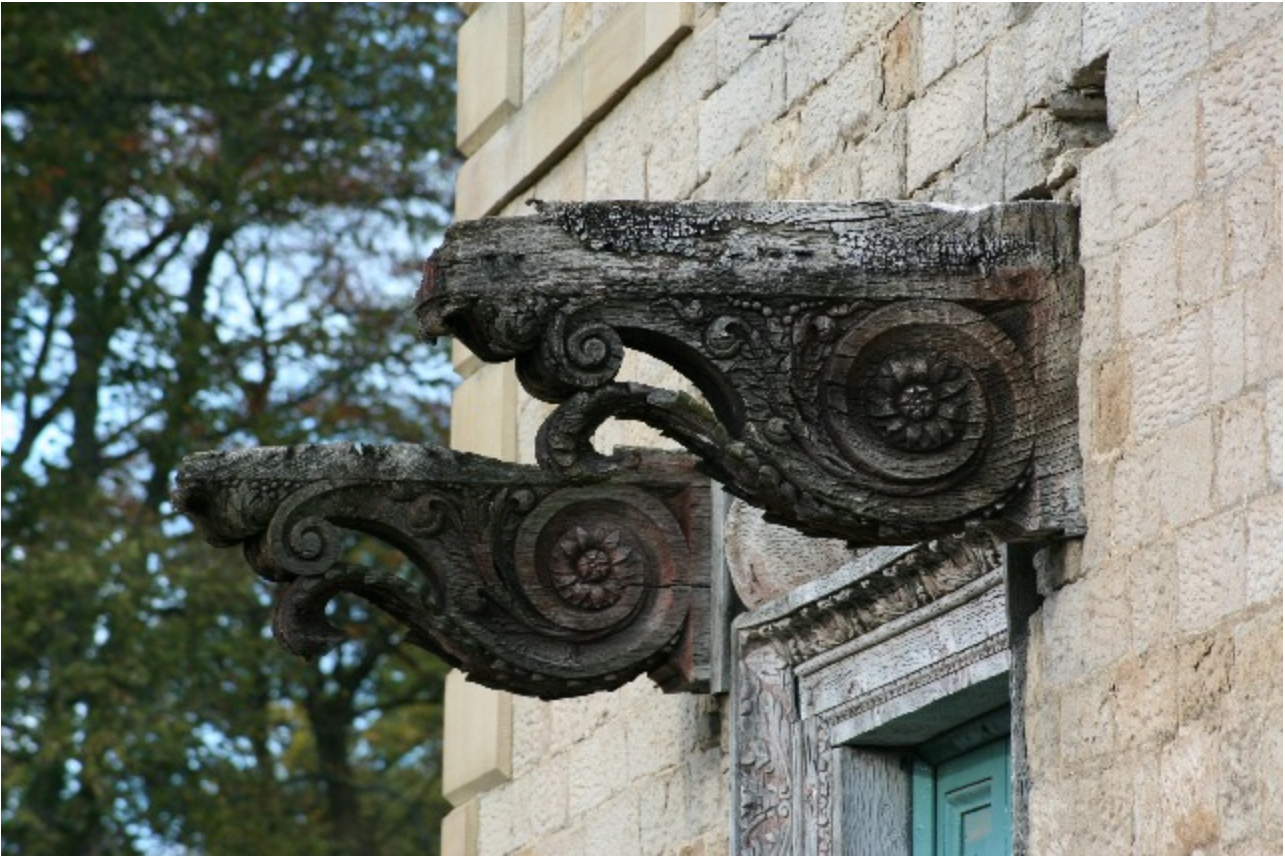
Plate 116. 17th century brackets

remaining (Plate 116). Looking at Plate 114, it can be seen that this Vereker import replaced an earlier Gothic ogee-arched transomed sash window.
