Bedlington Old School  
Front Street West, Bedlington  
Northumberland  
NZ 426015 581860

## Archaeological Building Recording

Dysart Developments Ltd

109-14-HS | December 2014

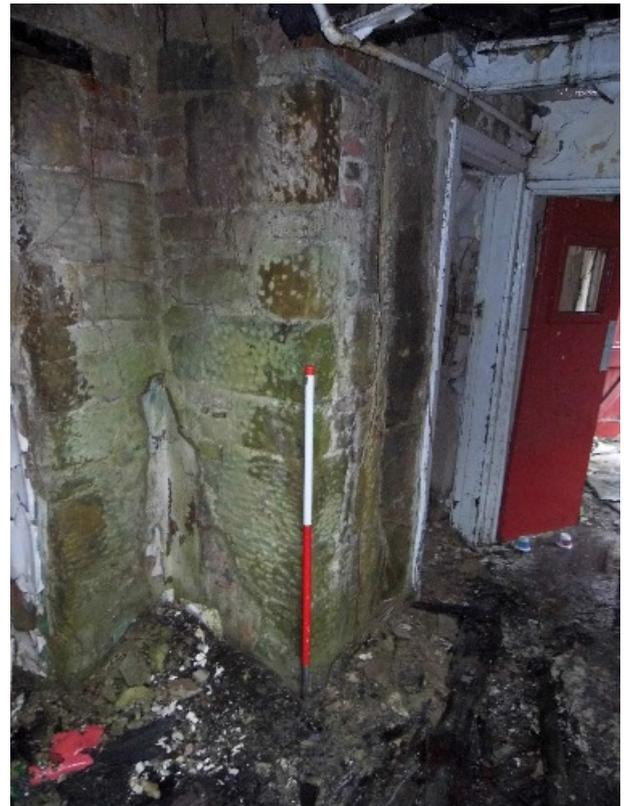
Plate 10. View from within the lobby, looking southeast (frame BOS14022)

3.3.3 The lobby area is structurally unsound in its ceiling and in debris strewn across the floor. Of interest in this area is the visible stonework that once marked the edge of the original phase 1 school build. Plates 10 and 11 show the area in detail, with Plate 11 providing a close-up view of the original building edge.

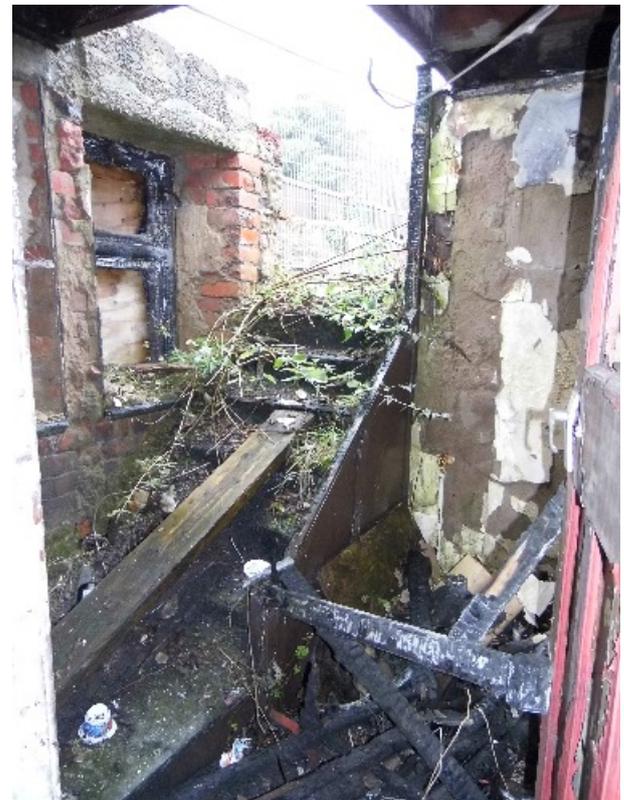
Plate 13. The kitchen (Area 4) looking southwest (frame BOS14026)

- 3.3.8 **Area 4 (kitchen):** 5.1m x 4m. The kitchen was severely damaged by fire (see *Plate 13* above), rendering it too dangerous to enter. The room was photographed from the doorway. The ceiling had mostly collapsed and the floor was strewn with debris, making it impossible to gauge safe footing.
