Cow Tag 198 Function Code P11.3 P11.4

Brief Description: [timber element, p/s, condition, fragments]
Portuli Plank, broken off at scarf end facing aft; Forward scarf slightly damaged too

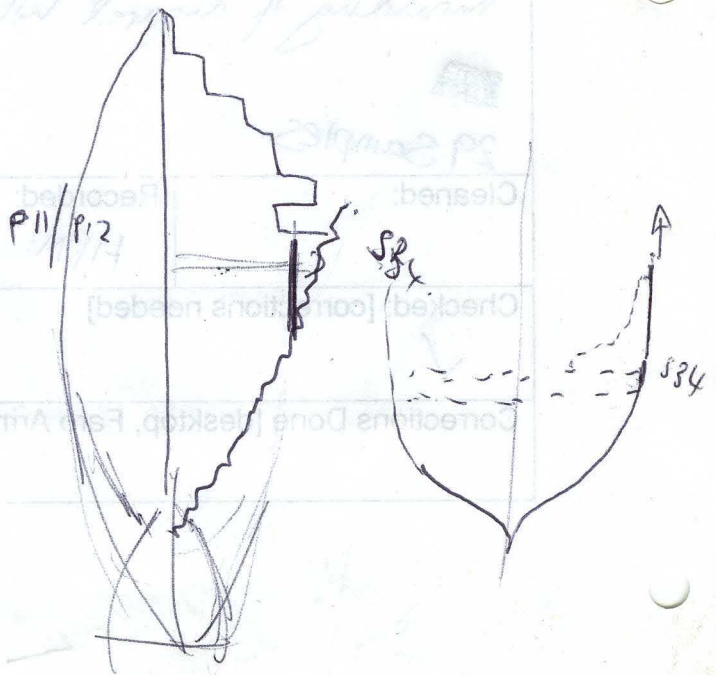
cut back to take
O/S traps

Armed hole (indicated)
normal from inward, has under
from station 22.

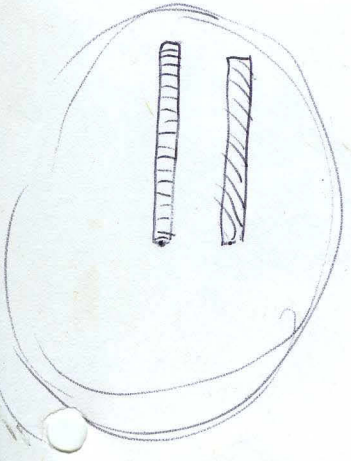
198 P11_3 hpm 27/06/05

- scribed line between ~~4+5~~ treenail at F24 inboard
- 2 additional nails at scarf (forward)
- 3 additional nails ~~at~~ between 2+3 treenails F25+F26 (inboard)
- ON THE BOW SIDE SCARF - ~~EDGE~~ LOWER EDGE -> AROUND / UNDER ~~IT~~ V. SMALL ADDITIONAL NAILS - ~~LOOK LIKE~~ IN CRACK (?) HAVE BEEN FOUND SOME PLANT MATERIAL. SAMPLE NO
- lower forward inboard face at scarf - 4 additional nails
- V. interesting, unfinished, unused angled hole (8x10mm) at F22 - mistake? for next one join of planking? Suggests holes angled from inboard and with c 8mm bit. 2 treenails at F22.
