| Cow Tag 207 | | Function Code 54.4 |
| Brief Description: [timber element, p/s, condition, fragments] VERY WELL PRESERVED PLANK | | |

207 S4_4 Toby N. Jones 15 March 2006

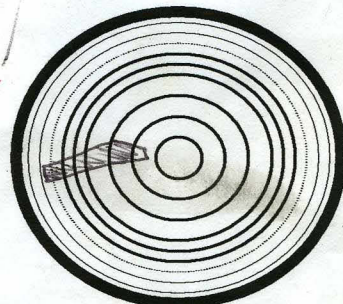
| Notable Features: [tool marks, scribed lines, decoration, repairs] POINTS TO LOOK OUT FOR WHEN RECORDING ufos 6 INSCRIBED LINES AFT OF FORW. END, INBD. - Type 2. Several tear tears on inboard face near knots. | | |
| Wood Science: [rings, ARW, knots, sapwood, conversion] Substantial Sapwood, Tight grain - good dendro candidate. Interesting variety of treenail heads - narrow + wide mid ft. knots. Some knots off radial aft becoming radial forward. c 125H + 10'S ARW = 233/135. Pith beyond lower edge. | | |

| Recommended action: [samples, additional photos, moulding, queries and problems] Check inboard cross nail (see plot) against relevant framing timber for spike. DENJ. Photos - see plot. | | |
