THE HA HA

PRIEST WOOD AND VICAR WOOD KEDLESTON HALL, DERBYSHIRE

Archaeological Evaluation and Walkover Survey on behalf of the National Trust

Document No: TJC2016.25
OASIS No: thejessop-255360

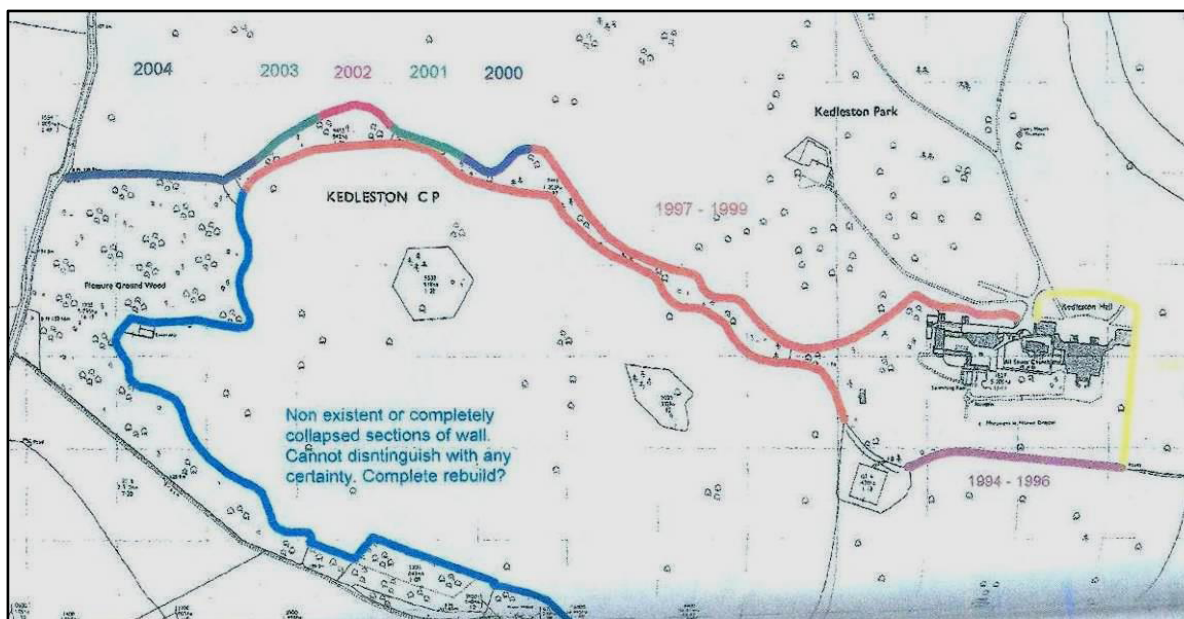
Figure 4: Location of repairs undertaken by the National Trust (after HTLA 2015, Fig.5/48)

It should also be noted that the extant masonry and brick sections of the ha ha have previously undergone a programme of maintenance and rebuilding as appropriate. This work was initially undertaken between 1994 and 2004 by the National Trust (see **Figure 4**), with subsequent repairs still in progress following the 2008 Quinquennial Inspection.

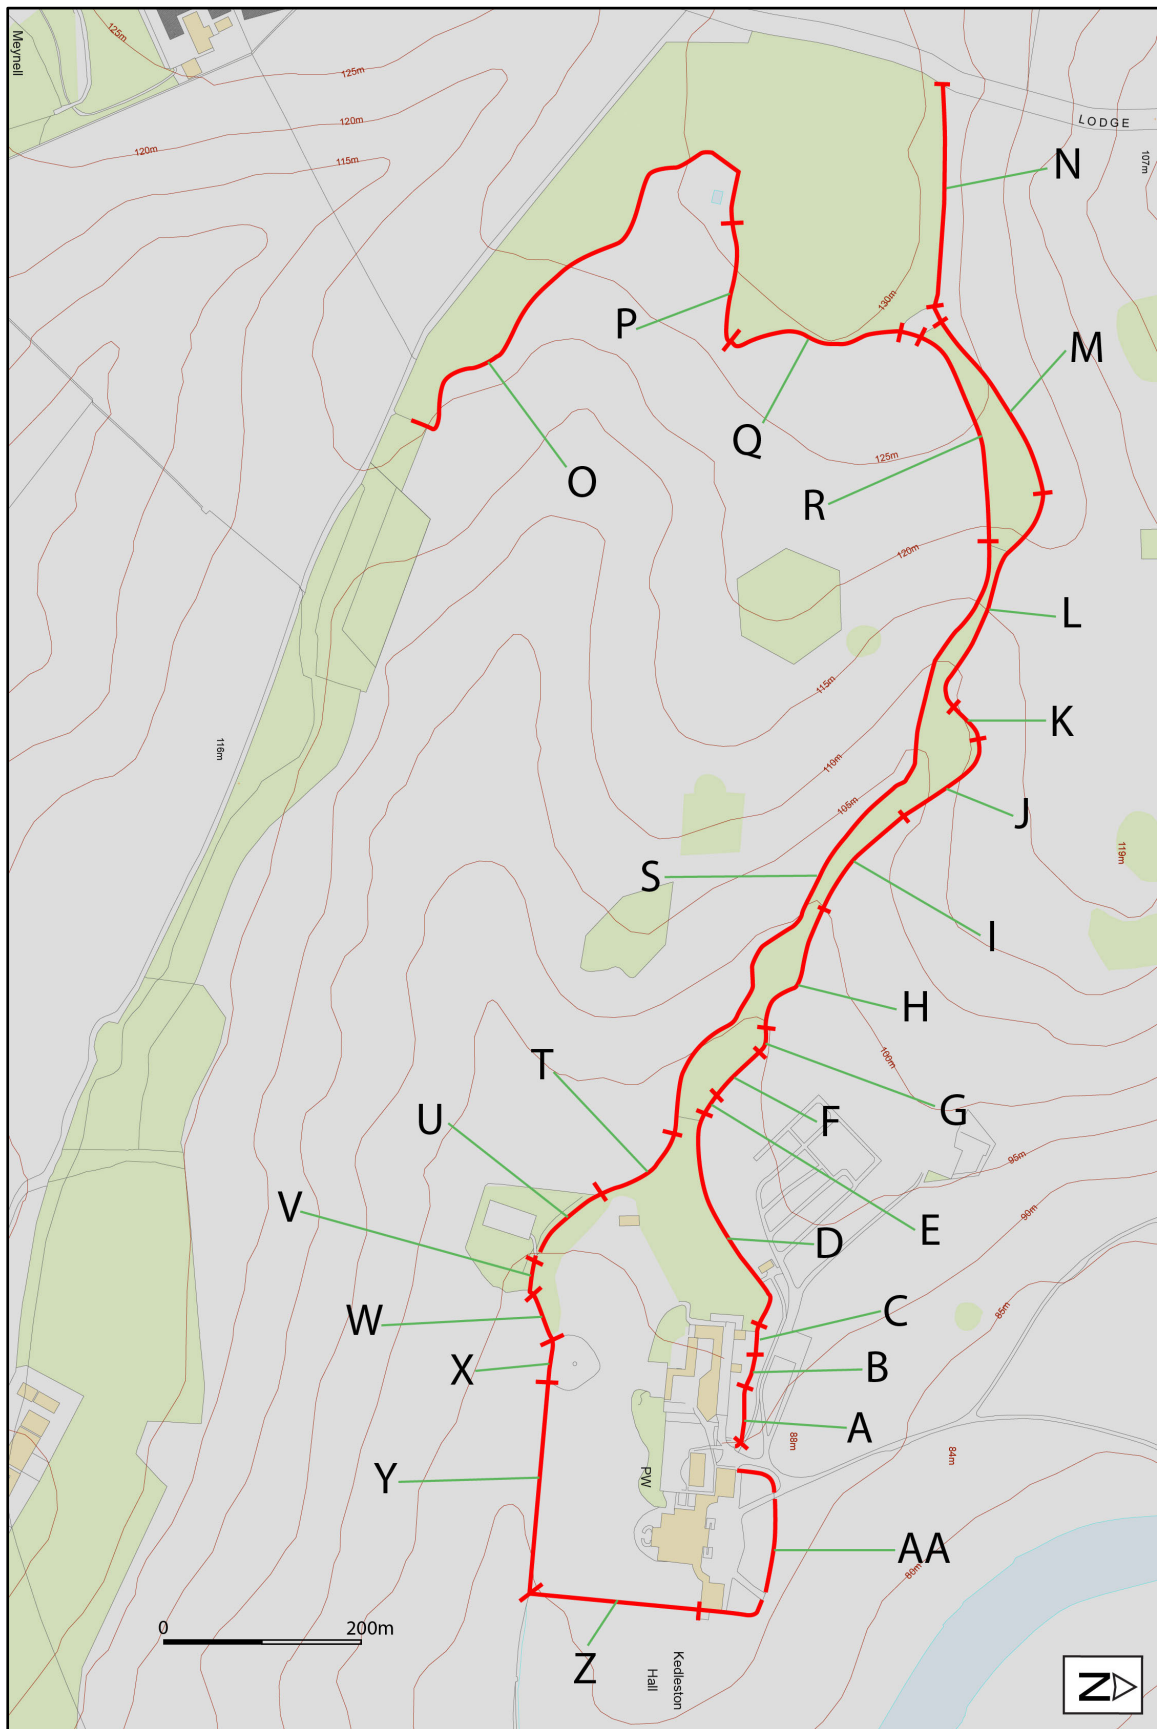
Figure 5: Location of constructional segments of ha ha (A-AA)

This section of the report presents a summary overview of the whole of the ha ha that circumnavigates Kedleston Hall, the gardens and Pleasure Grounds. The wall was examined in the form of walkover survey, the results of which are presented as a gazetteer as **Appendix 4** and on **Figure 5**.

This programme of archaeological investigation of the ha ha that circumnavigates Kedleston Hall and the Pleasure Grounds has established that the ha ha has a total of 27 different distinct sections of walling (**Figure 5**).

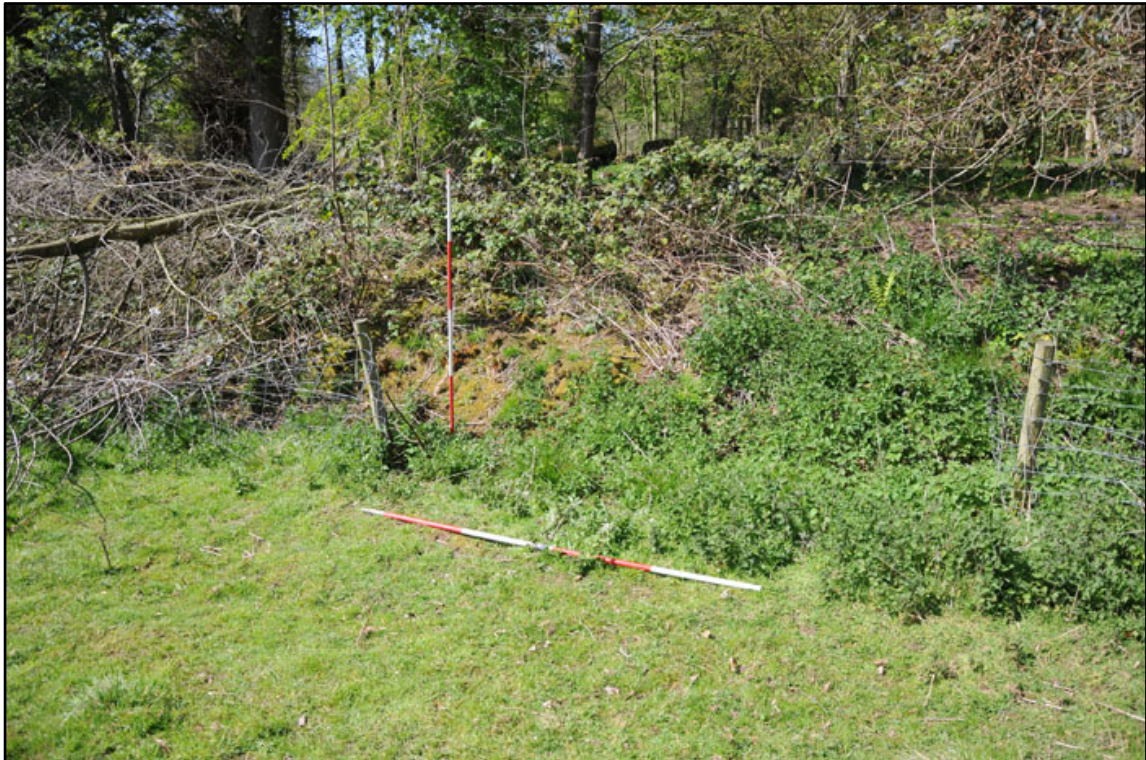
Appendix 3.1: General view of TrI prior to excavation, looking southwest (2m scale).

Tr1 measured 1m x 6m and was orientated west-east (**Figure 2**). Prior to the excavation, no traces of any masonry were visible and the course of the ha ha was denoted by an earthen bank c.1.5m in height and with a gently curved profile (**Appendix 3.1**).

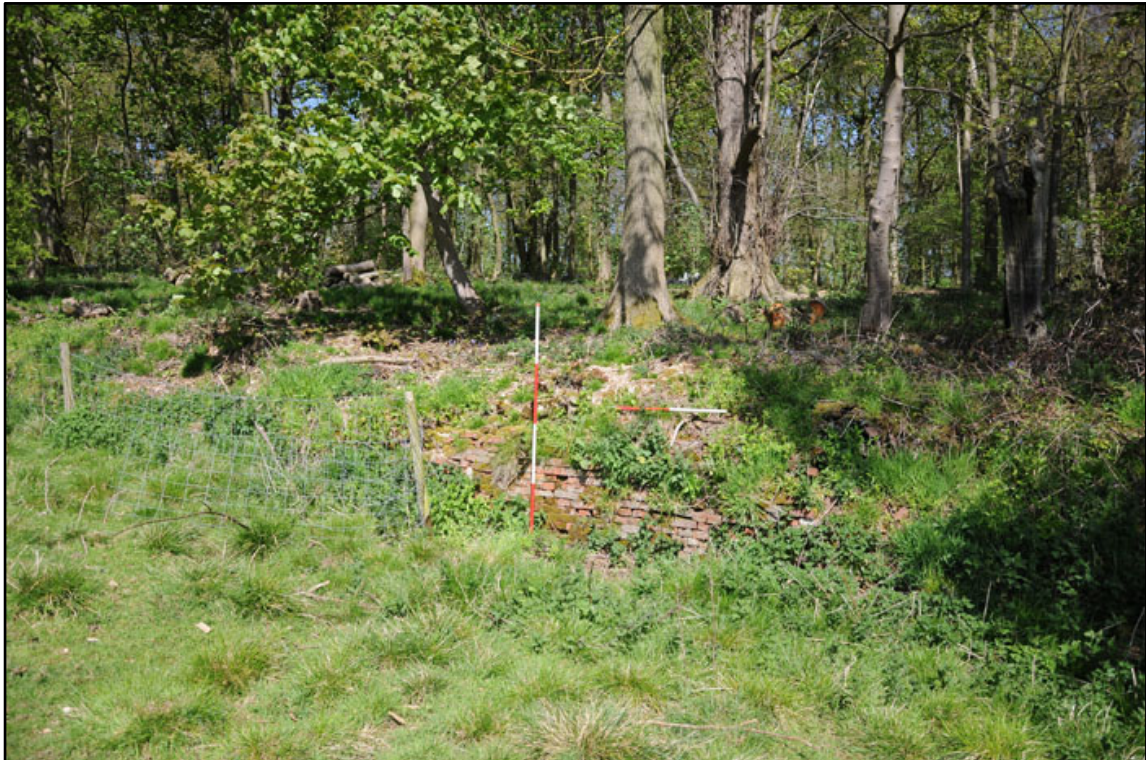
Appendix 3.5: General view of Tr2 prior to excavation, looking northwest (2m scale).

Tr2 measured 1m x 5m and was orientated north-south (**Figure 2**). Prior to the excavation sections of brickwork **203** (**Appendix 3.5**) were recorded that formed an external face to the ha ha that was 1.3m in height with an angled profile.

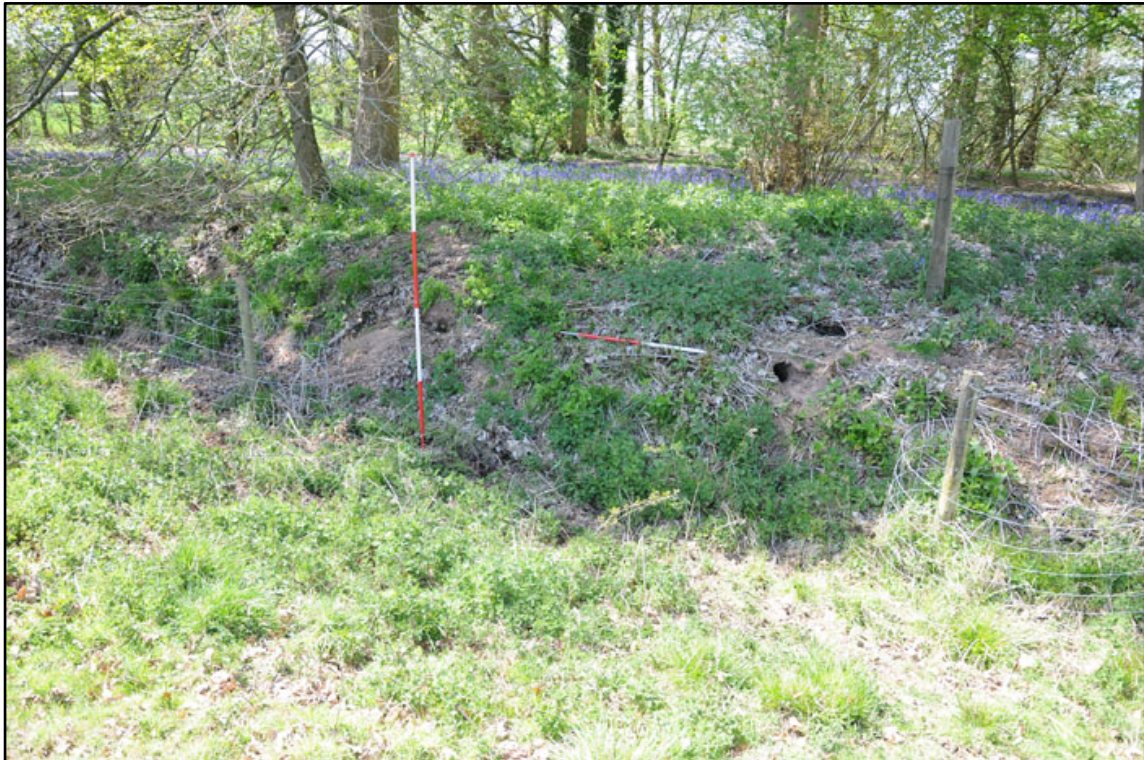
Appendix 3.8: General view of Tr3 prior to excavation, looking southwest (1m/2m scale).

Tr3 measured 1m x 6m and was orientated northwest-southeast (**Figure 2**). Prior to the excavation no traces of any masonry were visible and the course of the ha ha was denoted by heavily vegetated earthen bank c.1.7m in height, with a steeply angled profile (**Appendix 3.8**).

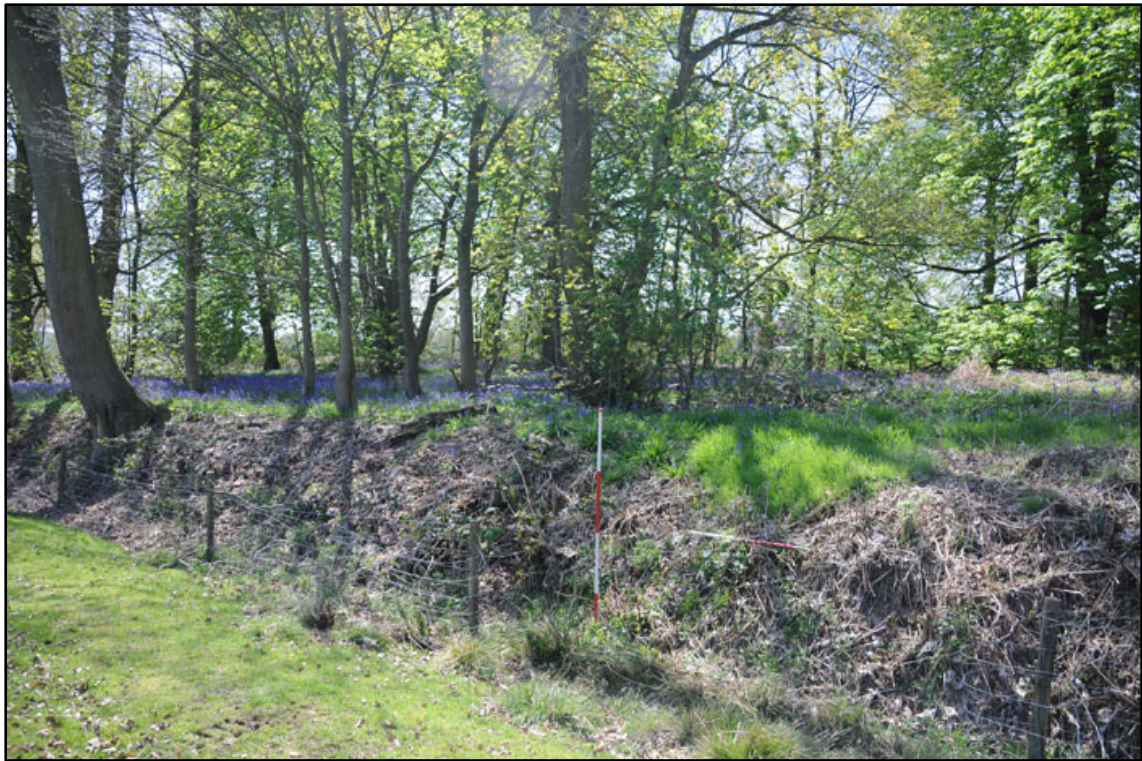
Appendix 3.12: General view of Tr4 prior to excavation, looking east (1m/2m scale).

Tr4 measured 1.8m x 6.6m and was orientated west-east (**Figure 2**). Prior to the excavation, a small area of masonry was visible, obscured partially by vegetation. The ha ha comprised of a steep bank c.1.8m in height, with a steeply angled profile (**Appendix 3.12**). The initial cut of the trench (southern side) contained no stonework, nor was any evidence for the ha ha observed, so the trench was extended 0.9m to the north (**Appendix 3.13**).
