MARBLE HALL FLOORING, KEDLESTON HALL, DERBYSHIRE

Historic Fabric Survey on behalf of the National Trust

March 2017

Document No: TJC2017.03

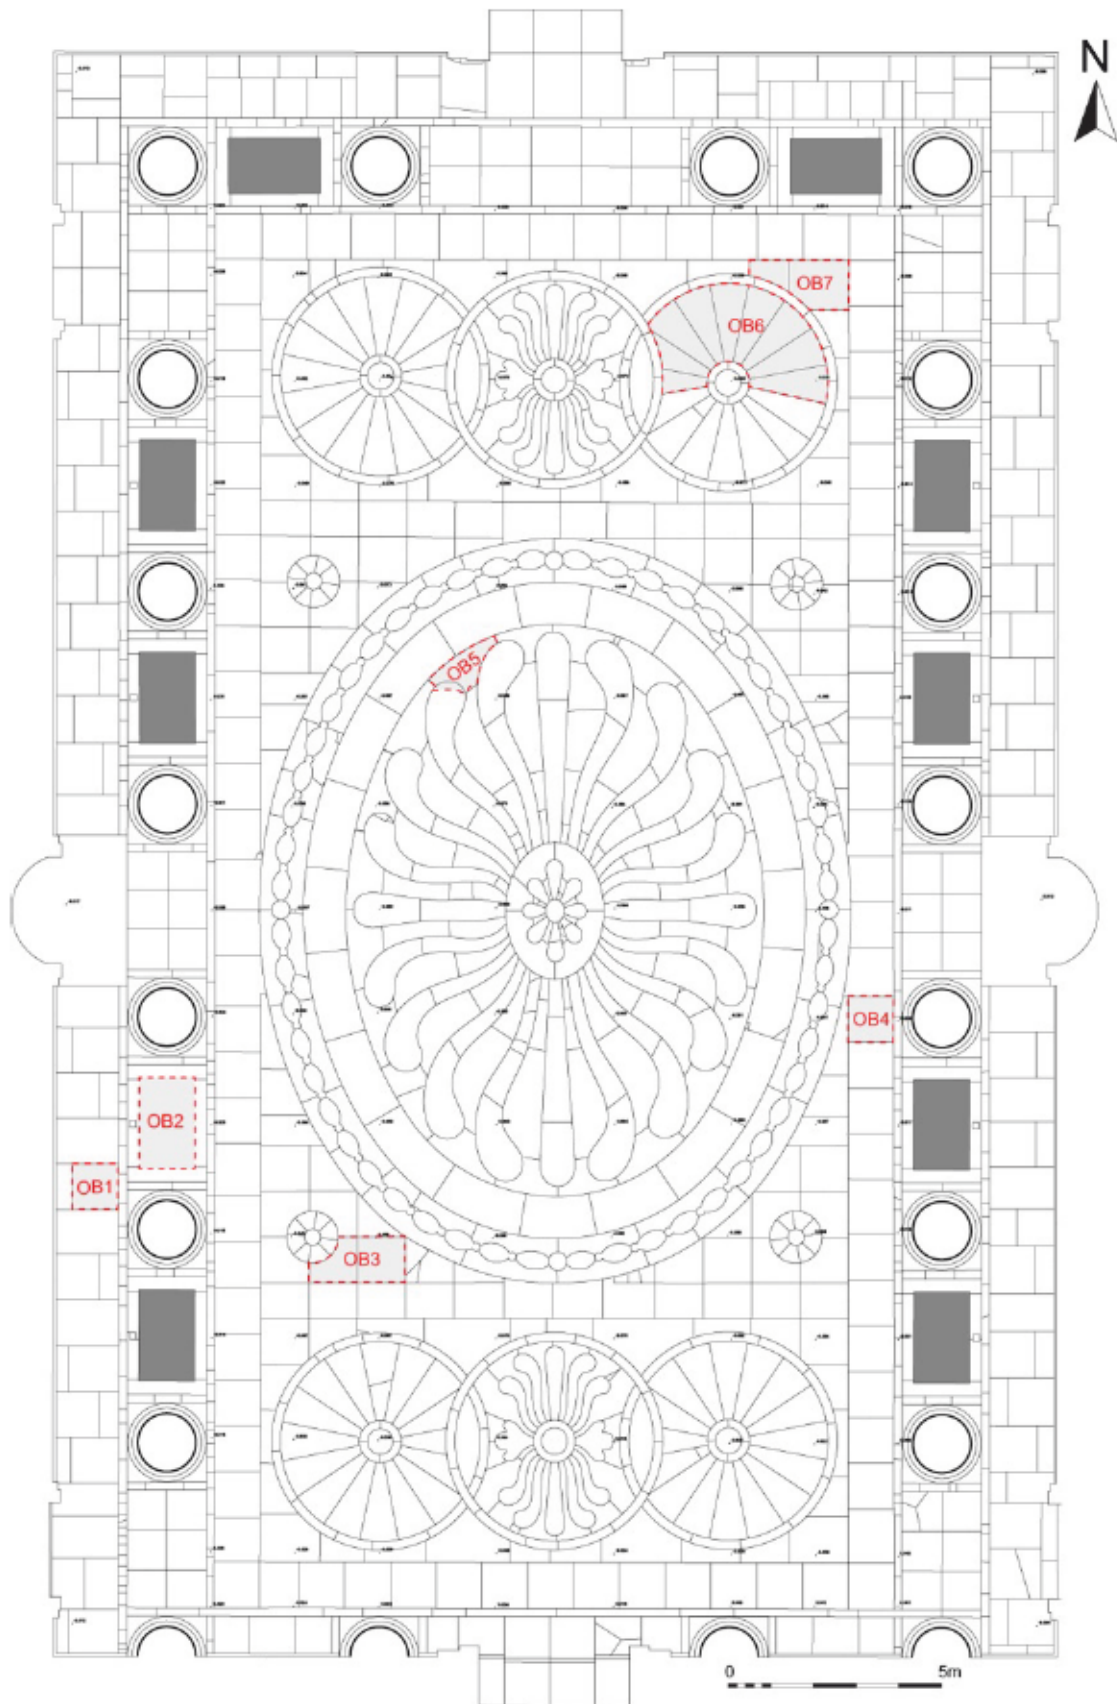
Figure 3: Floor plan of the Marble Hall with locations of archaeological observations

This section of the report presents the results of the archaeological survey and analysis of the exposed historic fabric that forms the floor of the Marble Hall. Seven individual areas were examined (OB1-OB7) (Figure 3), each of which is described in turn below (Appendices 2.1, 2.2) followed by a short discussion.

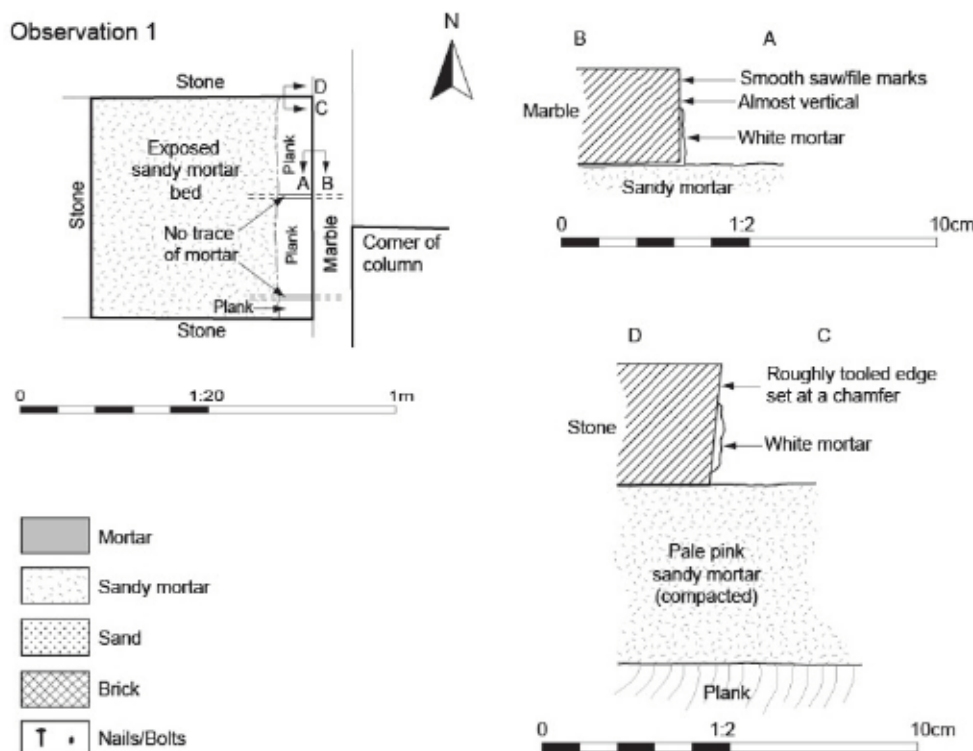
Figure 4: Plan with archaeological observations and cross-sections through OB1

A single floor slab measuring 0.58m x 0.58m had been lifted in the narrow aisle on the west side of the west colonnade (Figure 3). The paving slab (Hopton Wood Stone) was 3.2cm in thickness, with a slightly beveled edge containing traces of a white lime mortar/grout (Figure 4).

Beneath the paving slab was a layer of compacted pink mortar/sand (Appendix 2.3) 4.8cm in depth, and which overlay thick timber planks (Appendix 2.4). Three planks were exposed below the sand which were orientated west-east, measuring c.26cm in width, with a gap of 0.5–1cm between them.

No traces of mortar torching was observed covering the joints.

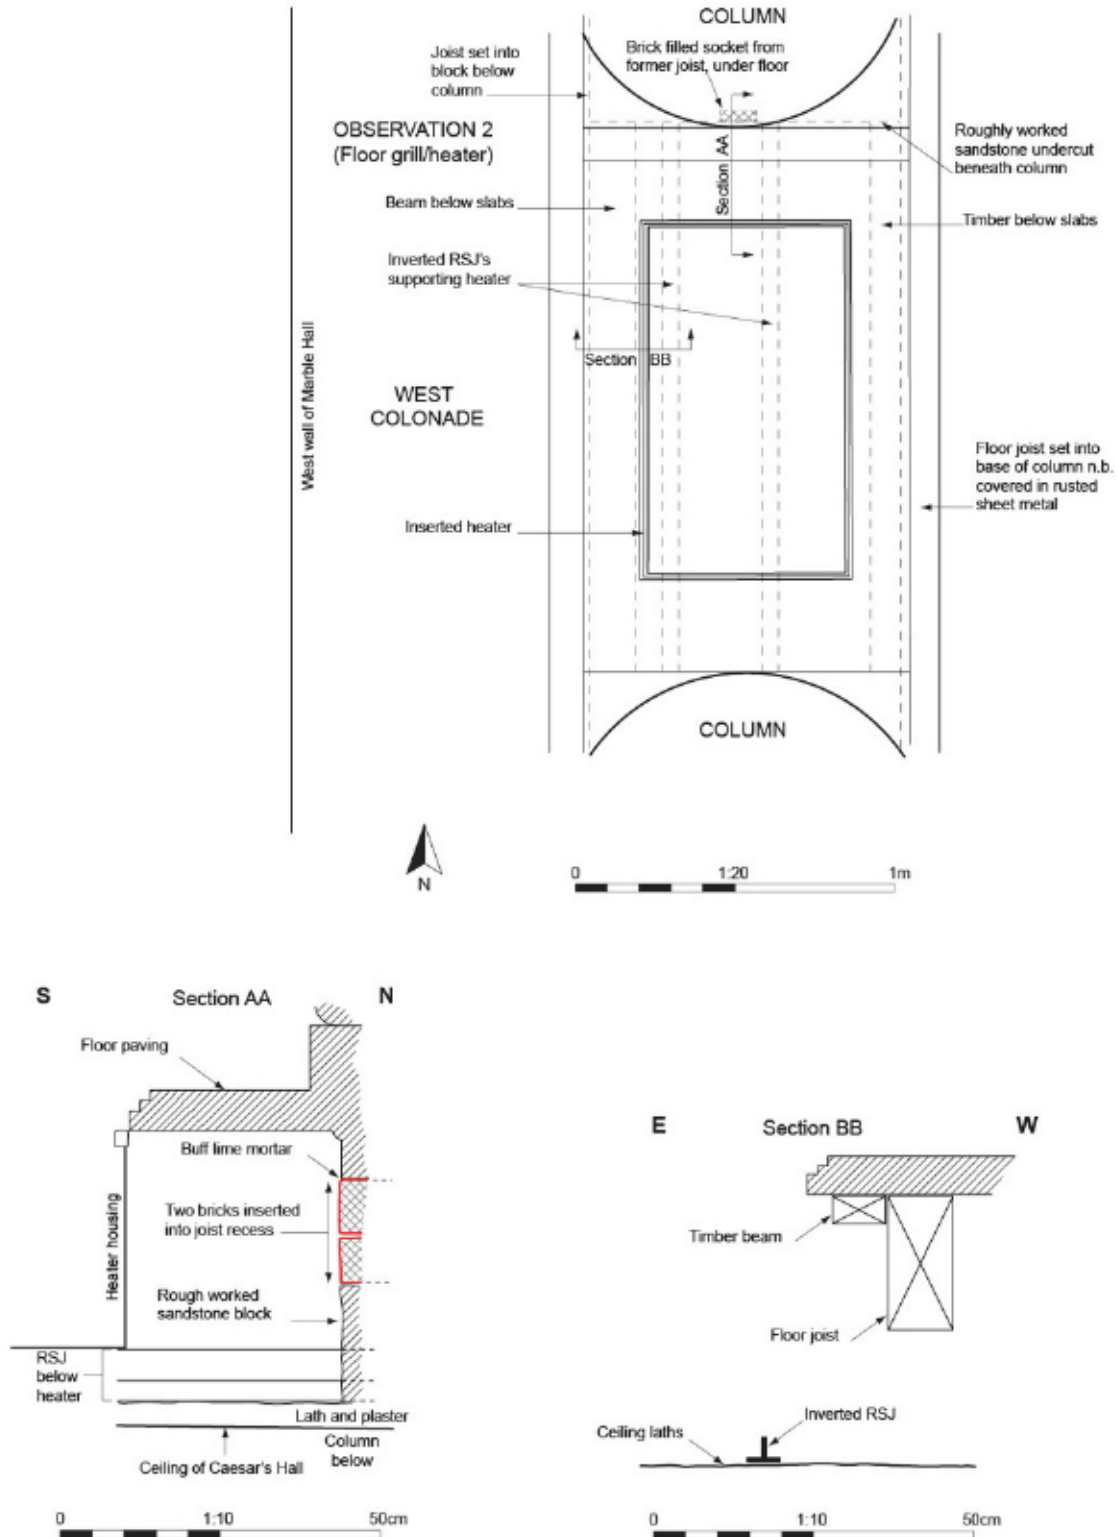
Figure 5: Plan with archaeological observations and cross-sections through OB2

Following the removal of the metal grill (**Appendix 2.5**) above one of the floor heaters between the columns in the west colonnade (**Figure 3**), a narrow gap around the edge of the heating unit was revealed allowing the floor void to be observed (**Appendix 2.6**). The opening for the heater measured 0.62m x 1.08m (**Figure 5**), however an area of approximately was observed 0.96m x 1.4m below the floor.

The marble paving around the edge of the heater is up to 6cm in thickness (**Figure 5**), below which the floor void measures 42cm to the underside of the lath and plaster ceiling of Caesars Hall. The floor heaters are a secondary insertion into the floor of the Marble Hall, c.1910 in date, although whether existing large paving slabs were reworked, or new ones introduced into the room to take the opening for each heater is unclear. The heaters are supported on two inverted T shaped narrow rails/RSJs that are orientated north-south (**Appendix 2.6**) and apparently fixed into the stonework beneath each column.

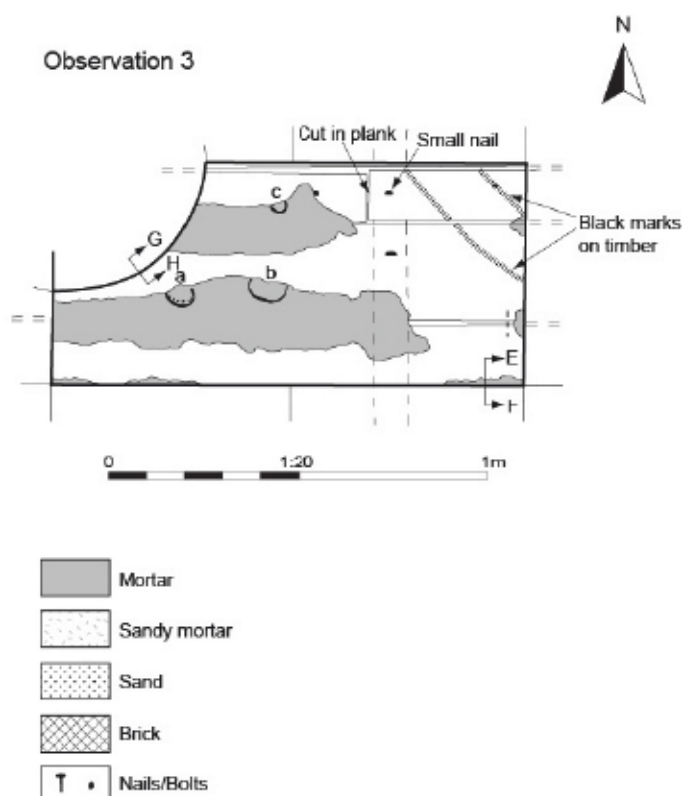
Figure 6: Plan with archaeological observations of OB3

Beneath the paving was a deposit of compacted yellow sand containing occasional small fragments of brick/tile (Figure 7). The sand was 10.5–11.5cm in thickness and overlay timber floor planks that were orientated west–east. The planks measured c.25cm in width, with a thickness of 4.5cm (Figure 6).

The planks were horizontally laid and secured to form a level upper surface with concealed timber dowels, c.1.2–1.4cm in diameter and at a depth of 1cm below the upper surface of each plank. The floor planks are also secured from above into each of the upper floor joists with pairs of nails (**Appendix 2.10**), one on each side of the plank.

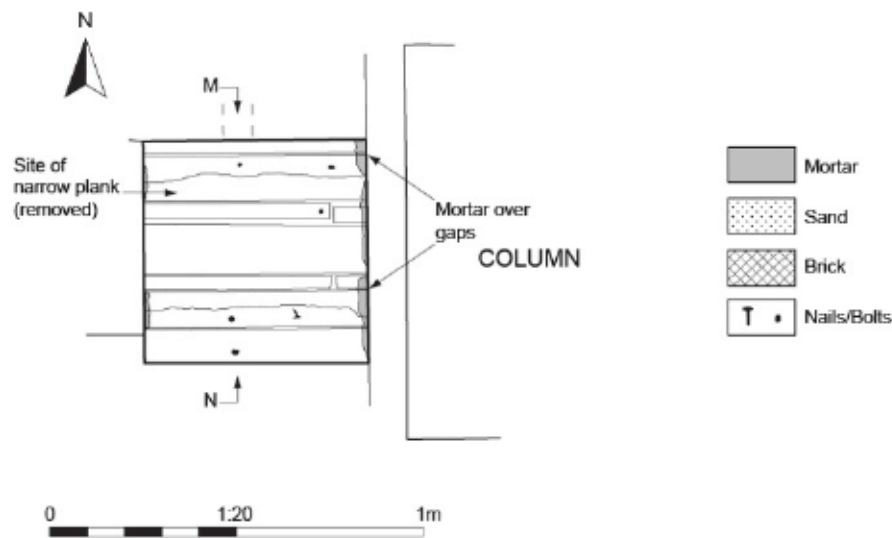
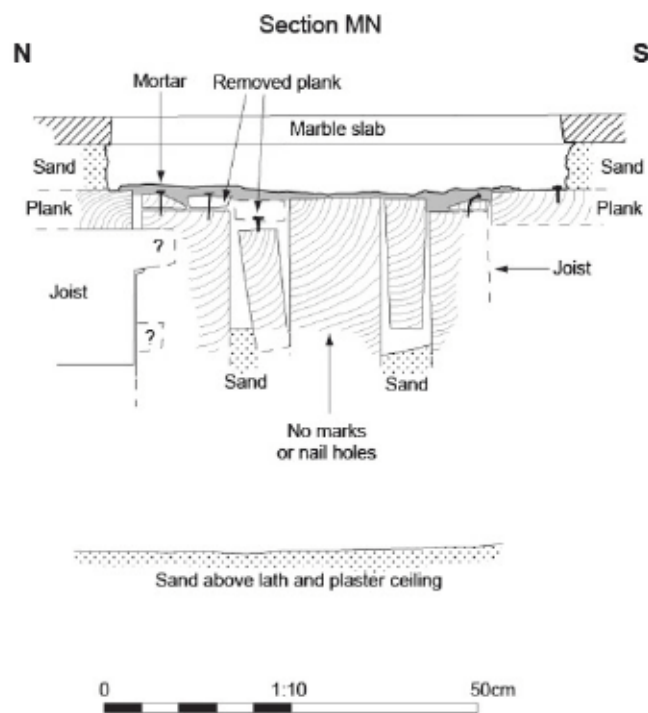
Figure 10: Plan with archaeological observations and cross-sections through OB4

A single floor slab measuring 0.58m x 0.58m was lifted against one of the columns (**Appendix 2.15**) along the eastern side of the room (**Figure 3**), a site where water had historically been leaking from the roof above. The marble slab was 3.5cm in thickness, with a slightly beveled edge (**Figure 10**). Following the removal of the sand sub-floor (**Appendix 2.16**), a series of sections of timber planks orientated west-east were exposed. The timbers were set at differing heights and represent a historical repair or alteration in this area. Thin planks had been nailed into the top of the underlying floor beams, which had then been covered with a layer of mortar.

Unfortunately, due to the insertion of additional timbers, it has not been possible to establish the full dimensions of the exposed beams which are interpreted as representing longitudinal beams that span the width of the room between the columns. A cross-section drawing across the beams does however, help demonstrate the stages of alteration (Figure 10).

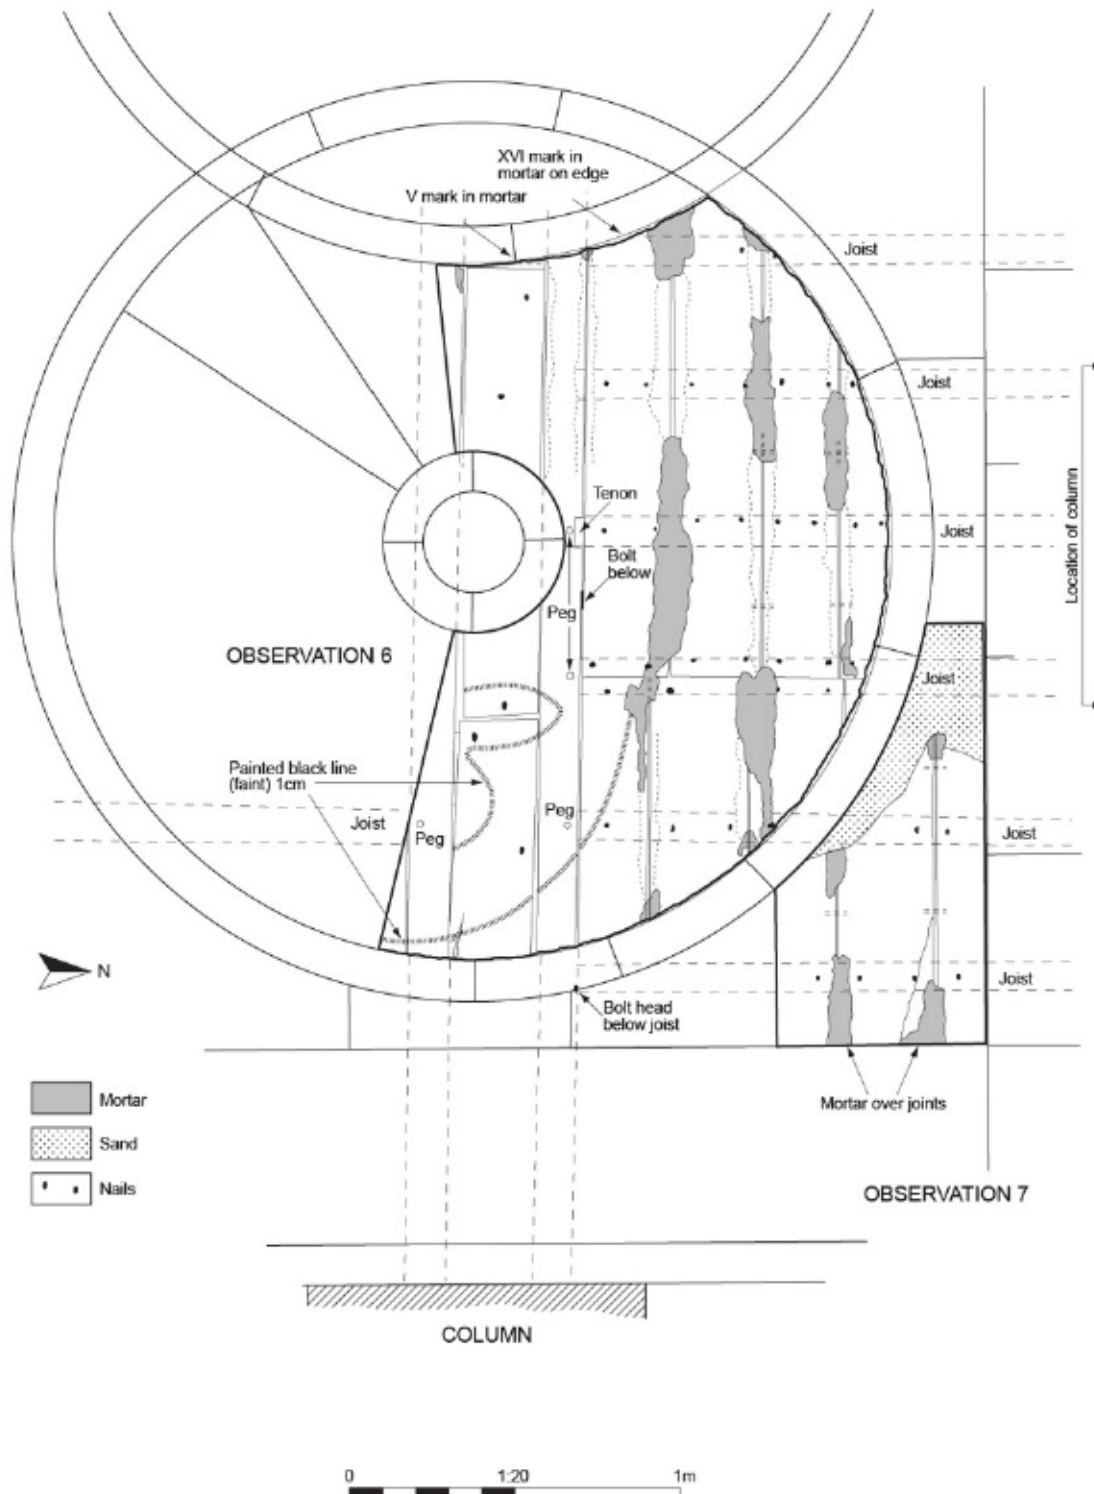
Figure 12: Plan with archaeological observations in OB6 and OB7

Following the removal of the sand sub-floor, which was 11.5cm in thickness, the upper surface of the timber floor structure was exposed. This comprised sections of eleven floor planks and two principal floor beams (**Figure 12**). Covering the joints in the planks was a spread of mortar torching (**Appendix 2.22**), consistent with that observed elsewhere within the floor structure. No impressed marks were noted in the mortar.

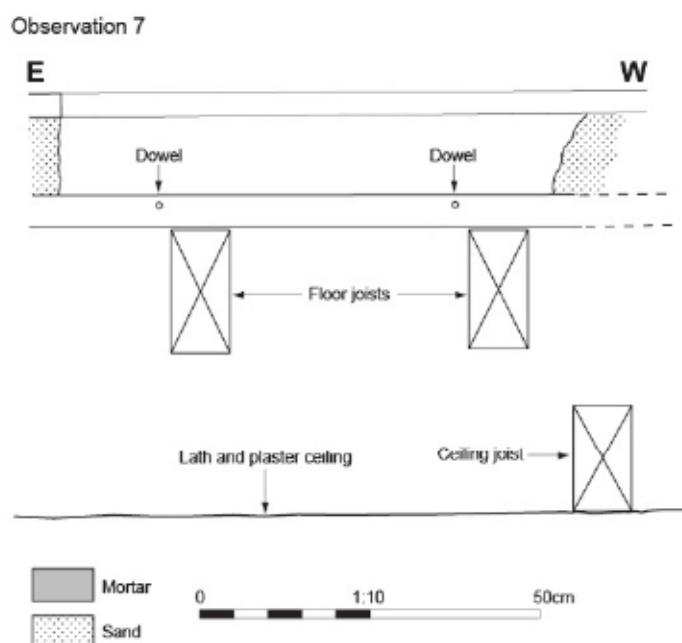
Figure 13: Cross-section (W-E) through OB7

The floor planks were secured to one another with concealed wooden dowels (Appendix 2.30), set at 43.5cm centres. Each plank was secured to the upper floor joists with pairs of nails, which were covered with mortar torching to prevent the sand from seeping down to the ceiling void below. This void below the floor planks was 42cm in height. The joists were orientated north-south, with the upper joists measuring 8.5cm x 17.5cm and the lower joists 8.5cm x 15.5cm (Appendix 2.31). The upper and lower joists were offset from one another by c.6cm (Figure 13). The joists were tenoned into the principal floor beams, all of which appear to be oak with prominent medullary rays. At the base of the floor void transverse ceiling joists span between the lower floor joists (Appendix 2.31). Many contain saw marks that indicate they were pit sawn, and they are lap joint at each end where the timbers are secured on the underside of the lower joist.

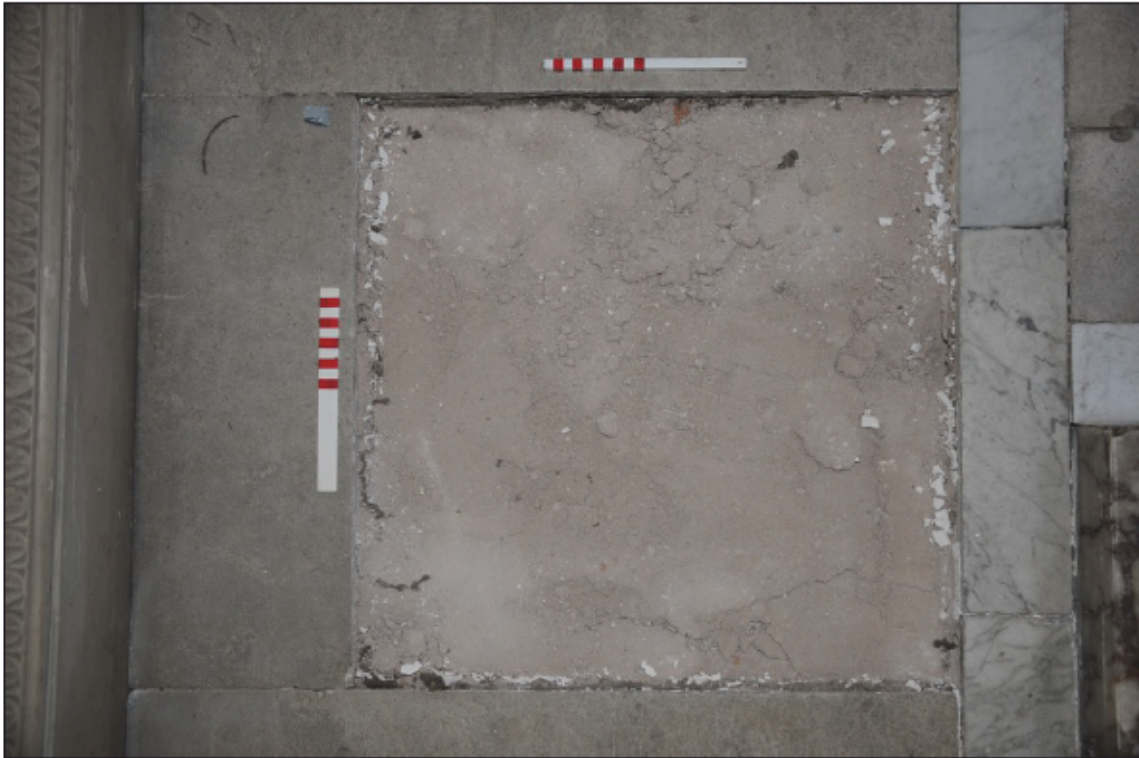
Appendix 2.3: General view of pale pink sand/mortar subfloor in OBI (20cm scale). **Photo No.9.**

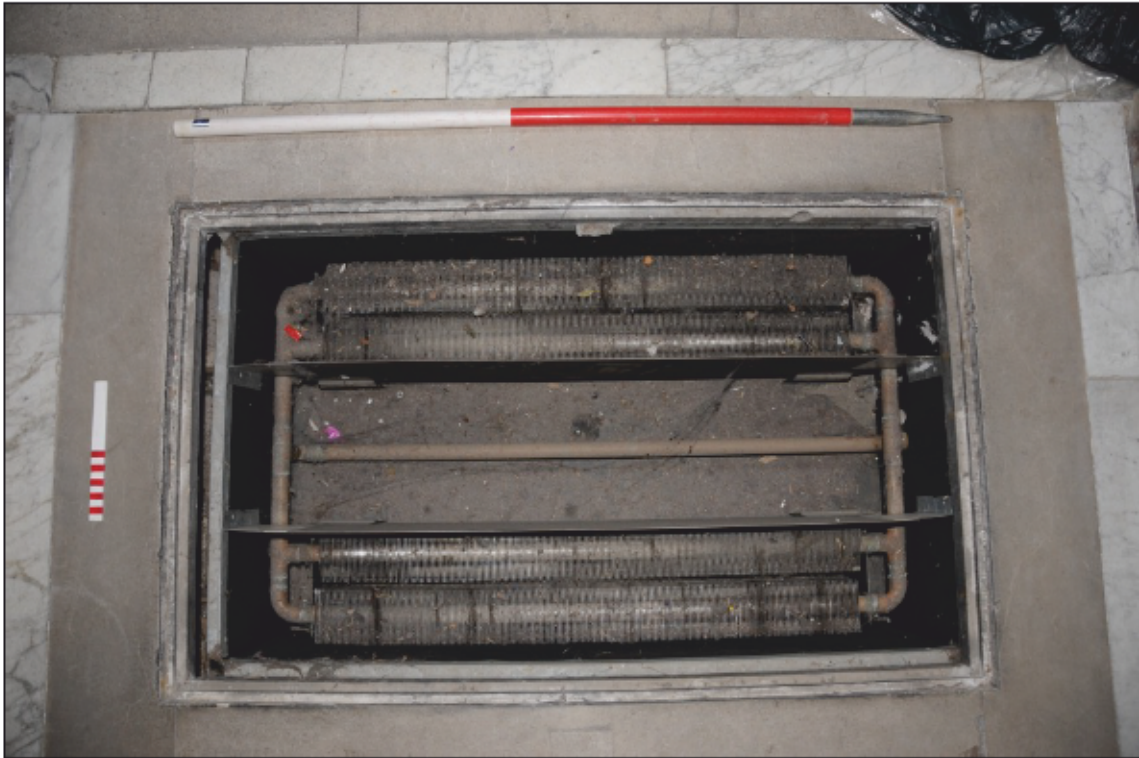
Appendix 2.5: General view of inserted floor heater in OB2 from above (20cm scale). **Photo No.17.**

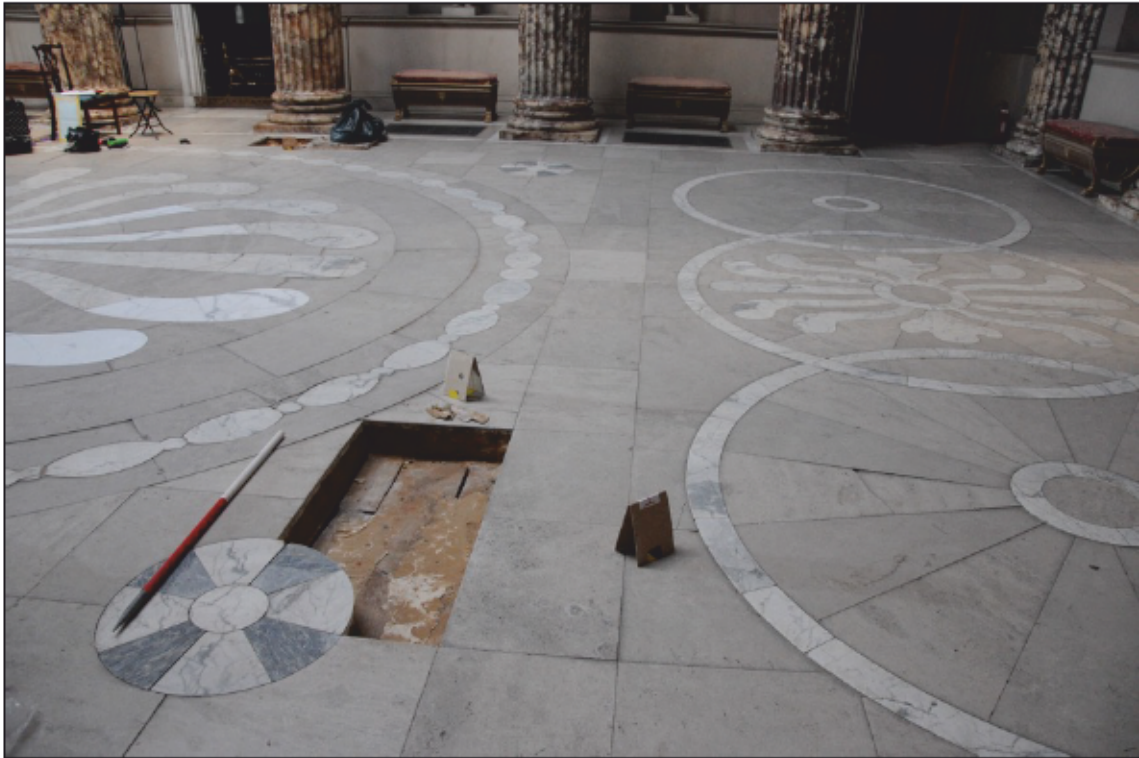
Two paving slabs measuring an area of c.0.58 x 1.24m (Figure 3) had been removed against the rounded edge of a decorative roundel in the southwest section of the floor (Appendix 2.8). The marble paving of the main floor slabs was 3.2cm in thickness, although the black and white veined marble used for the roundel was thicker at 3.5cm (Appendix 2.13). The paving had a slightly beveled edge and traces of white mortar/grout were noted still adhering in places.

Appendix 2.8: General view of OB3, looking east (1m scale). **Photo No.26.**

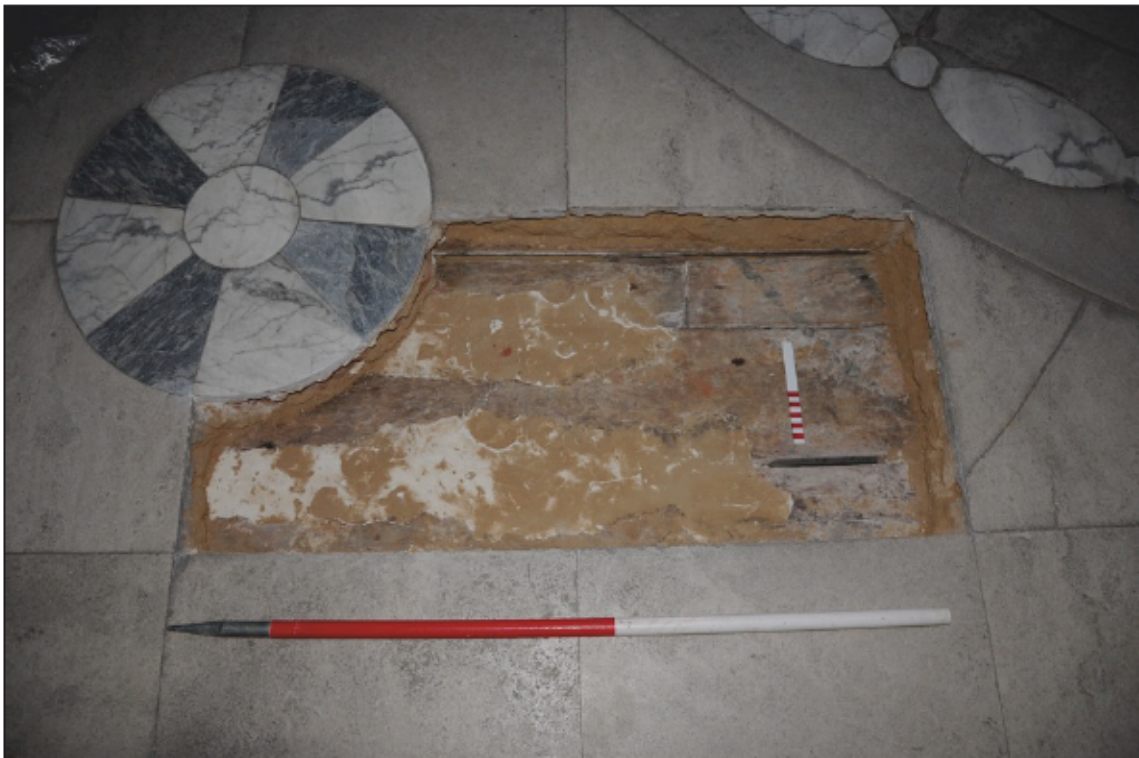
The final feature that was recorded within OB3 consists of two curved painted lines in the northeast corner (**Appendix 2.9**). They were applied directly to the upper surface of the floor planks and measured 2cm in width and were 13cm apart (**Appendix 2.10**). The lines continue below the mortar torching right to the edges of the exposed planks and are interpreted as the setting out of a paving design prior to the mortar being laid. It is interesting to note that the painted arcs have no resemblance to the finished marble paving in this part of the room.

Appendix 2.9: General view of OB3 from above, looking north (20cm/1m scale). **Photo No.28.**

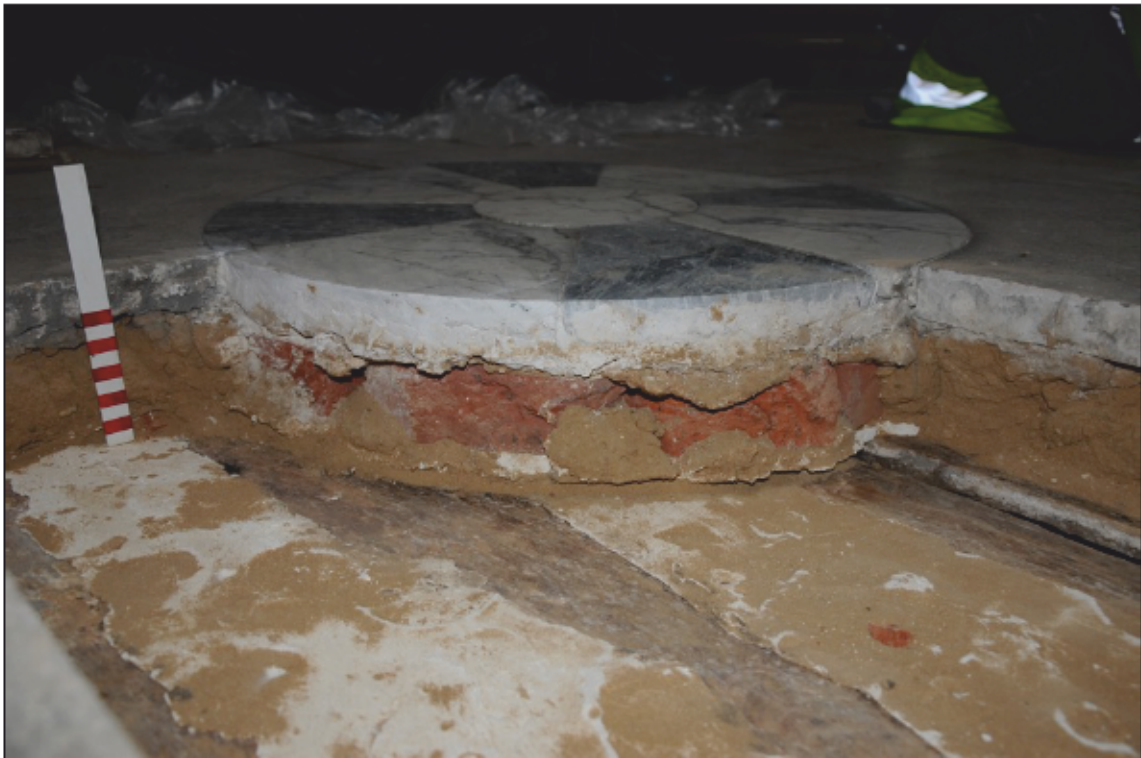
Covering the joints between the floor planks was a layer of mortar torching, which was 12–16cm in width and c.1cm in thickness (**Appendix 2.11**). The purpose of this mortar was to prevent the sand from seeping down to the ceiling void below above Caesars Hall. The mortar continued beneath the brick and mortar foundation that supported the circular roundel (**Appendix 2.13**), indicating that the floor planks and mortar torching pre-dated the formation of these foundations. The foundation for the roundel was however, laid before the sand sub-floor was laid down.

Appendix 2.13: Detail of roundel in OB3, looking west; note mortar torching covering joints (20cm scale). **Photo No.35.**

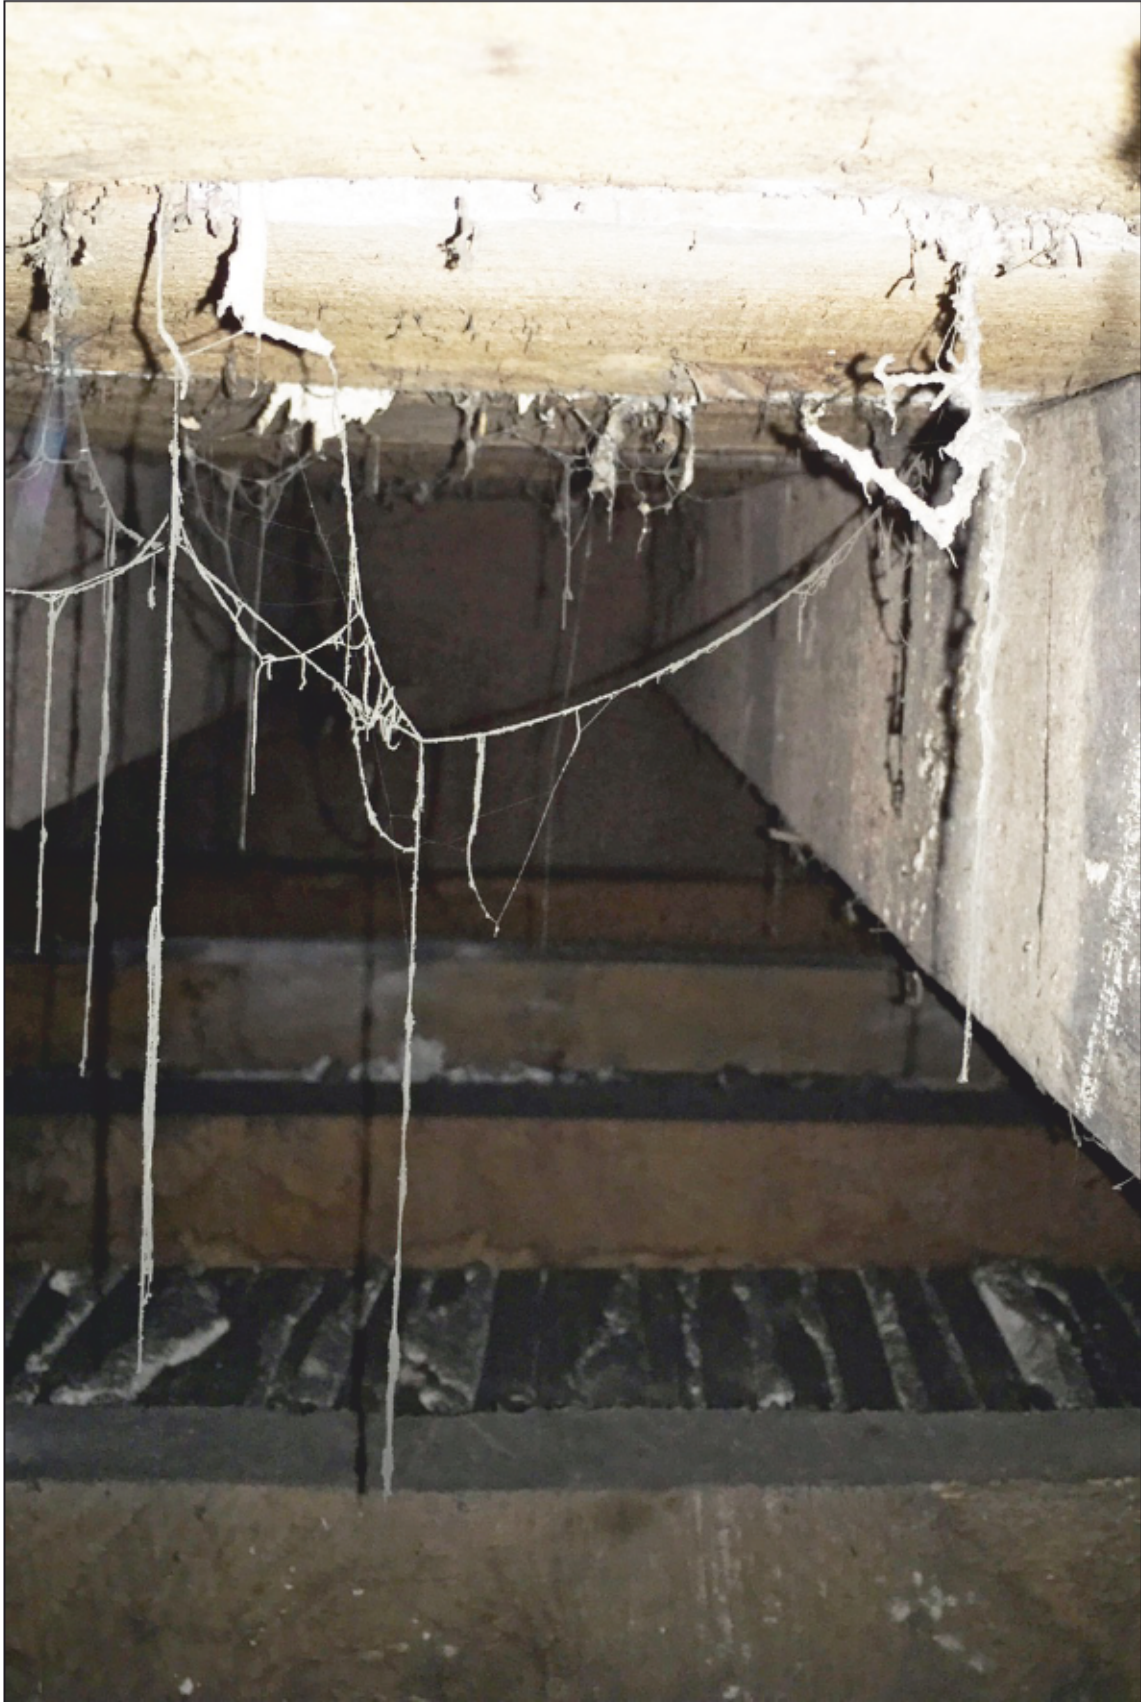
The floor planks were supported on north–south joists (Appendix 2.14), with the principal floor beams running west–east spanning between column on either side of the room, a distance of c.10m. It has not been possible to establish whether these floor beams are trussed in any way, or have additional strengthening the centre to counteract the natural deflection in the floor once the weight of the sand had been added. The floor void measured 43cm to the underside of the floor planks, making a total thickness from the ceiling of Caesars Hall to the paving of the Marble Hall of 0.63–0.65m.

Appendix 2.14: View of floor structure below OB3, looking south. Photo No.45.

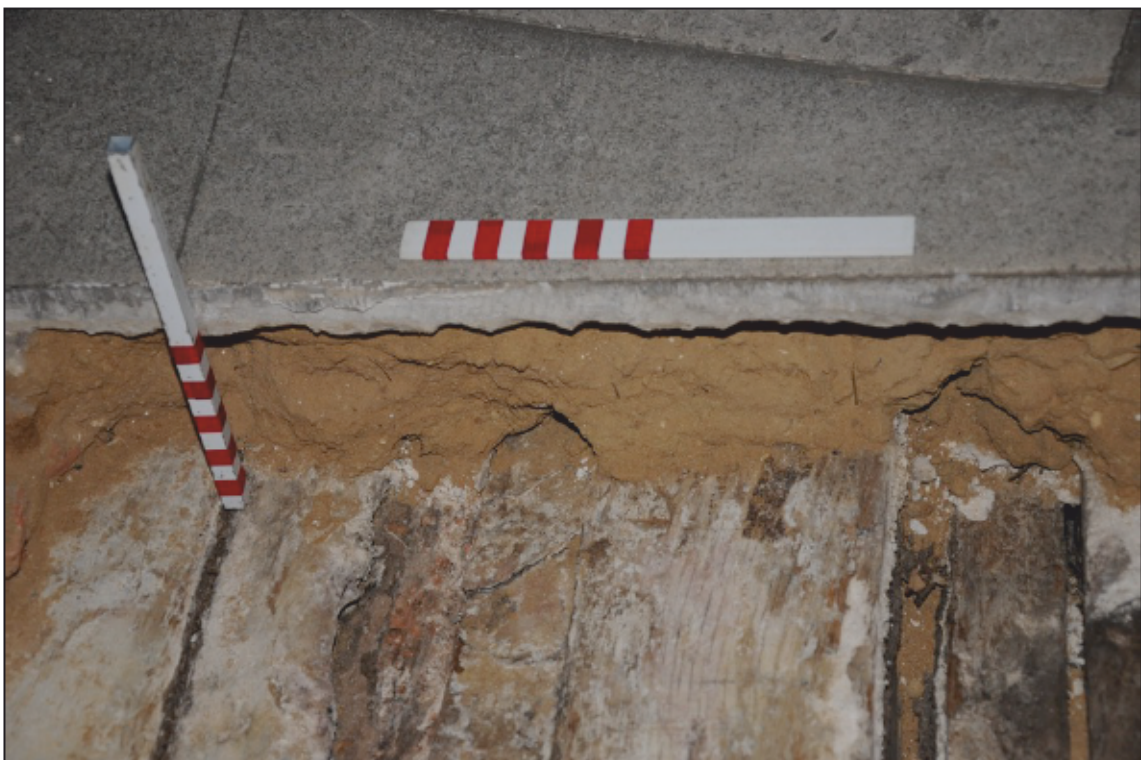
Appendix 2.16: Detail of flooring in OB4, looking east (20cm scale). **Photo No.51.**

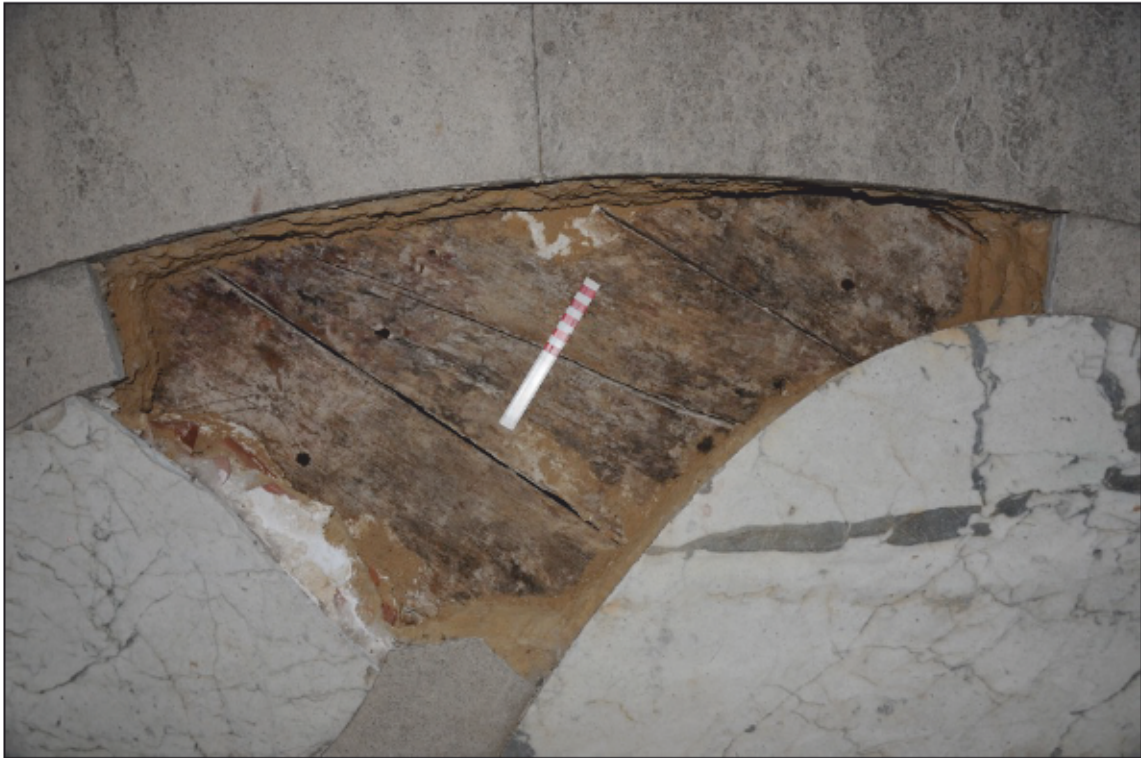
Two curved sections of paving at the terminal of one of the decorative marble petals was removed in the northwest area of the floor (**Figure 3**). It is an irregular shaped area, c.0.5m x c.1.5m. Following the removal of the marble paving a sub-floor deposit of yellow sand 12.5cm thick was removed (**Appendix 2.17**).

Appendix 2.17: General view of OB5, looking north (20cm scale). **Photo No.57.**

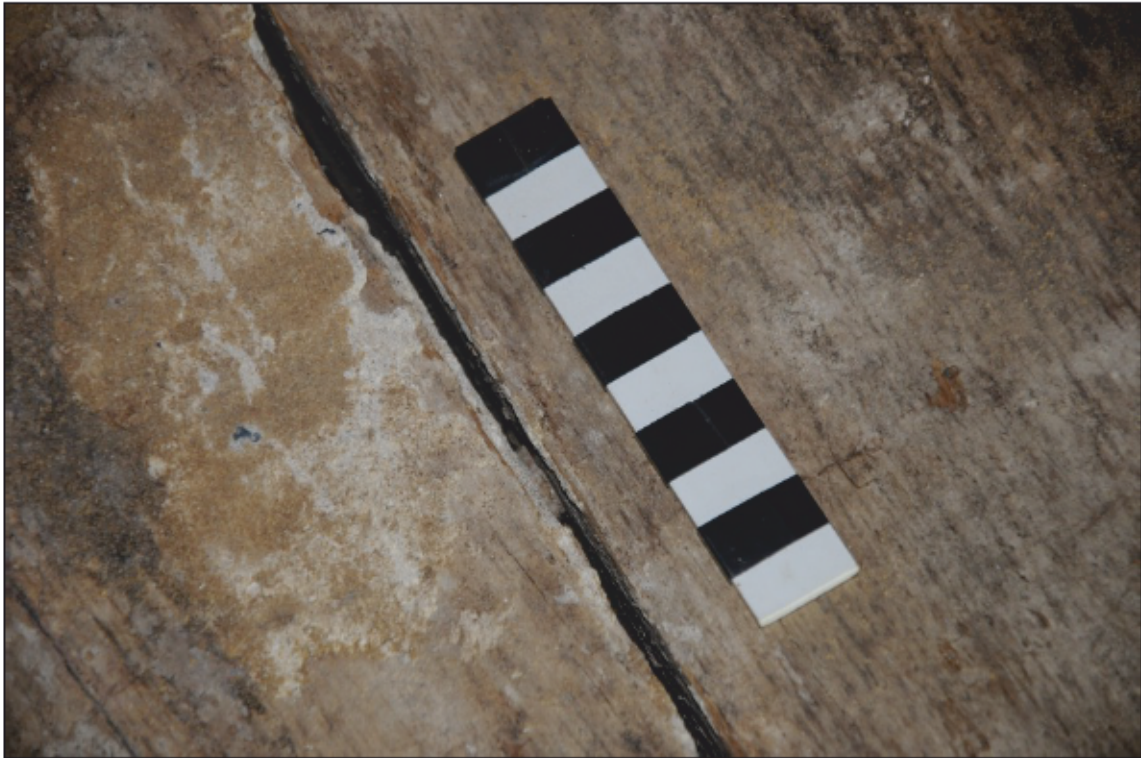
Appendix 2.19: Detail of dowel between floor planks in OB5 (10cm scale). **Photo No.58.**

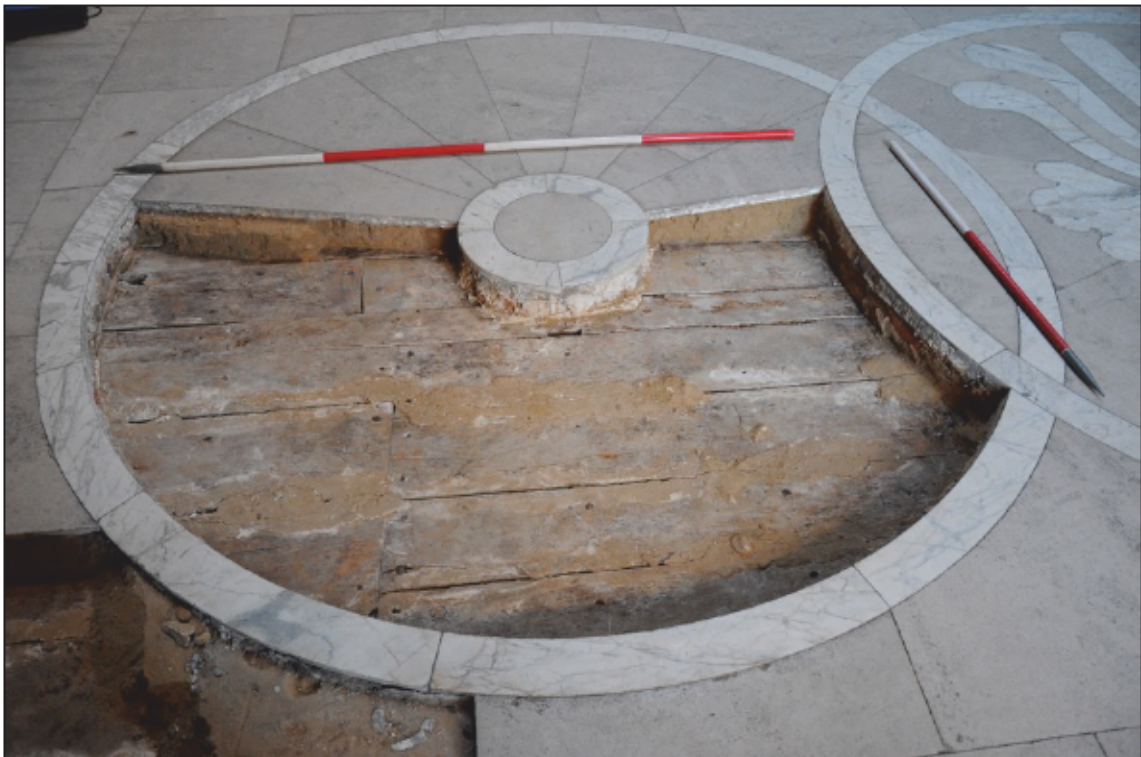
Approximately 60% of the paving slabs within one of the decorative circular motifs in the northeast section of the Marble Hall (**Figure 3**) were removed exposing an area of the floor structure that measured c.1.5m x 2.1m (**Appendix 2.20**). Following the removal of the paving slabs, which were cut as triangular segments, it was noted that cut into the ends of each slab were Roman numerals. These indicate that the slabs were cut and prepared prior to being laid as a floor, presumably in a masonry workshop, or framing yard. The slabs were 3.2cm in thickness.

Appendix 2.20: General view looking south of OB6 (1m/2m scale). **Photo No.62.**

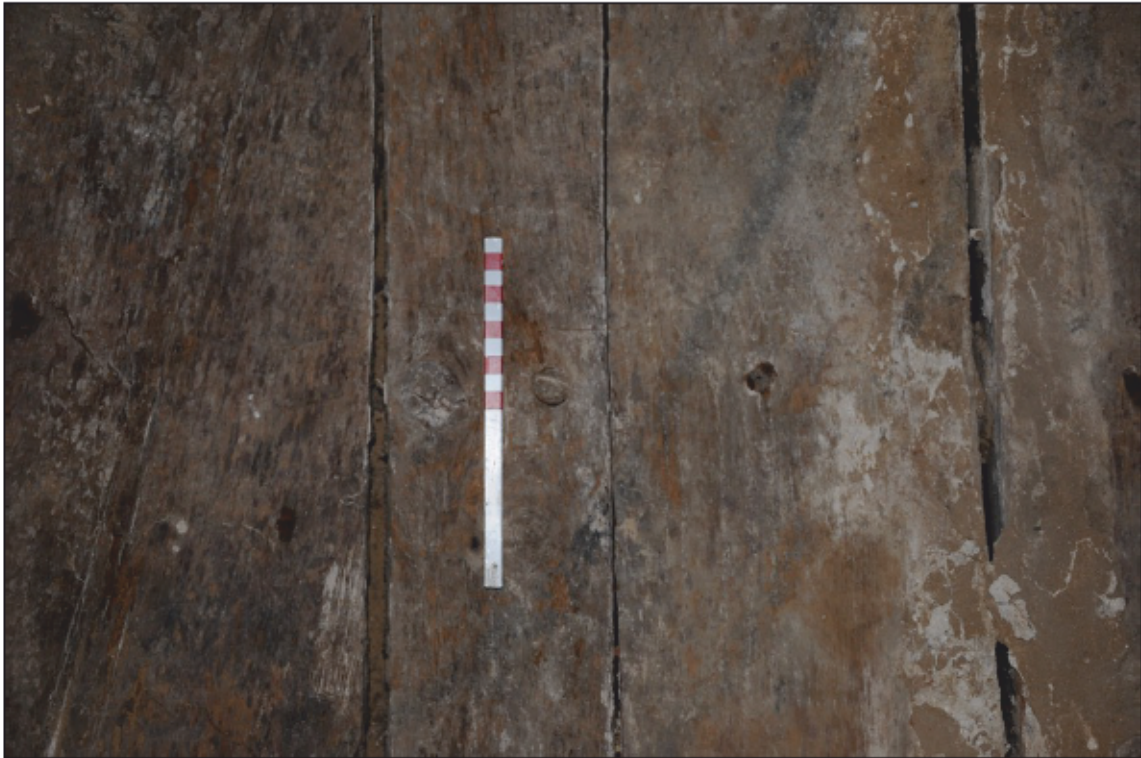
Faint traces of two black lines 2cm in width were noted in the southeast area. One was in the form of a lobe or petal (**Appendix 2.26**), and the other a large curved arc (**Appendix 2.21**). The paint extended to the edge of the floor planks and pre-dated the laying of the mortar torching over the joints. Similar to the painted arcs in OB3, these lines do not represent the actual design on the floor of the room. They presumably representing a proposed layout, perhaps similar to the one illustrated on a plan from c.1760 (**Appendix I.1**), which included various designs and some have been incorporated in the final scheme.

Appendix 2.21: Detail of painted lines in OB6, looking west (20cm scale). **Photo No.63.**

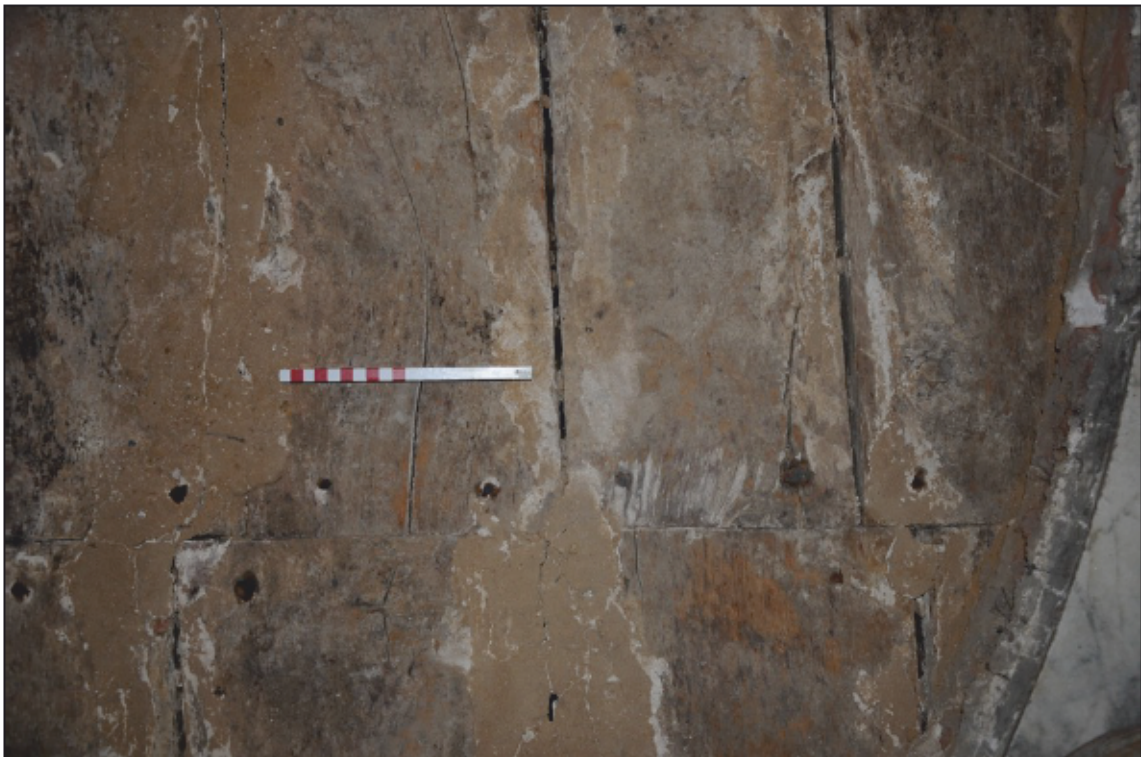
The timber planks were 22cm to 25cm in width and 4.5cm in thickness. They were secured with concealed wooden dowels and nailed onto the upper joists. A joint in the planking (**Appendix 2.22**) was noted, which was located above one of the upper joist. The edges of the planks were offset from one another, suggestive that they were laid in stages.

Appendix 2.22: Detail of joint in floor planks in OB6, looking west (20cm scale). **Photo No.67.**
