MARBLE HALL FLOORING, KEDLESTON HALL, DERBYSHIRE

Historic Fabric Survey on behalf of the National Trust

March 2017

Document No: TJC2017.03

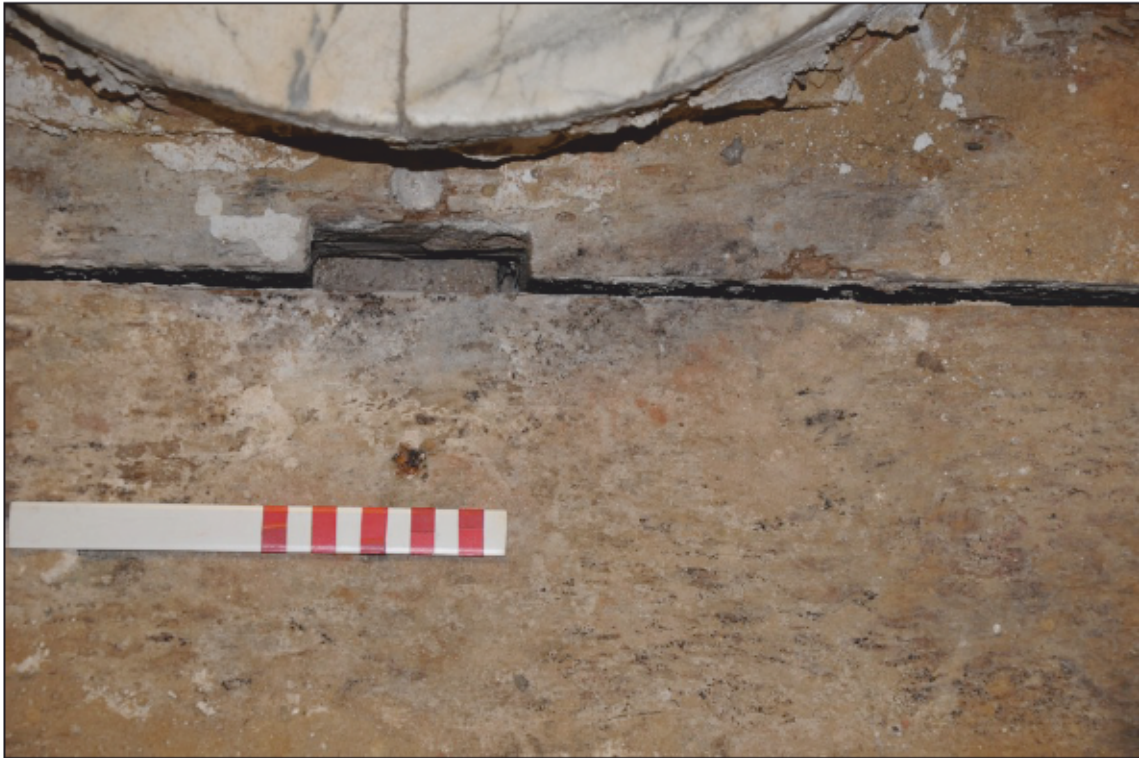
Tenoned and pegged into either side of the principal floor beams are upper floor joists (**Appendix 2.21**). A total of five joists were noted in OB6, which measured 8.5cm x 17.5cm and were set at irregular spacing of between 32cm to 40cm. One of the joists terminated adjacent to the central roundel, and whilst it was pegged in position, a rectangular mortice had been cut out of the upper face (**Appendix 2.23**), the purpose of which is unclear.

Appendix 2.23: Detail of exposed mortice and tenon in OB6, looking south (20cm scale). **Photo No.80.**

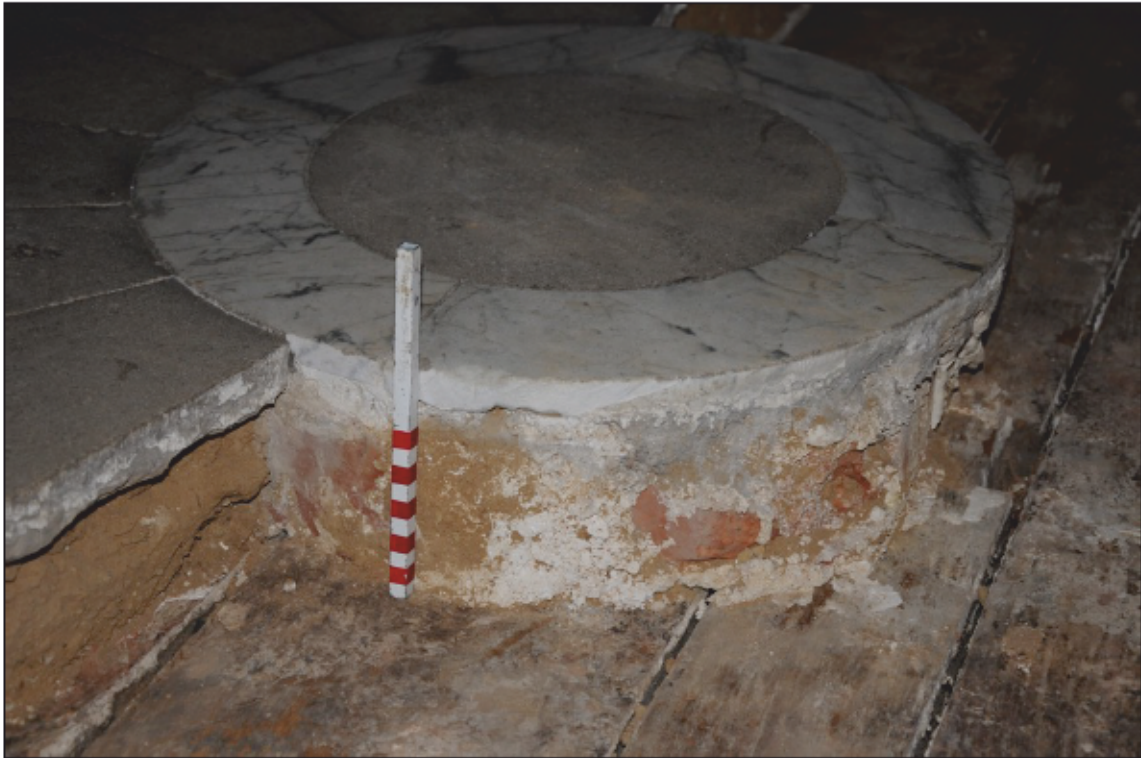
The centre of the marble circle of paving comprised a plain decorative roundel of white and grey veined marble (**Appendix 2.25**). Beneath this was a brick and white mortar foundation which had been laid directly over the mortar torching that covered the joints in the floor planks. A similar foundation was noted that supported the external circular strip of white veined marble (**Appendix 2.24**). This comprised of a low curved wall, possibly formed with the use of shuttering that had been removed prior to laying the marble paving. Unlike the foundations beneath the marble petals in OB5, there was no undercut beneath either of these sections of foundation.

Appendix 2.25: Detail of mortar and brick foundation below roundel in OB6, looking southwest (20cm scale). **Photo No.74.**

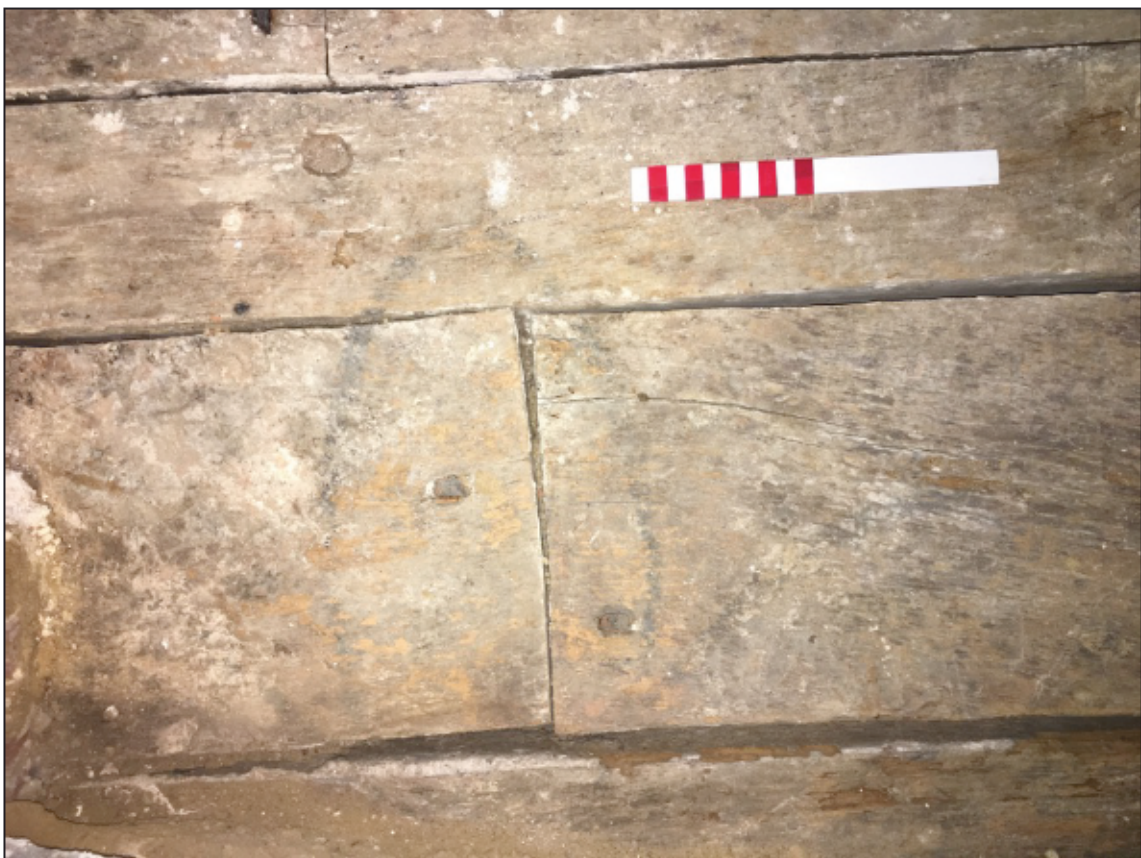
Faint traces of two black lines 2cm in width were noted in the southeast area. One was in the form of a lobe or petal (**Appendix 2.26**), and the other a large curved arc (**Appendix 2.21**). The paint extended to the edge of the floor planks and pre-dated the laying of the mortar torching over the joints. Similar to the painted arcs in OB3, these lines do not represent the actual design on the floor of the room. They presumably representing a proposed layout, perhaps similar to the one illustrated on a plan from c.1760 (**Appendix I.1**), which included various designs and some have been incorporated in the final scheme.

Appendix 2.26: Detail of painted leaf/petal in OB6, looking north (20cm scale). **Photo No.83.**

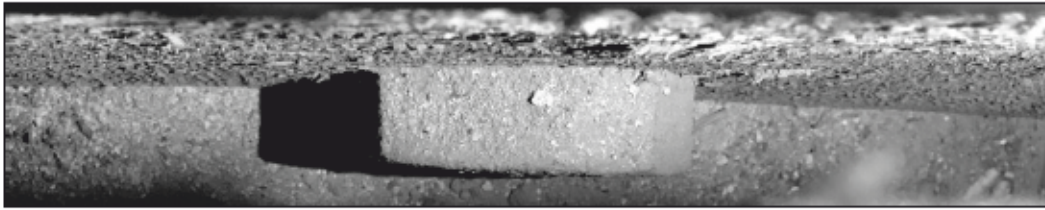
Appendix 2.27: Detail of square nut in floor beam below floor planks in OB6. **Photo No.84.**

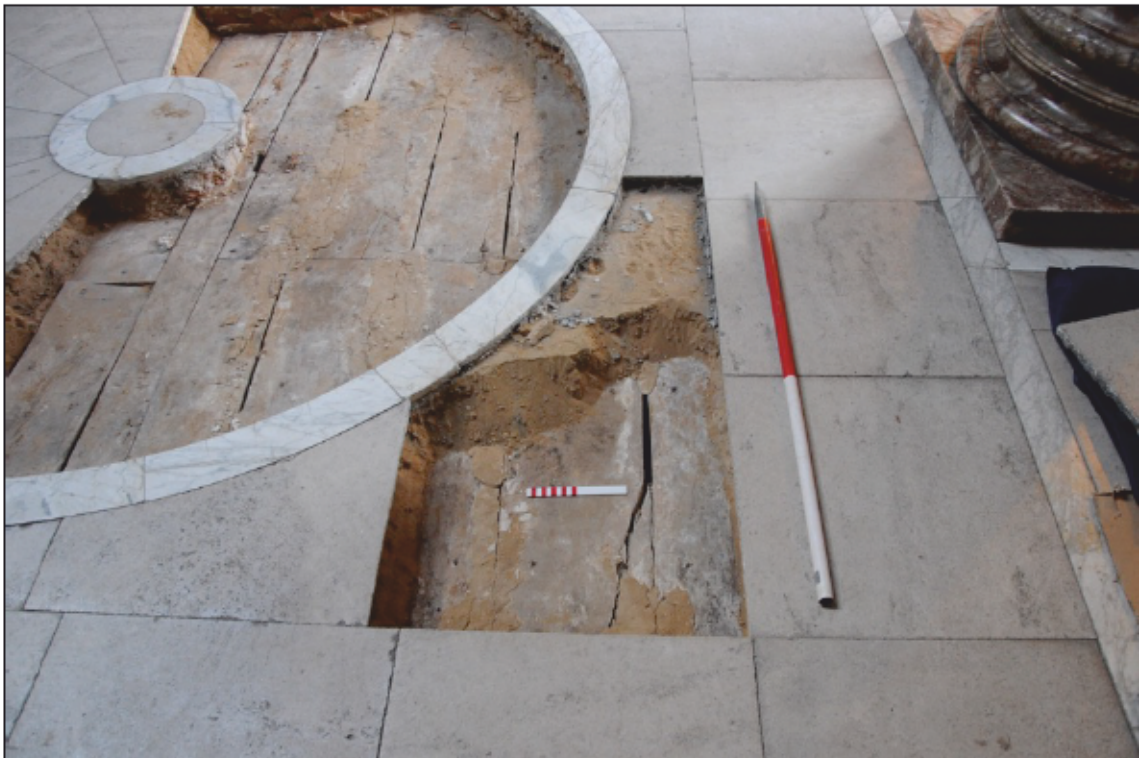
Two floor slabs measuring 0.63m x 1.27m had been lifted on the north side of the circular marble border that defined OB6 (Figure 3). Half of the sand that formed the sub-floor bedding material had been removed exposing three floor planks (Appendix 2.29). The sand was 11.5cm in thickness and visually similar in composition and colour to the sand removed from OB6.

Appendix 2.29: General view of OB7, looking west (20cm/1m scale). **Photo No.88.**

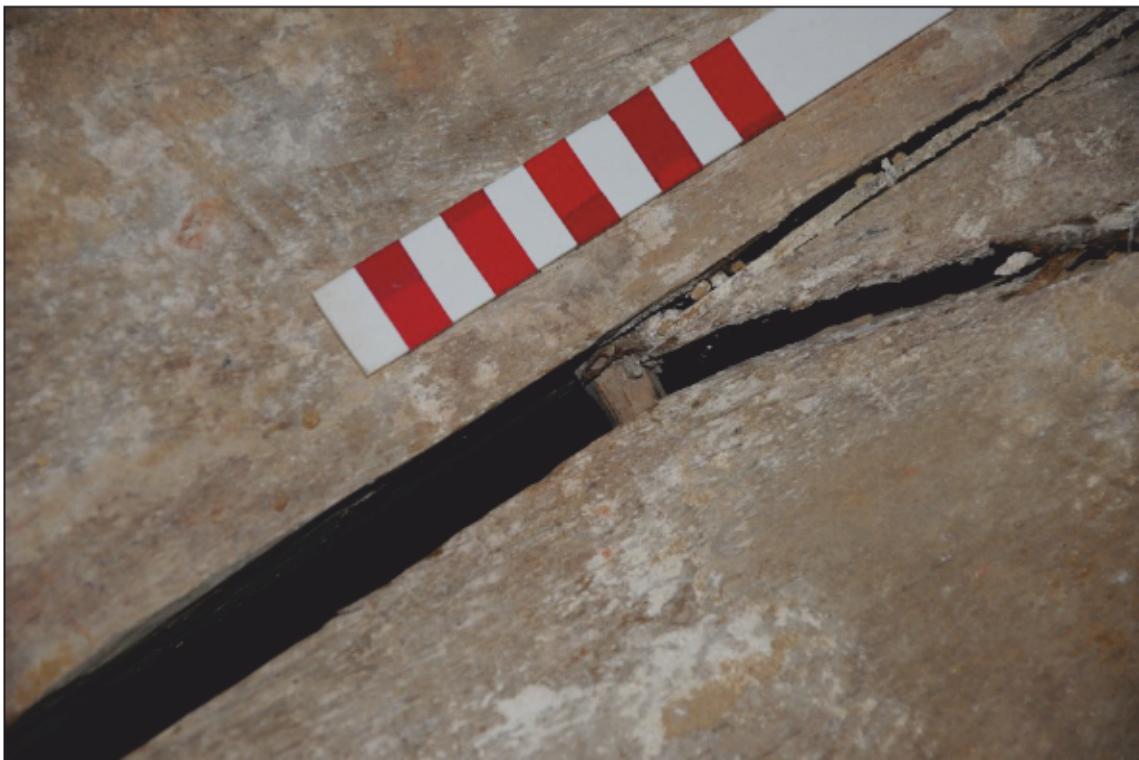
The floor planks were secured to one another with concealed wooden dowels (Appendix 2.30), set at 43.5cm centres. Each plank was secured to the upper floor joists with pairs of nails, which were covered with mortar torching to prevent the sand from seeping down to the ceiling void below. This void below the floor planks was 42cm in height. The joists were orientated north-south, with the upper joists measuring 8.5cm x 17.5cm and the lower joists 8.5cm x 15.5cm (Appendix 2.31). The upper and lower joists were offset from one another by c.6cm (Figure 13). The joists were tenoned into the principal floor beams, all of which appear to be oak with prominent medullary rays. At the base of the floor void transverse ceiling joists span between the lower floor joists (Appendix 2.31). Many contain saw marks that indicate they were pit sawn, and they are lap joint at each end where the timbers are secured on the underside of the lower joist.

Appendix 2.30: Detail of dowel in OB7, looking south (1cm scale divisions). **Photo No.91.**
