NORTHLIGHT HERITAGE	Former Sun Foundry
REPORT: 32	280 Kennedy Street, Glasgow
PROJECT ID: 4278161	
DATA STRUCTURE REPORT	Level 1 Standing Building Survey

Former Sun Foundry

28 Kennedy Street, Glasgow

Data Structure Report

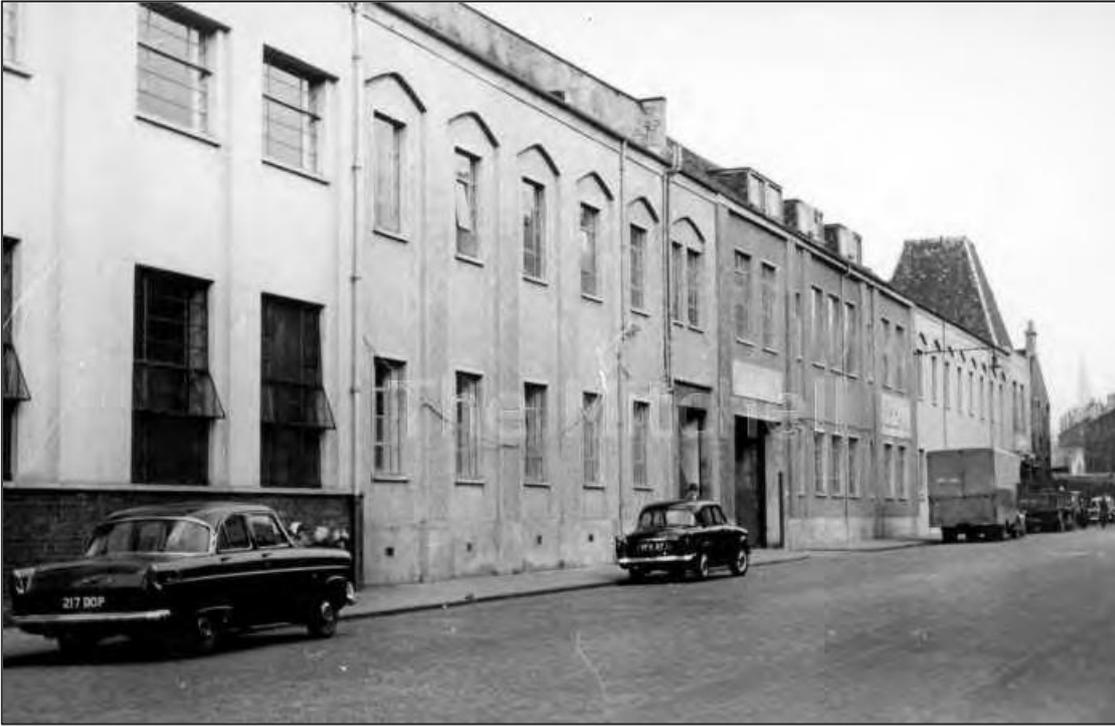
Plate 7: Looking east along the Kennedy Street frontage in 1962 (Mitchell Library: C3432). Some of the original features of the facade can still be identified. The eastern tower can be seen in the distance and the remnants of the central portion of the range (seen in Plate 1 capped with a large central tower) can be seen in the raised west-facing gable in the middle ground. New dormer windows have been inserted and windows at east and west ends are much altered. Arches over the windows and vertical columns correspond to Plate 1 illustration. The arched entrance through to the courtyard has been removed or covered over.
