Fig 1. Brackenridge Old Farmhouse (OF), south elevation, looking west.

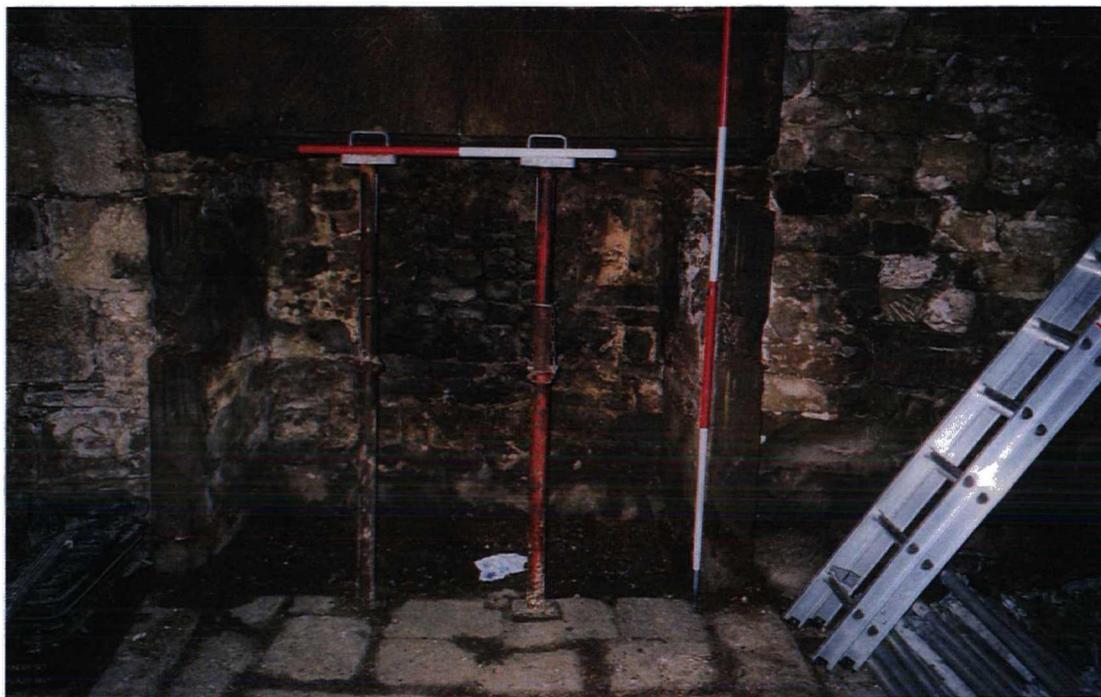
Fig 12 Brackenridge OF, interior ground floor, west end. The later stall partitions (above) mask a fine 19<sup>th</sup> century hearth or fireplace – Fig 13 below.
