Howgrave Hall
An Archaeological Assessment
of the Banqueting House,
with notes on the Hall
and Garden enclosure.

Peter F Ryder
Historic Buildings Consultant
2000/Revised October 2004

An Archaeological Assessment of the Banqueting House, with notes on the Hall and the Garden enclosure

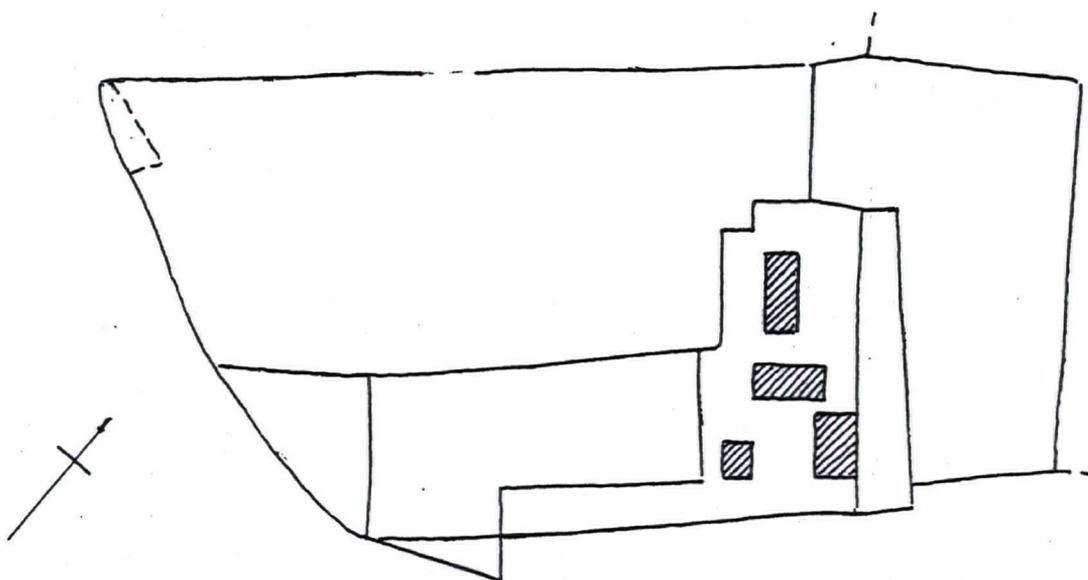
- 13.1 The 1760 Estate Map (tracing). The Hall and banqueting House are identifiable, together with what was presumably a barn to the north, and another structure, now lost, to the south-west. There are additional boundary lines within the large garden enclosure.

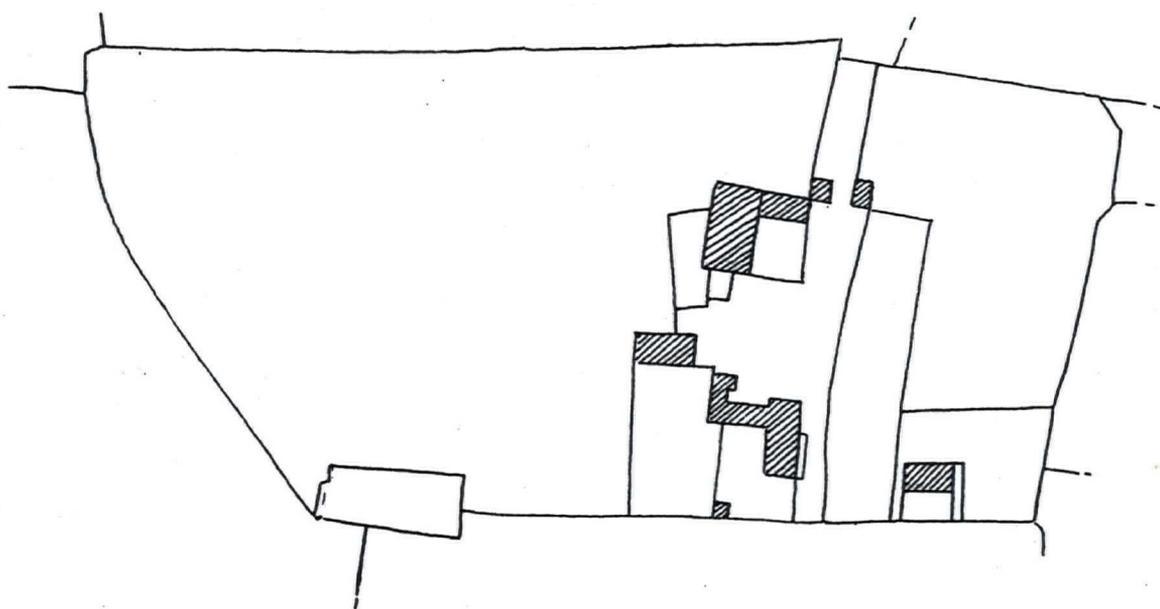
- 13.2 The 1811 Field Map (tracing) showing the buildings in more detail. An additional range, perhaps an outbuilding, has been added to the Hall. One enclosure remains within the garden area. The narrow enclosure immediately to the east of the Hall and buildings is termed the 'Lady Orchard' on the map.

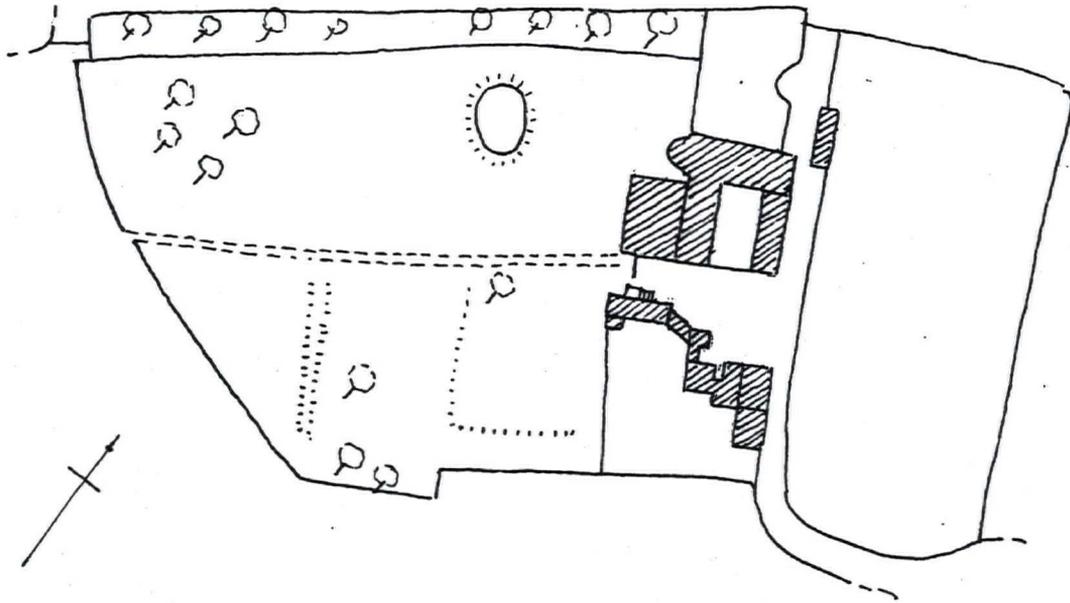
- 13.3. The 1891 Ordnance Survey 25":1 mile map (tracing). The Hall appears to be divided into three separate dwellings. The 'Lady Orchard' has gone and the farm buildings have developed into a full foldyard layout, apparently with a horse engine at the west end of the north range.

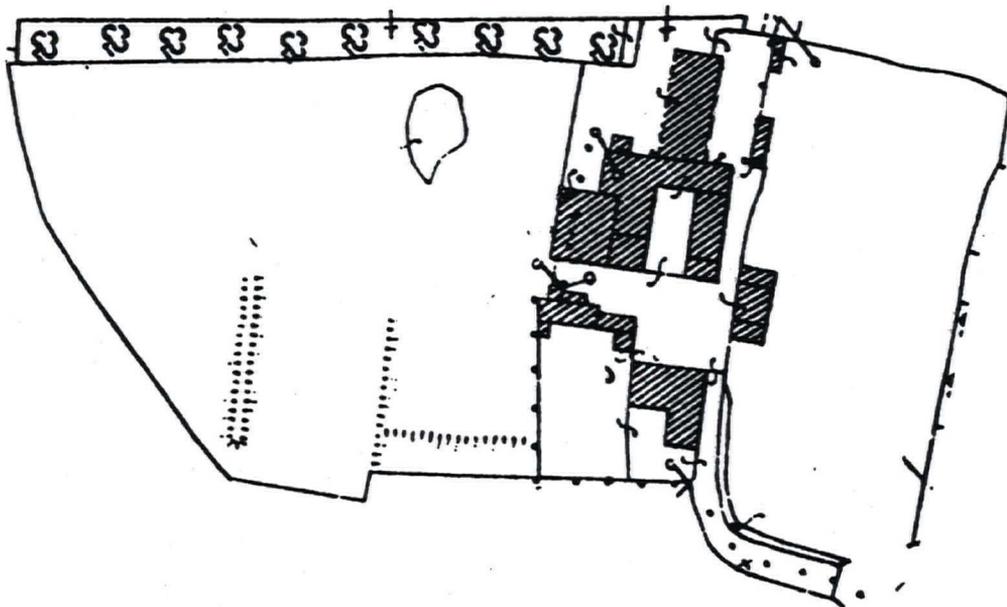
- 13.4 The 1929 Ordnance Survey 25":1 mile map. The Hall is in its present form and the farm buildings have been altered again, the engine house having gone and a new Dutch barn (?) having been added to the north.
