**Abbeydale Industrial Hamlet Mill Pond –
Archaeological Watching Brief
Sheffield City Council**

Report Title: **Abbeydale Industrial Hamlet Mill Pond – Written Scheme of Investigation for Archaeological Monitoring**

Revision: **Version 1**
Issue Date: **December 2014**
Report Ref: **4763**

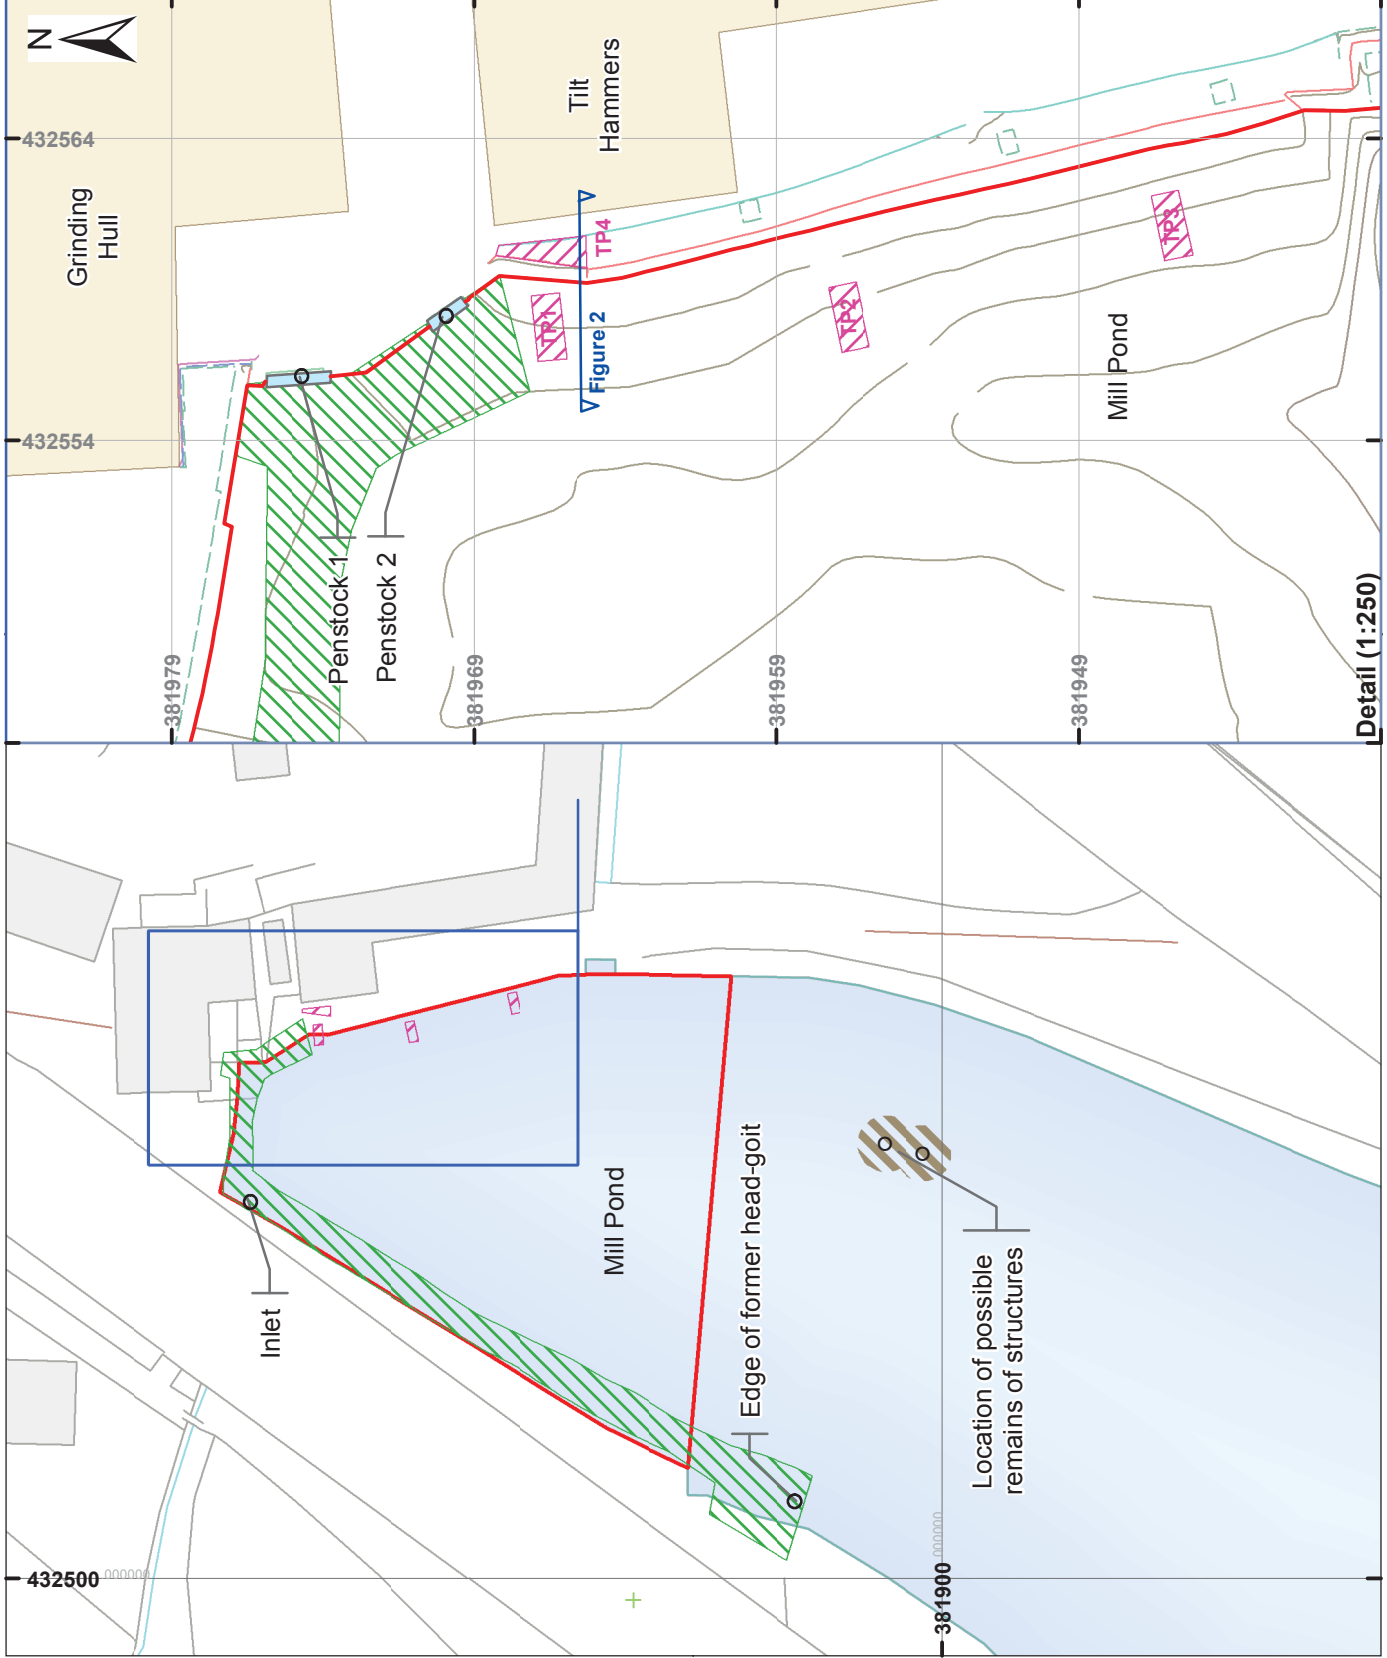
4.5.1 A rubble spread was observed in a raised area towards the centre of the pond. The rubble comprised unsorted angular narrow slabs of sandstone. Whilst no edges were discernible, two possible centres to the spread were recorded with a handheld GPS at:

Rubble spread associated with possible structures
