Stours Farm, Lower Stokes Road, Ashen Sudbury Essex CO10 8JQ  
Description and analysis of the farmyard buildings at Stours Farm.  
Surveyed 14 02 2011.

## Descriptions of the Buildings.

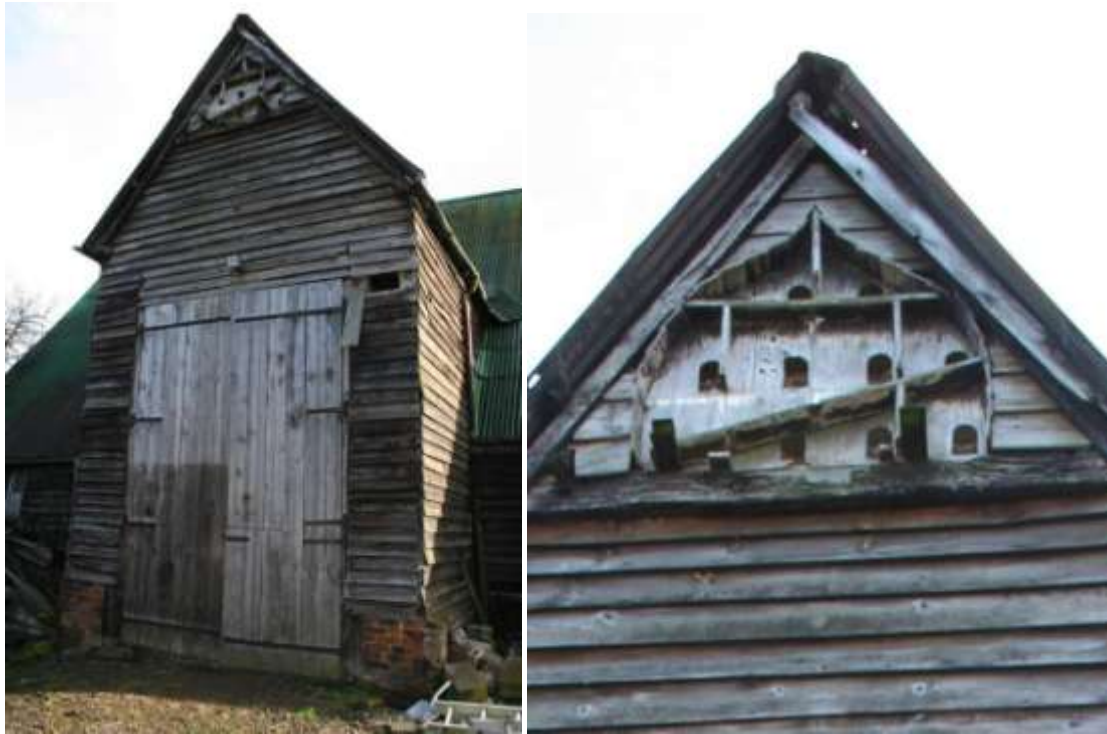
Full height doors and above a dovecote made from an upturned boat hull.

The lower part of the southern leaf has the first three planks sawn through as though to create a half door but this was abandoned when the circular saw broke (owner - pers comm) and a hasty timber plate has been nailed on the inside to patch it all up. The doors are held closed with two home-made latches hung on a timber crossbar. There are pintles or sockets for previous upper and lower doors remaining in the jambs

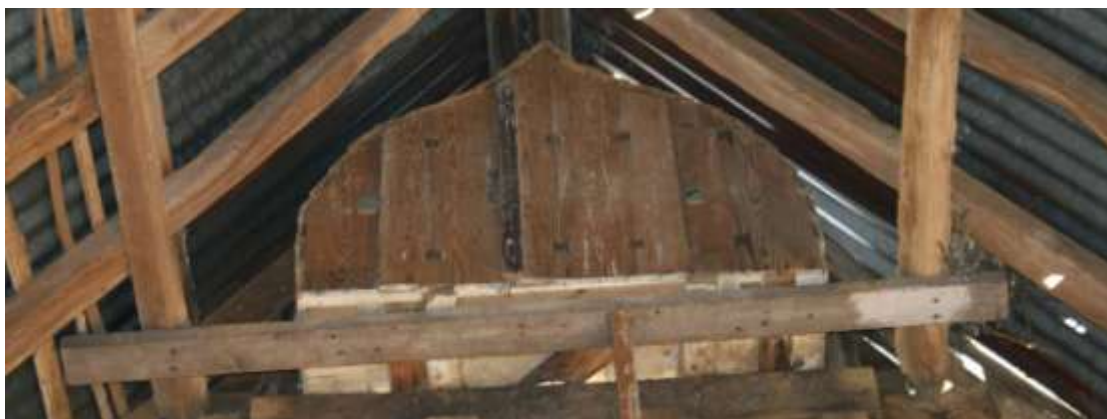
Clinker built dovecote with hinged panels for access to the rear.

Above the doors is a very interesting dovecote. It appears to have been made out of a clinker built boat inverted and sawn through. Inside it can be seen that the back has a series of hinged panels with turn-buckles to allow access to the nests. The back is pencil marked and must be C20th. The supporting structure is machined softwood held with French nails.

According to the owner the dovecote was made by Italian prisoners of war between 1940 and 1945.

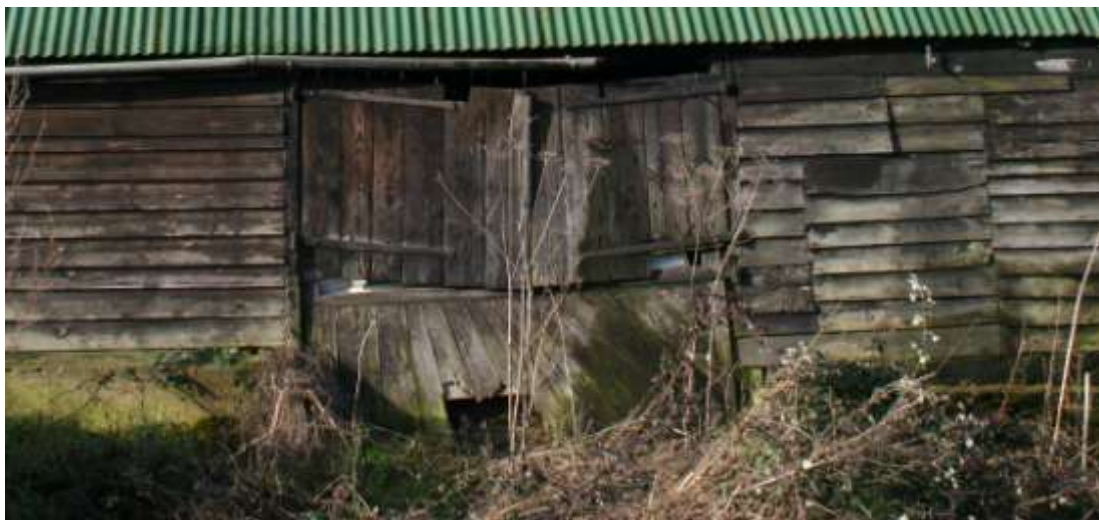
The low central doorway with two types of door. Note boarded section to the right.

There is a low, inserted doorway, beneath the wall plate in the central midstrey which is pegged through for studs. The upper half has two vertically boarded, edge-moulded, tongue and groove softwood doors. The long wrought iron pintle straps are bifurcated at the terminals and nailed in place.

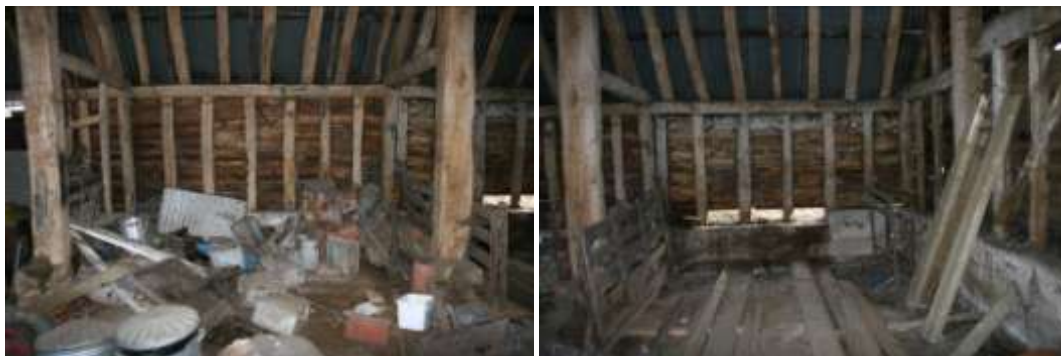
Comparing Bays 4 and 5 on the eastern side. Note awkward disposition of studs in Bay 5.

The walls are constructed from 5-6in wide studs cut to 3in deep. These are all fully pegged but it is evident that the frame has been completely dismantled and reassembled in a new configuration. Some of the studs are upside down and a number in the south wall are set at right angles. This is given away by the darts and ledger mortices cut in the faces of the timbers.

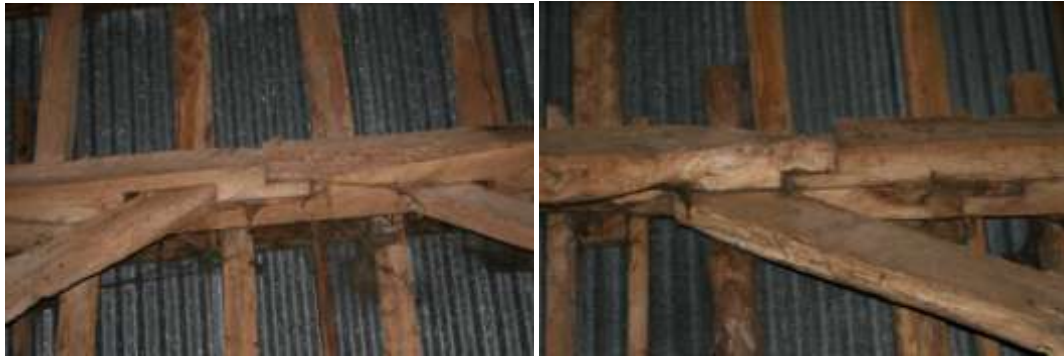
Scarf joints in the arcade plates weakened by the insertion of mortices for braces.

There are face halved and bridled scarf joints with face pegs in the arcade plates, wall plates and the midstrete tie-beams which connect to the midstrete porch top plates. Here the tie-beam has a reduced terminal to allow the joint to be made to a smaller section timber (previous photograph). The scarves in the arcade plates are weakened by the mortices for the braces being either inserted or adjacent to them and may imply a later modification.

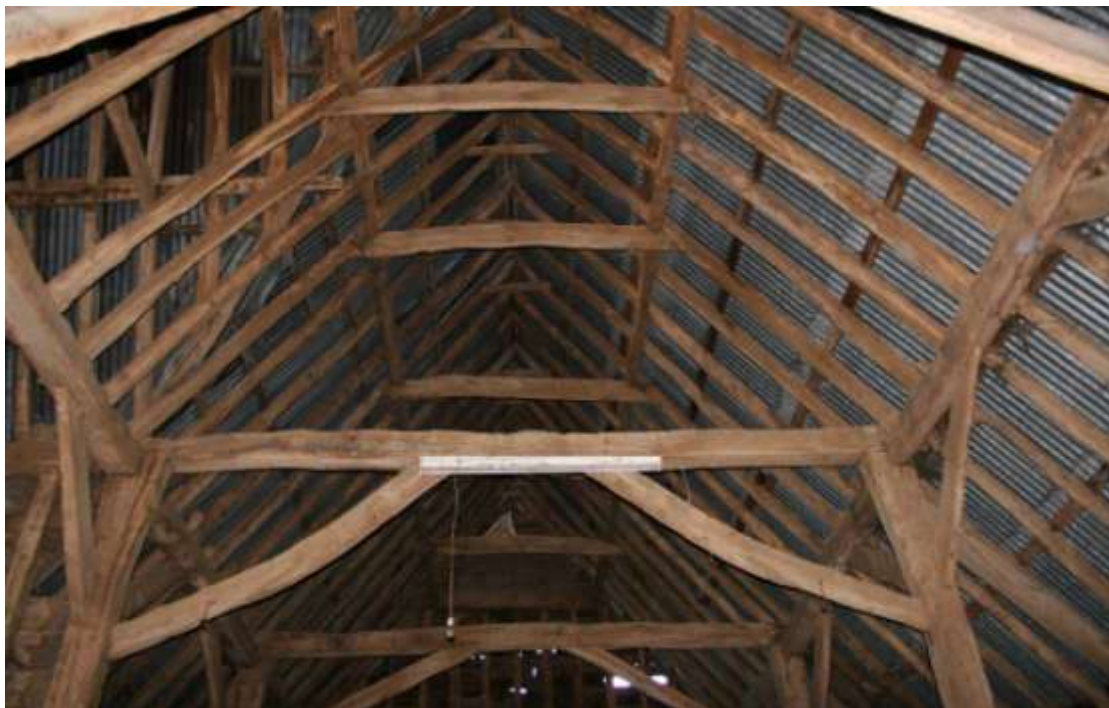
The roof has no principal rafters and is a clasped side purlin construction with long collars.

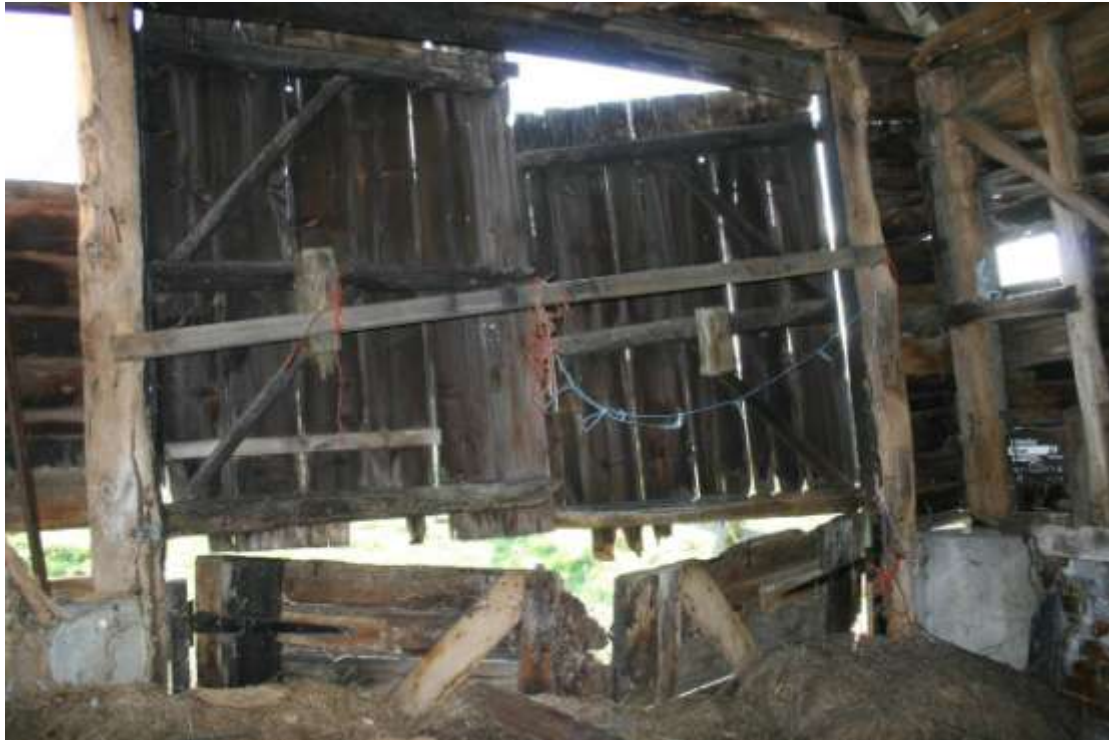
The porch doors are vertical, edge moulded softwood boards, tongue and grooved with a gate and ledger construction. The wrought iron pintle straps have spooned terminals but each is different as though reused from elsewhere. The bottoms of the doors are raggedly sawn off and it is likely they were originally full height. There are redundant pintles in the jambs on either side.

The lower leaves have horizontal plain boards and are hung on mild steel T-strap hinges screwed to battens fixed to the inside of the jambs. It seems they were made from earlier doors that were set with the boards vertical. It is easier to see from inside.

South doors in the midstrey porch. The upper doors may be original, the lower home-made.

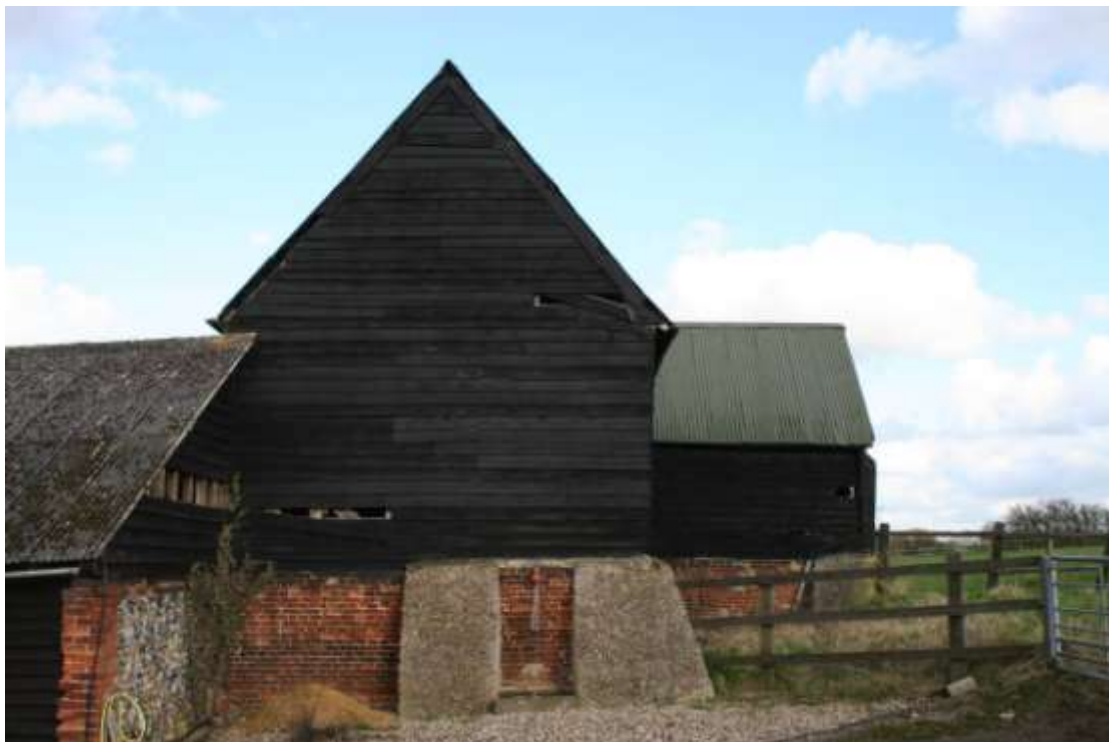
Western elevation showing concrete buttresses.

The western elevation is a plain gable with modern weatherboards. The West Stable abuts the NW corner. The plinth is buttressed with poured concrete.

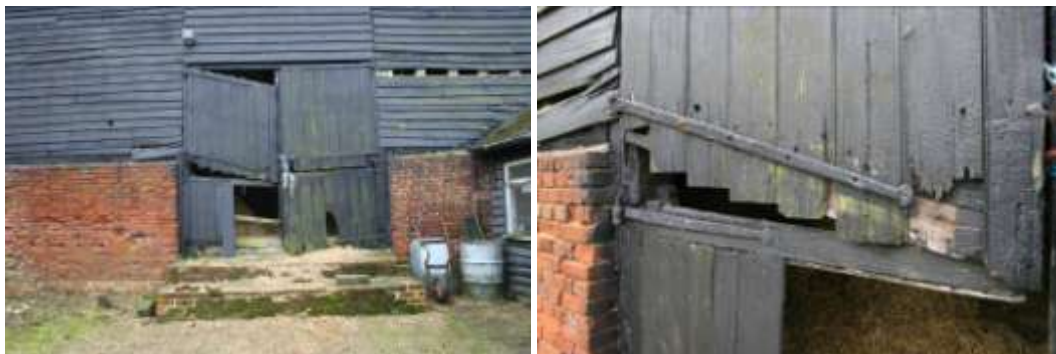
The doors on the northern side.

The doors are in a sorry state almost hanging off their wrought iron pintle strap hinges. The upper leaves are vertically boarded softwood, tongue and grooved, gate and ledger with edge moulded boards. They are poor quality. The lower leaves are softwood plain boards rebated into the frame and hung on shorter wrought iron pintle straps.

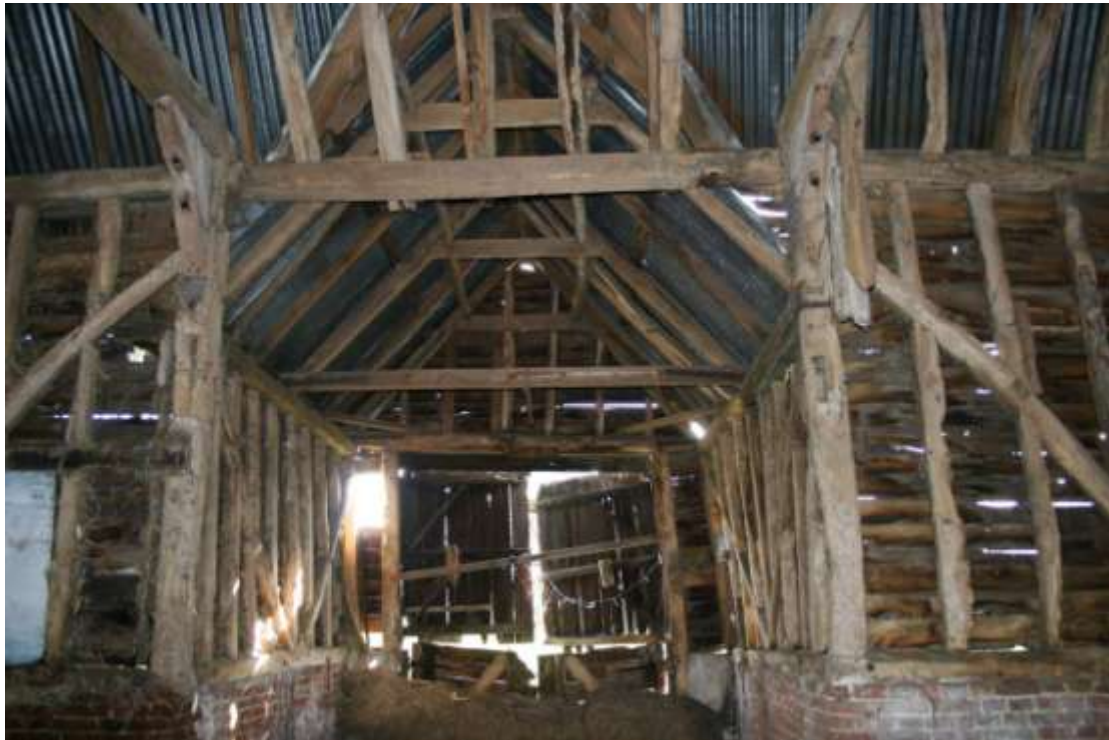
Looking south into the midstrey porch. Note interrupted studwork and reused timber.

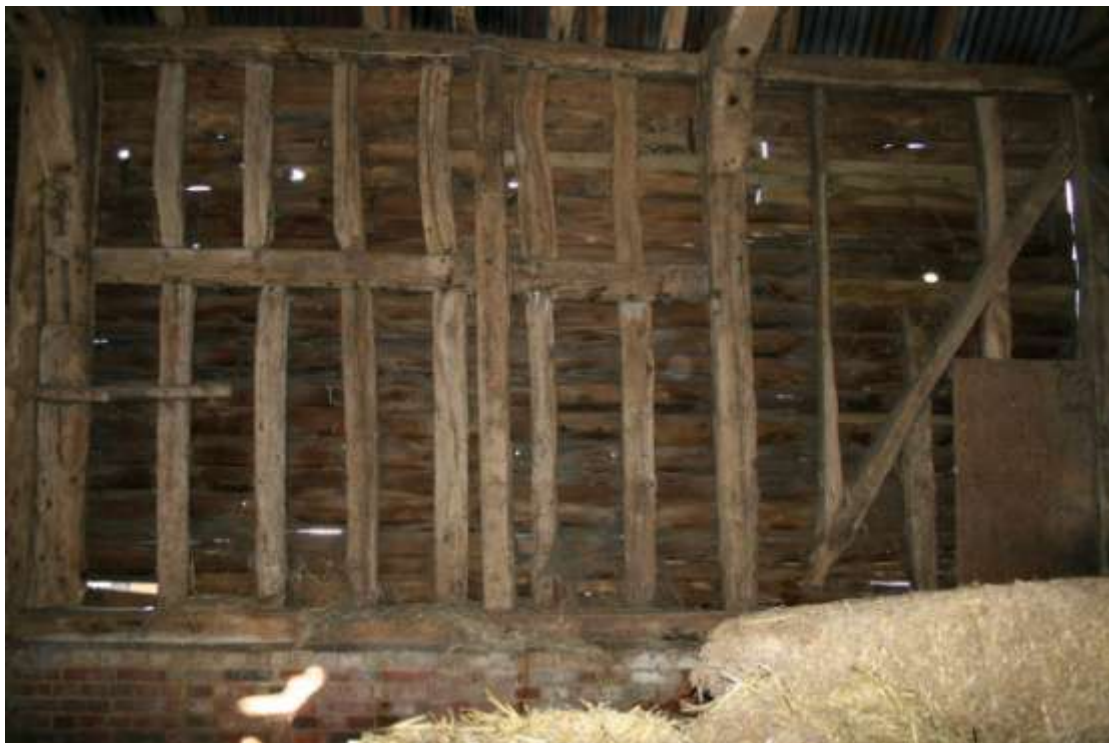
South wall, Bays 4 and 5. Studwork from an earlier house and Georgian nailed bracing.

Unlike the East Aisled Barn which is fully pegged in construction the 5 bay South Barn is held together with ironwork at every major joint, be it nails, bolts or iron ties. The timber-frame is raised on the red brick plinth and is for the most part reused oak. The curved braces in the walls are elm and there are elm quarter poles as well as other unidentified timbers, some with the bark still on.

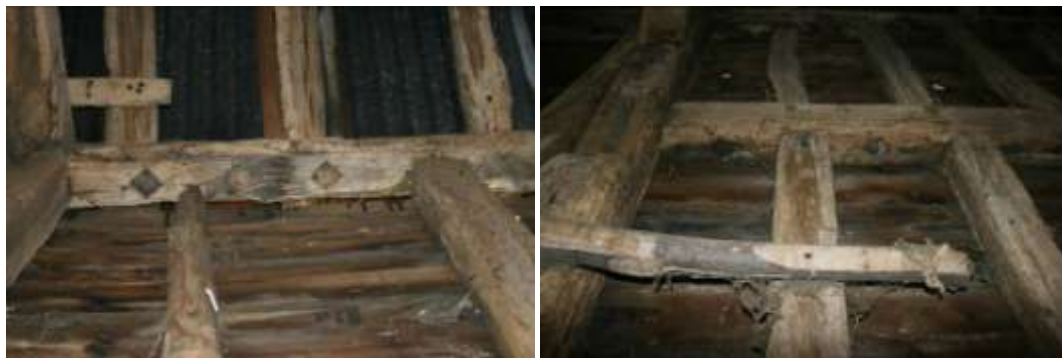
Top-plate (left) in Bay 1 and midrail in Bay 4 have diamond mortices for heavy mullions.

The top-plates and the mid-rail have mortices for diamond mullions and there are remnants of shutter grooves. The easternmost tie-beam has diamond mortices and mortices for a fully framed end wall. (See roof description later).

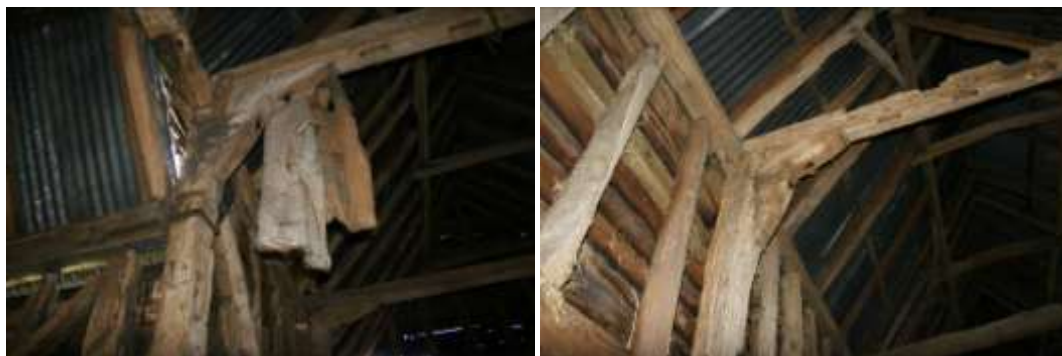
Wrought iron tie on the midstrete post. Square headed bolts on the hanging knees.

The principal posts have been hacked or sawn back to a constant square section leaving the large empty matrices of the original braces. The braces have been superseded by hanging knees fastened with square headed threaded bolts. There are wrought iron L-ties and pin-ties on the principal posts connecting them to the midstrete porch. The door jambs are bolted through to the frame.

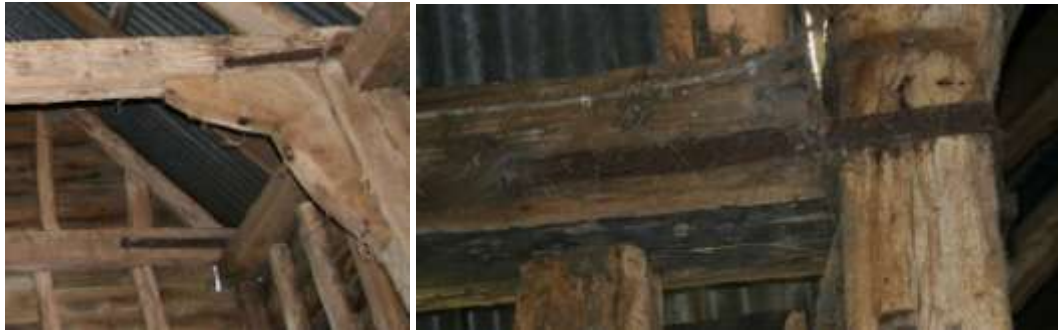
L-ties on the tie-beams with bolts through the hanging knees. Mild steel L-tie on midstrey.

Wrought iron ties have been used throughout to connect the main timbers. There are three easily recognised types. The L-ties are used to connect timbers such as tie-beams and posts at right angles to each other. Flat straps are used to connect across in-line joints like scarfs. Pin-ties are used to pass through a timber and anchor to the flank of another to pull them together. These are relatively rare and are recognised by their forged round heads and stapled shanks.

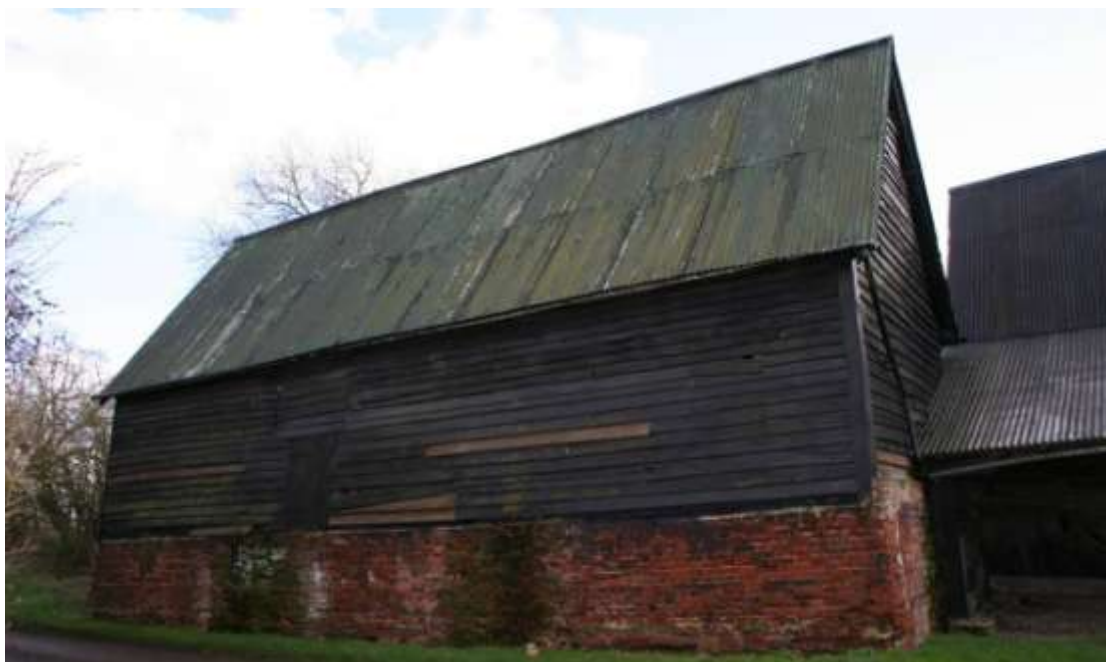
The northern elevation gives close onto the road to allow loading through the hatch door.

The northern elevation consists of a 21 course stepped brick plinth of red and orange 55&65x110x230mm handmade bricks set in a beige sandy mortar in 9 courses of Flemish bond over English bond. There are a couple of courses of Fletton repairs in the west corner.

The 7in cold tarred weatherboards are in good condition and fastened with French nails. There are several recent replacement boards fastened with French nails which have not been tarred. The roof is clad in corrugated iron sheets and is very steep and suitable for thatching. The rainwater goods are painted metal and in reasonable condition.

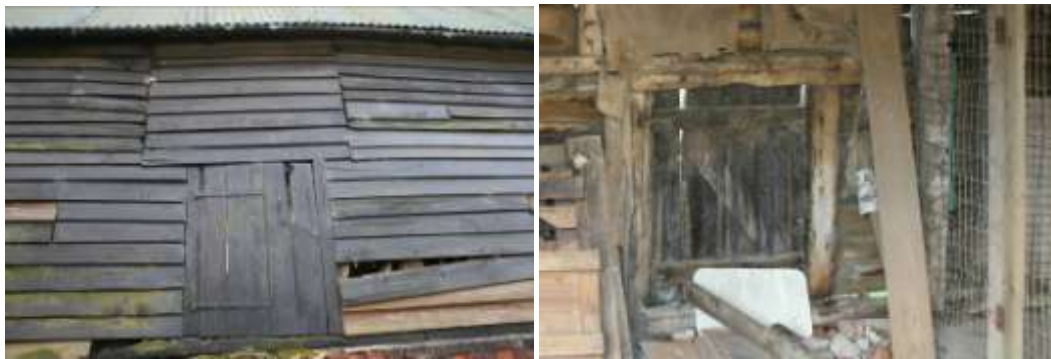
The hatch door from the road and inside.

There is a small gate and ledger hatch door with wrought iron pintles that opens out high to the roadside but is at floor level inside. A larger hatch has been blocked above which may have been a window. A solitary pintle remains to show there was a door or shutter.

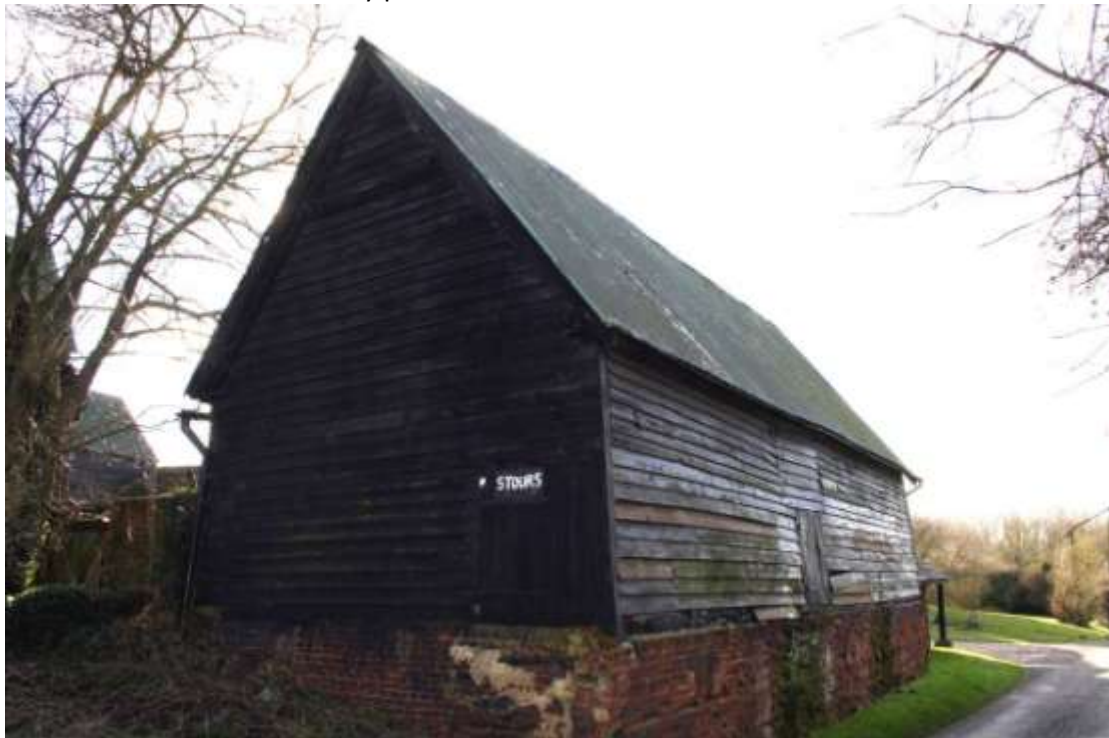
The eastern elevation presents the gable to the road. There is a small hatch door under the sign.

The building presents a plain gable end to the road clad with C20th weatherboards. There is a small vertically boarded gate and ledger door in the NE corner which like the other is high to the road but at floor level inside making it ideal to load off a cart into. It has long wrought iron pintle hinges and appears C19th. Below is an iron cramp being used to stabilise the brickwork of the plinth which has had several repairs. The ground here has been made up and is overgrown.

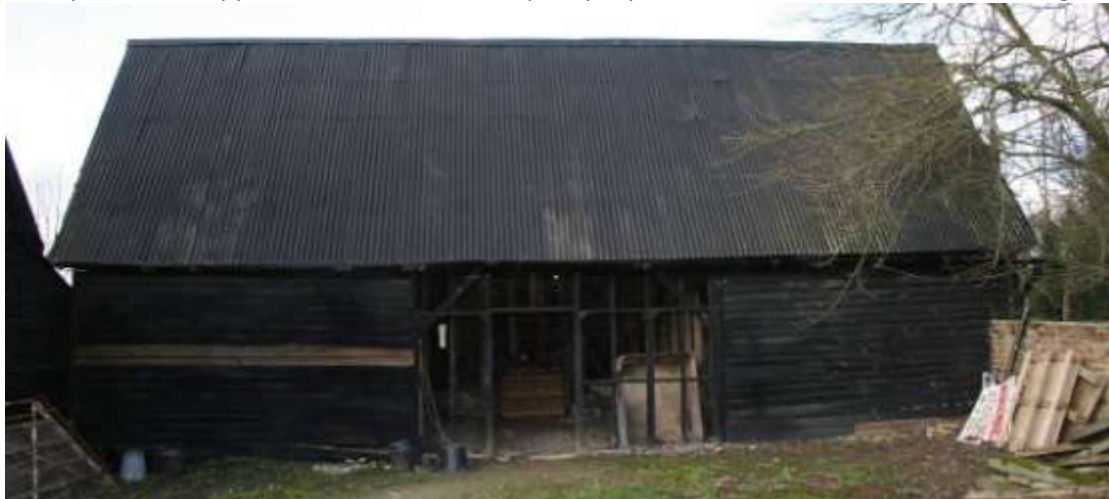
The southern elevation has original boards and netting for dog kennels.

The southern elevation is clad with hot-tarred 7in weatherboards fixed with wrought iron nails. The central bay of the three is open with a skeleton frame of modern softwood supporting galvanised netting to act as a cage. There is an opening for a door but no door.

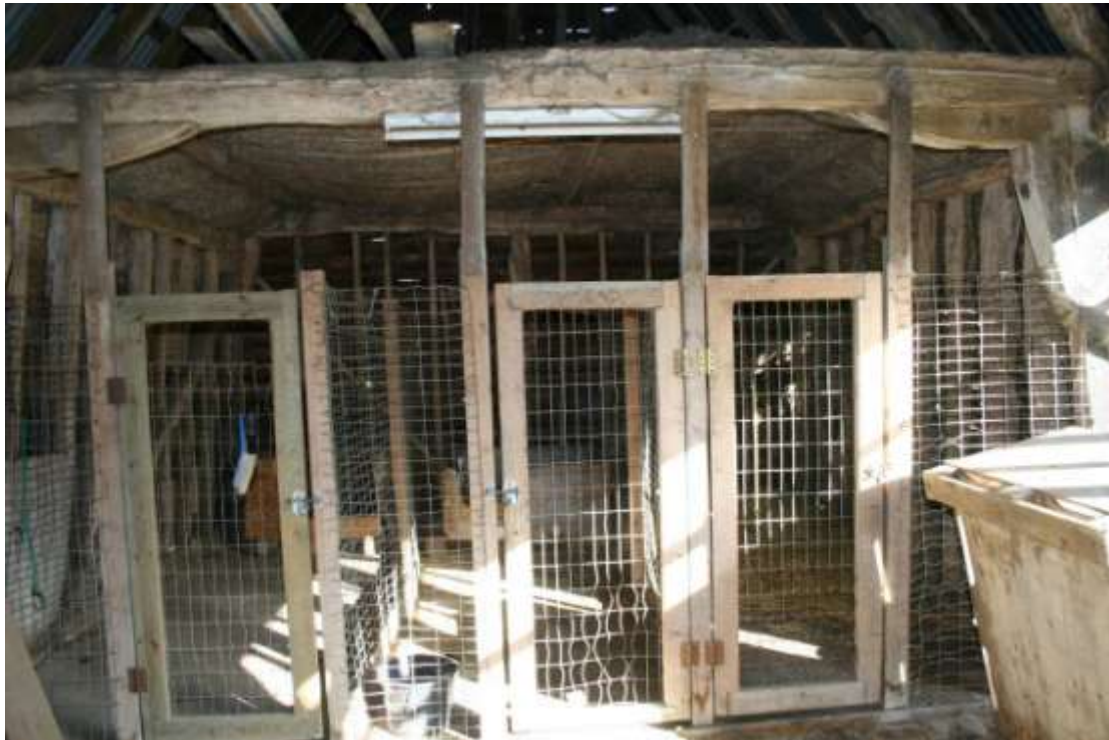
Modern softwood frames cobbled together with wire fencing to make dog kennels.

The open bay gives onto three dog pounds on either side. These are quite recent and put together from oddments of modern machined timbers and heavy duty wire fencing as well

as the odd sheet of corrugated iron. The eastern bay also has a lowered ceiling insulated with straw. Each bay has a dog box. The kennels are still in use.

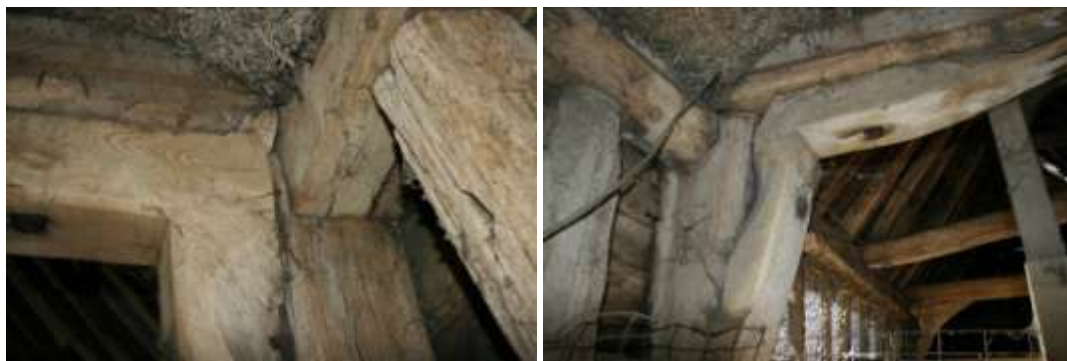
Square post in the north wall has tiny upstand. Hanging knees made from tree roots.

The hanging knees appear cut on a bandsaw and have a display face into the centre of the building while the obverse reveals a very gnarly root structure. The principal posts on the southern side have proper jowls but are profiled to follow the curve of the re-used and eroded top-plate. The tie-beams are secured with wrought iron L-ties.

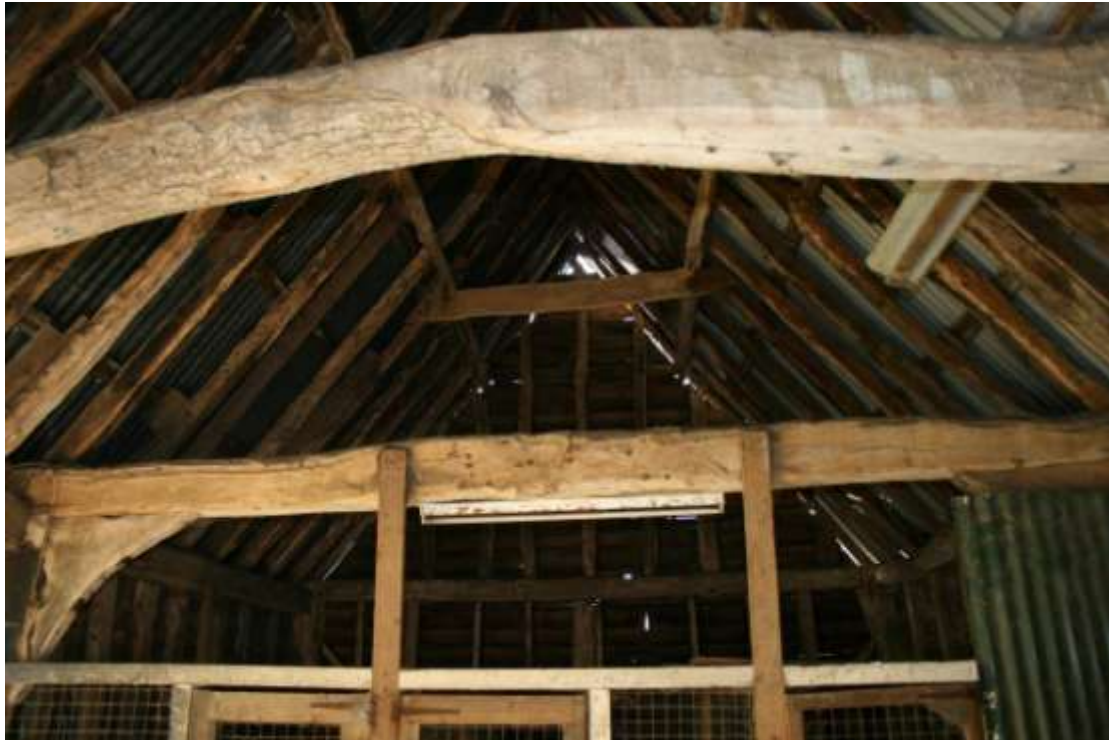
Main tie-beams are re-used oak. Central tie-beam is bark covered elm.

The main tie-beams are of interest as they are both re-used. They are clearly from a crown post roof, pegged for braces and the central post. There is an additional central one (without hanging knees) made of roughly finished elm. The two crown post tie-beams have very clear apotropaic marks facing into the central bay. (See later section on Apotropaic marks).

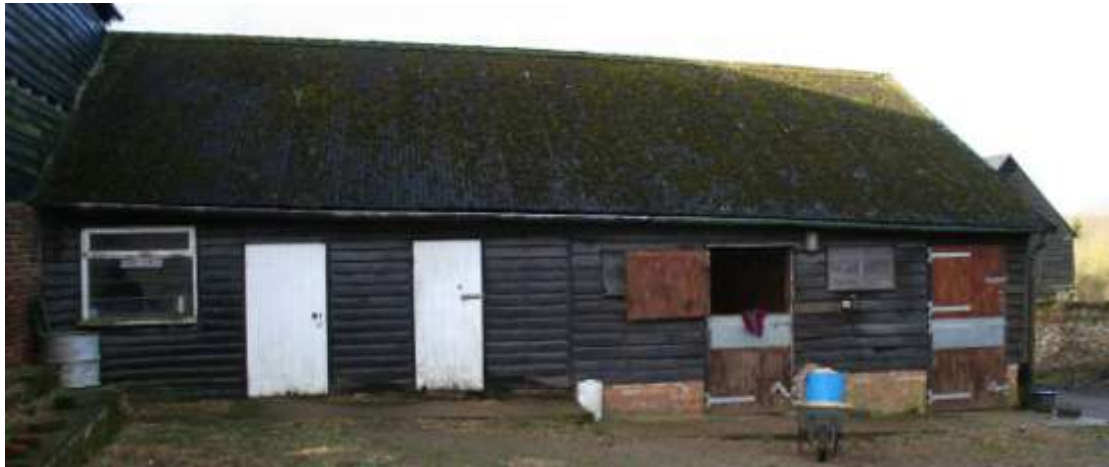
Eastern elevation of the West Stables.

The eastern elevation faces into the farmyard and has doors for the Office, Tack Room and two stalls. The walls are timber-framed clad with C20th weatherboards standing on a Fletton brick plinth bedded with grey cement. The roof is of corrugated asbestos sheets and the rainwater goods are painted metal in fair condition.

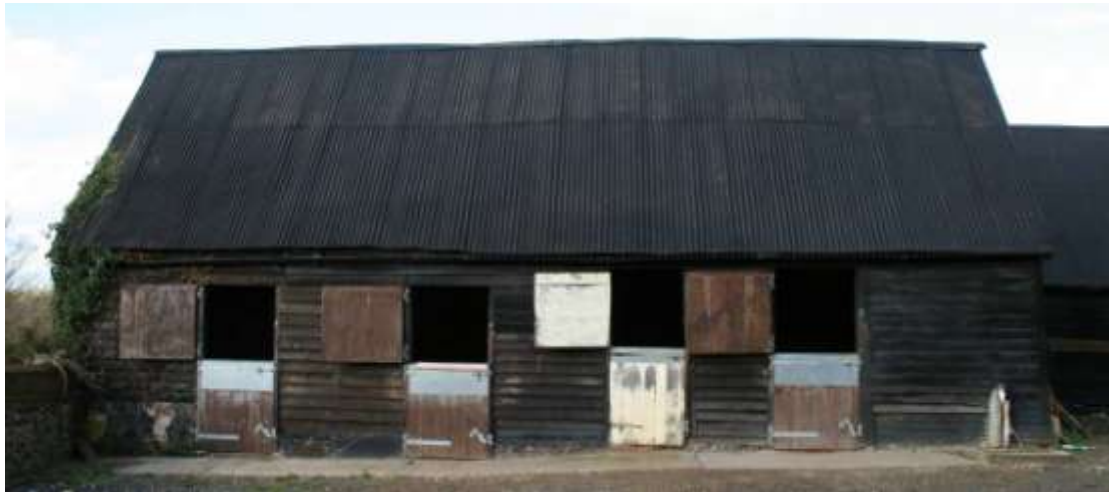
The southern elevation faces into the farmyard and has four horse stalls.

The North Stables has four openings with split stable doors to the same pattern as those in the West Stables (east side) but in a more weathered condition. The doors to Stall 3 (from the west) are an earlier version with mild steel strap hinges instead of the stout galvanised reversible hinges. It has been refurbished with a new bolt and kick lock.

The timber-frame is repaired with C20th weatherboards and stands on a brick plinth painted over with tar. There are some original 76in boards at the eastern end. The roof is corrugated iron painted black. The rainwater goods are painted metal in fair condition.

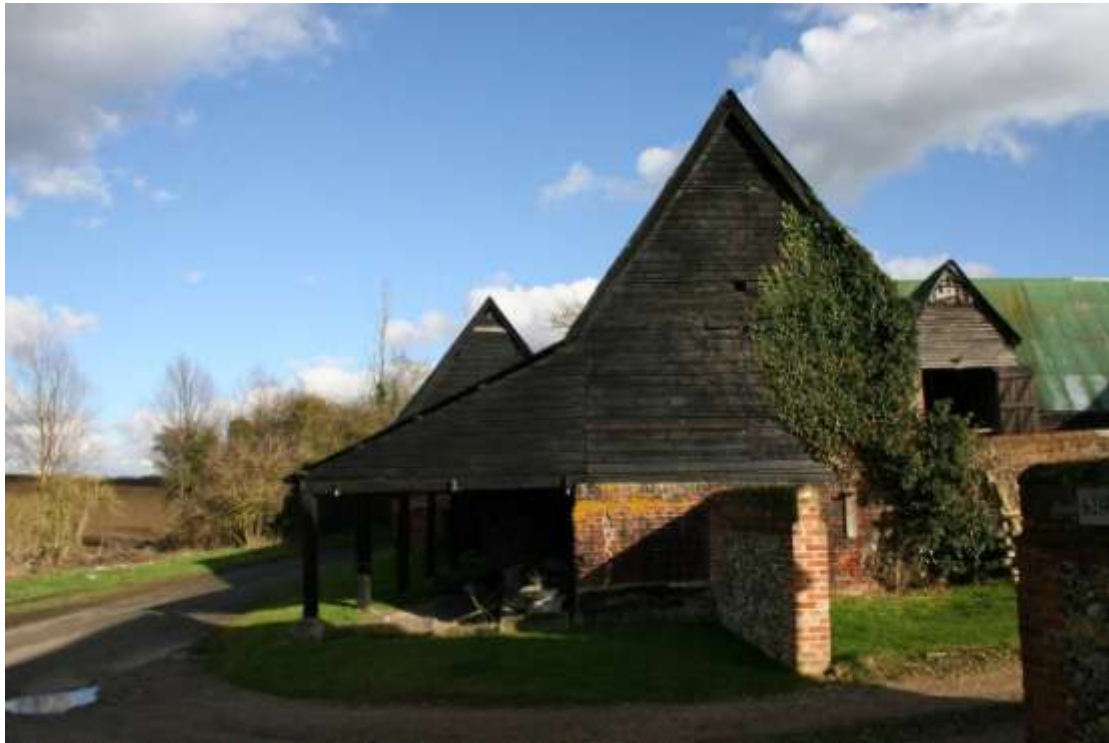
The western gable end is sat on a very deep plinth.

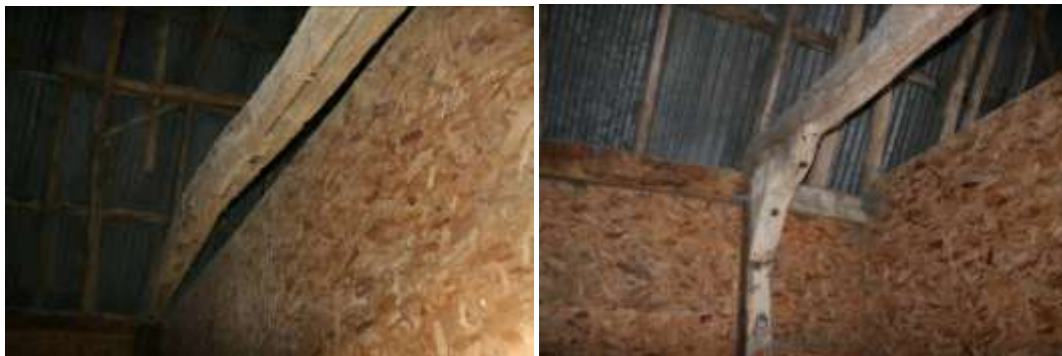
Like the West Stables the walls have been boarded out with OSB and the timber-framing is not visible. However the main posts and tie-beams are exposed and it can be seen that they have the same type of hanging knees as the Store secured with square headed bolts and wrought iron L-ties. The tie-beams are a mix of elm and reused oak from a crown post roof.

Tie-beam re-used from a crownpost roof (left) and an elm tie-beam with hanging knee.

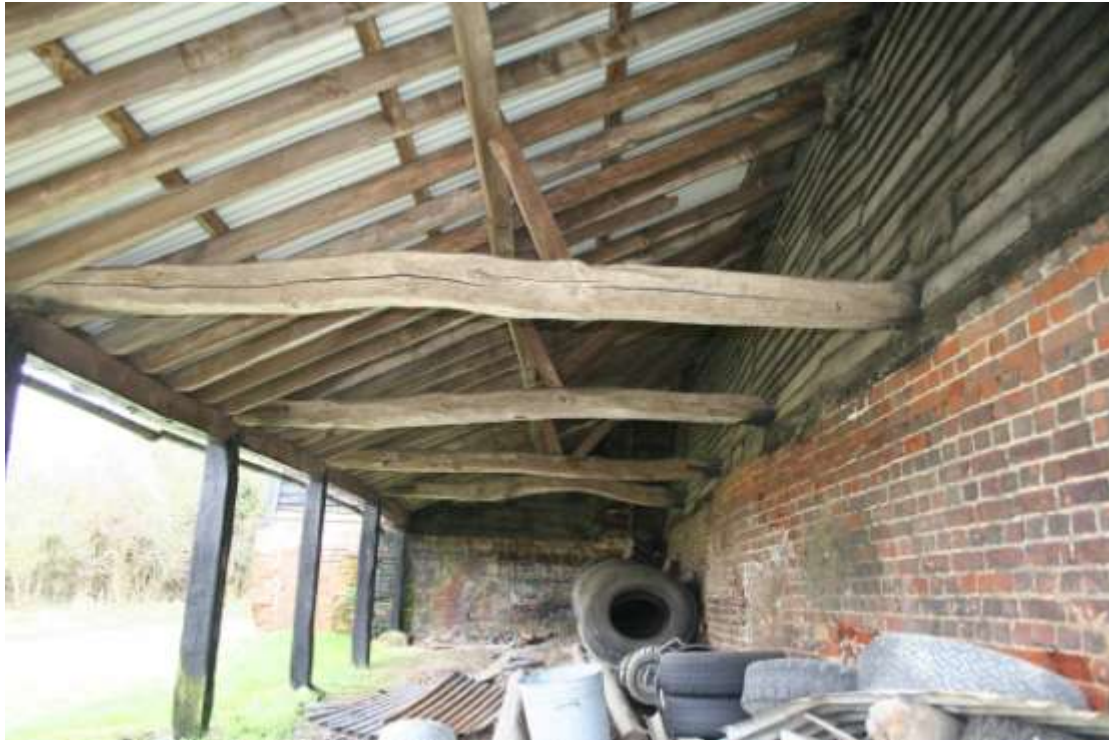
Interior of the Open Shelter looking east.

The roof is a simple lean-to with a central purlin supported on raking struts from the waney elm tie-beams which are held with large iron L-ties rusty enough to be mild steel. Some of the rafters are machined to 2x7in but most are elm quarter poles. There are some additional struts nailed on later.

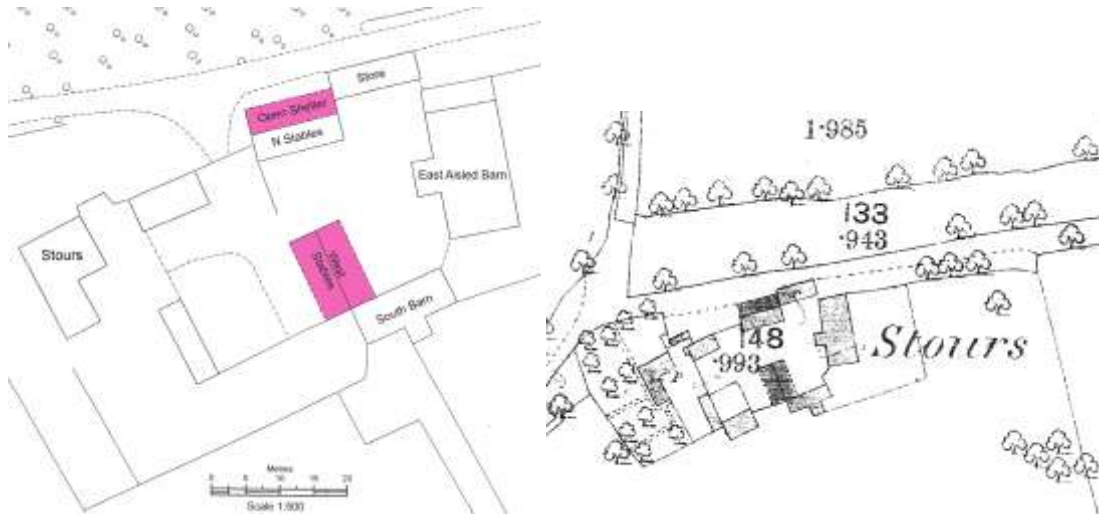
Phase 2. The 1876 OS map shows the appearance of the Open Shelter and West Stables.

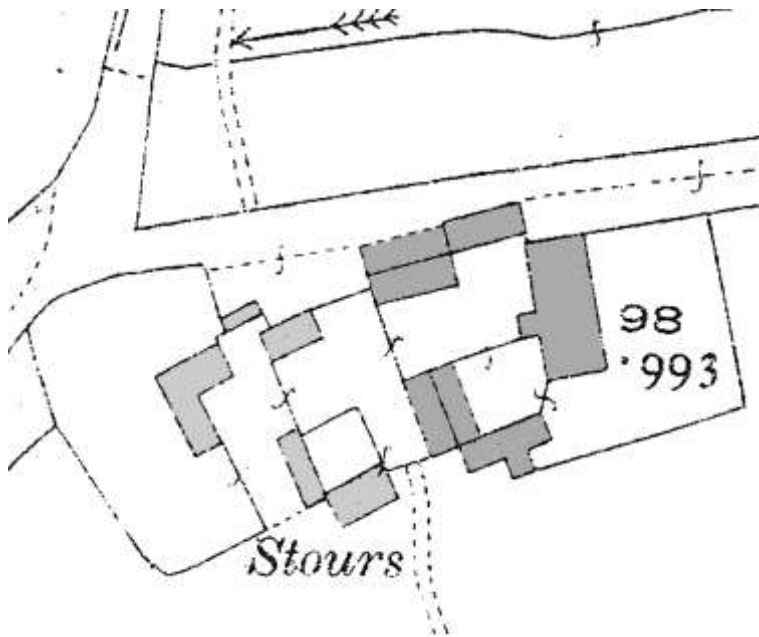
The site in 1922.

The 1922 OS map shows that Stours retained its layout into the C20th. Here and there are repairs in Fletton bricks which became very popular in the 1920's (most of the houses in Sible Hedingham were built out of Flettons in 1924 for example).
