Berwick Hall Farm, Park Lane, Toppesfield, Essex.
Description and analysis of farm buildings at the site.
Surveyed 15 09 2011. BDC 10/01438/FUL

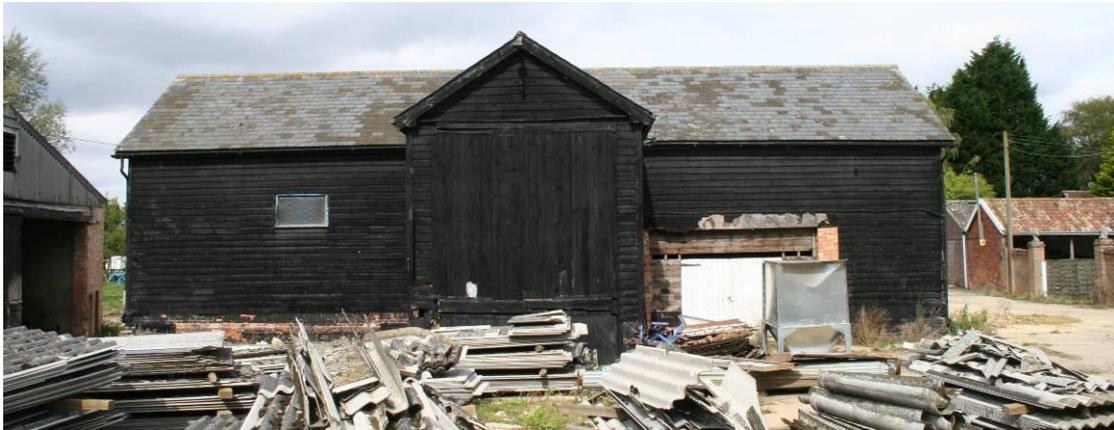
Southern Elevation

The south elevation has the midstrey porch. Asbestos is from demolition of modern barns.

The southern elevation has a full height midstrey porch. Either side the weather-boarded stud walls were originally blank and stand on a tarred plinth of 65x110 x230mm fine red bricks with smooth faces, sharp arrises and shallow regular frogs. The plinth has a double course of coping bricks. The weather-boards are very regular machined timbers fixed with some wrought iron rose-headed nails but comprehensively repaired with French nails. The roof is of 12x24in grey slates at a suitable pitch. The rainwater goods are of painted metal.

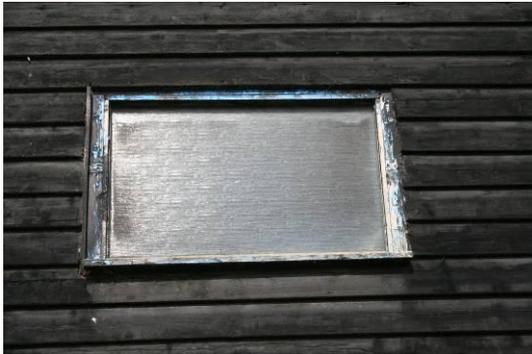
Obscured glass fixed casement in the western half of the barn.

In the western half of the barn there is a C20th high level fixed casement fitted with a pane of obscured glass which gives a little light inside. Random windows like this were often fitted for specific purposes such as lighting gantries for machinery.

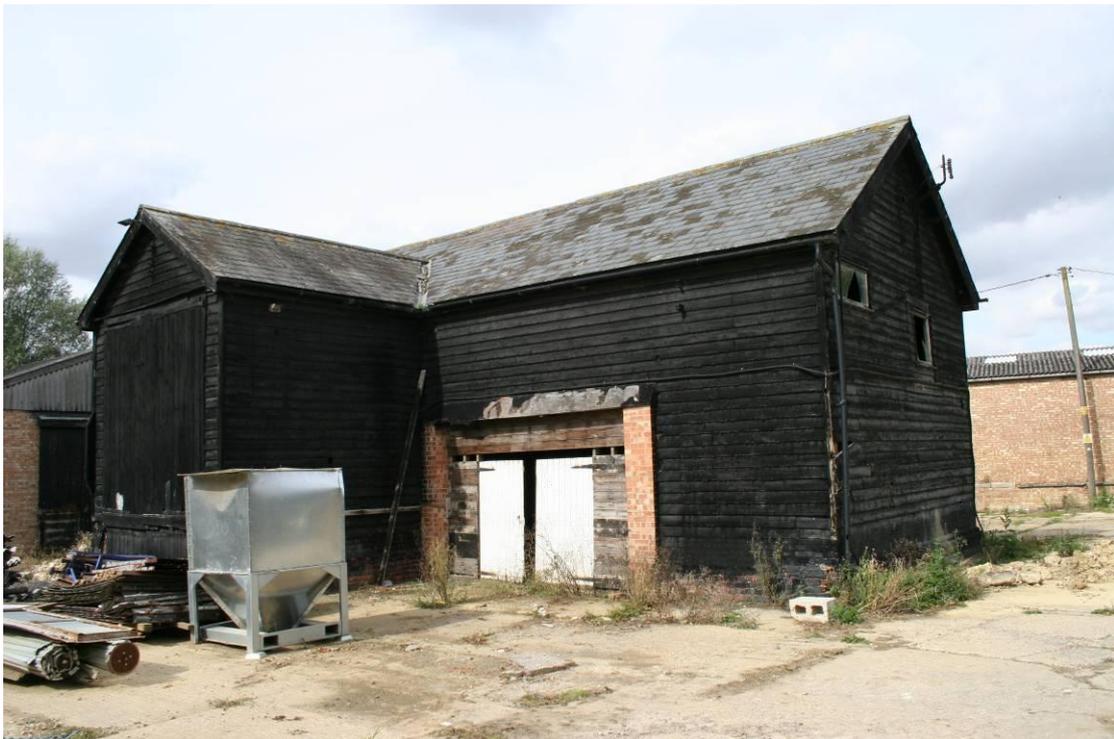
The full height doors are paired with those on the north elevation.

The full height split doors are a matched pair with those on the north elevation which at the time of the survey were more accessible. See later description. The midstrete porch has a self-contained toilet block built inside against the doors and so these are no longer used. They have been maintained however as at least one of the pintles has a C20th hex headed bolt.

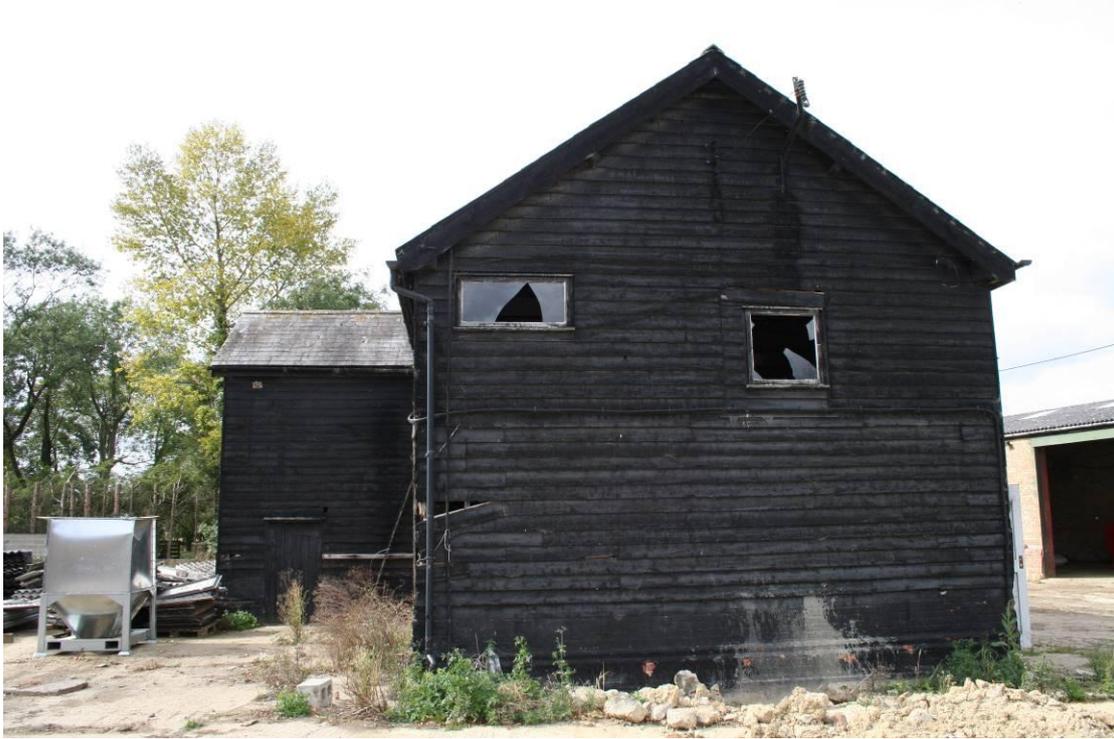
Western Elevation

Western elevation has the flank of the porch with an original pedestrian door. C20th lights.

The timber-framed and boarded gable end stands on the red brick plinth. The gable has two inserted C20th plain glass lights. One is inserted into the aperture for a former hatch door, the pair of which is in-situ at the other end of the barn. Again the positions of the windows and odd sizes imply they were for lighting areas of modern machinery.

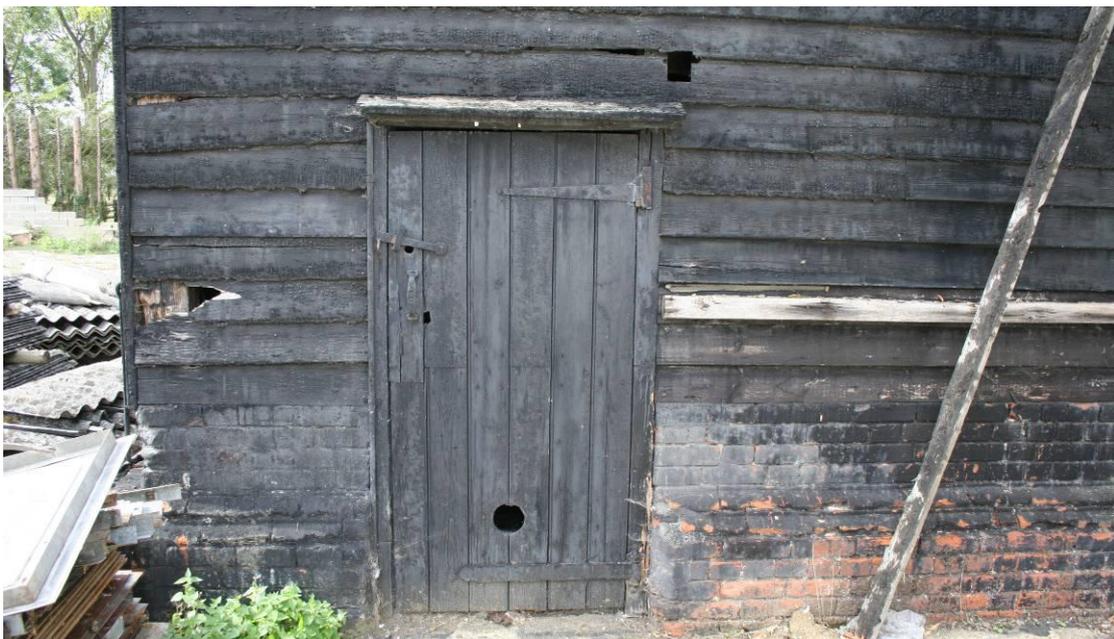
Pedestrian door in the flank of the midstrey may be original. Note socket in the boards.

There is a pedestrian door in the east side of the midstrey made from tongue and grooved edge-moulded vertical softwood boards nailed to gate and ledgers. It is now hung on a mild steel T-strap and a reversible hinge but it is likely it is the original. The finger latch is authentic and the woodstock lock box has been removed from the inside. The construction details match those of the full height doors. Inside the door jambs form storey posts and are integrated into the frame.

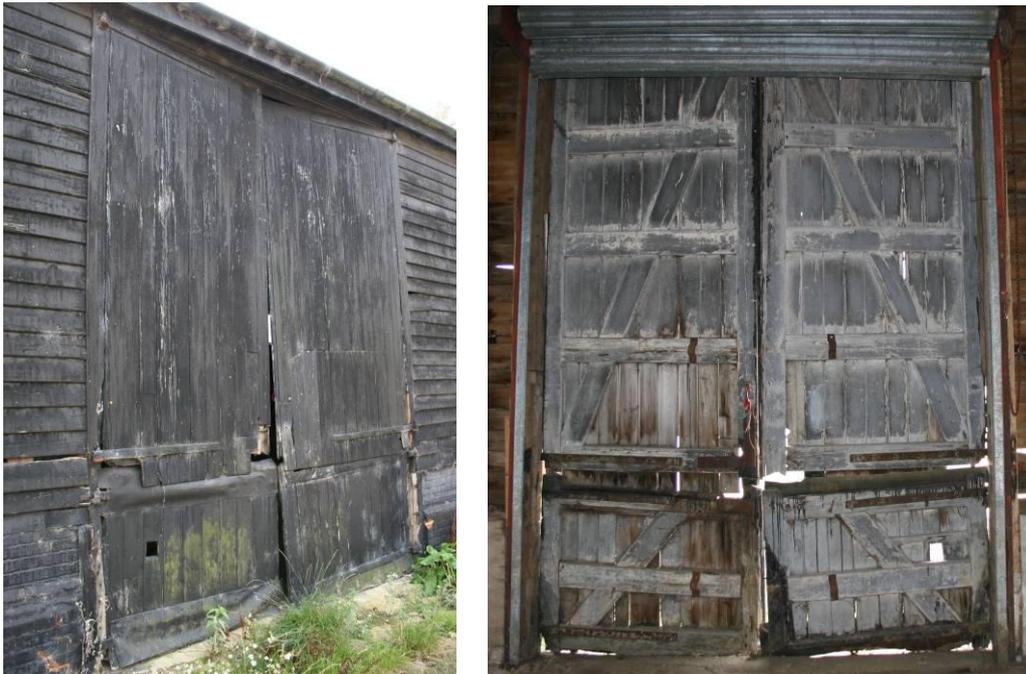
The full height doors from outside and inside.

The doors in the midstreych porch and the north wall are identical in scale and construction details. The upper leaves are exactly 10ft tall and 5ft wide while the lower are 44in. They are constructed from vertical edge-moulded softwood boards nailed to ledgers and interrupted gate braces. They are hung on strip milled iron pintles rusty enough to be mild steel but finished traditionally with decorated terminals. The straps are secured with round clouts and square headed carriage bolts to the inside of the doors and are cranked to pass through so the pintles are on the outside. The doors were painted duck-egg green on the inside.

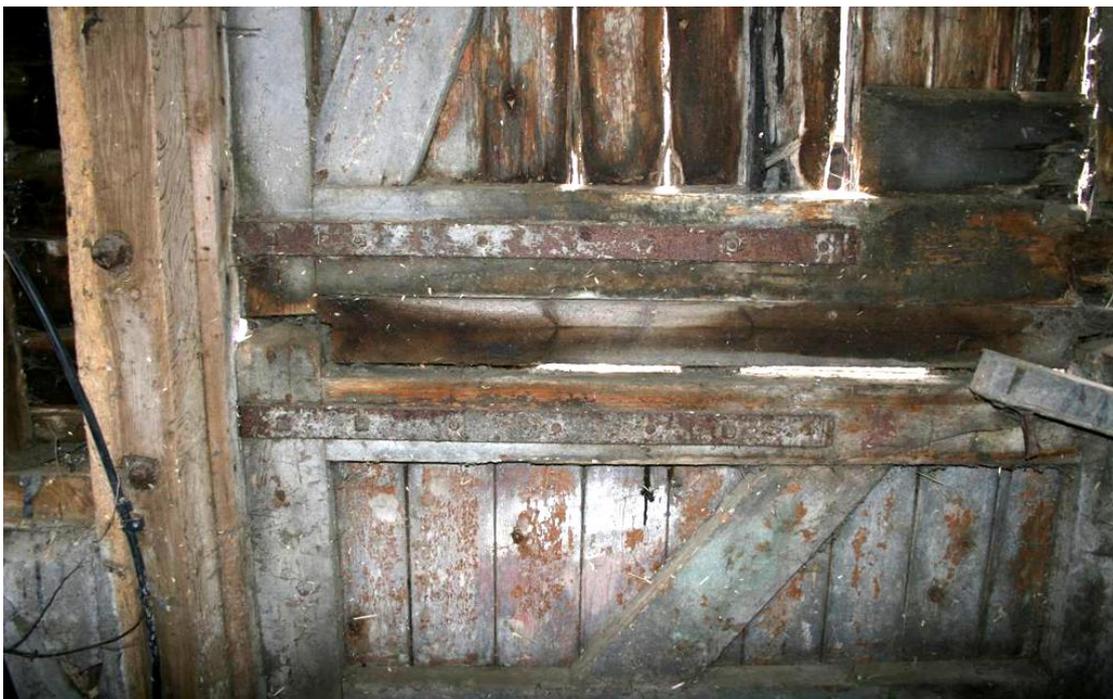
Detail of the midstreych door hinges.

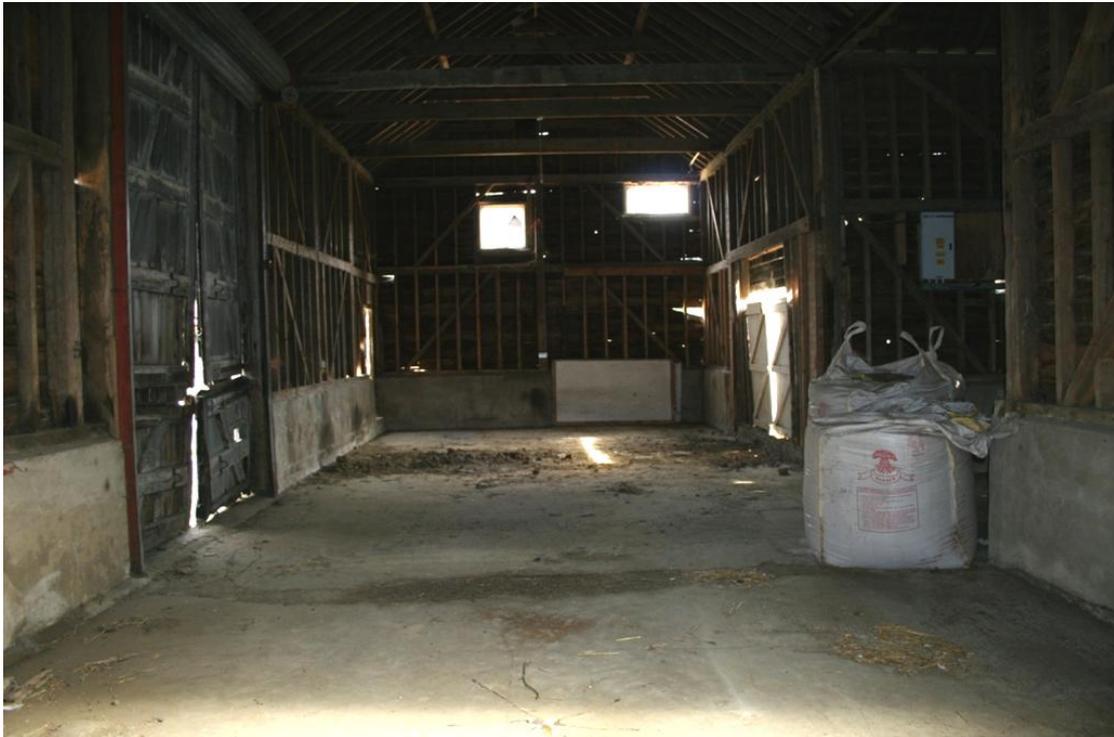
The barn is made entirely of fresh, machined softwood.

The 5 bay barn (defined by the tie-beams) has a large central midstrey porch and is made entirely of freshly cut softwood, some of it bearing the timber merchant's marks made with a race knife.

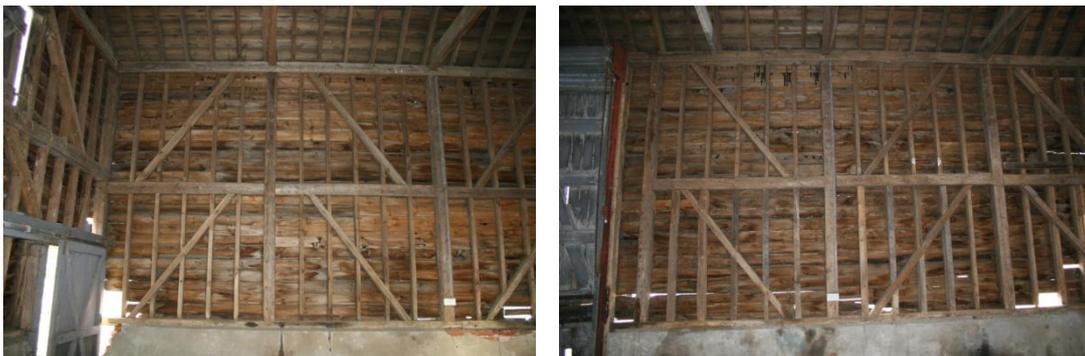
The NW and NE panels. The NE lower studs have been doubled up in the C20th

The 2x4in machined studs are set in panels each with a diagonal primary brace and are interrupted and nailed. In the eastern half the lower studs have been doubled up later on to reinforce the frame to 2x6in studs. Presumably this was done when the grain drying equipment was installed. The principals and mid-rails are 6in square. The doors have separate full height jambs.

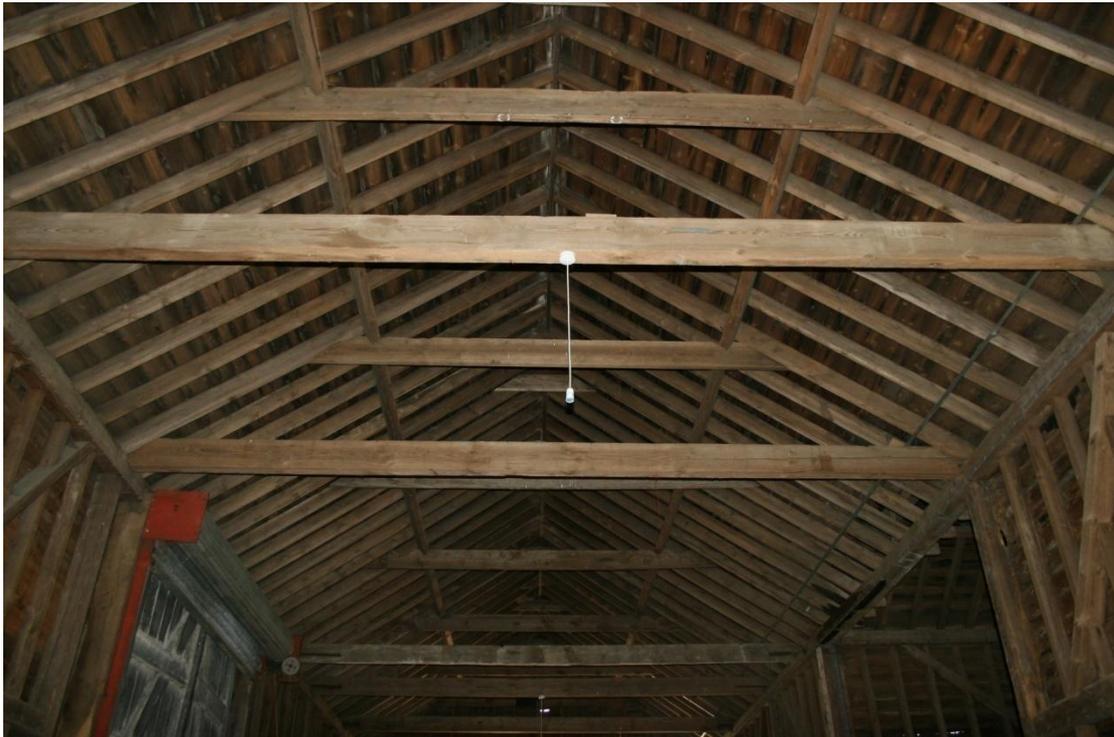
Roof Structure

Uniform softwood clasped purlin roof. Looking E.

The roof is a uniform simple clasped side purlin roof with 2x4in common rafters and 3x4in principal rafters secured with lapped and nailed collars every sixth one. The main tie-beams are 4x8in and sit over the principal posts with exception of the one to the east of the main doors which has been moved, possibly to accommodate the steel roller door or the machinery that was once installed.

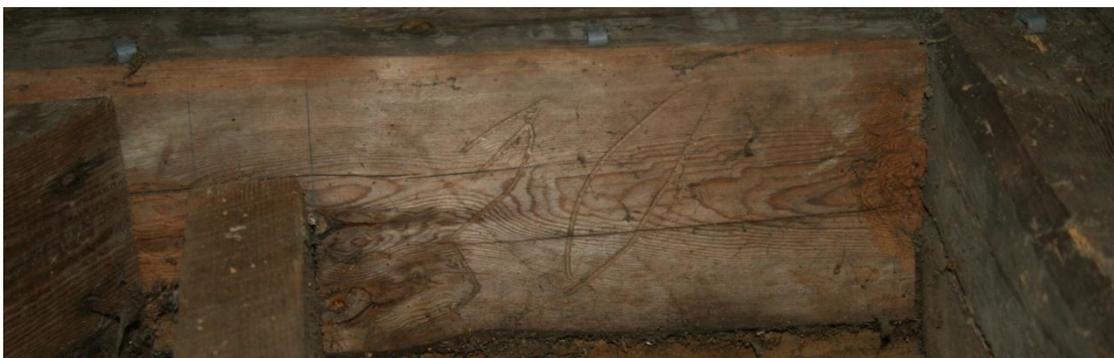
Merchant's mark scored on the underside of the mid-rail. Reads 30. Note pencil marks.

There are two clear merchant's marks on the undersides of the mid-rails and another on a principal post in the north wall. They read 1X25, 6X31 and 30. They are made with a race knife in the same ornate font before the mortices were cut and hence are not carpenter's marks. There were no apotropaic marks and the only graffiti found was some pencil calculations and the initials MA scored on the sole plate near the NE door in a modern hand.

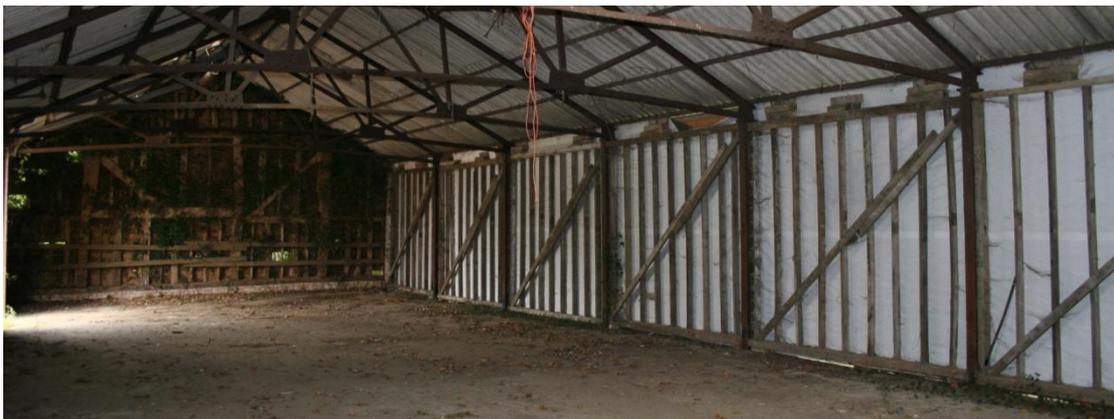
Southern Elevation.

Southern elevation only visible from inside the barn.

The southern elevation is composed of C20th 1.5x3.5in softwood studs spanned with diagonal braces nailed through. The exterior is clad in weatherboards recently reapplied as there is a breathable membrane placed beneath them. The exterior is only visible from a private garden. The softwood is quite greyed with age and probably original to the steel frame.

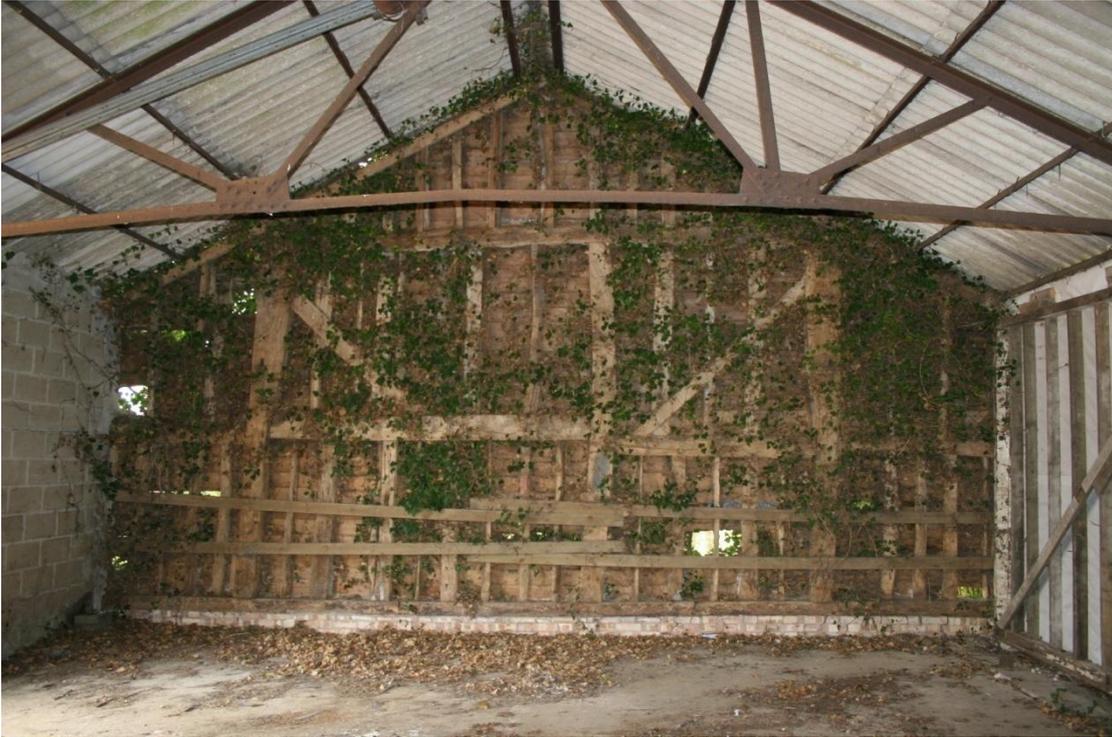
Eastern elevation has the remnants of the gable of a timber-framed aisled barn.

Both ends of the Steel Barn retain the timber-framed gable ends of an aisled barn. Both ends have been heavily repaired with nailed studwork but retain the original principal timbers.

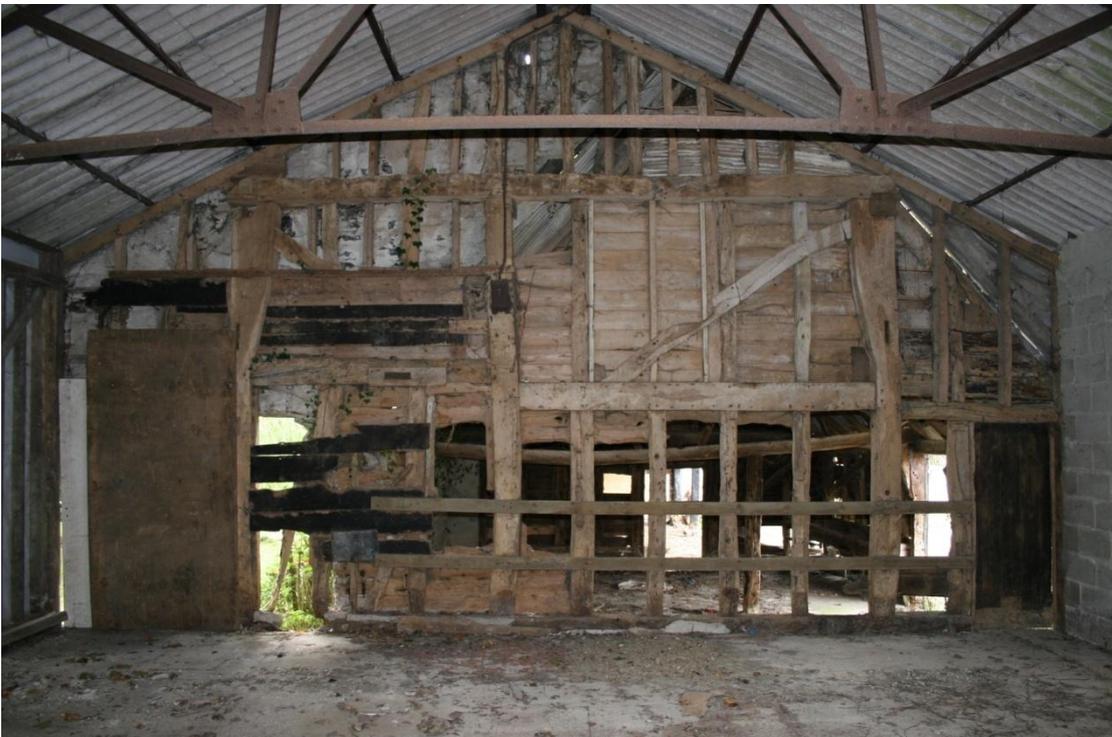
The western elevation retains the other end of the aisled barn.

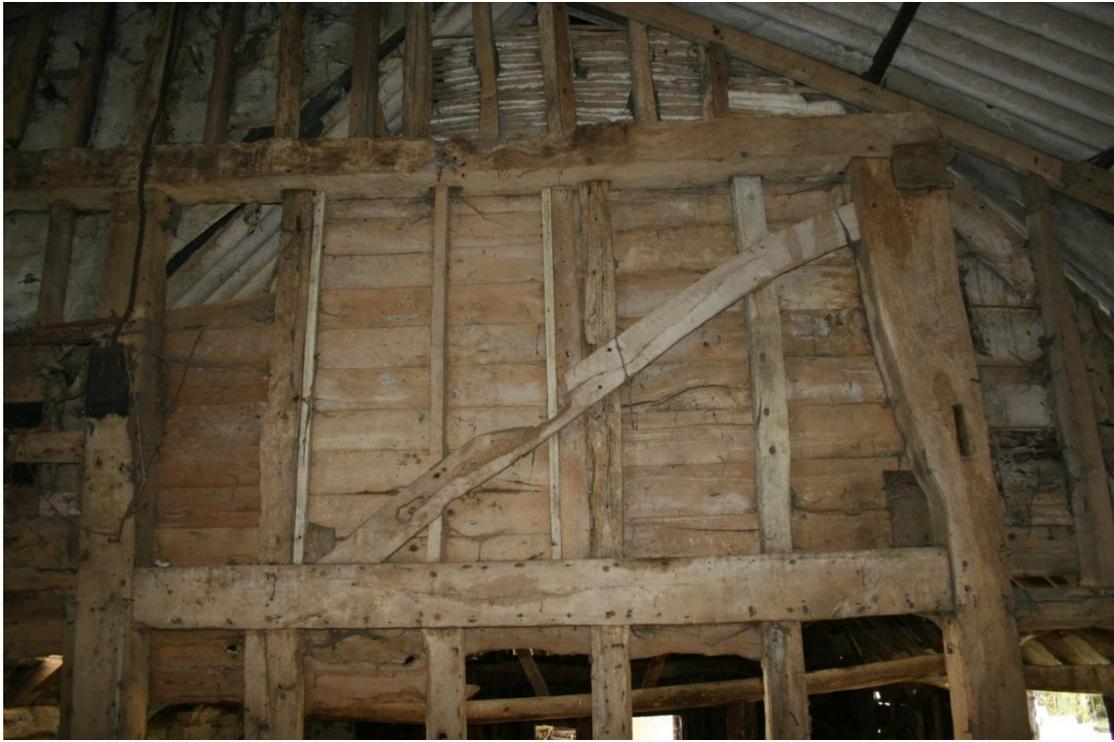
West gable end. Heavily jowled arcade post, long curving braces and sawn off arcade plate.

The frame consists of heavily jowled arcade posts with long sinuous down-braces onto the mid-rails. The mid-rails are offset about the storey post which itself is offset to the south of the frame. The arcade plates have been sawn off leaving cubes of timber retaining the tie-beam. One is missing completely in the SW post revealing the underside of the dovetail.

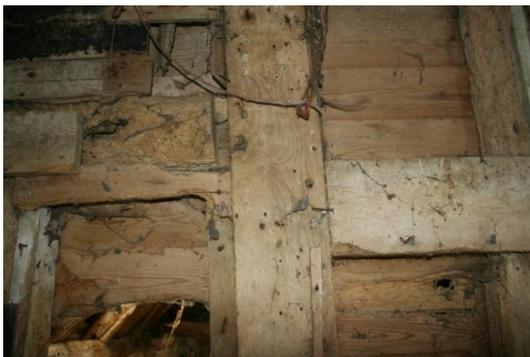
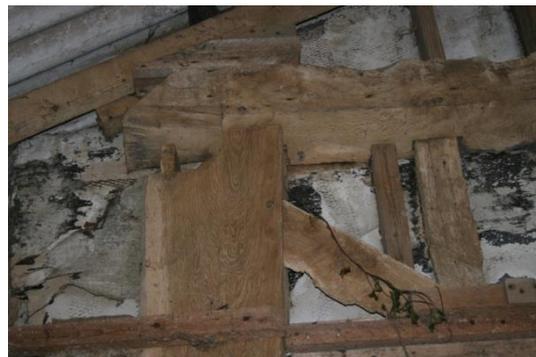
Offset mid-rails. Post head revealing dovetail and main tenon. Both in west gable.

The arcade ties are set at the same height below the 9x6in mid-rails but are only 6x6in in section. The larger mid-rail is in better repair than the other timbers and appears axe finished. The 8x7in corner posts retain mortices for up braces to the now removed arcade plates. The original studs (still pegged in position) are cut to 6x4in and set on the flat and have mortices and darts for wattle and daub panels. Many of the other studs are nailed in place and are reused or ¼ poles.

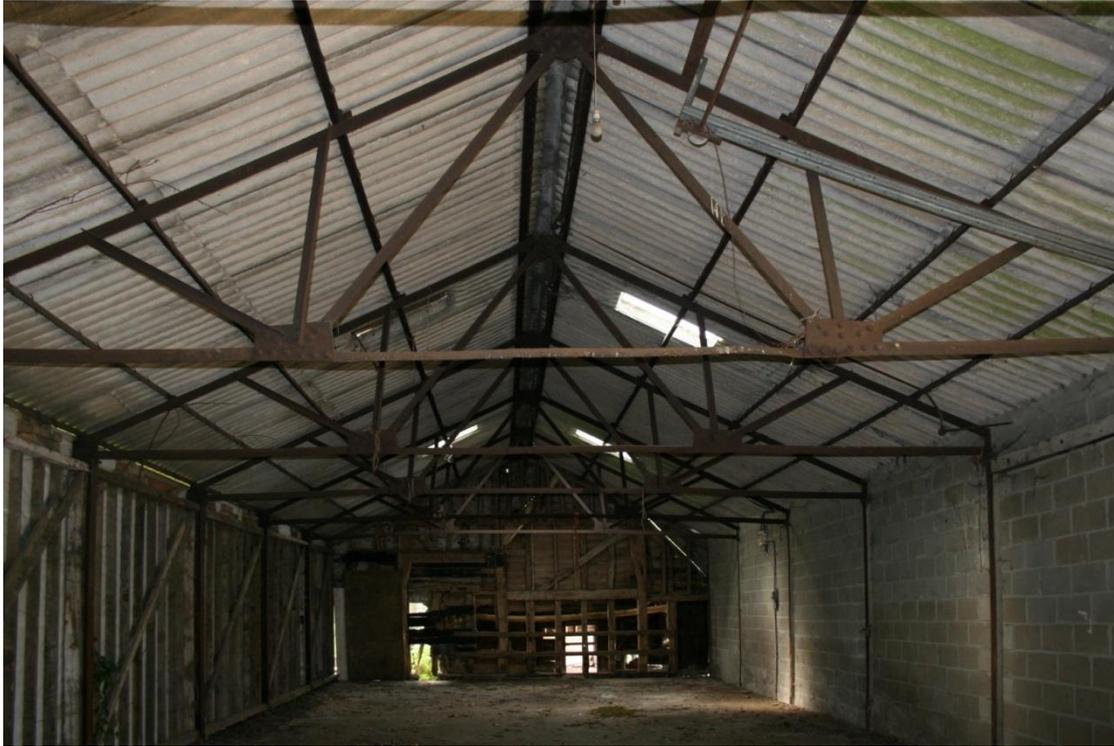
The roof is composed of 5 steel stressed trusses made from angle iron and bolted with hex head bolts. There are 4 steel purlins on either side to which the asbestos sheets are bolted through. The ridge is covered with galvanised iron. A slotted rail for a cable operated shutter door is suspended above the doorway. Rectified photograph follows.

The roof is a C20th steel trussed construction. Looking E. Note rail for sliding shutter.

The timber-framed gable ends have been altered to accommodate of the pitch of the steel framed roof. The original roof would have been much higher and the principal rafters would have run from the wall plates to the top of the aisle posts and then on up to the apex. The aisle ties give an idea of where the original wall plates would have been. The pitch of the earlier roof can be seen in the NW corner of the barn where it coincides with that of the Stables. Most of the timber above the tie-beam is machine sawn C20th work including the rafters. This means that the small section of pargetting must also be C20th. See also the photograph on page 13.

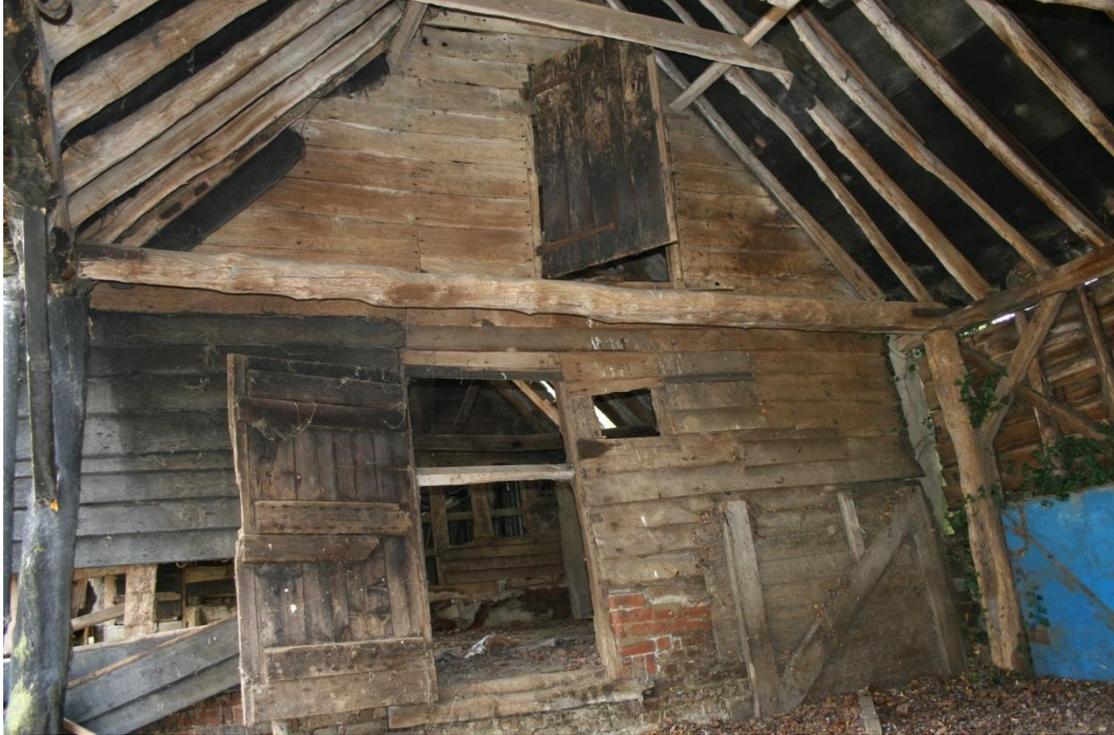
West Elevation.

The west elevation of the Stables is visible in the Shelter.

The western elevation was evidently the exterior of the Stables for some time as there are two external doors fitted in the frame. The high level door would have been for a grain loft which has subsequently been removed. The two doors are of the same construction details as the main door and both have seen plenty of service having been repaired with large nailed ledgers.

They are both reused in this position. Each has keyholes and shadows where Woodstock locks have been removed but there are no corresponding mortices or notches in the frames. The upper door is cut down and has a wrought iron hasp for a padlock. It could be supposed that they were all old doors modified for use in the Stables. There is a stray timber sticking out of the frame below the upper door and it is likely there was a set of stairs there.

The weather-boarding is piecemeal, fastened with wrought iron nails and there are two small sections that were probably openings beside the lower door. The boards on the north side are hot-tarred against the rain and so are the doors.

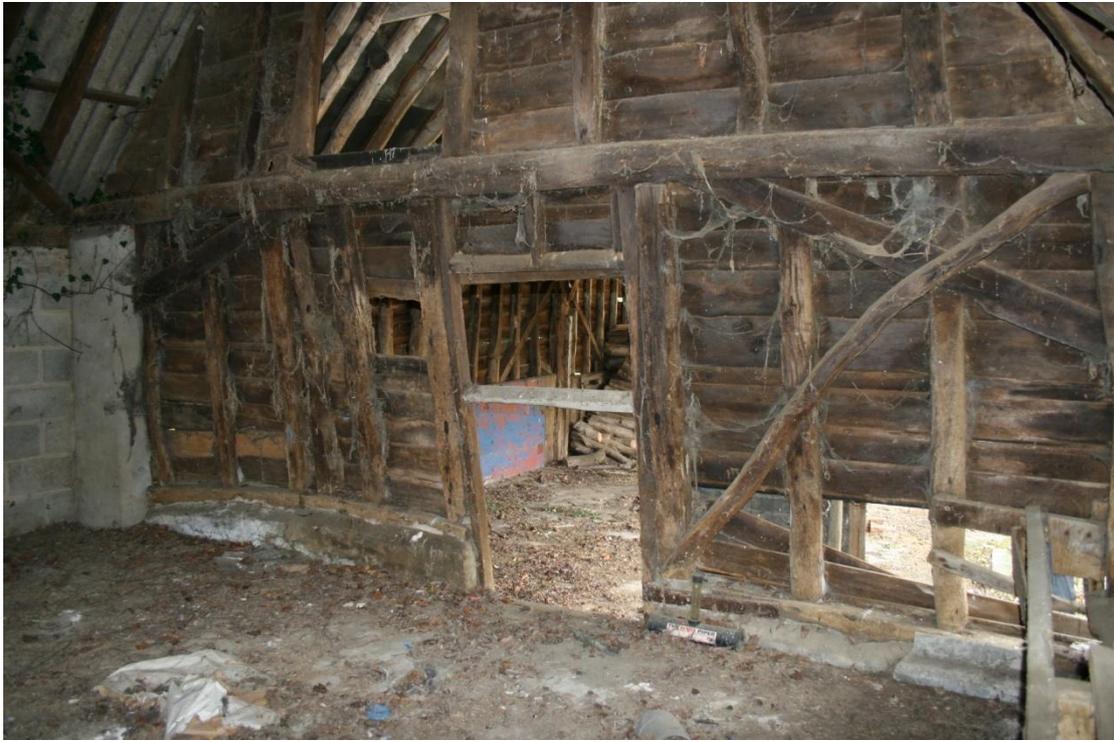
The western wall is a reused timber-frame from a much earlier building.

The western wall is composed of a reused frame from an earlier building with heavy jowled principal posts and long straight up-braces to the tie-beam. Most of the 6in wide syds appear original to the frame but the braces are wedged in place implying it has been reassembled. The low wall height of only 6ft reinforces this idea. There is also an added curving brace between the northern corner post and the door jamb. By contrast all the studs above are nailed in place and the whole frame weather-boarded to skin it for strength.

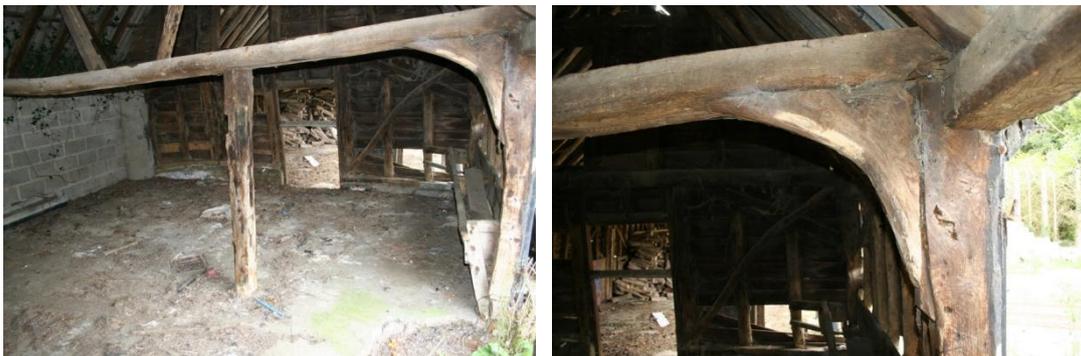
Although there is a high level hatch door above the tie-beam there was no real evidence for a hay loft although the likelihood is very high. The rear wall has been replaced with blockwork and the central tie-beam is very flimsy and supported a reused top-plate, full of mortices and in very poor condition. The northern end of the tie beam has a hanging knee clouted into place against the jowled post of the doorframe.

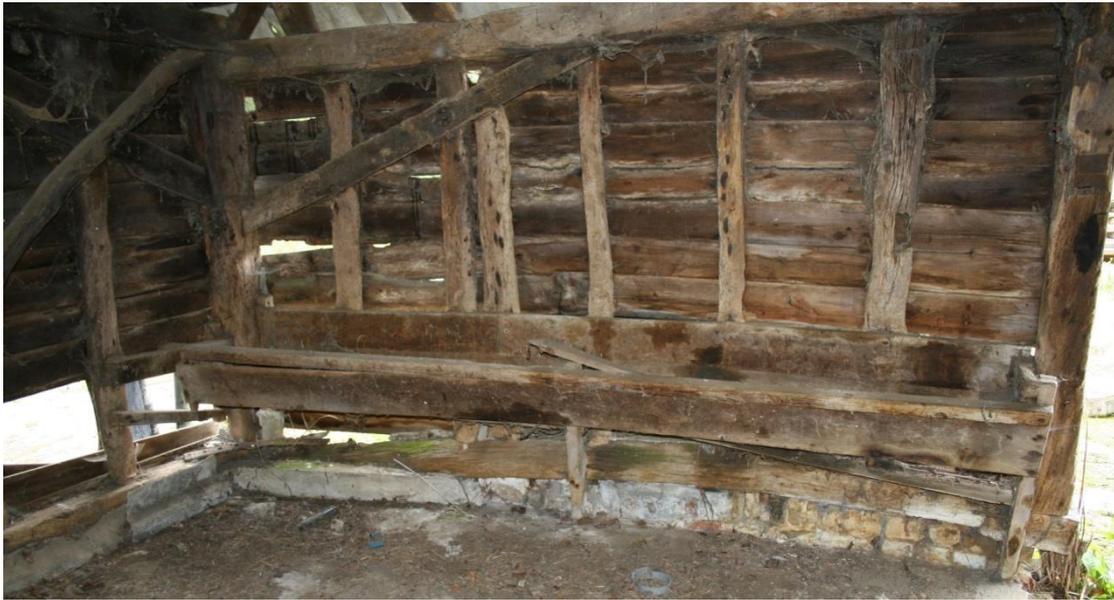
The northern wall has a reused frame and a feed trough.

The northern wall is also composed of parts of an old frame retaining the reused 6in studs and a long straight brace from the corner post to the top-plate. There are also narrower nailed in studs with bleed marks from old nails showing they have been turned. A poor quality timber feed trough has been nailed together and fixed to the western side of the wall indicating that at one time there was a stable here. All the other fixtures one might expect like tethering rings, hay rack or a split stable door are not present.

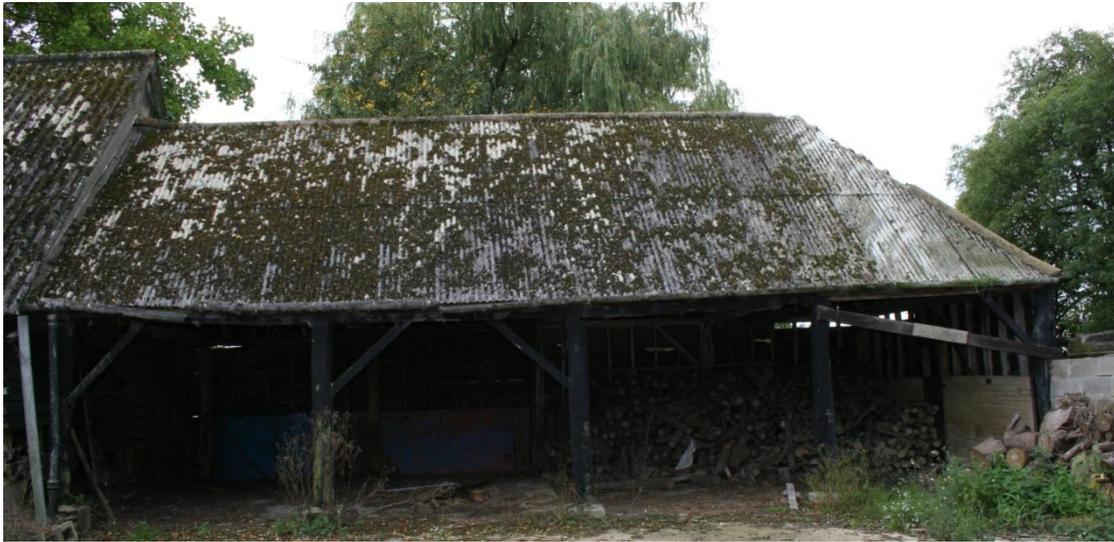
North Elevation.

Northern elevation of the Shelter.

The Shelter is a four bay timber framed building open on the northern side with a corrugated asbestos roof and asbestos rainwater goods. The top-plate is supported on 5 rectangular posts now stood on concrete plinths. Each post has an added modern softwood brace to prevent racking but also prevents vehicles from entering easily. One brace is just a heavy plank nailed across the westernmost bay.

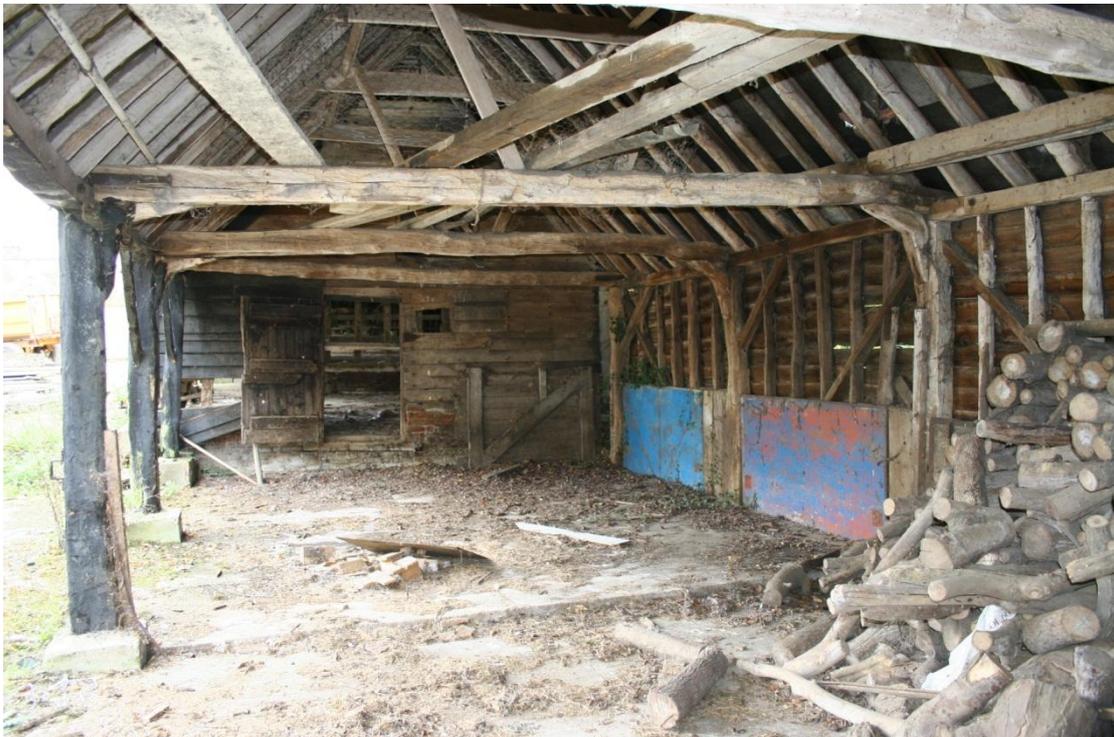
The southern wall is clad with older weatherboards on the exterior.

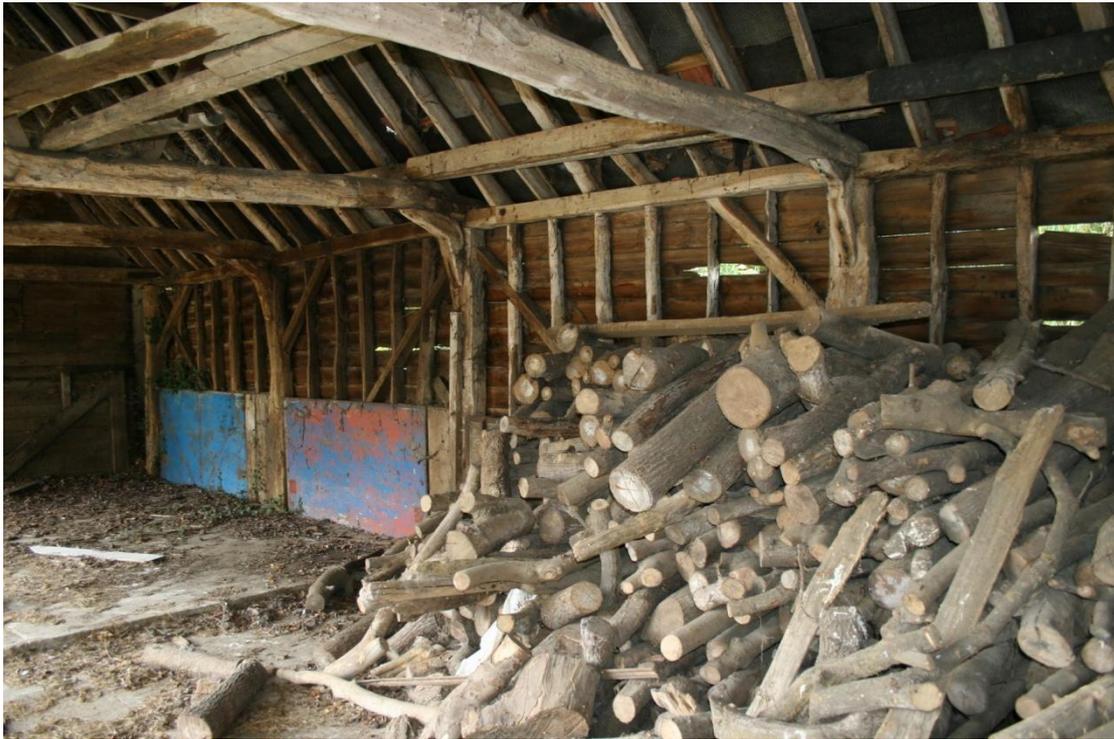
South Elevation.

Interrupted studwork frame.

The exterior of the southern elevation is only visible from the private garden. The timber-framed interrupted stud wall is clad with older weather-boards finished with hot tar. Most of the studs are $\frac{1}{4}$ or $\frac{1}{2}$ poles while the principal posts are of reused oak. The tie-beams are roughly finished trees of which one has the reddish grey hue of elm while the others are less distinct. The hanging knees are gnarly roots heavily clouted but not bolted to the beams.

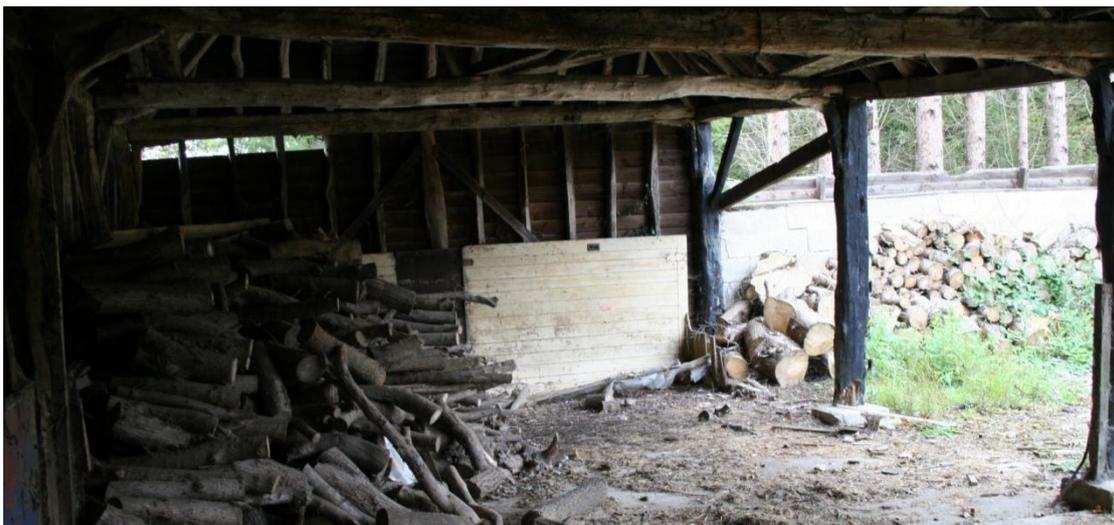
Like the south wall the exterior can only be seen from a private garden and is similarly clad in older, hot-tarred weather-boards. The frame is of the same interrupted nailed scantling studwork. The inside of the Shelter has been clad with a variety of LC20th boards, including plywood and doors. This has been done so the large pile of logs does not push the weather boards off the frame.

The western wall is protected with C20th doors.

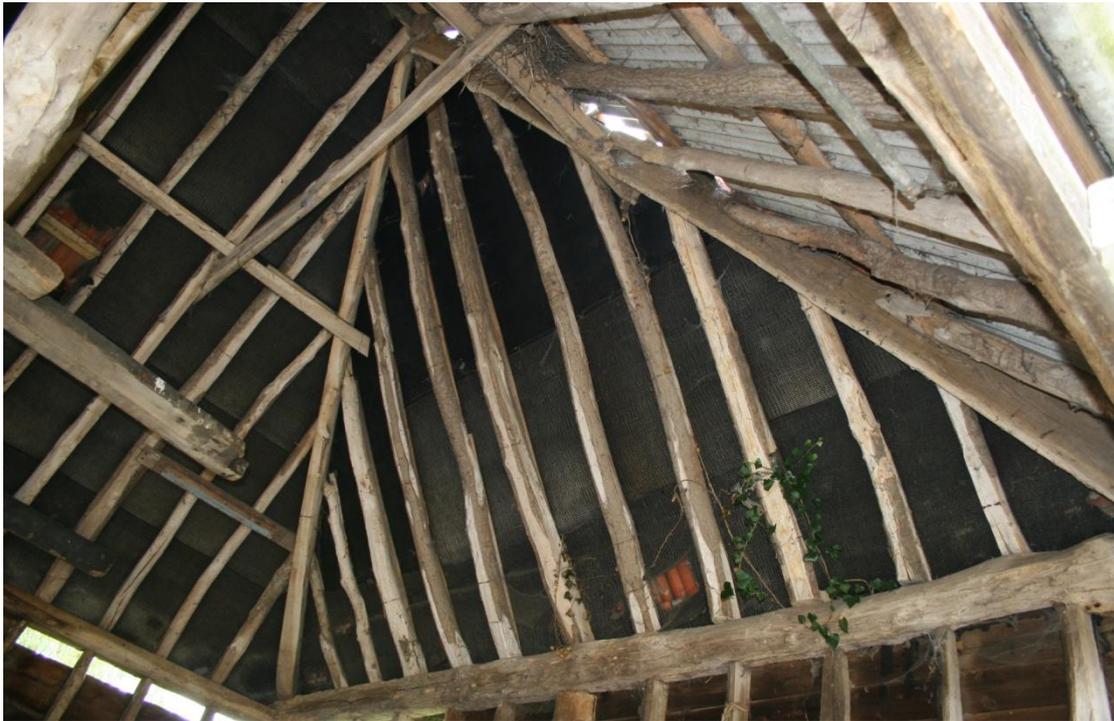
The hipped end of the roof over the western wall.

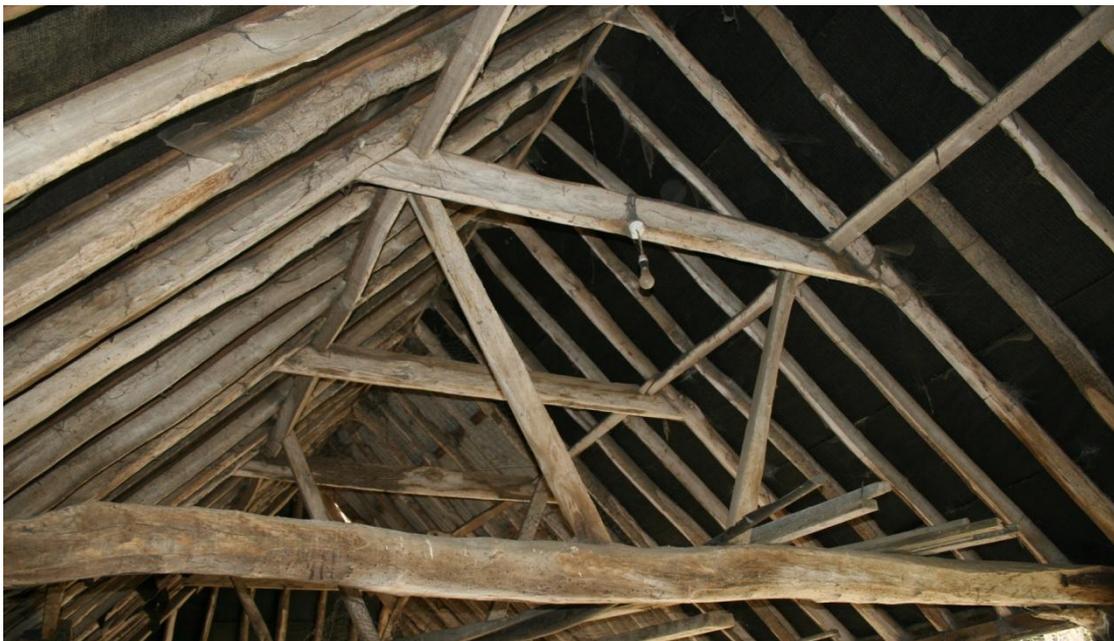
The Roof Structure.

Side purlin roof with raking struts.

The roof is a simple clasped side purlin design with raking struts to the tie-beams which are secured with iron ties. The straight machined collars are lapped and nailed to the rafters which are nailed to a ridge-piece. Most of the rafters are $\frac{1}{4}$ poles but there are several simple poles cut from the hedgerow. Nearly all still have the bark on. The roof is neatly hipped at the western end obviating the need for windbraces.

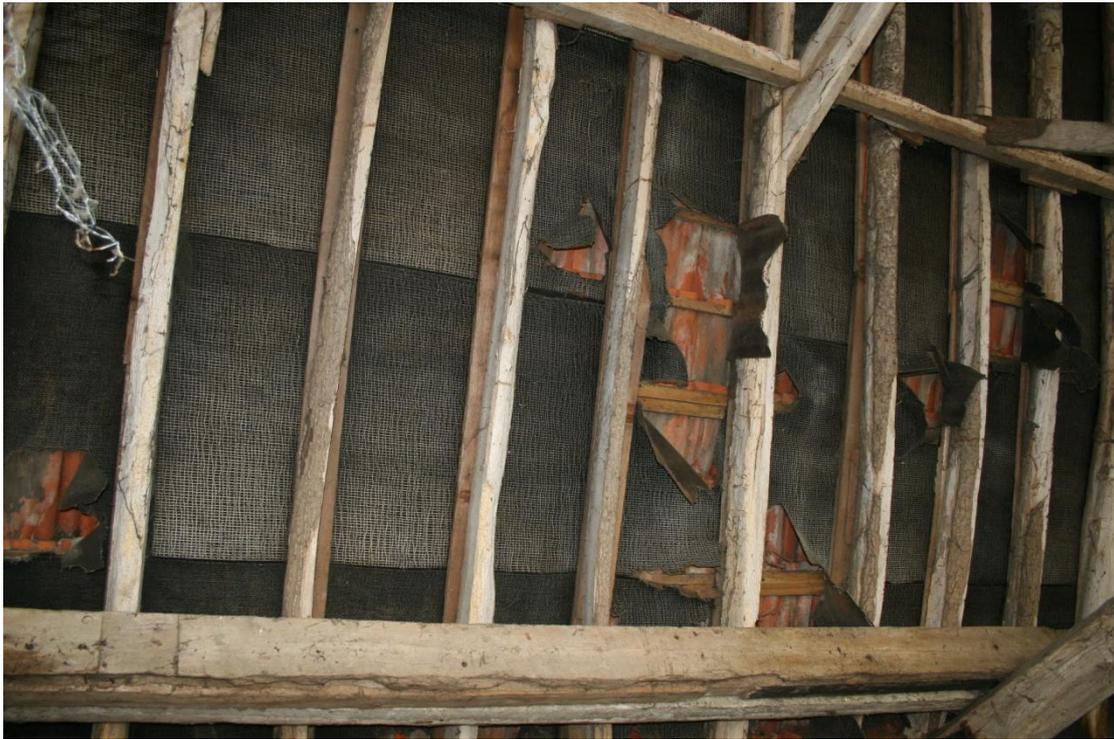
The rear roof has EC20th machined clay tiles.

While the front has an asbestos roof, the rear and hip has EC20th machine made clay nibbed tiles hung on reasonably fresh battens. There are also sections of cotton threaded asphalt underlay which was in use from the 1960's to the late 1980's.
