Berwick Hall Farm, Park Lane, Toppesfield, Essex.
Description and analysis of farm buildings at the site.
Surveyed 15 09 2011. BDC 10/01438/FUL

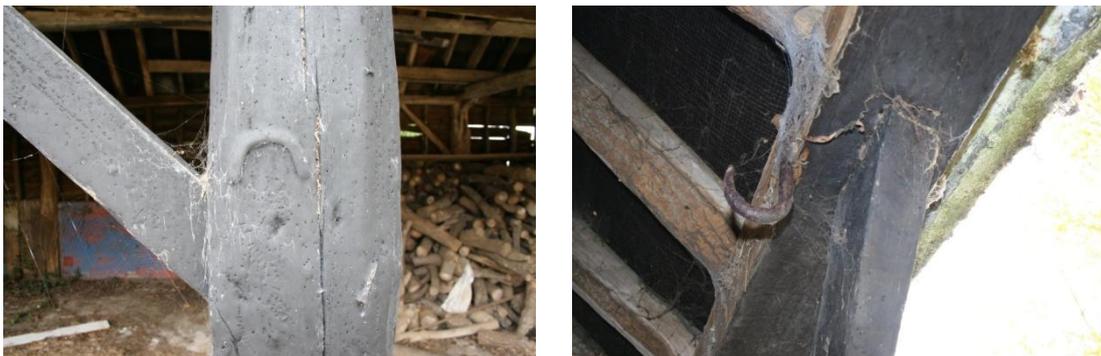
Inverted heel tap used as a good luck charm. Large suspension hook on the same post.

No marks of any kind were found in the Shelter. However nailed to one of the posts is a heel tap from an old boot. These are quite commonly found in farm buildings and nearly always in an inverted position. Contrary to popular modern belief the luck does not fall out of them. Shoes are quite often associated with luck and are stored away in houses or hidden in the chimney piece to bless the house.
