Home Farm, Wadesmill, Youngsbury, Thundridge. Herts. SG11 1BP.
Description and analysis of the South Barn. Surveyed 06 11 2013. **3/13/0842/FP.**

Planning app. no: 3/13/0842/FP. Permission has been given to convert the former South Barn into a dwelling house. This report describes and analyses the building to English Heritage Level 3 to satisfy a planning condition for archaeological recording.

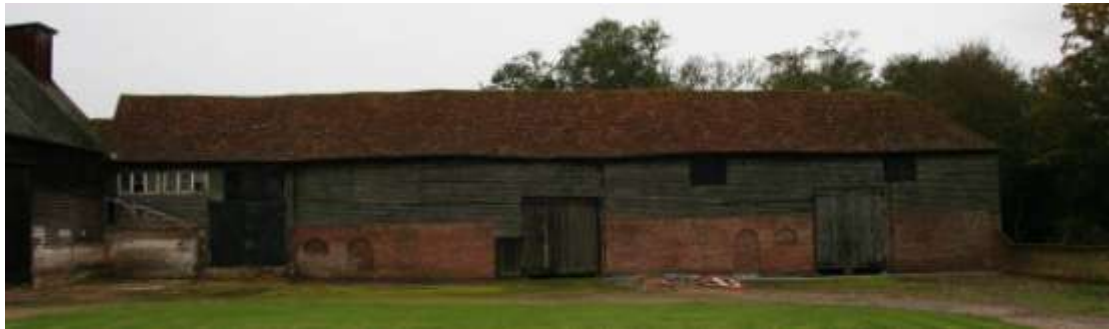
The northern elevation. Note the blocked in arch headed openings.

The building consists of a long narrow brick range of 14 bays defined by 12 full trusses and one inserted truss. The earlier brickwork is made from red 60x100x230mm handmade bricks with creased faces, sharp arrises and horizontal pressure lines. Where visible they have shallow frogs – a crucial feature for dating. These are set in a beige lime mortar containing crushed flint aggregate.

There is a sequence of blocked arch headed, slit and square windows that are infilled with a combination of the earlier reds and later London Stock style bricks 60x110x225mm of similar properties but are brindled, pink or yellow and characterised by specks of black brieze in the fabric. At the eastern end the first two bays are built off a Stock brick wall and form the end of a now removed outshot. Its slack pitch roof can be seen outlined in the boarding.

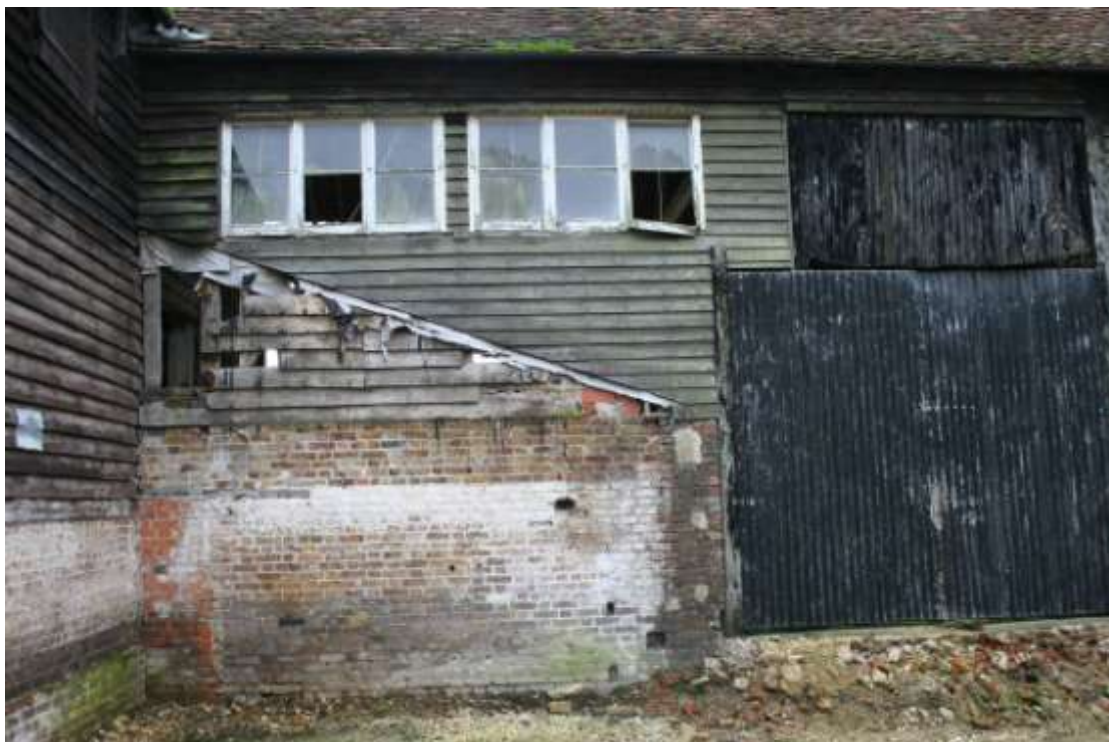
The eastern end of the elevation adjacent to the older threshing barn.

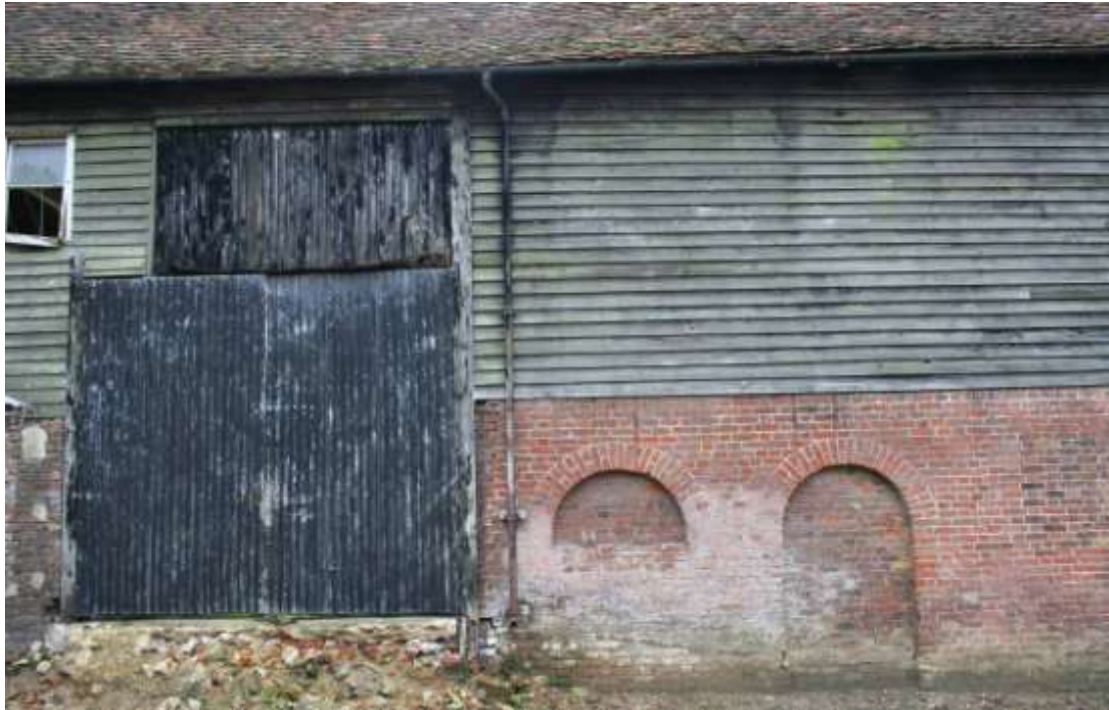
Enlarged full height doors and blocked arch headed window and doorway.

The brick walls are extended upwards with a scantling timber-frame clad with C20th bandsawn softwood 7in weather-boarding fastened with galvanised French nails. There are three sets of double doorways. That to the eastern end has lost its original doors and the frame has been altered with steel beams seen on the inside. The other doors are C19th style vertically boarded softwood, gate and ledger doors hung on wrought iron pintles. (See Internal Description for more detail on the doors).

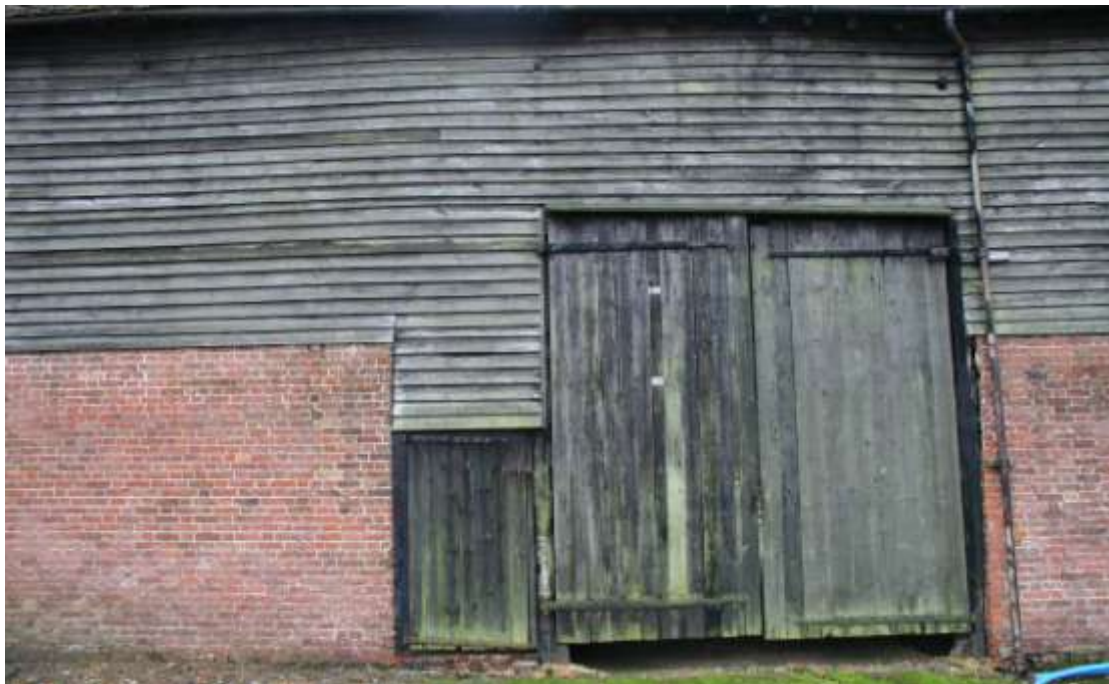
The central doors with pedestrian door. Note the 'leap' sockets on the door jambs.

The central doorway has an additional pedestrian door. It is noted that only the western doorway has properly closed brickwork indicating the others were cut through the brickwork later. There is a pair of symmetrically placed arch headed windows and doors that have been carefully blocked with matching bricks on the outside. There are also shadows of blocked square windows and doorways that are much more easily seen inside. It is certain that the brickwork is earlier than the timber-frame.

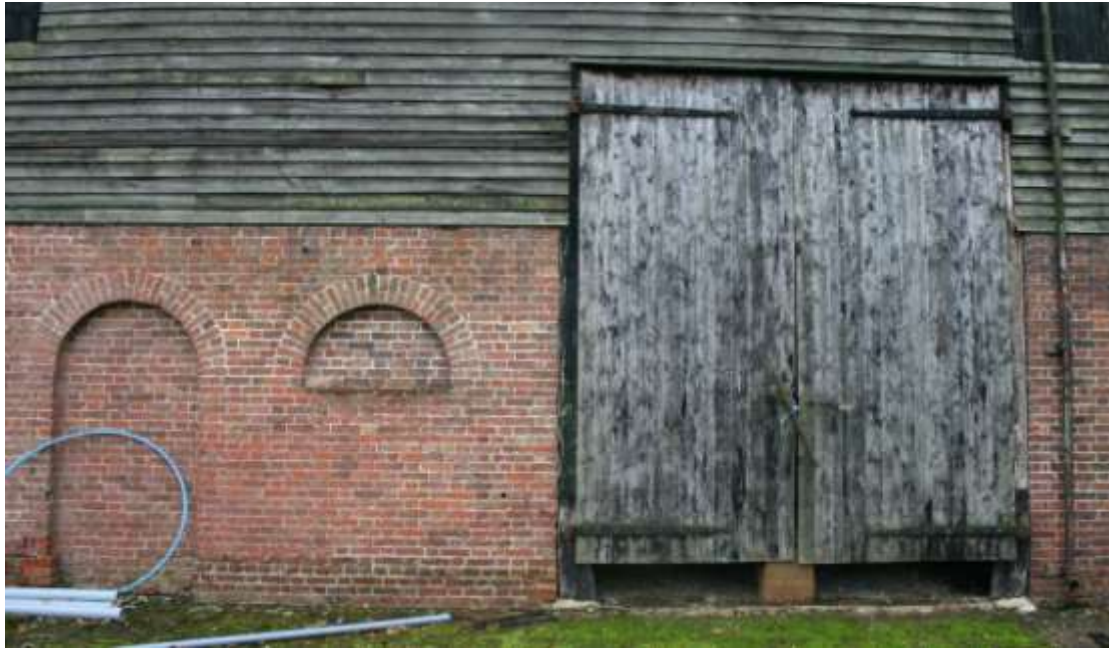
The westernmost doorway. Again the jambs have sockets for the 'leap'.

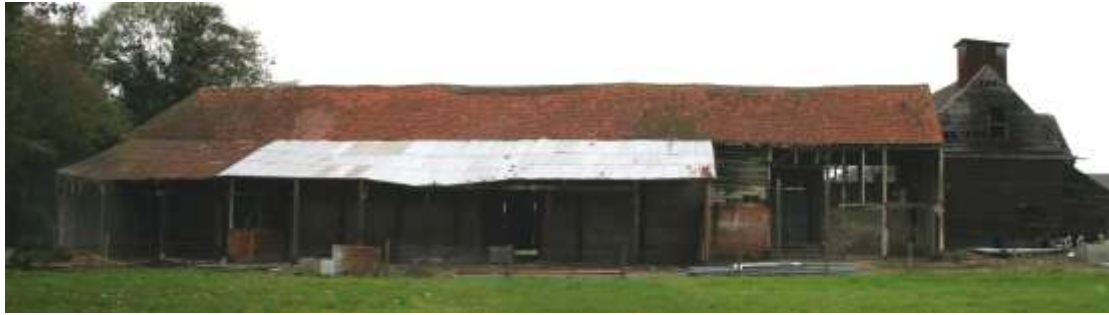
The southern elevation.

The south of the brick barn has a lean-to that originally ranged the whole length of the building. Some of it collapsed in the LC20th and was pulled away for safety reasons. The rest of it is in a very parlous state. The trusses retain some original timbers, now precariously pinned and cross-battened but most of the principal posts have been replaced with telephone poles or RSJ's (Rolled Steel Joists). It is evident from the concrete pillars that the posts rotted off at the base.

The shallow pitch roof is clad with two phases of corrugated iron sheets and the owner recalls the roof was raised at the eaves in the 1960's to accommodate the much larger farm machinery that was stored there. The second phase of very shiny corrugated roofing was put in place at the end of the century when it was still required.

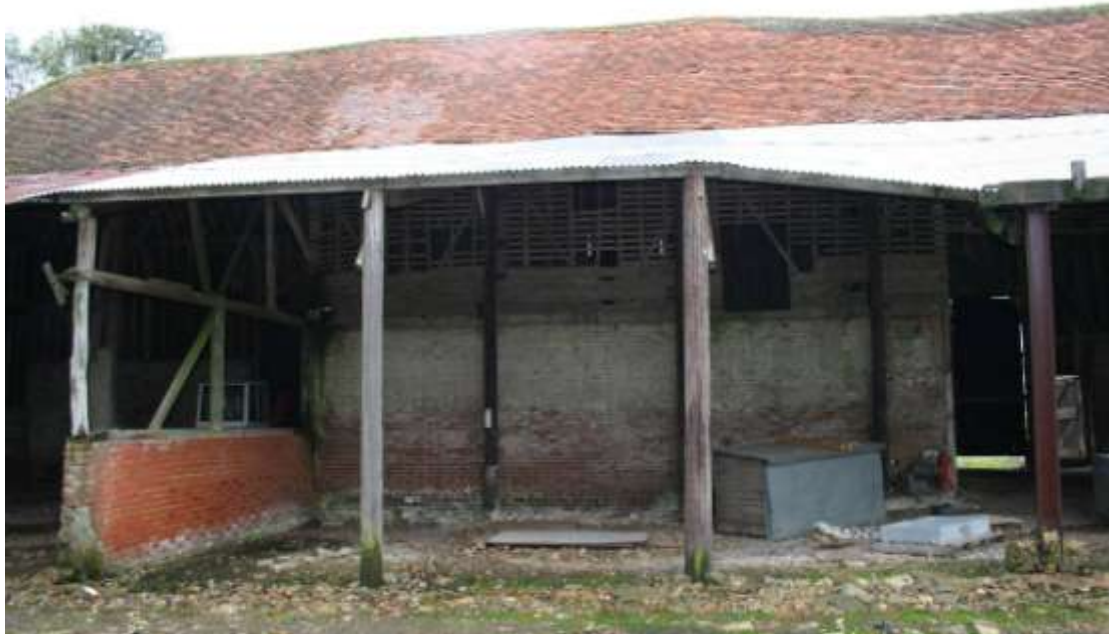
Southern elevation. Bays 4-6. Note the added brick plinth.

Only the trusses in Bays 1-3 retain any of the older frame. The other bays are rebuilt using LC20th machined softwood supported on telephone posts and RSJ's. There is a timber-framed partition completing the remaining Bay 7 but this is entirely C20th. The upper section reused some older scantling timber and the principal rafter indicates the former pitch of the roof. However the frame has been rebuilt with a new machined tie-beam and the 50x100mm softwood studs and weather-boards below it are all LC20th.

A brick plinth remains of bright red brick handmade 65x110x225mm frogged bricks set in beige sandy lime mortar. The brickwork is set in Flemish bond with a central rowlock course. Its character is M-LC19th.

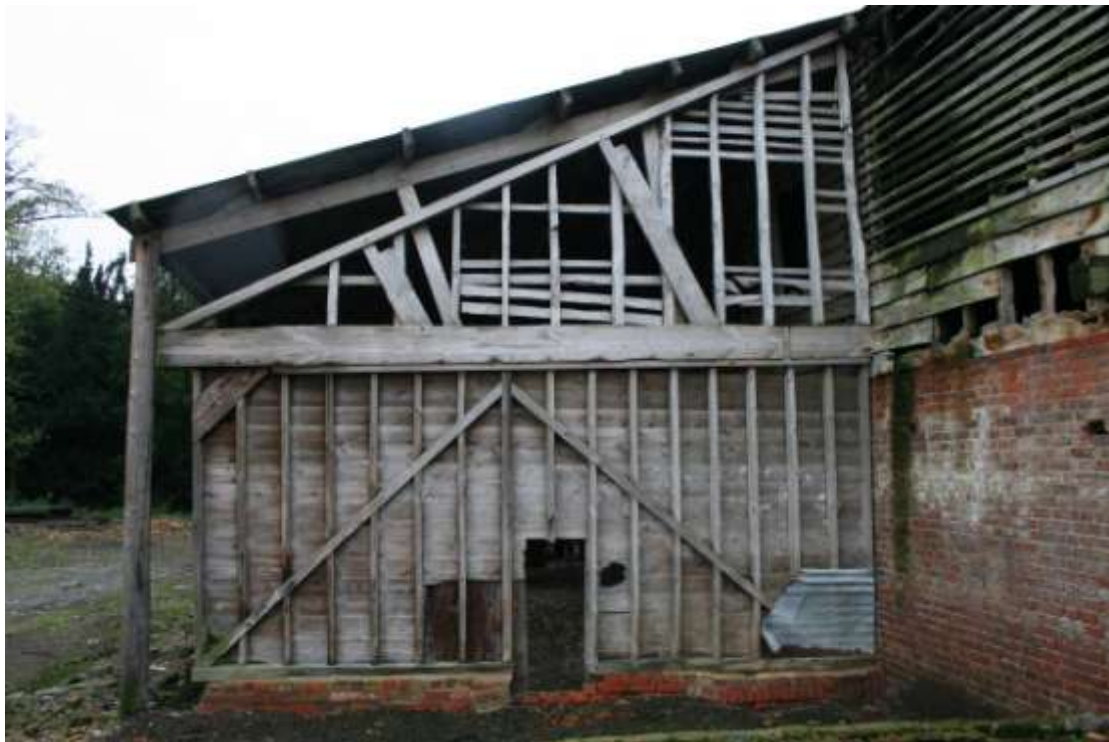
Eastern elevation of the partition wall to Bay 7.

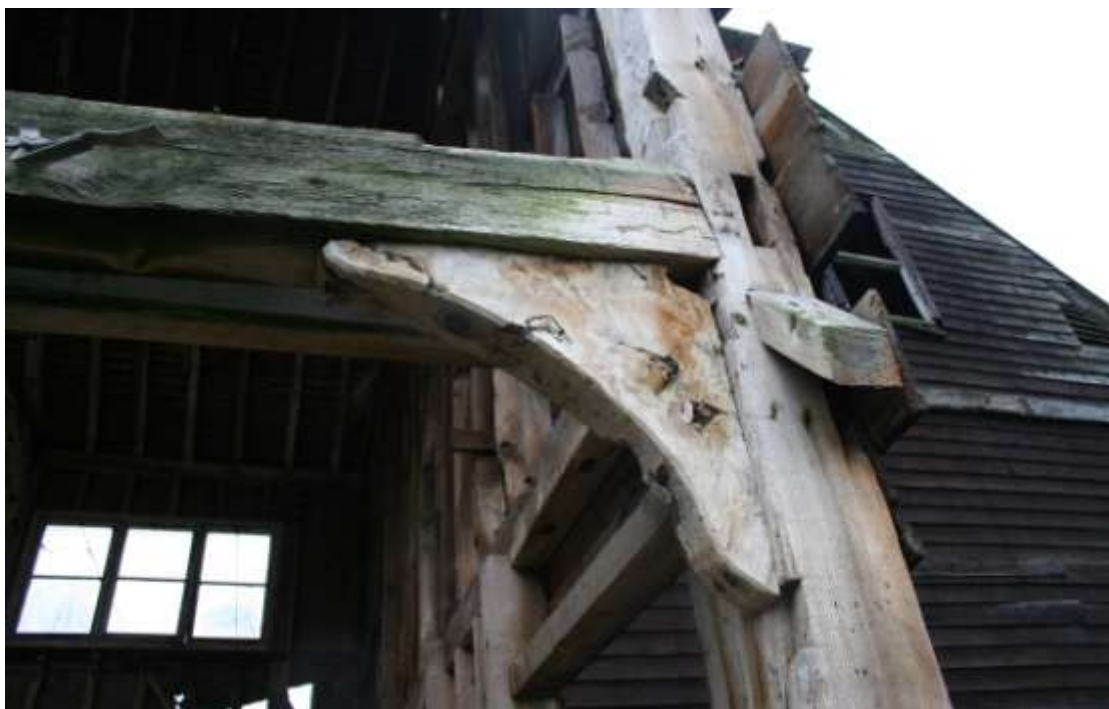
The eastern end of the building has lost the lean-to and it is evident that the brick wall range did not extend this far as the rest of the barn is made up of full height timber-framing of which only the principal posts and mid-rails remain. The joints were strengthened with hanging knees, nailed and broached (very large nails) rather than bolted.

Junction of the corner post and mid-rail.

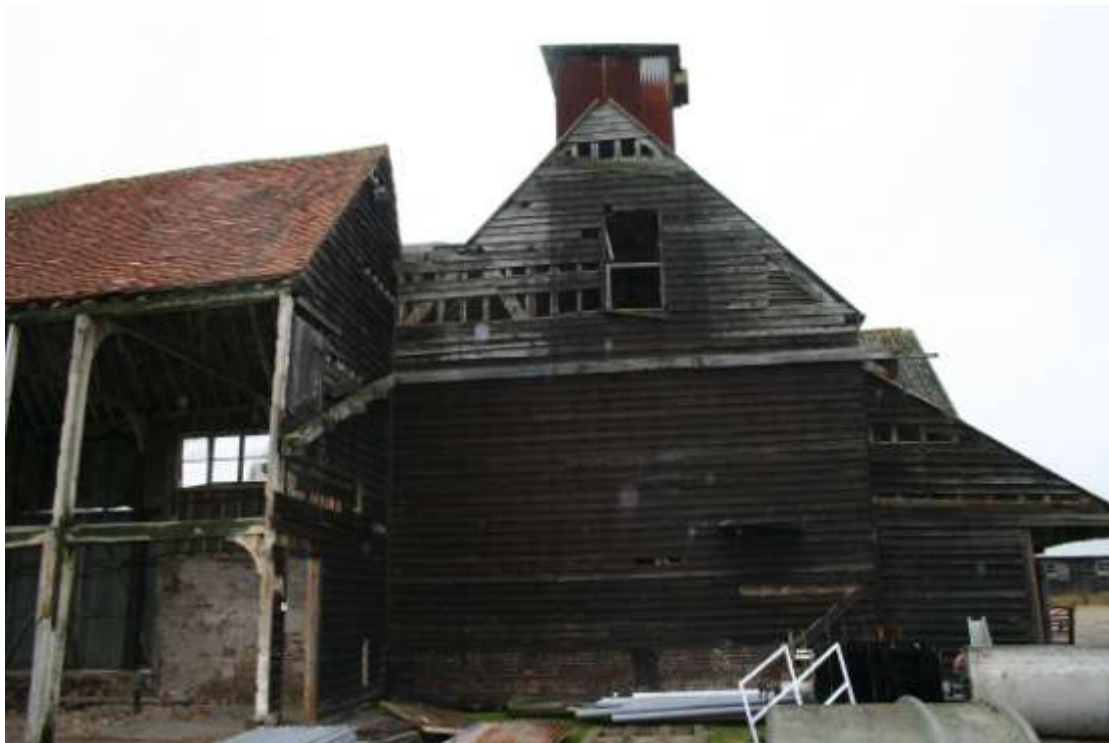
The southern elevation of the Threshing Barn adjacent to the South Barn.

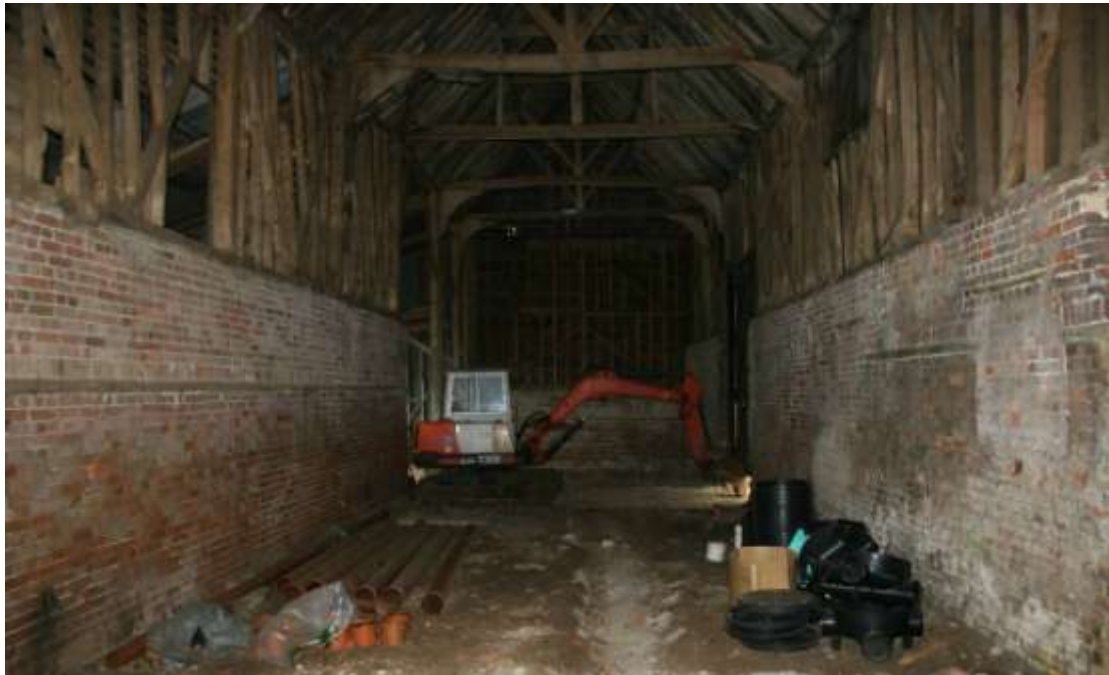
Looking W inside the barn towards Bays 1-4.

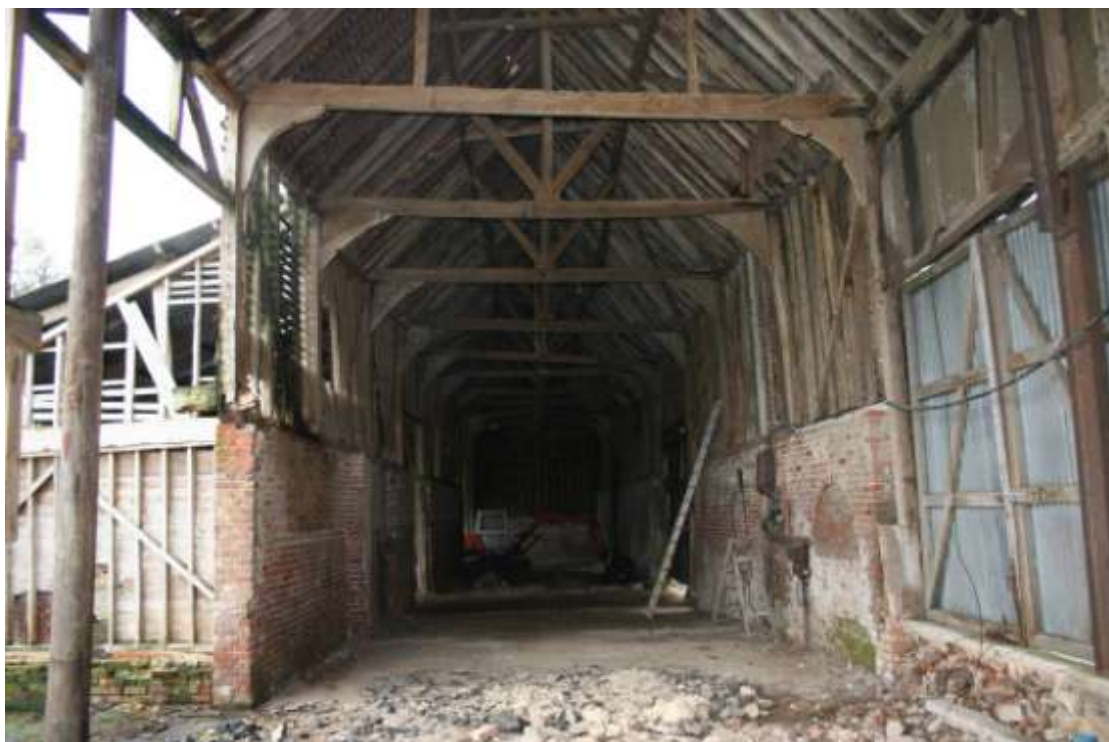
Looking W inside the barn towards Bays 4-10.

The brick range is one long open space but scars in the walls show it was previously subdivided. It is also evident that Bays 1-3 and 11-12 were added to the earlier brickwork structures.

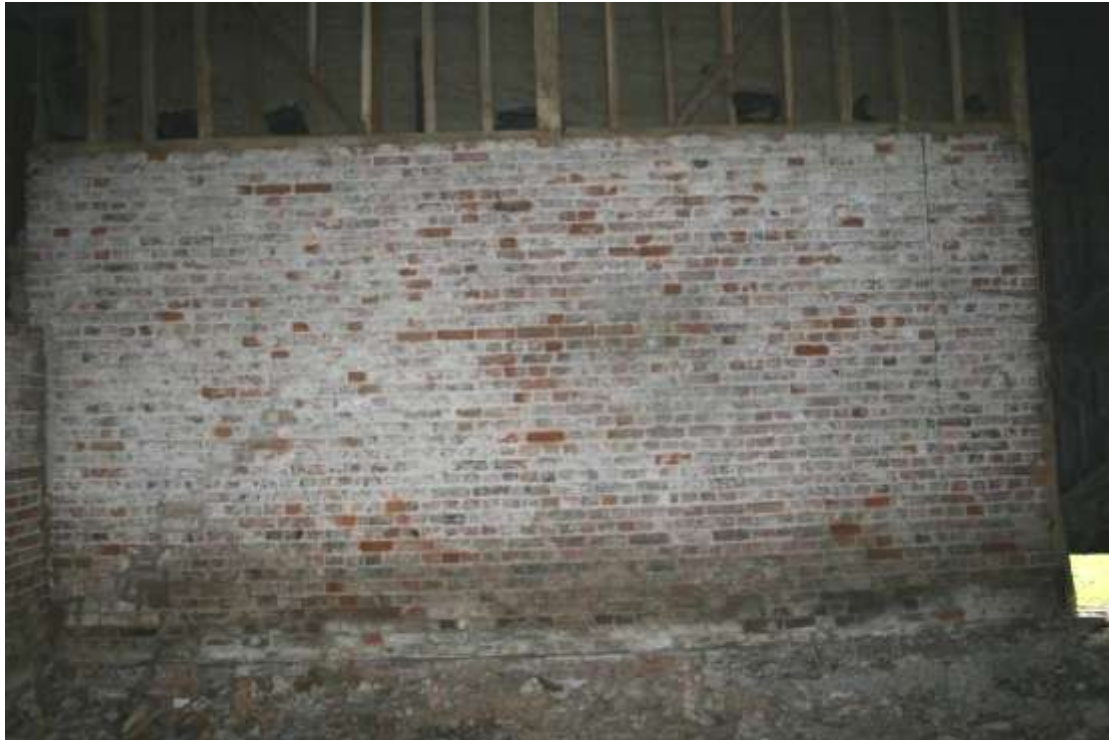
North wall Bays 1-2. This wall appears as it was built. Both ends are correctly closed.

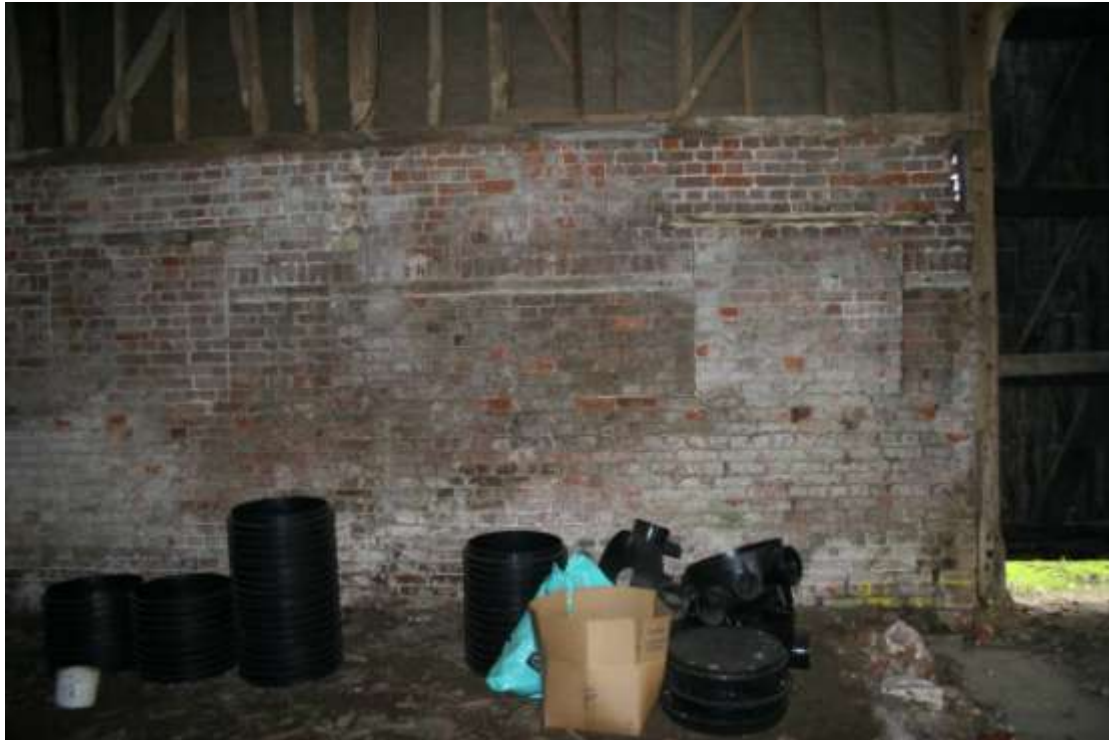
In both Bays 4 and 10 the arch headed openings have been blocked with very similar bricks. There are also blocked in rectangular openings with timber lintels in Bays 5,6,8 and 9. These broach timber-strakes under rowlock courses and the arrangement suggests there was originally one longer wall that was remodelled with square windows when the large barn doors were inserted.

Two blocked windows in Bays 5 and 6.

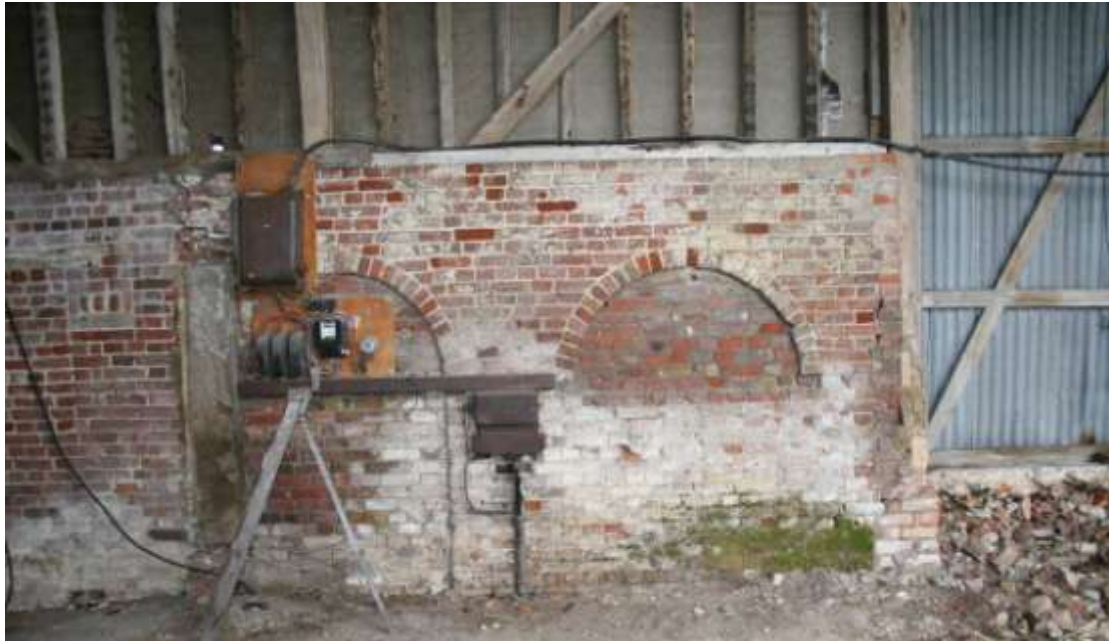
Blocked arch headed openings in Bays 9 and 10.

The blocked arch headed openings were originally doors and windows. Scars in the brickwork show that the earlier building terminated under Trusses 3 and 10 giving a six bay building. How this was defined internally is difficult as the roof has been rebuilt but it is noticeable that these Bays have heavier, triangular, solid spandrel hanging knees noticeably different in character to the others. Looking up in the roof (see later section) there appears to be three discrete sections as well as more modern repairs.

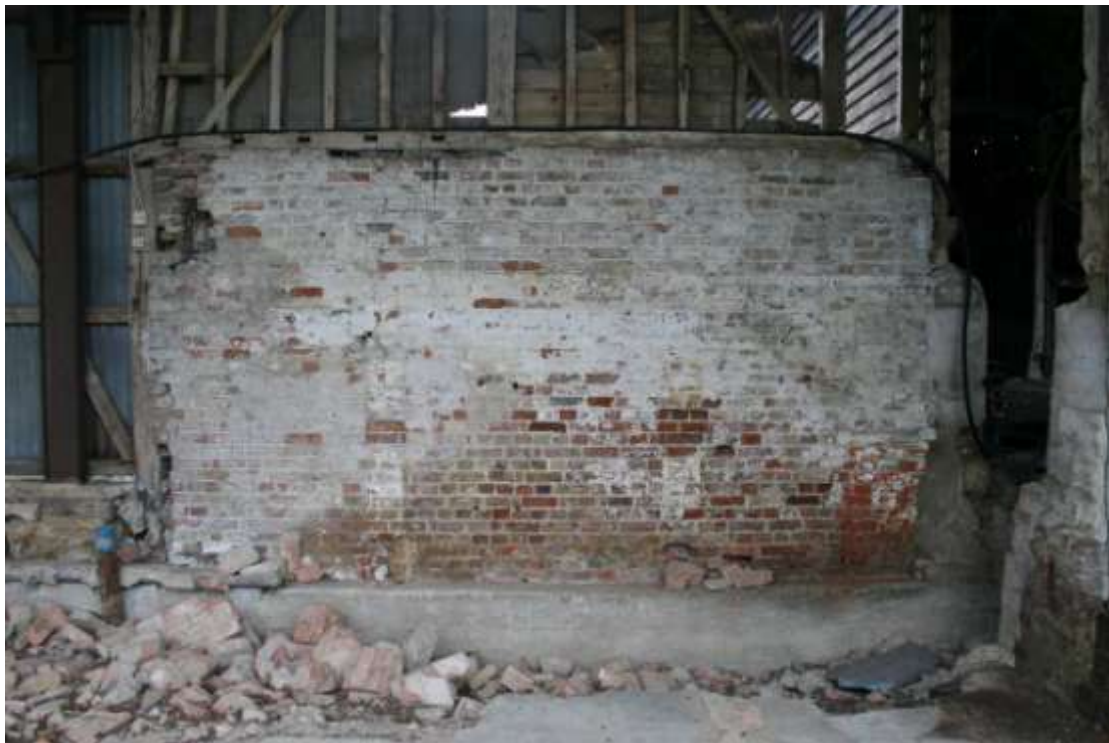
Bay 12 and 13. Later Stock brickwork wall.

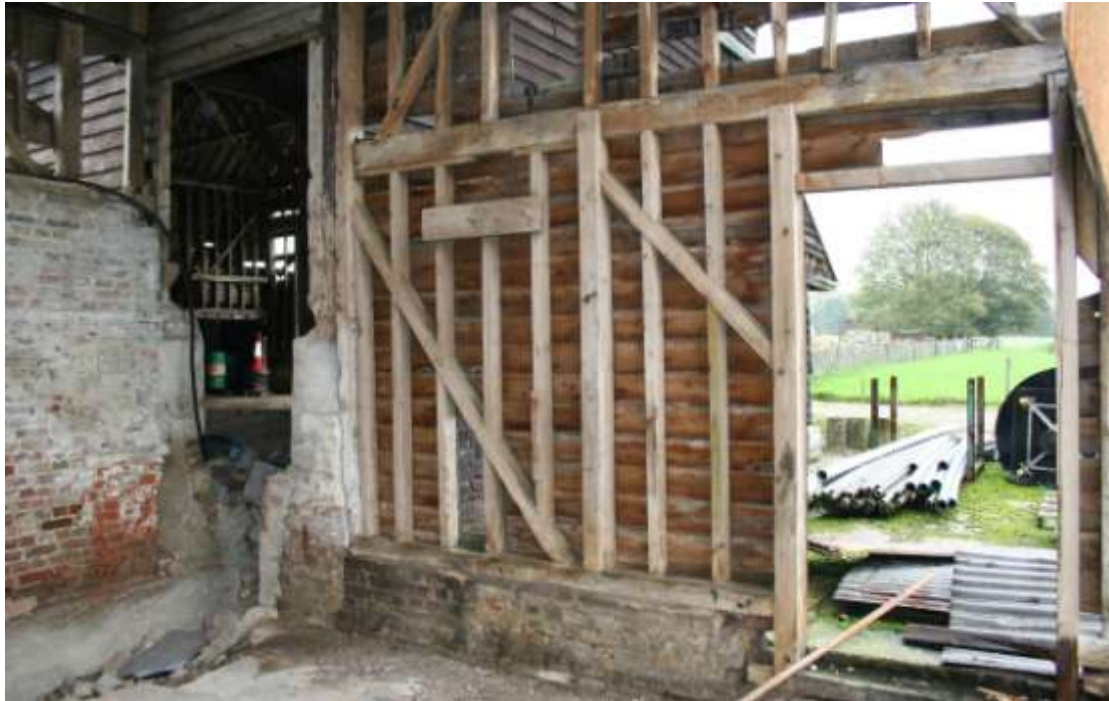
The eastern elevation. The South Barn is built off the Threshing Barn.

The eastern end of the South Barn has a full height timber-frame that has been built off the corner post of the adjacent Threshing Barn. The lower wall panel is a LC20th rebuild while the upper retains much of the scantling frame. There would have been raised machine platforms at this end and a set of MC20th casements has been fitted in the north wall to light the area. A small floodlight also remains.

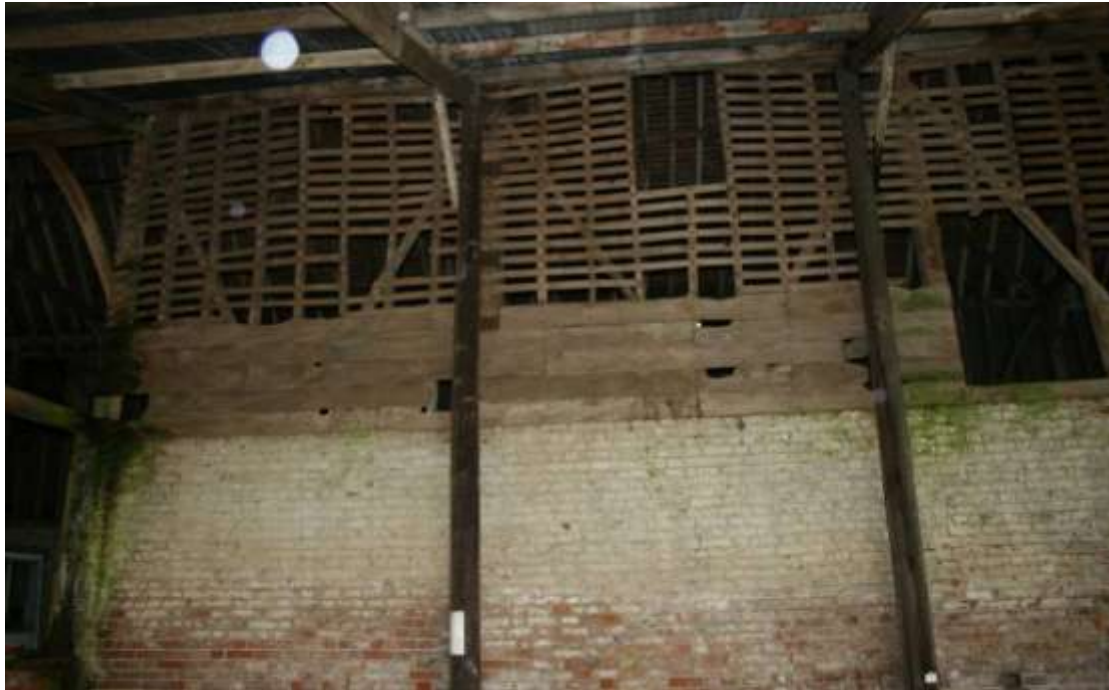
The southern barn wall Bays 3-5 from the south.

The southern wall is easier to see from the outside under the lean-to. The scantling frame retains some early weather-boards for about five courses above the brickwork but the rest has been ventilated by applying widely spaced battens. All the openings appear to be later interventions and lack the queen closers that define the original brickwork. Internally there was one continuous timber strake to apply panelling to.

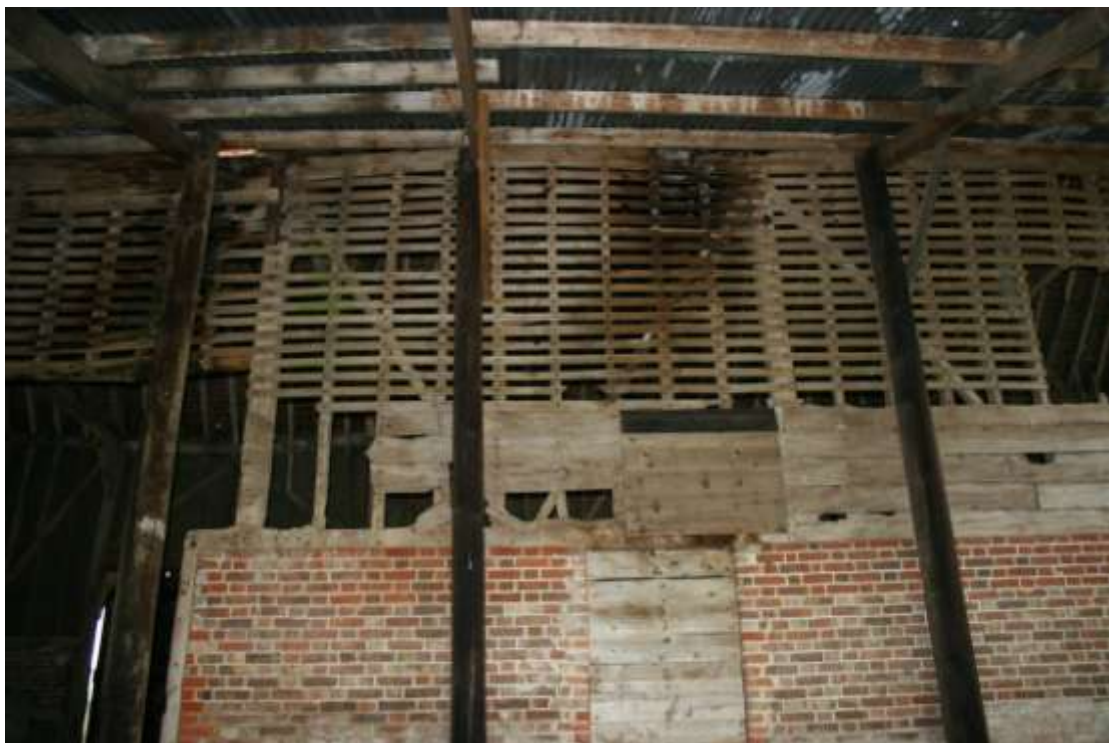
The southern barn wall Bays 6-7 from the south.

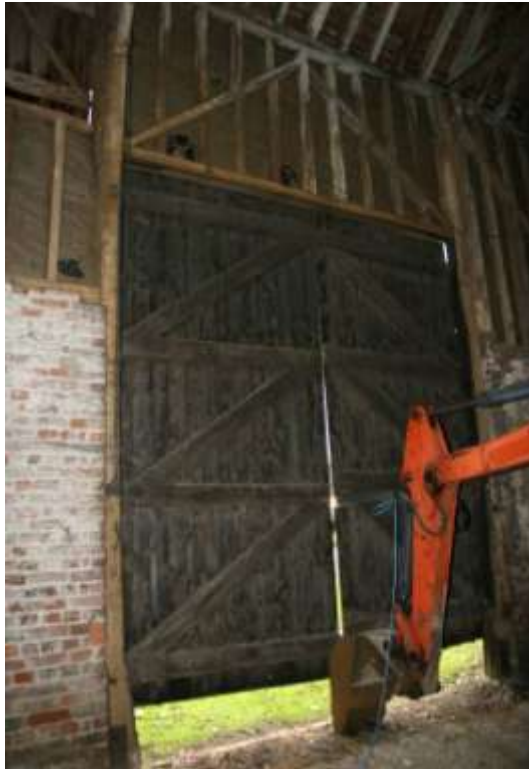
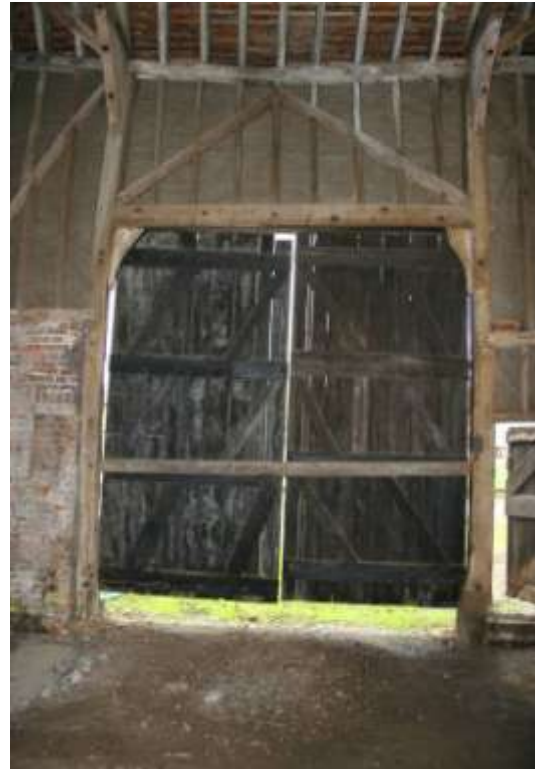
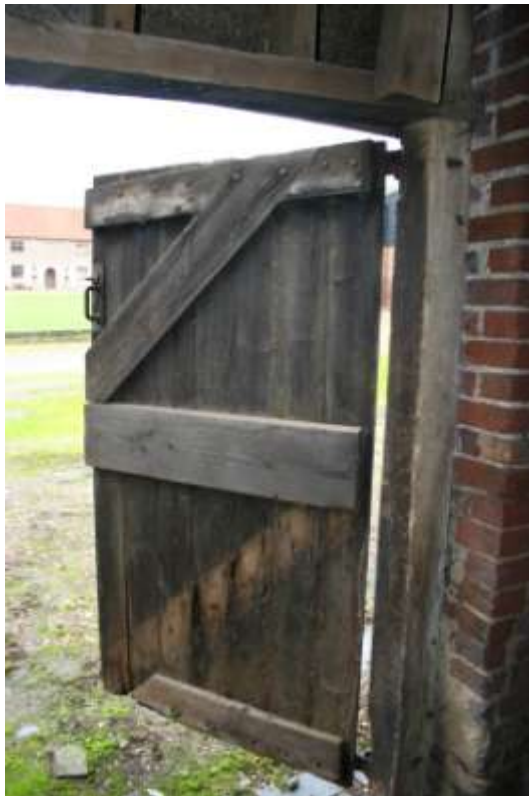
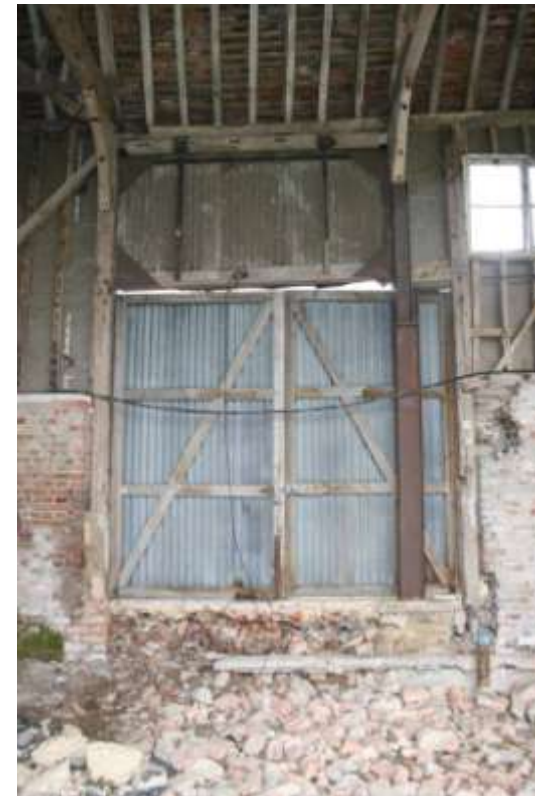
Details of the west, central, central pedestrian and eastern doors.

The tall barn doors and the pedestrian door appear to be original to the pattern of EC19th gate and ledger doors, however they were all made by the owner about 20 years ago.

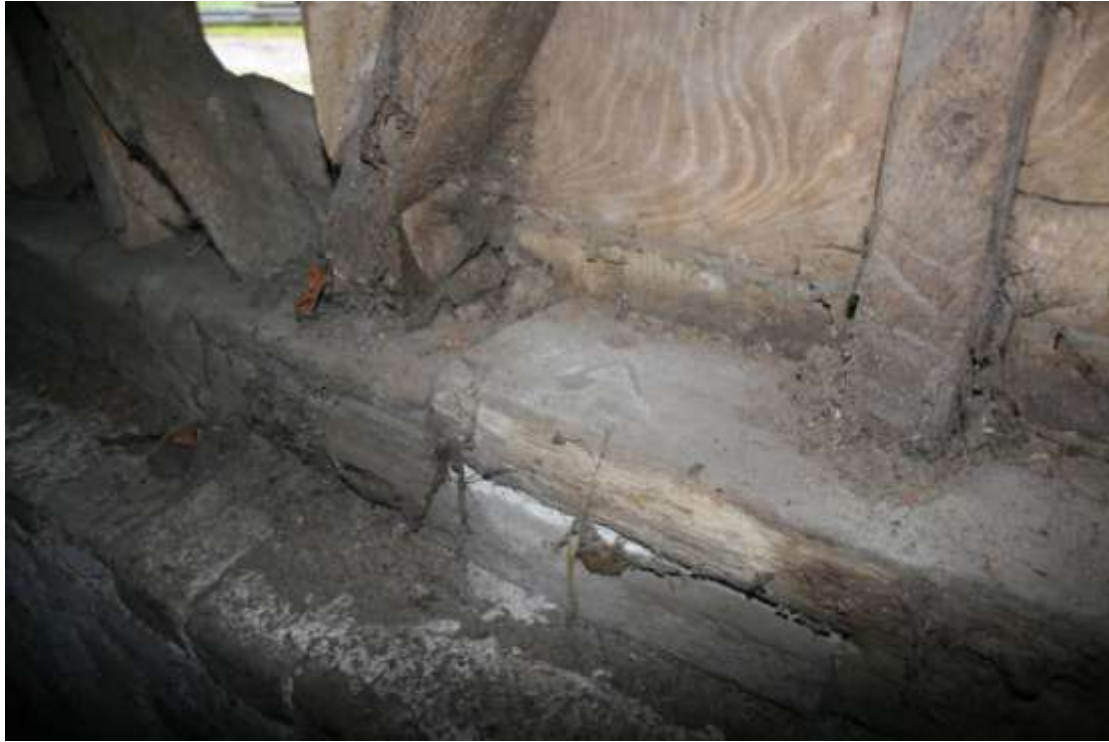
Carpenter's mark on the scarf on the south wall under Truss 4.

The cill plate on the south wall is marked with a sequence numbering the simple scarf joints. Those visible are V and VI (under Truss 8) and indicate the sequence was anti clockwise from the NW corner.

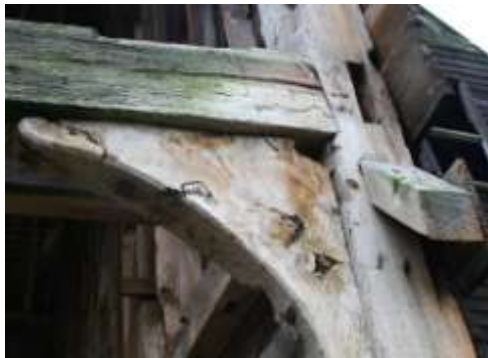
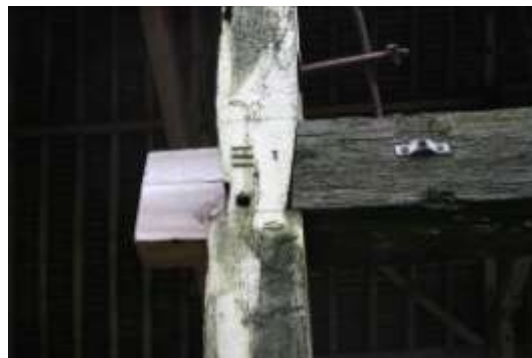
The full height frame in the SE corner.

The full height frame at the eastern end is marked on the principal posts and mid-rails with a bolster. Only I and III are visible as the other marks are overlaid. It is likely the whole frame is numbered on the outside.

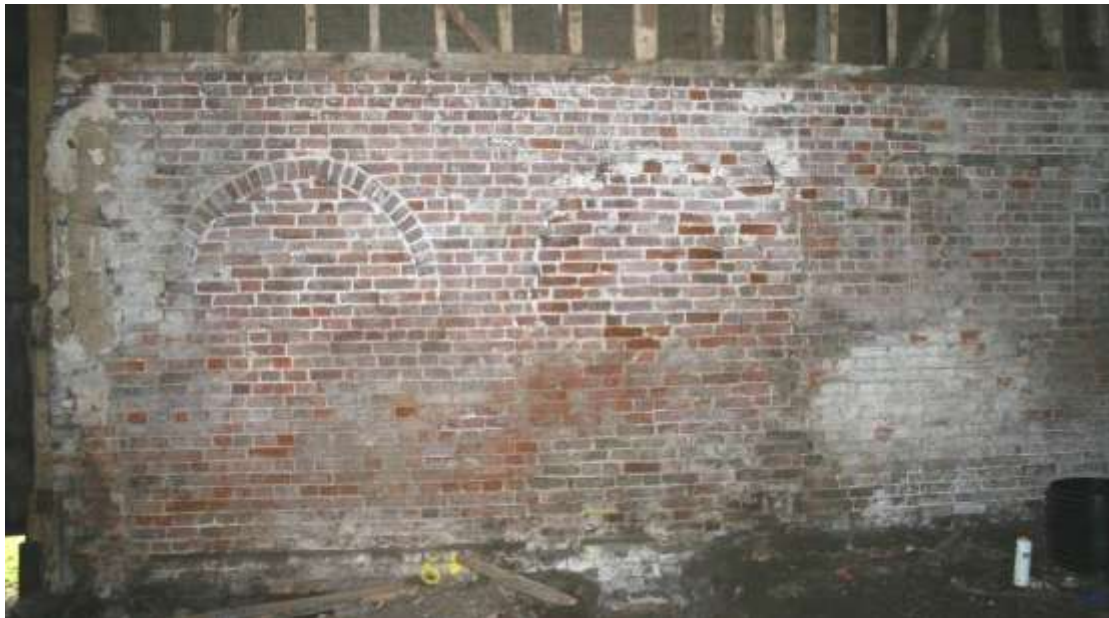
For some operational reason the arch-headed openings were blocked in with very similar bricks to those used to build the earlier brick structure and new rectangular window openings with timber lintels were created. It seems likely the bricks removed were reused for the blockings. The mortar is remarkably similar and there could not have been too many years between the original work and the alteration.

The blocked in arch headed openings. To the RHS is a later rectangular window also blocked.
