49 Swan Street, Sible Hedingham, Essex. CO9 3RA.
Description and analysis of the timber-framed house. Surveyed 03 02 2014.

Scope of this Report

This report records the fabric and analyses the building to EH/RCHME Level 3 to inform the proposed works and mitigate any necessary changes to restore the building. The building is a prominent landmark in the village and the current owner Mr Brian Day aims to sensitively repair the building to maintain its current appearance.

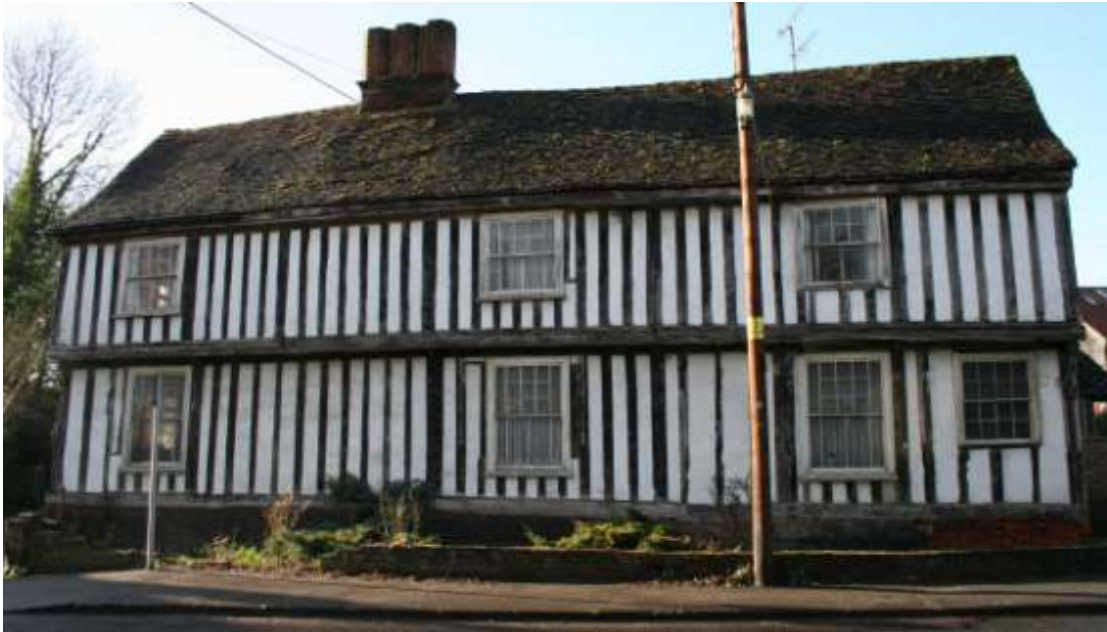
The eastern elevation onto the road. The sash windows have been altered in the M-LC19th.

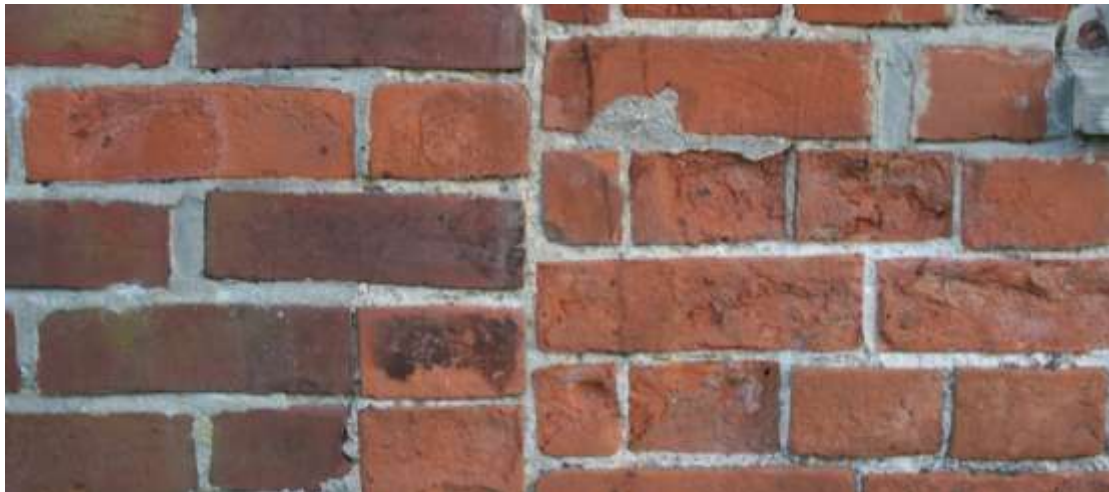
Sample of a section of brickwork adjacent to the Laundry.

The walls of the outshot are constructed of handmade bricks and many have been reused in the newer sections. The older ones are laid in Flemish bond in a gravel rich greyish lime mortar and the quoins are finished with queen closer bricks. The design of the brickwork is organic with one outshot sprung off another. The bricks are undoubtedly from the village brickworks which proliferated in the C19th.

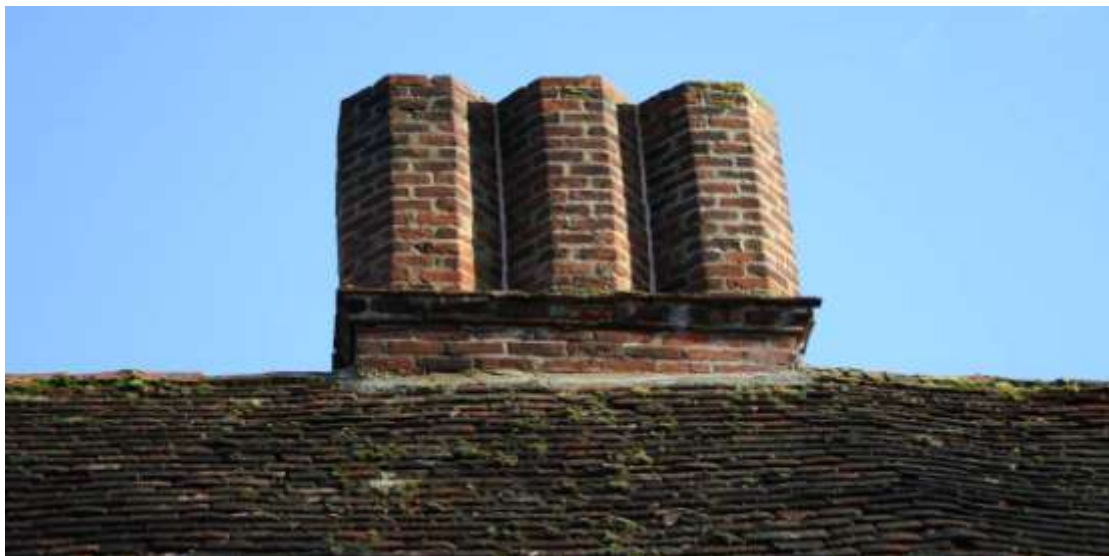
Detail of the main stack.

The House has two substantial brick chimney stacks. That to the rear, now in the Laundry is of red 65x110x225mm red bricks set in lime mortar and of a pattern common in the C19th. It retains a single EC20th cannon barrel type chimney pot. The main stack has three axial linked octagonal shafts of thin red and purple bricks heavily buttered with grey cement. Originally they would have been taller with decorative caps but they have been rebuilt in the LC20th.

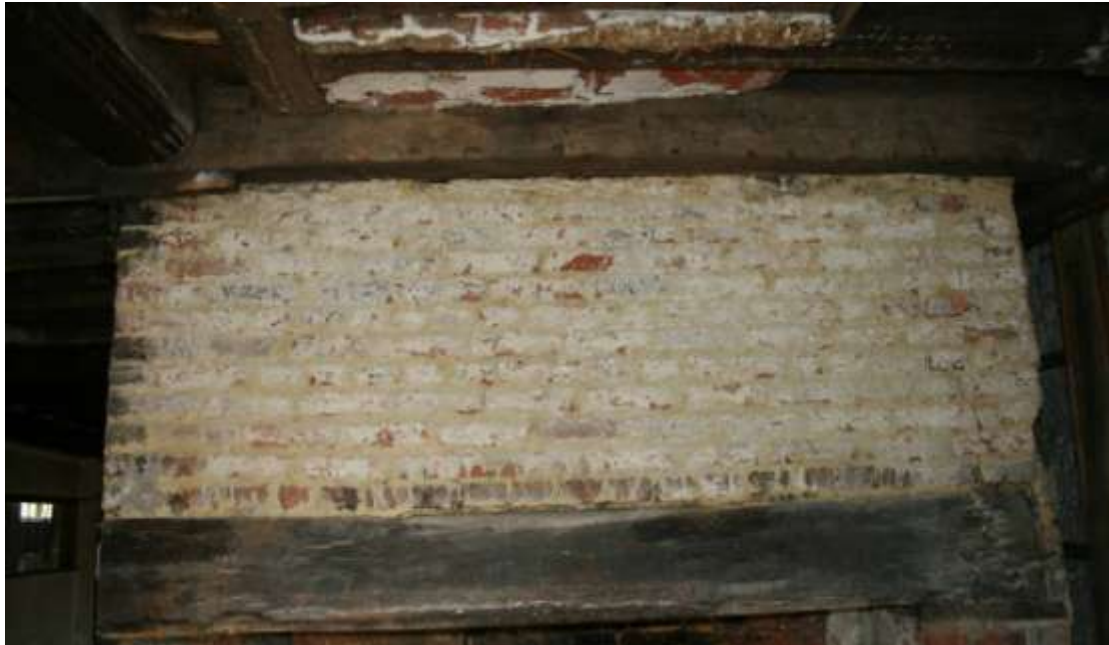
The painted firebreast of the firestack in Room 1.

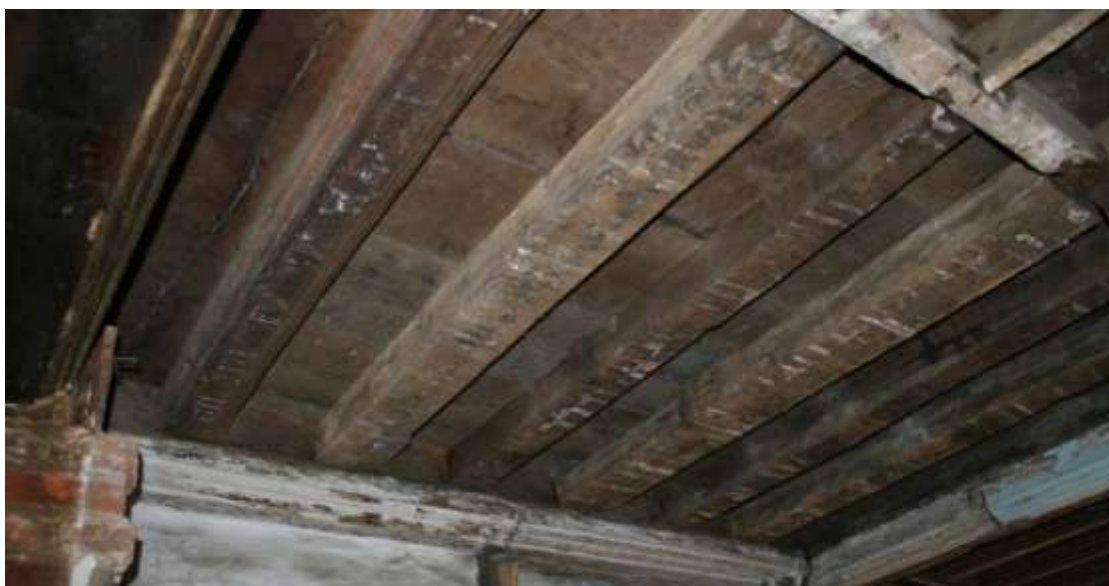
Wall painting on a door jamb reused in the ceiling. Looking E.

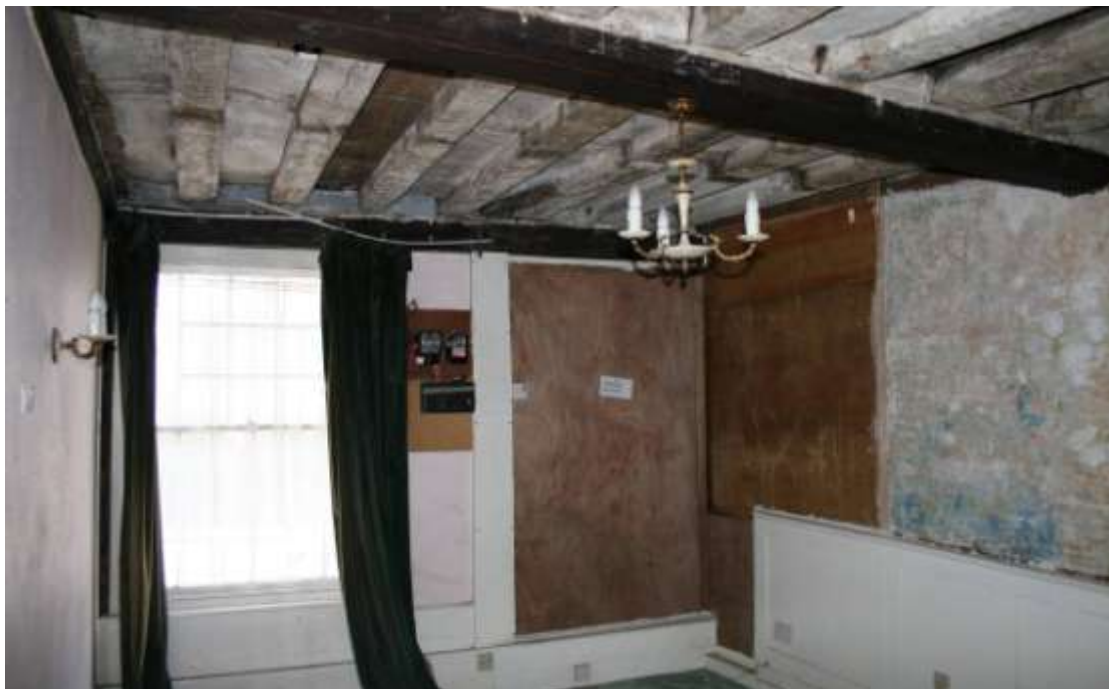
Looking E at a former blocked doorway.

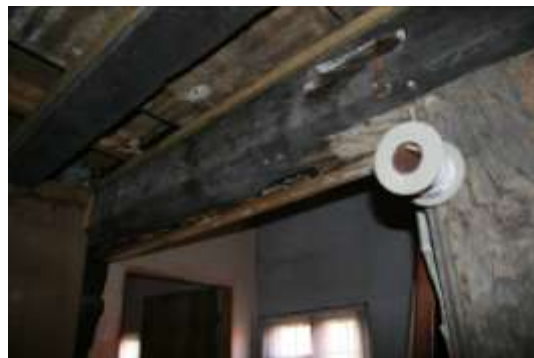
The doorway into the extension.

The principal corner post has a slot mortice for a curving brace set to the back of the post. This indicates the front wall has been rebuilt to house the sash window. There is a doorway broken through the outer wall to connect to a small lobby to access the downstairs shower room. The studs have been removed and a nailed timber bracket put in place. Like much of the house this area has been left unfinished.

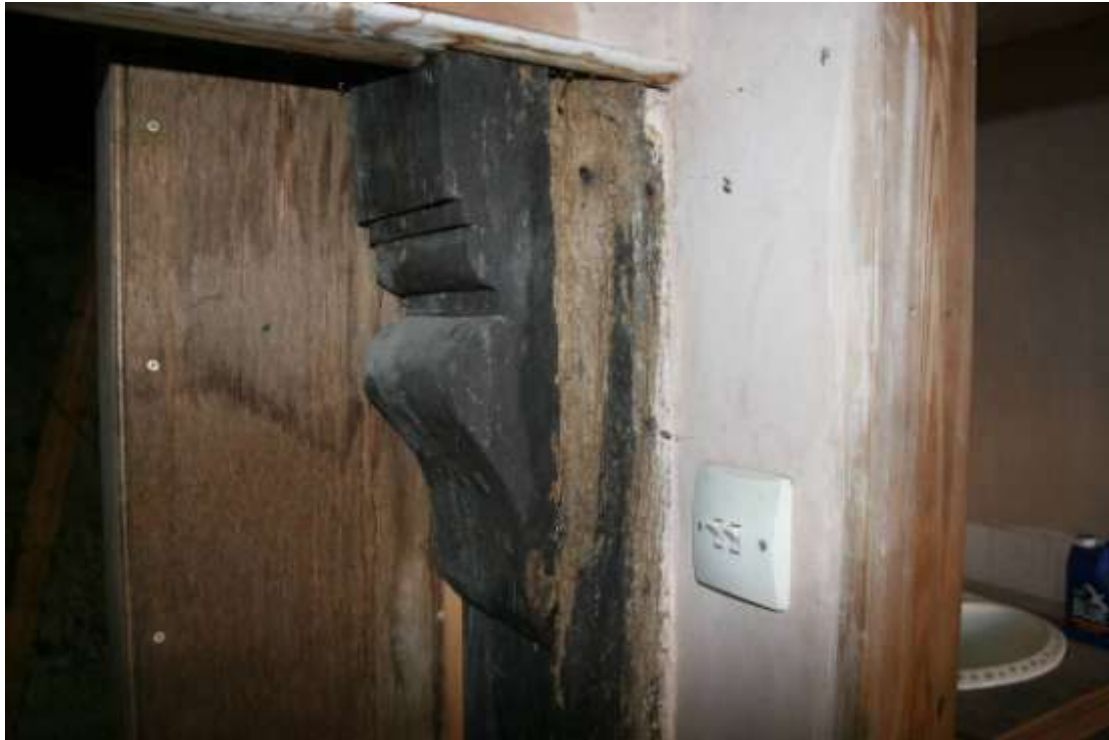
The bracket in the Shower Room lobby.

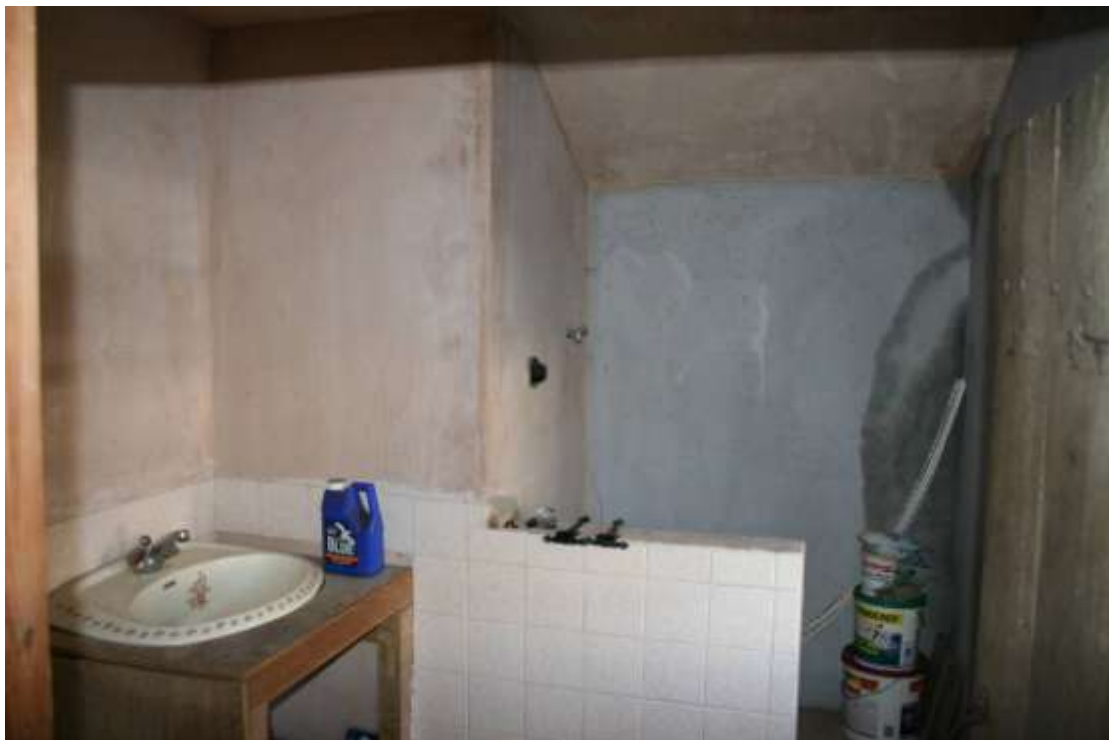
The Shower Room is recently decorated and unfinished.

The Shower Room is entirely modern in its decor, which is unfinished. Of interest is the oak boarded C18th/C19th style door and a free-standing C19th four panel door.

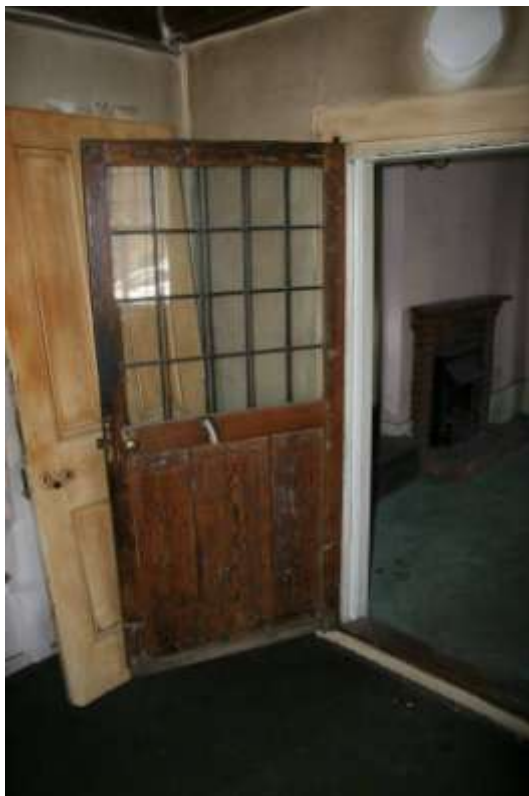
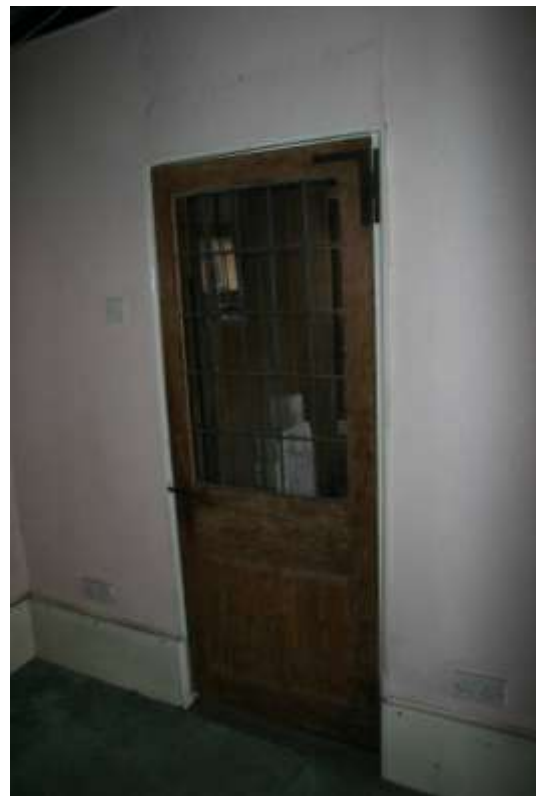
Pine doors altered in the LC20th and screwed in place. Room 2/3 and then Room 3/4.

The doors on the ground floor are EC19th pine doors that have been altered with leaded lights. Other four panel doors lie around and it is likely but not certain they came from the house before the C20th renovations took place.

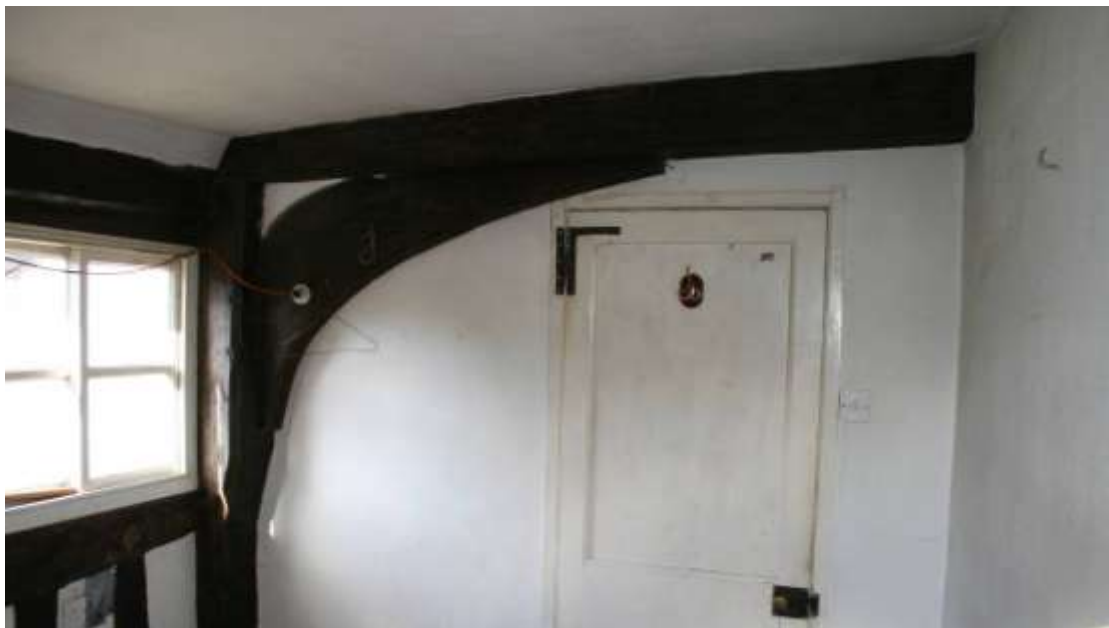
The frame and two panel door in Bedroom 1.

The frame is exposed in Bedroom 1 and the heavy brace of the tie-beam can be seen. Secured with four pegs in the tie-beam and three in the jowled post, there was a series of spandrels on each truss stiffening the frame. A number have been removed causing the frame to rack slightly.

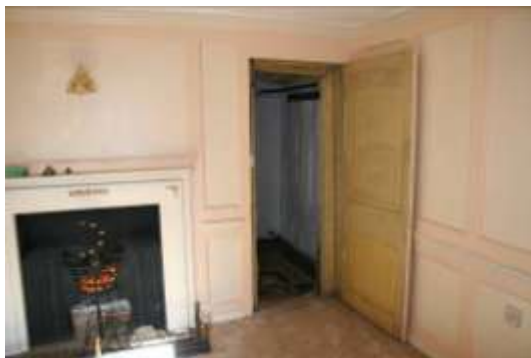
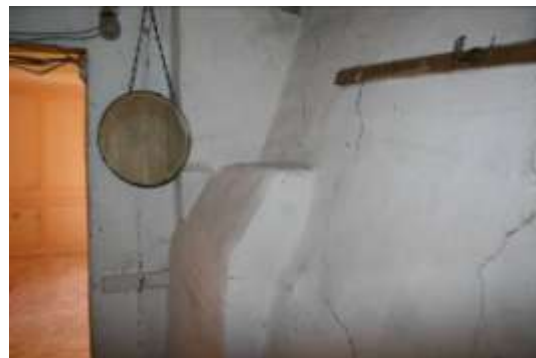
The closet to the side of the fireplace shows the plastered firestack.

The closet has an earlier, smaller door frame. Inside, the flank of the firestack is plastered and the walls have battens for C19th coat hooks which have all been snapped off. When the fire was lit this little room would have been warm and suitable to keep clothes. Inside the brickwork has been altered to insert the fireplace and poor quality battens applied to support the panelled wall as one build.

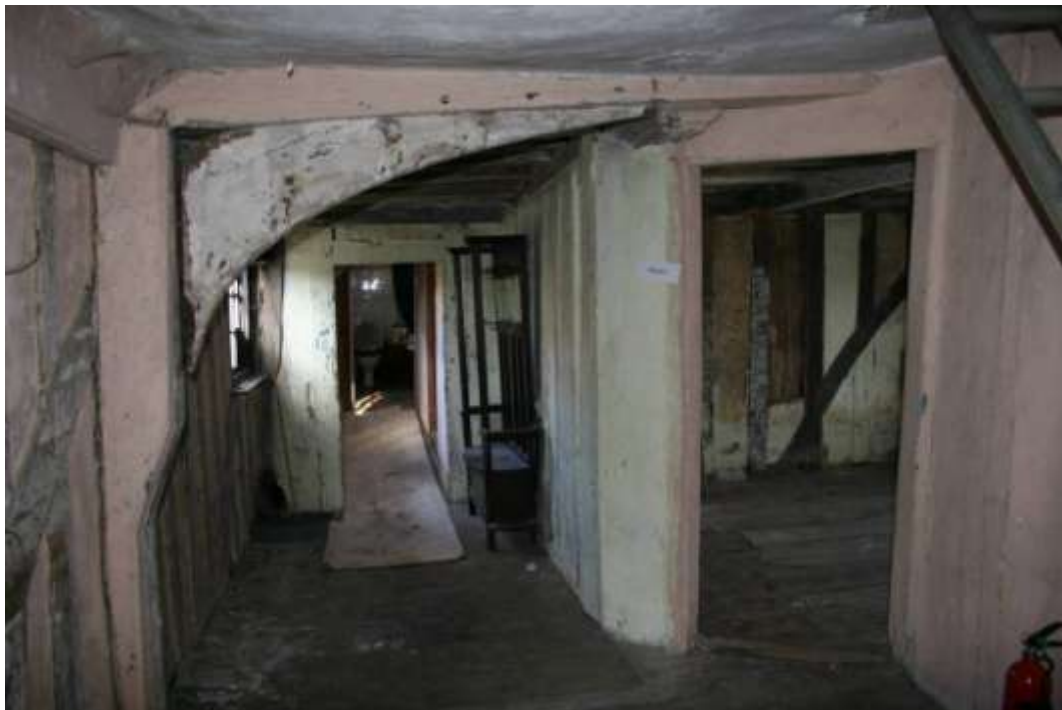
The Landing looking into Bedroom 3 and N down the corridor.

Bedrooms 3 and 4 have been created by inserting a scantling studwork partition forming the corridor. This is a common LC18th or EC19th alteration to provide privacy in the rooms. (Scantling is poor quality narrow section timber sometimes just cut from the hedgerow).

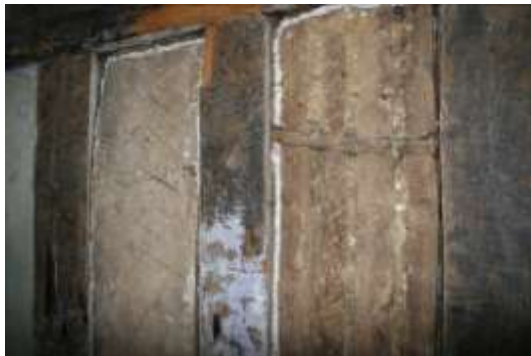
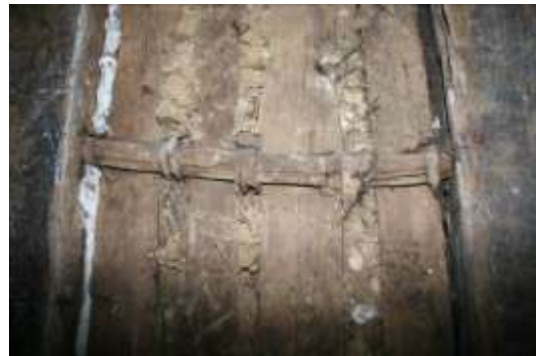
Detail of the wattle and daub panels in the northern wall.

The scantling partition is lath and plastered on both sides but the original oak frame is exposed in the northern partition wall and still retains the wattle and daub panels which exhibit their structure. Horizontal ledgers split from branches are wedged in to the darts cut in the flanks of the studs. Vertical riven wattles are wedged in the grooves cut in the top and cill plates and then bound to the ledgers with bark withies. The panel was then packed with daub made from chalky boulder clay dug out of the garden and mixed with chopped straw and other organic material. This was then floated to a smooth finish and scribed with a diamond pattern to receive a lime render.

Over time the wattle panels have shrunk back and it is likely they are the original ones rather than later replacements. The studs do not have nails for later laths and there are several blackened taper burn marks.

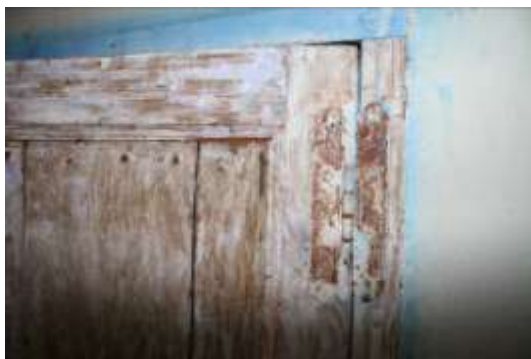
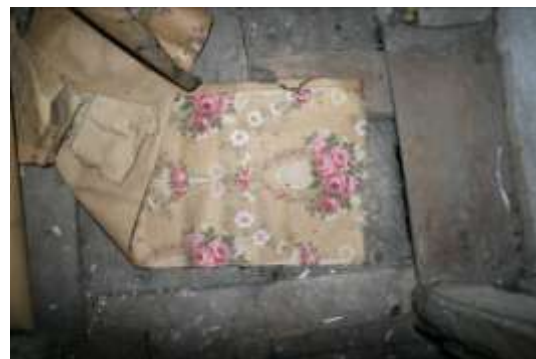
Detail of the closet door hinges. Old wall paper marked 'Made in England'.

The closets were also wallpapered with Victorian or Edwardian style printed wall paper marked 'Made in England'. The floorboards were also rather loose implying they had been used to hide things and indeed a number of everyday objects were found in the voids.

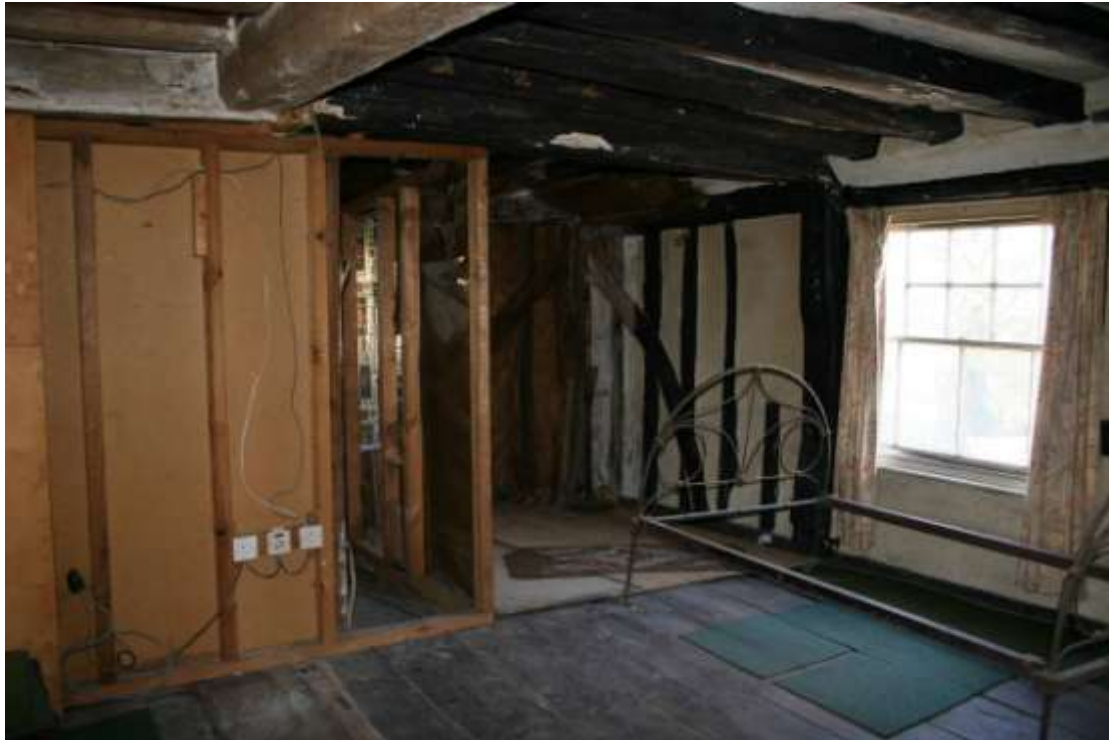
Looking NE in Bedroom 4. The inserted bathroom is LC20th.

Like the other bedrooms, Bedroom 4 has been created out of a larger single room of two bays. Today it contains a bathroom fabricated from machined studwork and plywood.

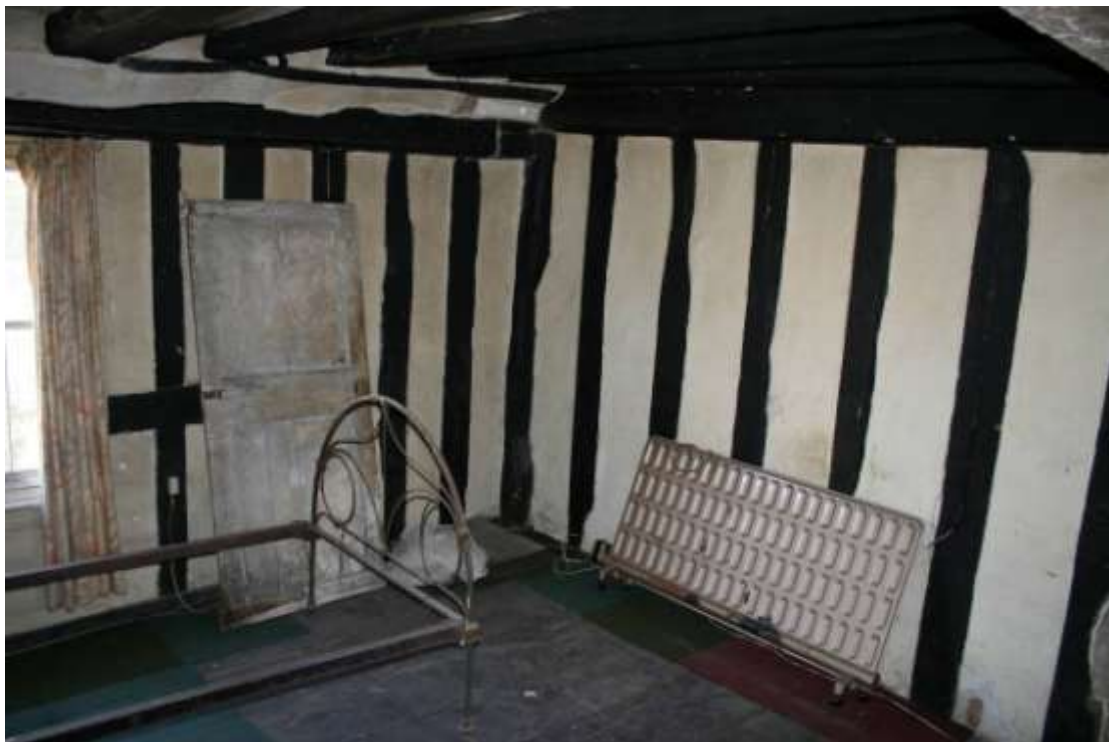
Looking SE in Bedroom 4.

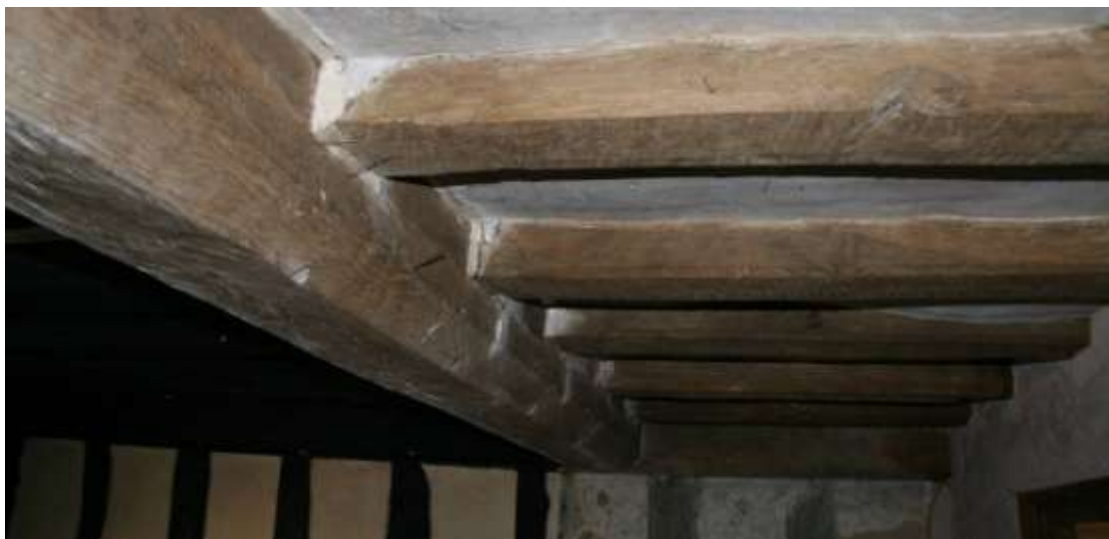
The bathroom was most likely constructed in the 1960's or early 1970's by Mr Brookes and later partly dismantled for redecoration. There is a series of small mortices in the floorboards and two larger ones in the axial joist of the ceiling to indicate the room was previously subdivided into smaller cells. The style of the design indicates this was done in the LC19th or EC20th when the house was divided into three dwellings. The decor of the room, part painted black part original implies the layout was retained at least until Mr Brookes ownership in the 1960's. The unpainted timbers are clearly axe finished and ceilings appear correctly framed.

The original finish of the ceiling timbers. Looking S.

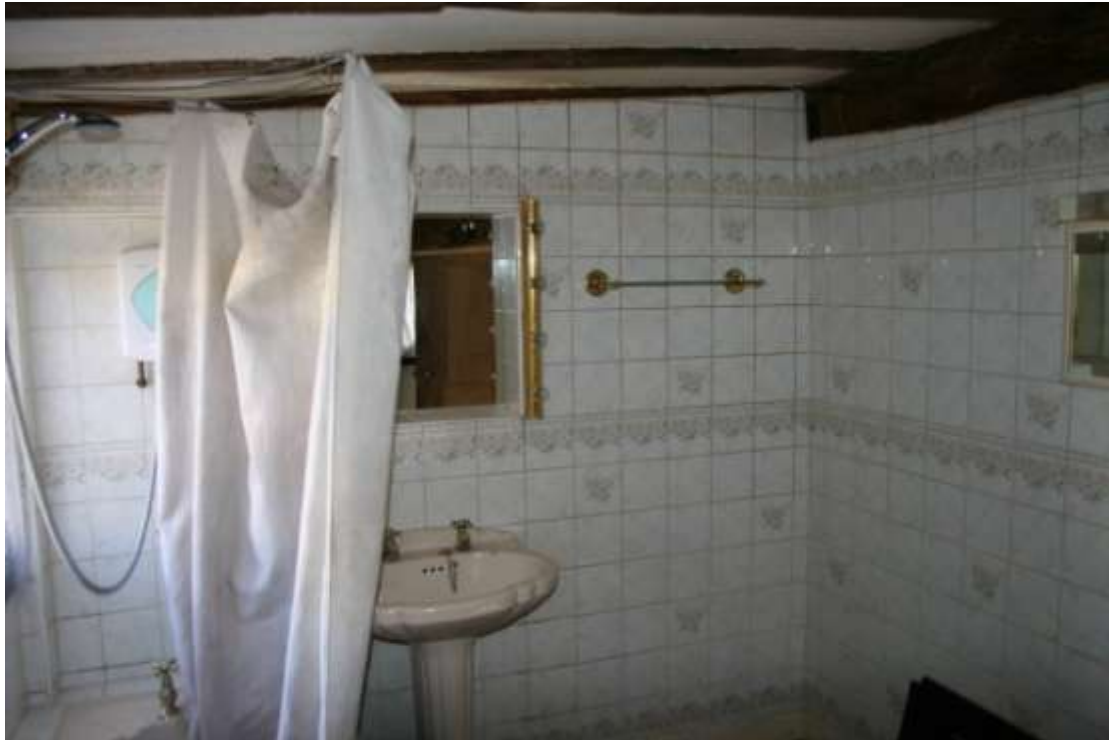
Looking E inside the Bathroom.

The Bathroom is outfitted with sanitary ware common in the 1980's and 90's and can still be purchased today. The racking of the frame is evident in the ceiling.

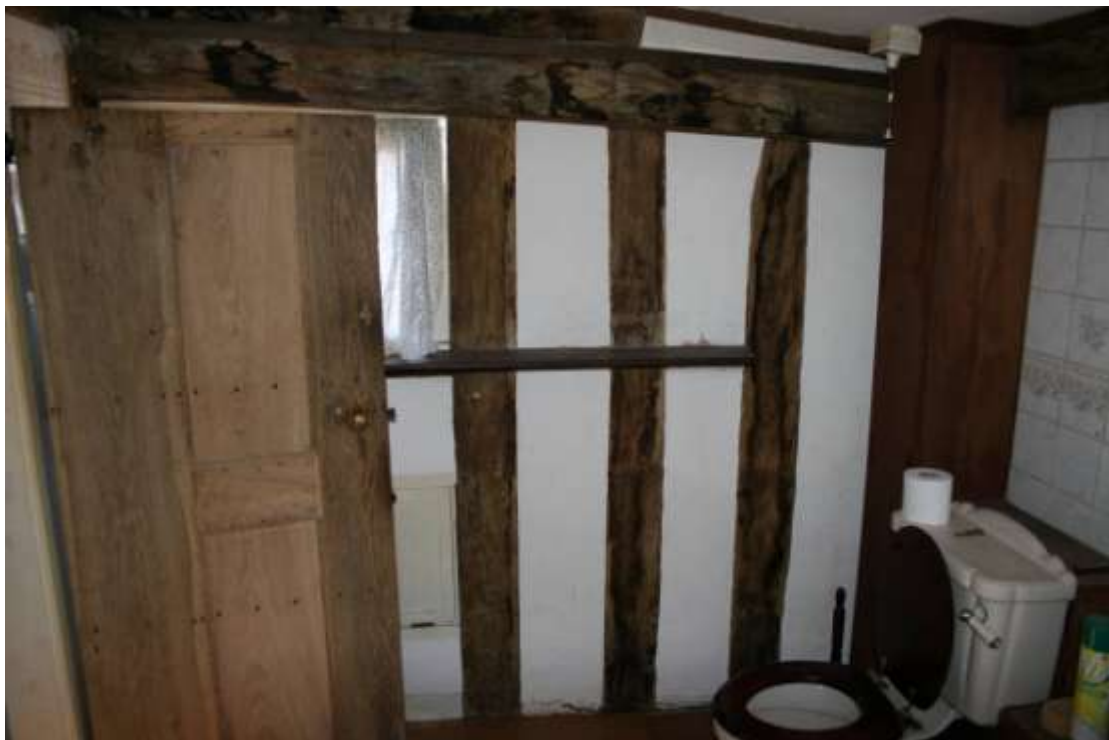
Looking W in the Bathroom. The door is homemade LC20th.

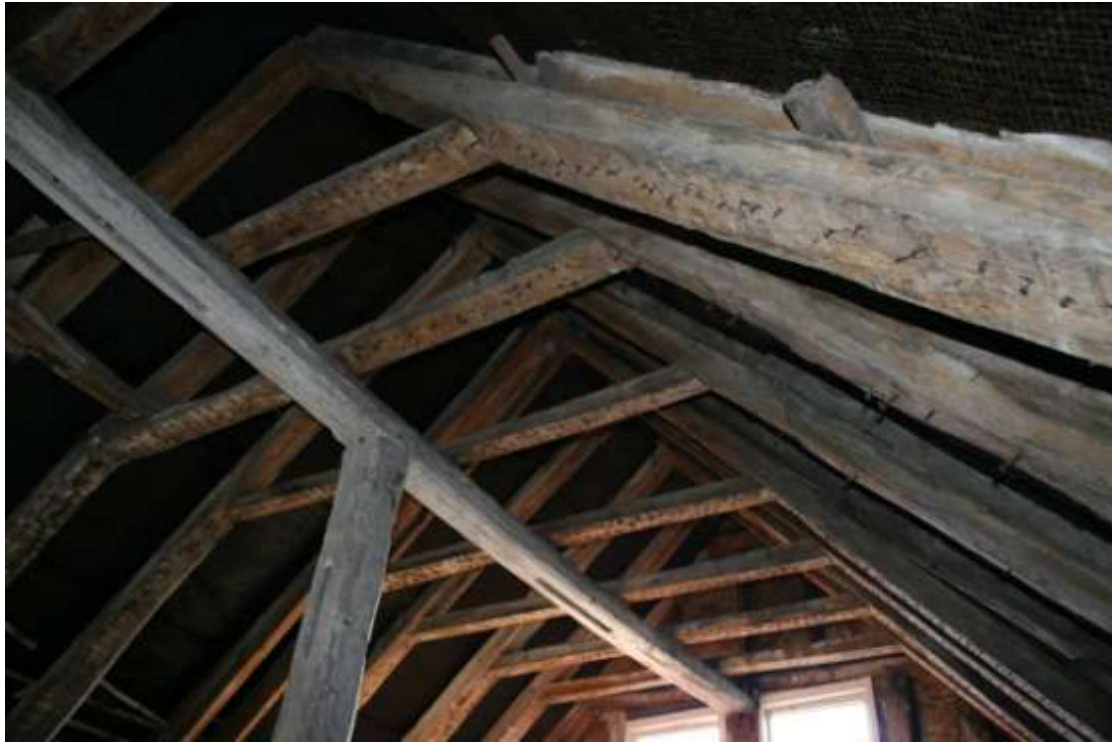
Looking upwards SE into the South Attic.

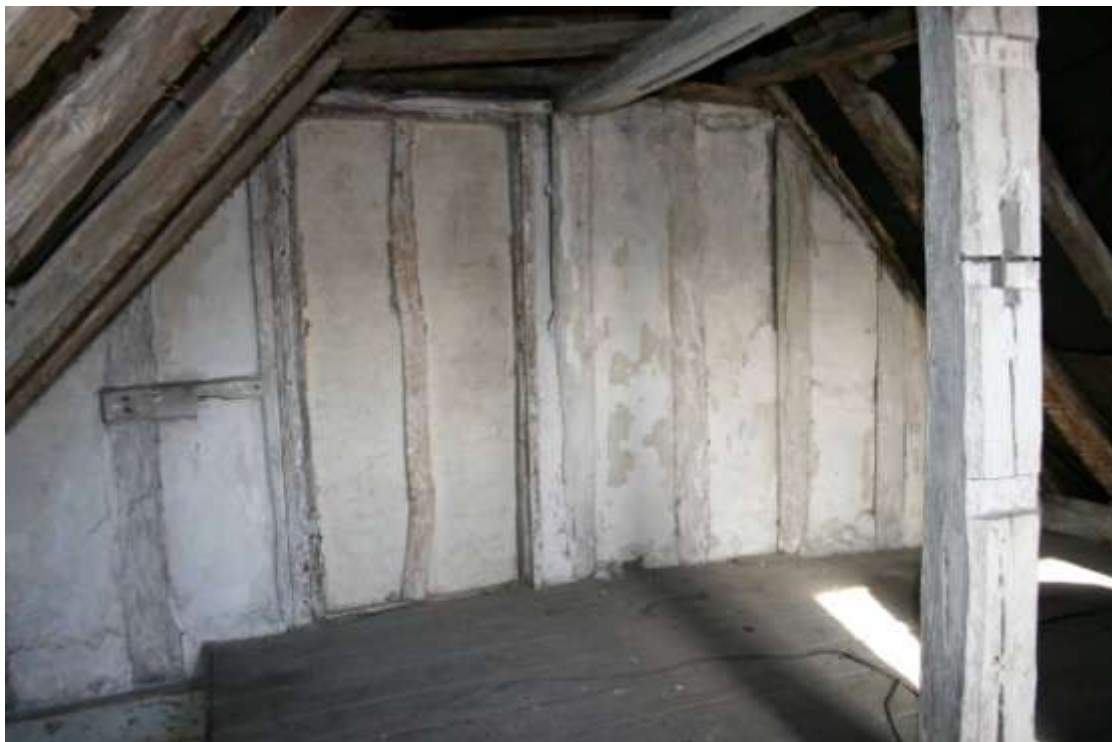
Looking N in the South Attic. There is a blocked doorway.

There is a doorway into the next attic that was blocked up long ago with an inserted waney stud and lath and plaster and there is a short rail nailed to the wall that would have been part of the stair or ladder to get up to the room. Previously this room was lath and plastered throughout but it has all been stripped away. The current window is modern and older photographs indicate that there wasn't one here originally.

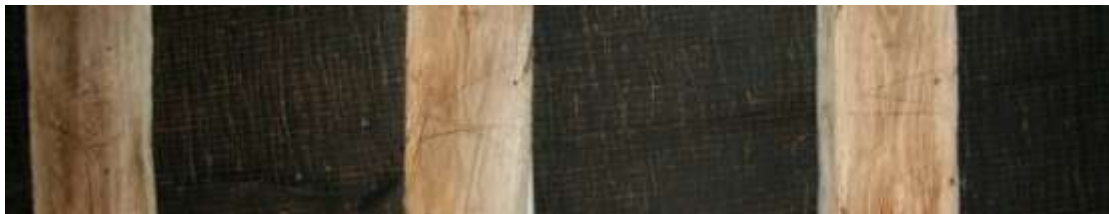
Carpenter's marks on the rafters.

The numbers, made with a race knife, are out of order but this is not surprising as the roof has been rebuilt several times. The heavy asphalt membrane shows the house was completely reroofed in the 1960's to 1980's and so most likely when Mr Brookes renovated the house. A few riven lath remain to show that the roof was also previously tiled.

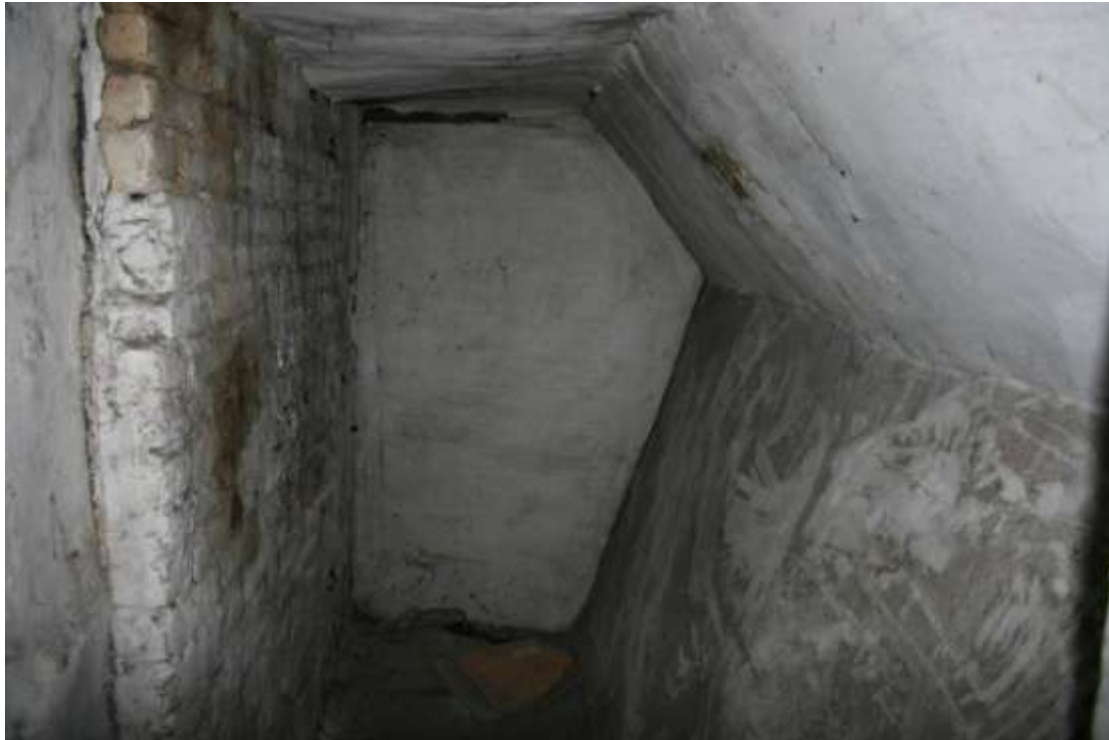
Looking S at the blocked doorway into the South Attic. The brickwork is the firestack.

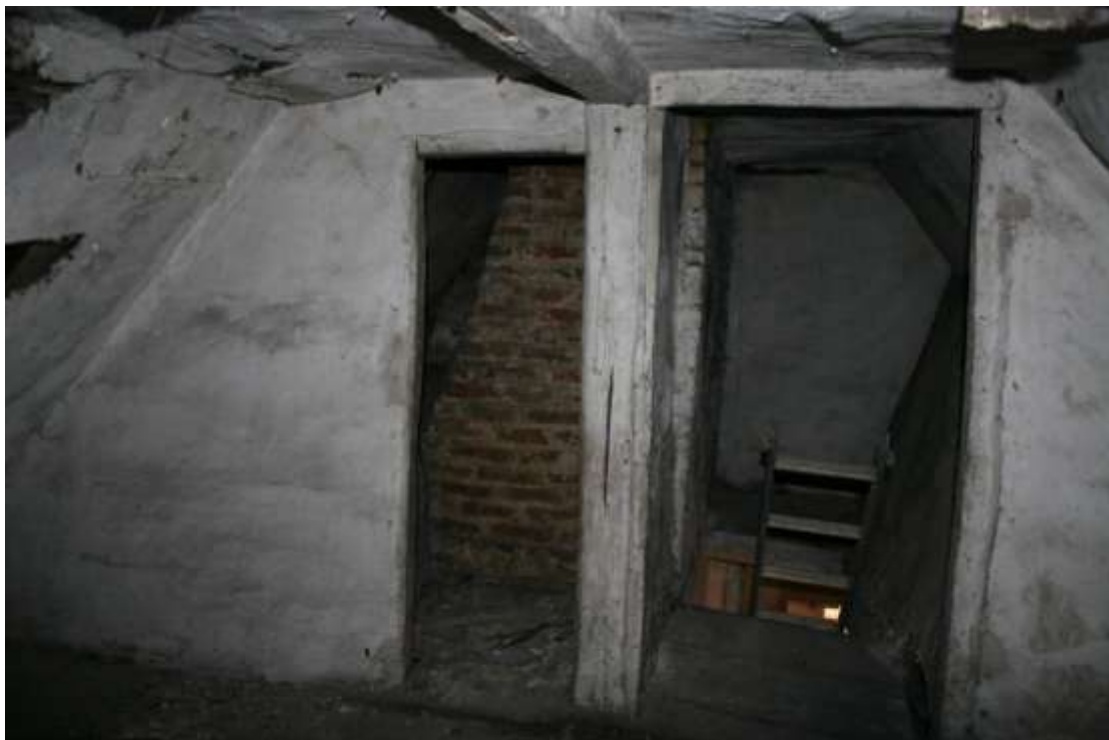
Looking S in the Central Attic at the firestack and entrance landing.

The roof construction is consistent throughout. There is a small landing to allow access to both attics and a closet door into the void beside the firestack.

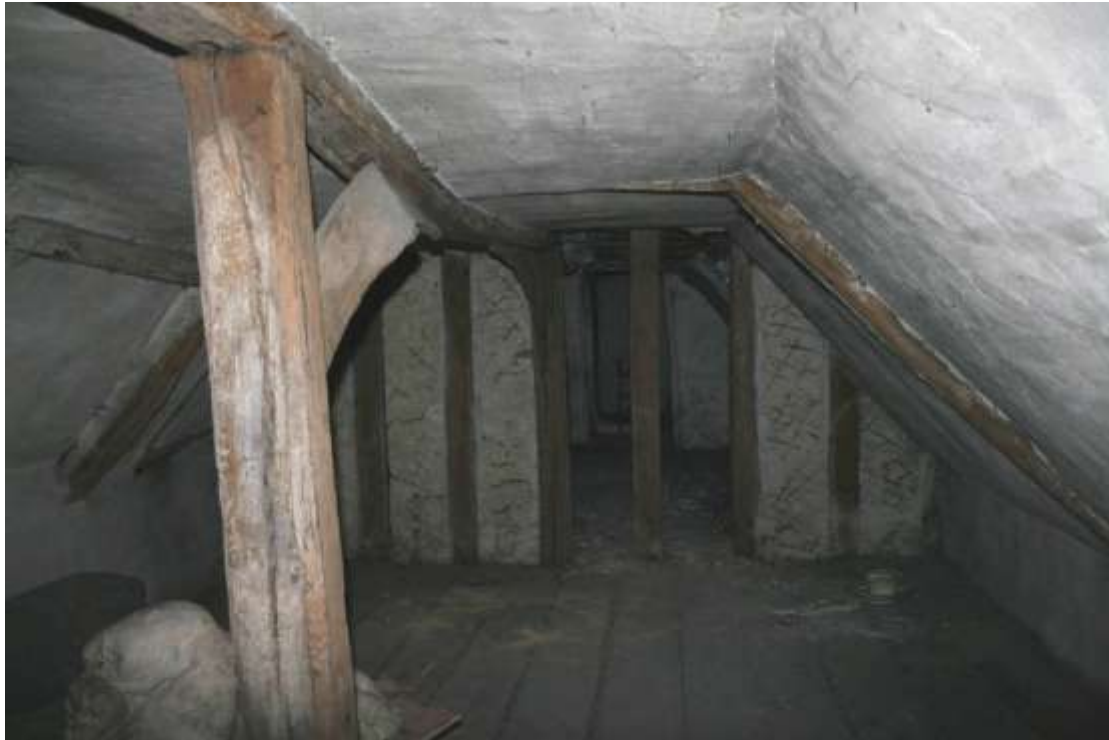
Looking S in the North Attic.

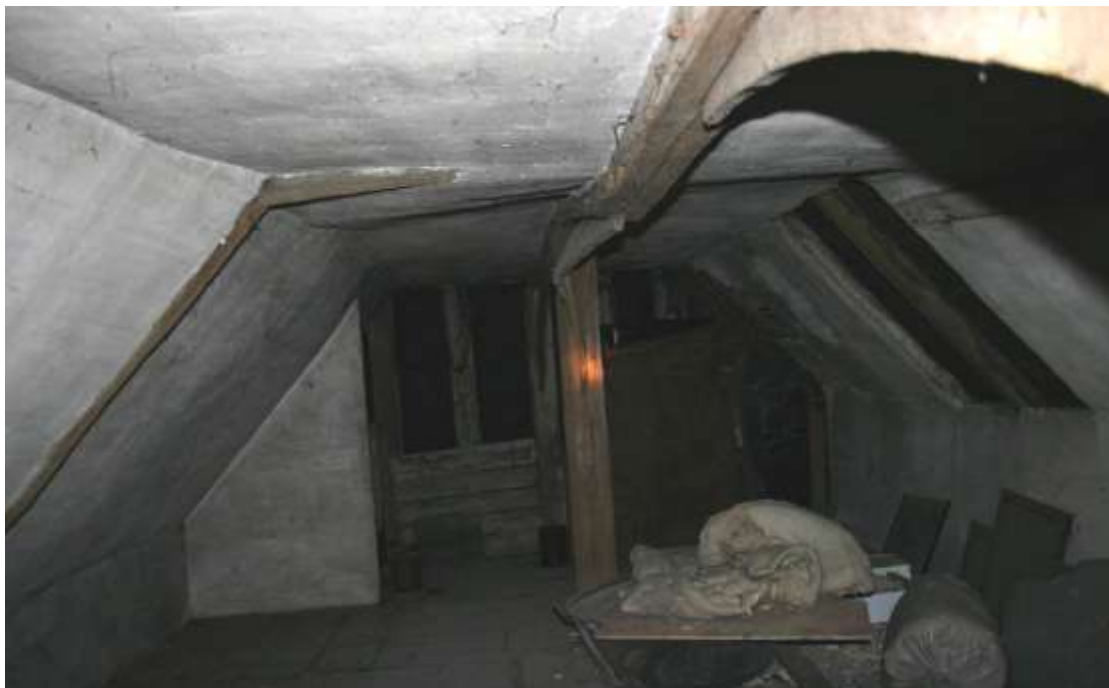
Looking N in the North Attic. Note the framing for a dormer window.

The North Attic is the most complete and originally had a dormer window and a window in the gable end. It must have been accessed from the north end through the current bathroom.
