Creeksea Place Farm Barn, Ferry Road, Creeksea, Essex.
Description and analysis of a timber-framed barn at Creeksea Place Farm.
Surveyed 03 07 2009.

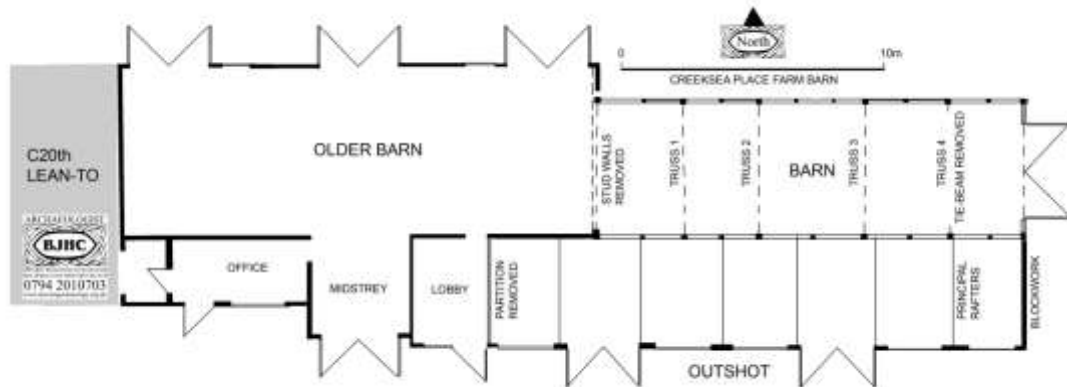
The Barn and its disposition to its conjoining buildings.

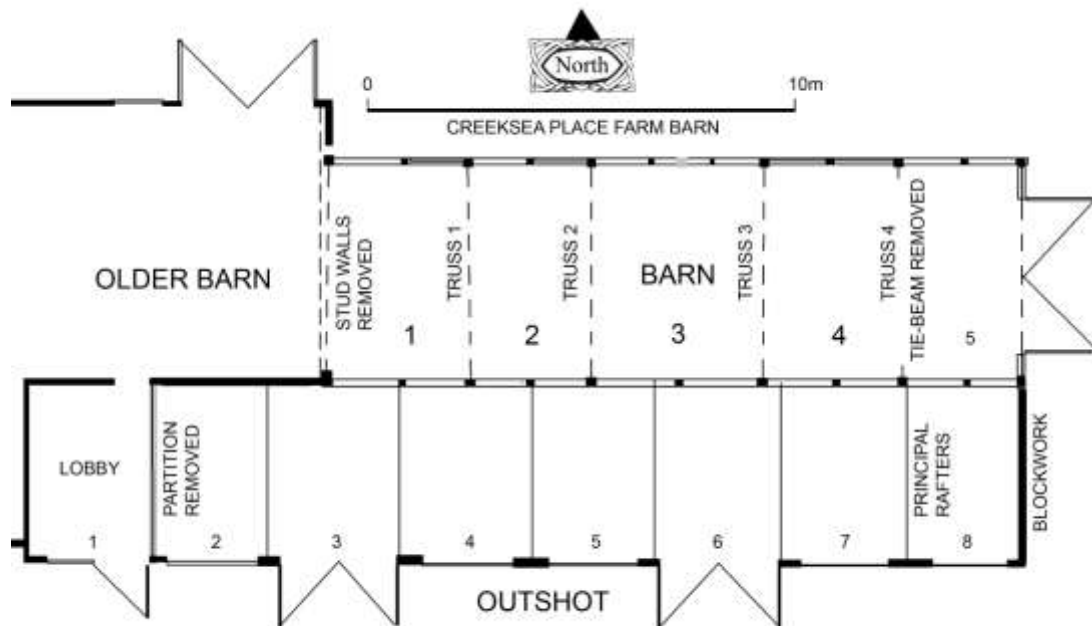
The Barn and Outshot showing detail of the plan form.

The barn is of five bays. The central one is 4.0m (13ft) wide while the others are 3.9m (9ft 6in) measuring between the centres of the posts which vary from 7-8in wide by 5-6in deep.

The posts support tie-beams spanning the barn at 3.65m (12ft) up, each of which is secured with a hanging knee held in position with very large iron spikes and two or three bolts. Most of the bolts are round headed forelock bolts but to the west there are also square headed screw threaded bolts.

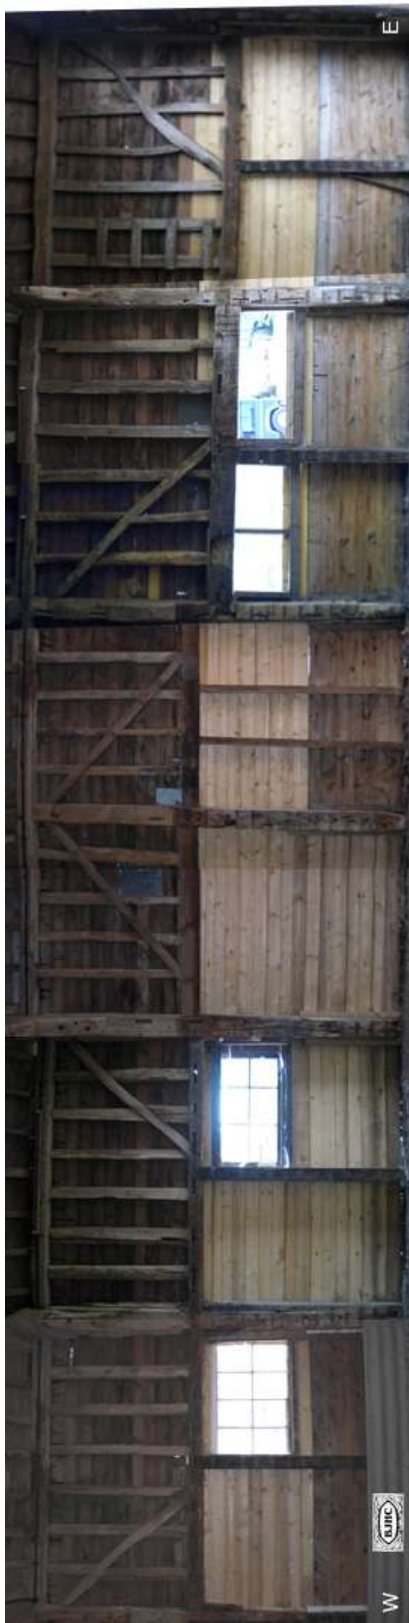
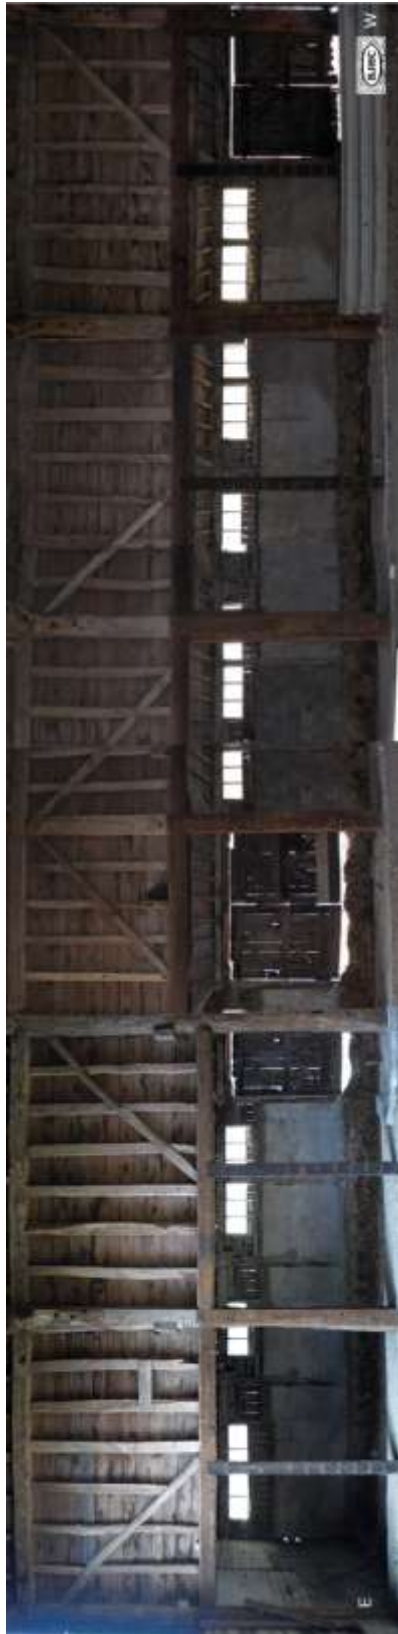
Composite photographs of the internal walls. North above. NTS.

While some of the timber appears to be oak, faded to its characteristic grey colour , none of the knees are and most of the midrails and posts appear to be red softwood.

Each post is connected with a mid-rail to its neighbour and below this all the timber studwork has been removed. In each bay is a single C20th timber nailed in place with galvanised french nails except in the central bay where there are original storey posts to counter the larger span. This bay differs from the others in that there are two diagonal downbraces off the central post.

The panels above the mid-rails are composed of scantling timber with a single primary brace and 6 nailed in interrupted studs in each bay. The braces all have a slight curve and have been sawn on at least two faces.

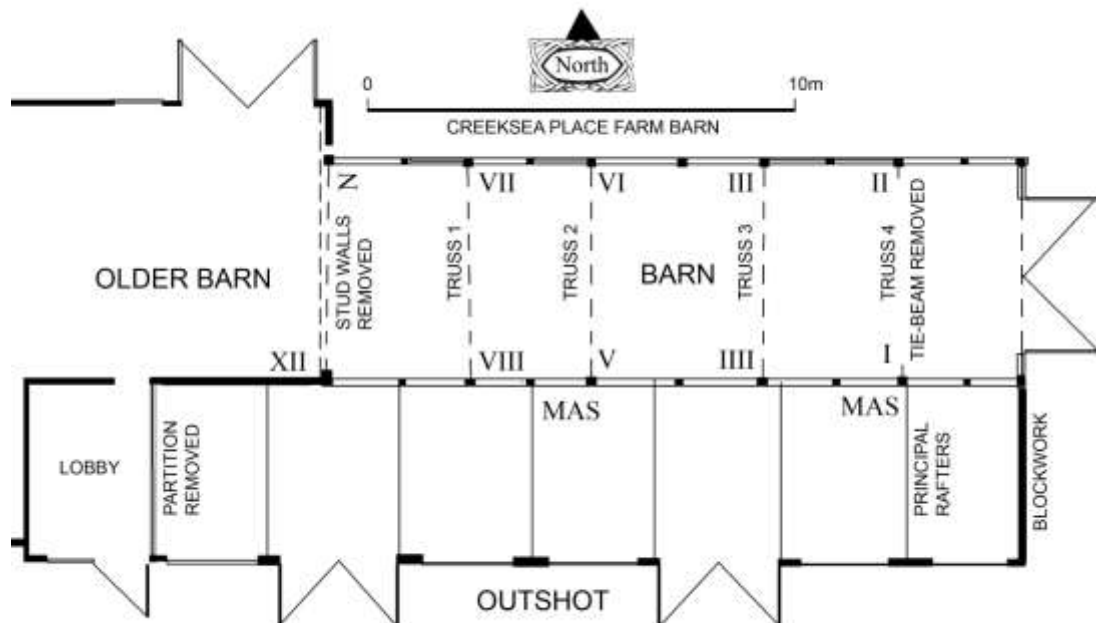
Carpentry Marks.

Plan of the barn showing the visible carpenters marks and merchants paint marks (on Outshot).

The hanging knees and posts are numbered from I to N (the mark for X is missing) but curiously they begin from Truss 4 (from the west) and not the end wall as might be expected because the east wall does not have any hanging knees. In Truss 3 the knees have been removed and in Truss 5 they remain but the tie-beam has been sawn off on both sides.
