Coleraines, North Hill, Little Baddow, Chelmsford, Essex.

Description and analysis of the timber-framed Stables.

Surveyed 22 01 2010 by Barry Hillman-Crouch MSt PA DipFA BSc HND.

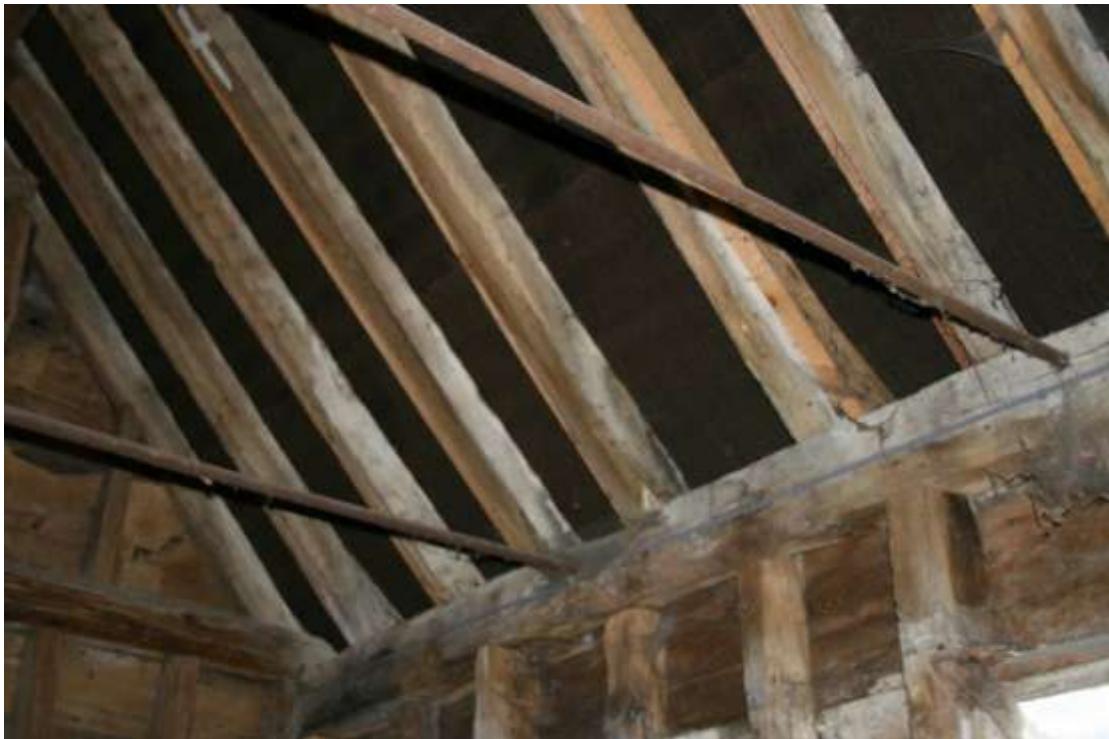
There are three mild steel tie-rods spanning the building passing through the top-plates. These are actually steel tubes which are threaded at either end and secured with hexagonal headed C20th nuts against small square mild steel pattress plates. The only other ironwork repair visible is a mild steel strap across the failed scarf joint in the top-plate of the north wall of the Eastern Stalls which is painted with grey primer and secured with hex headed bolts. (See photo for roof structure extreme right).
