Norton Hall Barn, St Stephen's Road, Cold Norton, Essex
Description and analysis of a brick and timber-framed barn adjacent to Norton Hall.
Surveyed 30 04 2010.

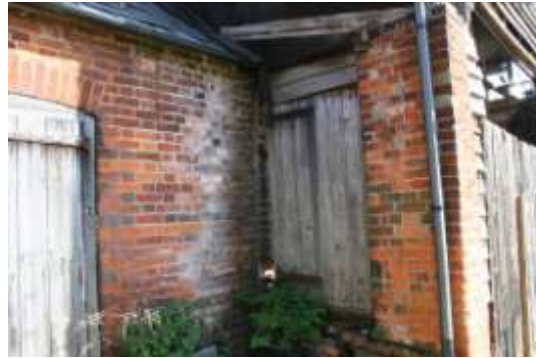
The flanks of the porch are constructed in hard red, orange and over fired purple bricks 60-65x110x220mm set in a 10-15mm bed of hard white mortar with a flint chip aggregate. These bricks are consistent throughout the barn but differ slightly in size in the Outshut walls where most of the bricks measure narrower at 65x105x220mm. However all the walls are 330mm (13in) wide. The eastern flank is failing and the brickwork damaged.

Failing eastern flank of the porch and (right) the side entrance to the porch.

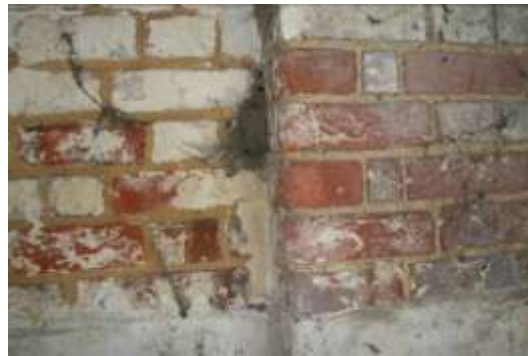
Bricked in doorway visible in the Stables. Mortar is markedly different.

Either side of the porch are the two Outshuts. Although symmetrical with two doorways in each elevation, the Western Outshut has been obscured by the addition of the Stables and the northernmost doorway bricked in. While the blocking bricks are similar in appearance to the originals they are slightly larger at 65x110x230mm and set in a beige sandy mortar in a 10-15mm bedding joint. These are the same as the rest of the Stables walls and it is natural to assume they were put in at the same time as it was constructed.

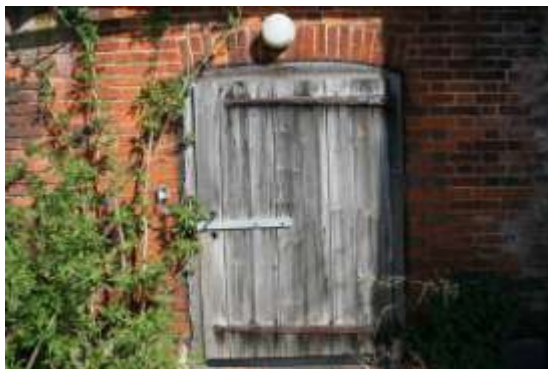
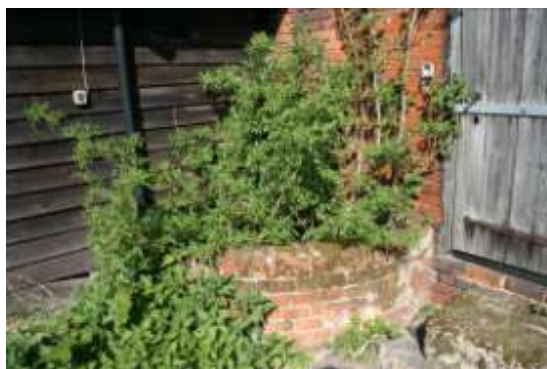
The main pedestrian entrance and (right) a C20th water trough.

The other door in the Western Outshut has a C20th vertically boarded gate and ledger door with C21st fittings save for the very long spoon ended strap hinges. These are hand wrought and the terminals also have two incised vertical bars which is a throwback to the incision of the saltire cross and bars on door furniture. However the metal is badly rusted and has no patina so it is likely that they are mild steel. The countersunk holes are drilled rather than hot-punched so it seems they are late C19th or early C20th.

In the corner formed by the Stables and the Western Outshut is a semi-circular brick built water trough fed by rainwater from the roof valley above. Whilst the bricks look old the construction is entirely in grey cement and so mid C20th onwards.

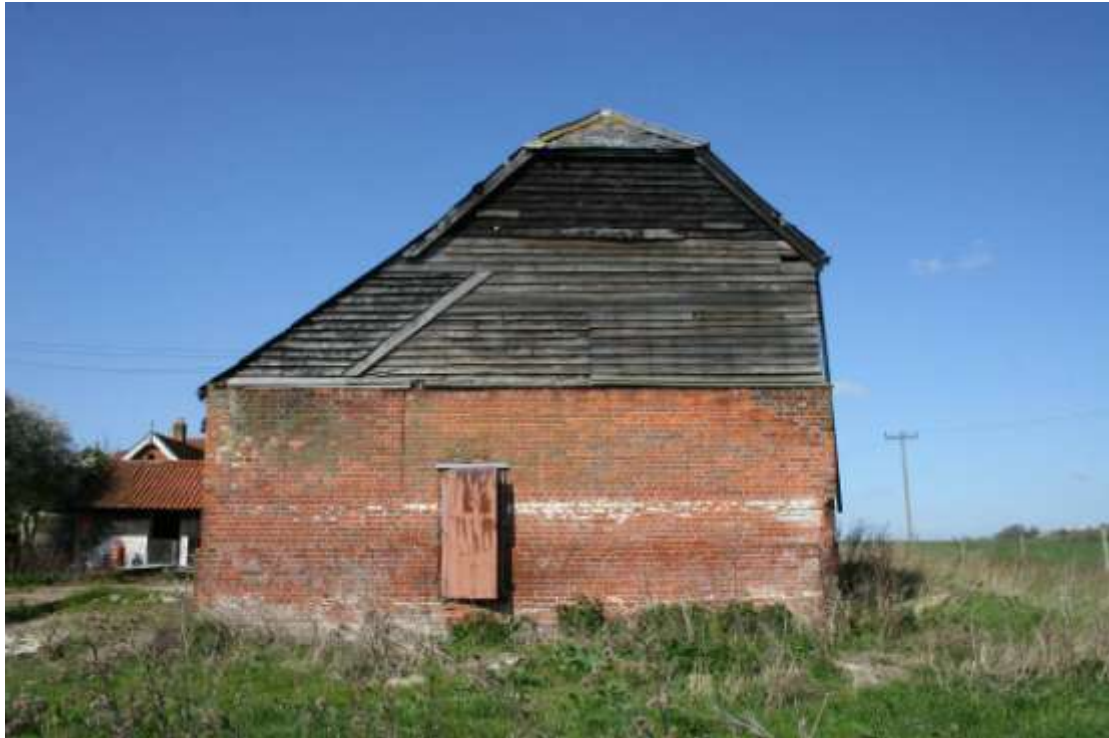
The eastern elevation shows several episodes of weatherboarding.

The eastern elevation is composed of the wall of the original brick Barn butted against the wall of the Eastern Outshut. The Barn wall is properly closed at each corner although the NE corner has been chamfered back for half its height perhaps in repair of damage caused by vehicles rounding the corner. There is a considerable gouge in the brickwork that looks like the turn of a cart or tractor wheel about 2m off the ground and another near the inserted door.

The 13in walls are laid in Flemish bond set in a 10-15mm bed of hard white mortar with a flint chip aggregate. A door has been inserted into the SE corner of the barn resulting in the failure of the brickwork above it.

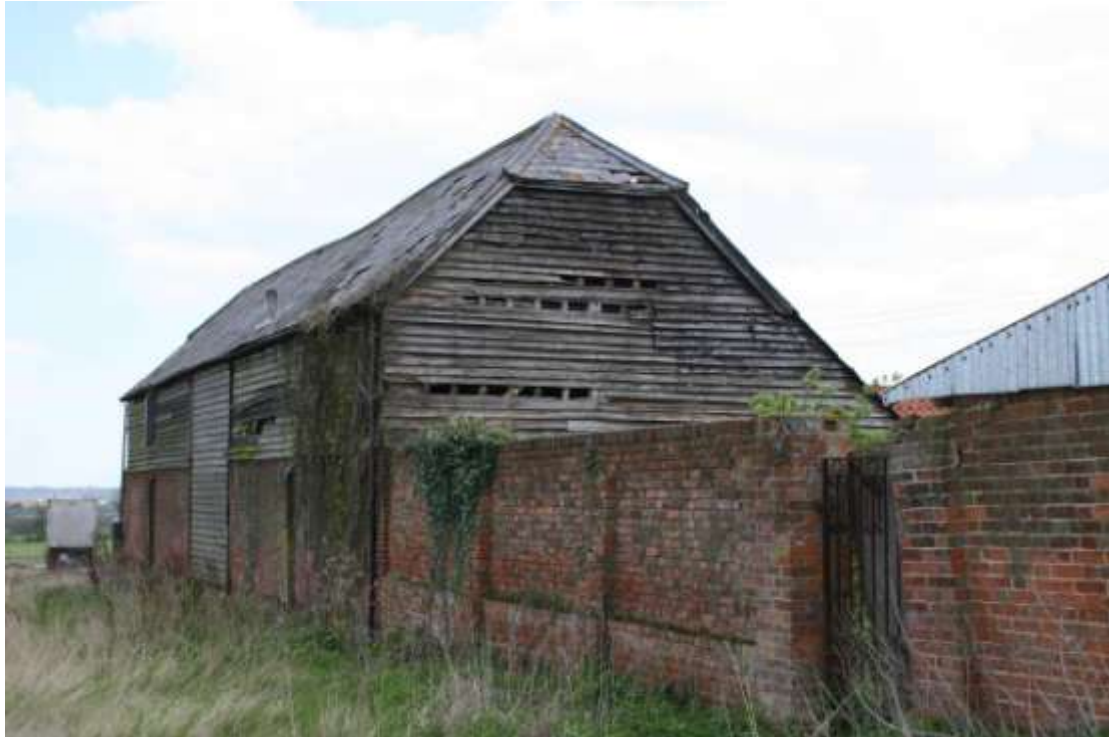
The western elevation is hidden from view in a private courtyard.

There is a wall butted to the end of the barn of a mixture of brick sizes from the other buildings set in a beige sandy mortar contrasting with the hard white flinty lime mortar of the barn. There is a break where a wrought mild steel gate is set and the wall continues built using the hard white mortar and meets the other buildings of Norton Hall.

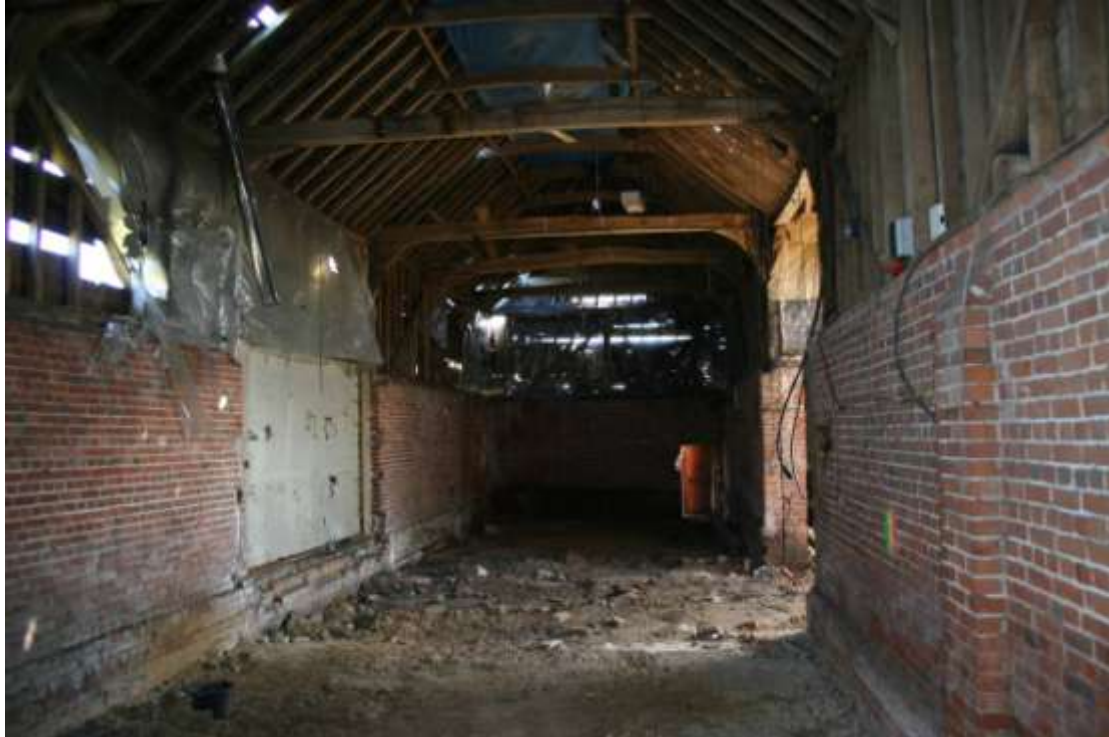
Inside of the Barn looking eastwards. The floors and dividing walls have been removed.

Internally the barn is devoid of any fixtures and fittings that may have indicated its early use. The floors have been removed but in the rubble can be seen many chunks of asphalt from the dressing floors that were originally present. It is also evident from the rubble that there were concrete floors and at the time of the survey these remained in the Outshuts.

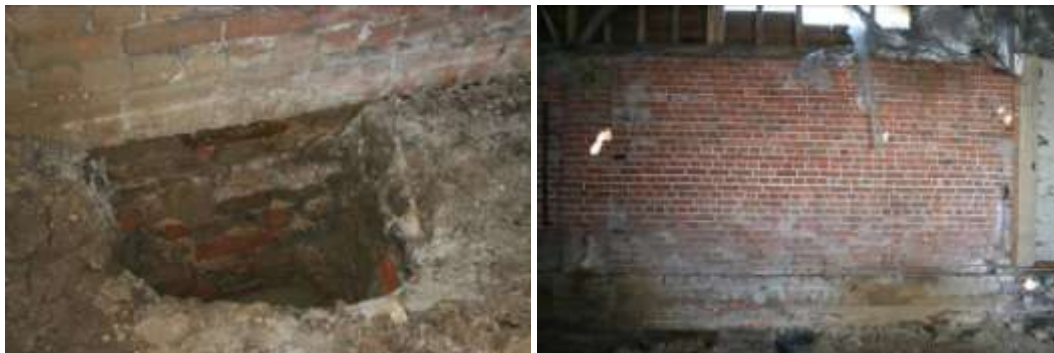
The brick walls are in very good condition and a small test pit has been dug to reveal the brick foundation which descends at least one metre below the floor surface. Looking in the section it is apparent that the floor has been made up of mixed clays and brick rubble put in after the plinths were built as there is no cut for a construction trench. The plinth and foundation are therefore about 1.8m (6ft) deep. The brick wall above varies slightly in height between 2.184m and 2.260m (7ft2in and 7ft5in) around the barn - a variation caused by settlement no doubt.

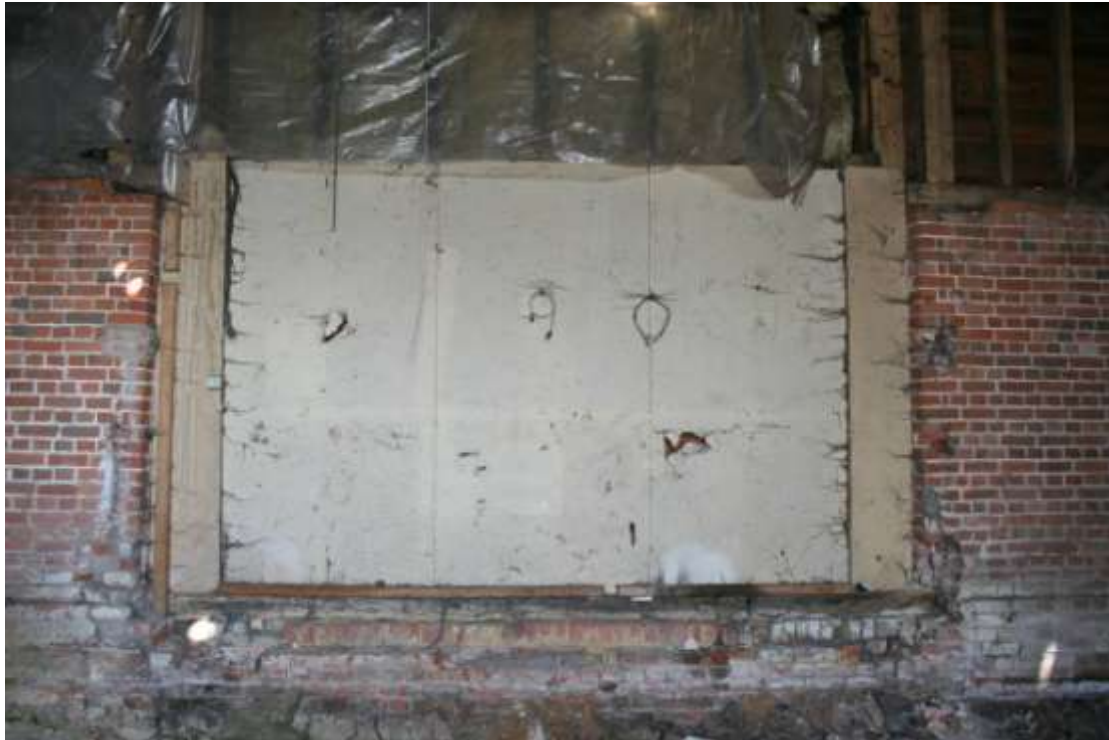
Walls scars in the door jambs show where two dividing walls crossed the barn.

In the floor of the barn are two 330mm (13in) wide brick foundations that link the door jambs of the north doorway with the porch. In the jambs on both sides of the barn are scars in the brickwork up to at least 5ft above the plinth to show where the internal walls were

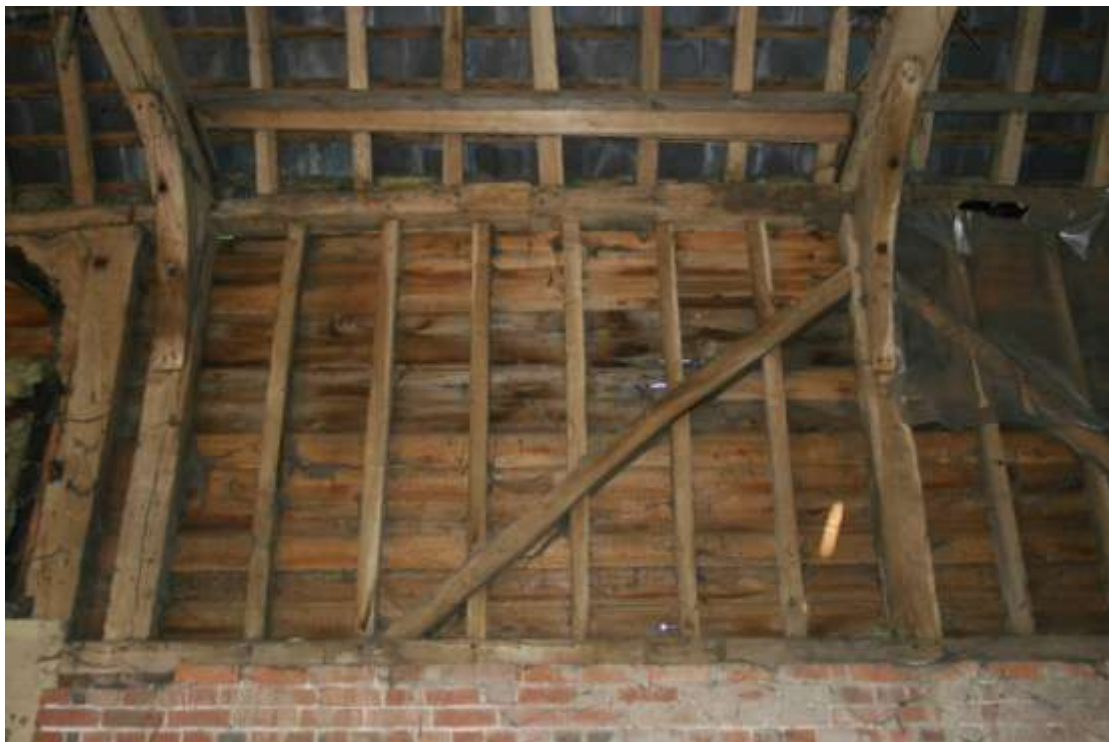
The wall panel in Bay 5 (north side) typifies the construction of the timber frame.

Above the brick walls is a timber-frame constructed in seven bays. Much of the eastern end was clad in plastic sheeting and insulation but it was still visible. The construction is consistent with a single diagonal brace in each bay dropping from the principal post and pegged into the sill plate. The narrow section pit sawn studs are interrupted and nailed in place with wrought iron rose headed cleats.

The studs set at 15in centres are cut on a module of 2.75in x 4in deep while the principals are 7in x 6in deep. The Listing describes the timber as softwood but the grey knot free timber tinged with red is much more like elm. The structure is fully framed and appears remarkably sound and complete.

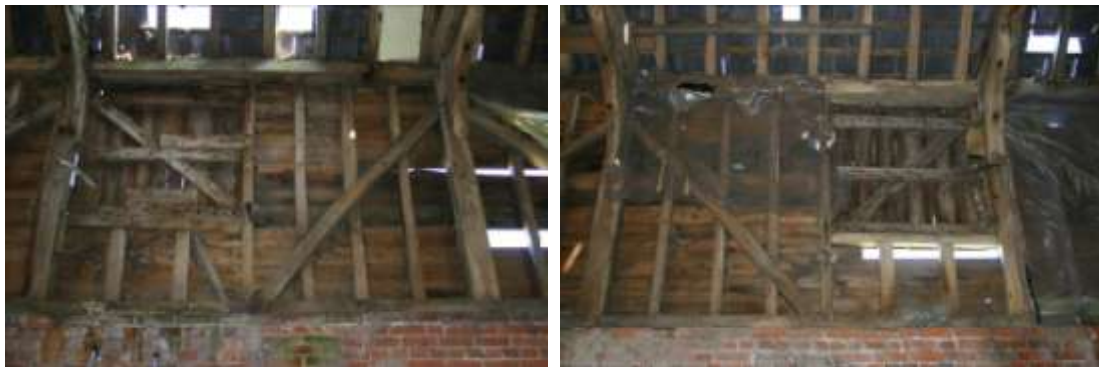
The two loft doors are fully framed and original to the build.

The two loft doors (Bays 2 and 6 north side) are of an identical gate and ledger design fastened with clenched wrought iron nails and are correctly framed. The top-plate shows no mortices above the doors showing the openings were part of the original design. The doors are fastened from the inside implying a floor or ladder to reach them.

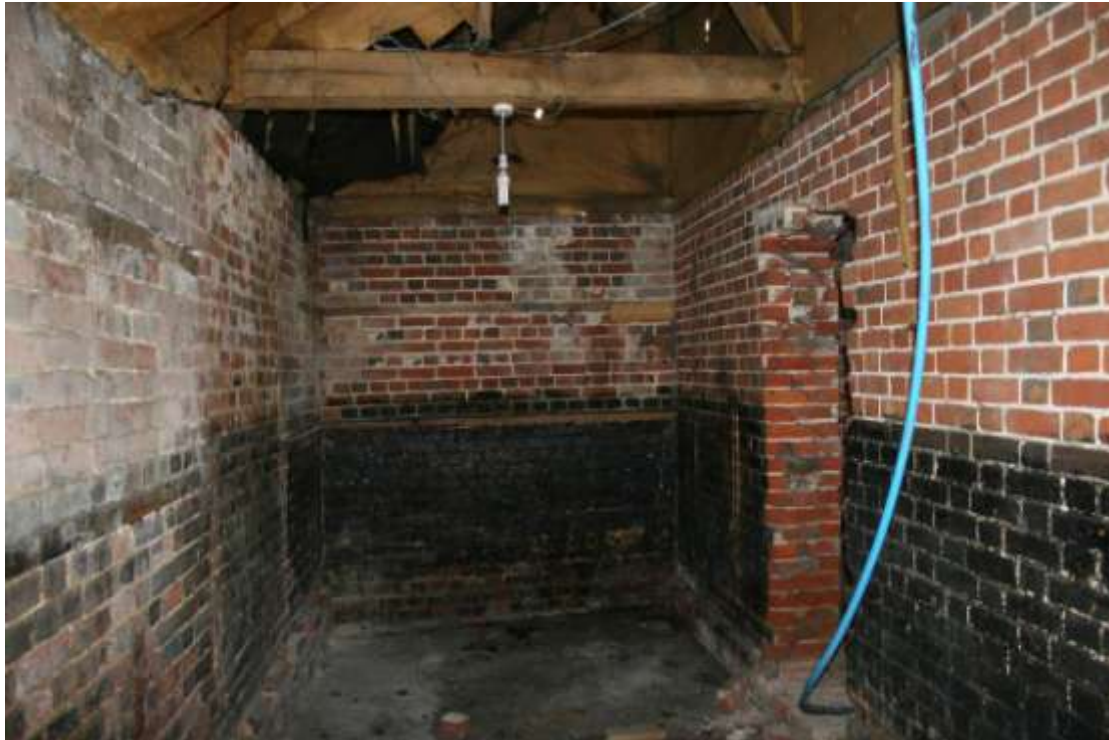
Interior of the Western Outshut.

The interior of the Western Outshut is bare of fittings except for some horizontal timber strakes in the walls and pilaster which imply that furniture or boarding was once fixed to the walls. The rear of the blocked in doorway into the Stables is visible and a new doorway has been cut through into the Barn very recently. The brickwork is painted with tar which passes over the blocked doorway and the letters HS are painted on the wall.

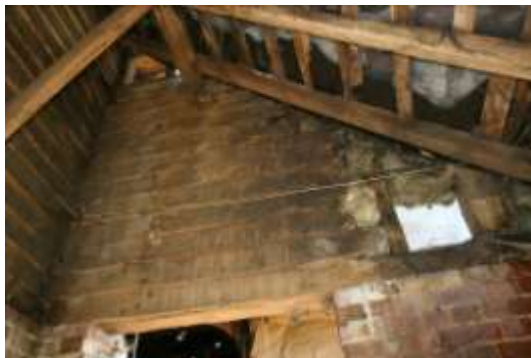
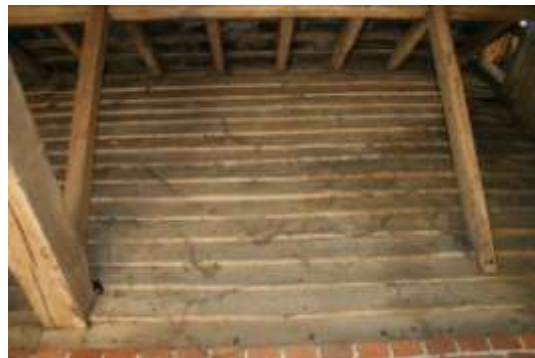
The weatherboarding above the Western Outshut is clean and untarred.

The weatherboarding applied to the Barn wall and the side of the porch is in very good, clean condition and has not been tarred. This implies most strongly that the Outshut was here from the beginning protecting the woodwork.

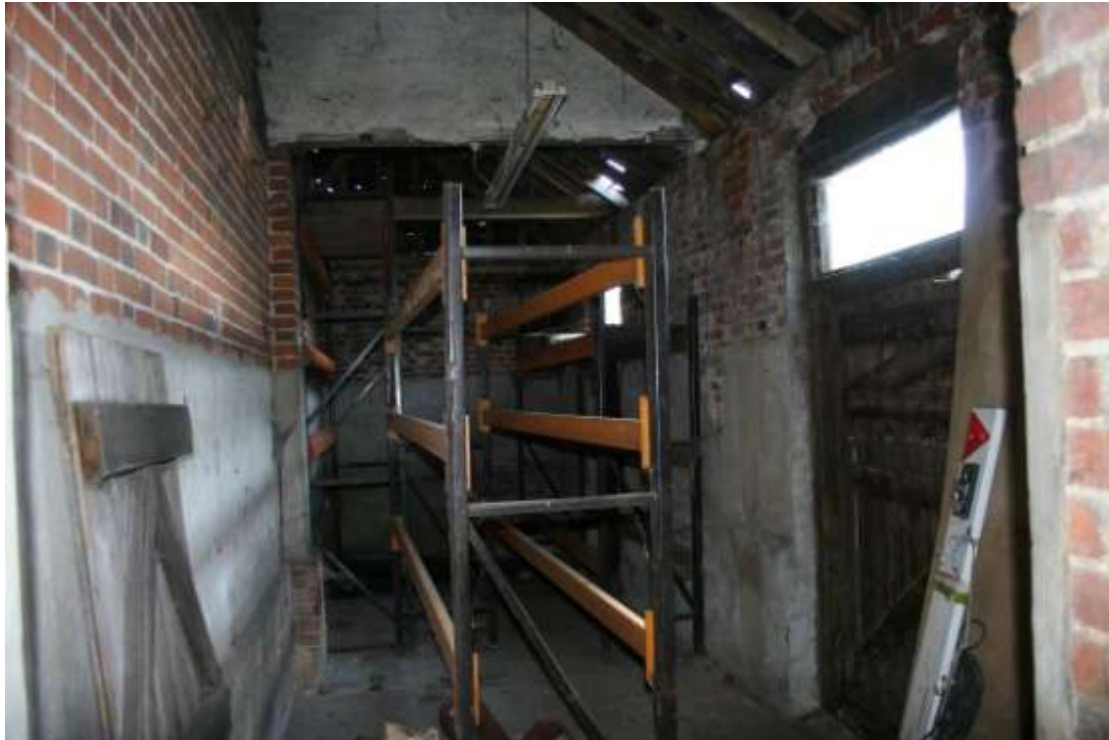
Looking into the Eastern Outshut. Lath and plaster division still in-situ above.

The lower half of the walls of the Eastern Outshut have been rendered with grey cement and the steel racking shows that this was used as a storeroom in the C20th. Prior to that the Outshut was divided into two rooms by a timber partition in the centre.

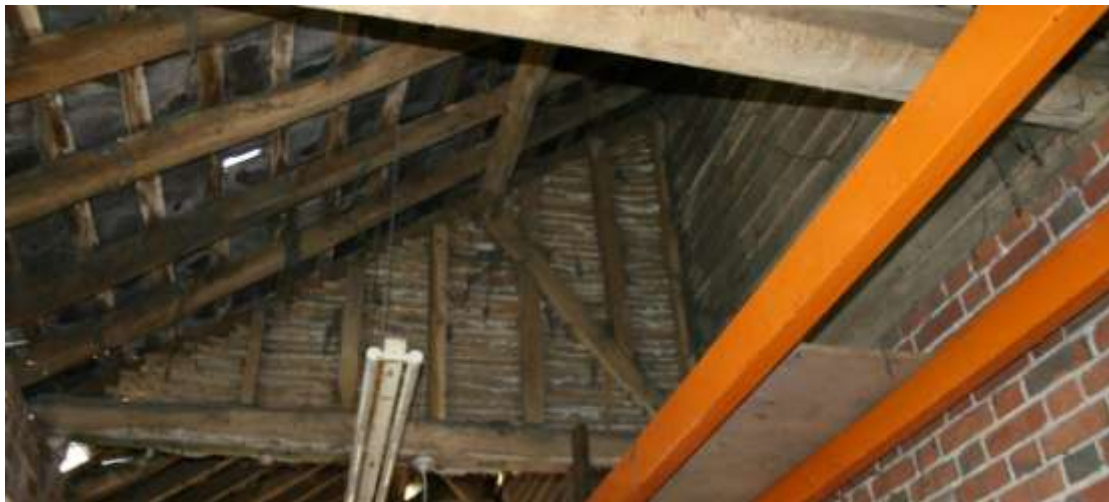
Lath and plaster partition from the eastern side.

Remaining above the tie-beam is a lath and plaster studwork partition. The underside of the tie-beam has mortices for a stud wall below and there are timber strakes in the pilaster for nailing studwork to.

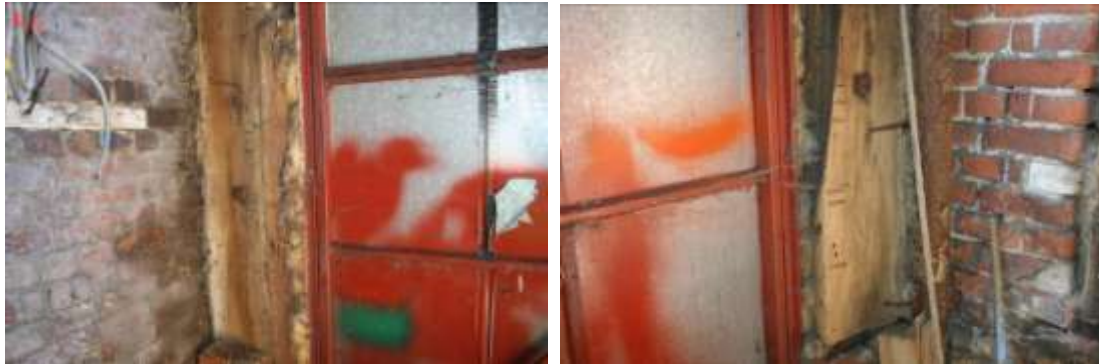
The drop slots for the leaps in the porch posts are numbered.

The porch has two very tall doorposts which are swollen at the base to accommodate built in drop-slots for the leaps. These are boards that are dropped in to create the threshold and to alter the quality of the draught of air that passed through the barn so that winnowing would be most effective. The strength of the airflow was altered according to the weight of the grain to be winnowed so that the lighter seeds would not be blown away.

The drop-slots have been numbered from I to VIII to correspond with the leaps or perhaps the type of grain. Here it can also be seen that the hinges for the doors were screw-threaded with flat square nuts.

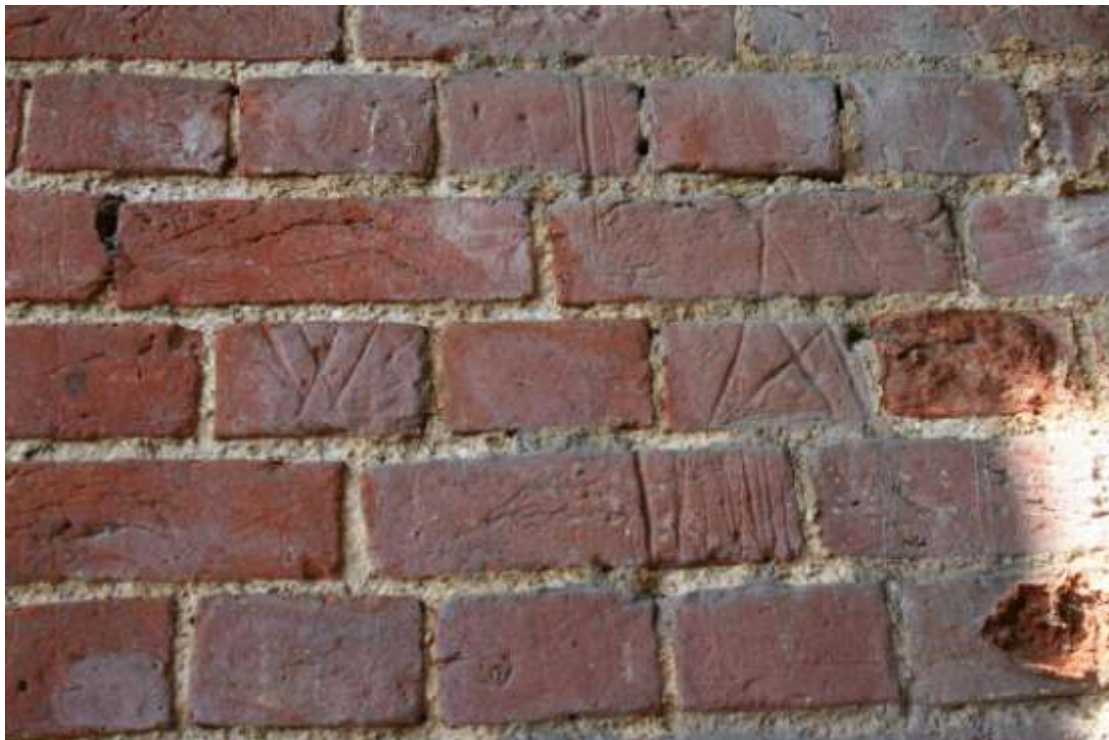
Carved marks in the brickwork of the western flank of the porch.

In the western flank of the porch at about head height there are a number of letters and marks carved into the brickwork. One is very definitely a letter W and close by is an A with an X within it. There is also a series of vertical lines like tally marks.

The other marks of interest are the letters and symbols carved in the porch. The W is often attributed to V V for the Virgin Mary (Virgin of Virgins) and is often carved quite frenetically on C17th timbers over and over again. However W is a very common initial and is found all over the county on older buildings. The resident of Norton Hall from at least 1839 (Tithe Award) to 1874 (Post Office Directory) was one William Clarke and this may refer to him as it is carefully carved.

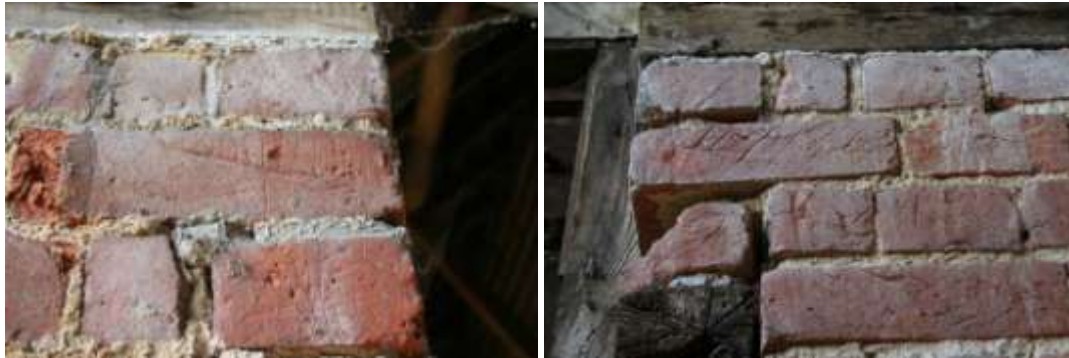
Scratched tally marks in the doorjambs of the Western (left) and Eastern Outshuts.

More tally marks have been carved into the brickwork of the door jambs into both Outshuts. It is likely that some of these are apotropaic marks to ward off bad luck but the letter W is so common that it is found carved everywhere on older buildings without apparent reason.

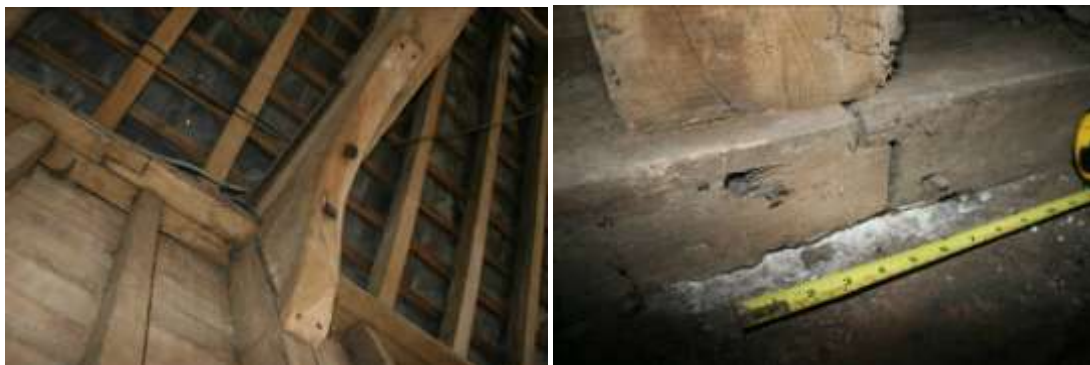
Scarf joints in the top-plate (left) and the sole plate.

Scarf joints are important dating features in timber-frames. That in the top plate is a face halved and bladed scarf of normal design. That in the sill plate is a more unusual side halved and bridled scarf with a very short body. (Alcock et al 1996 F29 j&p). Both scarfs have the tenons from studs passed through them to arrest any side movement.

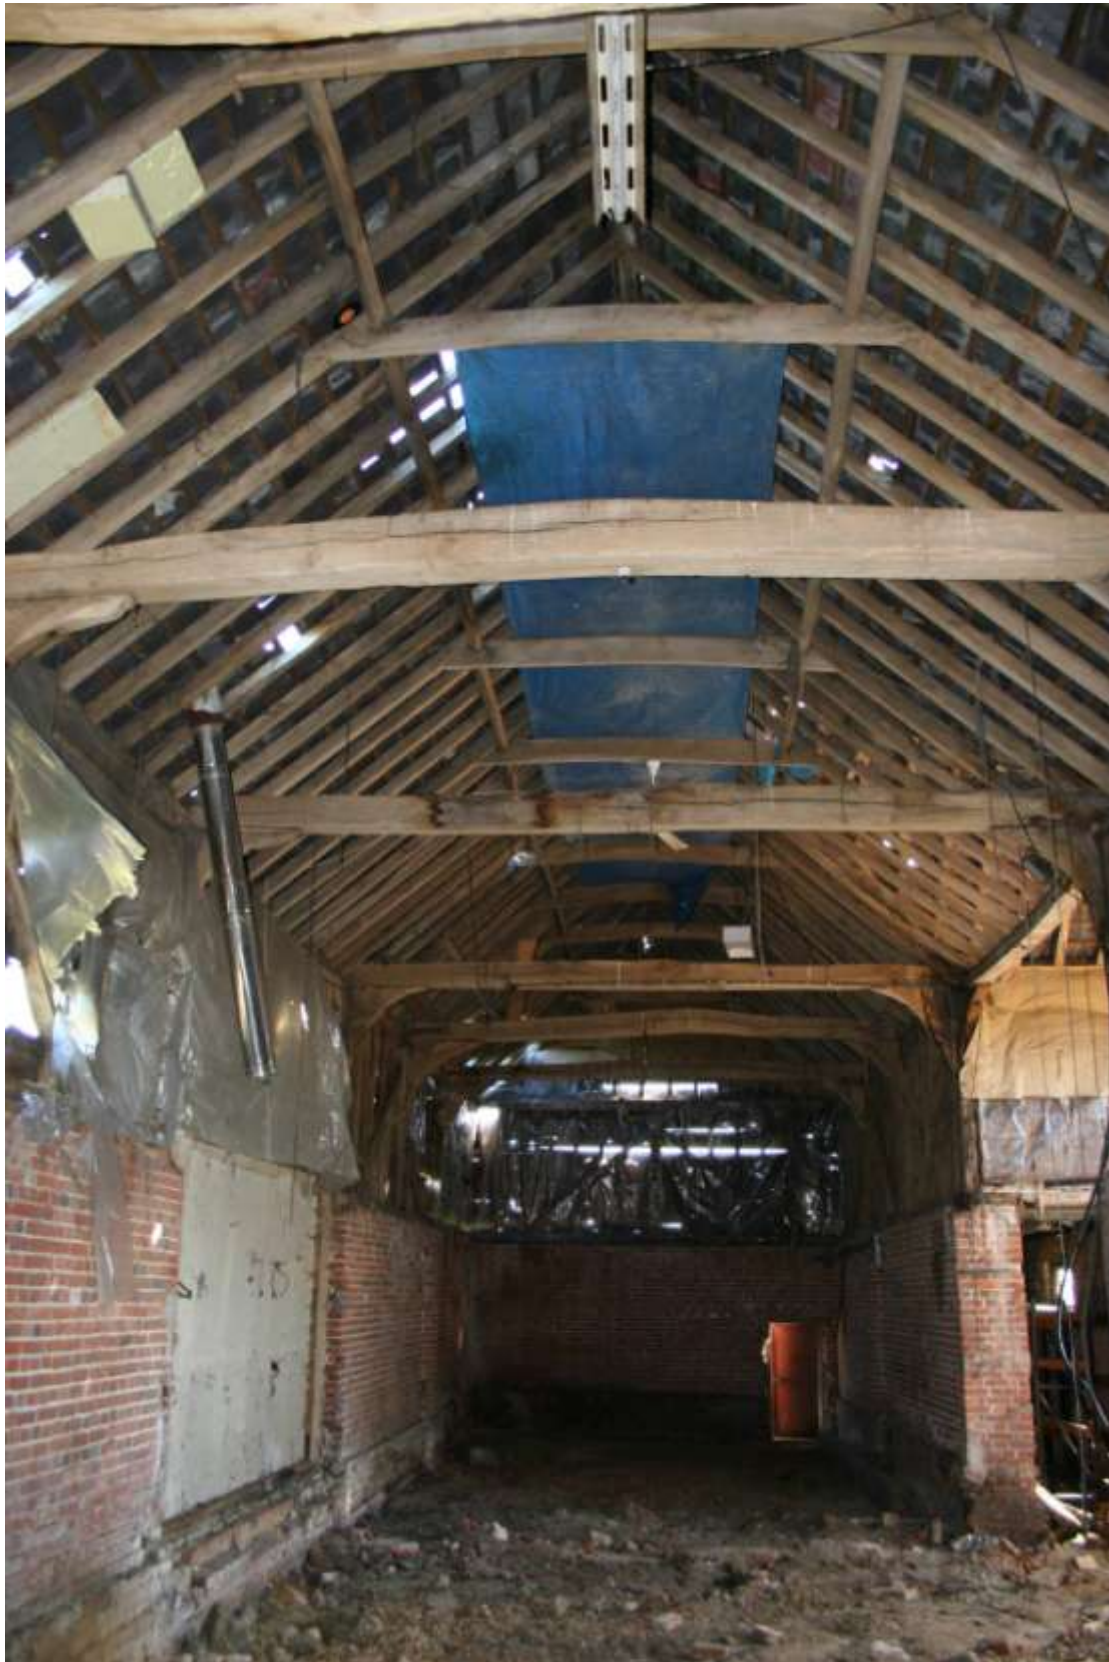
Simple clasped side purlin roof. See also the architect's section drawing.

The roof is a remarkably simple clasped side purlin design. The purlins are held by thin deep collars lapped and pegged into the rafters. There are no trusses as such as there are no principal rafters springing off the tie-beams. The rafters are all 3in x 4in in section and are battened with 1/2in x 2in battens laid on the flat to support the grey slates. The rafter pairs are nailed onto a narrow ridge piece and there is the occasional nailed on reinforcing gusset.

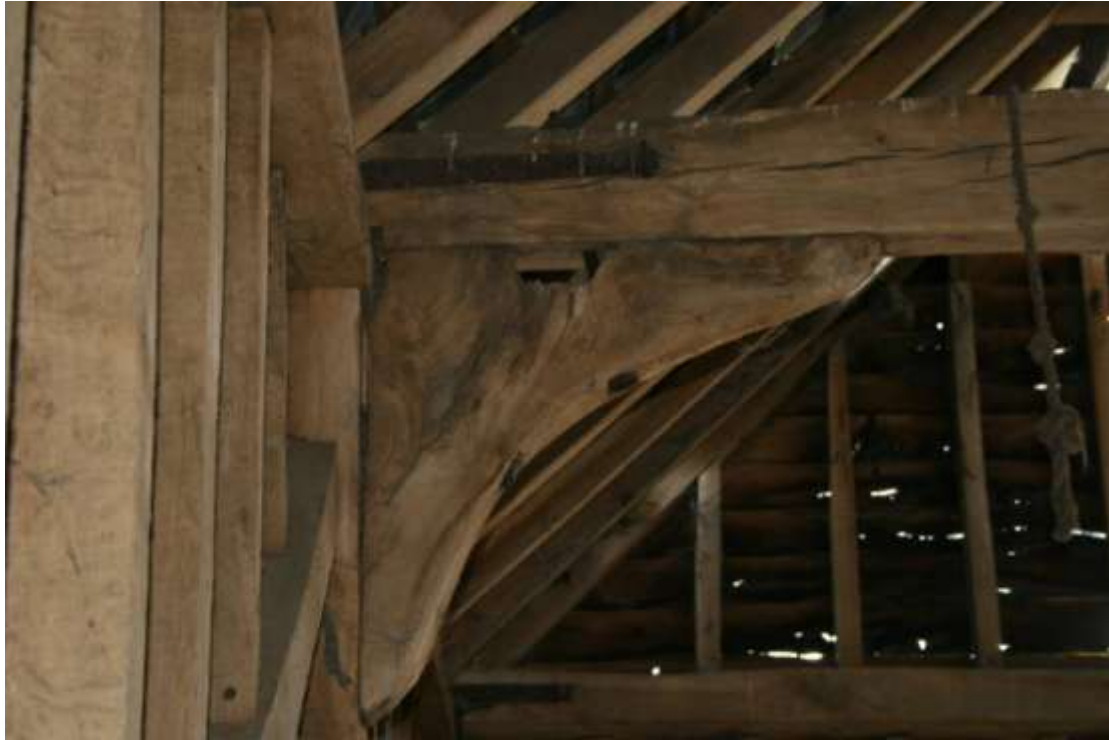
Hanging knee fastened with screw-threaded bolts.

The tie-beams curve slightly upwards and are held with hanging knees which are fastened with screw-threaded bolts with flat, square nuts. The joint is further reinforced with a wrought iron L-tie fixed with a square staple and clout nails. All the roof timber has the appearance of elm and is in excellent condition.

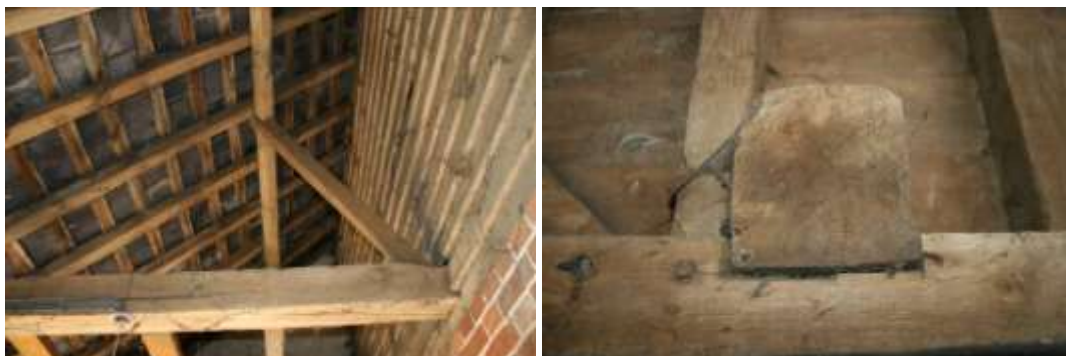
Roof structure of the Western Outshut and the end of a tie-beam visible inside the Barn

The roof structure is also simple within the Outshuts with a single purlin clasped with nailed and birdsmouthed struts off the tie-beams. The ends of the tie-beams are dovetailed across the sill plate of the barn frame. The rafters are narrower at 3in square.

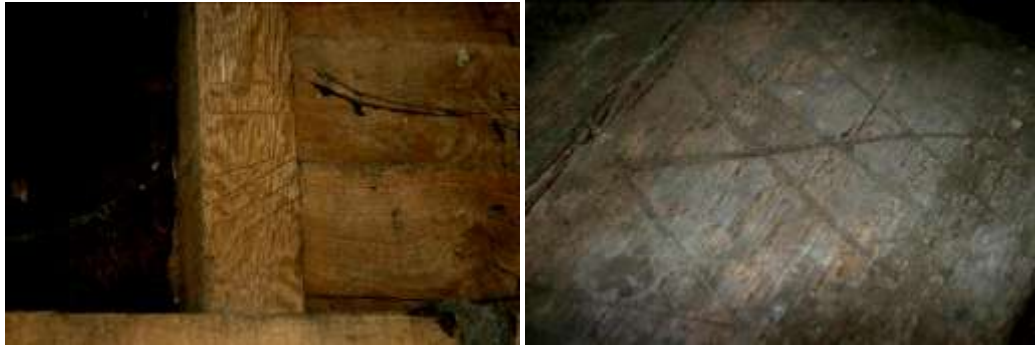
Carpentry marks on the stud (left) and on the sill plate. Contrast boosted for clarity.

It is likely that the entire frame is numbered throughout but is done so on the exterior hidden beneath the weatherboarding. The give away is that stud XXXXII in the SE corner has been put in the wrong way round. Also where the porch studs are exposed in the Western Outshut one of the studs is numbered XI on its exterior.

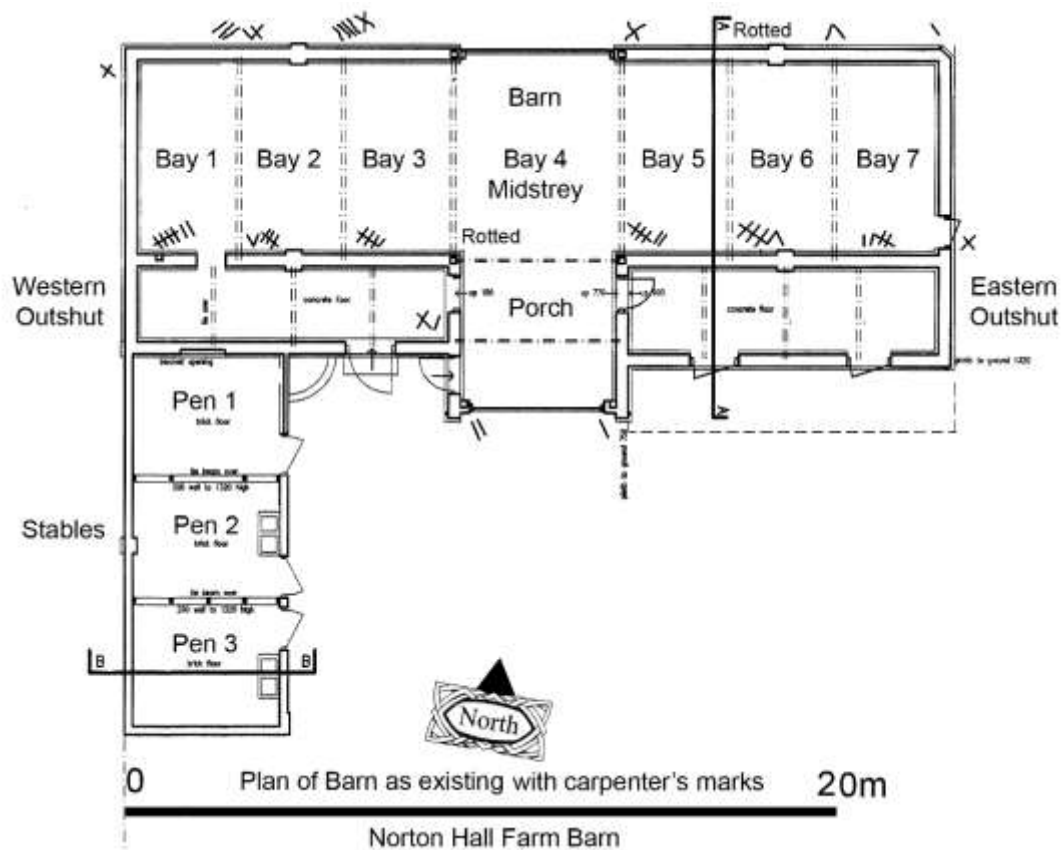
Carpenter's marks visible in the Barn.

There is a series of numbers on the top of the sill plate adjacent to the principal posts that do not correspond with the stud positions. There is also an X marked on each end sill plate. That in the SE corner passes under the corner post. The two hanging knees in the porch doorway are marked I and II with a bolster but none of the others are marked. All the other marks have been made with a race knife and the X's run together.

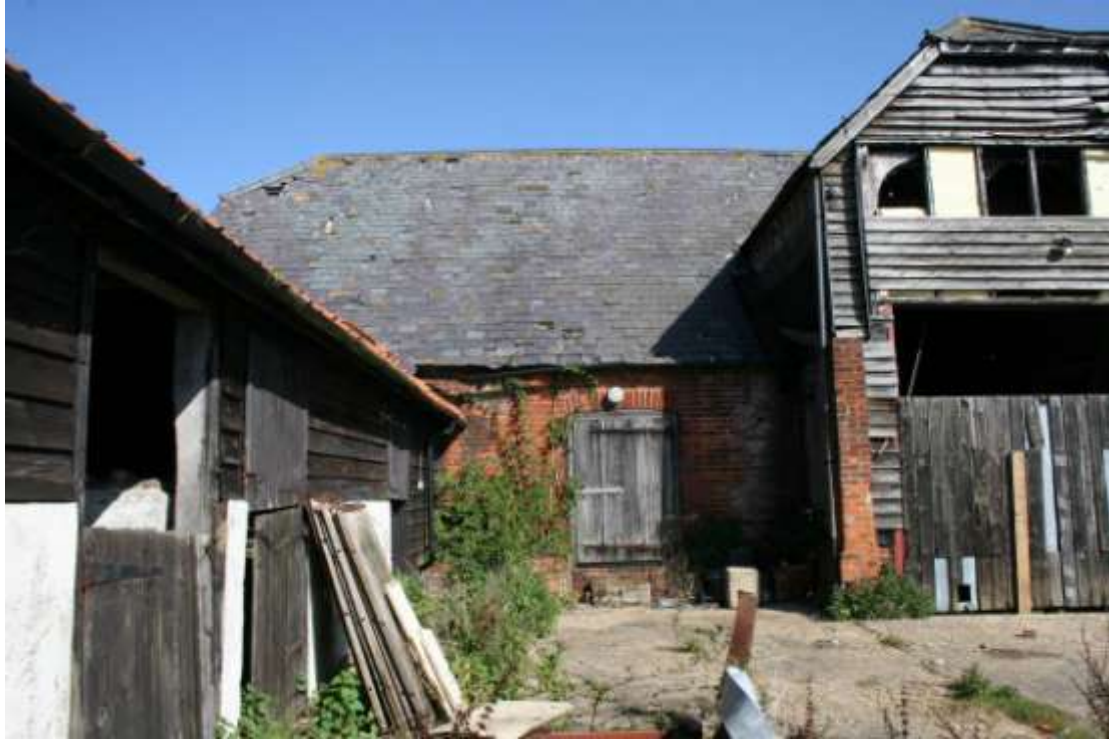
The eastern elevation of the Stables where it meets the Barn

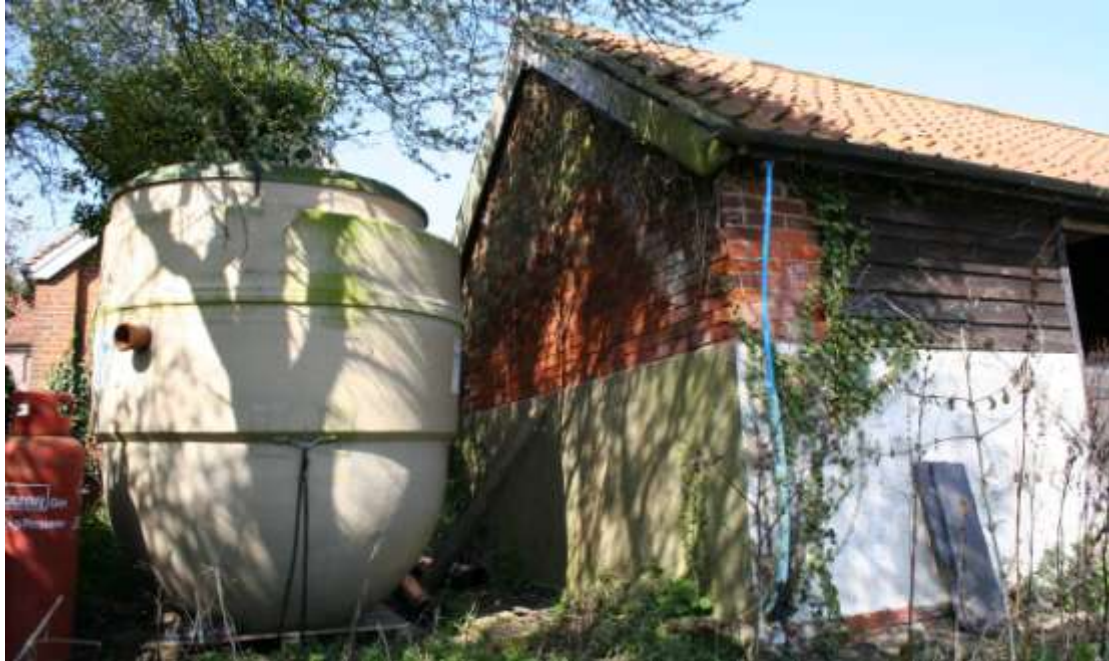
The southern elevation is obscured by a septic tank.

The southern elevation is the plain brick gable end of the Stables under white painted softwood barge boards. The brickwork has been rendered over with grey cement to about 1.32m from the ground and this carries round the front at the height of the weatherboarding.

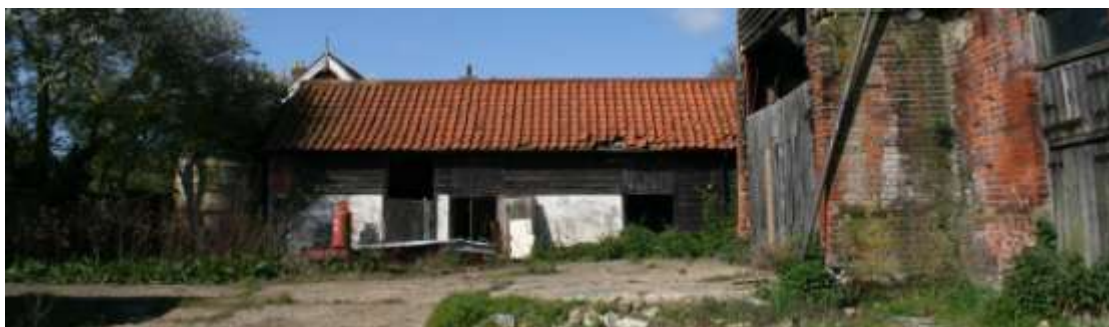
The eastern elevation of the Stables.

The eastern elevation has a cement clad 9in brick wall with a C20th weather boarded timber-frame above. There are three sets of split stable doors of which two of the lower leaves are original.

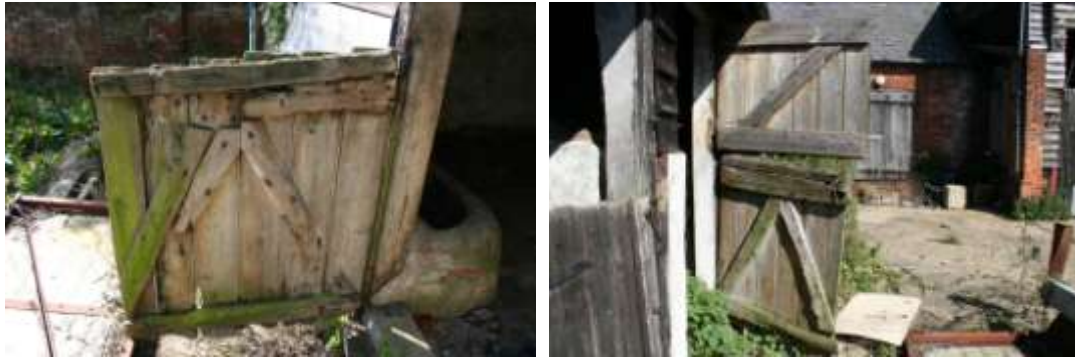
Lower leaves of split stable door appear original.

The lower leaves are typified by an inverted V brace of irregular hand hewn timber nailed and clenched onto vertical edge moulded boards. Most of the door furniture has been replaced with mild steel strap hinges but there is a hand wrought iron pintle strap with a leaf terminal remaining. The wrought iron hasps are also probably original. The other doors are C20th softwood with mild steel fittings.

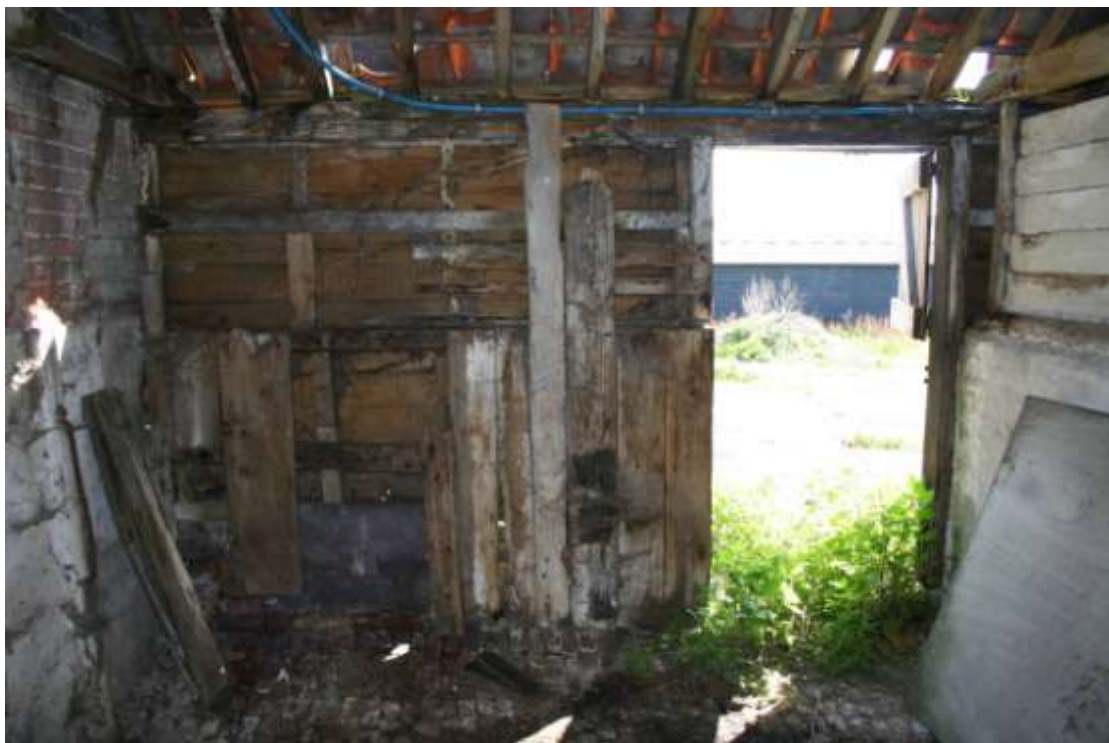
Interior of Pen 1. Vertical boards and thick slate tiles. Note sliding tether bar to left.

Pen 1 conjoins with the brick wall of the Barn. The partition wall is of brick to 1.330m and then is finished in whitewashed weatherboard on sawn, well chewed softwood studs. The western wall is of brick while the eastern is a random arrangement of vertical boards over where the brick wall has failed. This section is where the semi-circular brick trough is built on the outside. At floor level there are two large, thick slate floor tiles inserted into the wall as though to prevent access through to the trough. There is no water trough inside the pen but there is a sliding tether bar fixed to a post on the north wall.

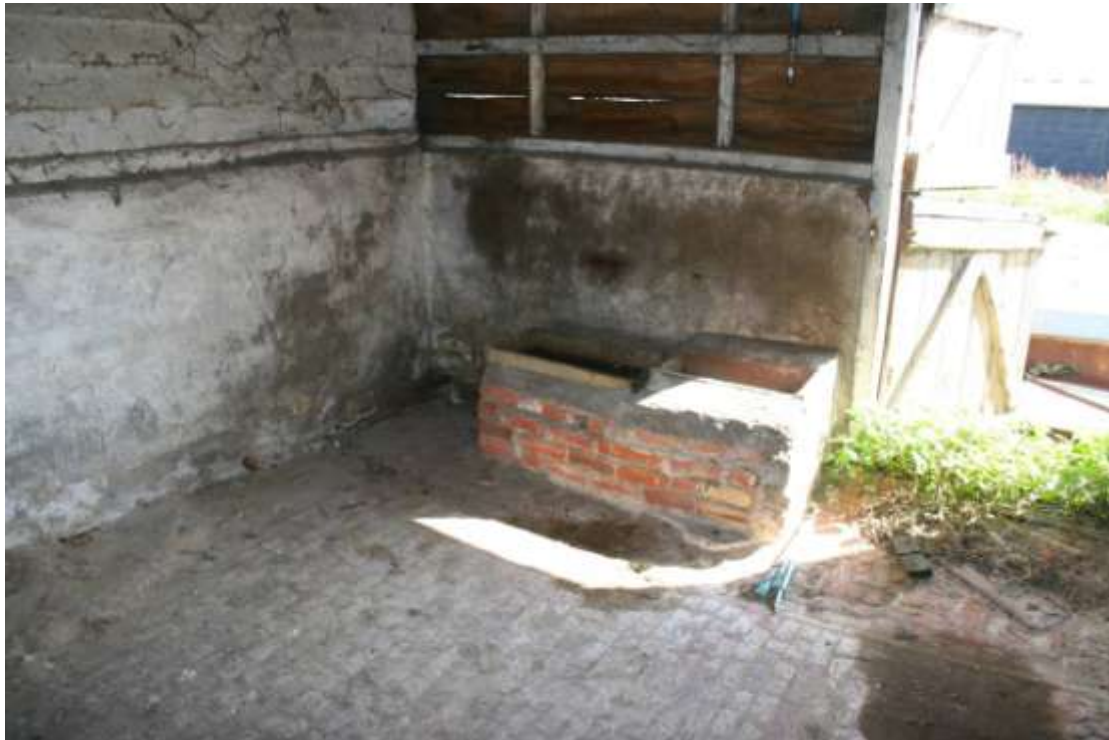
Interior of Pen 2 with C20th water and feed trough. Note gutter in the floor.

Pen 2 is remarkable only for its sparse fittings which consist of a C20th brick built water and feed trough low to the ground suitable for a large pig or small pony. The brick floor is formed with a gutter and a drain.

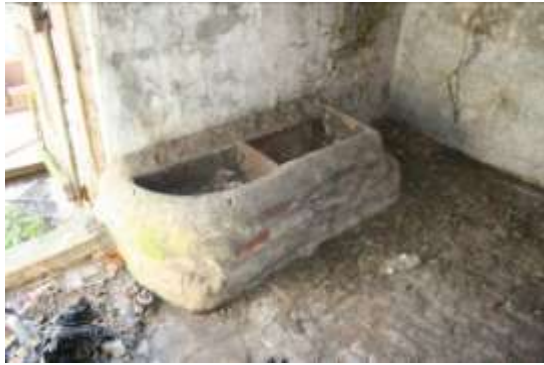
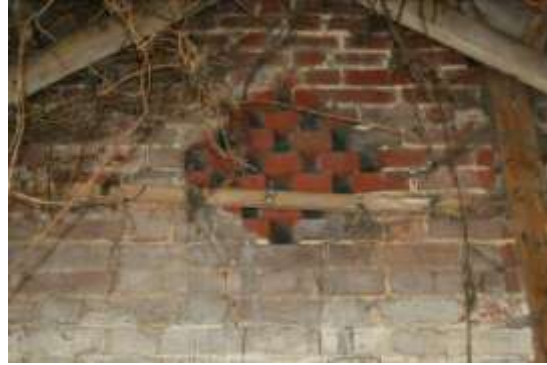
C20th brick trough and the diagonal grille in the gable end.

Pen 3 also has C20th brick feed and water trough but no other fittings. The brick grille is visible high up in the gable end.
