Norton Hall Barn, St Stephen's Road, Cold Norton, Essex
Description and analysis of a brick and timber-framed barn adjacent to Norton Hall.
Surveyed 30 04 2010.

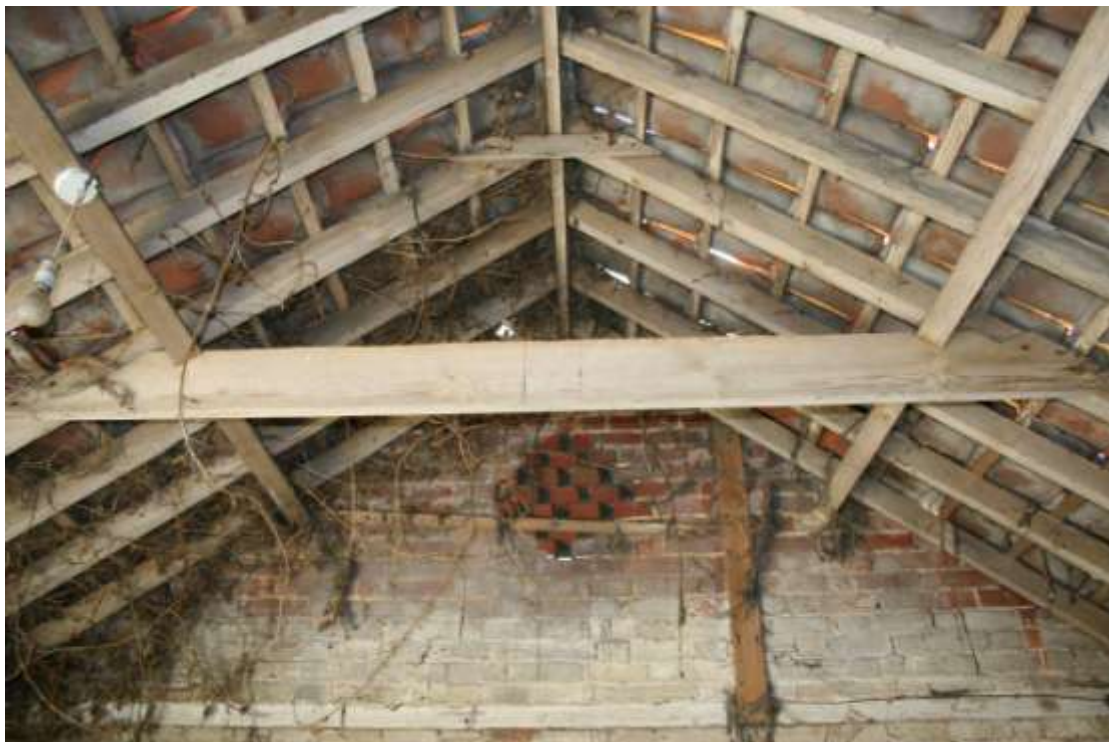
The roof is made of machine sawn softwood.

The roof is a clasped side purlin construction of machine sawn softwood with 50x100mm (2x4in) common rafters and 75 x 100mm (3x4in) principal rafters set at 380mm (15in) centres. The narrow, deep collars are halved and nailed in place and there is a narrow ridge piece. The entire structure is nailed with wrought iron nails. The nibbed pantiles are hung on 50x25mm (2x1in) battens. There are no carpenter's assembly marks.
