Yardley Hall, Yardley Hall Lane, Walden Road, Thaxted, Essex.
Description and analysis of a timber-framed barn and outhouses at
Yardley Hall Farm.
Surveyed 10 01 2011.

The Barn is Listed: 1. THAXTED Barn at Yardley Hall TL 53SE: 1/5 II 2. C17 barn, timber framed and weatherboarded barn, with red plain tile hipped roof. 3 bays long. Hipped midstrete to west. IoE Number: 122266.

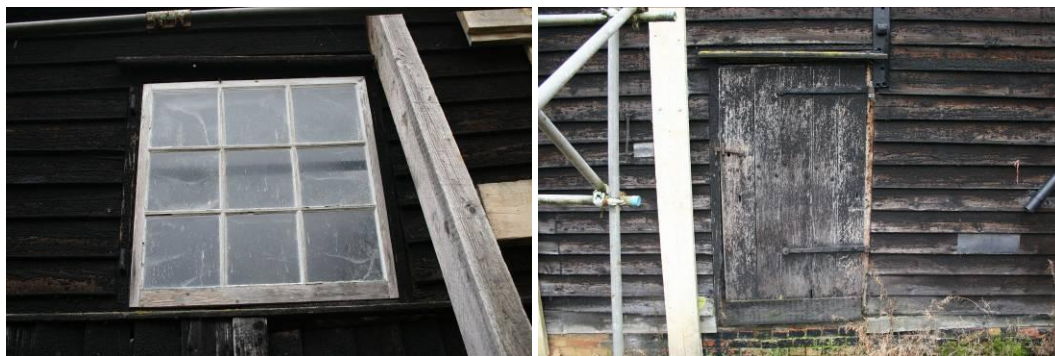
Re-used sash window above the central doors and pedestrian side door.

Above the central doors a reused 9 pane sash window has been inserted in place of an earlier hatch door whose presence is indicated by two redundant pintles.

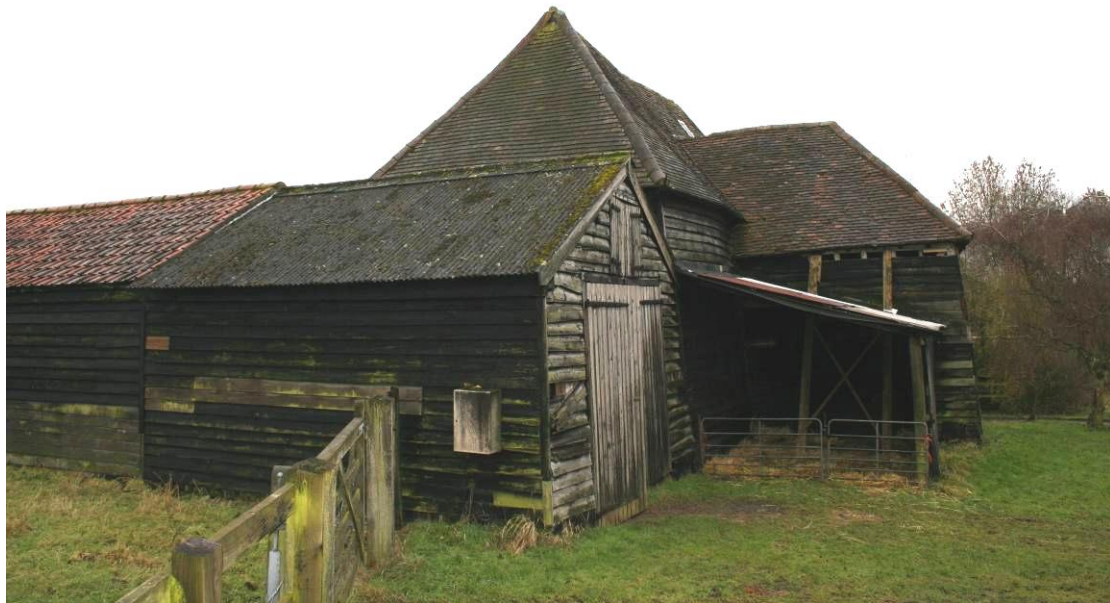
The northern elevation is obscured by the Workshop and Lean-to.

The northern elevation is mostly covered up by the Workshop which has been sprung off the end of the Barn by applying a timber plate to rest its rafters on. There is a small hatch door below the eaves more visible from the inside. The weather-boarding is visible inside the workshop and appears original.

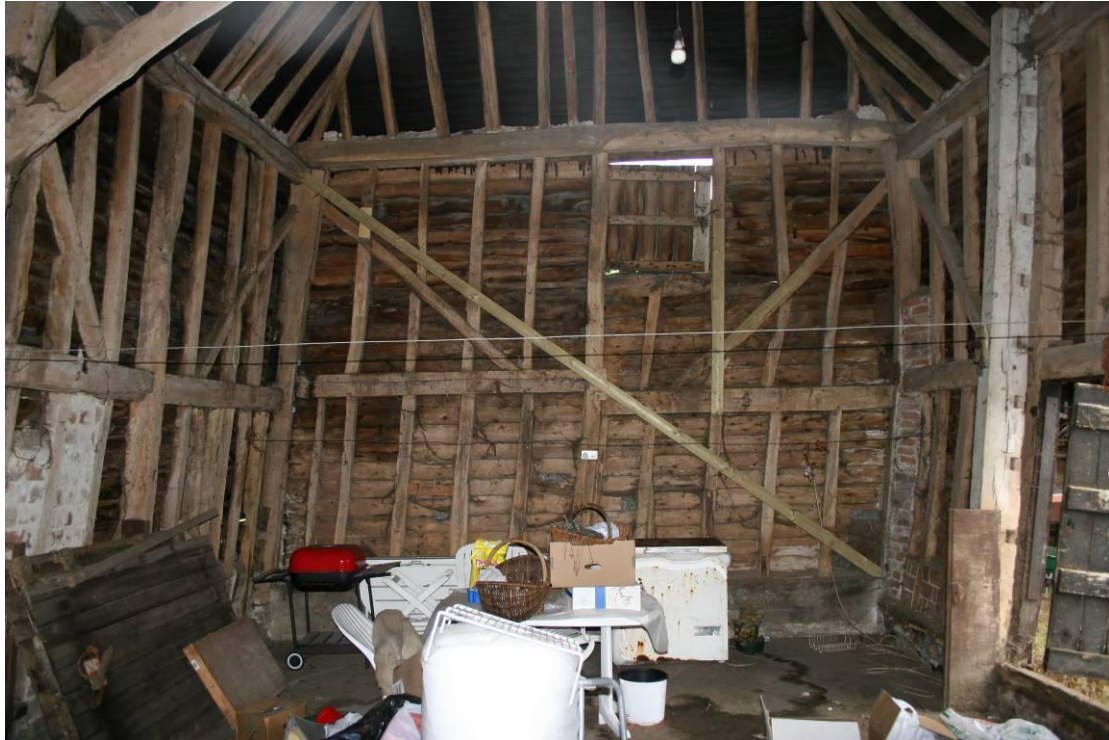
The north wall of the Barn from inside. Note off-set mid-rails and high level hatch door.

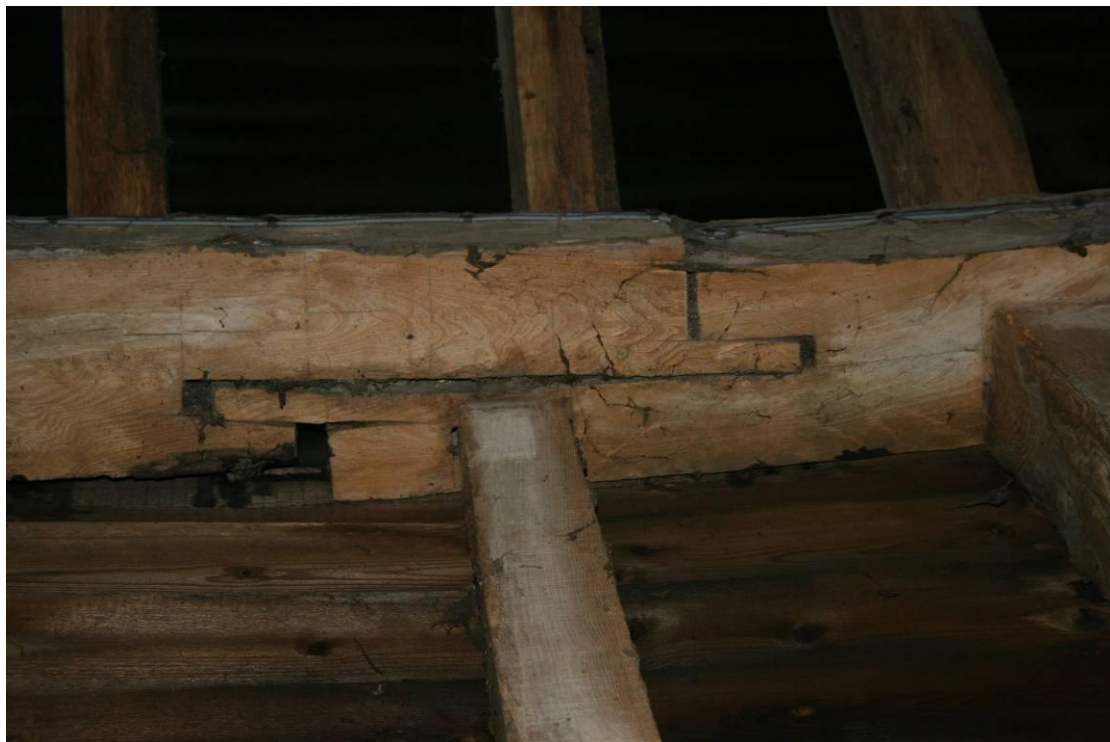
Scarf joint in the NW wall top-plate.

The scarf joints are visible in the NW and SW wall top-plates. They are face halved and bladed scarfs. The joints are scored on the underside. The top-plates are very long, spanning two and a half bays, approximately 24ft. The sole plates are shorter and do not require scarfs.

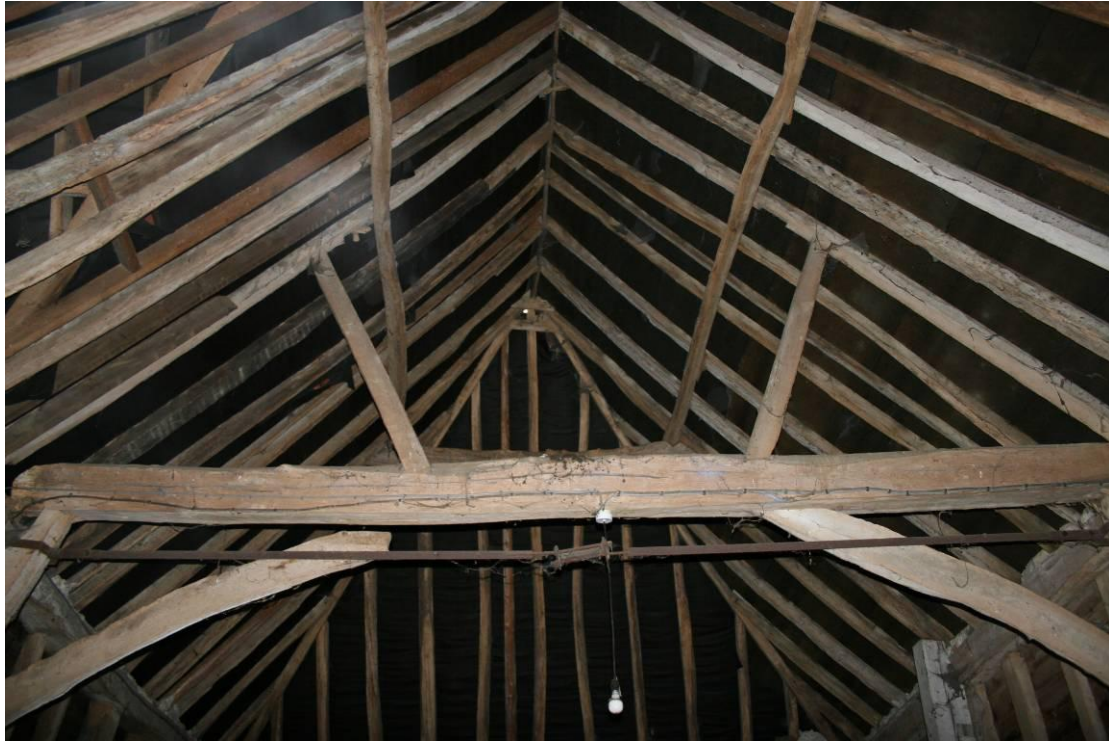
Collar side purlins and queen strut roof structure. Northern truss collar is missing. Looking N.

The northernmost truss has failed at both jowls and been reinforced with steel tie-rod.

The two main trusses have narrow section elm posts with clumsy jowls. The northernmost truss has failed at both jowls and badly split out. The movement has been arrested by a homemade mild steel tie-rod assembly. This has been inserted to stabilise rather than reverse the movement. The flat bars are of mild steel secured with hex head bolts and the turnscrew assembly is welded together. Another mild steel strap has been applied connecting to the midstre top-plate. One spandrel has fallen out of its mortice.

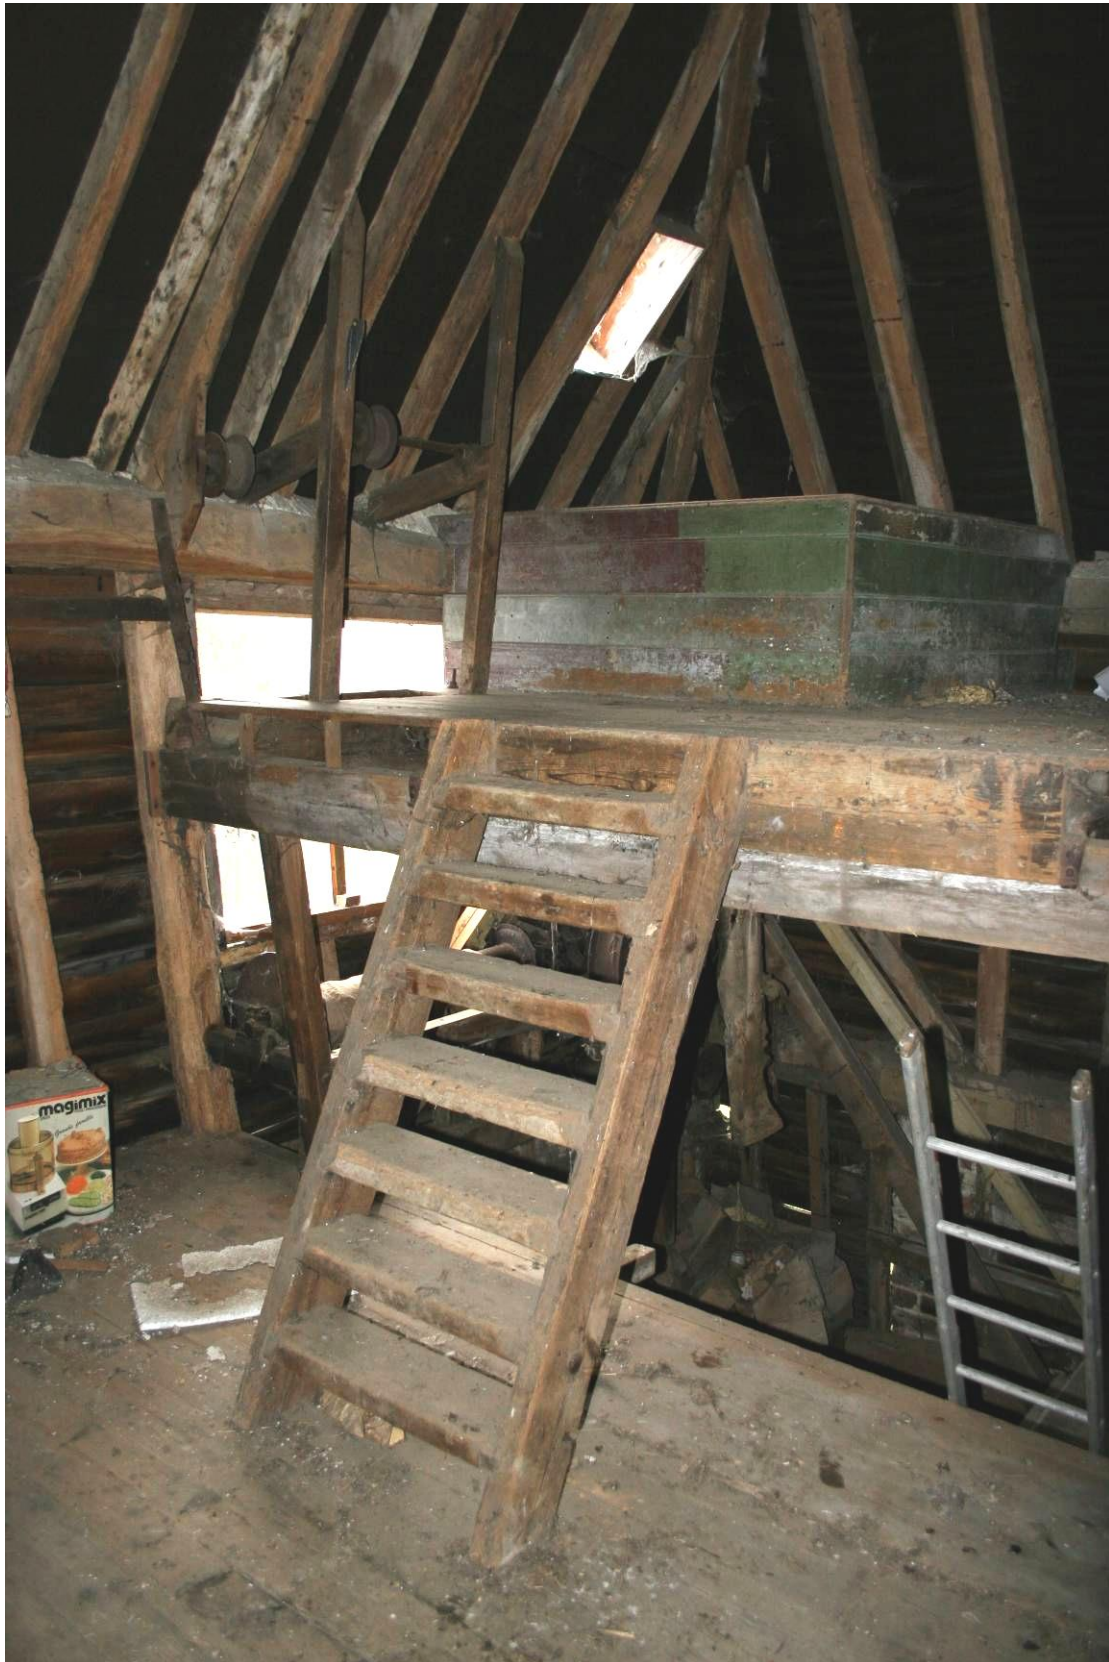
The grain platform occupies most of the southern bay. The barn really is this crooked.

The grain platform consists of two floors supported on narrow section machined softwood joists hung off a central superstructure. The main vertical support beam, which is nearly the full height of the barn is a reused plate from a C19th building with many pencil marked mortices. The beam is rebated into the tie-beam and secured with a steel strap, carriage screwed into place. Horizontal beams are connected on either side and rest on the mid-rail to the east and the top-plate to the west. Horizontal beams also run axially to support the centres of the tongue and groove boarded floors. The joists are supported on applied plates carriage screwed to the frame of the Barn.

Grain hopper on the top floor. Connecting ladder between the two floors. Machinery behind. Looking SW.

The installation of the machinery undoubtedly contributed to the failure of the frame in the high winds of AD2000. It is significant that the main vertical strut supporting the platforms is a pair for the repair timber on the NE wall as this indicates a failure very close to the installation time of the machinery. Also the frame of the south wall has been considerably altered by cutting through the diagonal brace to insert the sack rolling machine and the door on the ground floor.

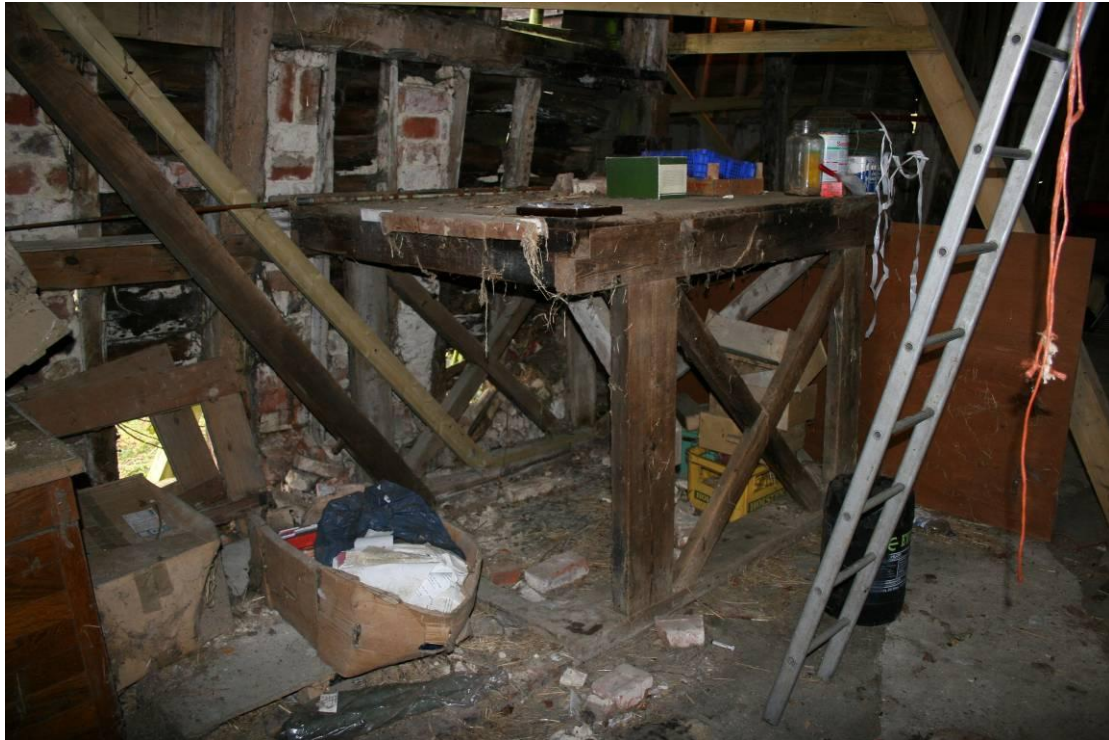
Fuel tank trestle. Looking NW.

The two platforms are connected by a sturdy timber ladder and there was a ladder to the lower platform which has been removed (owner -pers comm). On the ground there is a large trestle support platform and this was undoubtedly for a fuel tank as the SE corner is soaked in diesel.

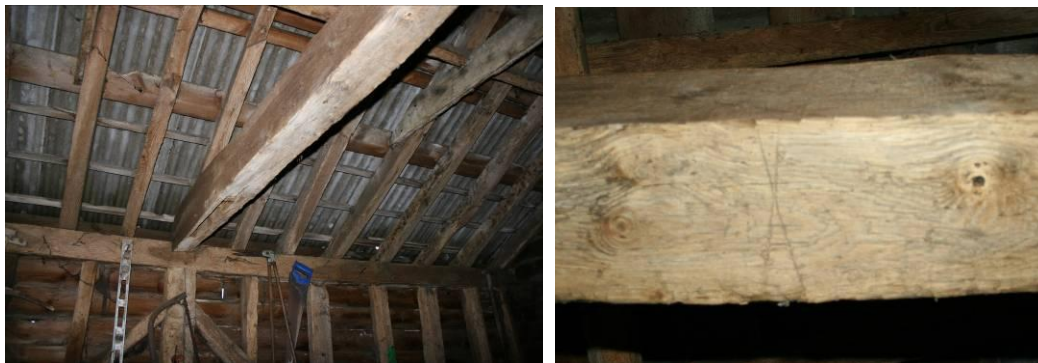
There is a central tie-beam that has been cut down in length and section from a much longer earlier timber with deep mortices for spandrels each having three peg-holes. The centre of the underside of the tie-beam is marked with a long X which may be an apotropaic mark. (See later section).

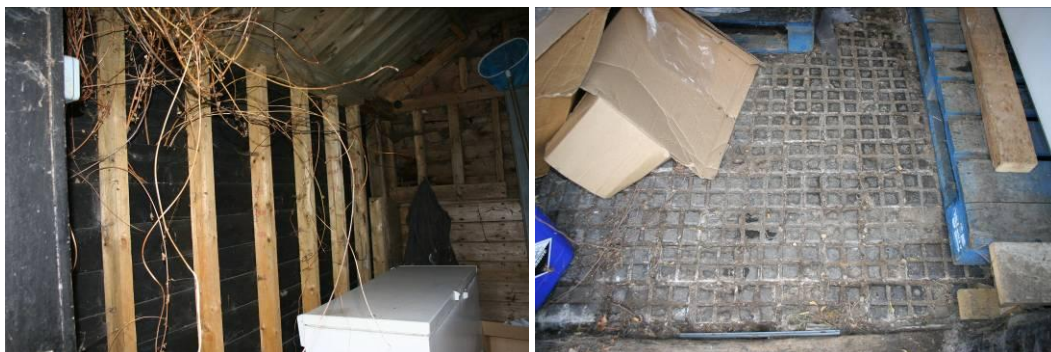
The southern elevation has been rebuilt with modern timber. Engineered brick floor.

Inside it can be seen that the southern elevation is recent being constructed of green tanalised machined softwood and new weather-boards. The floor is made of blue/grey engineered stable bricks (sometimes called 'Furrowed blue Staffordshire bricks') to prevent the horses slipping. Some of this has been removed to install the filtration pump for the swimming pool.

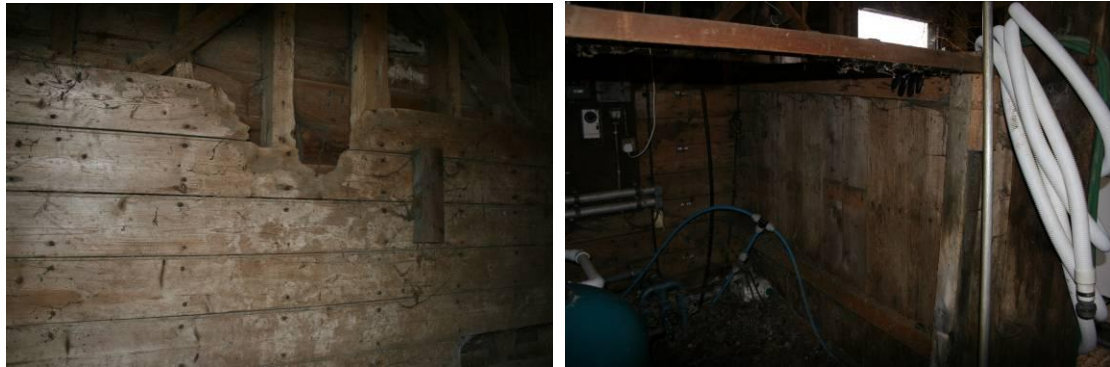
Chewed through kick boards on the eastern wall. C20th central partition.

There is a centrally placed timber partition that divides the room axially. Constructed of edge-moulded boards, modern machined timber and a railway sleeper it is a curious addition indicating the Stable was used into the C20th unless it was put there specifically to protect the swimming pool pump.

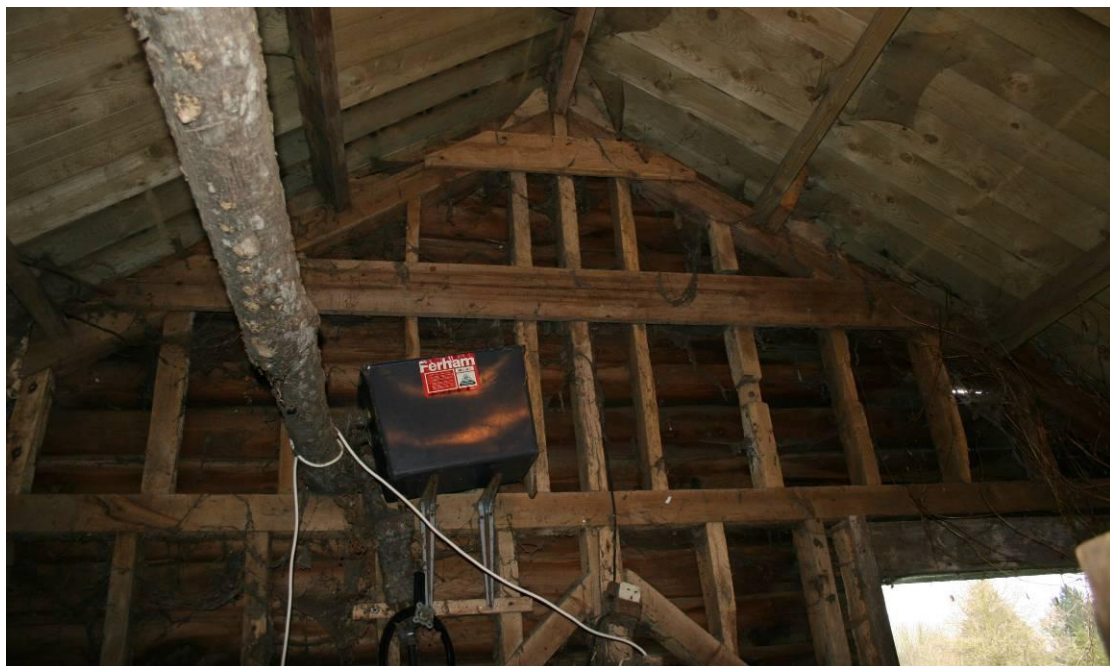
A C20th roof has been added in place of a clasped side purlin construction.

The current roof is a LC20th addition in machined and tannalised softwood. On both the eastern and western wall the original collars have been removed and replaced with band-sawn planks nailed on with large French nails. It seems most likely that these replace collars to take clasped purlins similar to those in the Workshop.

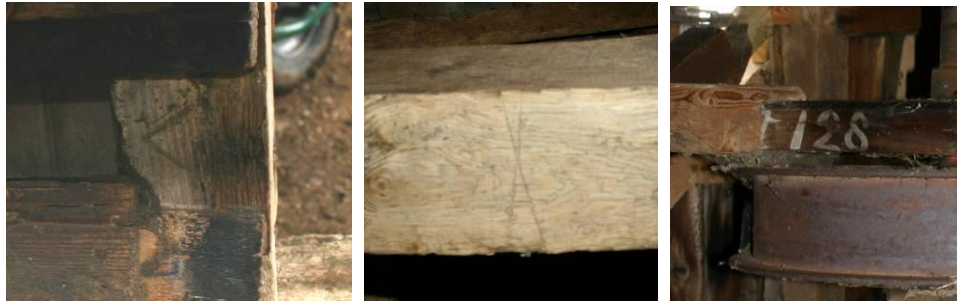
Marks in the Workshop and on the grain machinery.

There are so few marks of any kind that it is possible to consider them all together. The position of each is recorded in the main text. The timber-frame in the northern end of the Shelter has a stud marked V using a wide bolster visible in the Workshop. It is highly likely the rest of the frame is also numbered up.

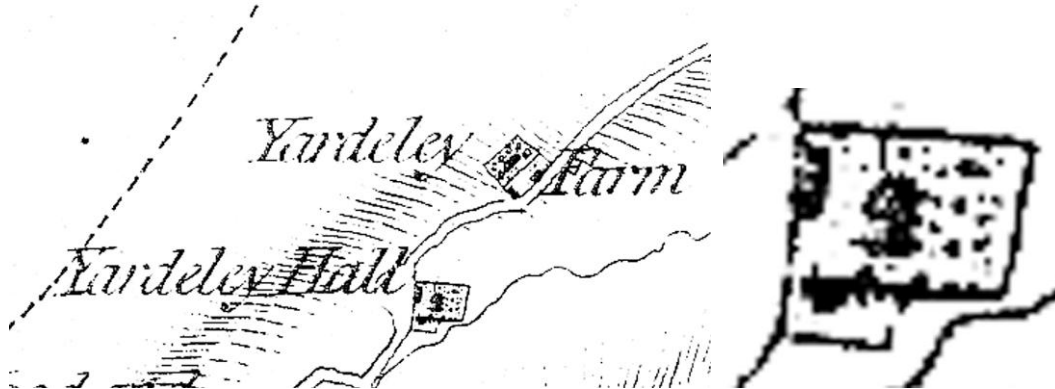
1777 Chapman & Andre map of Essex

In 1777 Chapman and Andre recorded Yardley Hall situated to the east of a small green to the SW of Yardley Farm. A large enclosure with two buildings is shown, the largest of which must be the Hall. The other may be a barn on the side of the lane but its position does not correspond with the current Barn.

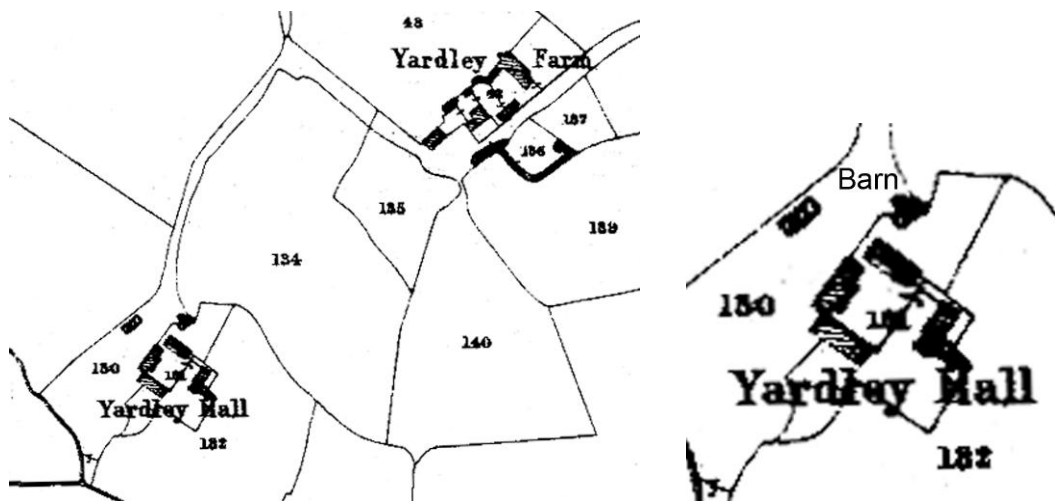
1844 Tithe Map ERO D/CT3 48

In 1844 the position of Yardley Hall is shown more clearly with a developed farmyard immediately to its north-western side. The Barn is now shown to the north as a separate building in the same position and of the same plan as the current Barn. There is also another substantial building across the green to the NW.

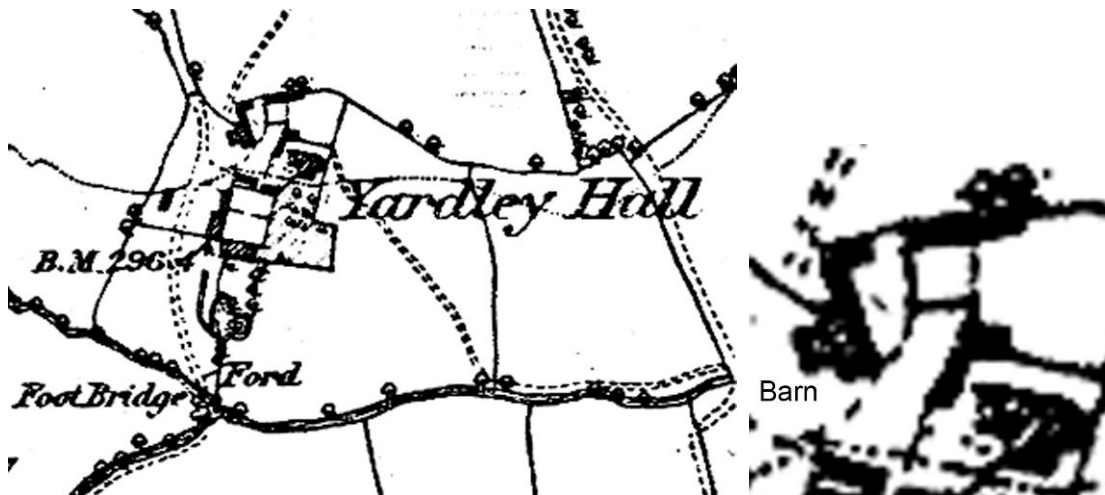
1876 1st Edition Ordnance Survey - 6in scale.

By 1876 the original Yardley Hall has vanished and a new building erected to the NE of the main farmyard. A small building has been added to the north end of the Barn and another longer building placed parallel to the current Stable. The additions do not correspond with the position of the buildings today. There is also a small range of buildings between the Hall and the Barn. Unfortunately the large scale OS is not available in the Essex Record Office.

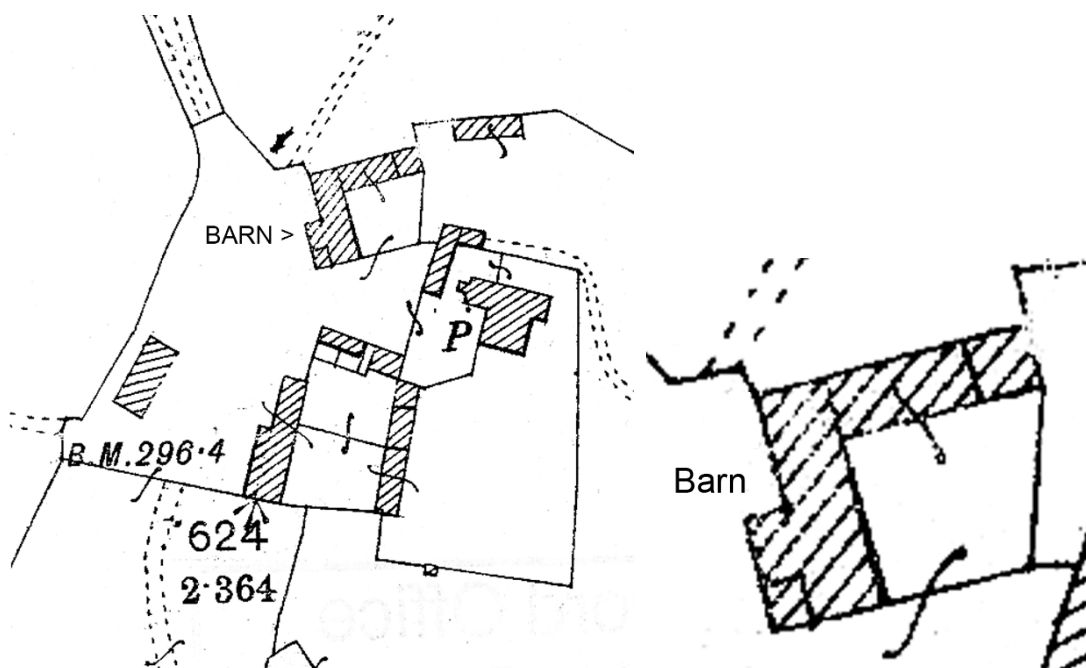
1897 2nd Edition Ordnance Survey.

The 1897 OS survey gives a clear picture of the layout of the farm. The Barn, Workshop, Shelter and Stable appear in the same position as today. There is a small outshot added to the SW corner of the Barn

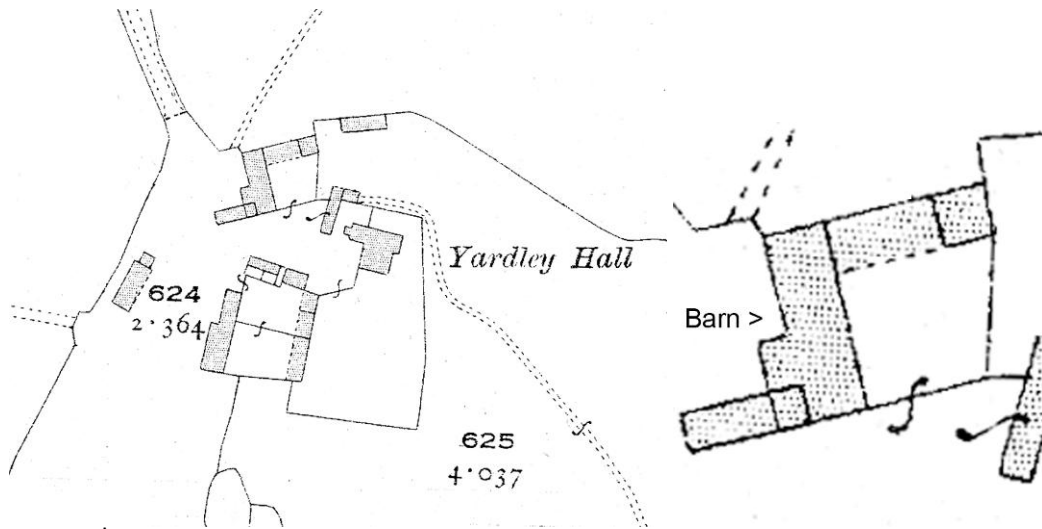
1921 3rd Edition Ordnance Survey.

In 1921 the New Series OS map shows the Shelter to be open to the south side by using a dashed line convention. There is also another building added to the SW corner of the Barn.

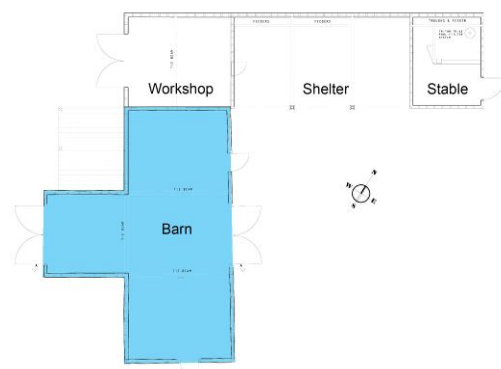
Phase 1. c.1800. Erection of the Barn.

Despite the Listing entry claiming a C17th date for the Barn there is nothing in the carpentry or brickwork to suggest a building much earlier than c.1800. While it is true that there are two trusses with raking queen posts and curved spandrels they are cut from elm and assembled with wrought ironwork. The ironwork is a definitive type being twisted into shape rather than upset in the forge. It is also custom made rather than re-used cart tires.

Chapman and Andre's map of 1777 does not show the Barn while it is clearly depicted on the Tithe Map of 1844. It is most likely it was built in response to the grain embargoes imposed during the Napoleonic War of 1799 to 1815.

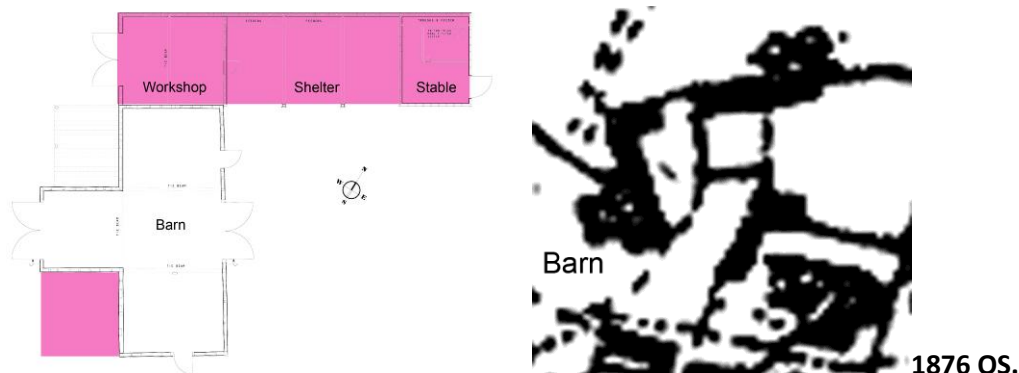
Phase 2. 1876 to 1897. Erection of the Outbuildings

The Ordnance Survey of 1876 shows the Barn but none of the other buildings in-situ. There is however a small outshot on the northern end of the Barn that sits in the footprint of the current Workshop. It may be that this was dismantled, the frame reused and the brick plinth exploited for the new range of buildings.

The Barn had a building added to its SW corner which has left no trace when removed in the C20th. By 1897 the farm had developed into a large livestock concern as evidenced by the open cattle shelters and pig sties of the southern farmyard and the many areas corralled by fences.

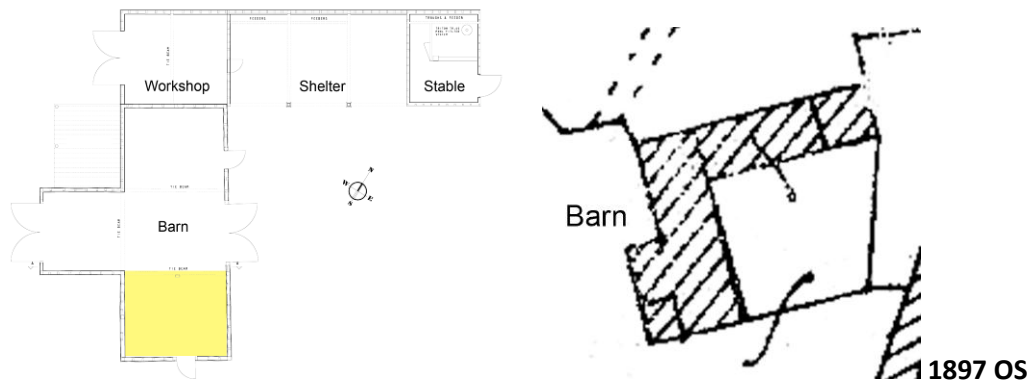
Phase 3 - EC20th. Insertion of the grain platforms and machinery.

At some point it was decided to process the grain on site rather than send it directly to the miller. To this end a substantial investment was made in inserting a two tier grain platform and the machinery to process and pack it into sacks.

The machinery is undated and has no brand names. It is constructed of cast iron gears and pulleys and mild steel sheets and plates riveted together. The fixings have both square and hex head nuts which while were available for specialised engineering like locomotives and gun carriages from the mid C19th were not generally available until the rise of the motor car. For this reason the installation should be dated to the Edwardian period or later.

That its operation severely affected the barn can be seen in the immediate need to reinforce the eastern wall with a re-used timber identical to one used in the super-structure of the platform. In the course of installation the southern wall was weakened by cutting through the SW diagonal brace and by inserting the doorway and window. Most of the wall was dismantled and then reclad with some new boards characterised by circular saw marks.

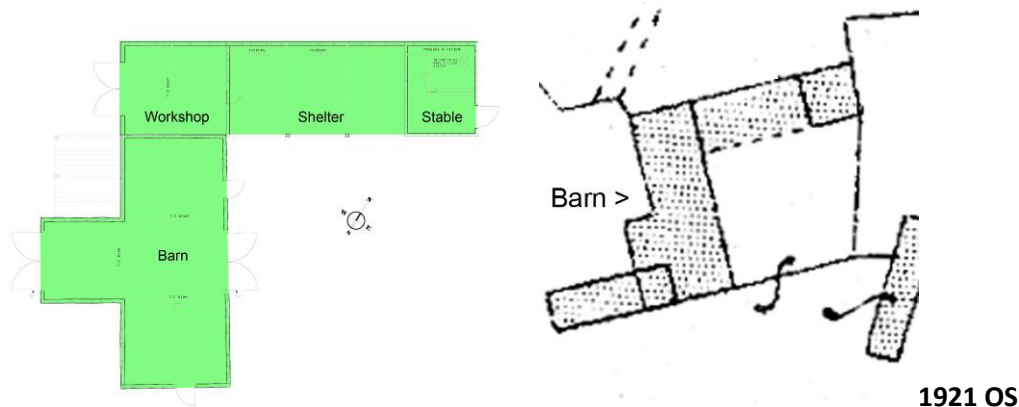
Phase 4. C20th reroofing and alterations.

One of the peculiarities of the Ordnance Survey maps is their use of line conventions to depict the buildings. In the 1921 the Shelter is shown as open-sided by the use of a dashed line. The previous editions do not use this convention although the fabric and design of the building clearly indicate this has always been the case.

Apart from the addition of a narrow building to the SW of the Barn (now lost) the activity of the later C20th is confined to roof and building repairs.

At the same time the lower main doors of the Barn were replaced using the reversible hinges so popular at the time. The rear leap was sawn in half and made into a gate and a fixed panel. It may be that the 9 pane sash window was installed in place of the hatch above the rear doors as this is a typical bodge of that era. The roof lights also probably went in at this time. The frame was suffering and was reinforced with a mild steel tie-rod assembly.
