The Old Rectory, Bell Lane, Lt Bardfield, Essex.  
Description and analysis of a timber-framed stables at the Old Rectory.  
Surveyed 24 01 2011.

Barry Hillman-Crouch  
Design & Recording Services

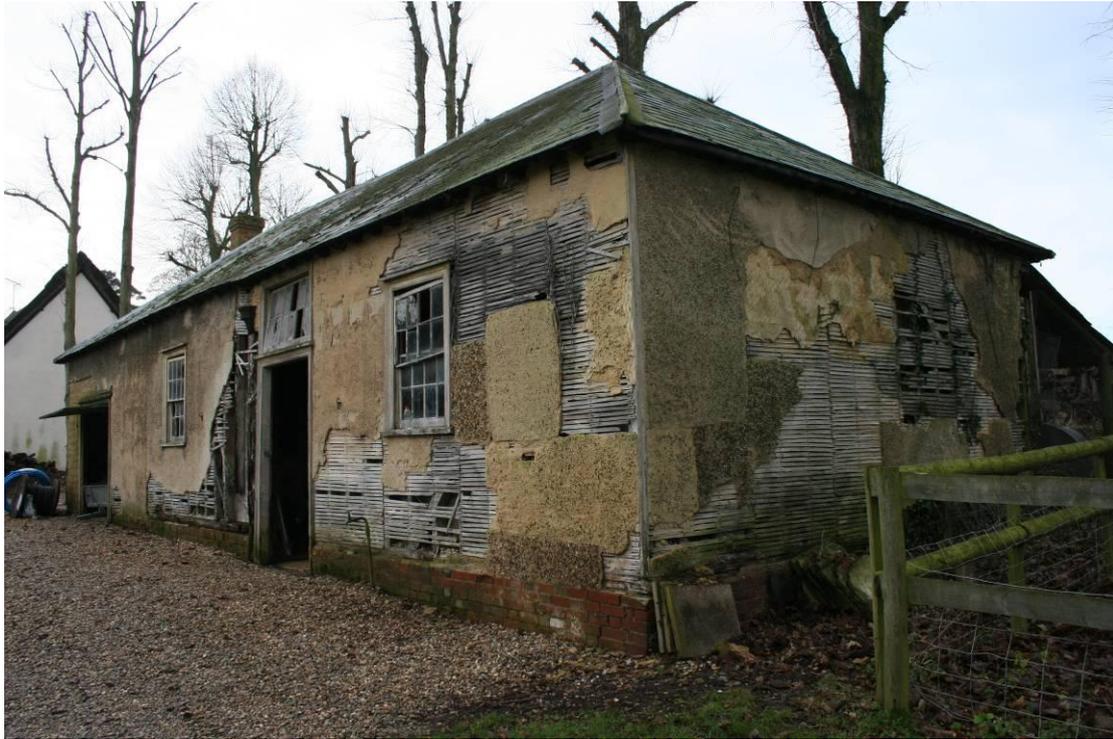
The Stables looking SW. Jan 2011.

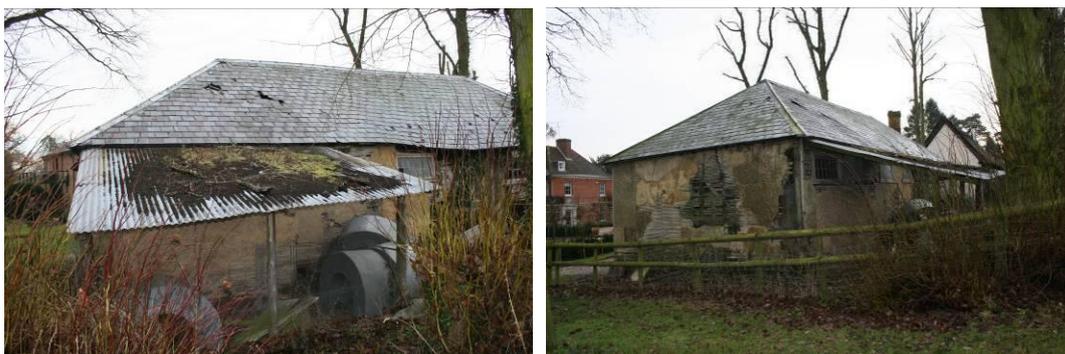
Lean-to shelter.

Attached to the NW flank is a makeshift shelter of reused machined timbers with a corrugated iron roof. It has been wired up the eaves with chicken wire in the manner of an aviary but it is more likely to be an abandoned rabbit run. There is a hatch into Bay 4 at ground level. The partition in Bay 4 has been similarly wired and there is a notice on the door to 'Beware of the Rabbits'.

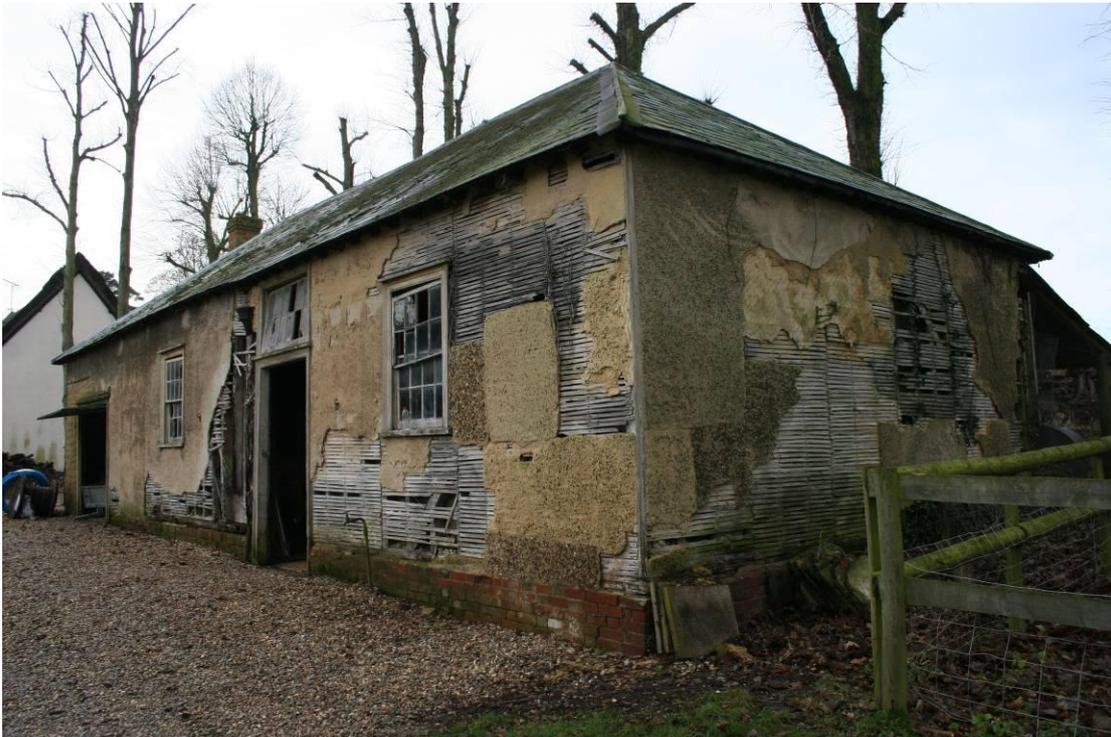
Western elevation - oblique view. This is the front of the building.

The blocked in doorway corresponds with the dimensions of the other and the render is beige sandy lime. The new render is well defined by the application of a fine gravel pebble dash. The brick plinth below has also been inserted and is laid in a Flemish bond without a soldier course.

The plinth has been constructed in several styles and of two types of bricks. To the north (Bay 5) the red brickwork is properly laid in Flemish style with closer bricks set in a beige sandy mortar. The bricks here are 60x105x215mm and the headers are mostly overfired to purple. This section looks remade.

The central section (Bays 3 and 4) have larger red bricks, 65x110x225mm laid in Flemish bond with a soldier course. They are set in a fine white mortar. The blocked door has similar bricks and there is a damp course of roofing slate inserted one brick below the sole plate. Elsewhere fragments of grey slate can be seen directly under the plate.

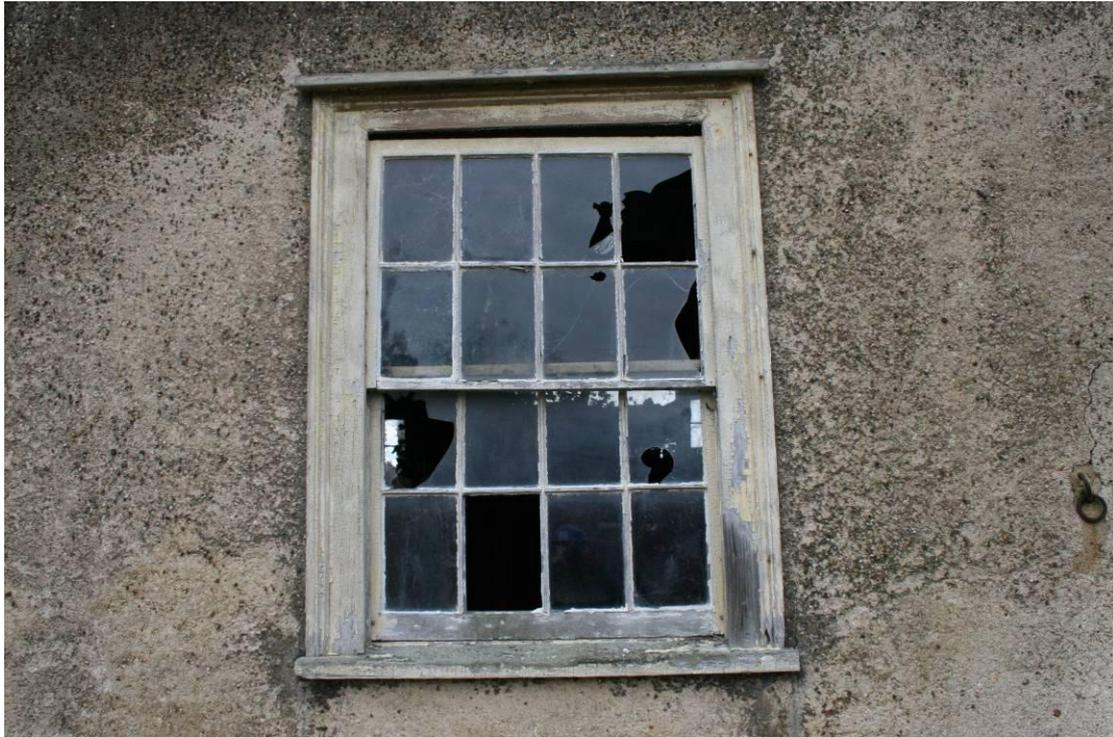
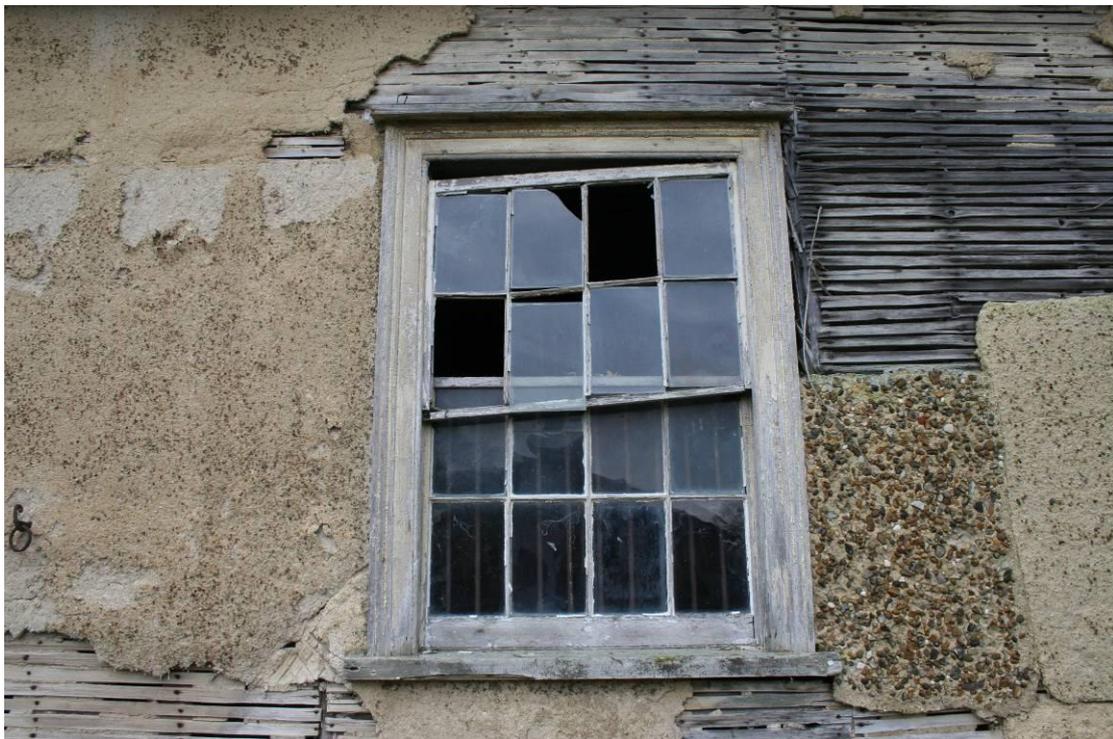
Sash window to Bay 3.

Sash window to Bay 5

There are a pair of double hung 8/8 pane unhorned sash windows giving light into Bays 3 and 5. Most of the glass is free from defects and is likely C20th replacements. The timber surrounds match that of the main doorway and there is small plain pentice board. There is a wrought iron lashing ring in the wall beside each window.

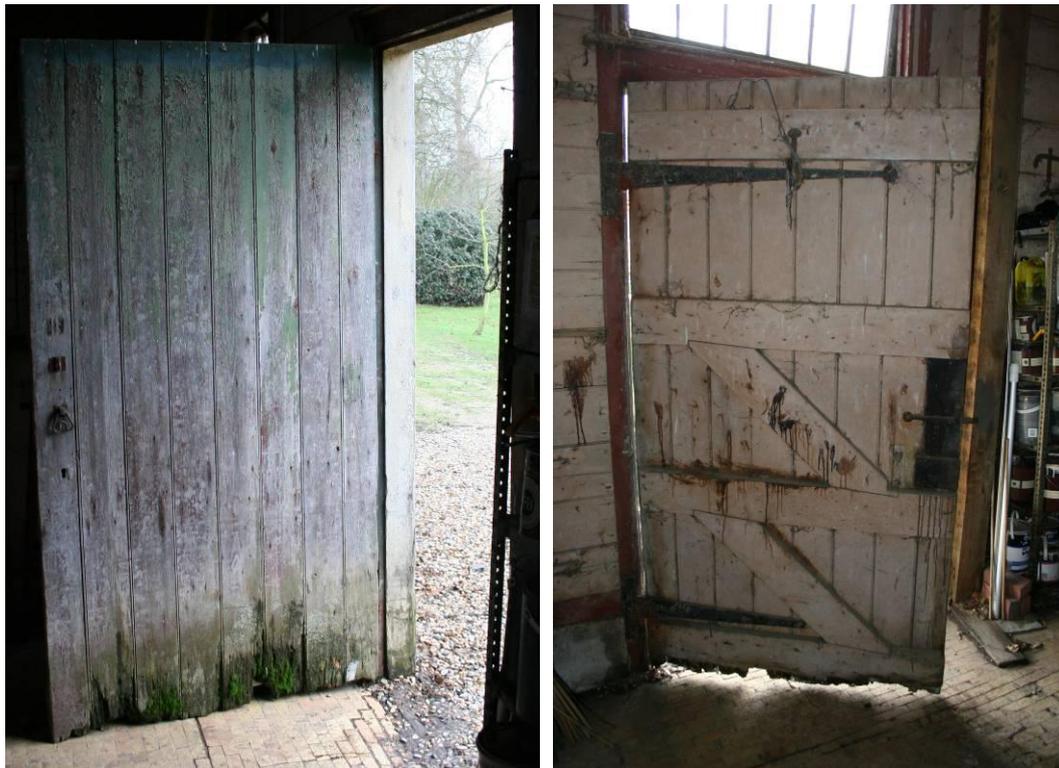
Front and rear of the main door into Bay 4.

Room 1 is entered through a single doorway into Bay 4. The door is a machine made, vertically boarded, edge-moulded, tongue and groove softwood door with flat gate and ledgers on the obverse side. They are of a slightly unusual design in that the gate battens have been let into the top and bottoms of the horizontal ledgers.

There is no gate bar at the top to allow for the huge mild steel T-strap hinge which is screwed to the frame. There is an elegant forged drop handle operating a wrought iron Suffolk latch which is both screwed and bolted in place. The latch is inscribed with the Saltire Cross - a revival of a superstition involving witchcraft.

There is a mild steel lock box but also a shadow for a much larger lock box. There is also a keyhole on the other side showing that the door has been reversed. The frame shows no sign of previous locks so the door is reused in its present position. The inside is painted pink to match the rest of the decor and the outside was once green.

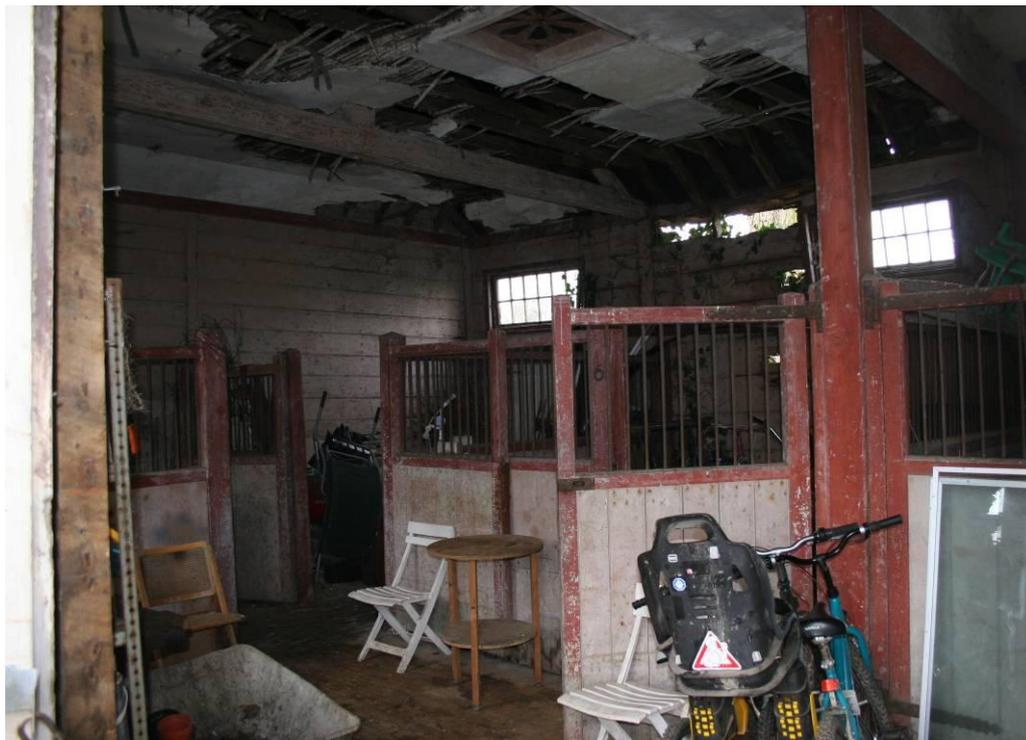
The entrance lobby spans 3 bays and allows easy access to all the horse stalls.

The door gives onto an entrance lobby that spans the three central bays and allows free movement to all the partitioned horse stalls within. The floor is made of smooth yellow paviors 45x90x160mm set on edge.

The floors within the partitions are custom made for each stall each designed to drain to a centre point where there is a cast iron grate manufactured by 'G W Burgess - Patent'. These floors are constructed of larger paviors 45x??x215mm and the floors in Bay 5 have even larger bricks at 60x??x215mm. This hierarchy of sizes may indicate the size of the animal meant for the stall.

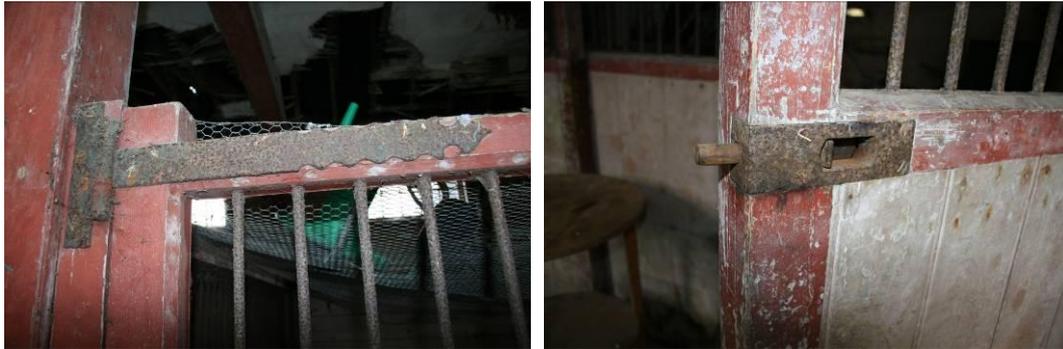
Ornate hinges and captive bolts on the stall doors.

Each door has two ornate mild steel strap hinges screwed into position and an elegant captive bolt which the horses cannot reach. The outfitting is good quality and it is a surprise that there are no brand names on the hardware.

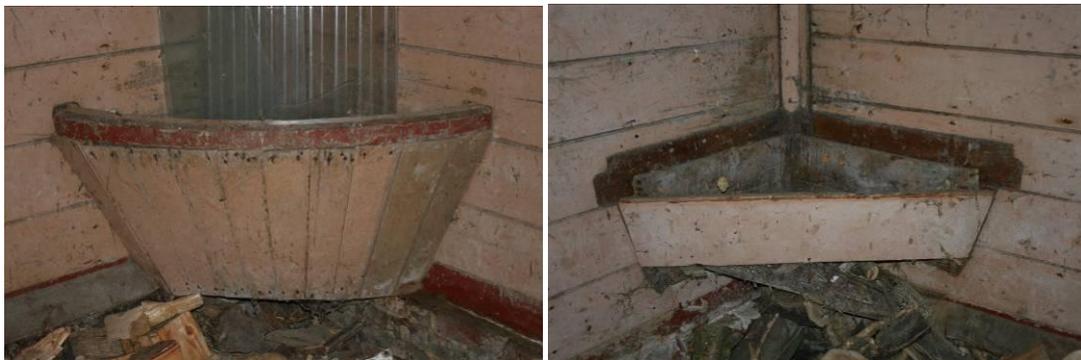
Mangers from Bay 5 NE corner (left) and NW corner.

Each stall has been outfitted with timber mangers set into the corners. This has been done in two phases. There are a set of mangers that are designed like quarter barrels, nicely finished with metal rims and another set of more traditional triangular timber mangers nailed together. Where one has fallen apart, in the NW corner of Bay 5, it can be seen that the previous finish was of varnished wood. The central partition in Bay 5 has been removed and with it two mangers whose shadows in the paintwork show them to have been the barrel type.

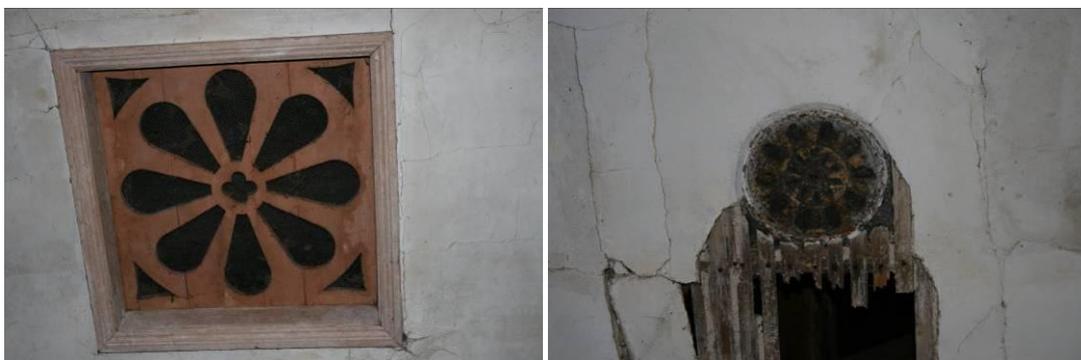
Each stall has a ventilation grille above it to expel heat and smell.

In the ceilings above each stall there are ventilation grilles. There are two large timber and mesh grilles above the central stalls designed as florettes. The other stalls have smaller iron grilles which appear adjustable with a central keyhole for a rod.

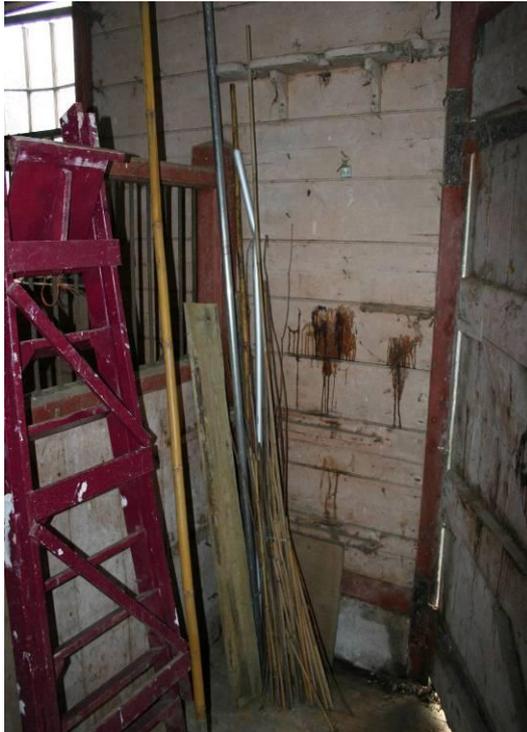
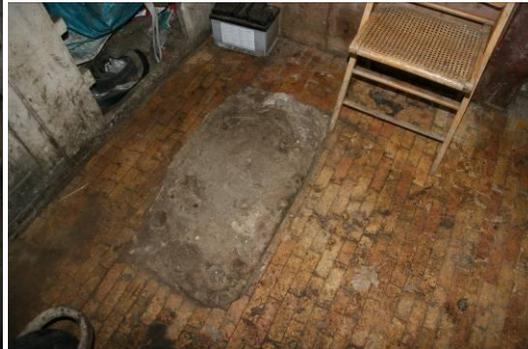
Broom hangers and shelving by the door. Concrete machine base in the floor.

A section of the yellow paved floor in Bay 3 has been removed and a large lump of cast concrete poured. There are circular sockets for tubes in each corner to support a machine or platform. The object has been removed and the concrete has been broken up. There is a LC20th improvised work bench with vice and some Dexion shelving

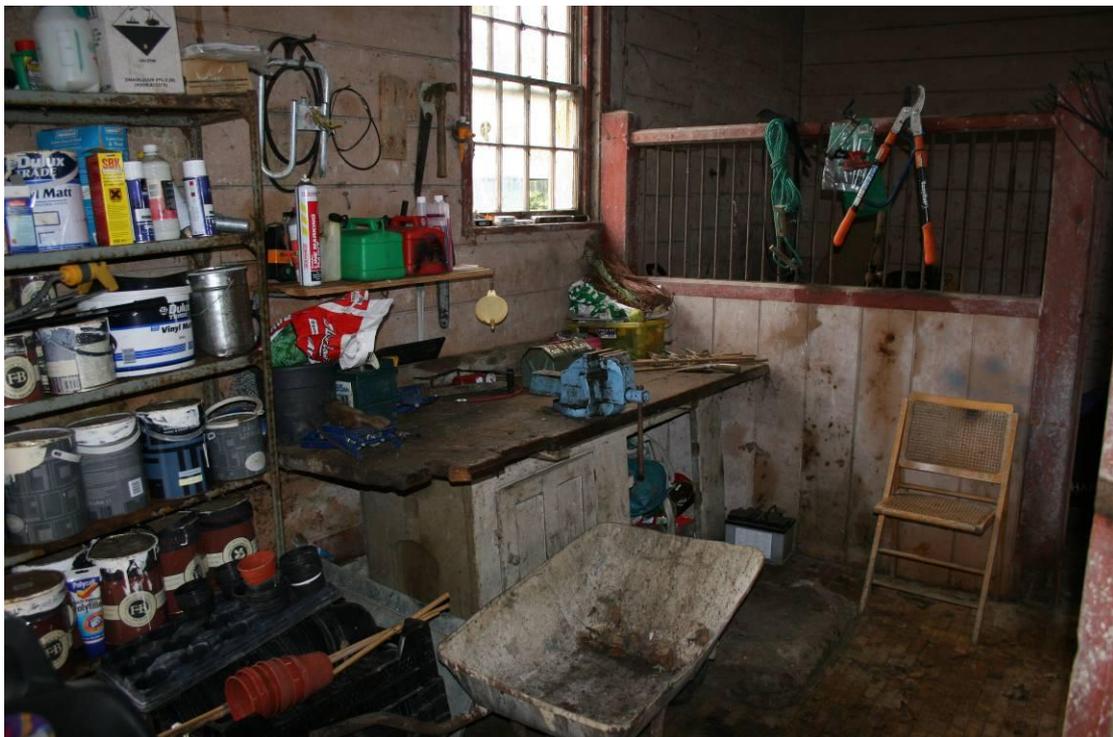
An improvised workbench and dexion shelving is LC20th.

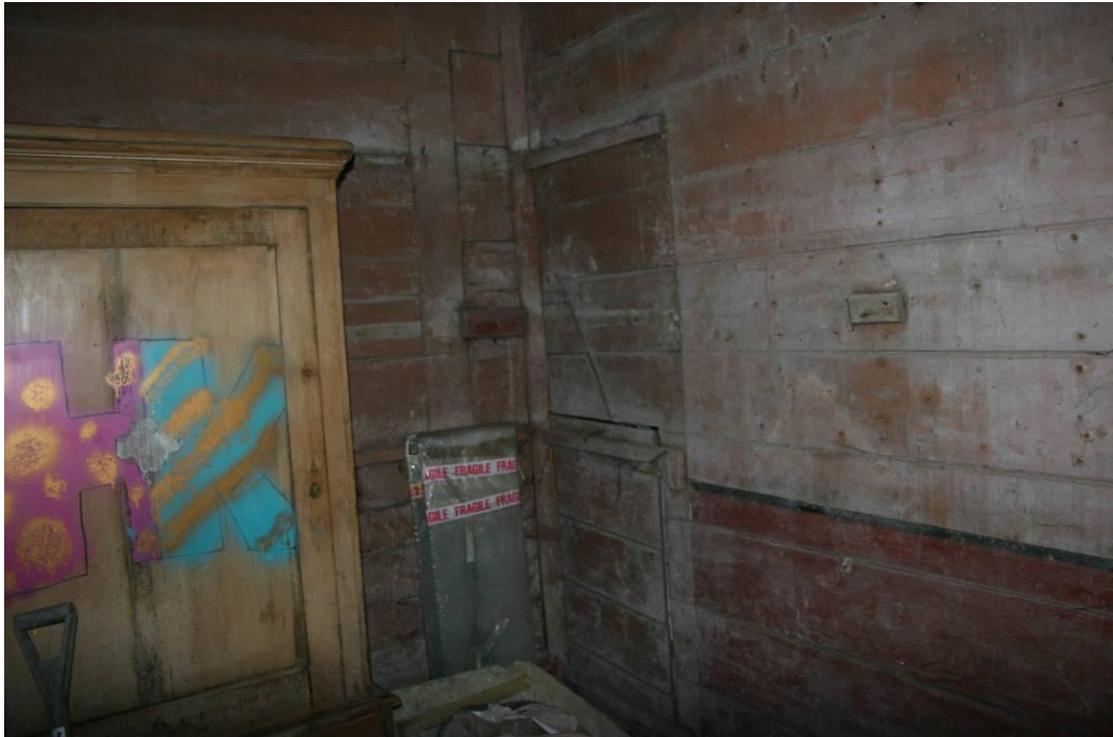
The NW corner of Room 2 with battens for removed cabinets. Modern wardrobe.

Room 2 has a poured concrete floor. The walls are boarded in the same manner as Room 1 with edge-moulded horizontal boards of various sizes. The partition wall has 10in deep boards. In the NW corner the boards have been sawn through but left in situ as a removable panel but the use is not obvious.

The western wall is battened out for shelves and the variation in the paint colours shows there was a large closed cabinet right across the back of the room. It also shows that the paint was originally much darker than the light pink it is today.

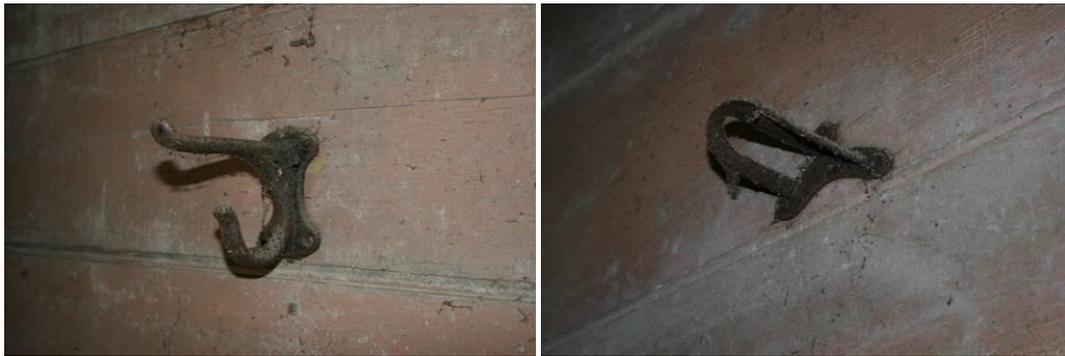
Collar hook and harness hanger.

Like Room 1 there are harness hangers on the walls and also heavy duty collar hangers put much lower down. There are screw holes to show where others have fallen out. The heavy duty hooks are still available to almost the same pattern.

Most of the fixtures and fittings are made of mild steel which wasn't discovered until 1855 and would have slowly superseded wrought iron as the metal of choice. Its main disadvantage is that it rusts very quickly if not protected or painted which would account for the failure of many of the hooks and hangers.

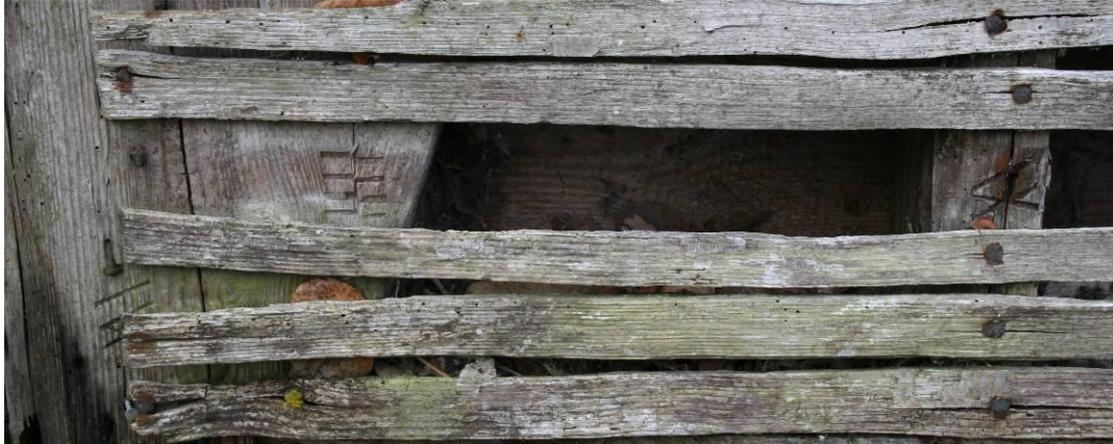
There are a series of numbers marked on the bases of the studs visible in the eastern wall.

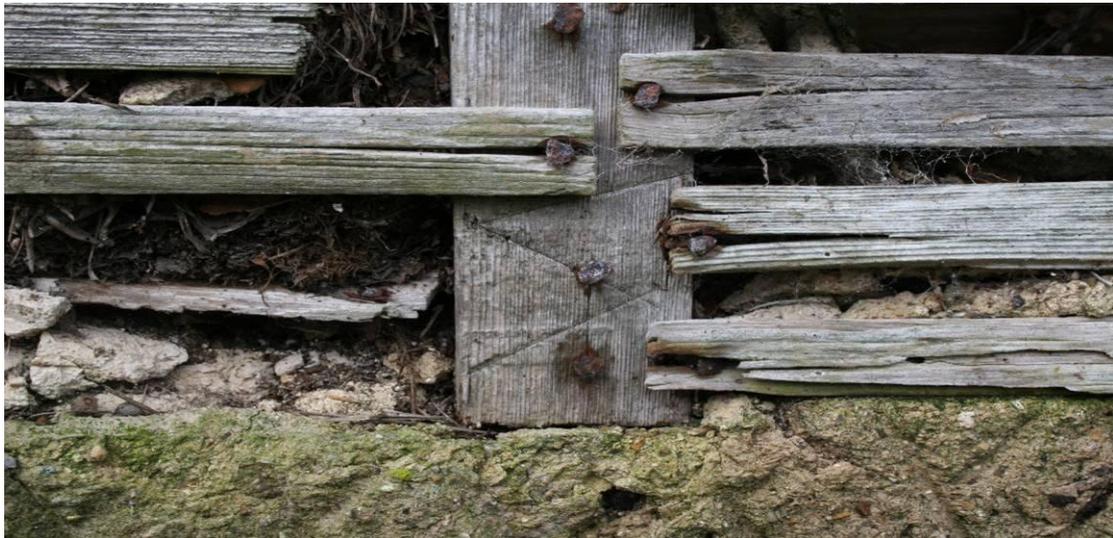
The marks are made in two styles with a chisel or a blade.

Two series of carpenter's marks are visible on the timber frame in the eastern wall and it is certain that the rest of the frame is numbered. The frame visible to Bay 5 is marked with a thin blade and is marked I to N (1 to 9).

The frame visible to Bays 2,3 and 4 was marked with a narrow chisel point from I to XVI (1 to 16) although the first few studs have rotted away losing the numerals. The diagonal brace is also marked across its joint with the principal post as IIII. Both series run N-S.

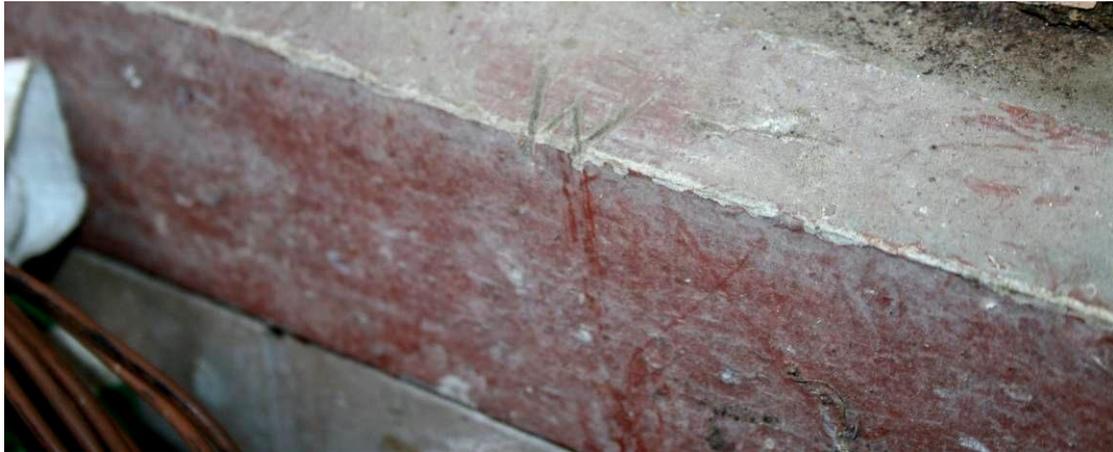
Letter W carved on the partition (also an X scratched in the patina).

M and W are often called Marian marks after the Virgin Mary. M is more obvious but W represents V V or Virgin of Virgins. However it must be remembered that many men were called William and there are thousands of W's scored all over Essex without any reference to witches.

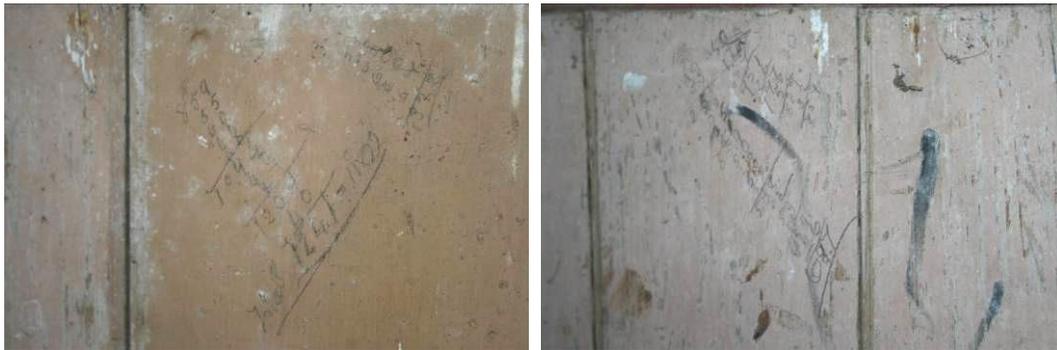
Long, complicated sums and multiplication written on the partitions.

On both sides of the partition to Bay 5 there are pencilled sets of sums in an old fashioned hand but the multiplication indicates this must be C20th. On the wall above the workbench is the calculation of a quadratic equation - hardly the pastime of a stable boy.

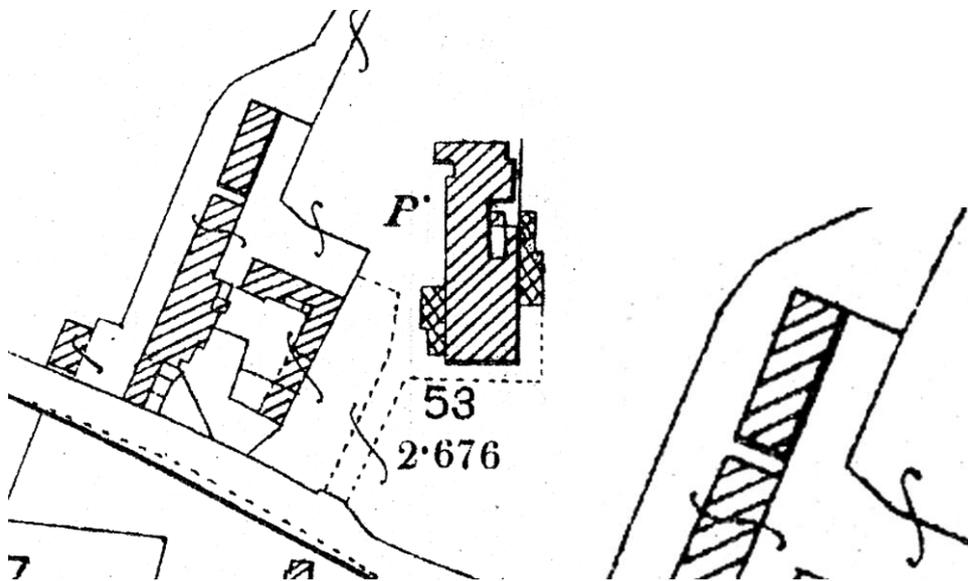
**1878 First Edition Ordnance Survey**

By 1878 a building of the same proportions has appeared in the position of the Stables. A lane runs from the road to the rear of the Stables and northwards to an enclosure. To the south a whole new complex has been developed and the Rectory has been massively extended. Rev. Richard Henry White, M.A., rector is listed in the Post Office Directory of Essex 1874 as living here.

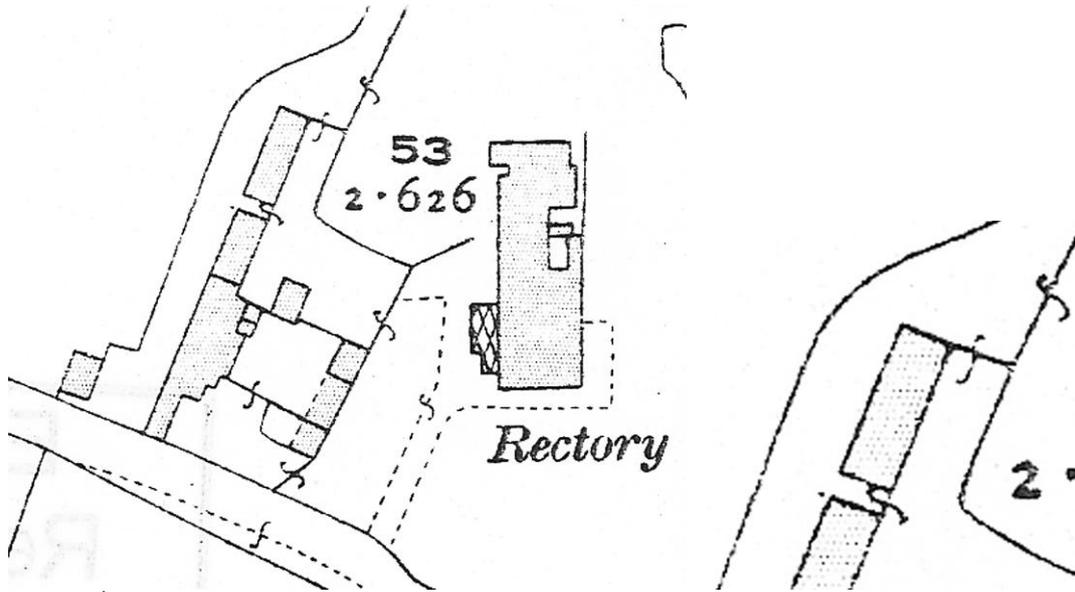
**1898 Second Edition Ordnance Survey**

By 1898 there are some minor changes to the layout of the site in that a number of flowerbeds and fences have been removed. The 2nd Edition OS does not show trees except where they are densely placed as in orchards and woodlands so many may still remain.

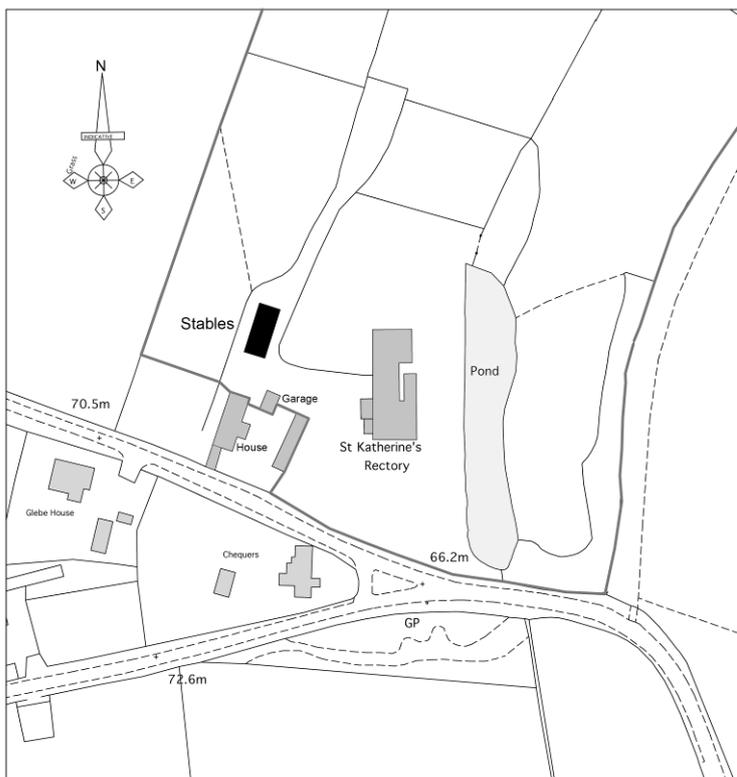
**1921 3<sup>rd</sup> Edition (New Series) Ordnance Survey.**

By 1921 there has been a significant amount of demolition elsewhere on the site. The buildings forming the northern side of the complex have been removed save for one which is a garage today.

A large glass house first shown in 1878 has been removed from the eastern flank of the Rectory.

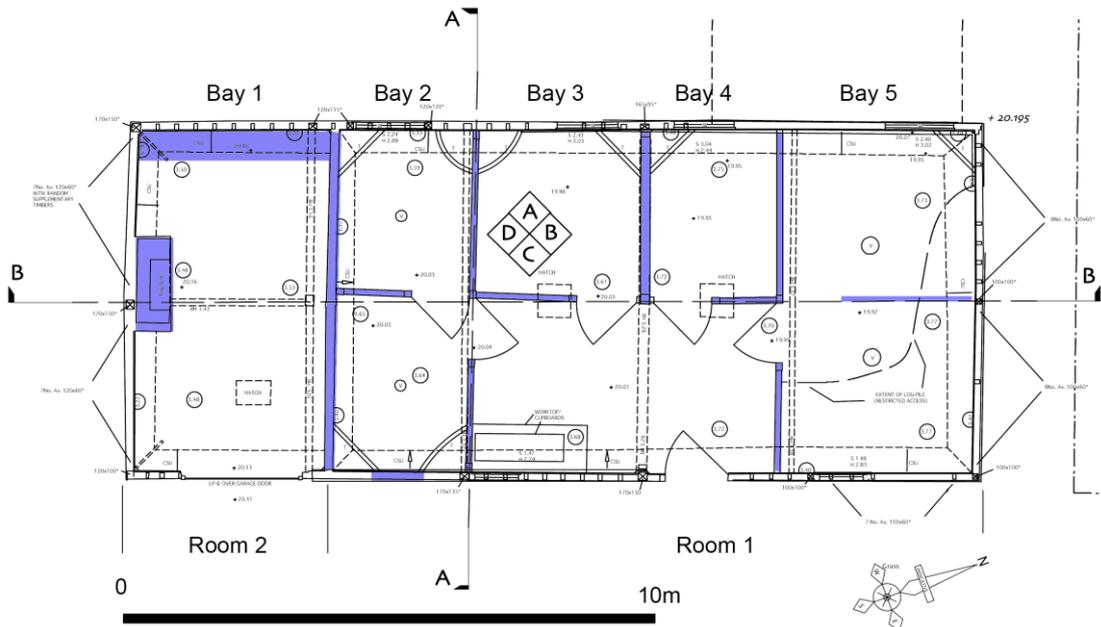
### Phase 1. Mid C19th.

Map evidence suggests that the Stables appeared on the site between 1839 and 1878. The fabric of the building being composed of machined timbers and pre-fabricated trusses secured with threaded bolts supports a date much nearer 1878 when these materials were freely available. In 1839 most agricultural buildings were still being fabricated with pit sawn quarter-poles in the walls and rafters.

The building was boarded internally from the first and the original finish appears to be varnished wood. The internal layout was different as there were two entrance doors and it seems likely another sash window into Bay 1.
