Birds Farm Henham

A report on the barn

David Andrews
2012

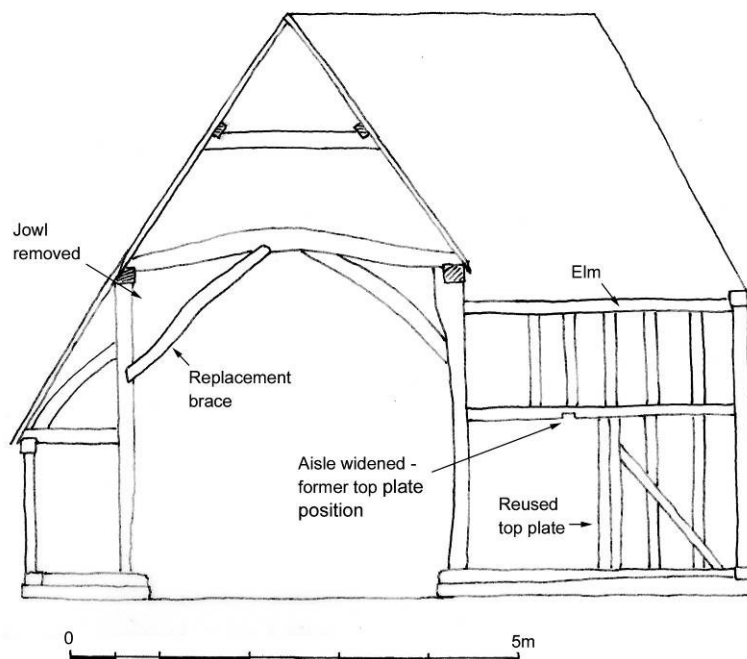
East-west section A-A1 through the midstorey, looking south

The north wall includes some reused timber. The east arcade post in this truss has had the top of the jowl (which would have connected to the tie-beam) removed, and the top plate sits at the edge of the top of the post, in a way that suggests these members have been re-assembled and misaligned.
