St Paul's Cathedral

Cleaning and refurbishment projects 2003–5

John Schofield
Cathedral Archaeologist

2005, revised 2014

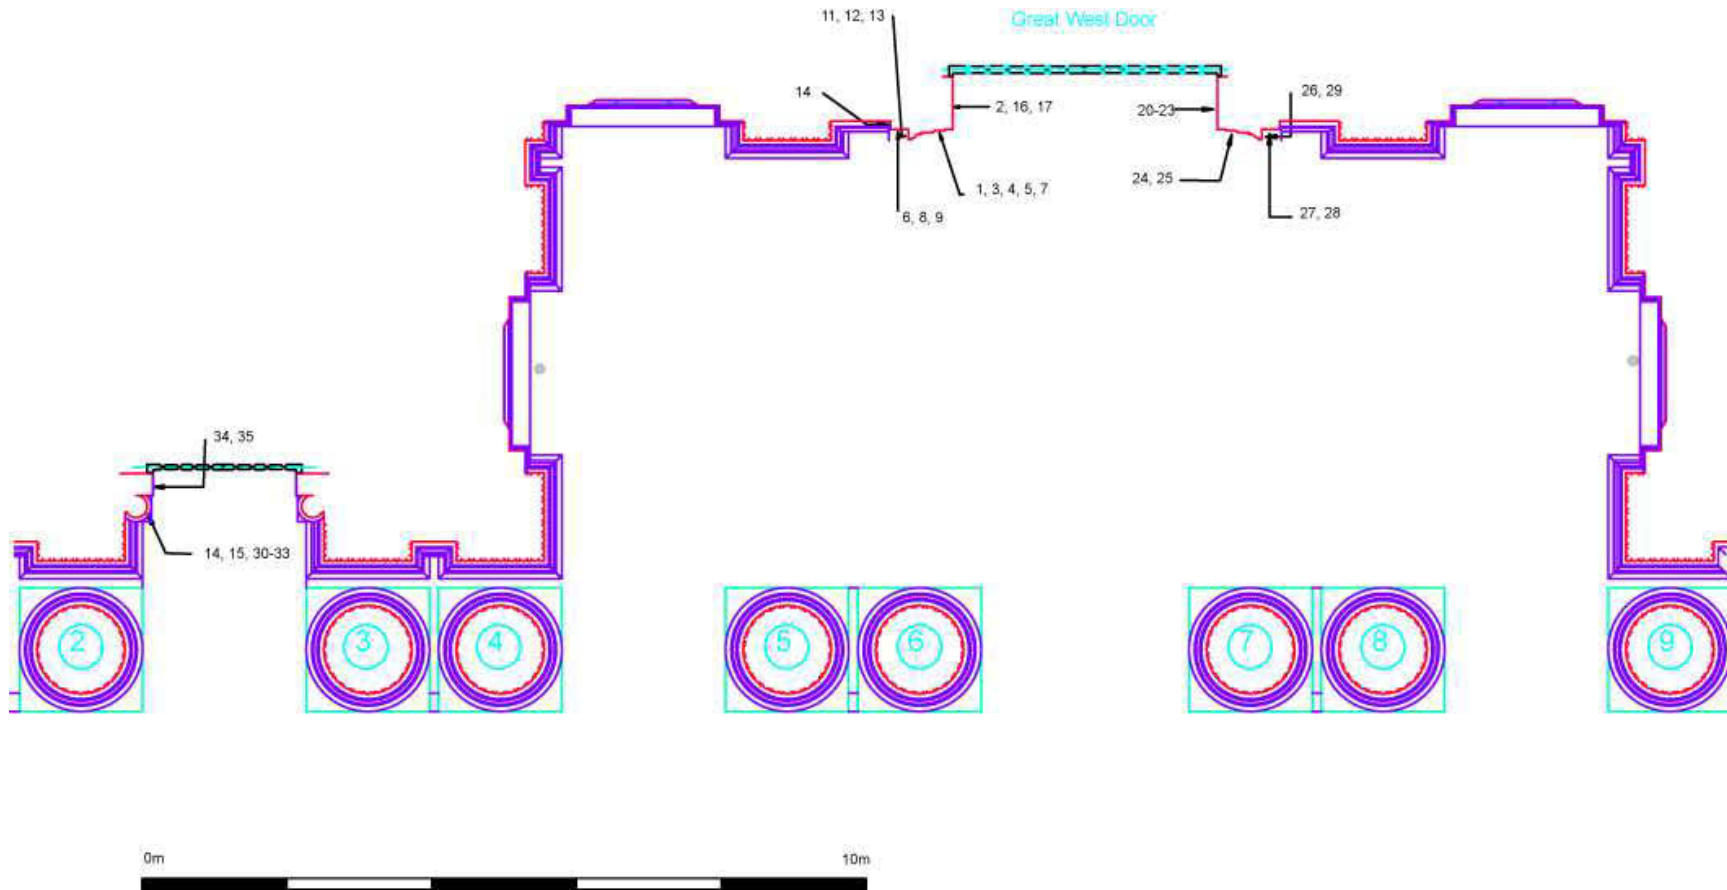
Fig 18 Plan of ground floor of west end outside the west doors, showing locations of photographed graffiti [based on PMT site plan 07-304]

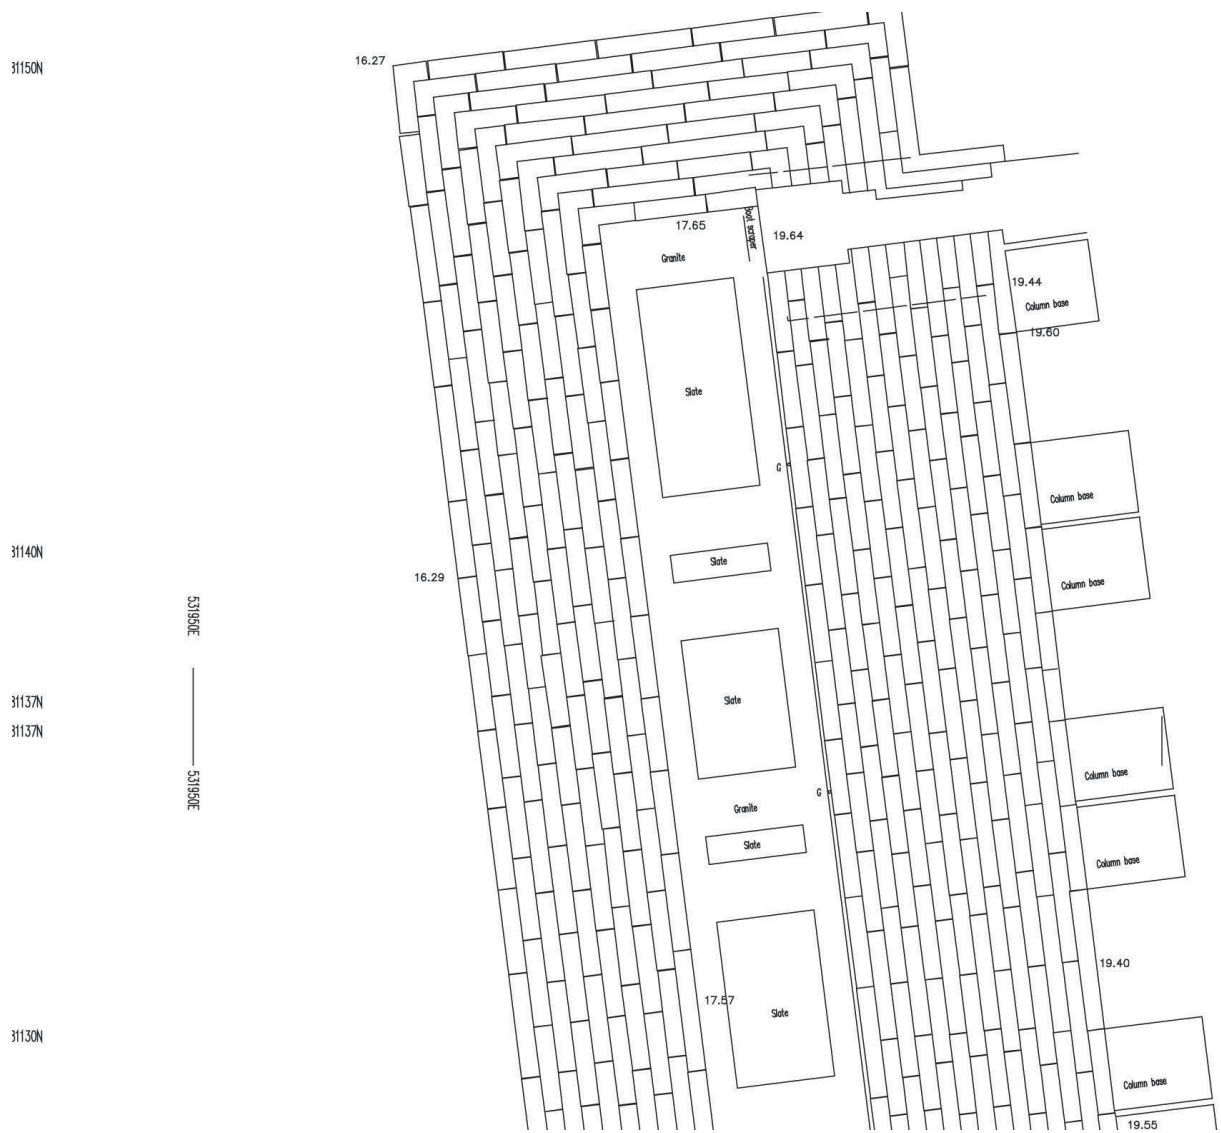
Fig 62 Survey of west steps, N part (PMT). The original CAD drawing has levels on every block of each step

A survey of the steps was undertaken by the architect, and this has been edited to form Fig 62 and Fig 63.

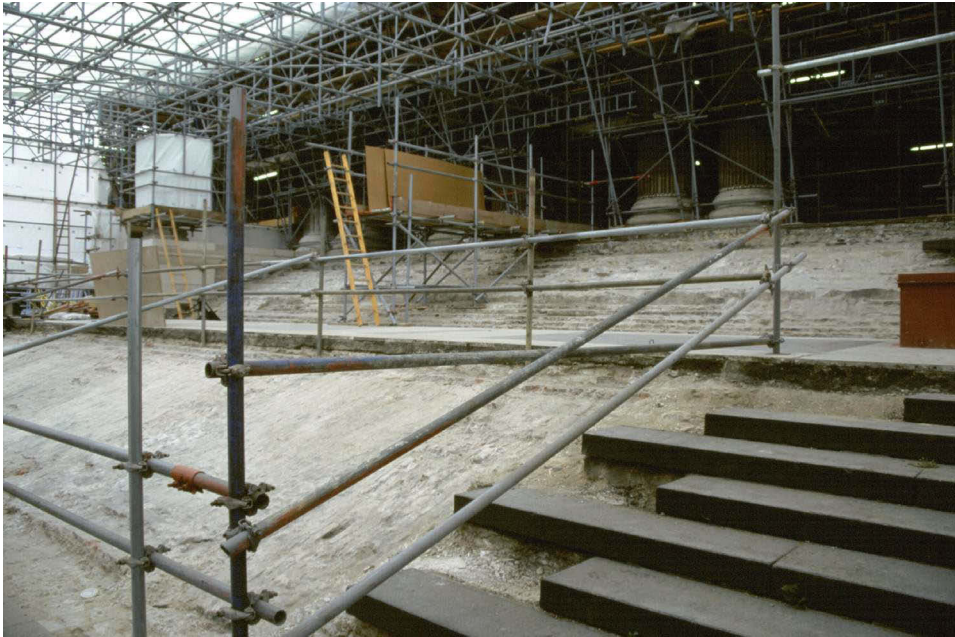
Fig 64 The west steps from the south-west, with the majority of steps removed; those on the right remain from the pre-restoration arrangement

Fig 64 shows the site from the south-west, and the manner of working; the majority of the steps were removed, but those at the south end left in place for public access to the cathedral via the south-west door (to the right in the photograph). The archaeological recording comprised only a general monitoring and recording of the brick substructure of the steps, including evidence of the original curved outer edges of the lower section (Fig 65-Fig 66).

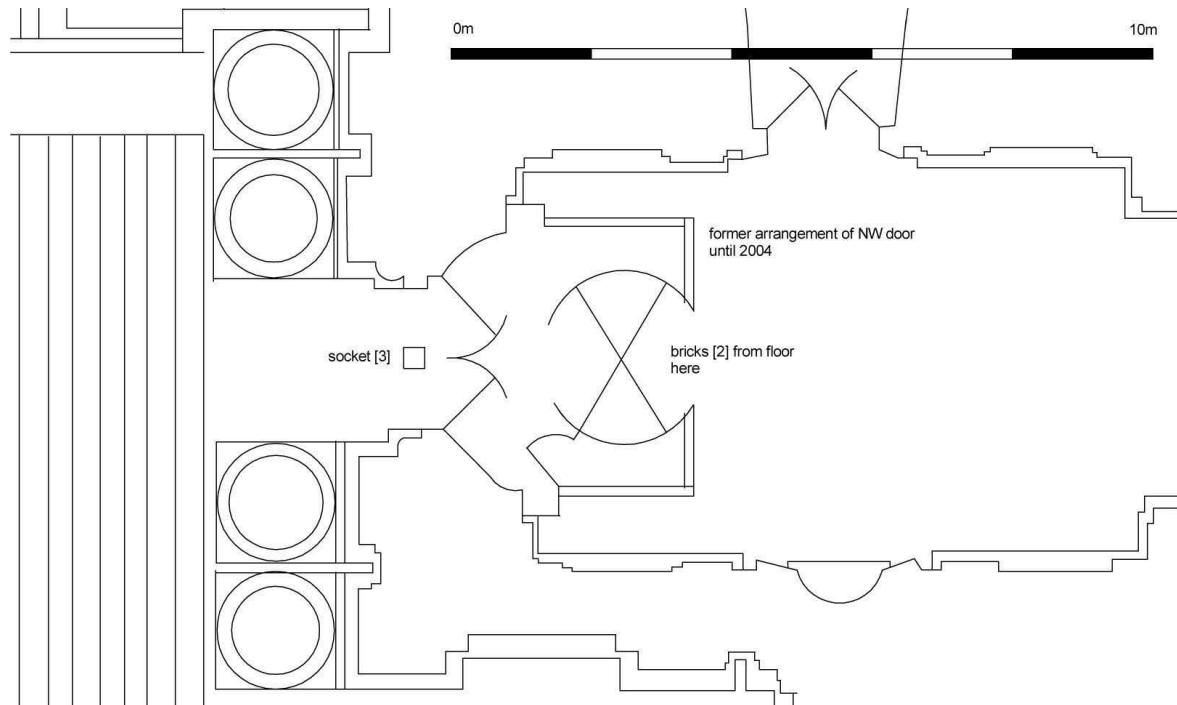
Fig 76 north-west door refurbishment: location of socket [3] and general location of point from which brick samples [2] were recovered

In the north-western lobby an unexplained socket, context [3] lay in the floor of the entrance (Fig 76; Fig 77). It was formed on all four sides and at the bottom by stone blocks let into the brickwork of the vault of the underlying crypt. The internal dimensions were exactly 1ft (30cm) cube. Its purpose is unknown. It may have been a socket for a large vertical timber, such as part of some scaffolding, but its position within the threshold of the door argues against this. The top of the brick vaulting of the underlying crypt had been excavated for the works; bricks were sampled from the vault which was briefly exposed [2]. At the same time as this refurbishment, electricians were inserting new wiring into the vaulting above, that is the vault over the north aisle, and a brick from that vault was recovered by Emma Hardisty of Martin Stancliffe Architects; this is noted as context [4]. The specialist report on these bricks by Terence Smith follows.

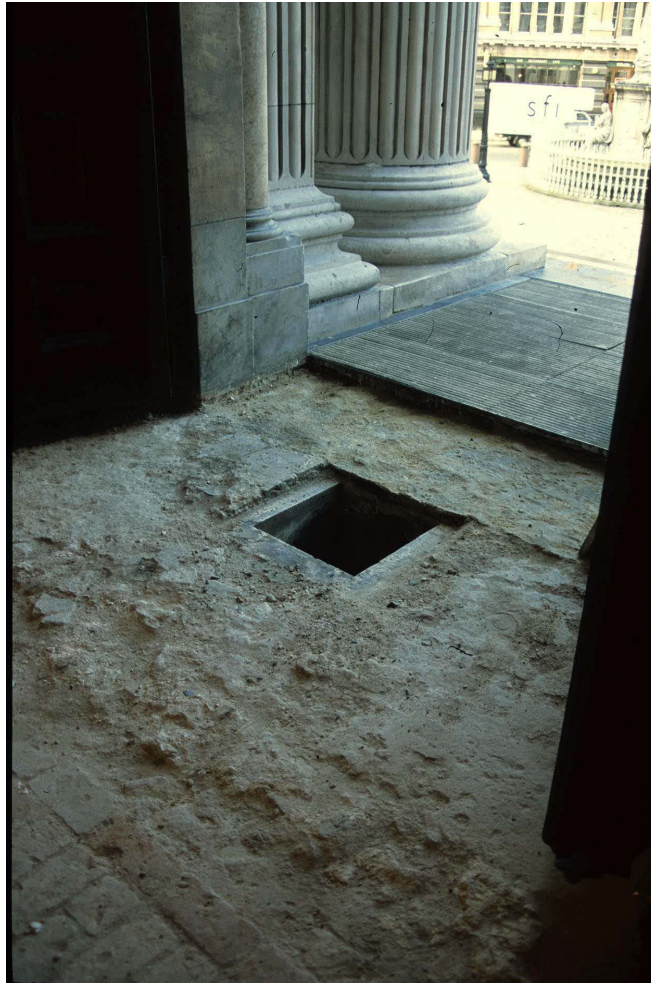
Fig 77 The NW doorway, with the former revolving door removed: socket [3], looking SW

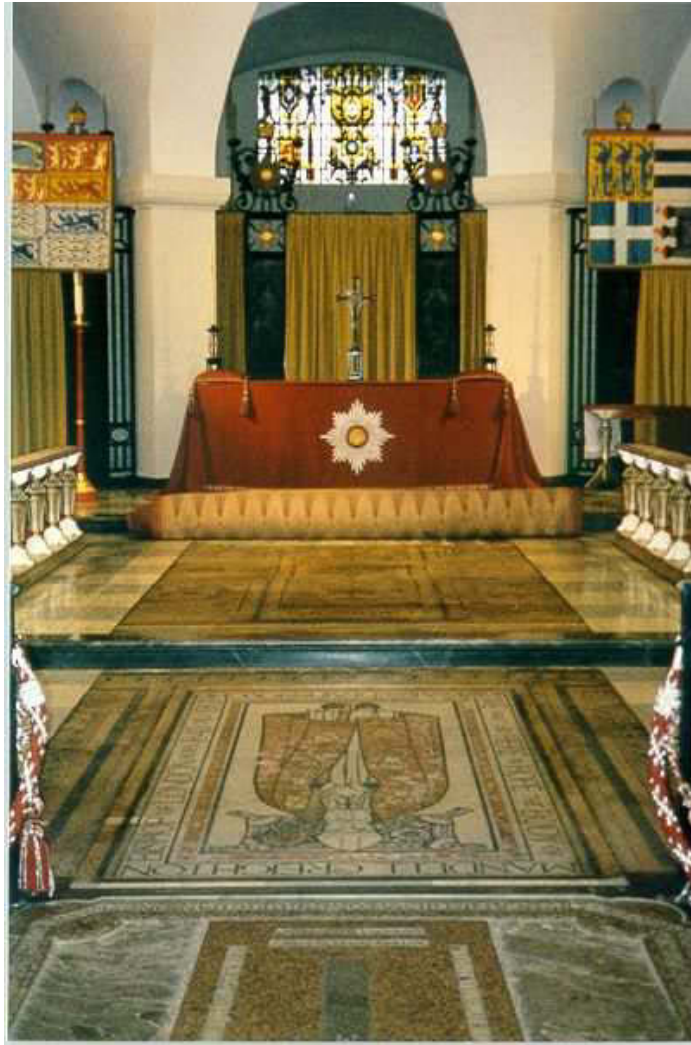
Fig 80 OBE Chapel, looking east: the ledger of Bishop Creighton in the foreground, Penrose's mosaic on both sides and to the east, and the 1950s vinyl tiles (some of which have been removed)

The protracted discussions about this project, which went through several different design proposals, is laid out in the Surveyor's proposal document of October 2002 which outlined the final proposal which was carried out. The general wish was to improve the floor of the OBE Chapel, which was a conglomerate of parts of the mosaic laid here by Penrose in 1875, the fine ledger of Bishop Mandell Creighton of 1901, and vinyl tiles of the post-War creation of the OBE Chapel (Fig 80; Fig 81).

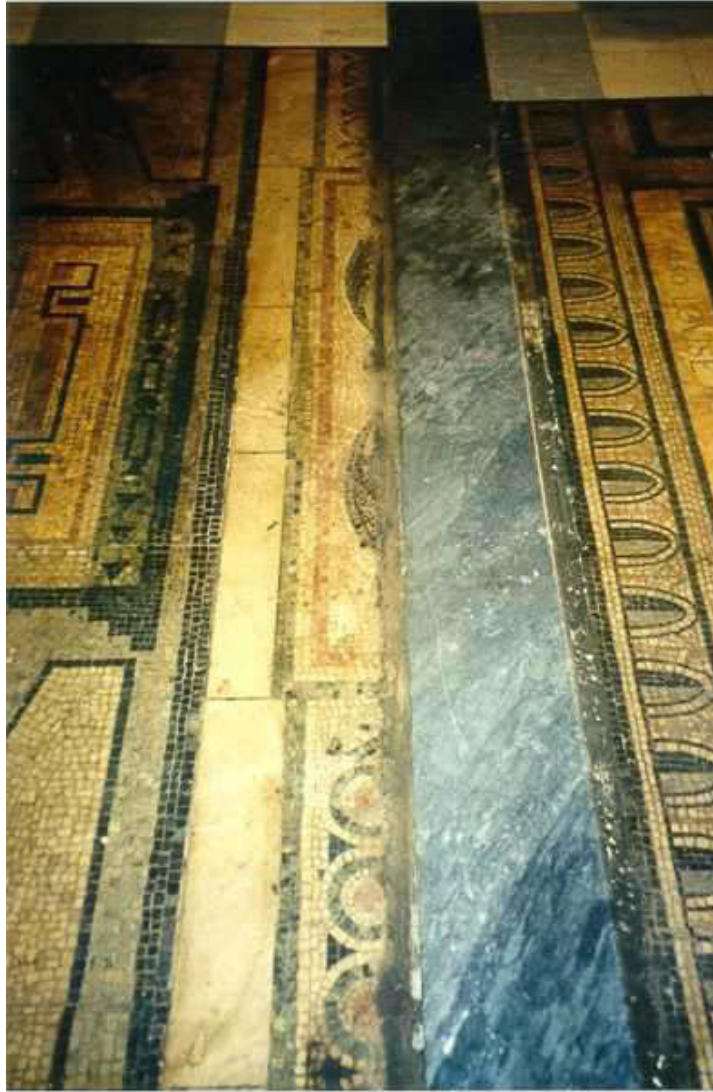
Fig 82 detail of the step between the central bay (left) and the western bay (right), looking south

6. In the central bay, to clean and restore the central part of the mosaic, making up its eastern section where it has been damaged by the insertion of a step (Fig 82). This will be done with tesserae taken from the removed parts of the mosaic.

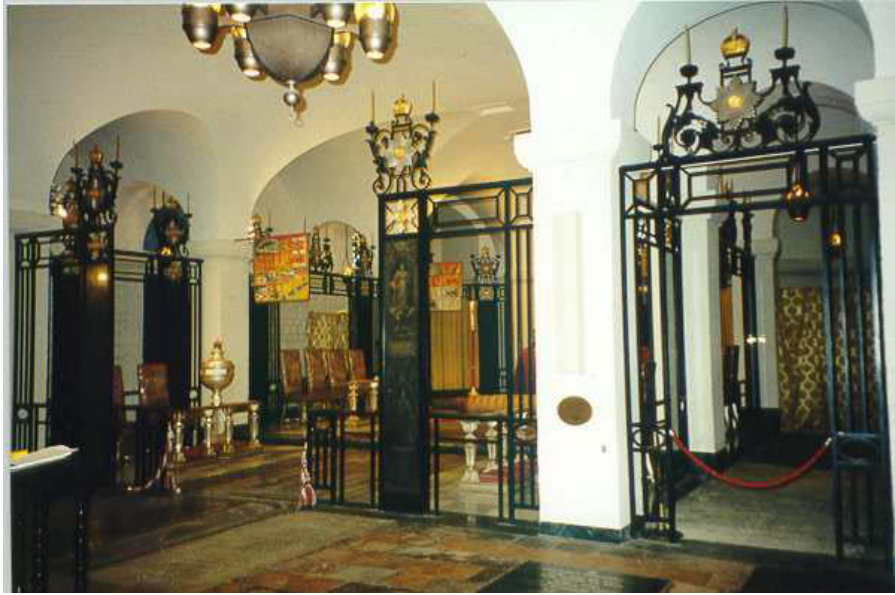
It was virtually certain that the present ambulatory floors of concrete (Fig 85; Fig 86) have totally removed the partial mosaics formerly in the ambulatory.

Fig 85 View of the OBE Chapel from the south-west, showing the main bays and the south ambulatory (right)

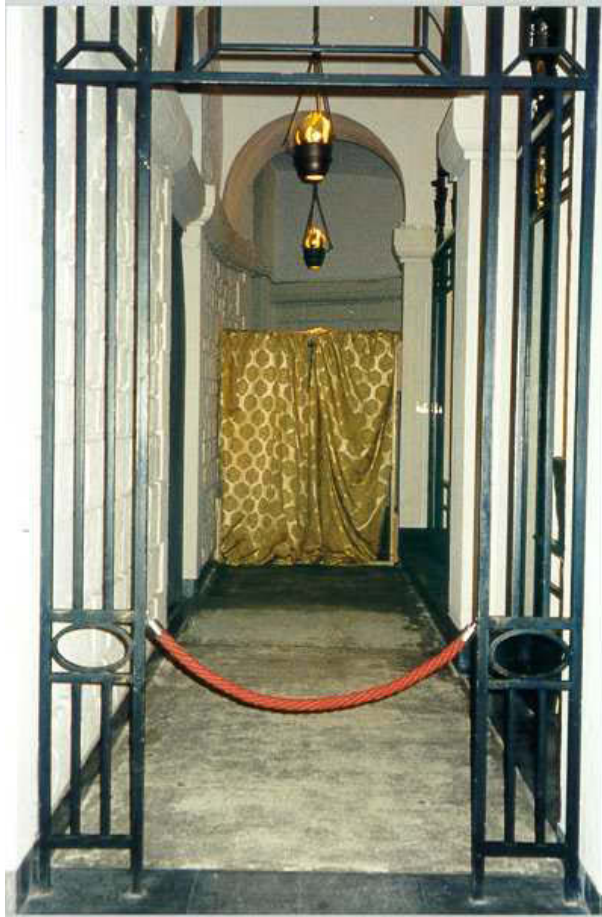
Fig 86 The north ambulatory passage, looking east; the concrete floor had been laid within living memory of cathedral works staff

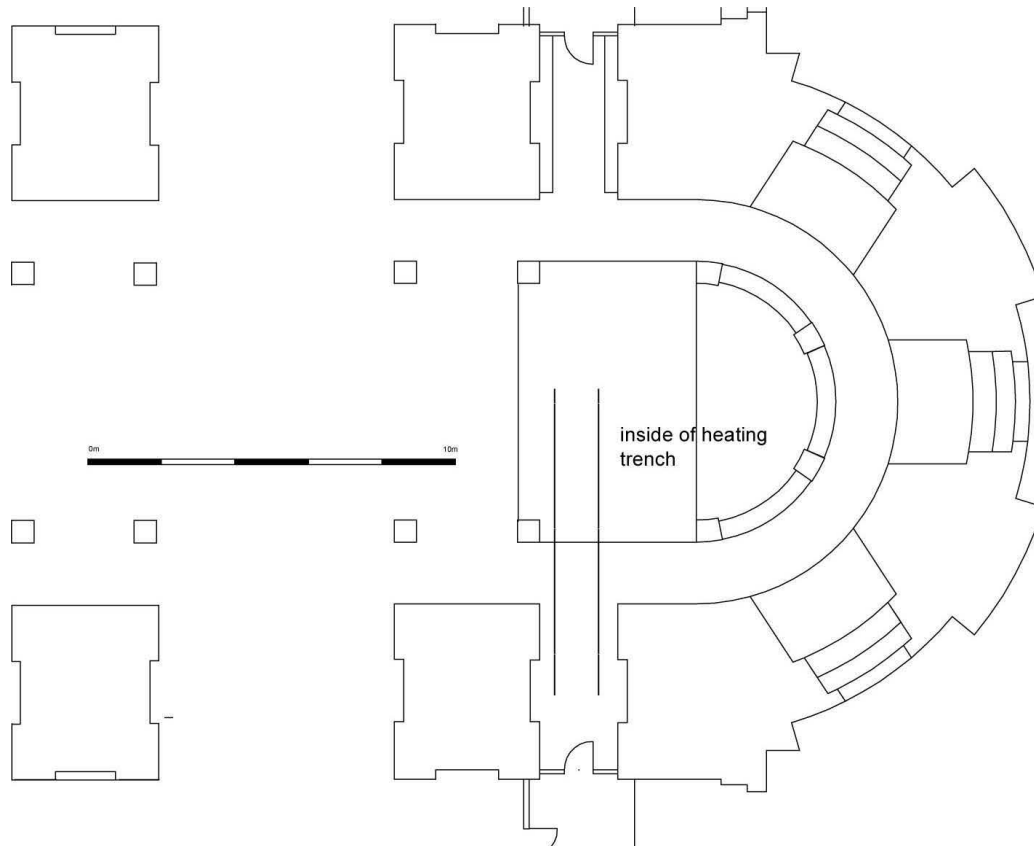
Since the intention was to dig down, during replacing the various parts of the floor, only to a depth of 250mm or less if possible, and a trial hole has already indicated in excess of 300mm of concrete in the ambulatory behind the altar, there was little implication in these proposals for the disturbance of archaeological strata beneath the modern concrete. The archaeological assessment of this project pointed to the possibility that removal of the concrete flooring of the side aisles, and of the mosaic itself, might reveal intact stratigraphy of the Roman to medieval periods beneath, though this was a remote possibility. Monitoring of the building works by the Cathedral Archaeologist was carried out for this purpose, but in the event no such stratigraphy was observed as the new works did not intrude into strata prior to the 19th century. The line of a heating duct, previously little known, was recording crossing the crypt from north to south, with pipes in within it which still functioned as part of the heating system inserted by Macartney in the first decade of the 20th century. This decade therefore seems to be the date of the re-arrangement of the ledgers. The duct is shown on the plan next, Fig 87.

Fig 87 plan, heating duct below floor of OBE Chapel
